# Profile/Photo Observation Report

Date:	08/31/2021	Weather:		Coding:	PACP 7.0
Pipe Length (ft):	217.0	Owner:	City of Hobart	Pre Clean:	Heavy Cleaning
P.O.#:	YES502259	Surveyor:	S. Bucklin	PSR:	P-504-108-106
Customer:	City of Hobart	Clean Date:	08/28/2021	Shape:	C

Street:	North Virginia Street	Flow Control:	Not Controlled
City:	Hobart, IN	Year Renewed:	
Location:	Alley	Tape/Media #:	
Purpose:	Routine Assessment	Dia/Height:	12"
Use:	Sanitary Sewage Pipe	Material:	CP
Drain Area:		Lining:	
Category:	NA		
Comment:			
Location Details:		Direction of Survey:	Upstream
US MH:	M-504-106	DS MH:	M-504-108
		Total Length Surveyed (ft):	202.7

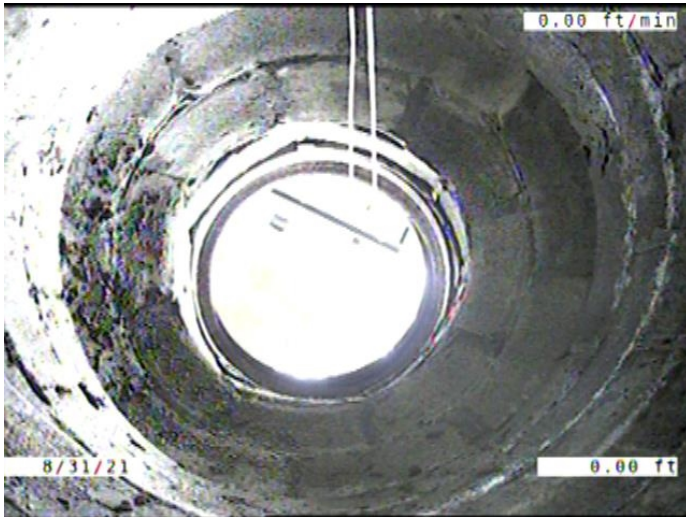
Code: **AMH**  
Description: **Manhole**

Distance (ft): **.0**  
Structural Grade: **0**  
O&M Grade: **0**  
Clock Start/From:  
Clock To:  
1st Value:  
2nd Value:  
Value Percent:  
Continuous Index:  
Within 8" of Joint: **NO**  
Remarks: **M-504-108**

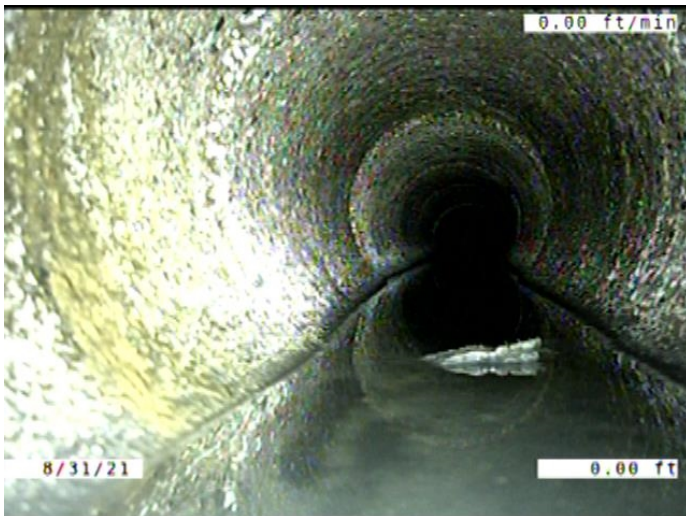
Code: **MWL**  
Description: **Miscellaneous Water Level**

Distance (ft): **.0**  
Structural Grade: **0**  
O&M Grade: **0**  
Clock Start/From:  
Clock To:  
1st Value:  
2nd Value:  
Value Percent: **5.000**  
Continuous Index:  
Within 8" of Joint: **NO**  
Remarks:

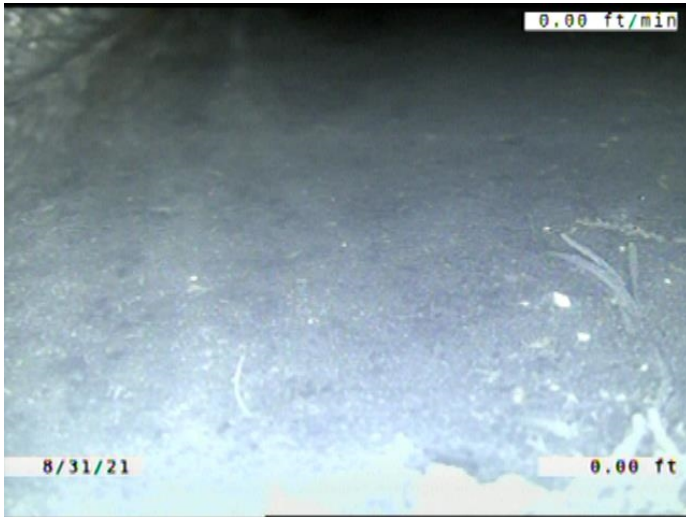
Code: **DSF**  
Description: **Deposits Settled Fine**

Distance (ft): **.0**  
Structural Grade: **0**  
O&M Grade: **2**  
Clock Start/From: **5**  
Clock To: **7**  
1st Value:  
2nd Value:  
Value Percent: **5.000**  
Continuous Index: **S01**  
Within 8" of Joint: **YES**  
Remarks:

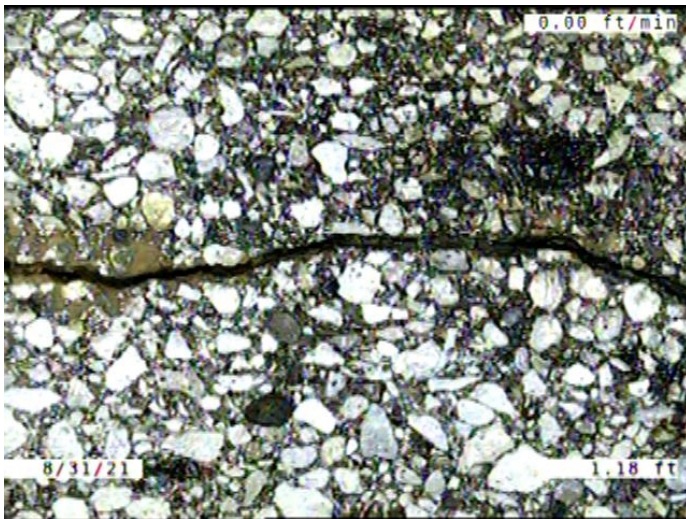
Code: **FS**  
Description: **Fracture Spiral**

Distance (ft): **1.2**  
Structural Grade: **3**  
O&M Grade: **0**  
Clock Start/From: **8**  
Clock To: **4**  
1st Value:  
2nd Value:  
Value Percent:  
Continuous Index:  
Within 8" of Joint: **NO**  
Remarks:

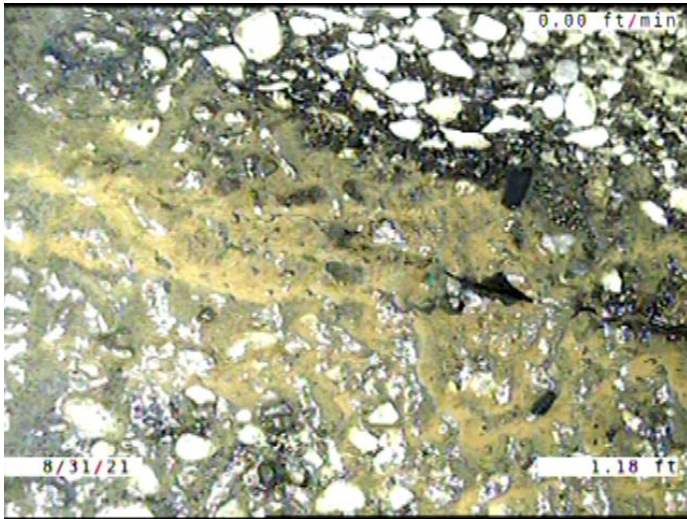
Code: **ISJ**  
 Description: **Infiltration Stain Joint**

Distance (ft): **1.2**  
 Structural Grade: **0**  
 O&M Grade: **1**  
 Clock Start/From: **8**  
 Clock To: **11**  
 1st Value:  
 2nd Value:  
 Value Percent:  
 Continuous Index:  
 Within 8" of Joint: **YES**  
 Remarks:

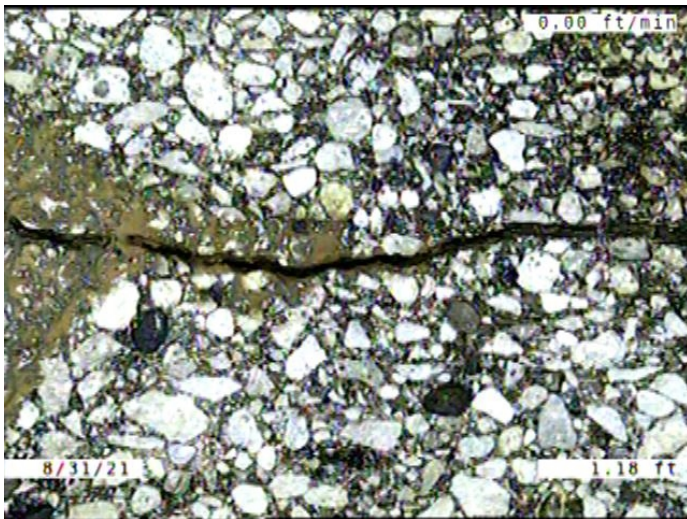
Code: **IWB**  
 Description: **Infiltration Weeper Barrel**

Distance (ft): **1.2**  
 Structural Grade: **0**  
 O&M Grade: **2**  
 Clock Start/From: **11**  
 Clock To:  
 1st Value:  
 2nd Value:  
 Value Percent:  
 Continuous Index:  
 Within 8" of Joint: **NO**  
 Remarks:

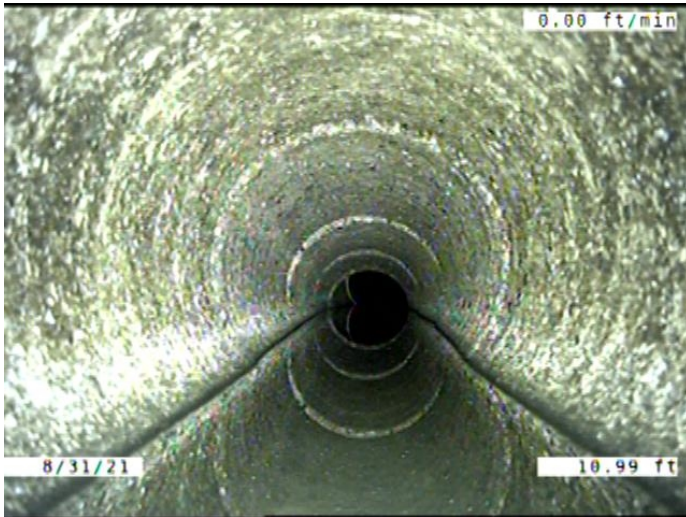
Code: **MWLS**  
 Description: **Miscellaneous Water Level Sag**

Distance (ft): **11.0**  
 Structural Grade: **2**  
 O&M Grade: **0**  
 Clock Start/From:  
 Clock To:  
 1st Value:  
 2nd Value:  
 Value Percent: **10.000**  
 Continuous Index: **S02**  
 Within 8" of Joint: **NO**  
 Remarks:

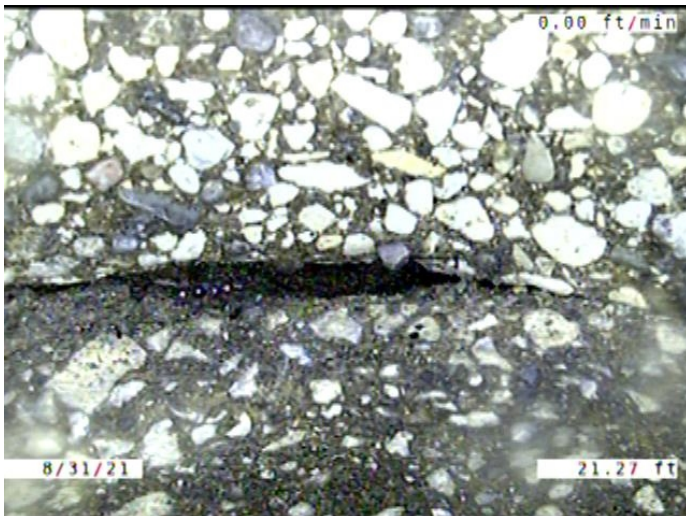
Code: **JOM**  
 Description: **Joint Offset Medium**

Distance (ft): **21.3**  
 Structural Grade: **3**  
 O&M Grade: **0**  
 Clock Start/From:  
 Clock To:  
 1st Value:  
 2nd Value:  
 Value Percent:  
 Continuous Index:  
 Within 8" of Joint: **NO**  
 Remarks:

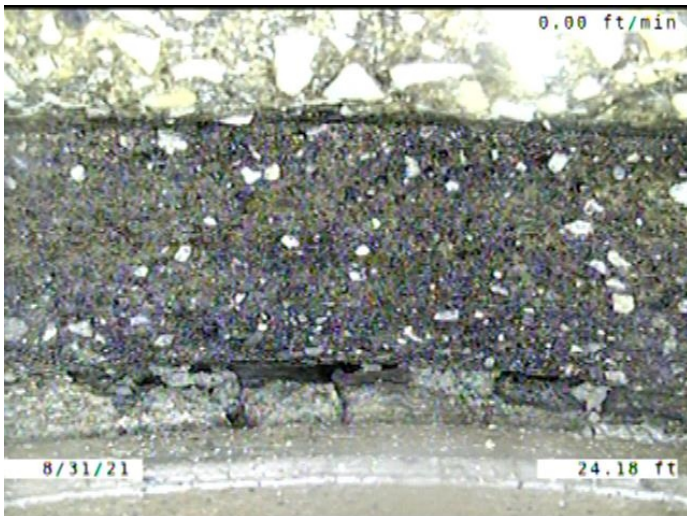
Code:	<b>JAL</b>
Description:	<b>Joint Angular Large</b>
Distance (ft):	<b>24.2</b>
Structural Grade:	<b>4</b>
O&M Grade:	<b>0</b>
Clock Start/From:	
Clock To:	
1st Value:	
2nd Value:	
Value Percent:	
Continuous Index:	
Within 8" of Joint:	<b>NO</b>
Remarks:	<b>SOIL VISIBLE</b>

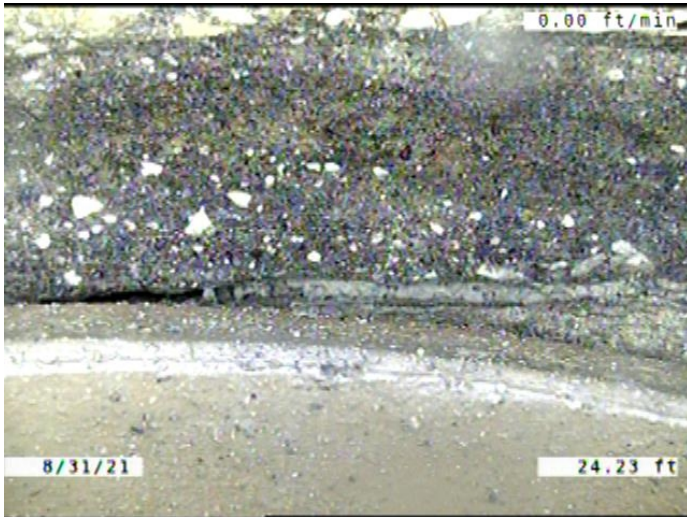
Code: **MMC**  
 Description: **Miscellaneous Material Change**

Distance (ft): **24.2**  
 Structural Grade: **0**  
 O&M Grade: **0**  
 Clock Start/From:  
 Clock To:  
 1st Value:  
 2nd Value:  
 Value Percent:  
 Continuous Index:  
 Within 8" of Joint: **NO**  
 Remarks: **CONCRETE TO VCP**

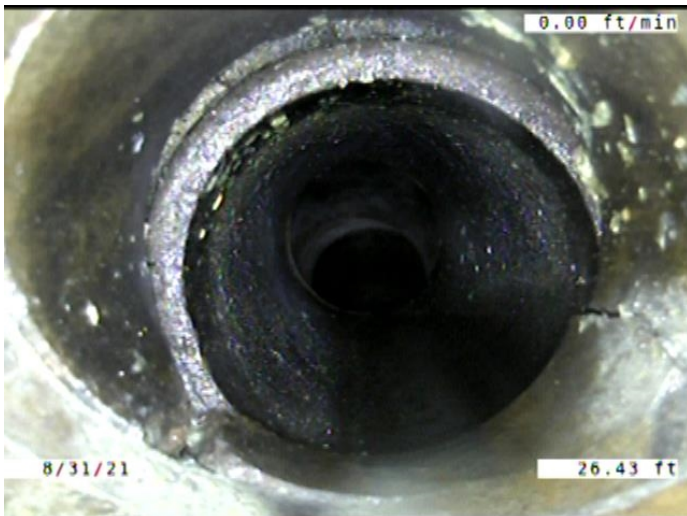
Code: **TFD**  
 Description: **Tap Factory Defective**

Distance (ft): **26.4**  
 Structural Grade: **0**  
 O&M Grade: **3**  
 Clock Start/From: **1**  
 Clock To:  
 1st Value: **4.000**  
 2nd Value:  
 Value Percent:  
 Continuous Index:  
 Within 8" of Joint: **YES**  
 Remarks: **Debris**

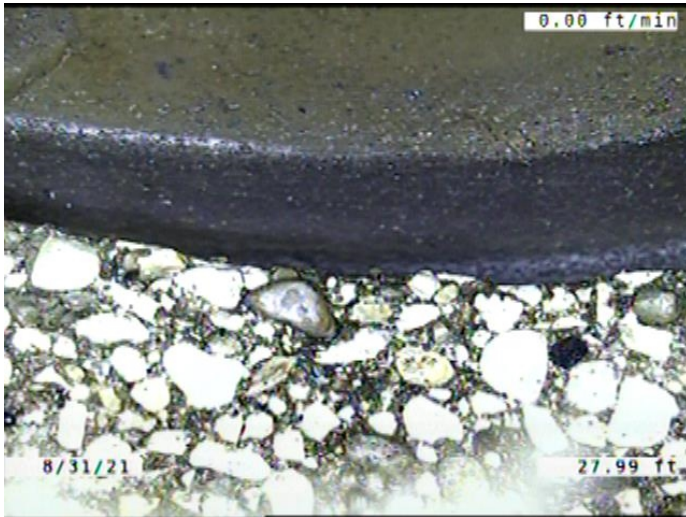
Code: **MMC**  
 Description: **Miscellaneous Material Change**

Distance (ft): **28.0**  
 Structural Grade: **0**  
 O&M Grade: **0**  
 Clock Start/From:  
 Clock To:  
 1st Value:  
 2nd Value:  
 Value Percent:  
 Continuous Index:  
 Within 8" of Joint: **NO**  
 Remarks: **VCP TO CONCRETE**

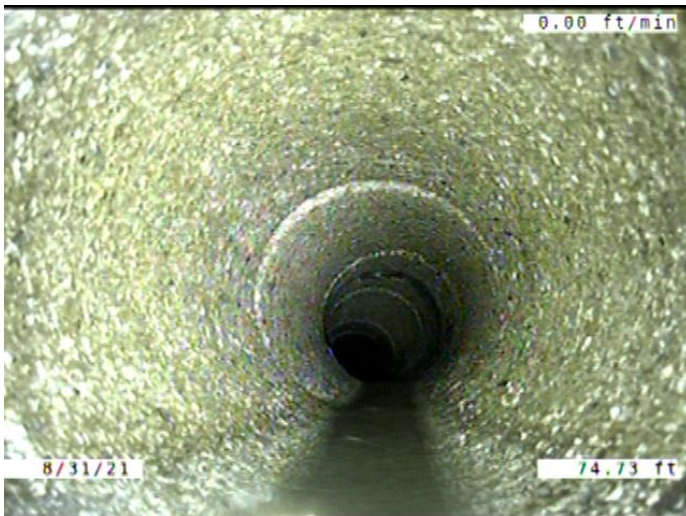
Code: **MWLS**  
 Description: **Miscellaneous Water Level Sag**

Distance (ft): **74.7**  
 Structural Grade: **2**  
 O&M Grade: **0**  
 Clock Start/From:  
 Clock To:  
 1st Value:  
 2nd Value:  
 Value Percent: **10.000**  
 Continuous Index: **F02**  
 Within 8" of Joint: **NO**  
 Remarks:

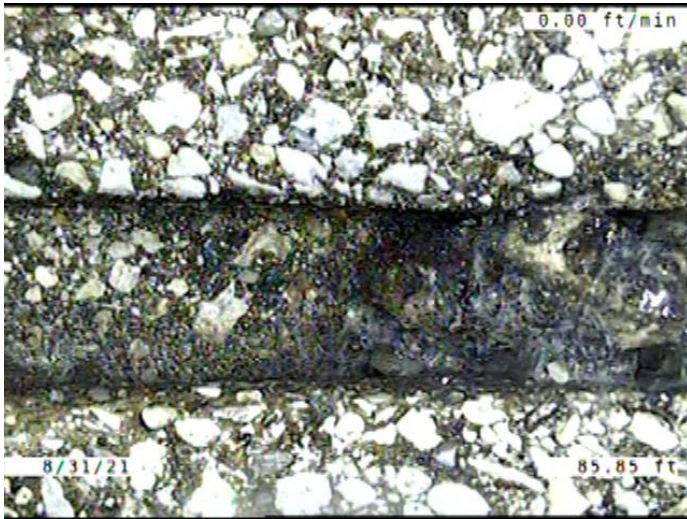
Code: **JAM**  
Description: **Joint Angular Medium**

Distance (ft): **85.8**  
Structural Grade: **3**  
O&M Grade: **0**  
Clock Start/From:  
Clock To:  
1st Value:  
2nd Value:  
Value Percent:  
Continuous Index:  
Within 8" of Joint: **NO**  
Remarks:

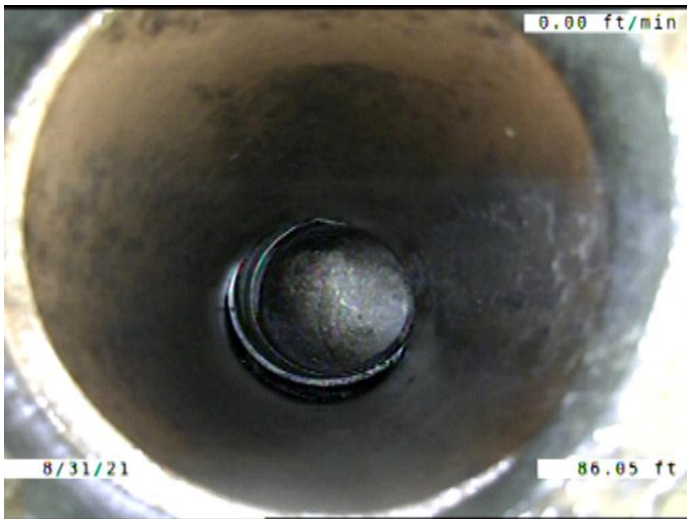
Code: **TBD**  
Description: **Tap Break-in/Hammer Defective**

Distance (ft): **86.0**  
Structural Grade: **0**  
O&M Grade: **3**  
Clock Start/From: **12**  
Clock To:  
1st Value: **4.000**  
2nd Value:  
Value Percent:  
Continuous Index:  
Within 8" of Joint: **NO**  
Remarks: **Debris**

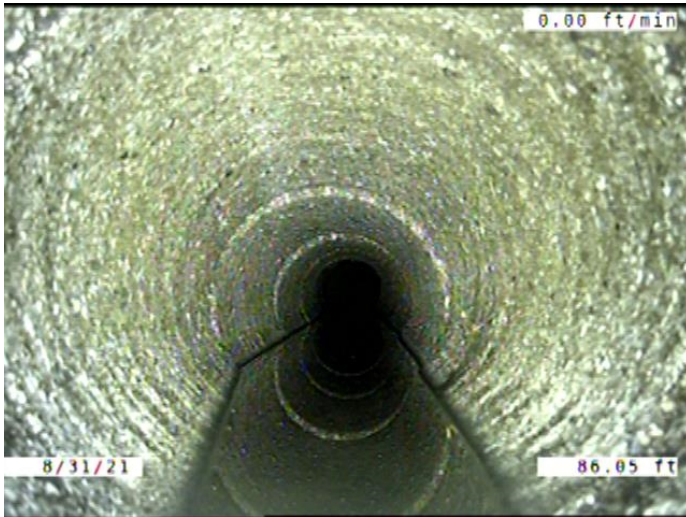
Code: **MWLS**  
 Description: **Miscellaneous Water Level Sag**

Distance (ft): **86.0**  
 Structural Grade: **2**  
 O&M Grade: **0**  
 Clock Start/From:  
 Clock To:  
 1st Value:  
 2nd Value:  
 Value Percent: **5.000**  
 Continuous Index: **S03**  
 Within 8" of Joint: **NO**  
 Remarks:

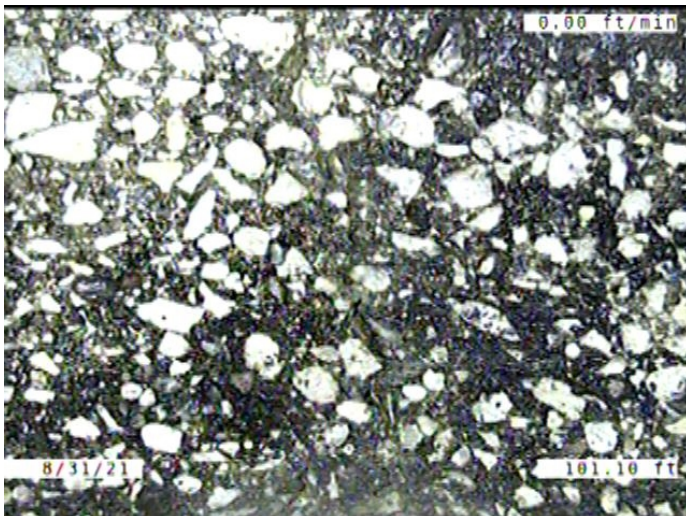
Code: **CM**  
 Description: **Crack Multiple**

Distance (ft): **101.1**  
 Structural Grade: **3**  
 O&M Grade: **0**  
 Clock Start/From: **11**  
 Clock To: **12**  
 1st Value:  
 2nd Value:  
 Value Percent:  
 Continuous Index:  
 Within 8" of Joint: **YES**  
 Remarks:

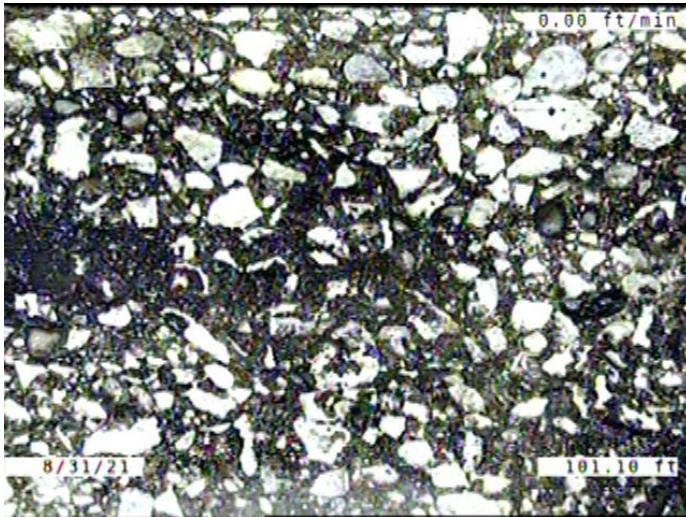
Code: **ISB**  
 Description: **Infiltration Stain Barrel**

Distance (ft): **101.1**  
 Structural Grade: **0**  
 O&M Grade: **1**  
 Clock Start/From: **8**  
 Clock To: **4**  
 1st Value:  
 2nd Value:  
 Value Percent:  
 Continuous Index:  
 Within 8" of Joint: **YES**  
 Remarks:

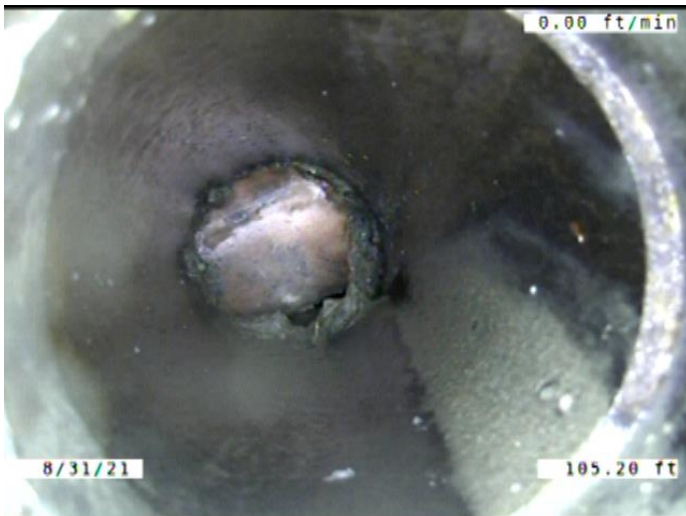
Code: **TBD**  
 Description: **Tap Break-in/Hammer Defective**

Distance (ft): **105.2**  
 Structural Grade: **0**  
 O&M Grade: **3**  
 Clock Start/From: **12**  
 Clock To:  
 1st Value: **4.000**  
 2nd Value:  
 Value Percent:  
 Continuous Index:  
 Within 8" of Joint: **NO**  
 Remarks: **Debris**

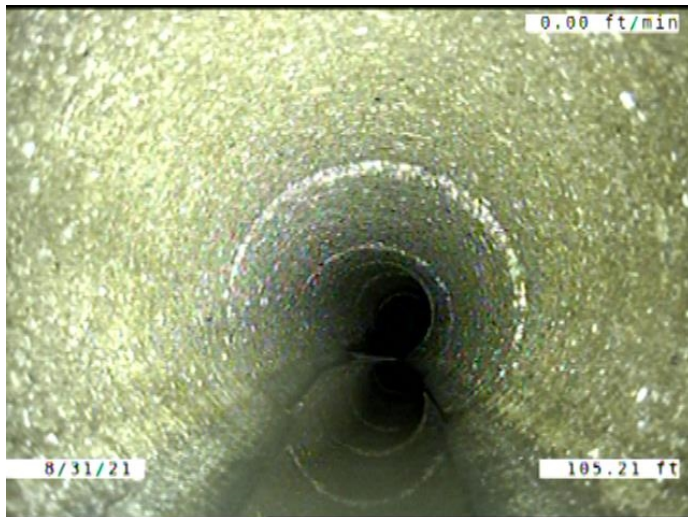
Code: **MWLS**  
 Description: **Miscellaneous Water Level Sag**

Distance (ft): **105.2**  
 Structural Grade: **2**  
 O&M Grade: **0**  
 Clock Start/From:  
 Clock To:  
 1st Value:  
 2nd Value:  
 Value Percent: **5.000**  
 Continuous Index: **F03**  
 Within 8" of Joint: **NO**  
 Remarks:

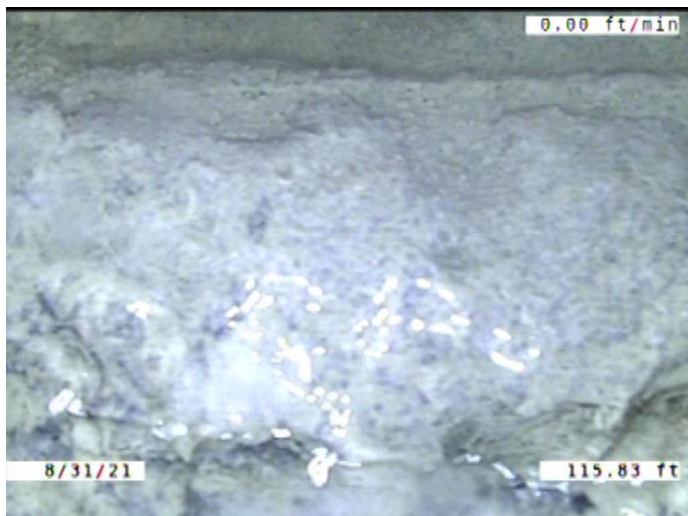
Code: **DSC**  
 Description: **Deposits Settled Hard/Compacted**

Distance (ft): **115.8**  
 Structural Grade: **0**  
 O&M Grade: **2**  
 Clock Start/From: **5**  
 Clock To: **7**  
 1st Value:  
 2nd Value:  
 Value Percent: **5.000**  
 Continuous Index:  
 Within 8" of Joint: **YES**  
 Remarks:

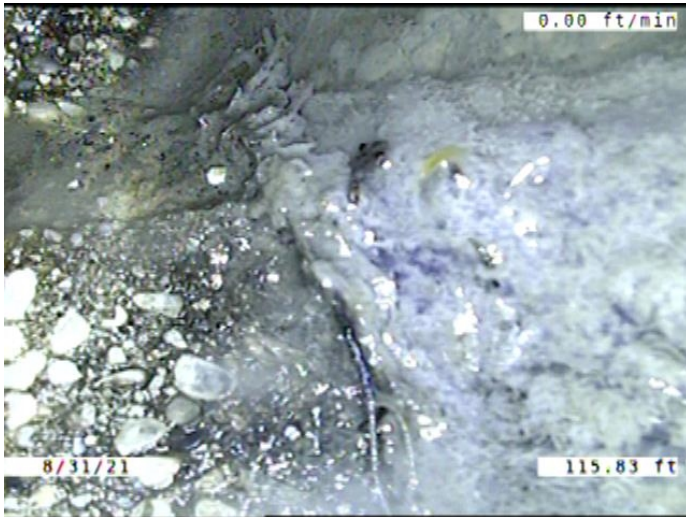
Code: **RFJ**  
 Description: **Roots Fine Joint**

Distance (ft): **115.8**  
 Structural Grade: **0**  
 O&M Grade: **1**  
 Clock Start/From: **7**  
 Clock To:  
 1st Value:  
 2nd Value:  
 Value Percent:  
 Continuous Index:  
 Within 8" of Joint: **YES**  
 Remarks:

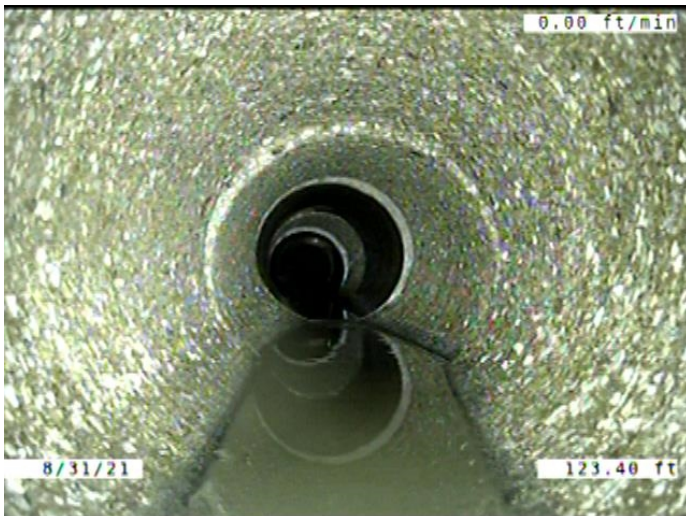
Code: **MWLS**  
 Description: **Miscellaneous Water Level Sag**

Distance (ft): **123.4**  
 Structural Grade: **2**  
 O&M Grade: **0**  
 Clock Start/From:  
 Clock To:  
 1st Value:  
 2nd Value:  
 Value Percent: **5.000**  
 Continuous Index: **S04**  
 Within 8" of Joint: **NO**  
 Remarks:

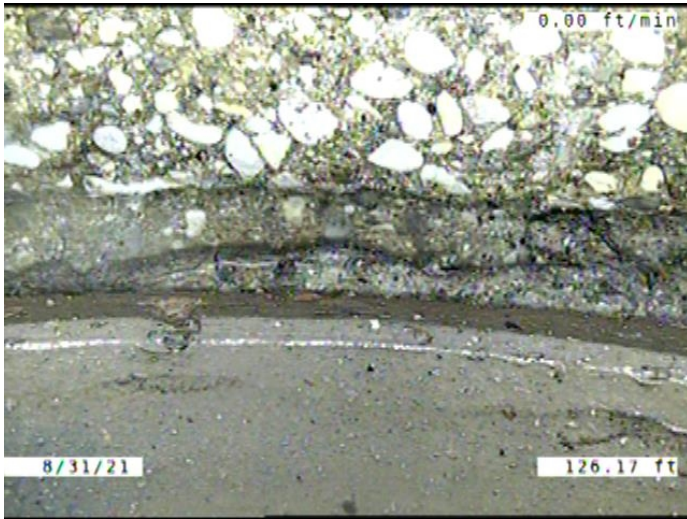
Code: **MMC**  
 Description: **Miscellaneous Material Change**

Distance (ft): **126.2**  
 Structural Grade: **0**  
 O&M Grade: **0**  
 Clock Start/From:  
 Clock To:  
 1st Value:  
 2nd Value:  
 Value Percent:  
 Continuous Index:  
 Within 8" of Joint: **NO**  
 Remarks: **CONCRETE TO VCP**

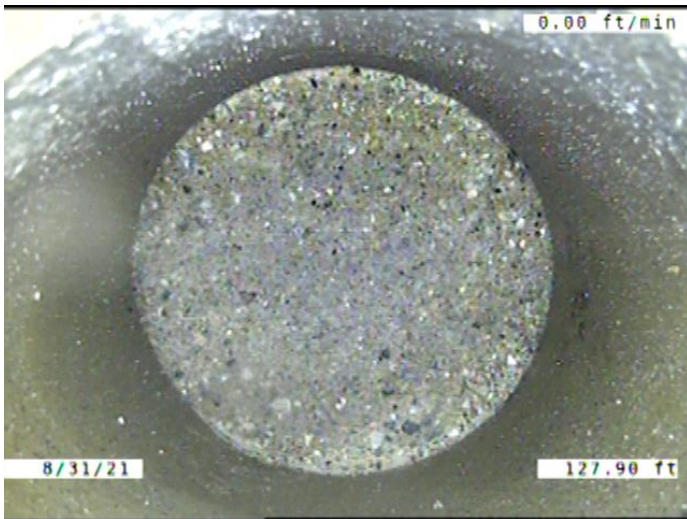
Code: **TFC**  
 Description: **Tap Factory Capped**

Distance (ft): **127.9**  
 Structural Grade: **0**  
 O&M Grade: **0**  
 Clock Start/From: **11**  
 Clock To:  
 1st Value: **4.000**  
 2nd Value:  
 Value Percent:  
 Continuous Index:  
 Within 8" of Joint: **YES**  
 Remarks:

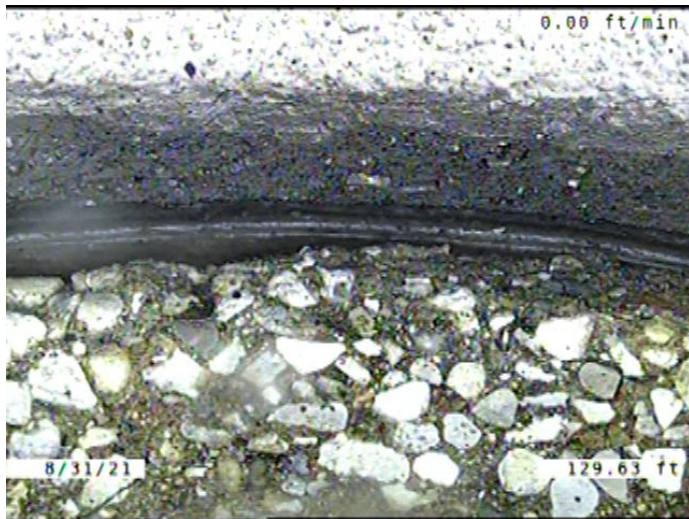
Code: **MMC**  
 Description: **Miscellaneous Material Change**

Distance (ft): **129.6**  
 Structural Grade: **0**  
 O&M Grade: **0**  
 Clock Start/From:  
 Clock To:  
 1st Value:  
 2nd Value:  
 Value Percent:  
 Continuous Index:  
 Within 8" of Joint: **NO**  
 Remarks: **VCP TO CONCRETE**

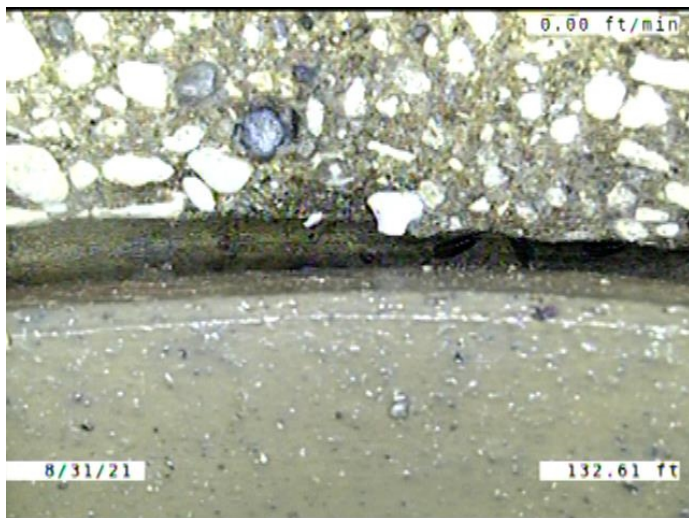
Code: **MMC**  
 Description: **Miscellaneous Material Change**

Distance (ft): **132.6**  
 Structural Grade: **0**  
 O&M Grade: **0**  
 Clock Start/From:  
 Clock To:  
 1st Value:  
 2nd Value:  
 Value Percent:  
 Continuous Index:  
 Within 8" of Joint: **NO**  
 Remarks: **CONCRETE TO VCP**

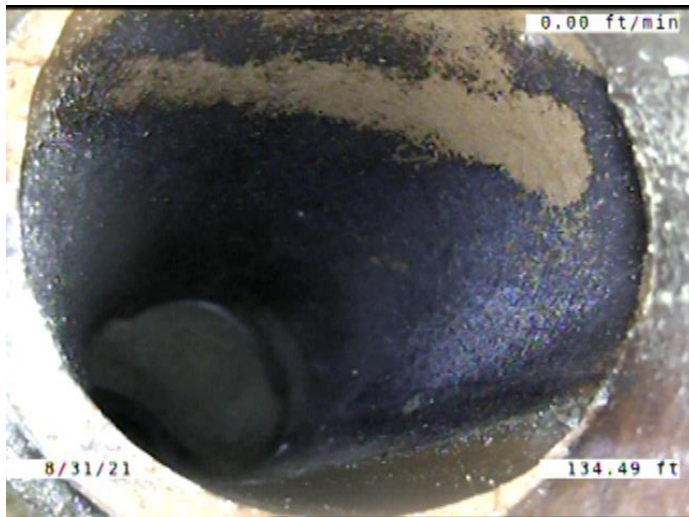
Code: **TBI**  
 Description: **Tap Break-in Intruding**

Distance (ft): **134.5**  
 Structural Grade: **0**  
 O&M Grade: **2**  
 Clock Start/From: **1**  
 Clock To:  
 1st Value: **4.000**  
 2nd Value: **1.000**  
 Value Percent:  
 Continuous Index:  
 Within 8" of Joint: **YES**  
 Remarks:

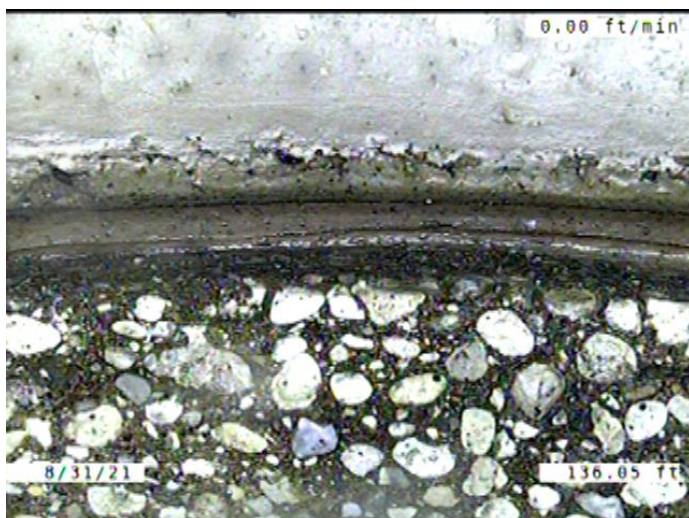
Code: **MMC**  
 Description: **Miscellaneous Material Change**

Distance (ft): **136.1**  
 Structural Grade: **0**  
 O&M Grade: **0**  
 Clock Start/From:  
 Clock To:  
 1st Value:  
 2nd Value:  
 Value Percent:  
 Continuous Index:  
 Within 8" of Joint: **NO**  
 Remarks: **VCP TO CONCRETE**

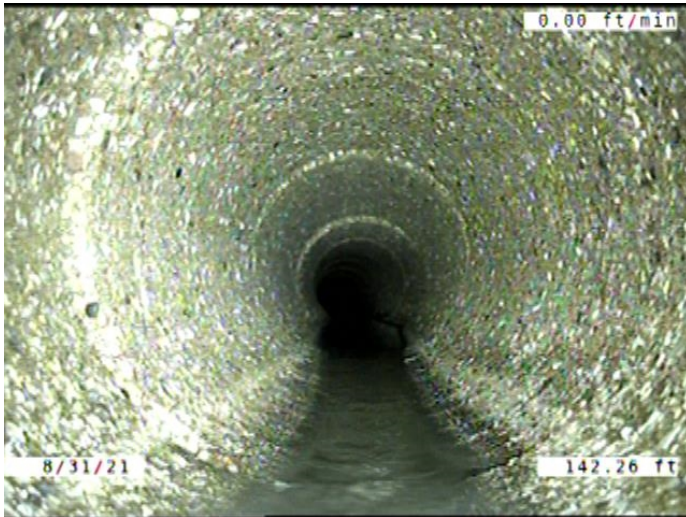
Code: **MWLS**  
 Description: **Miscellaneous Water Level Sag**

Distance (ft): **142.3**  
 Structural Grade: **2**  
 O&M Grade: **0**  
 Clock Start/From:  
 Clock To:  
 1st Value:  
 2nd Value:  
 Value Percent: **5.000**  
 Continuous Index: **F04**  
 Within 8" of Joint: **NO**  
 Remarks:

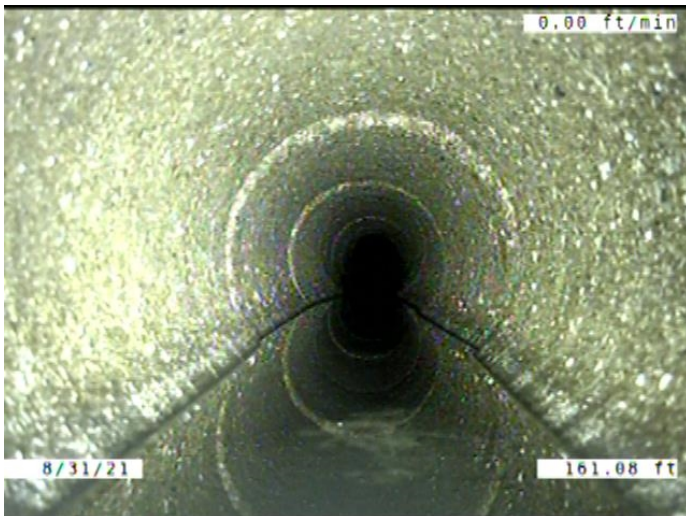
Code: **MWLS**  
 Description: **Miscellaneous Water Level Sag**

Distance (ft): **161.1**  
 Structural Grade: **2**  
 O&M Grade: **0**  
 Clock Start/From:  
 Clock To:  
 1st Value:  
 2nd Value:  
 Value Percent: **5.000**  
 Continuous Index: **S05**  
 Within 8" of Joint: **NO**  
 Remarks:

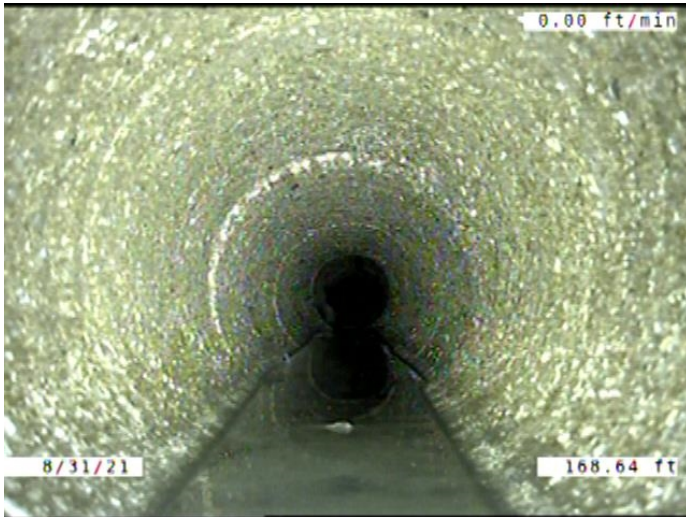
Code: **MWLS**  
 Description: **Miscellaneous Water Level Sag**

Distance (ft): **168.6**  
 Structural Grade: **2**  
 O&M Grade: **0**  
 Clock Start/From:  
 Clock To:  
 1st Value:  
 2nd Value:  
 Value Percent: **5.000**  
 Continuous Index: **F05**  
 Within 8" of Joint: **NO**  
 Remarks:

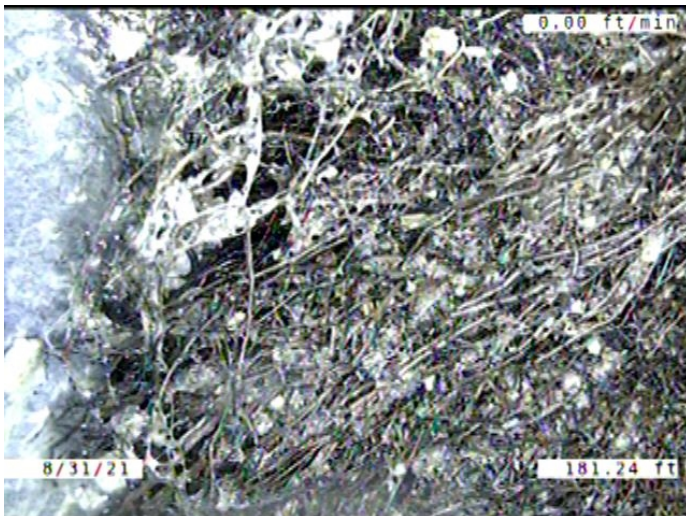
Code: **RMJ**  
 Description: **Roots Medium Joint**

Distance (ft): **181.2**  
 Structural Grade: **0**  
 O&M Grade: **3**  
 Clock Start/From: **3**  
 Clock To: **4**  
 1st Value:  
 2nd Value:  
 Value Percent: **5.000**  
 Continuous Index:  
 Within 8" of Joint: **YES**  
 Remarks:

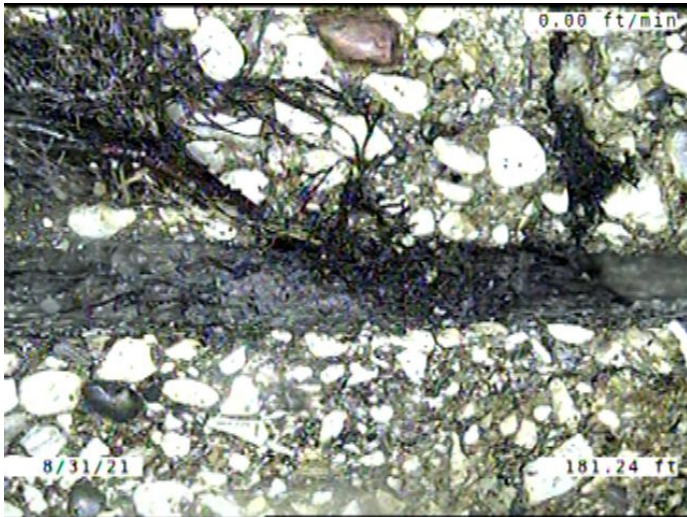
Code: **RFJ**  
 Description: **Roots Fine Joint**

Distance (ft): **181.2**  
 Structural Grade: **0**  
 O&M Grade: **1**  
 Clock Start/From: **8**  
 Clock To: **9**  
 1st Value:  
 2nd Value:  
 Value Percent:  
 Continuous Index:  
 Within 8" of Joint: **YES**  
 Remarks:

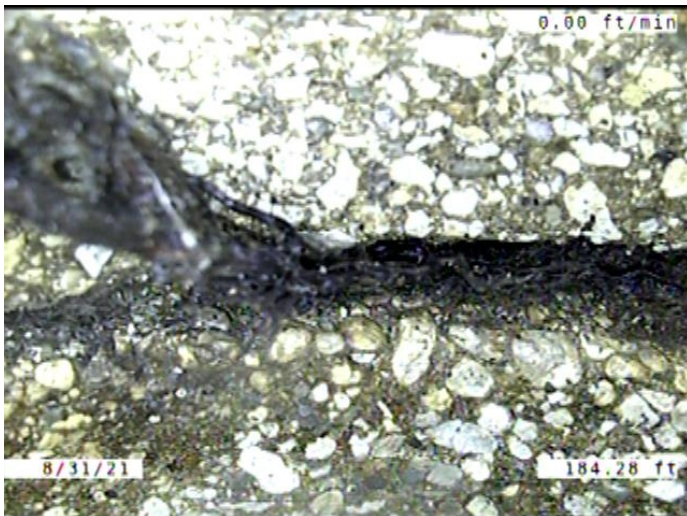
Code: **RFJ**  
 Description: **Roots Fine Joint**

Distance (ft): **184.3**  
 Structural Grade: **0**  
 O&M Grade: **1**  
 Clock Start/From: **9**  
 Clock To: **3**  
 1st Value:  
 2nd Value:  
 Value Percent:  
 Continuous Index:  
 Within 8" of Joint: **YES**  
 Remarks:

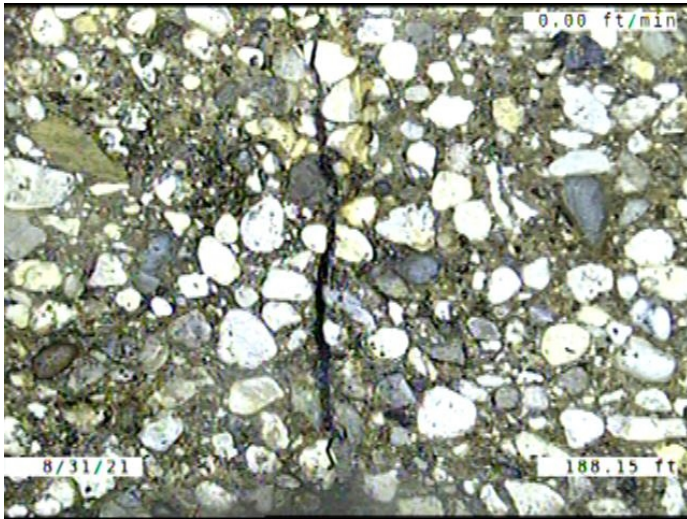
Code: **FL**  
 Description: **Fracture Longitudinal**

Distance (ft): **188.1**  
 Structural Grade: **3**  
 O&M Grade: **0**  
 Clock Start/From: **2**  
 Clock To:  
 1st Value:  
 2nd Value:  
 Value Percent:  
 Continuous Index:  
 Within 8" of Joint: **YES**  
 Remarks:

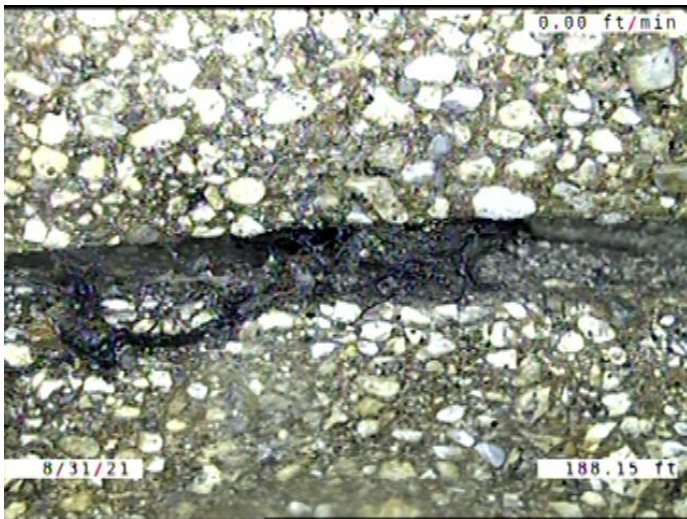
Code: **RFJ**  
 Description: **Roots Fine Joint**

Distance (ft): **188.2**  
 Structural Grade: **0**  
 O&M Grade: **1**  
 Clock Start/From: **8**  
 Clock To: **9**  
 1st Value:  
 2nd Value:  
 Value Percent:  
 Continuous Index:  
 Within 8" of Joint: **YES**  
 Remarks:

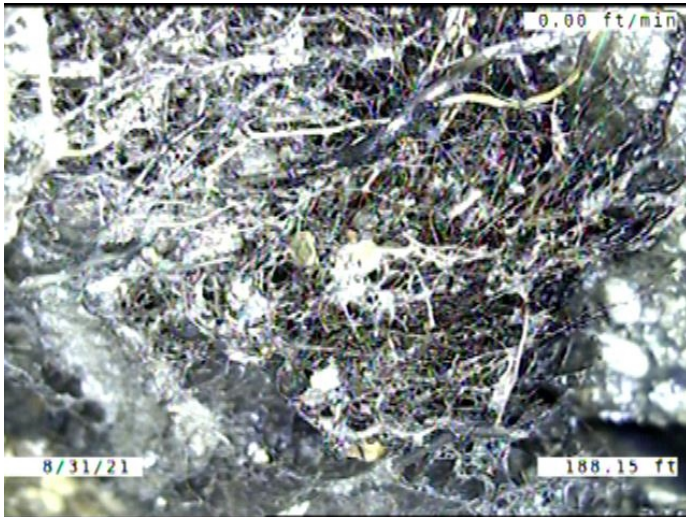
Code: **RMJ**  
 Description: **Roots Medium Joint**

Distance (ft): **188.2**  
 Structural Grade: **0**  
 O&M Grade: **3**  
 Clock Start/From: **2**  
 Clock To: **5**  
 1st Value:  
 2nd Value:  
 Value Percent: **5.000**  
 Continuous Index:  
 Within 8" of Joint: **YES**  
 Remarks:

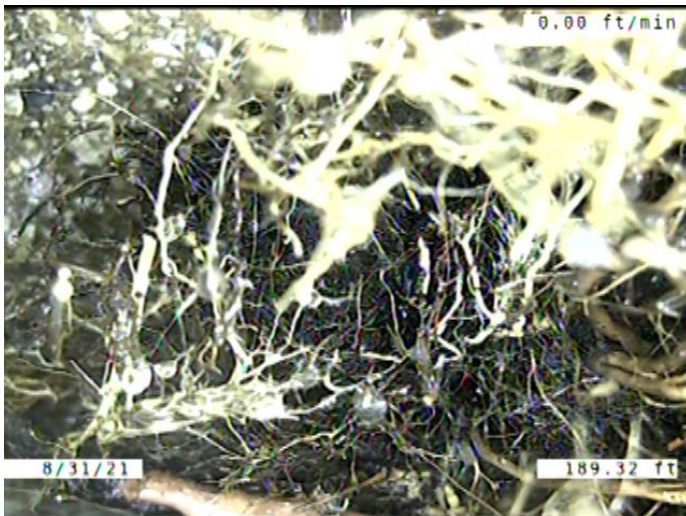
Code: **RMJ**  
 Description: **Roots Medium Joint**

Distance (ft): **189.3**  
 Structural Grade: **0**  
 O&M Grade: **3**  
 Clock Start/From: **7**  
 Clock To: **5**  
 1st Value:  
 2nd Value:  
 Value Percent: **40.000**  
 Continuous Index:  
 Within 8" of Joint: **YES**  
 Remarks:

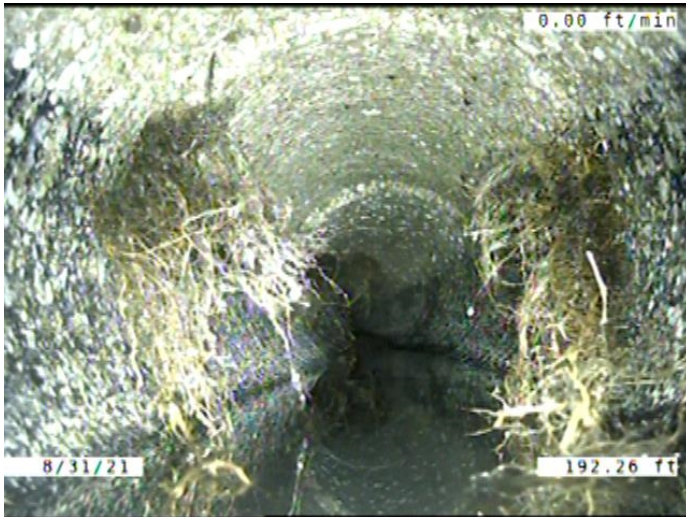
Code: **RMJ**  
 Description: **Roots Medium Joint**

Distance (ft): **192.3**  
 Structural Grade: **0**  
 O&M Grade: **3**  
 Clock Start/From: **2**  
 Clock To: **10**  
 1st Value:  
 2nd Value:  
 Value Percent: **20.000**  
 Continuous Index:  
 Within 8" of Joint: **YES**  
 Remarks:

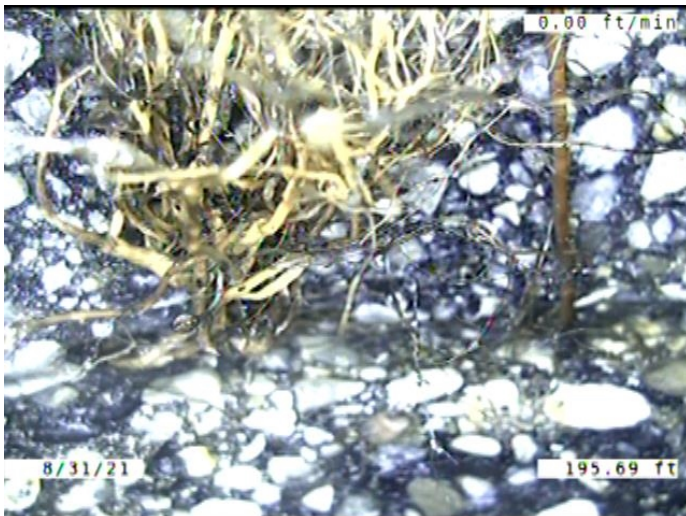
Code: **RMJ**  
 Description: **Roots Medium Joint**

Distance (ft): **195.7**  
 Structural Grade: **0**  
 O&M Grade: **3**  
 Clock Start/From: **9**  
 Clock To:  
 1st Value:  
 2nd Value:  
 Value Percent: **5.000**  
 Continuous Index:  
 Within 8" of Joint: **YES**  
 Remarks:

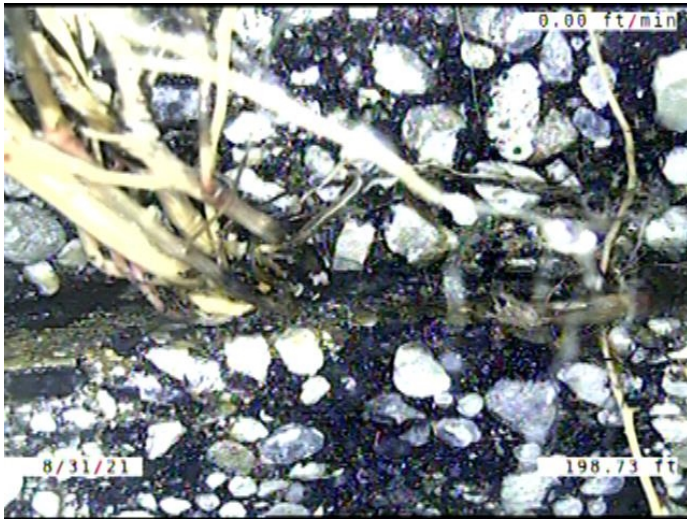
Code: **RFJ**  
 Description: **Roots Fine Joint**

Distance (ft): **198.7**  
 Structural Grade: **0**  
 O&M Grade: **1**  
 Clock Start/From: **9**  
 Clock To:  
 1st Value:  
 2nd Value:  
 Value Percent:  
 Continuous Index:  
 Within 8" of Joint: **YES**  
 Remarks:

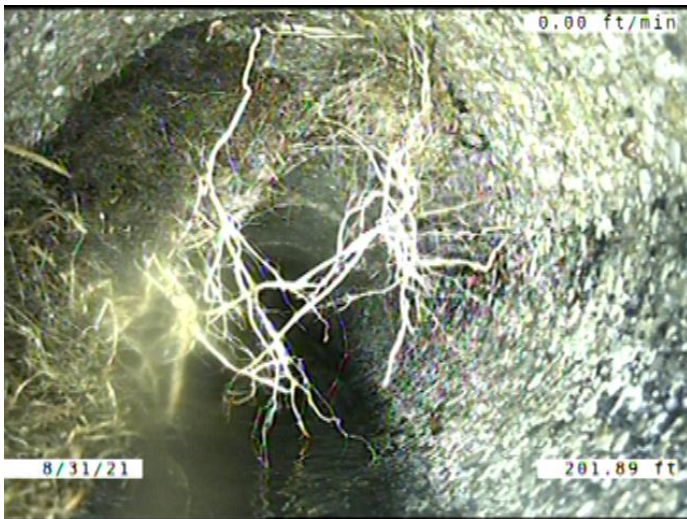
Code: **RMJ**  
 Description: **Roots Medium Joint**

Distance (ft): **201.9**  
 Structural Grade: **0**  
 O&M Grade: **3**  
 Clock Start/From: **7**  
 Clock To: **3**  
 1st Value:  
 2nd Value:  
 Value Percent: **40.000**  
 Continuous Index:  
 Within 8" of Joint: **YES**  
 Remarks:

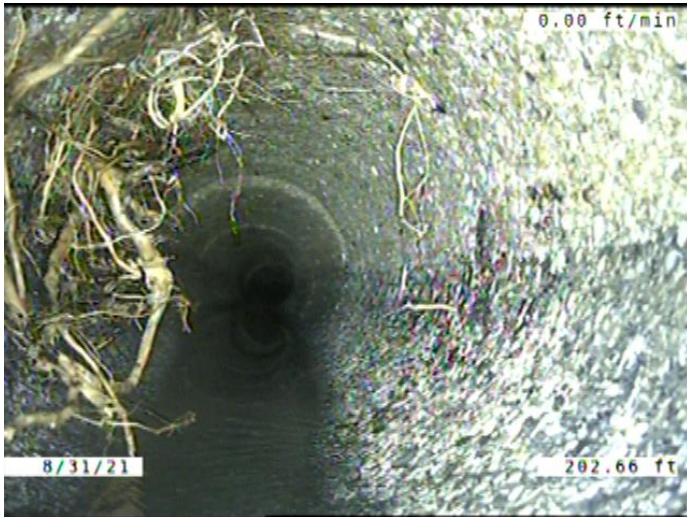
Code: **DSF**  
 Description: **Deposits Settled Fine**

Distance (ft): **202.7**  
 Structural Grade: **0**  
 O&M Grade: **2**  
 Clock Start/From: **5**  
 Clock To: **7**  
 1st Value:  
 2nd Value:  
 Value Percent: **5.000**  
 Continuous Index: **F01**  
 Within 8" of Joint: **YES**  
 Remarks:

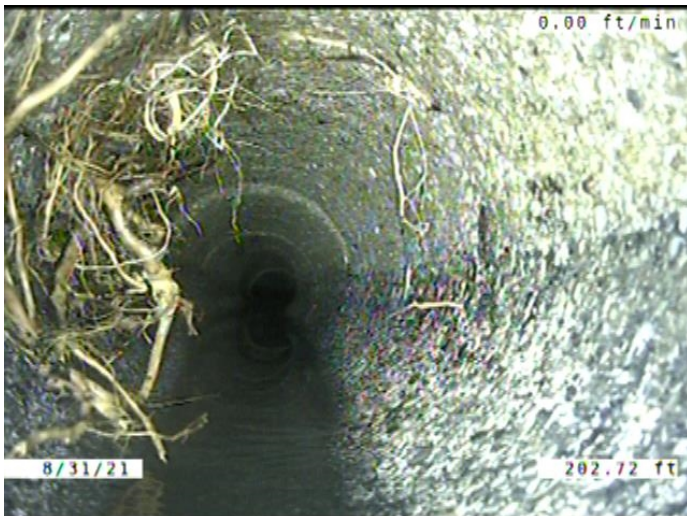
Code: **MSA**  
 Description: **Miscellaneous Survey Abandoned**

Distance (ft): **202.7**  
 Structural Grade: **0**  
 O&M Grade: **0**  
 Clock Start/From:  
 Clock To:  
 1st Value:  
 2nd Value:  
 Value Percent:  
 Continuous Index:  
 Within 8" of Joint: **NO**  
 Remarks: **CAMERA CANT MAKE IT PAST ROOTS**
