RedZone
ROBOTICS

Street:	North Virginia Street		Flow Control:	Not Controlled	
City:	Hobart, IN		Year Renewed:		
Location:	Alley		Tape/Media #:		
Purpose:	Routine Assessment		Dia/Height:	12"	
Use:	Sanitary Sewage Pipe		Material:	CP	
Drain Area:			Lining:		
Category:	NA				
Comment:					
Location Details:			Direction of Survey:	Upstream	
US MH:	M-504-106	DS MH:	M-504-108	Total Length Surveyed (ft):	202.7

Wednesday, October 13, 2021

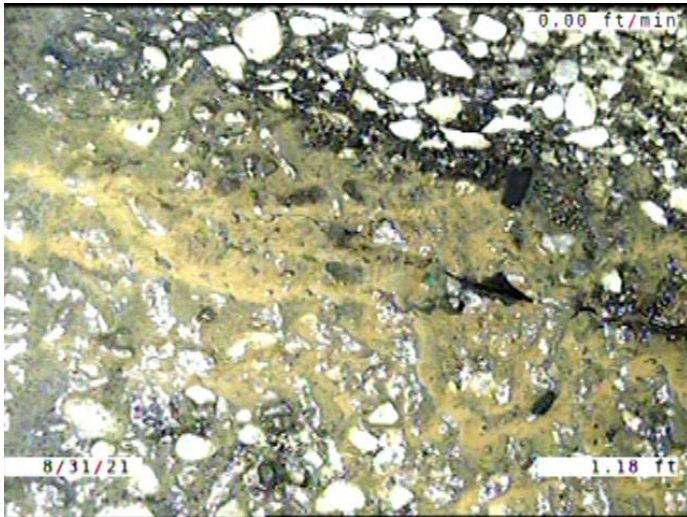
Code: **ISJ**
 Description: **Infiltration Stain Joint**

Distance (ft): **1.2**
 Structural Grade: **0**
 O&M Grade: **1**
 Clock Start/From: **8**
 Clock To: **11**
 1st Value:
 2nd Value:
 Value Percent:
 Continuous Index:
 Within 8" of Joint: **YES**
 Remarks:

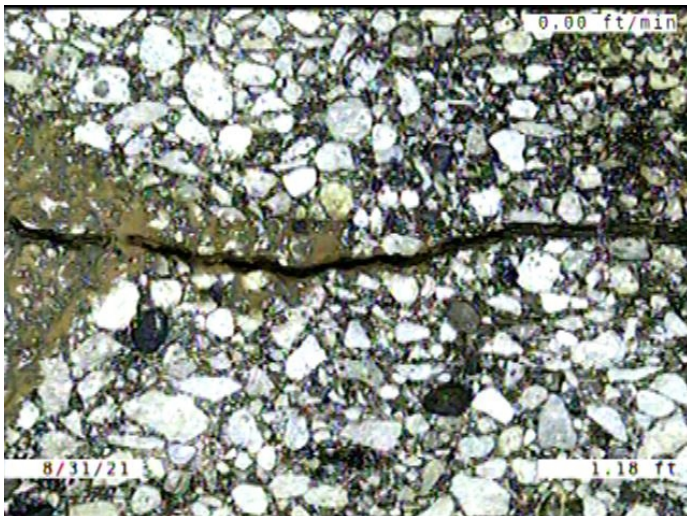
Code: **IWB**
 Description: **Infiltration Weeper Barrel**

Distance (ft): **1.2**
 Structural Grade: **0**
 O&M Grade: **2**
 Clock Start/From: **11**
 Clock To:
 1st Value:
 2nd Value:
 Value Percent:
 Continuous Index:
 Within 8" of Joint: **NO**
 Remarks:

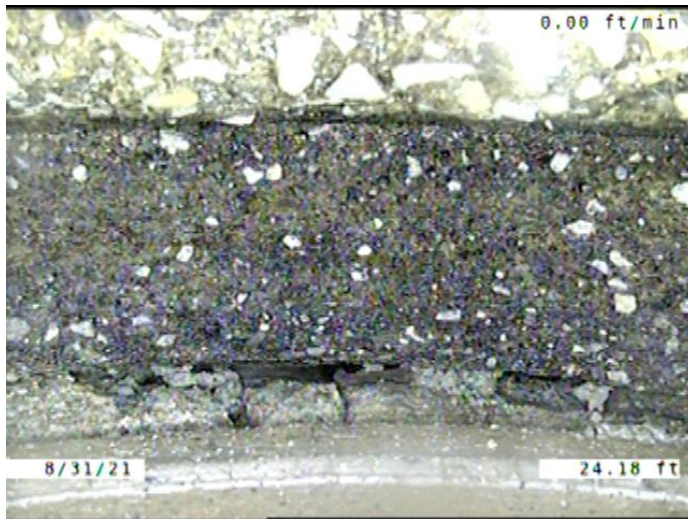
Code:	JAL
Description:	Joint Angular Large
Distance (ft):	24.2
Structural Grade:	4
O&M Grade:	0
Clock Start/From:	
Clock To:	
1st Value:	
2nd Value:	
Value Percent:	
Continuous Index:	
Within 8" of Joint:	NO
Remarks:	SOIL VISIBLE

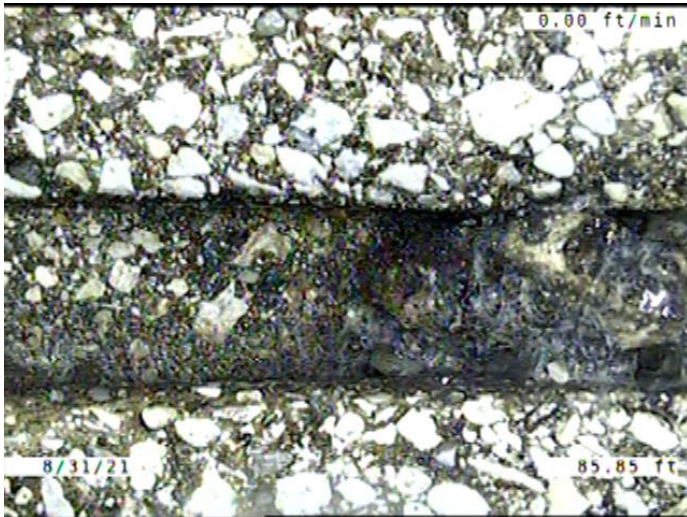
Code: **JAM**
 Description: **Joint Angular Medium**

Distance (ft): **85.8**
 Structural Grade: **3**
 O&M Grade: **0**
 Clock Start/From:
 Clock To:
 1st Value:
 2nd Value:
 Value Percent:
 Continuous Index:
 Within 8" of Joint: **NO**
 Remarks:

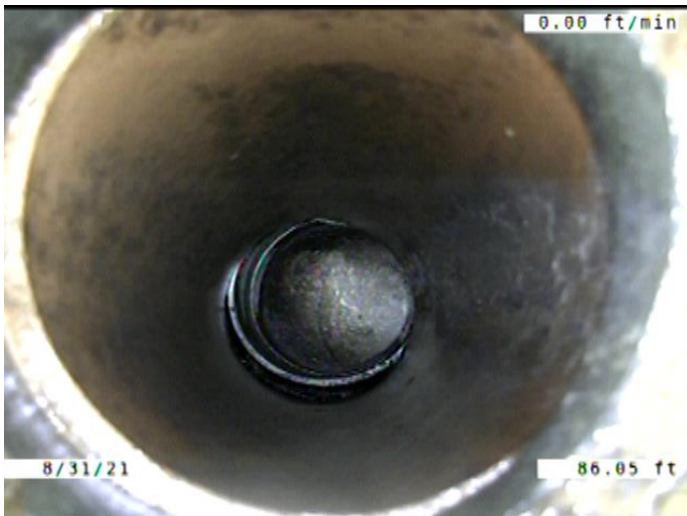
Code: **TBD**
 Description: **Tap Break-in/Hammer Defective**

Distance (ft): **86.0**
 Structural Grade: **0**
 O&M Grade: **3**
 Clock Start/From: **12**
 Clock To:
 1st Value: **4.000**
 2nd Value:
 Value Percent:
 Continuous Index:
 Within 8" of Joint: **NO**
 Remarks: **Debris**

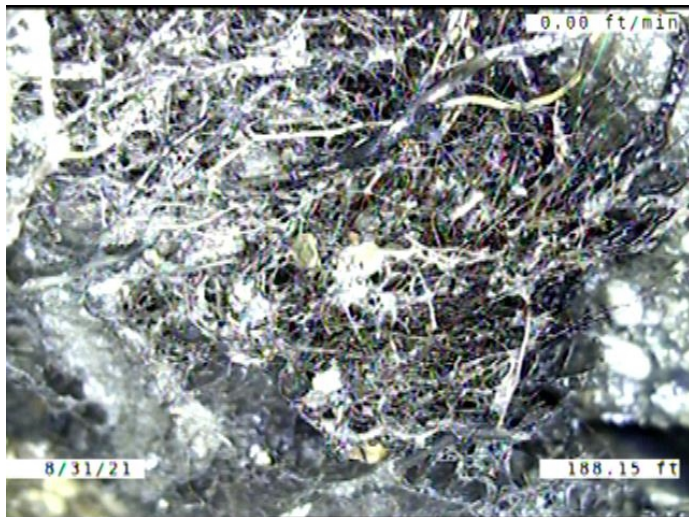
Code: **RMJ**
 Description: **Roots Medium Joint**

Distance (ft): **188.2**
 Structural Grade: **0**
 O&M Grade: **3**
 Clock Start/From: **2**
 Clock To: **5**
 1st Value:
 2nd Value:
 Value Percent: **5.000**
 Continuous Index:
 Within 8" of Joint: **YES**
 Remarks:

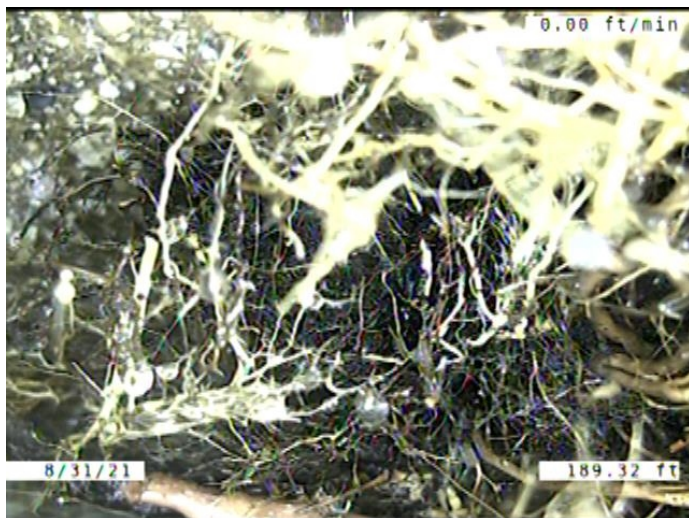
Code: **RMJ**
 Description: **Roots Medium Joint**

Distance (ft): **189.3**
 Structural Grade: **0**
 O&M Grade: **3**
 Clock Start/From: **7**
 Clock To: **5**
 1st Value:
 2nd Value:
 Value Percent: **40.000**
 Continuous Index:
 Within 8" of Joint: **YES**
 Remarks:

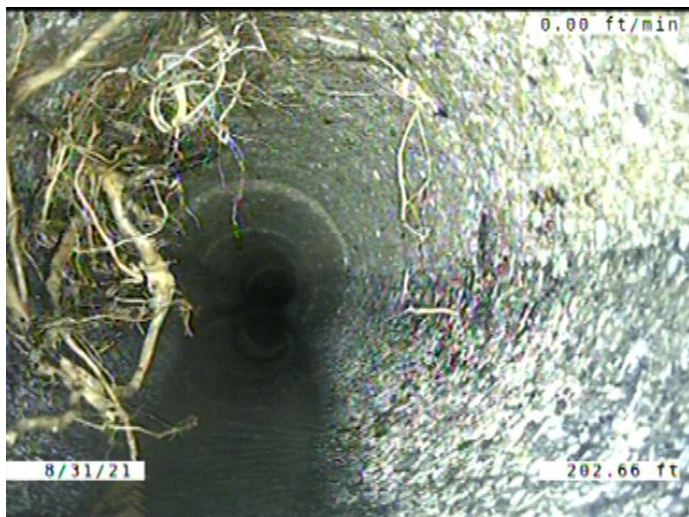
Code: **DSF**
 Description: **Deposits Settled Fine**

Distance (ft): **202.7**
 Structural Grade: **0**
 O&M Grade: **2**
 Clock Start/From: **5**
 Clock To: **7**
 1st Value:
 2nd Value:
 Value Percent: **5.000**
 Continuous Index: **F01**
 Within 8" of Joint: **YES**
 Remarks:

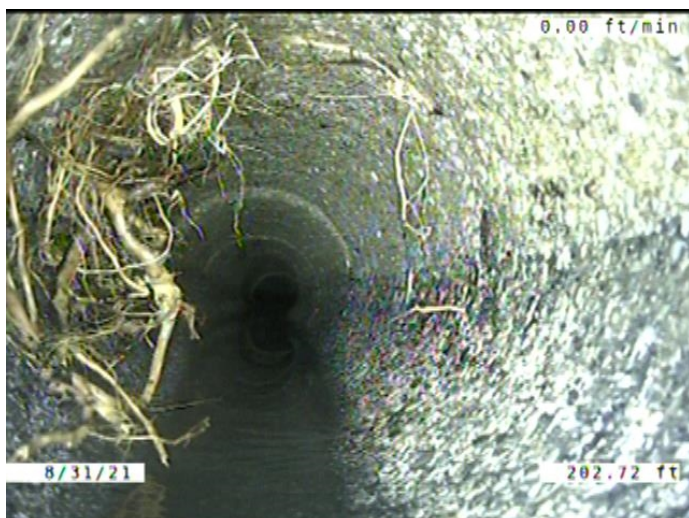
Code: **MSA**
 Description: **Miscellaneous Survey Abandoned**

Distance (ft): **202.7**
 Structural Grade: **0**
 O&M Grade: **0**
 Clock Start/From:
 Clock To:
 1st Value:
 2nd Value:
 Value Percent:
 Continuous Index:
 Within 8" of Joint: **NO**
 Remarks: **CAMERA CANT MAKE IT PAST ROOTS**
