Profile/Photo Observation Report

Date:	04/09/2018	Weather:		Coding:	PACP 6.0
Pipe Length (ft):	394.1	Owner:	NA	Pre Clean:	Not Known
P.O.#:		Surveyor:	Byrd Fitzgerald	PSR:	P-504-110-112
Customer:		Clean Date:	01/01/1900	Shape:	C

Street:	OFF W 41ST AVE	Flow Control:	Not Controlled
City:	Hobart, IN	Year Renewed:	
Location:	Other	Tape/Media #:	
Purpose:	Not Known	Dia/Height:	10"
Use:	Sanitary	Material:	CP
Drain Area:	NA	Lining:	
Category:	NA		
Comment:

Location Details:		Direction of Survey:	Upstream
US MH:	M-504-112	DS MH:	M-504-110
		Total Length Surveyed (ft):	52.2

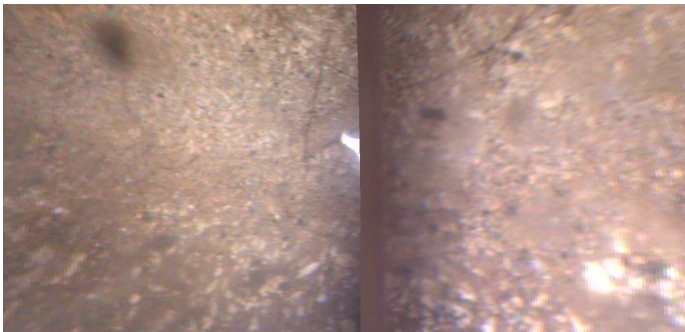
Code:	CM
Description:	Crack Multiple

Distance (ft):	3.7
Structural Grade:	3
O&M Grade:	0
Clock Start/From:	7
Clock To:	5
1st Value:	
2nd Value:	
Value Percent:	
Continuous Index:	S01
Within 8" of Joint:	
Remarks:

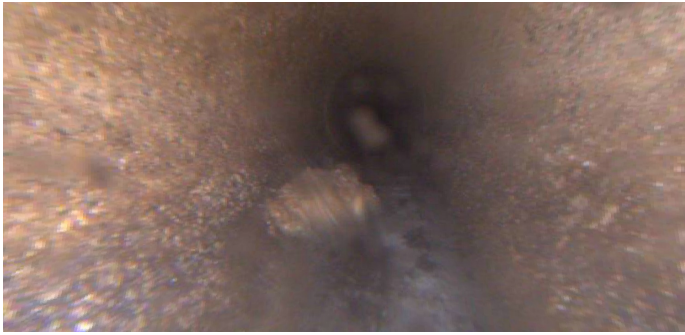
Code: **DSZ**
Description: **Deposits Settled Other**

Distance (ft): **3.7**
Structural Grade: **0**
O&M Grade: **2**
Clock Start/From: **6**
Clock To:
1st Value:
2nd Value:
Value Percent: **5.000**
Continuous Index:
Within 8" of Joint: **NO**
Remarks: **debris**

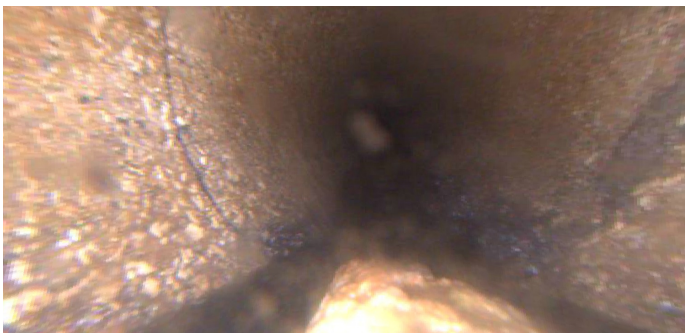
Code: **DSZ**
Description: **Deposits Settled Other**

Distance (ft): **17.3**
Structural Grade: **0**
O&M Grade: **2**
Clock Start/From: **6**
Clock To:
1st Value:
2nd Value:
Value Percent: **5.000**
Continuous Index:
Within 8" of Joint: **NO**
Remarks: **debris**

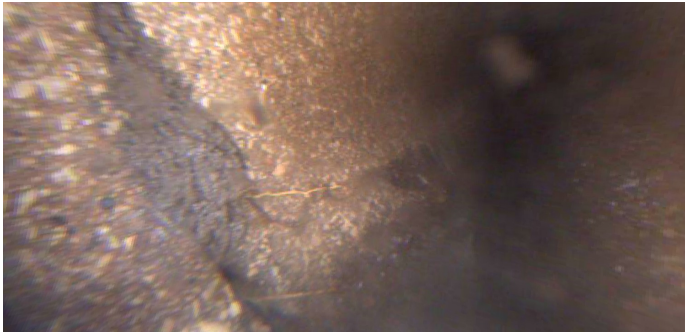
Code: **RFJ**
Description: **Roots Fine Joint**

Distance (ft): **29.5**
Structural Grade: **0**
O&M Grade: **1**
Clock Start/From: **7**
Clock To: **8**
1st Value:
2nd Value:
Value Percent:
Continuous Index:
Within 8" of Joint: **YES**
Remarks:

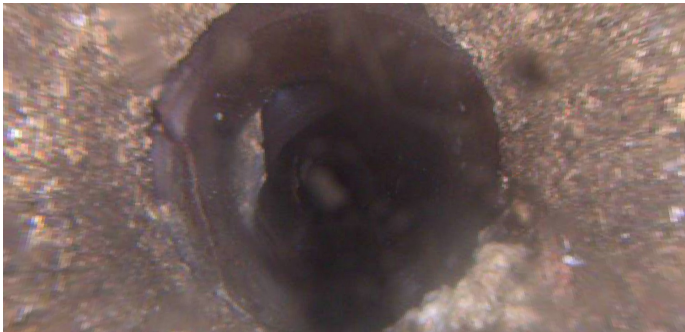
Code: **RFJ**
Description: **Roots Fine Joint**

Distance (ft): **35.0**
Structural Grade: **0**
O&M Grade: **1**
Clock Start/From: **10**
Clock To:
1st Value:
2nd Value:
Value Percent:
Continuous Index:
Within 8" of Joint: **YES**
Remarks:

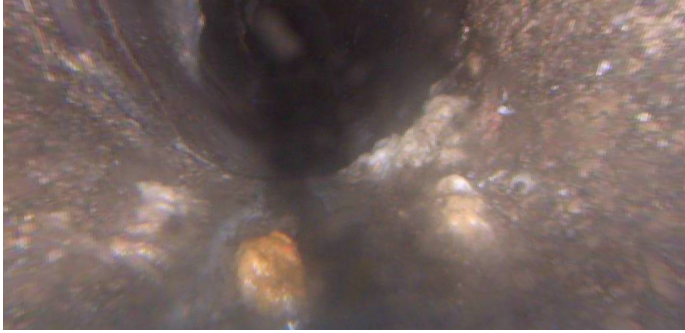
Code: **DSZ**
Description: **Deposits Settled Other**

Distance (ft): **35.0**
Structural Grade: **0**
O&M Grade: **2**
Clock Start/From: **6**
Clock To:
1st Value:
2nd Value:
Value Percent: **5.000**
Continuous Index: **S02**
Within 8" of Joint: **NO**
Remarks: **tissue/debris**

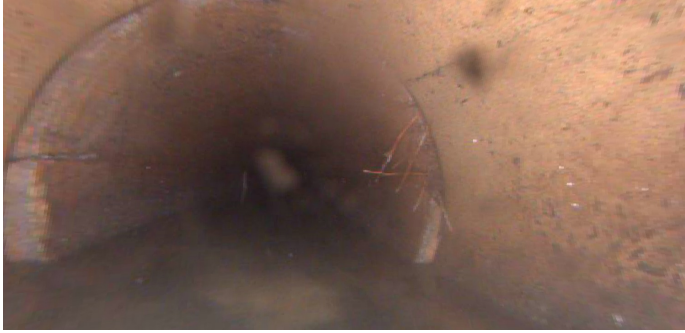
Code: **RFJ**
Description: **Roots Fine Joint**

Distance (ft): **47.0**
Structural Grade: **0**
O&M Grade: **1**
Clock Start/From: **9**
Clock To: **3**
1st Value:
2nd Value:
Value Percent:
Continuous Index:
Within 8" of Joint: **YES**
Remarks:

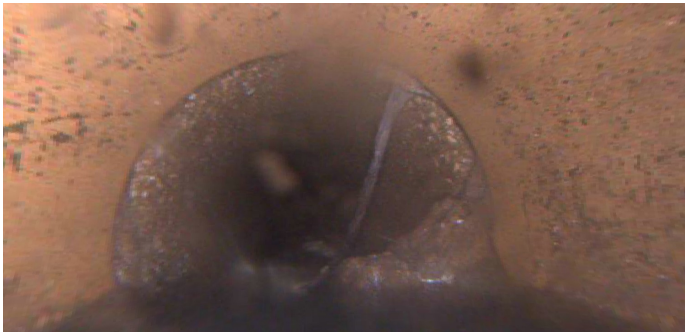
Code: **RMJ**
Description: **Roots Medium Joint**

Distance (ft): **51.7**
Structural Grade: **0**
O&M Grade: **3**
Clock Start/From: **1**
Clock To: **5**
1st Value:
2nd Value:
Value Percent: **15.000**
Continuous Index:
Within 8" of Joint: **YES**
Remarks:

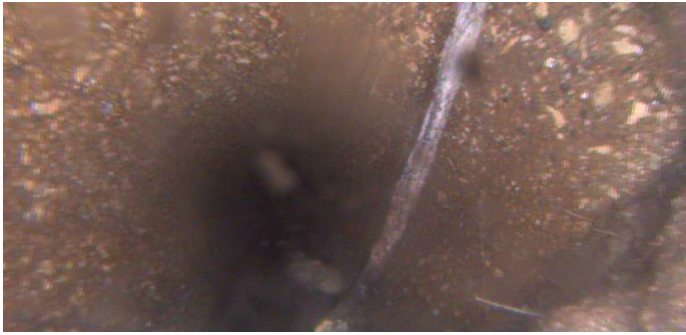
Code: **MSA**
Description: **Abandoned Survey**

Distance (ft): **52.2**
Structural Grade: **0**
O&M Grade: **0**
Clock Start/From:
Clock To:
1st Value:
2nd Value:
Value Percent:
Continuous Index:
Within 8" of Joint: **NO**
Remarks: **rmj**

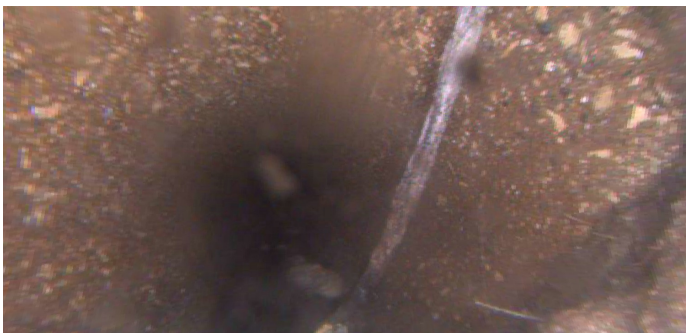
Code: **CM**
Description: **Crack Multiple**

Distance (ft): **52.2**
Structural Grade: **3**
O&M Grade: **0**
Clock Start/From: **7**
Clock To: **5**
1st Value:
2nd Value:
Value Percent:
Continuous Index: **F01**
Within 8" of Joint:
Remarks:

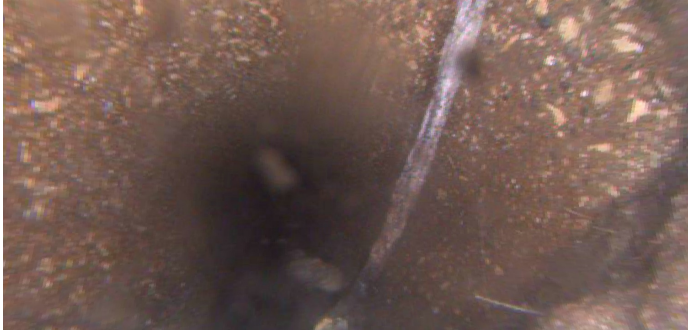
Code:	DSZ
Description:	Deposits Settled Other
Distance (ft):	52.2
Structural Grade:	0
O&M Grade:	2
Clock Start/From:	6
Clock To:	
1st Value:	
2nd Value:	
Value Percent:	5.000
Continuous Index:	F02
Within 8" of Joint:	NO
Remarks:	tissue/debris
