Profile/Photo Observation Report

Date:	04/09/2018	Weather:		Coding:	PACP 6.0
Pipe Length (ft):	394.1	Owner:	NA	Pre Clean:	Not Known
P.O.#:		Surveyor:	Byrd Fitzgerald	PSR:	P-504-110-112
Customer:		Clean Date:	01/01/1900	Shape:	C

Street:	W 40th ave	Flow Control:	Not Controlled
City:	Hobart, IN	Year Renewed:	
Location:	Other	Tape/Media #:	
Purpose:	Not Known	Dia/Height:	10"
Use:	Sanitary	Material:	CP
Drain Area:	NA	Lining:	
Category:	NA		
Comment:

Location Details:		Direction of Survey:	Upstream
US MH:	M-504-112	DS MH:	M-504-110
		Total Length Surveyed (ft):	52.2

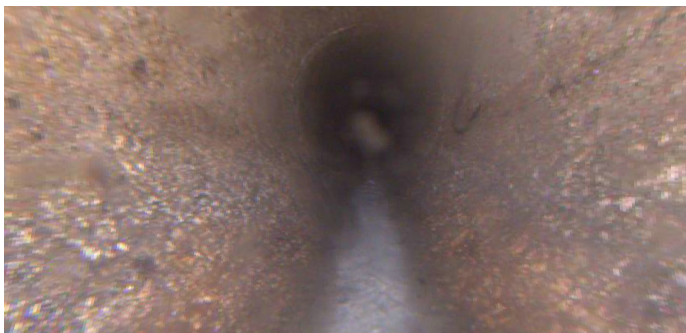
Code: **AMH**
Description: **Manhole**

Distance (ft): **.0**
Structural Grade: **0**
O&M Grade: **0**
Clock Start/From:
Clock To:
1st Value:
2nd Value:
Value Percent:
Continuous Index:
Within 8" of Joint: **NO**
Remarks: **M-504-110**

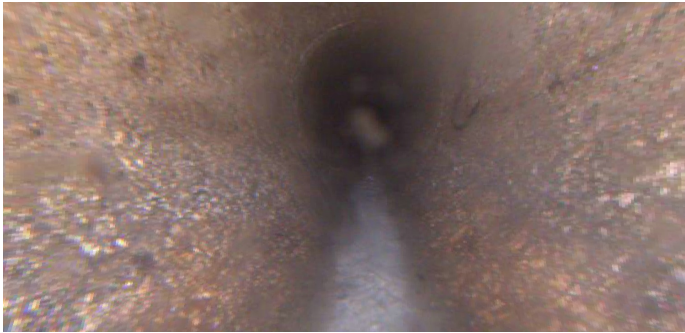
Code:	MWL
Description:	Water Level

Distance (ft):	.0
Structural Grade:	0
O&M Grade:	0
Clock Start/From:	
Clock To:	
1st Value:	
2nd Value:	
Value Percent:	5.000
Continuous Index:	
Within 8" of Joint:	NO
Remarks:

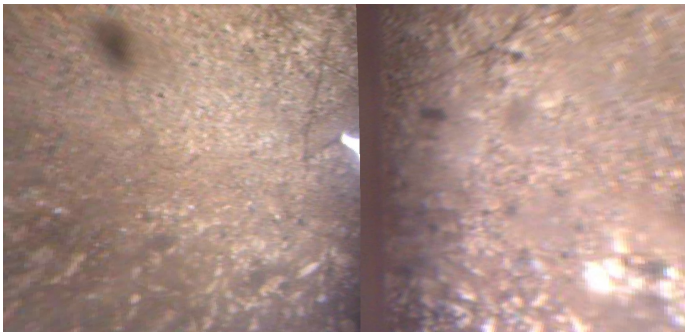
Code:	CM
Description:	Crack Multiple

Distance (ft):	3.7
Structural Grade:	3
O&M Grade:	0
Clock Start/From:	7
Clock To:	5
1st Value:	
2nd Value:	
Value Percent:	
Continuous Index:	S01
Within 8" of Joint:	
Remarks:

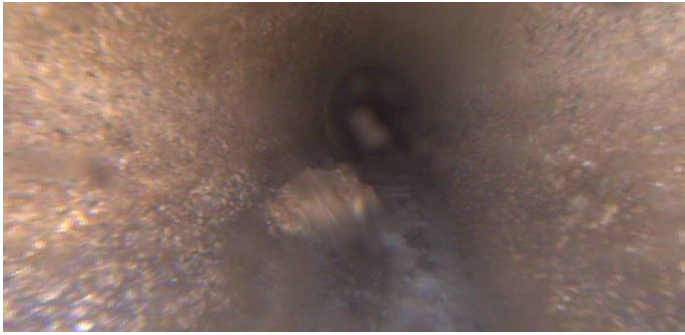
Code: **DSZ**
Description: **Deposits Settled Other**

Distance (ft): **3.7**
Structural Grade: **0**
O&M Grade: **2**
Clock Start/From: **6**
Clock To:
1st Value:
2nd Value:
Value Percent: **5.000**
Continuous Index:
Within 8" of Joint: **NO**
Remarks: **debris**

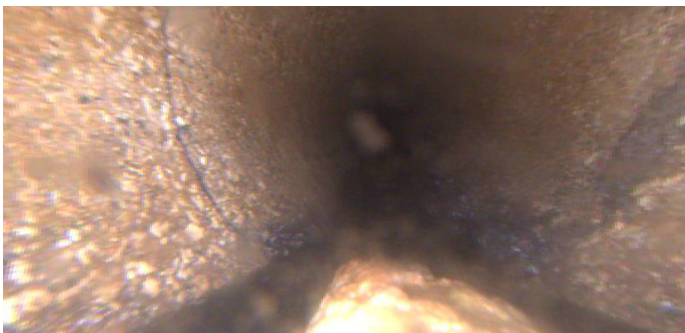
Code: **DSZ**
Description: **Deposits Settled Other**

Distance (ft): **17.3**
Structural Grade: **0**
O&M Grade: **2**
Clock Start/From: **6**
Clock To:
1st Value:
2nd Value:
Value Percent: **5.000**
Continuous Index:
Within 8" of Joint: **NO**
Remarks: **debris**

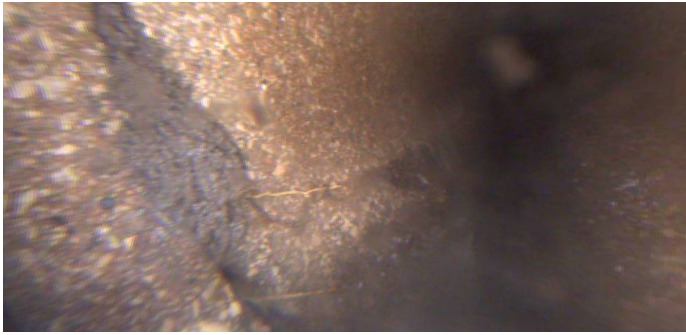
Code: **RFJ**
Description: **Roots Fine Joint**

Distance (ft): **29.5**
Structural Grade: **0**
O&M Grade: **1**
Clock Start/From: **7**
Clock To: **8**
1st Value:
2nd Value:
Value Percent:
Continuous Index:
Within 8" of Joint: **YES**
Remarks:

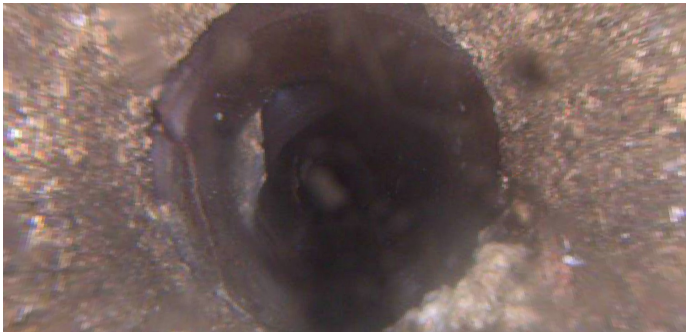
Code: **RFJ**
Description: **Roots Fine Joint**

Distance (ft): **35.0**
Structural Grade: **0**
O&M Grade: **1**
Clock Start/From: **10**
Clock To:
1st Value:
2nd Value:
Value Percent:
Continuous Index:
Within 8" of Joint: **YES**
Remarks:

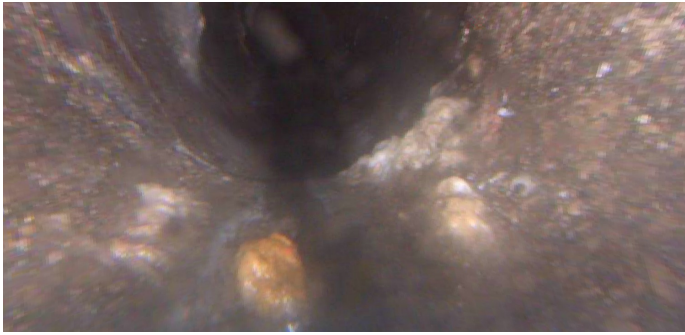
Code: **DSZ**
Description: **Deposits Settled Other**

Distance (ft): **35.0**
Structural Grade: **0**
O&M Grade: **2**
Clock Start/From: **6**
Clock To:
1st Value:
2nd Value:
Value Percent: **5.000**
Continuous Index: **S02**
Within 8" of Joint: **NO**
Remarks: **tissue/debris**

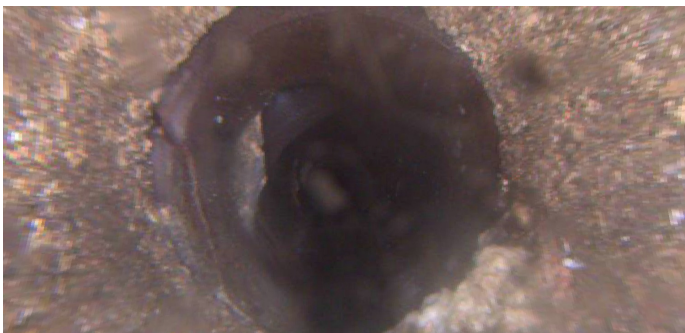
Code: **MMC**
Description: **Material Change**

Distance (ft): **35.0**
Structural Grade: **0**
O&M Grade: **0**
Clock Start/From:
Clock To:
1st Value:
2nd Value:
Value Percent:
Continuous Index:
Within 8" of Joint: **NO**
Remarks: **vcp**

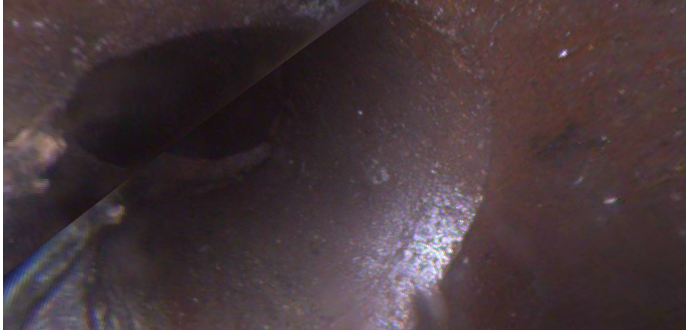
Code: **TF**
Description: **Tap Factory**

Distance (ft): **36.2**
Structural Grade: **0**
O&M Grade: **0**
Clock Start/From: **10**
Clock To:
1st Value: **4.000**
2nd Value:
Value Percent:
Continuous Index:
Within 8" of Joint: **YES**
Remarks:

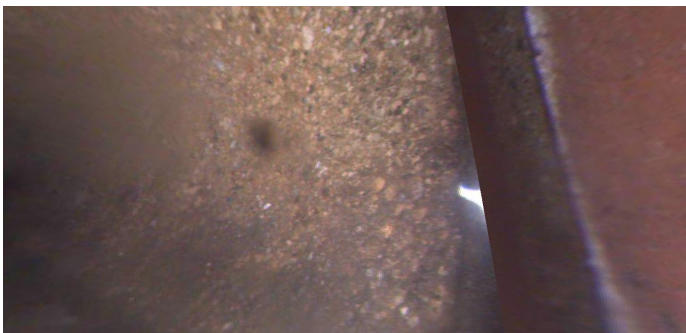
Code: **MMC**
Description: **Material Change**

Distance (ft): **38.6**
Structural Grade: **0**
O&M Grade: **0**
Clock Start/From:
Clock To:
1st Value:
2nd Value:
Value Percent:
Continuous Index:
Within 8" of Joint: **NO**
Remarks: **cp**

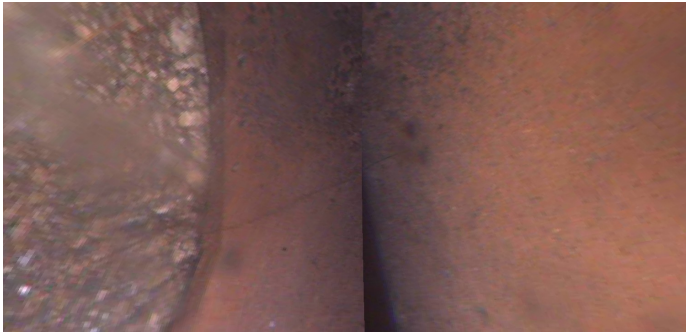
Code: **MMC**
Description: **Material Change**

Distance (ft): **41.9**
Structural Grade: **0**
O&M Grade: **0**
Clock Start/From:
Clock To:
1st Value:
2nd Value:
Value Percent:
Continuous Index:
Within 8" of Joint: **NO**
Remarks: **vcp**

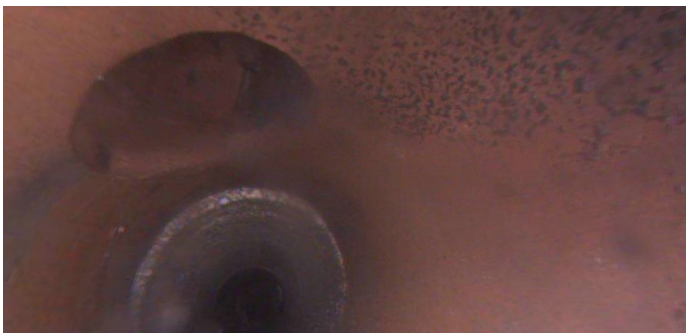
Code: **TFC**
Description: **Tap Factory Capped**

Distance (ft): **43.0**
Structural Grade: **0**
O&M Grade: **0**
Clock Start/From: **1**
Clock To:
1st Value: **4.000**
2nd Value:
Value Percent:
Continuous Index:
Within 8" of Joint: **YES**
Remarks:

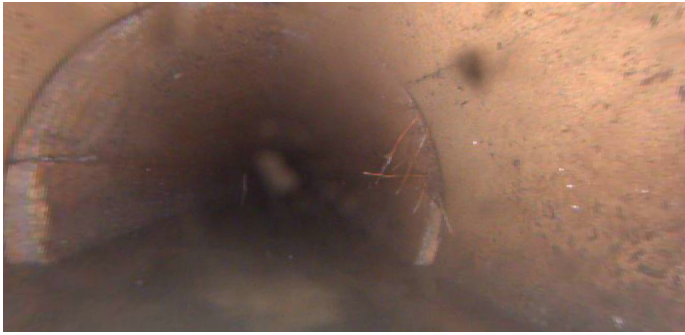
Code: **RFJ**
Description: **Roots Fine Joint**

Distance (ft): **47.0**
Structural Grade: **0**
O&M Grade: **1**
Clock Start/From: **9**
Clock To: **3**
1st Value:
2nd Value:
Value Percent:
Continuous Index:
Within 8" of Joint: **YES**
Remarks:

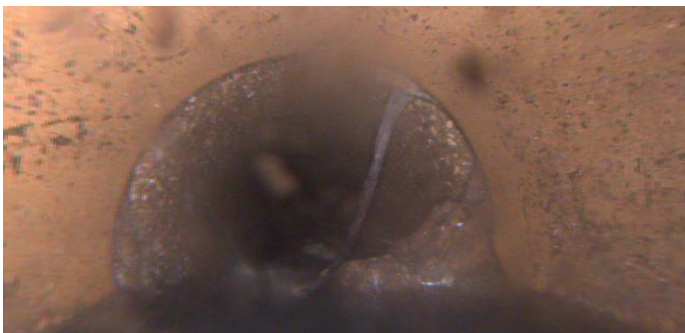
Code: **RMJ**
Description: **Roots Medium Joint**

Distance (ft): **51.7**
Structural Grade: **0**
O&M Grade: **3**
Clock Start/From: **1**
Clock To: **5**
1st Value:
2nd Value:
Value Percent: **15.000**
Continuous Index:
Within 8" of Joint: **YES**
Remarks:

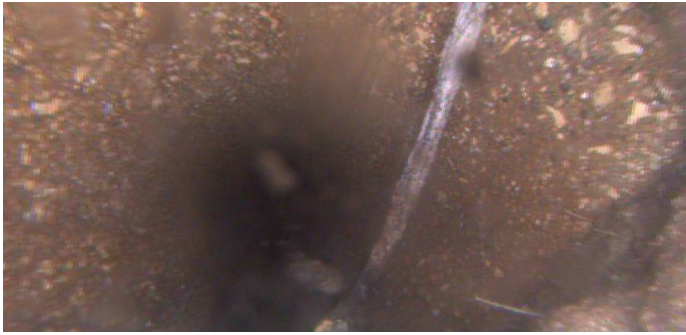
Code: **MSA**
Description: **Abandoned Survey**

Distance (ft): **52.2**
Structural Grade: **0**
O&M Grade: **0**
Clock Start/From:
Clock To:
1st Value:
2nd Value:
Value Percent:
Continuous Index:
Within 8" of Joint: **NO**
Remarks: **rmj**

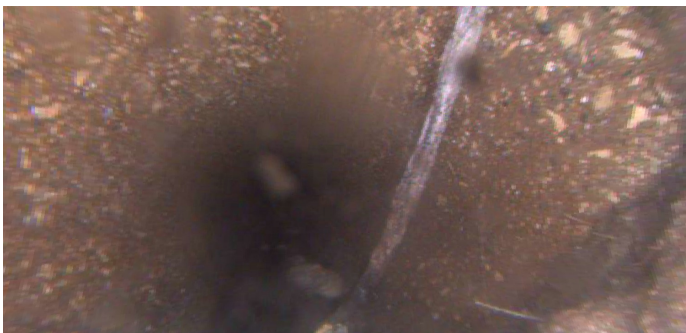
Code: **CM**
Description: **Crack Multiple**

Distance (ft): **52.2**
Structural Grade: **3**
O&M Grade: **0**
Clock Start/From: **7**
Clock To: **5**
1st Value:
2nd Value:
Value Percent:
Continuous Index: **F01**
Within 8" of Joint:
Remarks:

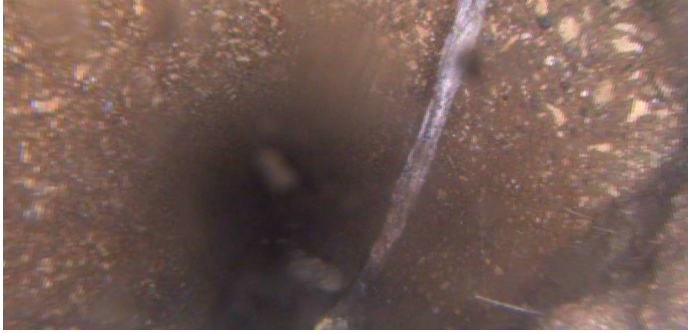
Code:	DSZ
Description:	Deposits Settled Other
Distance (ft):	52.2
Structural Grade:	0
O&M Grade:	2
Clock Start/From:	6
Clock To:	
1st Value:	
2nd Value:	
Value Percent:	5.000
Continuous Index:	F02
Within 8" of Joint:	NO
Remarks:	tissue/debris
