Profile/Photo Observation Report

Date:	09/07/2021	Weather:		Coding:	PACP 7.0
Pipe Length (ft):	194.7	Owner:	City of Hobart	Pre Clean:	Light Cleaning
P.O.#:	YES502259	Surveyor:	S. Bucklin	PSR:	P-504-110-112
Customer:	City of Hobart	Clean Date:	08/26/2021	Shape:	C

Street:	41st Avenue	Flow Control:	Not Controlled
City:	Hobart, IN	Year Renewed:	
Location:	Alley	Tape/Media #:	
Purpose:	Routine Assessment	Dia/Height:	10"
Use:	Sanitary Sewage Pipe	Material:	CP
Drain Area:		Lining:	None
Category:	NA		
Comment:			
Location Details:		Direction of Survey:	Upstream
US MH:	M-504-112	DS MH:	M-504-110
		Total Length Surveyed (ft):	194.7

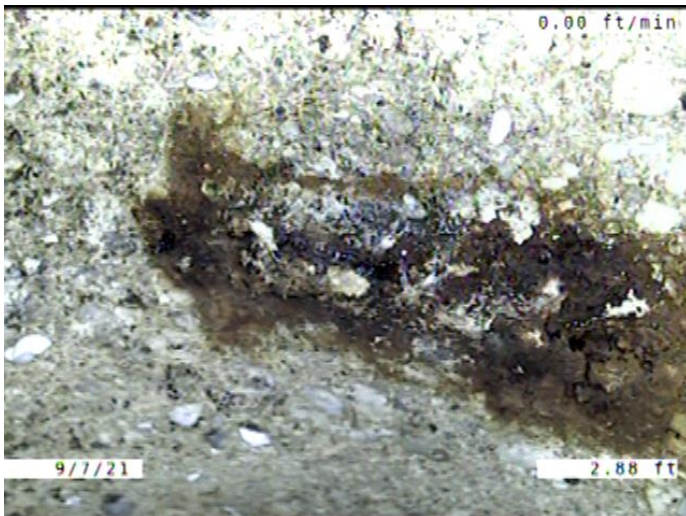
Code: **ISB**
Description: **Infiltration Stain Barrel**

Distance (ft): **2.9**
Structural Grade: **0**
O&M Grade: **1**
Clock Start/From: **12**
Clock To: **3**
1st Value:
2nd Value:
Value Percent:
Continuous Index:
Within 8" of Joint: **NO**
Remarks:

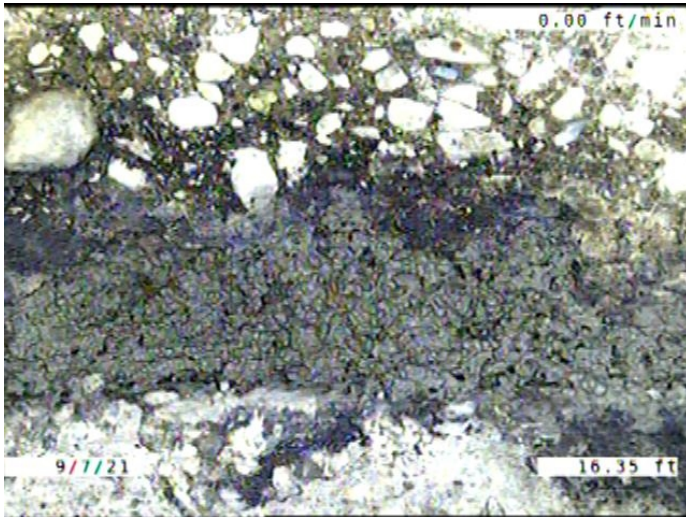
Code: **ISJ**
 Description: **Infiltration Stain Joint**

Distance (ft): **16.3**
 Structural Grade: **0**
 O&M Grade: **1**
 Clock Start/From: **7**
 Clock To: **5**
 1st Value:
 2nd Value:
 Value Percent:
 Continuous Index:
 Within 8" of Joint: **YES**
 Remarks:

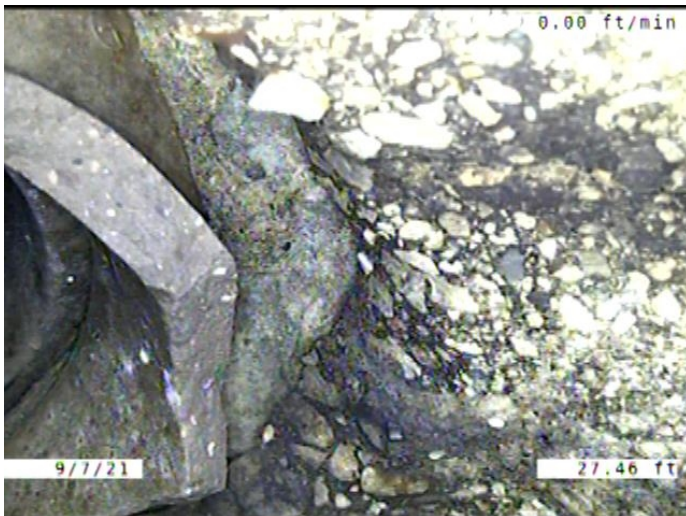
Code: **B**
 Description: **Broken**

Distance (ft): **27.5**
 Structural Grade: **4**
 O&M Grade: **0**
 Clock Start/From: **12**
 Clock To: **12**
 1st Value:
 2nd Value:
 Value Percent:
 Continuous Index:
 Within 8" of Joint: **YES**
 Remarks:

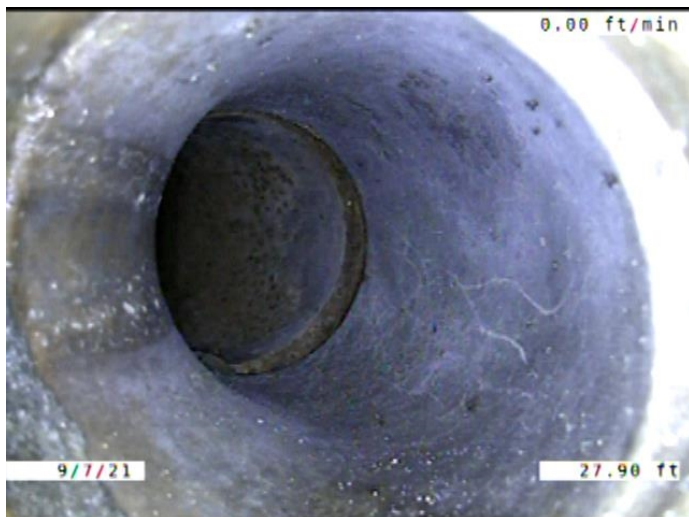
Code: **TBI**
 Description: **Tap Break-in Intruding**

Distance (ft): **27.9**
 Structural Grade: **0**
 O&M Grade: **2**
 Clock Start/From: **10**
 Clock To:
 1st Value: **4.000**
 2nd Value: **1.000**
 Value Percent:
 Continuous Index:
 Within 8" of Joint: **NO**
 Remarks:

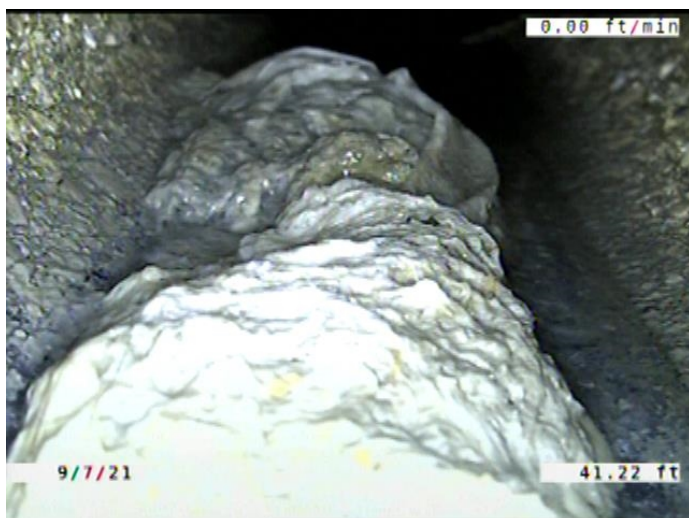
Code: **DSZ**
 Description: **Deposits Settled Other**

Distance (ft): **41.2**
 Structural Grade: **0**
 O&M Grade: **2**
 Clock Start/From: **5**
 Clock To: **7**
 1st Value:
 2nd Value:
 Value Percent: **5.000**
 Continuous Index:
 Within 8" of Joint: **YES**
 Remarks: **RAGS AND TP**

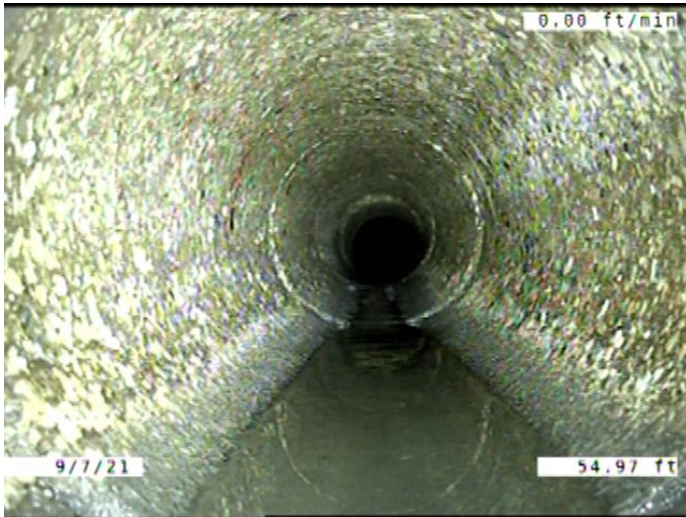
Code: **MWLS**
 Description: **Miscellaneous Water Level Sag**

Distance (ft): **55.0**
 Structural Grade: **2**
 O&M Grade: **0**
 Clock Start/From:
 Clock To:
 1st Value:
 2nd Value:
 Value Percent: **5.000**
 Continuous Index:
 Within 8" of Joint: **NO**
 Remarks:

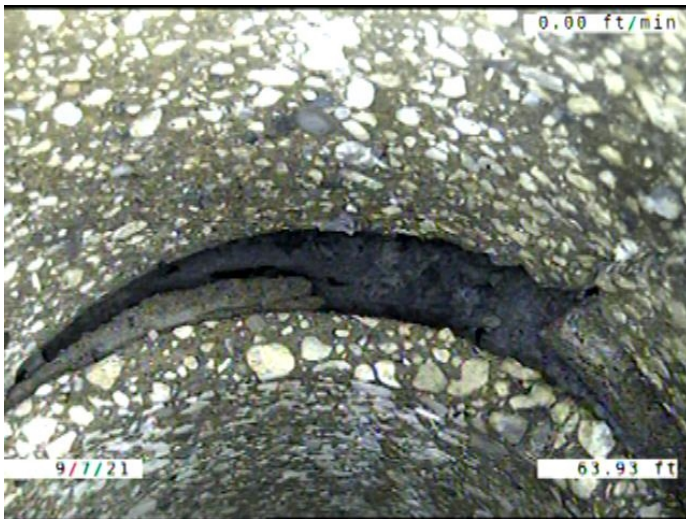
Code: **BVV**
 Description: **Broken Void Visible**

Distance (ft): **63.9**
 Structural Grade: **5**
 O&M Grade: **0**
 Clock Start/From: **7**
 Clock To: **5**
 1st Value:
 2nd Value:
 Value Percent:
 Continuous Index:
 Within 8" of Joint: **YES**
 Remarks:

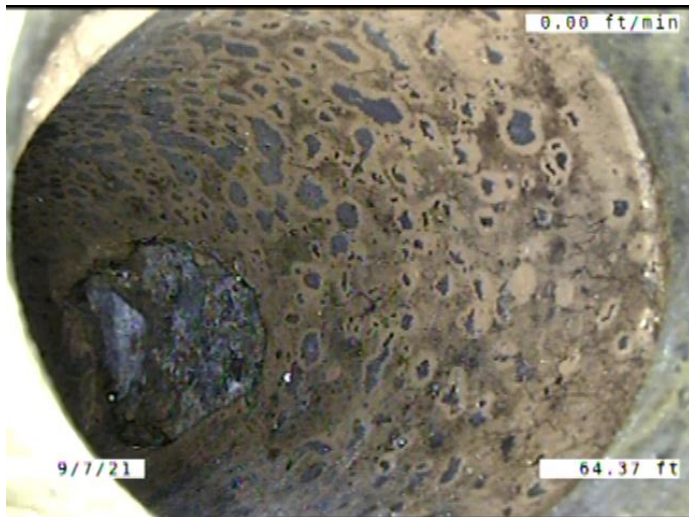
Code: **TBI**
 Description: **Tap Break-in Intruding**

Distance (ft): **64.4**
 Structural Grade: **0**
 O&M Grade: **2**
 Clock Start/From: **11**
 Clock To:
 1st Value: **4.000**
 2nd Value: **1.000**
 Value Percent:
 Continuous Index:
 Within 8" of Joint: **YES**
 Remarks:

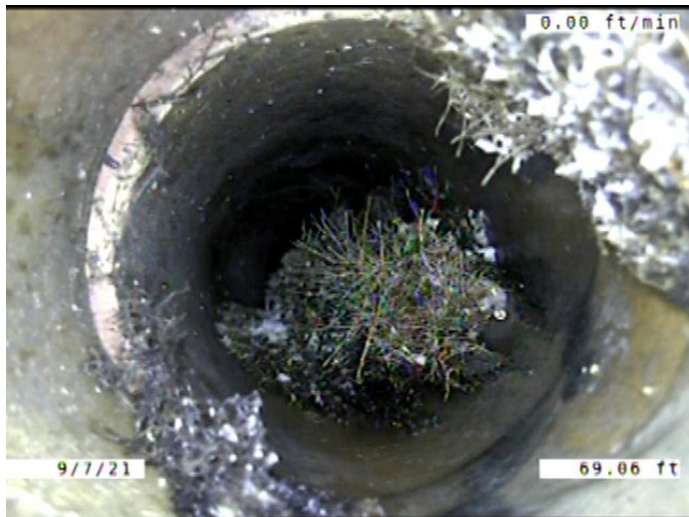
Code:	TF
Description:	Tap Factory
Distance (ft):	69.1
Structural Grade:	0
O&M Grade:	0
Clock Start/From:	1
Clock To:	
1st Value:	4.000
2nd Value:	
Value Percent:	
Continuous Index:	
Within 8" of Joint:	YES
Remarks:	ROOTS GROWING IN THE TAP

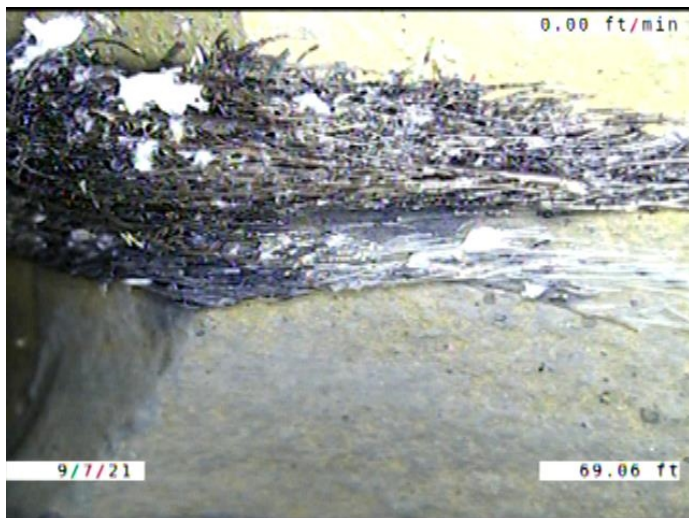
Code:	RFL
Description:	Roots Fine Lateral
Distance (ft):	69.1
Structural Grade:	0
O&M Grade:	1
Clock Start/From:	2
Clock To:	4
1st Value:	
2nd Value:	
Value Percent:	
Continuous Index:	
Within 8" of Joint:	NO
Remarks:

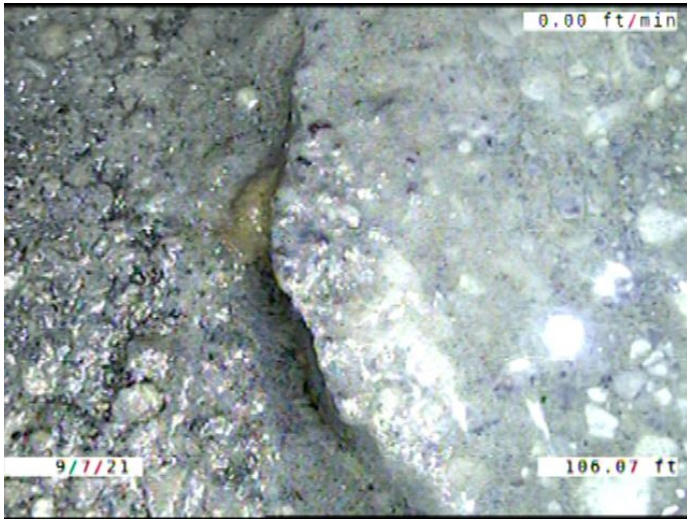
Code: **B**
 Description: **Broken**

Distance (ft): **106.1**
 Structural Grade: **4**
 O&M Grade: **0**
 Clock Start/From: **7**
 Clock To: **8**
 1st Value:
 2nd Value:
 Value Percent:
 Continuous Index:
 Within 8" of Joint: **NO**
 Remarks:

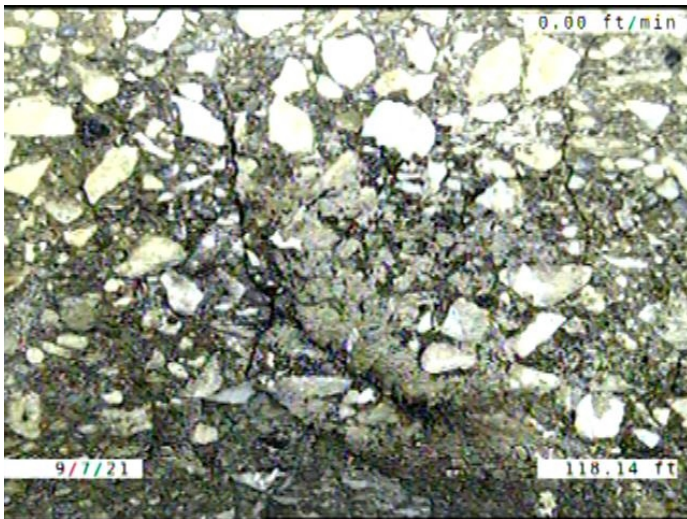
Code: **CM**
 Description: **Crack Multiple**

Distance (ft): **118.1**
 Structural Grade: **3**
 O&M Grade: **0**
 Clock Start/From: **12**
 Clock To: **4**
 1st Value:
 2nd Value:
 Value Percent:
 Continuous Index:
 Within 8" of Joint: **YES**
 Remarks:

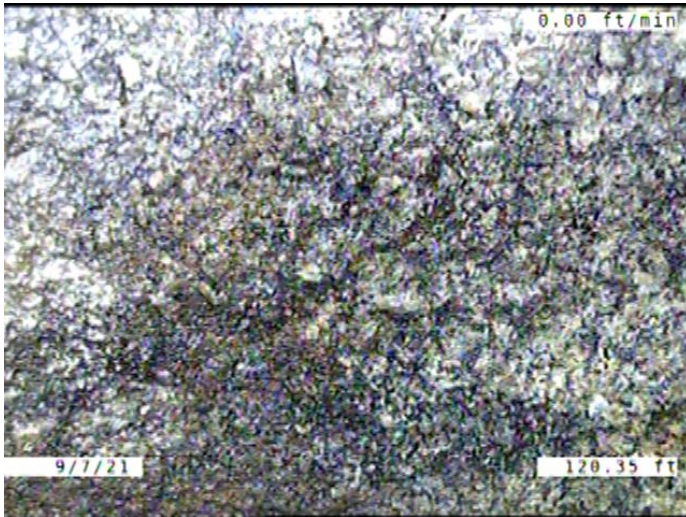
Code: **ISB**
 Description: **Infiltration Stain Barrel**

Distance (ft): **120.3**
 Structural Grade: **0**
 O&M Grade: **1**
 Clock Start/From: **7**
 Clock To: **11**
 1st Value:
 2nd Value:
 Value Percent:
 Continuous Index:
 Within 8" of Joint: **YES**
 Remarks:

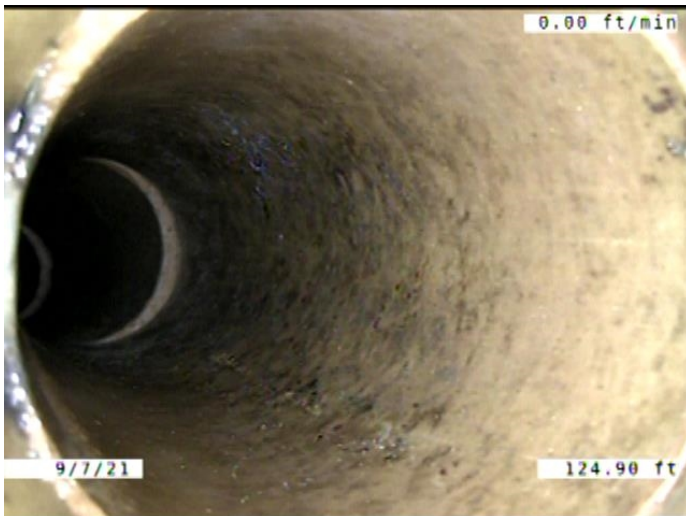
Code: **TBI**
 Description: **Tap Break-in Intruding**

Distance (ft): **124.9**
 Structural Grade: **0**
 O&M Grade: **2**
 Clock Start/From: **10**
 Clock To:
 1st Value: **4.000**
 2nd Value: **2.000**
 Value Percent:
 Continuous Index:
 Within 8" of Joint: **NO**
 Remarks:

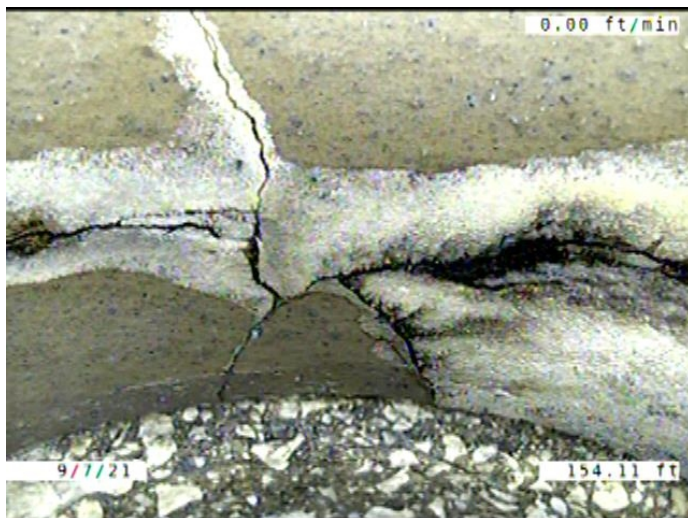
Code: **DAE**
 Description: **Deposits Attached Encrustation**

Distance (ft): **154.1**
 Structural Grade: **0**
 O&M Grade: **2**
 Clock Start/From: **7**
 Clock To: **5**
 1st Value:
 2nd Value:
 Value Percent: **5.000**
 Continuous Index:
 Within 8" of Joint: **YES**
 Remarks:

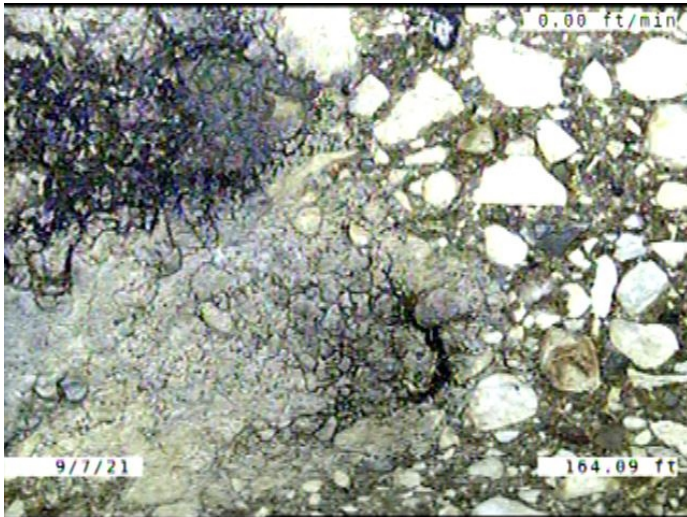
Code: **DAE**
 Description: **Deposits Attached Encrustation**

Distance (ft): **164.1**
 Structural Grade: **0**
 O&M Grade: **2**
 Clock Start/From: **7**
 Clock To: **11**
 1st Value:
 2nd Value:
 Value Percent: **5.000**
 Continuous Index:
 Within 8" of Joint: **NO**
 Remarks:

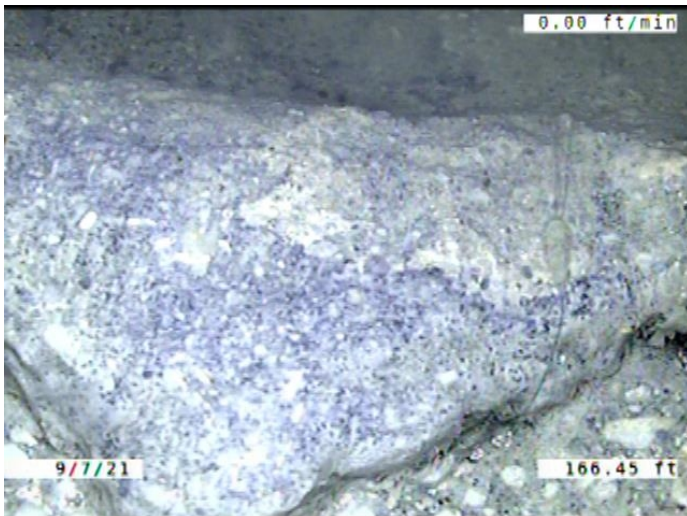
Code: **DAE**
 Description: **Deposits Attached Encrustation**

Distance (ft): **166.4**
 Structural Grade: **0**
 O&M Grade: **2**
 Clock Start/From: **5**
 Clock To: **7**
 1st Value:
 2nd Value:
 Value Percent: **5.000**
 Continuous Index: **S05**
 Within 8" of Joint: **YES**
 Remarks:
