# Profile/Photo Observation Report

Date:	09/07/2021	Weather:		Coding:	PACP 7.0
Pipe Length (ft):	194.7	Owner:	City of Hobart	Pre Clean:	Light Cleaning
P.O.#:	YES502259	Surveyor:	S. Bucklin	PSR:	P-504-110-112
Customer:	City of Hobart	Clean Date:	08/26/2021	Shape:	C

Street:	41st Avenue	Flow Control:	Not Controlled
City:	Hobart, IN	Year Renewed:	
Location:	Alley	Tape/Media #:	
Purpose:	Routine Assessment	Dia/Height:	10"
Use:	Sanitary Sewage Pipe	Material:	CP
Drain Area:		Lining:	None
Category:	NA		
Comment:			
Location Details:		Direction of Survey:	Upstream
US MH:	M-504-112	DS MH:	M-504-110
		Total Length Surveyed (ft):	194.7

O&M Index:	1.87	O&M Quick:	312I	O&M Rating:	116.00
Structural Index:	3.58	Structural Quick:	514A	Structural Rating:	68.00
Overall Index:	2.27	Overall Quick:	514A	Overall Rating:	184.00

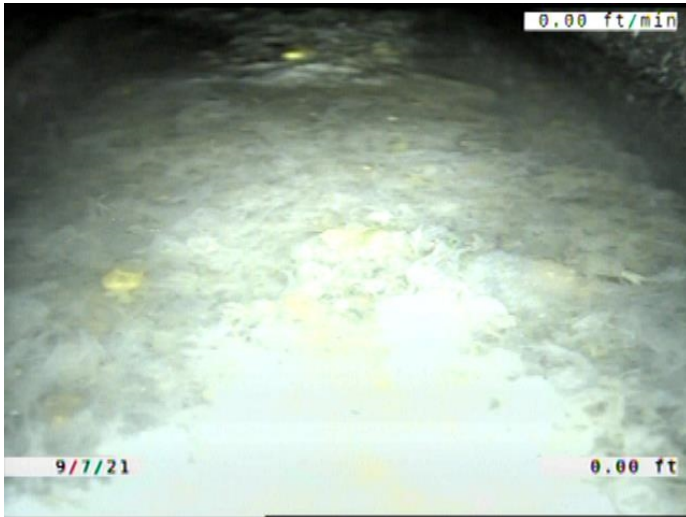
Code:	<b>DSF</b>
Description:	<b>Deposits Settled Fine</b>
Distance (ft):	<b>.0</b>
Structural Grade:	<b>0</b>
O&M Grade:	<b>2</b>
Clock Start/From:	<b>5</b>
Clock To:	<b>7</b>
1st Value:	
2nd Value:	
Value Percent:	<b>5.000</b>
Continuous Index:	<b>S01</b>
Within 8" of Joint:	<b>YES</b>
Remarks:

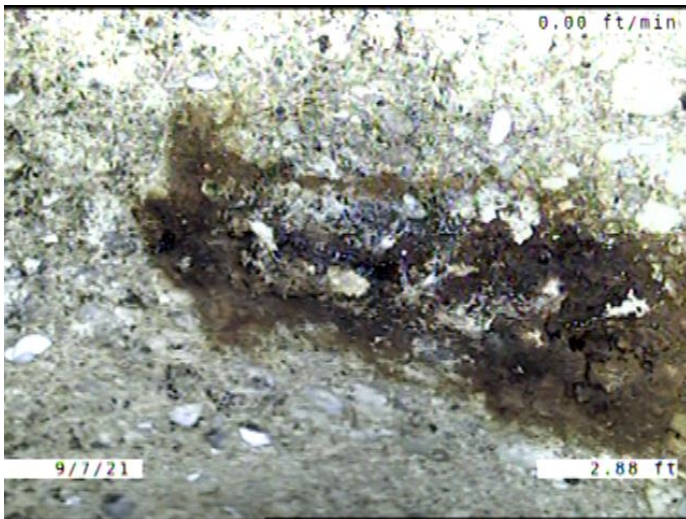
Code:	<b>ISB</b>
Description:	<b>Infiltration Stain Barrel</b>
Distance (ft):	<b>2.9</b>
Structural Grade:	<b>0</b>
O&M Grade:	<b>1</b>
Clock Start/From:	<b>12</b>
Clock To:	<b>3</b>
1st Value:	
2nd Value:	
Value Percent:	
Continuous Index:	
Within 8" of Joint:	<b>NO</b>
Remarks:

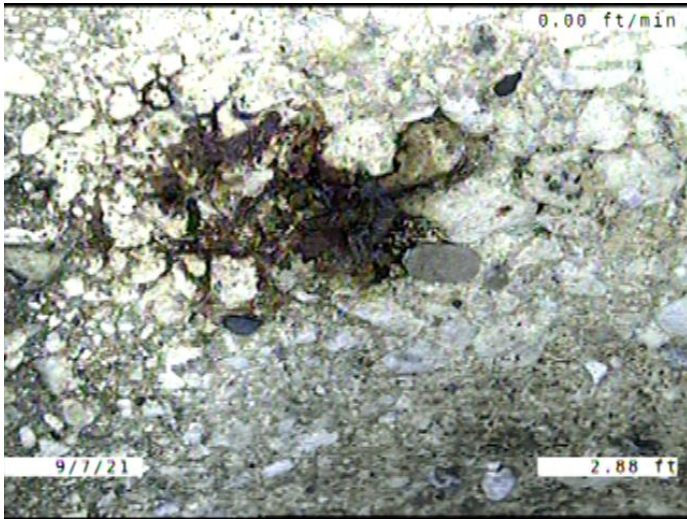
Code: **ISB**  
Description: **Infiltration Stain Barrel**

Distance (ft): **2.9**  
Structural Grade: **0**  
O&M Grade: **1**  
Clock Start/From: **9**  
Clock To: **10**  
1st Value:  
2nd Value:  
Value Percent:  
Continuous Index:  
Within 8" of Joint: **NO**  
Remarks:

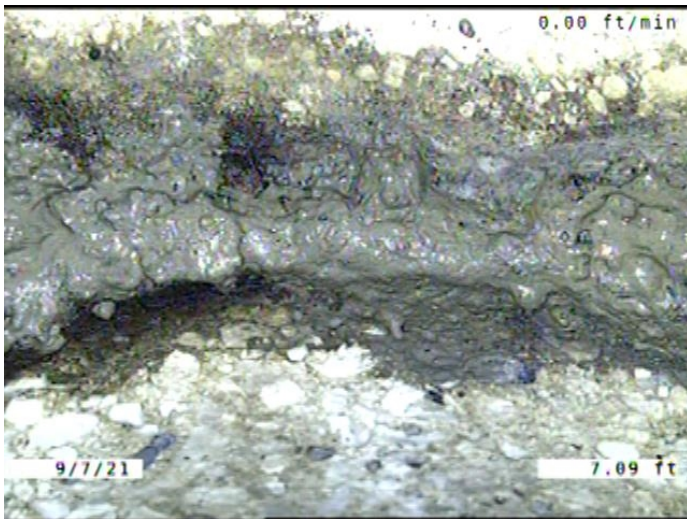
Code: **ISJ**  
Description: **Infiltration Stain Joint**

Distance (ft): **7.1**  
Structural Grade: **0**  
O&M Grade: **1**  
Clock Start/From: **8**  
Clock To: **4**  
1st Value:  
2nd Value:  
Value Percent:  
Continuous Index:  
Within 8" of Joint: **YES**  
Remarks:

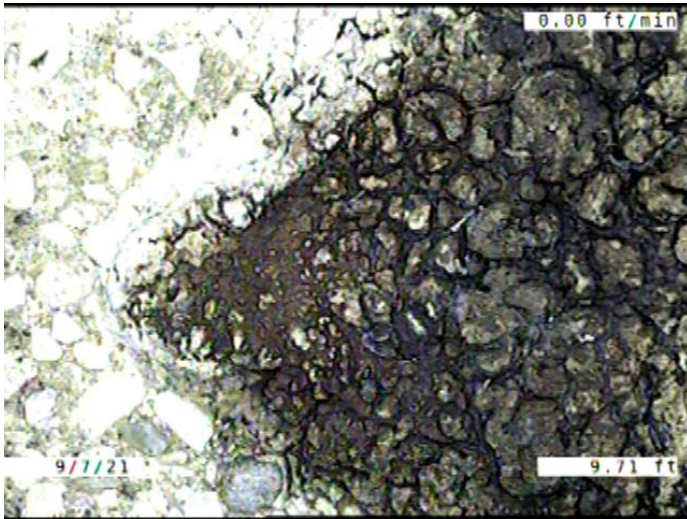
Code: **DAE**  
 Description: **Deposits Attached Encrustation**

Distance (ft): **9.7**  
 Structural Grade: **0**  
 O&M Grade: **2**  
 Clock Start/From: **2**  
 Clock To: **3**  
 1st Value:  
 2nd Value:  
 Value Percent: **5.000**  
 Continuous Index:  
 Within 8" of Joint: **YES**  
 Remarks:

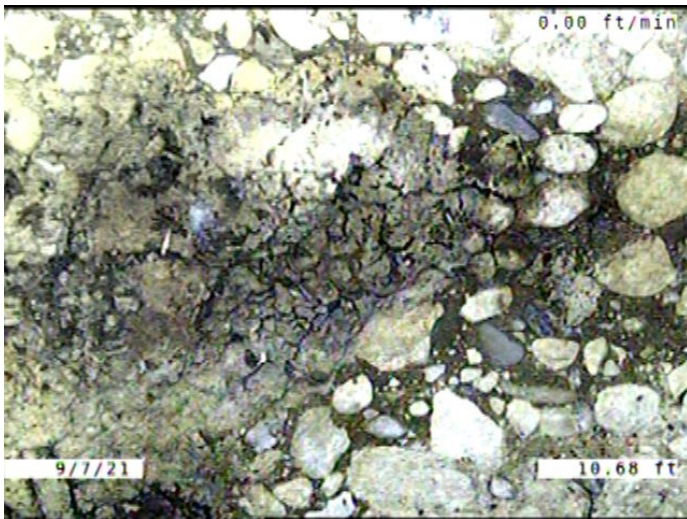
Code: **DAE**  
 Description: **Deposits Attached Encrustation**

Distance (ft): **10.7**  
 Structural Grade: **0**  
 O&M Grade: **2**  
 Clock Start/From: **9**  
 Clock To: **10**  
 1st Value:  
 2nd Value:  
 Value Percent: **5.000**  
 Continuous Index:  
 Within 8" of Joint: **YES**  
 Remarks:

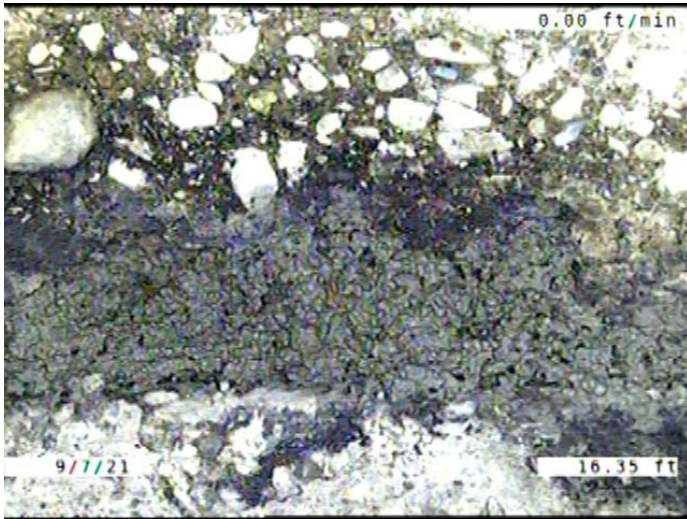
Code: **ISJ**  
 Description: **Infiltration Stain Joint**

Distance (ft): **16.3**  
 Structural Grade: **0**  
 O&M Grade: **1**  
 Clock Start/From: **7**  
 Clock To: **5**  
 1st Value:  
 2nd Value:  
 Value Percent:  
 Continuous Index:  
 Within 8" of Joint: **YES**  
 Remarks:

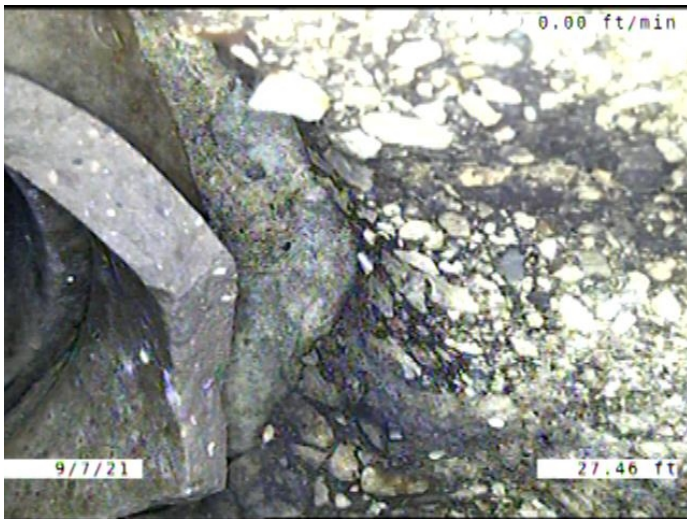
Code: **B**  
 Description: **Broken**

Distance (ft): **27.5**  
 Structural Grade: **4**  
 O&M Grade: **0**  
 Clock Start/From: **12**  
 Clock To: **12**  
 1st Value:  
 2nd Value:  
 Value Percent:  
 Continuous Index:  
 Within 8" of Joint: **YES**  
 Remarks:

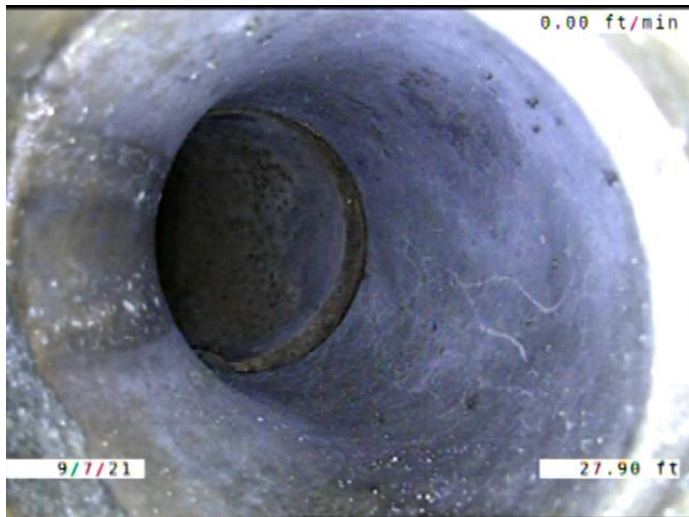
Code: **TBI**  
 Description: **Tap Break-in Intruding**

Distance (ft): **27.9**  
 Structural Grade: **0**  
 O&M Grade: **2**  
 Clock Start/From: **10**  
 Clock To:  
 1st Value: **4.000**  
 2nd Value: **1.000**  
 Value Percent:  
 Continuous Index:  
 Within 8" of Joint: **NO**  
 Remarks:

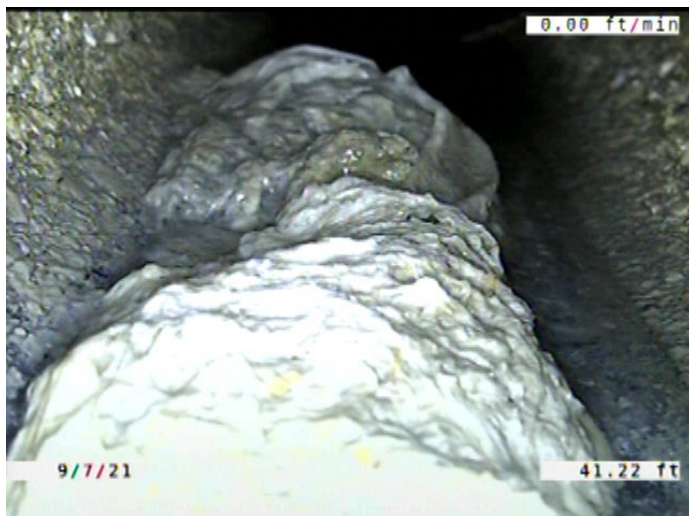
Code: **DSZ**  
 Description: **Deposits Settled Other**

Distance (ft): **41.2**  
 Structural Grade: **0**  
 O&M Grade: **2**  
 Clock Start/From: **5**  
 Clock To: **7**  
 1st Value:  
 2nd Value:  
 Value Percent: **5.000**  
 Continuous Index:  
 Within 8" of Joint: **YES**  
 Remarks: **RAGS AND TP**

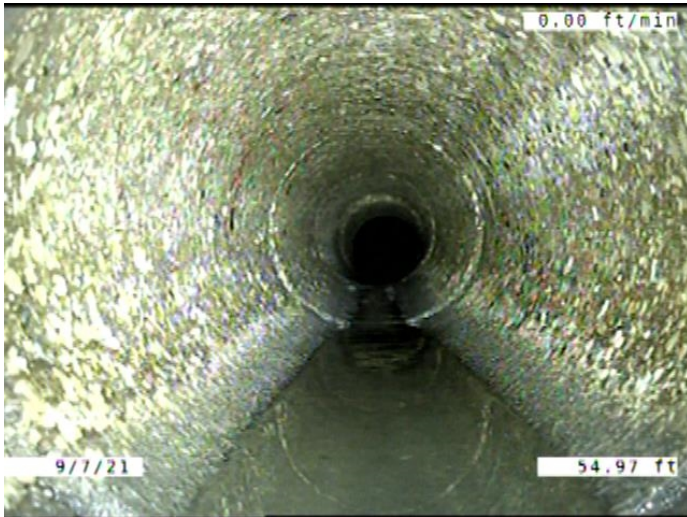
Code: **MWLS**  
 Description: **Miscellaneous Water Level Sag**

Distance (ft): **55.0**  
 Structural Grade: **2**  
 O&M Grade: **0**  
 Clock Start/From:  
 Clock To:  
 1st Value:  
 2nd Value:  
 Value Percent: **5.000**  
 Continuous Index:  
 Within 8" of Joint: **NO**  
 Remarks:

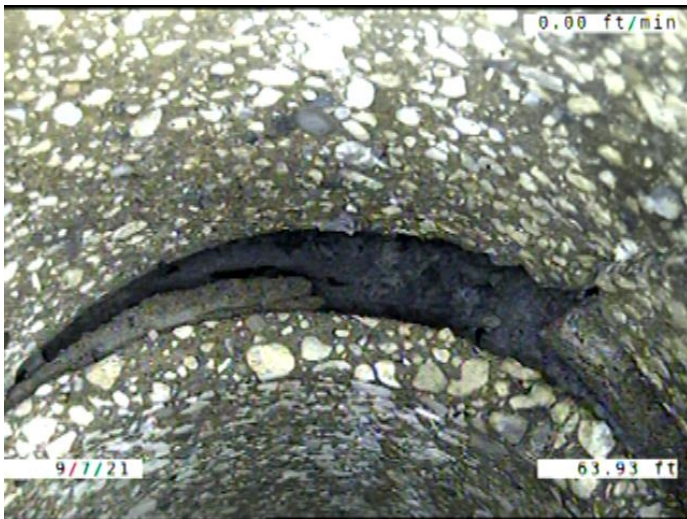
Code: **BVV**  
 Description: **Broken Void Visible**

Distance (ft): **63.9**  
 Structural Grade: **5**  
 O&M Grade: **0**  
 Clock Start/From: **7**  
 Clock To: **5**  
 1st Value:  
 2nd Value:  
 Value Percent:  
 Continuous Index:  
 Within 8" of Joint: **YES**  
 Remarks:

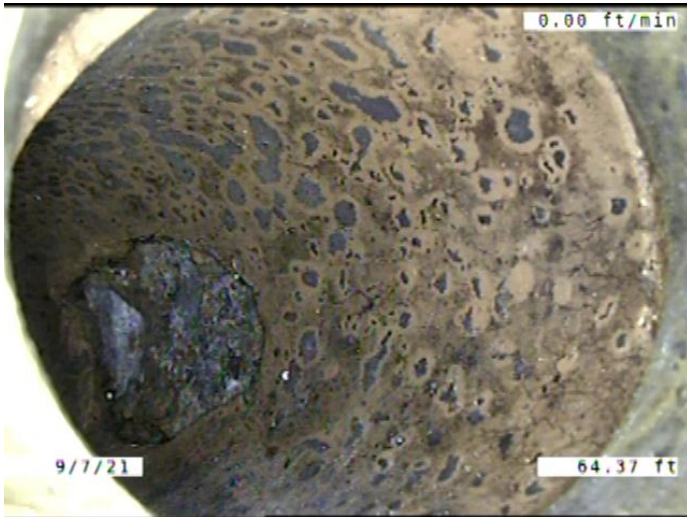
Code: **TBI**  
 Description: **Tap Break-in Intruding**

Distance (ft): **64.4**  
 Structural Grade: **0**  
 O&M Grade: **2**  
 Clock Start/From: **11**  
 Clock To:  
 1st Value: **4.000**  
 2nd Value: **1.000**  
 Value Percent:  
 Continuous Index:  
 Within 8" of Joint: **YES**  
 Remarks:

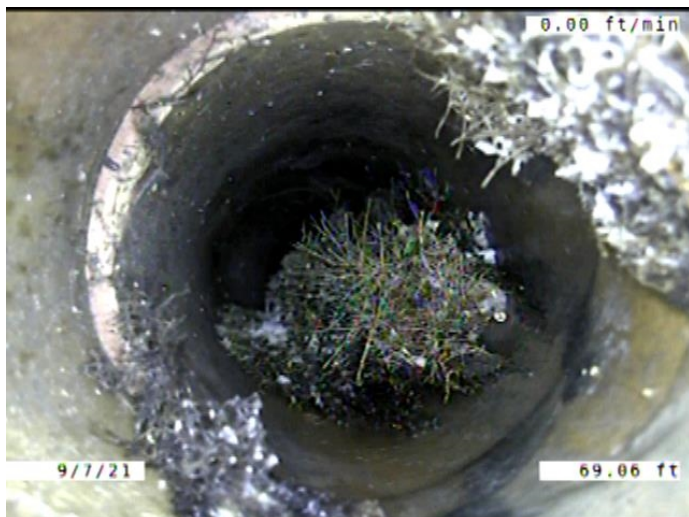
Code:	<b>TF</b>
Description:	<b>Tap Factory</b>
Distance (ft):	<b>69.1</b>
Structural Grade:	<b>0</b>
O&M Grade:	<b>0</b>
Clock Start/From:	<b>1</b>
Clock To:	
1st Value:	<b>4.000</b>
2nd Value:	
Value Percent:	
Continuous Index:	
Within 8" of Joint:	<b>YES</b>
Remarks:	<b>ROOTS GROWING IN THE TAP</b>

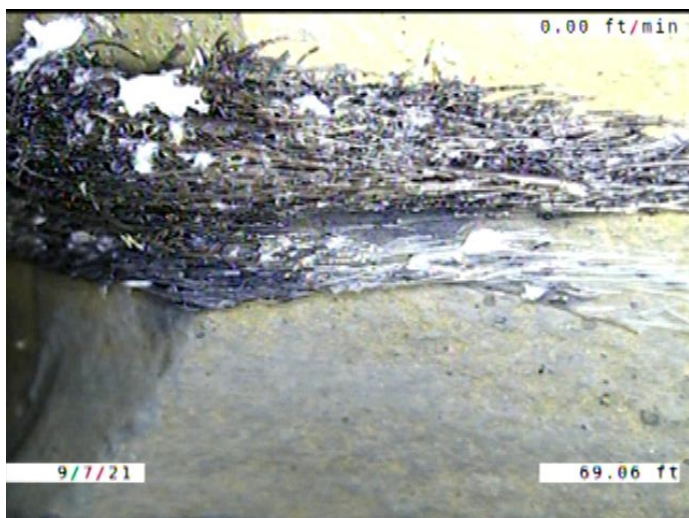
Code:	<b>RFL</b>
Description:	<b>Roots Fine Lateral</b>
Distance (ft):	<b>69.1</b>
Structural Grade:	<b>0</b>
O&M Grade:	<b>1</b>
Clock Start/From:	<b>2</b>
Clock To:	<b>4</b>
1st Value:	
2nd Value:	
Value Percent:	
Continuous Index:	
Within 8" of Joint:	<b>NO</b>
Remarks:

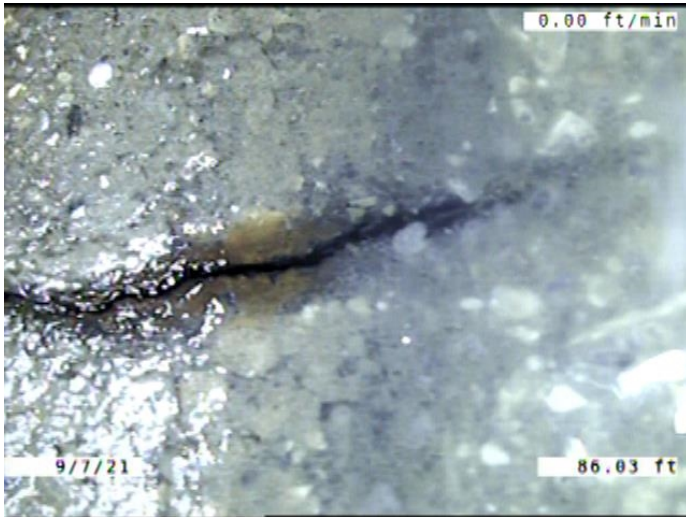
Code: **FM**  
 Description: **Fracture Multiple**

Distance (ft): **86.0**  
 Structural Grade: **4**  
 O&M Grade: **0**  
 Clock Start/From: **4**  
 Clock To: **8**  
 1st Value:  
 2nd Value:  
 Value Percent:  
 Continuous Index:  
 Within 8" of Joint: **YES**  
 Remarks:

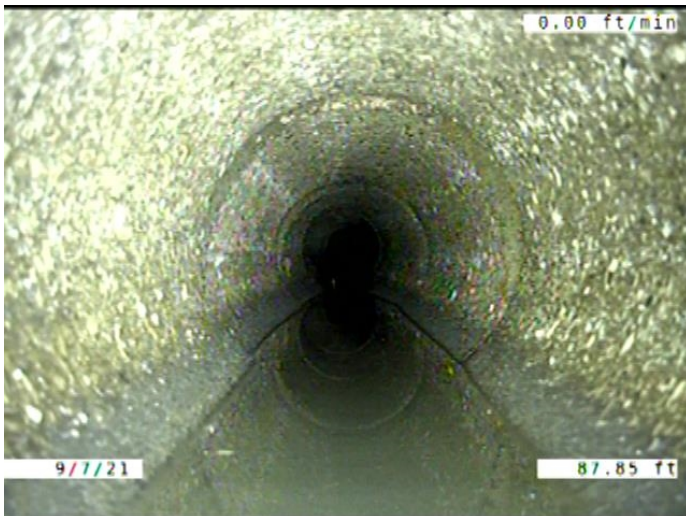
Code: **MWLS**  
 Description: **Miscellaneous Water Level Sag**

Distance (ft): **87.8**  
 Structural Grade: **2**  
 O&M Grade: **0**  
 Clock Start/From:  
 Clock To:  
 1st Value:  
 2nd Value:  
 Value Percent: **5.000**  
 Continuous Index: **S02**  
 Within 8" of Joint: **NO**  
 Remarks:

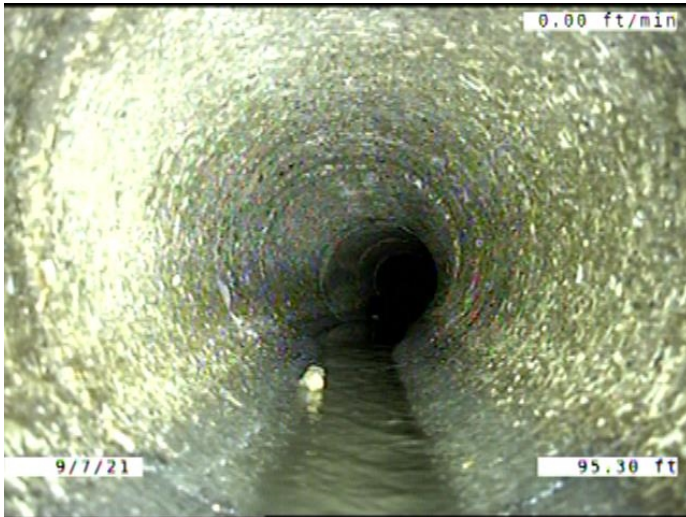
Code: **MWLS**  
 Description: **Miscellaneous Water Level Sag**

Distance (ft): **95.3**  
 Structural Grade: **2**  
 O&M Grade: **0**  
 Clock Start/From:  
 Clock To:  
 1st Value:  
 2nd Value:  
 Value Percent: **5.000**  
 Continuous Index: **F02**  
 Within 8" of Joint: **NO**  
 Remarks:

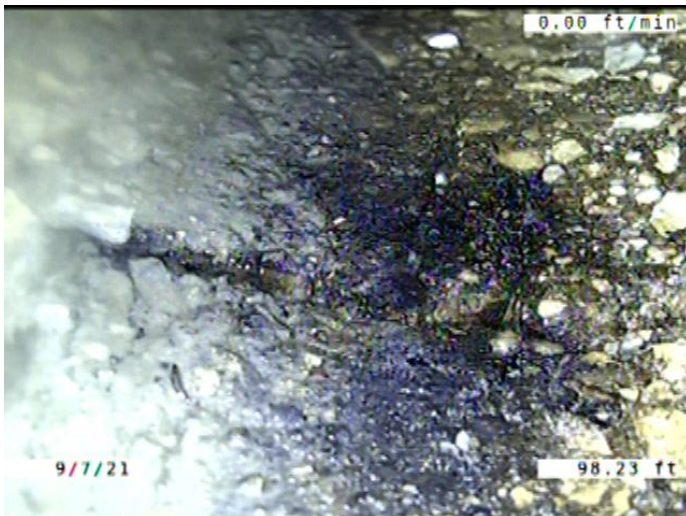
Code: **FM**  
 Description: **Fracture Multiple**

Distance (ft): **98.2**  
 Structural Grade: **4**  
 O&M Grade: **0**  
 Clock Start/From: **3**  
 Clock To: **9**  
 1st Value:  
 2nd Value:  
 Value Percent:  
 Continuous Index:  
 Within 8" of Joint: **YES**  
 Remarks:

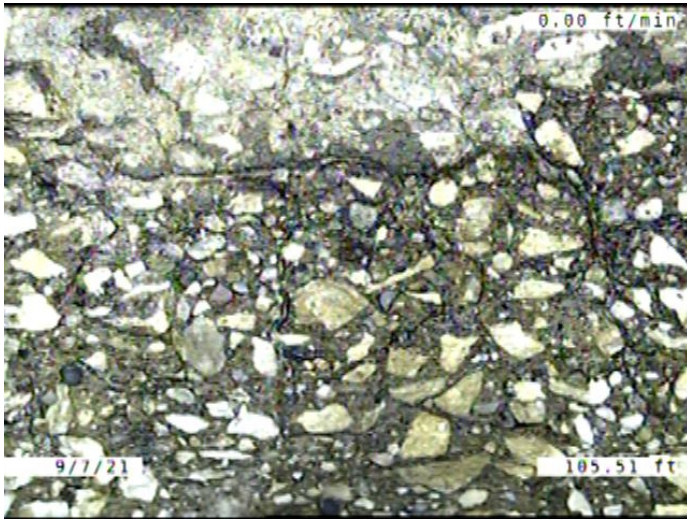
Code: **CM**  
 Description: **Crack Multiple**

Distance (ft): **105.5**  
 Structural Grade: **3**  
 O&M Grade: **0**  
 Clock Start/From: **12**  
 Clock To: **4**  
 1st Value:  
 2nd Value:  
 Value Percent:  
 Continuous Index:  
 Within 8" of Joint: **YES**  
 Remarks:

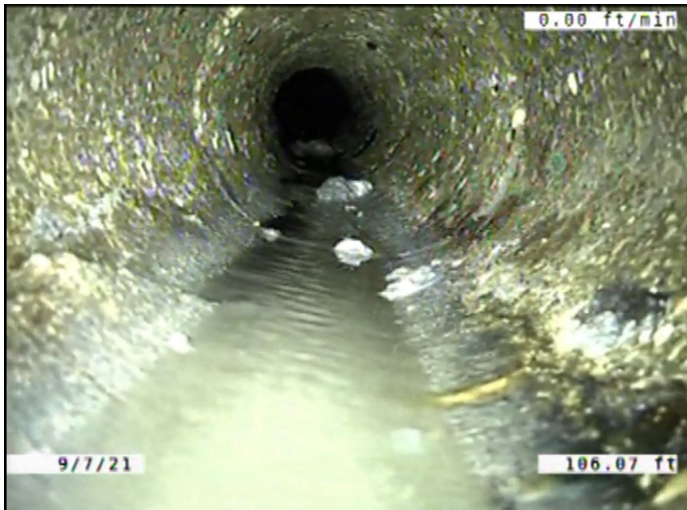
Code: **FM**  
 Description: **Fracture Multiple**

Distance (ft): **106.0**  
 Structural Grade: **4**  
 O&M Grade: **0**  
 Clock Start/From: **12**  
 Clock To: **12**  
 1st Value:  
 2nd Value:  
 Value Percent:  
 Continuous Index:  
 Within 8" of Joint: **YES**  
 Remarks:

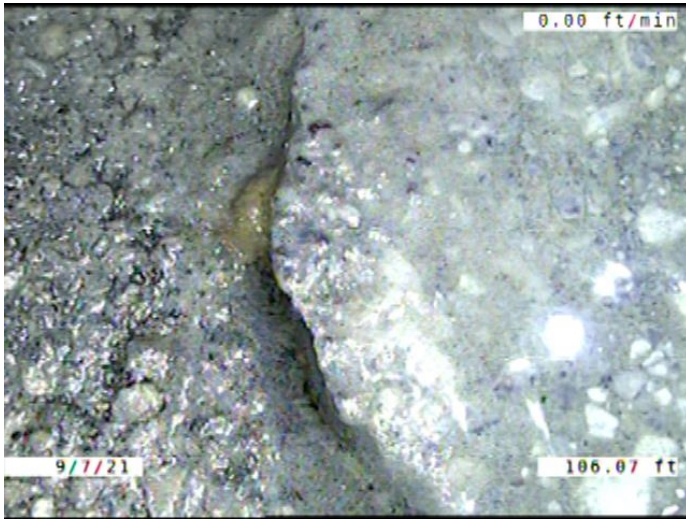
Code: **B**  
 Description: **Broken**

Distance (ft): **106.1**  
 Structural Grade: **4**  
 O&M Grade: **0**  
 Clock Start/From: **7**  
 Clock To: **8**  
 1st Value:  
 2nd Value:  
 Value Percent:  
 Continuous Index:  
 Within 8" of Joint: **NO**  
 Remarks:

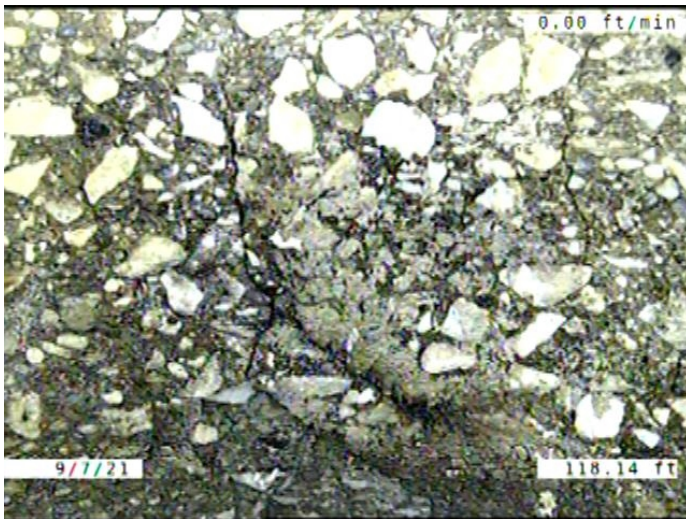
Code: **CM**  
 Description: **Crack Multiple**

Distance (ft): **118.1**  
 Structural Grade: **3**  
 O&M Grade: **0**  
 Clock Start/From: **12**  
 Clock To: **4**  
 1st Value:  
 2nd Value:  
 Value Percent:  
 Continuous Index:  
 Within 8" of Joint: **YES**  
 Remarks:

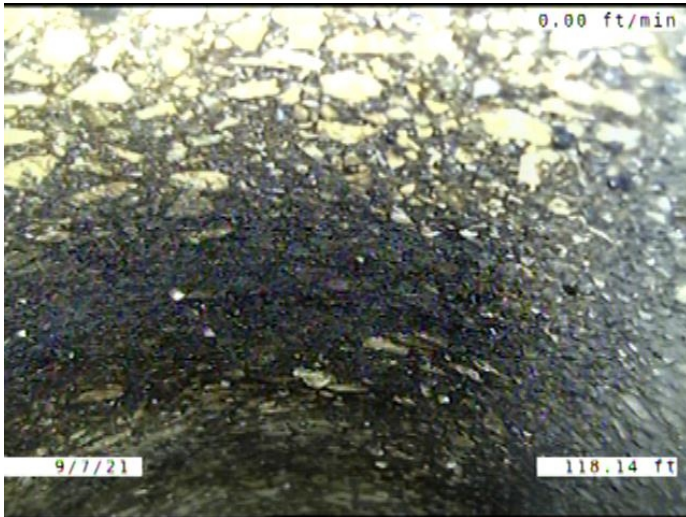
Code: **ISB**  
 Description: **Infiltration Stain Barrel**

Distance (ft): **118.1**  
 Structural Grade: **0**  
 O&M Grade: **1**  
 Clock Start/From: **12**  
 Clock To: **5**  
 1st Value:  
 2nd Value:  
 Value Percent:  
 Continuous Index:  
 Within 8" of Joint: **NO**  
 Remarks:

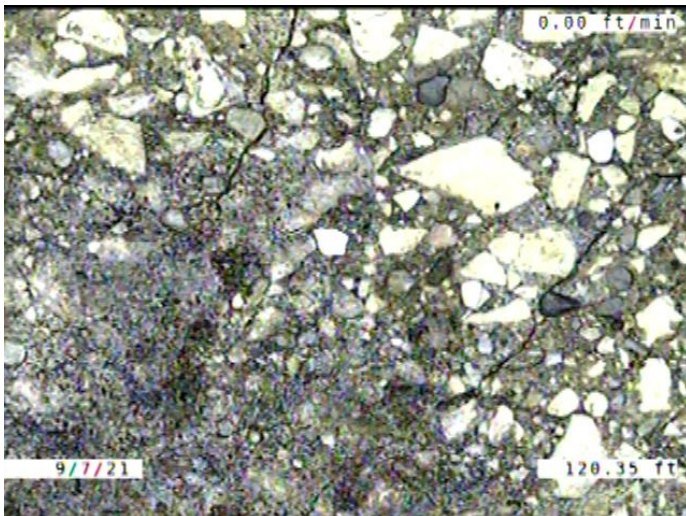
Code: **CM**  
 Description: **Crack Multiple**

Distance (ft): **120.3**  
 Structural Grade: **3**  
 O&M Grade: **0**  
 Clock Start/From: **10**  
 Clock To: **11**  
 1st Value:  
 2nd Value:  
 Value Percent:  
 Continuous Index:  
 Within 8" of Joint: **YES**  
 Remarks:

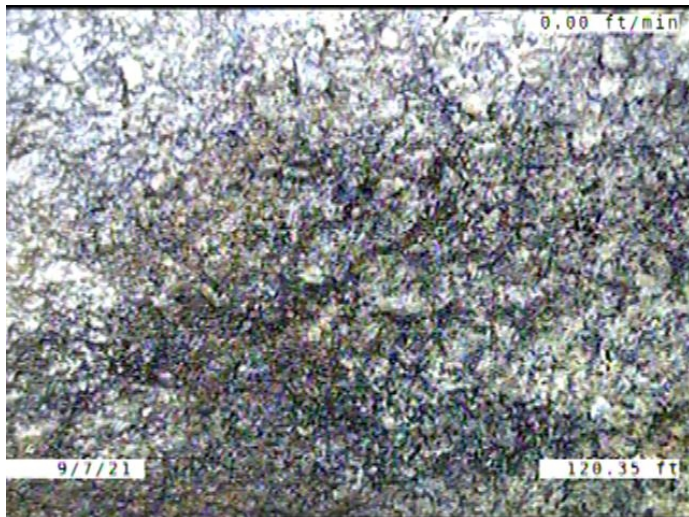
Code: **ISB**  
 Description: **Infiltration Stain Barrel**

Distance (ft): **120.3**  
 Structural Grade: **0**  
 O&M Grade: **1**  
 Clock Start/From: **7**  
 Clock To: **11**  
 1st Value:  
 2nd Value:  
 Value Percent:  
 Continuous Index:  
 Within 8" of Joint: **YES**  
 Remarks:

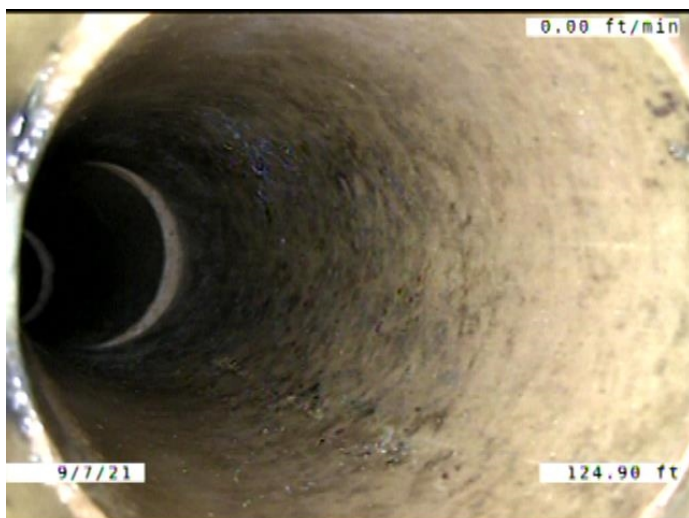
Code: **TBI**  
 Description: **Tap Break-in Intruding**

Distance (ft): **124.9**  
 Structural Grade: **0**  
 O&M Grade: **2**  
 Clock Start/From: **10**  
 Clock To:  
 1st Value: **4.000**  
 2nd Value: **2.000**  
 Value Percent:  
 Continuous Index:  
 Within 8" of Joint: **NO**  
 Remarks:

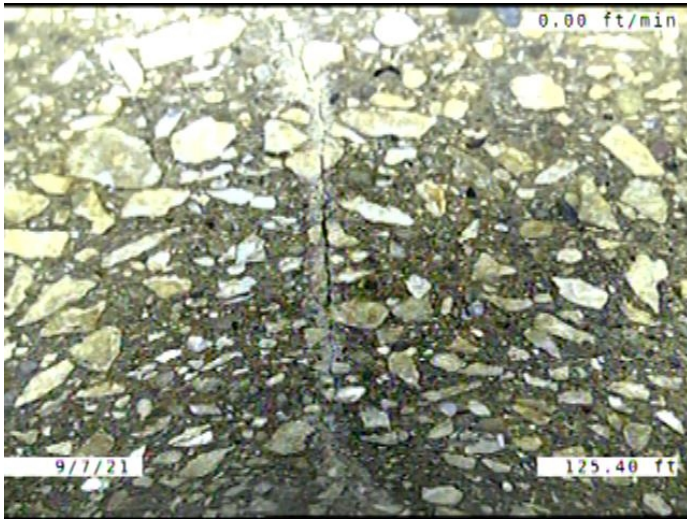
Code: **FM**  
 Description: **Fracture Multiple**

Distance (ft): **125.4**  
 Structural Grade: **4**  
 O&M Grade: **0**  
 Clock Start/From: **12**  
 Clock To: **12**  
 1st Value:  
 2nd Value:  
 Value Percent:  
 Continuous Index: **S04**  
 Within 8" of Joint: **YES**  
 Remarks:

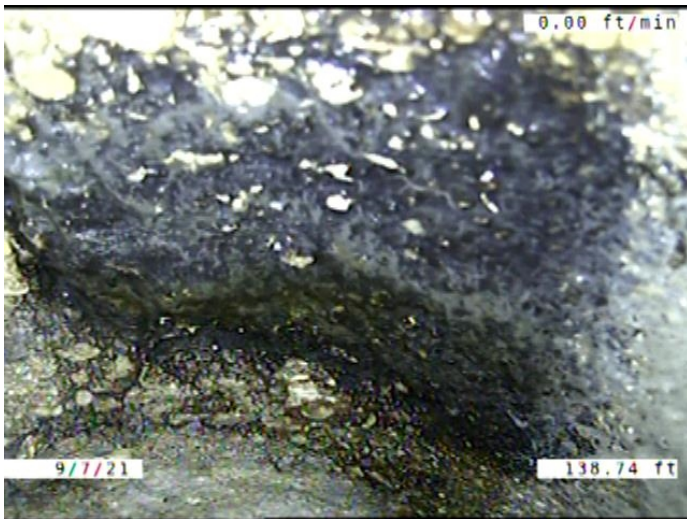
Code: **ISB**  
 Description: **Infiltration Stain Barrel**

Distance (ft): **138.7**  
 Structural Grade: **0**  
 O&M Grade: **1**  
 Clock Start/From: **2**  
 Clock To: **4**  
 1st Value:  
 2nd Value:  
 Value Percent:  
 Continuous Index:  
 Within 8" of Joint: **YES**  
 Remarks:

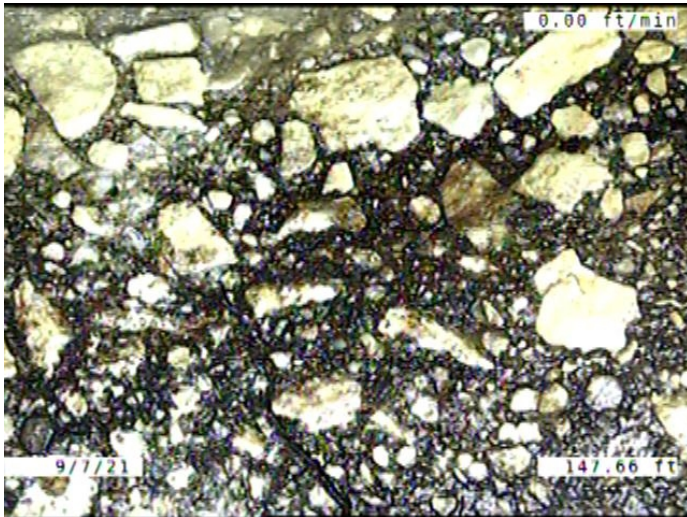
Code: **ISB**  
 Description: **Infiltration Stain Barrel**

Distance (ft): **147.7**  
 Structural Grade: **0**  
 O&M Grade: **1**  
 Clock Start/From: **12**  
 Clock To: **5**  
 1st Value:  
 2nd Value:  
 Value Percent:  
 Continuous Index:  
 Within 8" of Joint: **YES**  
 Remarks:

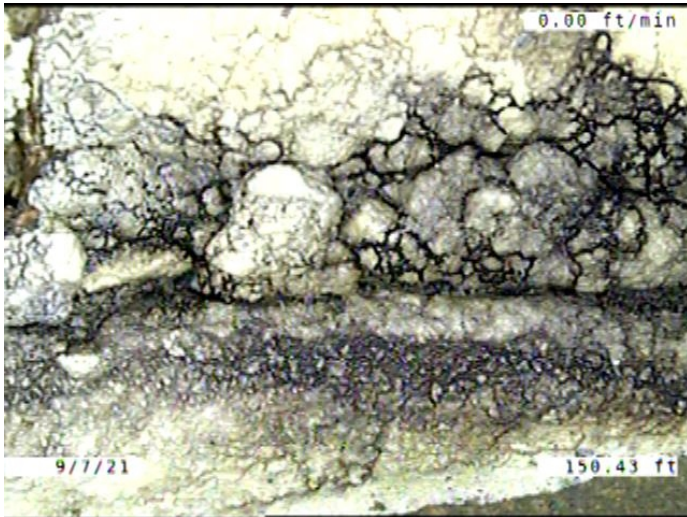
Code: **DAE**  
 Description: **Deposits Attached Encrustation**

Distance (ft): **150.4**  
 Structural Grade: **0**  
 O&M Grade: **2**  
 Clock Start/From: **7**  
 Clock To: **5**  
 1st Value:  
 2nd Value:  
 Value Percent: **5.000**  
 Continuous Index:  
 Within 8" of Joint: **YES**  
 Remarks:

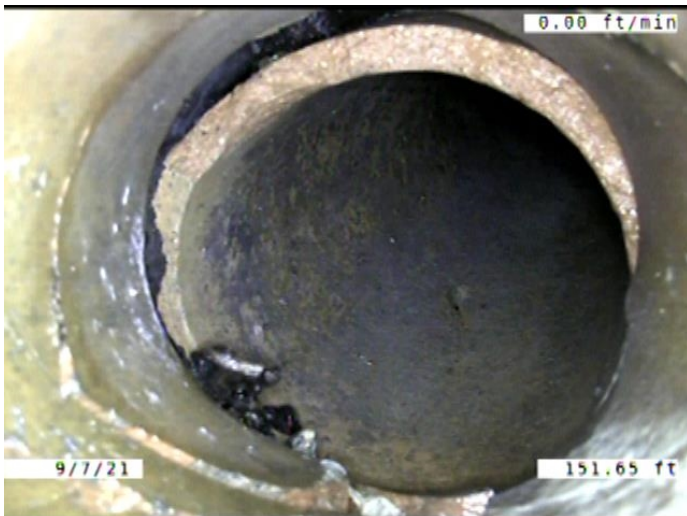
Code: **TFD**  
 Description: **Tap Factory Defective**

Distance (ft): **151.6**  
 Structural Grade: **0**  
 O&M Grade: **3**  
 Clock Start/From: **1**  
 Clock To:  
 1st Value: **4.000**  
 2nd Value:  
 Value Percent:  
 Continuous Index:  
 Within 8" of Joint: **YES**  
 Remarks: **Defective**

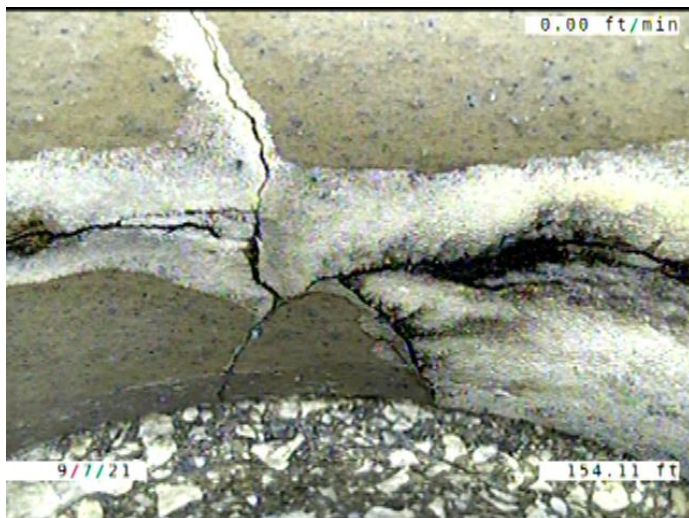
Code: **DAE**  
Description: **Deposits Attached Encrustation**

Distance (ft): **154.1**  
Structural Grade: **0**  
O&M Grade: **2**  
Clock Start/From: **7**  
Clock To: **5**  
1st Value:  
2nd Value:  
Value Percent: **5.000**  
Continuous Index:  
Within 8" of Joint: **YES**  
Remarks:

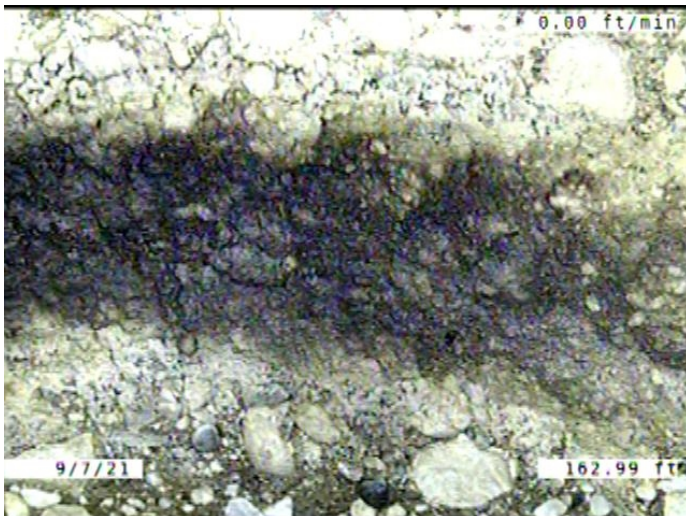
Code: **DAE**  
 Description: **Deposits Attached Encrustation**

Distance (ft): **163.0**  
 Structural Grade: **0**  
 O&M Grade: **2**  
 Clock Start/From: **12**  
 Clock To: **3**  
 1st Value:  
 2nd Value:  
 Value Percent: **5.000**  
 Continuous Index:  
 Within 8" of Joint: **YES**  
 Remarks:

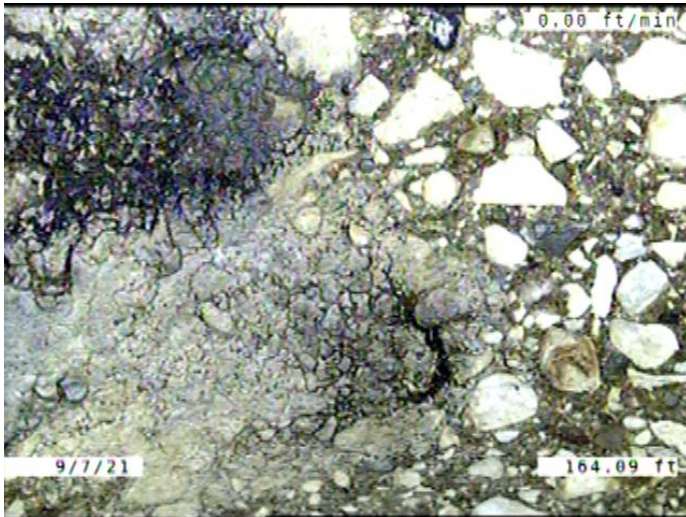
Code:	<b>DAE</b>
Description:	<b>Deposits Attached Encrustation</b>
Distance (ft):	<b>164.1</b>
Structural Grade:	<b>0</b>
O&M Grade:	<b>2</b>
Clock Start/From:	<b>7</b>
Clock To:	<b>11</b>
1st Value:	
2nd Value:	
Value Percent:	<b>5.000</b>
Continuous Index:	
Within 8" of Joint:	<b>NO</b>
Remarks:

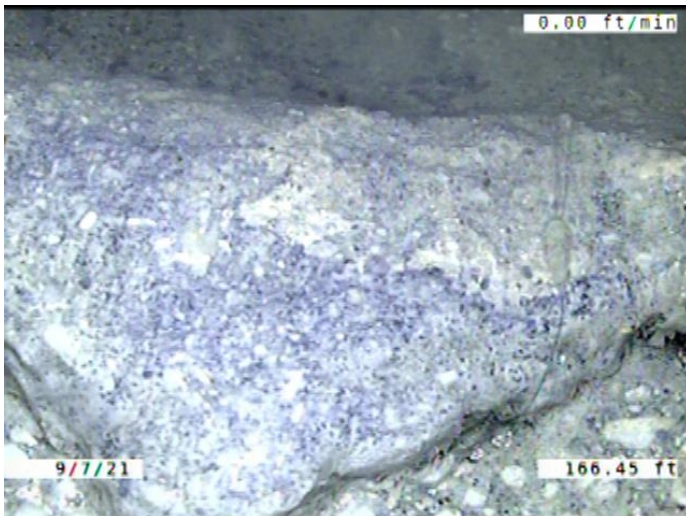
Code:	<b>DAE</b>
Description:	<b>Deposits Attached Encrustation</b>
Distance (ft):	<b>166.4</b>
Structural Grade:	<b>0</b>
O&M Grade:	<b>2</b>
Clock Start/From:	<b>5</b>
Clock To:	<b>7</b>
1st Value:	
2nd Value:	
Value Percent:	<b>5.000</b>
Continuous Index:	<b>S05</b>
Within 8" of Joint:	<b>YES</b>
Remarks:

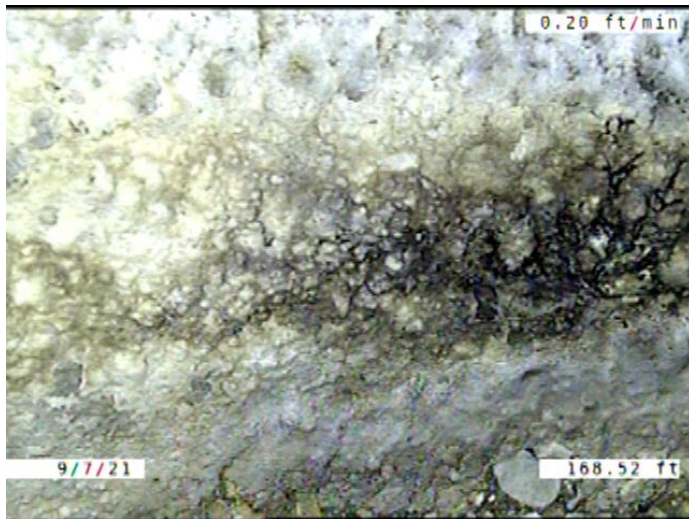
Code: **DAE**  
 Description: **Deposits Attached Encrustation**

Distance (ft): **168.5**  
 Structural Grade: **0**  
 O&M Grade: **2**  
 Clock Start/From: **7**  
 Clock To: **5**  
 1st Value:  
 2nd Value:  
 Value Percent: **5.000**  
 Continuous Index:  
 Within 8" of Joint: **YES**  
 Remarks:

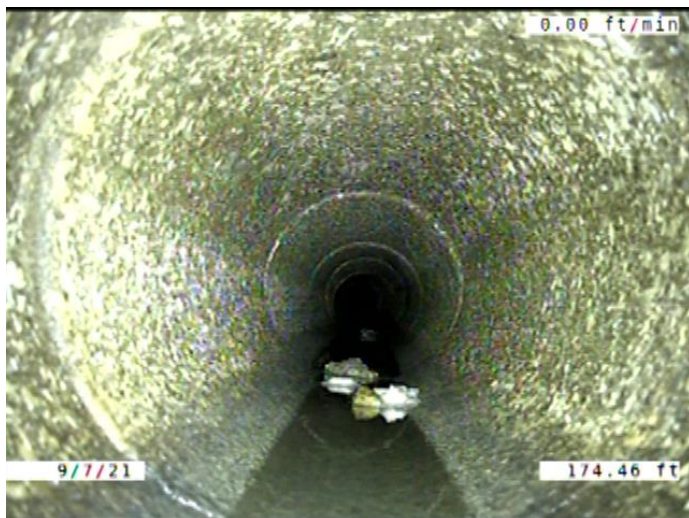
Code: **DAE**  
 Description: **Deposits Attached Encrustation**

Distance (ft): **174.5**  
 Structural Grade: **0**  
 O&M Grade: **2**  
 Clock Start/From: **5**  
 Clock To: **7**  
 1st Value:  
 2nd Value:  
 Value Percent: **5.000**  
 Continuous Index: **F05**  
 Within 8" of Joint: **YES**  
 Remarks:

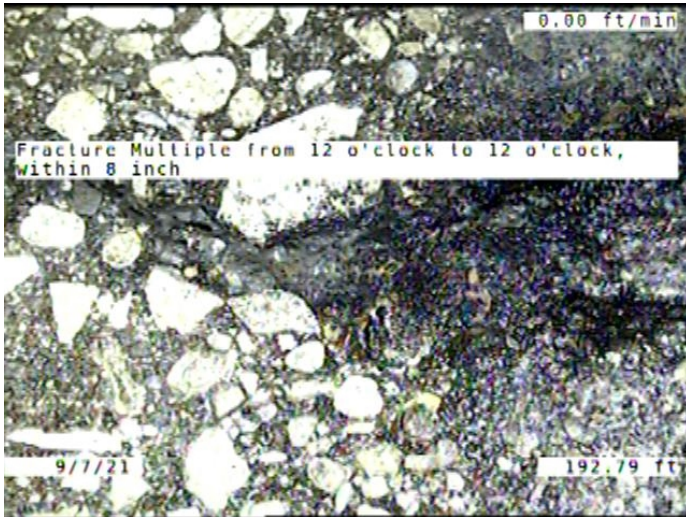
Code: **FM**  
 Description: **Fracture Multiple**

Distance (ft): **192.8**  
 Structural Grade: **4**  
 O&M Grade: **0**  
 Clock Start/From: **12**  
 Clock To: **12**  
 1st Value:  
 2nd Value:  
 Value Percent:  
 Continuous Index:  
 Within 8" of Joint: **YES**  
 Remarks:

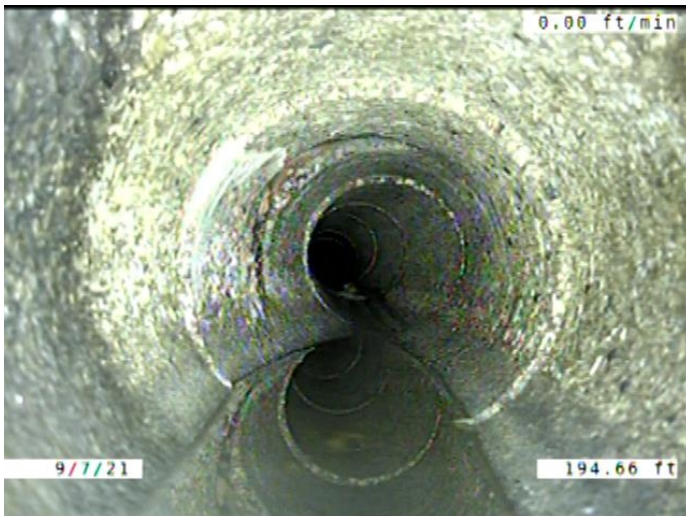
Code: **DSF**  
 Description: **Deposits Settled Fine**

Distance (ft): **194.7**  
 Structural Grade: **0**  
 O&M Grade: **2**  
 Clock Start/From: **5**  
 Clock To: **7**  
 1st Value:  
 2nd Value:  
 Value Percent: **5.000**  
 Continuous Index: **F01**  
 Within 8" of Joint: **YES**  
 Remarks:
