Profile/Photo Observation Report

Date:	04/17/2018	Weather:		Coding:	PACP 6.0
Pipe Length (ft):	367.8	Owner:	NA	Pre Clean:	Not Known
P.O.#:		Surveyor:	Byrd Fitzgerald	PSR:	P-504-112-111
Customer:		Clean Date:	01/01/1900	Shape:	C

Street:	OFF N COLORADO ST	Flow Control:	Not Controlled
City:	Hobart, IN	Year Renewed:	
Location:	Light Highway	Tape/Media #:	
Purpose:	Not Known	Dia/Height:	12"
Use:	Sanitary	Material:	VCP
Drain Area:	NA	Lining:	
Category:	NA		
Comment:

Location Details:		Direction of Survey:	Downstream
US MH:	M-504-111	DS MH:	M-504-112
		Total Length Surveyed (ft):	42.3

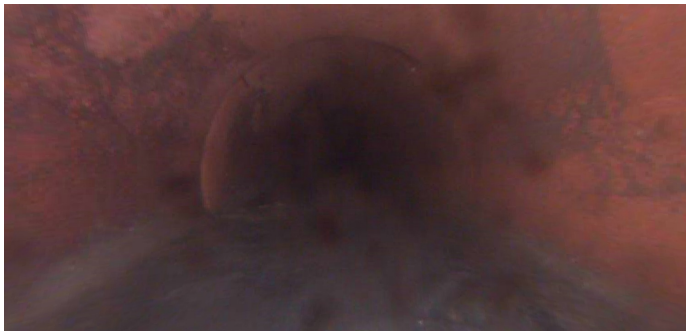
Code: **AMH**
Description: **Manhole**

Distance (ft): **.0**
Structural Grade: **0**
O&M Grade: **0**
Clock Start/From:
Clock To:
1st Value:
2nd Value:
Value Percent:
Continuous Index:
Within 8" of Joint: **NO**
Remarks: **M-504-111**

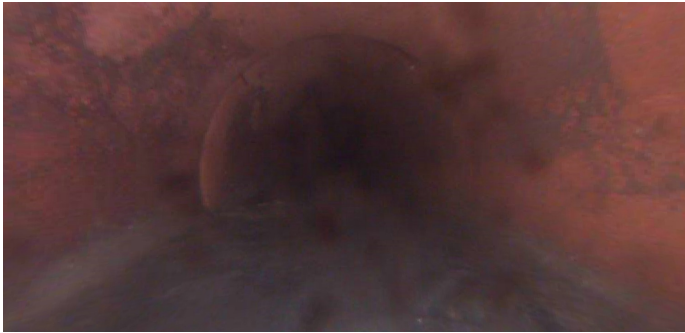
Code:	MWL
Description:	Water Level

Distance (ft):	.0
Structural Grade:	0
O&M Grade:	0
Clock Start/From:	
Clock To:	
1st Value:	
2nd Value:	
Value Percent:	25.000
Continuous Index:	
Within 8" of Joint:	NO
Remarks:

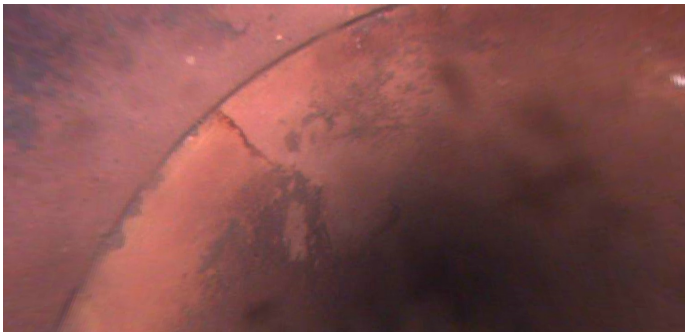
Code:	CL
Description:	Crack Longitudinal

Distance (ft):	1.9
Structural Grade:	2
O&M Grade:	0
Clock Start/From:	11
Clock To:	
1st Value:	
2nd Value:	
Value Percent:	
Continuous Index:	
Within 8" of Joint:	YES
Remarks:

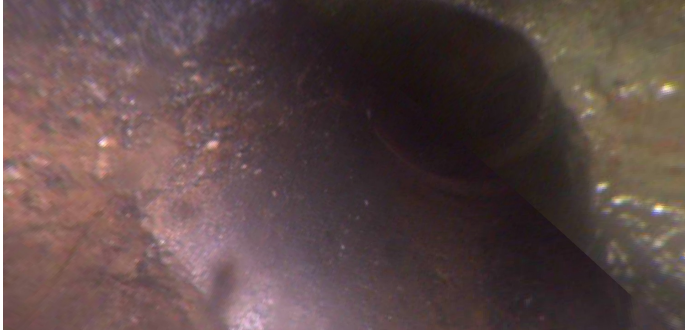
Code: **TF**
Description: **Tap Factory**

Distance (ft): **5.7**
Structural Grade: **0**
O&M Grade: **0**
Clock Start/From: **2**
Clock To:
1st Value: **4.000**
2nd Value:
Value Percent:
Continuous Index:
Within 8" of Joint:
Remarks:

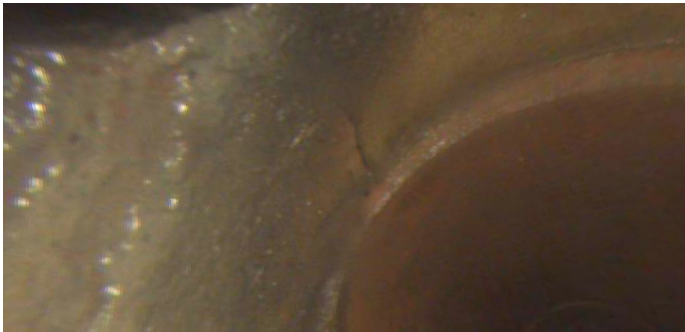
Code: **CL**
Description: **Crack Longitudinal**

Distance (ft): **5.7**
Structural Grade: **2**
O&M Grade: **0**
Clock Start/From: **2**
Clock To:
1st Value:
2nd Value:
Value Percent:
Continuous Index:
Within 8" of Joint: **YES**
Remarks:

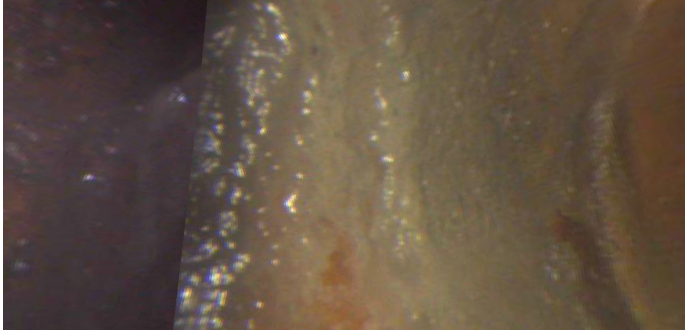
Code: **DAGS**
Description: **Deposits Attached Grease**

Distance (ft): **5.7**
Structural Grade: **0**
O&M Grade: **2**
Clock Start/From: **1**
Clock To: **5**
1st Value:
2nd Value:
Value Percent: **5.000**
Continuous Index:
Within 8" of Joint: **NO**
Remarks:

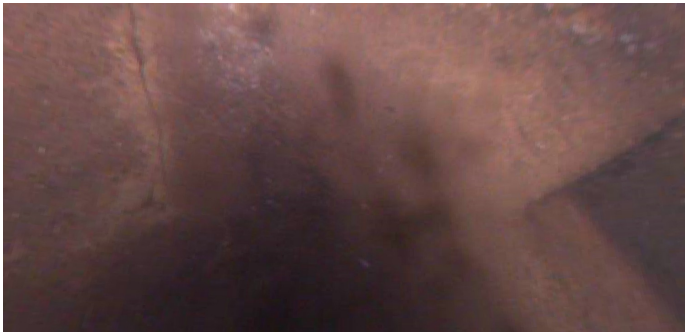
Code: **CM**
Description: **Crack Multiple**

Distance (ft): **5.9**
Structural Grade: **3**
O&M Grade: **0**
Clock Start/From: **11**
Clock To: **3**
1st Value:
2nd Value:
Value Percent:
Continuous Index: **S01**
Within 8" of Joint: **YES**
Remarks: **wandering in barrel/joints**

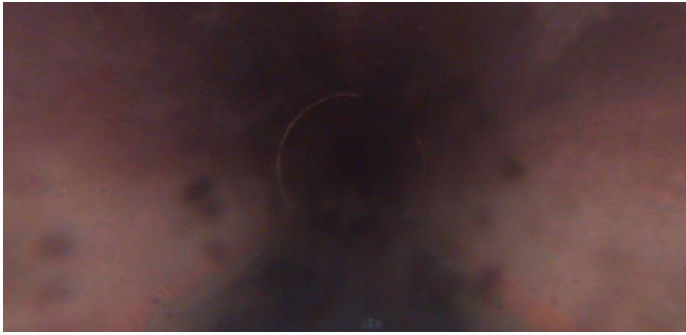
Code: **MSA**
Description: **Abandoned Survey**

Distance (ft): **42.3**
Structural Grade: **0**
O&M Grade: **0**
Clock Start/From:
Clock To:
1st Value:
2nd Value:
Value Percent:
Continuous Index:
Within 8" of Joint: **NO**
Remarks: **no blockage**

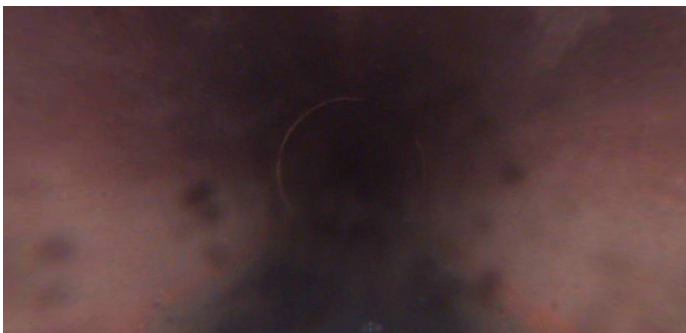
Code: **CM**
Description: **Crack Multiple**

Distance (ft): **42.3**
Structural Grade: **3**
O&M Grade: **0**
Clock Start/From: **11**
Clock To: **3**
1st Value:
2nd Value:
Value Percent:
Continuous Index: **F01**
Within 8" of Joint: **YES**
Remarks: **wandering in barrel/joints**
