Profile/Photo Observation Report

Date:	04/17/2018	Weather:		Coding:	PACP 6.0
Pipe Length (ft):	367.8	Owner:	NA	Pre Clean:	Not Known
P.O.#:		Surveyor:	Byrd Fitzgerald	PSR:	P-504-112-111
Customer:		Clean Date:	01/01/1900	Shape:	C

Street:	Summerlin	Flow Control:	Not Controlled
City:	Hobart, IN	Year Renewed:	
Location:	Light Highway	Tape/Media #:	
Purpose:	Not Known	Dia/Height:	12"
Use:	Sanitary	Material:	VCP
Drain Area:	NA	Lining:	
Category:	NA		
Comment:

Location Details:		Direction of Survey:	Downstream
US MH:	M-504-111	DS MH:	M-504-112
		Total Length Surveyed (ft):	42.3

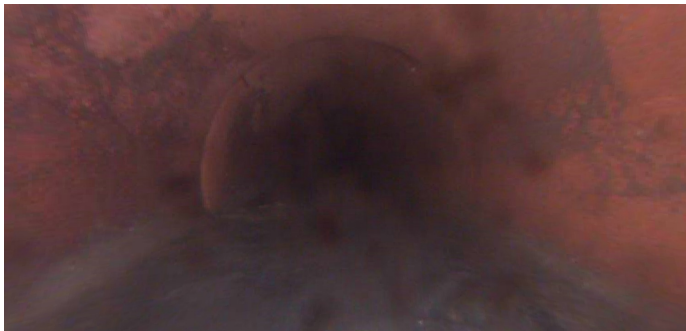
Code: **AMH**
Description: **Manhole**

Distance (ft): **.0**
Structural Grade: **0**
O&M Grade: **0**
Clock Start/From:
Clock To:
1st Value:
2nd Value:
Value Percent:
Continuous Index:
Within 8" of Joint: **NO**
Remarks: **M-504-111**

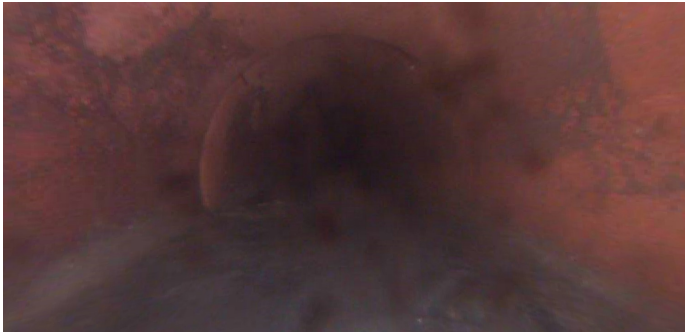
Code:	MWL
Description:	Water Level

Distance (ft):	.0
Structural Grade:	0
O&M Grade:	0
Clock Start/From:	
Clock To:	
1st Value:	
2nd Value:	
Value Percent:	25.000
Continuous Index:	
Within 8" of Joint:	NO
Remarks:

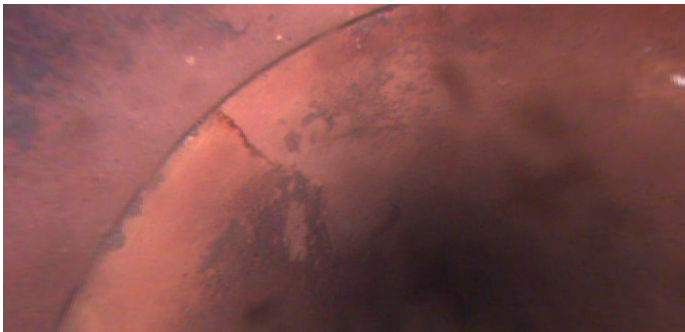
Code:	CL
Description:	Crack Longitudinal

Distance (ft):	1.9
Structural Grade:	2
O&M Grade:	0
Clock Start/From:	11
Clock To:	
1st Value:	
2nd Value:	
Value Percent:	
Continuous Index:	
Within 8" of Joint:	YES
Remarks:

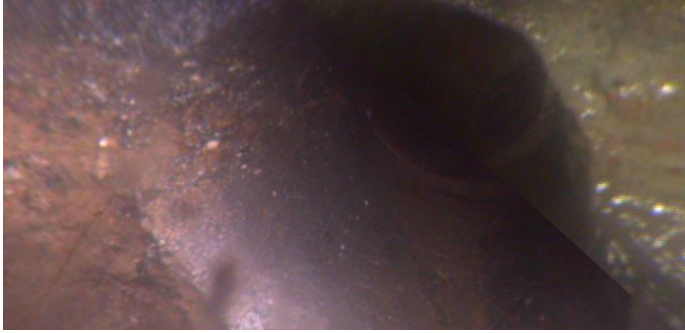
Code: **TF**
Description: **Tap Factory**

Distance (ft): **5.7**
Structural Grade: **0**
O&M Grade: **0**
Clock Start/From: **2**
Clock To:
1st Value: **4.000**
2nd Value:
Value Percent:
Continuous Index:
Within 8" of Joint:
Remarks:

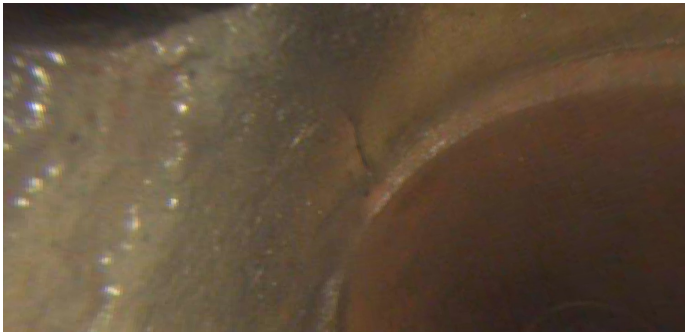
Code: **CL**
Description: **Crack Longitudinal**

Distance (ft): **5.7**
Structural Grade: **2**
O&M Grade: **0**
Clock Start/From: **2**
Clock To:
1st Value:
2nd Value:
Value Percent:
Continuous Index:
Within 8" of Joint: **YES**
Remarks:

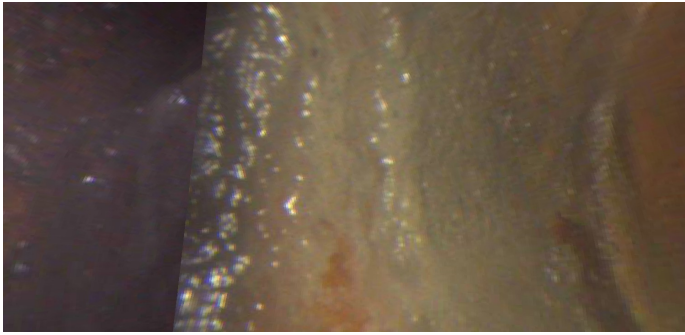
Code: **DAGS**
Description: **Deposits Attached Grease**

Distance (ft): **5.7**
Structural Grade: **0**
O&M Grade: **2**
Clock Start/From: **1**
Clock To: **5**
1st Value:
2nd Value:
Value Percent: **5.000**
Continuous Index:
Within 8" of Joint: **NO**
Remarks:

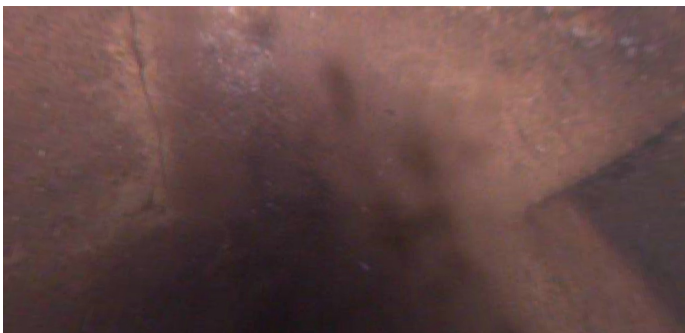
Code: **CM**
Description: **Crack Multiple**

Distance (ft): **5.9**
Structural Grade: **3**
O&M Grade: **0**
Clock Start/From: **11**
Clock To: **3**
1st Value:
2nd Value:
Value Percent:
Continuous Index: **S01**
Within 8" of Joint: **YES**
Remarks: **wandering in barrel/joints**

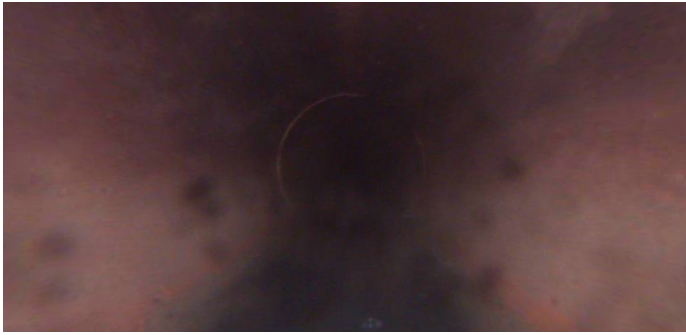
Code: **MSA**
Description: **Abandoned Survey**

Distance (ft): **42.3**
Structural Grade: **0**
O&M Grade: **0**
Clock Start/From:
Clock To:
1st Value:
2nd Value:
Value Percent:
Continuous Index:
Within 8" of Joint: **NO**
Remarks: **no blockage**

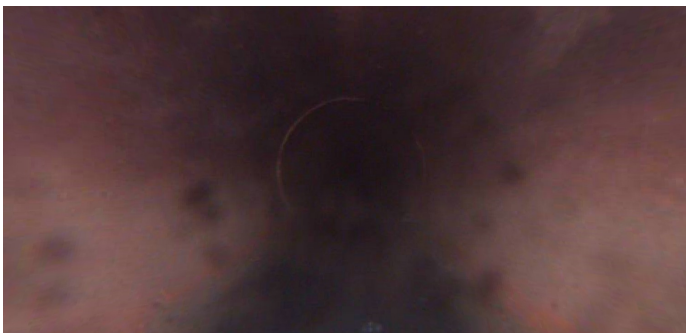
Code: **CM**
Description: **Crack Multiple**

Distance (ft): **42.3**
Structural Grade: **3**
O&M Grade: **0**
Clock Start/From: **11**
Clock To: **3**
1st Value:
2nd Value:
Value Percent:
Continuous Index: **F01**
Within 8" of Joint: **YES**
Remarks: **wandering in barrel/joints**
