Profile/Photo Observation Report

Date:	09/06/2021	Weather:		Coding:	PACP 7.0
Pipe Length (ft):	158.8	Owner:	City of Hobart	Pre Clean:	Heavy Cleaning
P.O.#:	YES502259	Surveyor:	S. Bucklin	PSR:	P-504-112-111
Customer:	City of Hobart	Clean Date:	08/26/2021	Shape:	C

Street:	North Colorado Street	Flow Control:	Not Controlled
City:	Hobart, IN	Year Renewed:	
Location:	Alley	Tape/Media #:	
Purpose:	Routine Assessment	Dia/Height:	12"
Use:	Sanitary Sewage Pipe	Material:	VCP
Drain Area:		Lining:	None
Category:	NA		
Comment:

Location Details:		Direction of Survey:	Downstream
US MH:	M-504-112	DS MH:	M-504-111.1
		Total Length Surveyed (ft):	158.8

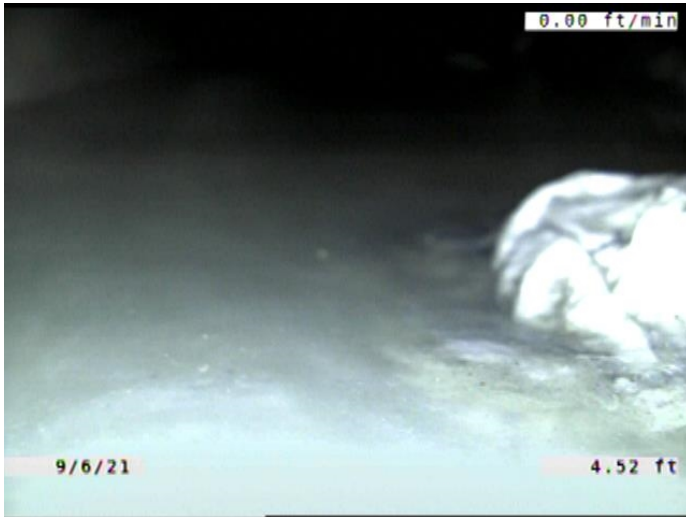
Code: **DSF**
 Description: **Deposits Settled Fine**

Distance (ft): **4.5**
 Structural Grade: **0**
 O&M Grade: **2**
 Clock Start/From: **5**
 Clock To: **7**
 1st Value:
 2nd Value:
 Value Percent: **5.000**
 Continuous Index: **S01**
 Within 8" of Joint: **YES**
 Remarks: **ALSO TP AND RAGS**

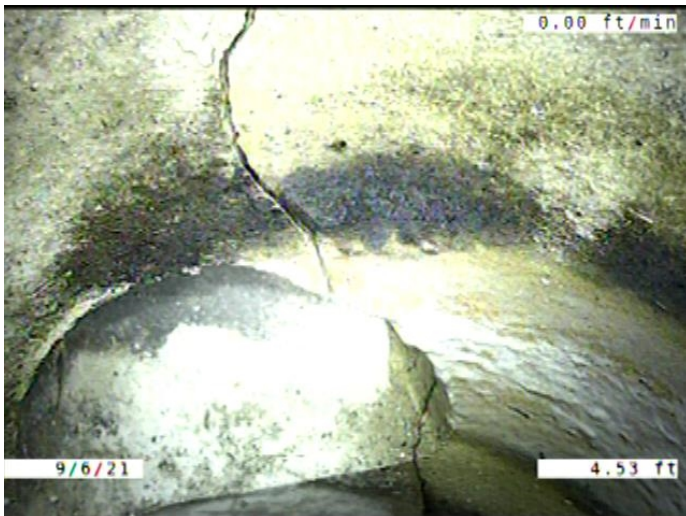
Code: **FM**
 Description: **Fracture Multiple**

Distance (ft): **4.5**
 Structural Grade: **4**
 O&M Grade: **0**
 Clock Start/From: **9**
 Clock To: **3**
 1st Value:
 2nd Value:
 Value Percent:
 Continuous Index: **S02**
 Within 8" of Joint: **YES**
 Remarks:

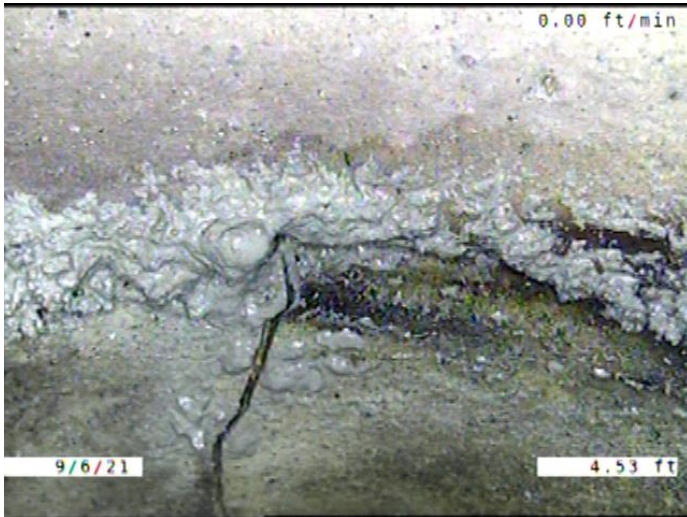
Code: **IWB**
 Description: **Infiltration Weeper Barrel**

Distance (ft): **4.5**
 Structural Grade: **0**
 O&M Grade: **2**
 Clock Start/From: **12**
 Clock To:
 1st Value:
 2nd Value:
 Value Percent:
 Continuous Index:
 Within 8" of Joint: **YES**
 Remarks:

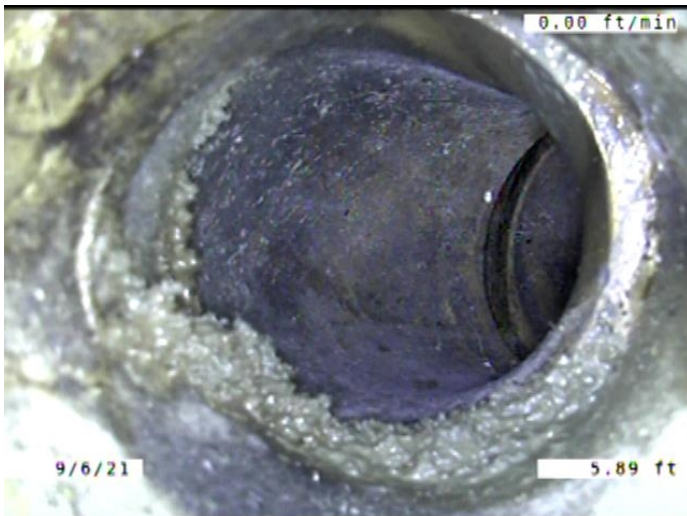
Code: **TFD**
 Description: **Tap Factory Defective**

Distance (ft): **5.9**
 Structural Grade: **0**
 O&M Grade: **3**
 Clock Start/From: **1**
 Clock To:
 1st Value: **4.000**
 2nd Value:
 Value Percent:
 Continuous Index:
 Within 8" of Joint: **YES**
 Remarks: **Defective**

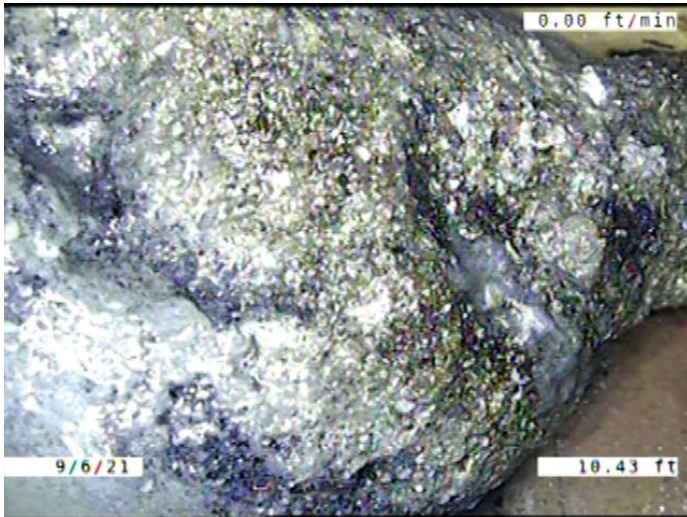
Code: **DAE**
 Description: **Deposits Attached Encrustation**

Distance (ft): **10.4**
 Structural Grade: **0**
 O&M Grade: **2**
 Clock Start/From: **4**
 Clock To: **5**
 1st Value:
 2nd Value:
 Value Percent: **5.000**
 Continuous Index:
 Within 8" of Joint: **YES**
 Remarks:

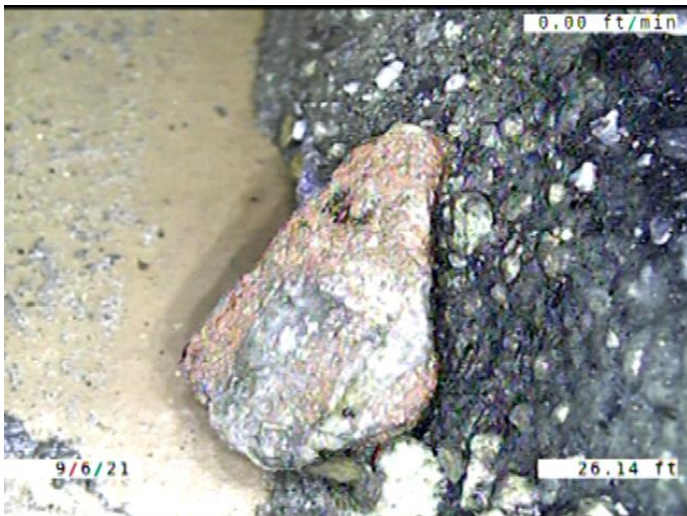
Code: **OBM**
 Description: **Obstruction Pipe Material in Invert**

Distance (ft): **26.1**
 Structural Grade: **0**
 O&M Grade: **2**
 Clock Start/From: **8**
 Clock To:
 1st Value:
 2nd Value:
 Value Percent: **5.000**
 Continuous Index:
 Within 8" of Joint: **YES**
 Remarks:

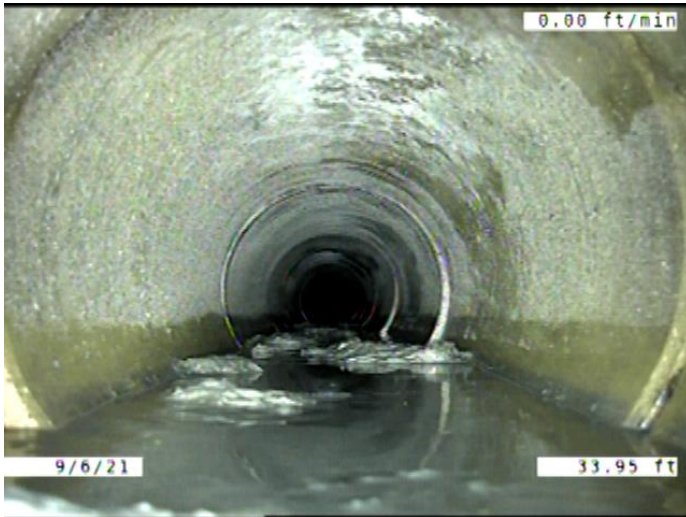
Code: **FM**
 Description: **Fracture Multiple**

Distance (ft): **34.0**
 Structural Grade: **4**
 O&M Grade: **0**
 Clock Start/From: **9**
 Clock To: **3**
 1st Value:
 2nd Value:
 Value Percent:
 Continuous Index: **F02**
 Within 8" of Joint: **YES**
 Remarks:

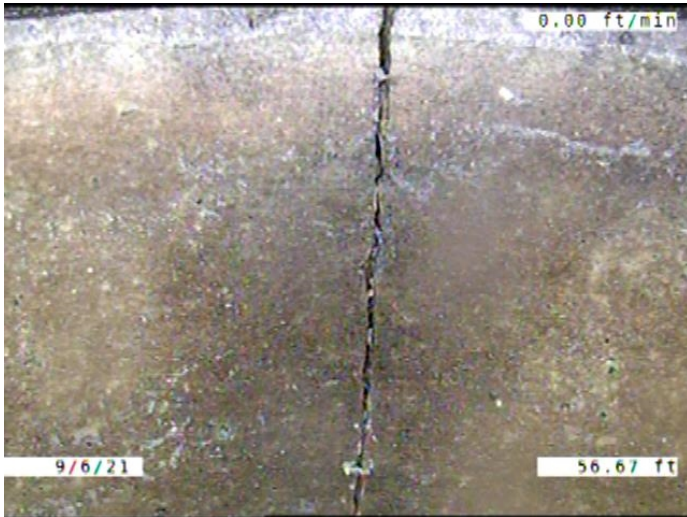
Code: **FM**
Description: **Fracture Multiple**

Distance (ft): **56.7**
Structural Grade: **4**
O&M Grade: **0**
Clock Start/From: **10**
Clock To: **12**
1st Value:
2nd Value:
Value Percent:
Continuous Index:
Within 8" of Joint: **YES**
Remarks:

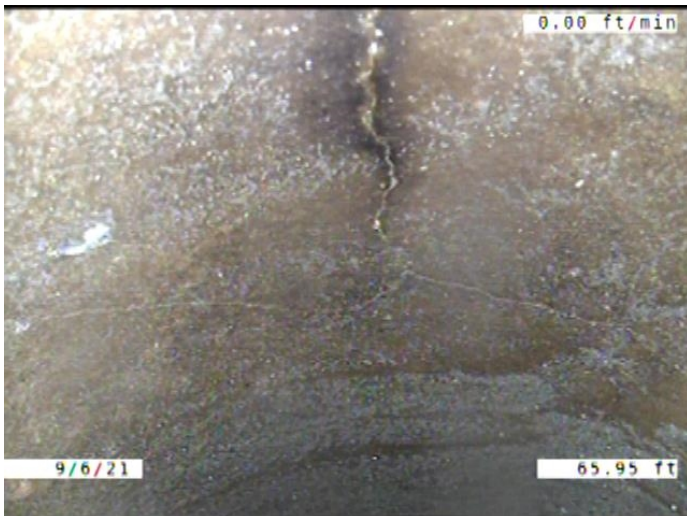
Code: **FM**
Description: **Fracture Multiple**

Distance (ft): **66.0**
Structural Grade: **4**
O&M Grade: **0**
Clock Start/From: **8**
Clock To: **3**
1st Value:
2nd Value:
Value Percent:
Continuous Index:
Within 8" of Joint: **YES**
Remarks:

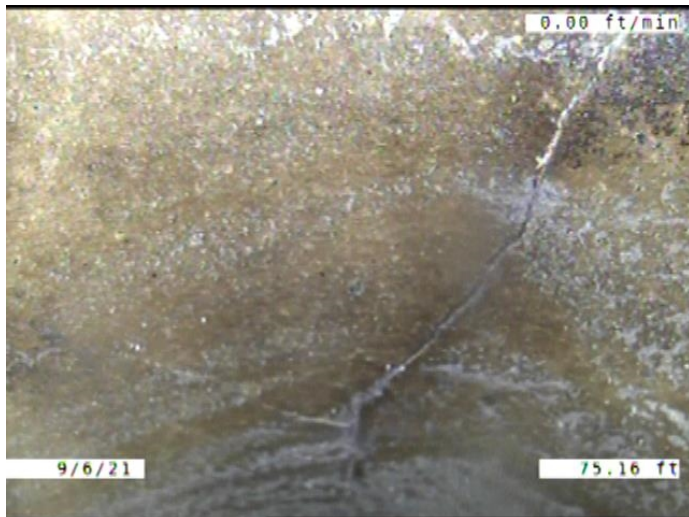
Code: **FM**
 Description: **Fracture Multiple**

Distance (ft): **75.2**
 Structural Grade: **4**
 O&M Grade: **0**
 Clock Start/From: **7**
 Clock To: **5**
 1st Value:
 2nd Value:
 Value Percent:
 Continuous Index: **S03**
 Within 8" of Joint: **YES**
 Remarks:

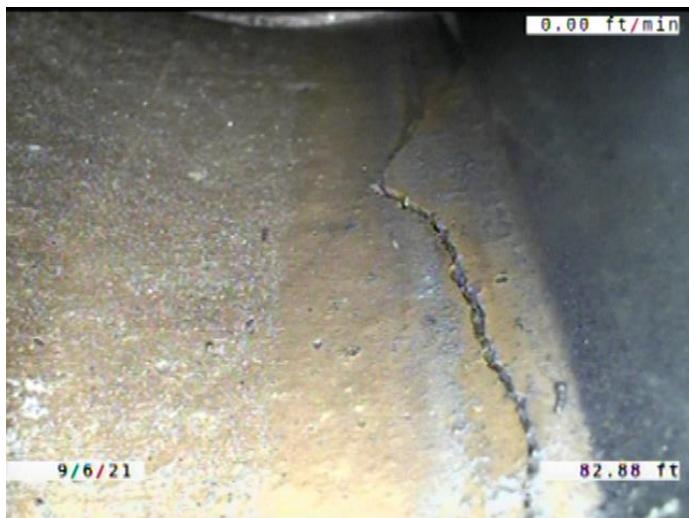
Code: **B**
 Description: **Broken**

Distance (ft): **82.9**
 Structural Grade: **4**
 O&M Grade: **0**
 Clock Start/From: **7**
 Clock To: **8**
 1st Value:
 2nd Value:
 Value Percent:
 Continuous Index:
 Within 8" of Joint: **YES**
 Remarks:

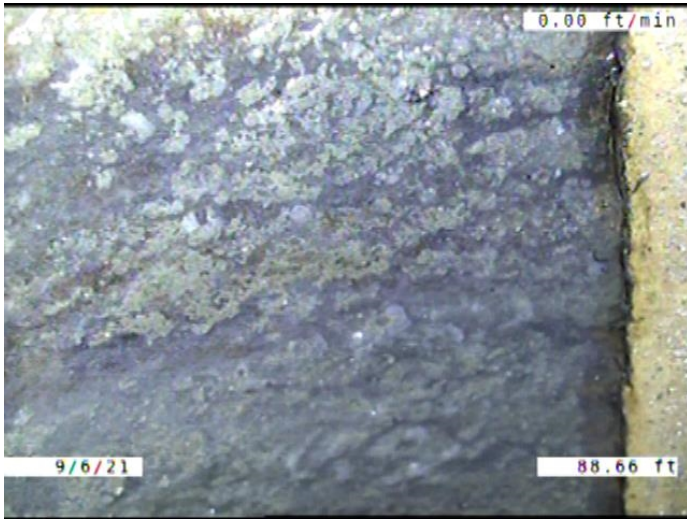
Code: **ISB**
Description: **Infiltration Stain Barrel**

Distance (ft): **88.7**
Structural Grade: **0**
O&M Grade: **1**
Clock Start/From: **7**
Clock To: **9**
1st Value:
2nd Value:
Value Percent:
Continuous Index:
Within 8" of Joint: **YES**
Remarks:

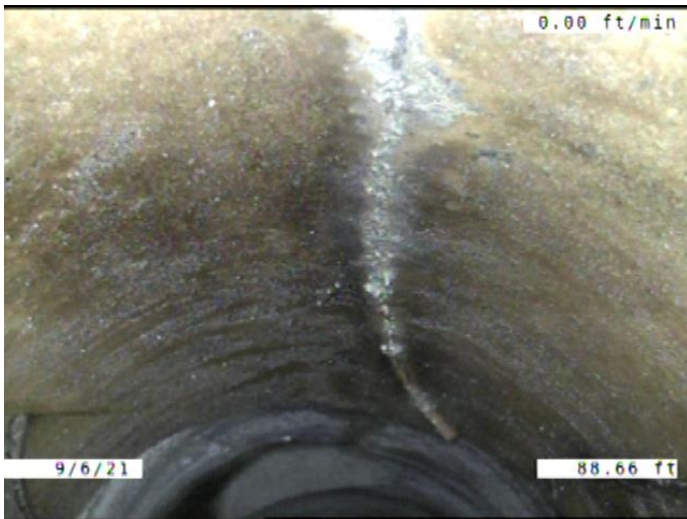
Code: **B**
Description: **Broken**

Distance (ft): **88.7**
Structural Grade: **4**
O&M Grade: **0**
Clock Start/From: **10**
Clock To: **1**
1st Value:
2nd Value:
Value Percent:
Continuous Index:
Within 8" of Joint: **YES**
Remarks:

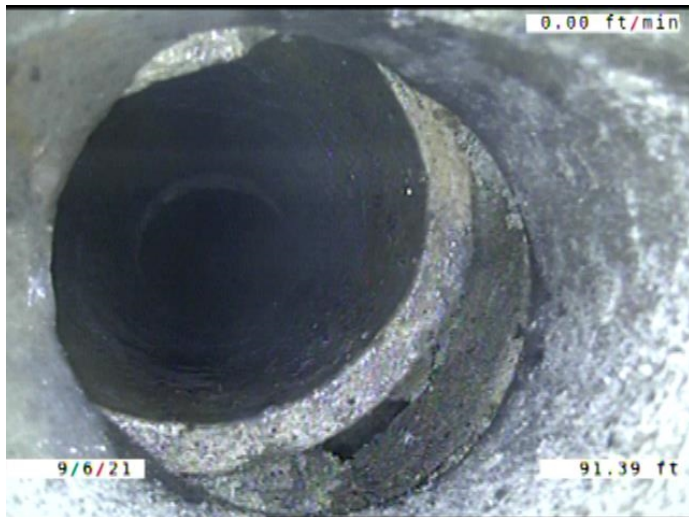
Code:	TFD
Description:	Tap Factory Defective
Distance (ft):	91.4
Structural Grade:	0
O&M Grade:	3
Clock Start/From:	11
Clock To:	
1st Value:	4.000
2nd Value:	
Value Percent:	
Continuous Index:	
Within 8" of Joint:	YES
Remarks:	SOIL VISIBLE AT THE FIRST JOINT BACK

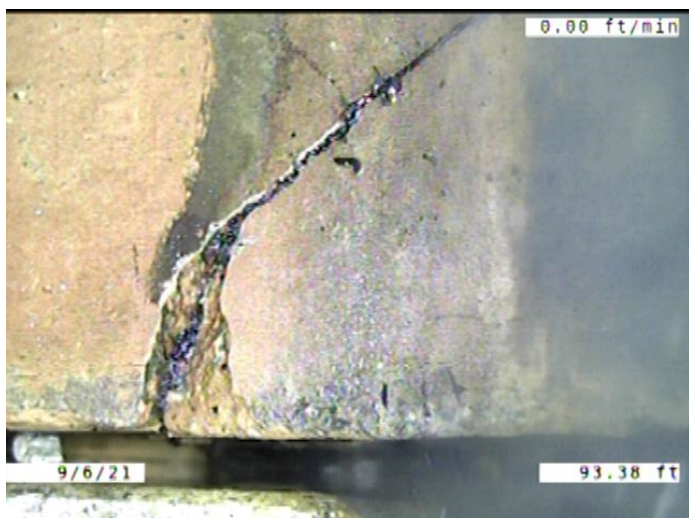
Code:	FM
Description:	Fracture Multiple
Distance (ft):	93.4
Structural Grade:	4
O&M Grade:	0
Clock Start/From:	7
Clock To:	5
1st Value:	
2nd Value:	
Value Percent:	
Continuous Index:	F03
Within 8" of Joint:	YES
Remarks:

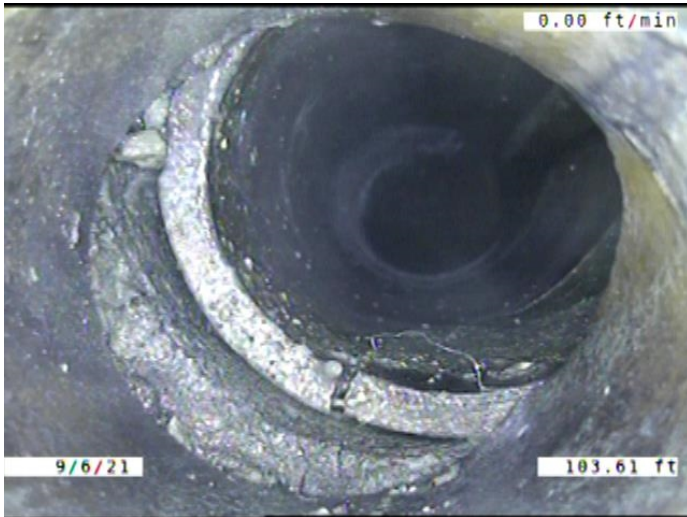
Code: **TFD**
 Description: **Tap Factory Defective**

Distance (ft): **103.6**
 Structural Grade: **0**
 O&M Grade: **3**
 Clock Start/From: **1**
 Clock To:
 1st Value: **4.000**
 2nd Value:
 Value Percent:
 Continuous Index:
 Within 8" of Joint: **YES**
 Remarks: **Defective**

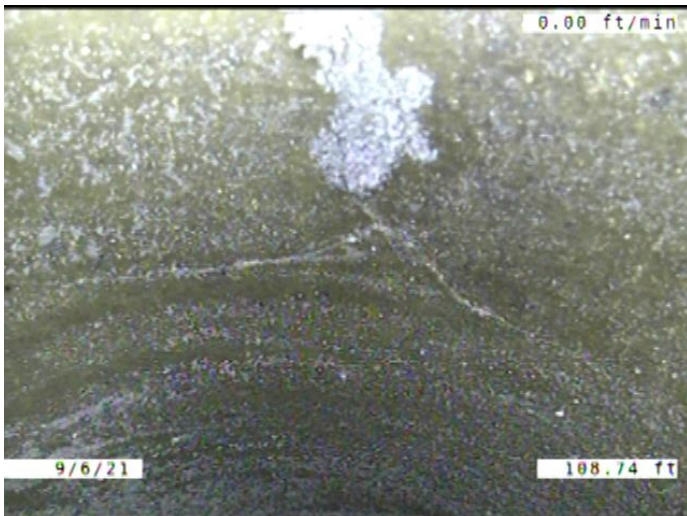
Code: **CM**
 Description: **Crack Multiple**

Distance (ft): **108.7**
 Structural Grade: **3**
 O&M Grade: **0**
 Clock Start/From: **10**
 Clock To: **3**
 1st Value:
 2nd Value:
 Value Percent:
 Continuous Index:
 Within 8" of Joint: **YES**
 Remarks:

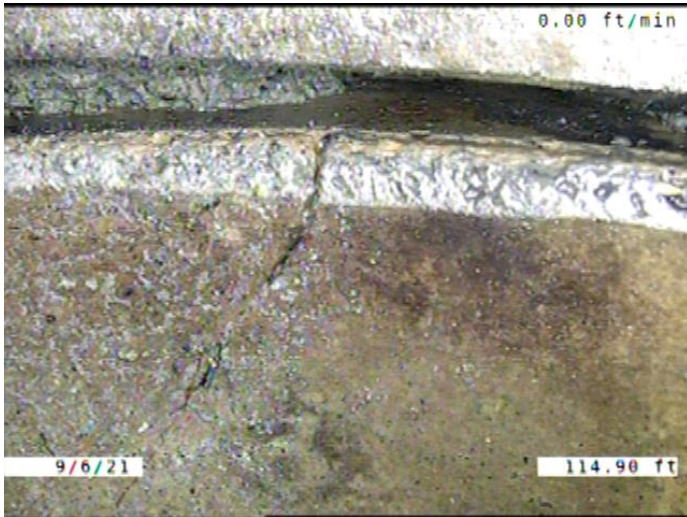
Code: **FS**
 Description: **Fracture Spiral**

Distance (ft): **114.9**
 Structural Grade: **3**
 O&M Grade: **0**
 Clock Start/From: **1**
 Clock To: **4**
 1st Value:
 2nd Value:
 Value Percent:
 Continuous Index:
 Within 8" of Joint: **YES**
 Remarks:

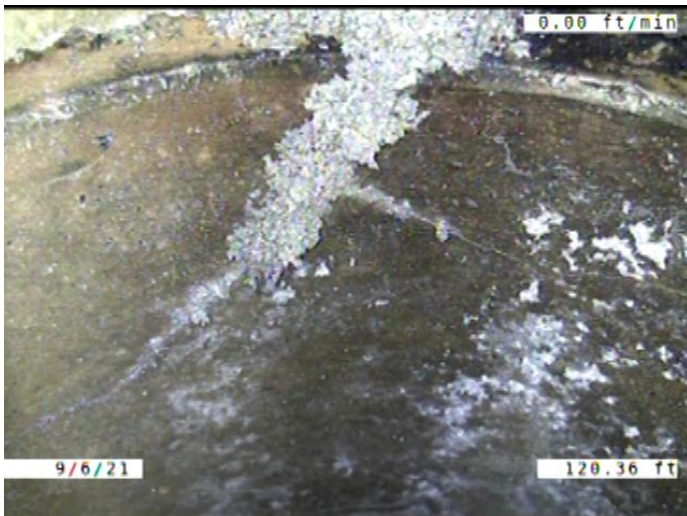
Code: **CM**
 Description: **Crack Multiple**

Distance (ft): **120.4**
 Structural Grade: **3**
 O&M Grade: **0**
 Clock Start/From: **8**
 Clock To: **2**
 1st Value:
 2nd Value:
 Value Percent:
 Continuous Index:
 Within 8" of Joint: **YES**
 Remarks:

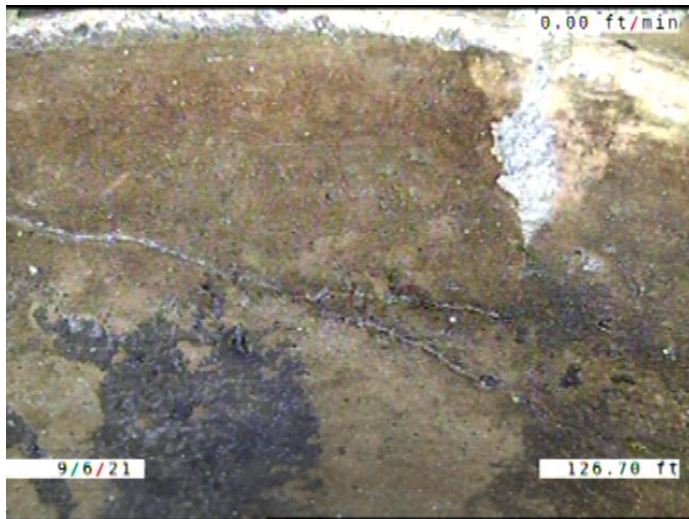
Code: **CM**
 Description: **Crack Multiple**

Distance (ft): **126.7**
 Structural Grade: **3**
 O&M Grade: **0**
 Clock Start/From: **11**
 Clock To: **4**
 1st Value:
 2nd Value:
 Value Percent:
 Continuous Index:
 Within 8" of Joint: **YES**
 Remarks:

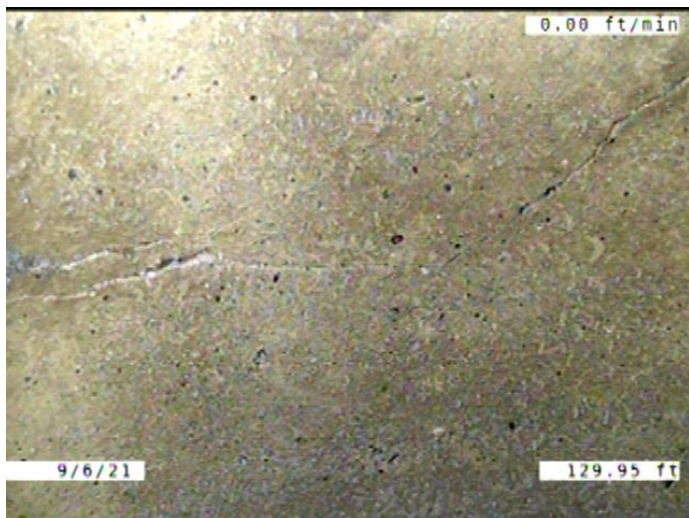
Code: **CM**
 Description: **Crack Multiple**

Distance (ft): **129.9**
 Structural Grade: **3**
 O&M Grade: **0**
 Clock Start/From: **7**
 Clock To: **12**
 1st Value:
 2nd Value:
 Value Percent:
 Continuous Index:
 Within 8" of Joint: **YES**
 Remarks:

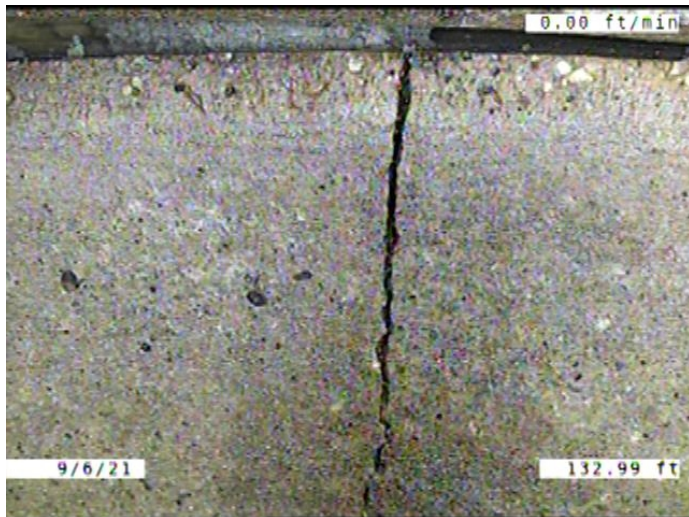
Code: **FS**
 Description: **Fracture Spiral**

Distance (ft): **133.0**
 Structural Grade: **3**
 O&M Grade: **0**
 Clock Start/From: **2**
 Clock To: **4**
 1st Value:
 2nd Value:
 Value Percent:
 Continuous Index:
 Within 8" of Joint: **YES**
 Remarks:

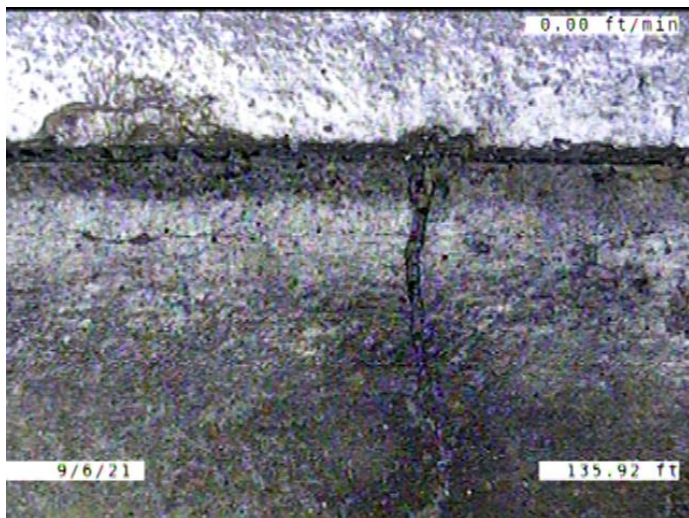
Code: **FM**
 Description: **Fracture Multiple**

Distance (ft): **135.9**
 Structural Grade: **4**
 O&M Grade: **0**
 Clock Start/From: **11**
 Clock To: **1**
 1st Value:
 2nd Value:
 Value Percent:
 Continuous Index:
 Within 8" of Joint: **YES**
 Remarks:

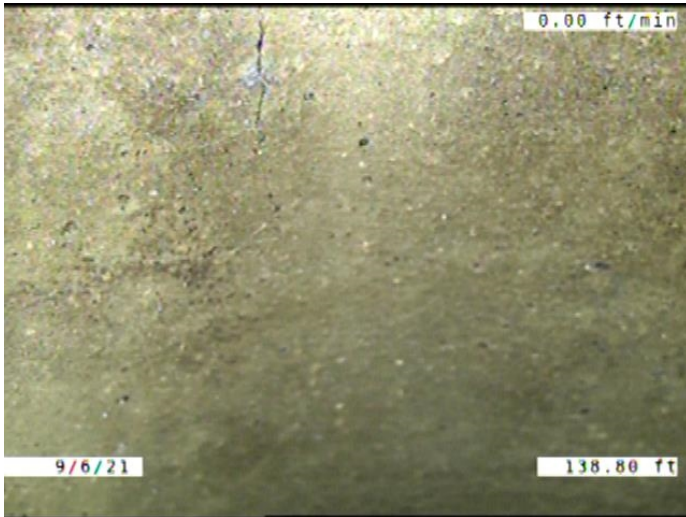
Code: **CS**
Description: **Crack Spiral**

Distance (ft): **138.8**
Structural Grade: **2**
O&M Grade: **0**
Clock Start/From: **8**
Clock To: **11**
1st Value:
2nd Value:
Value Percent:
Continuous Index:
Within 8" of Joint: **YES**
Remarks:

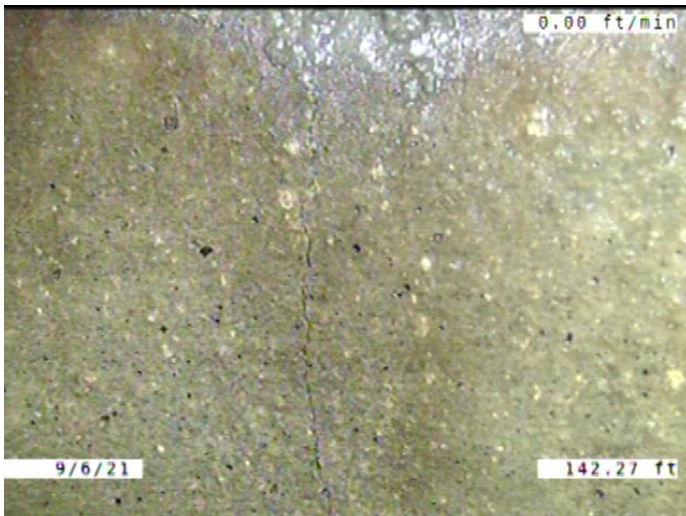
Code: **CL**
Description: **Crack Longitudinal**

Distance (ft): **142.3**
Structural Grade: **2**
O&M Grade: **0**
Clock Start/From: **3**
Clock To:
1st Value:
2nd Value:
Value Percent:
Continuous Index:
Within 8" of Joint: **YES**
Remarks:

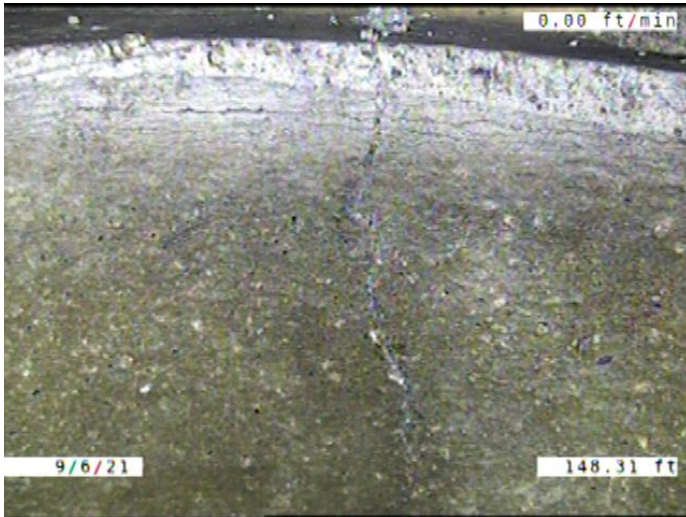
Code: **CL**
 Description: **Crack Longitudinal**

Distance (ft): **148.3**
 Structural Grade: **2**
 O&M Grade: **0**
 Clock Start/From: **12**
 Clock To:
 1st Value:
 2nd Value:
 Value Percent:
 Continuous Index:
 Within 8" of Joint: **YES**
 Remarks:

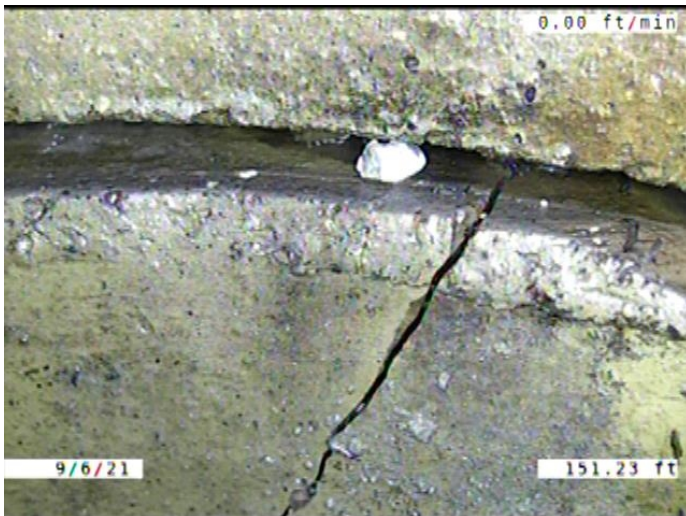
Code: **FM**
 Description: **Fracture Multiple**

Distance (ft): **151.2**
 Structural Grade: **4**
 O&M Grade: **0**
 Clock Start/From: **12**
 Clock To: **4**
 1st Value:
 2nd Value:
 Value Percent:
 Continuous Index:
 Within 8" of Joint: **YES**
 Remarks:

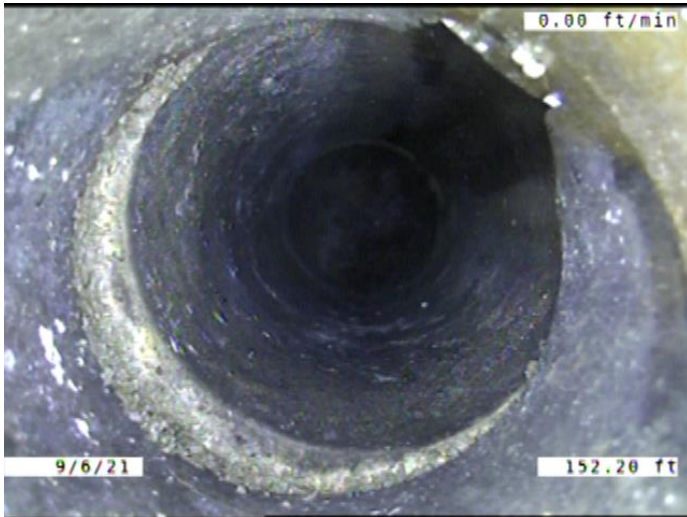
Code: **TFD**
 Description: **Tap Factory Defective**

Distance (ft): **152.2**
 Structural Grade: **0**
 O&M Grade: **3**
 Clock Start/From: **1**
 Clock To:
 1st Value: **4.000**
 2nd Value:
 Value Percent:
 Continuous Index:
 Within 8" of Joint: **YES**
 Remarks: **Defective**

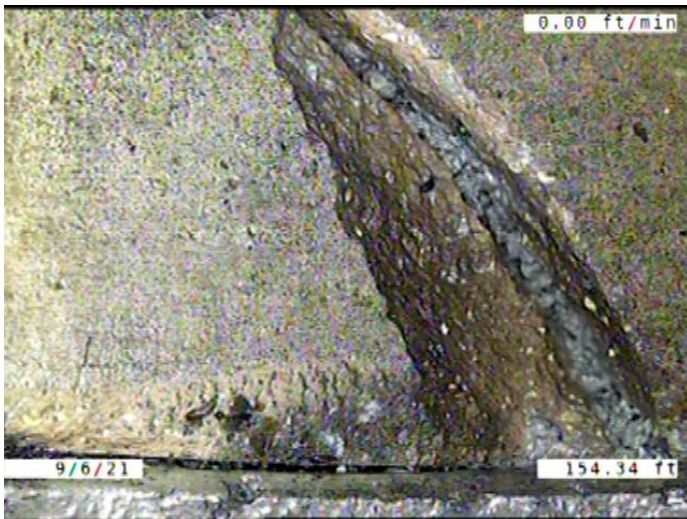
Code: **BSV**
 Description: **Broken Soil Visible**

Distance (ft): **154.3**
 Structural Grade: **5**
 O&M Grade: **0**
 Clock Start/From: **3**
 Clock To: **8**
 1st Value:
 2nd Value:
 Value Percent:
 Continuous Index:
 Within 8" of Joint: **YES**
 Remarks:

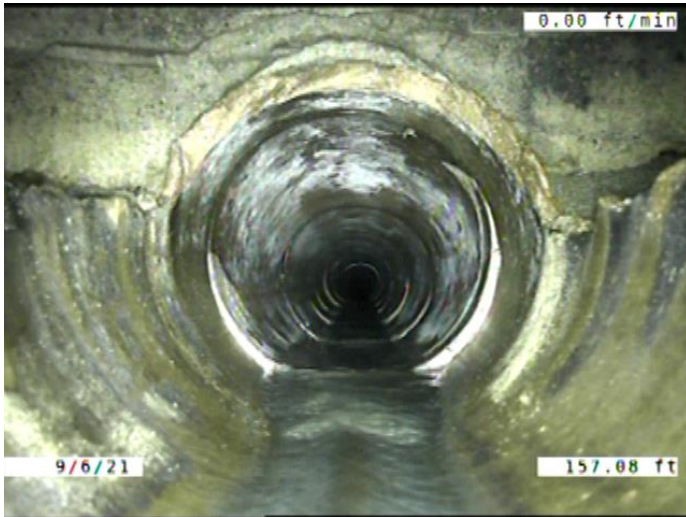
Code: **DSF**
 Description: **Deposits Settled Fine**

Distance (ft): **157.1**
 Structural Grade: **0**
 O&M Grade: **2**
 Clock Start/From: **5**
 Clock To: **7**
 1st Value:
 2nd Value:
 Value Percent: **5.000**
 Continuous Index: **F01**
 Within 8" of Joint: **YES**
 Remarks: **ALSO TP AND RAGS**
