Profile/Photo Observation Report

Date:	09/06/2021	Weather:		Coding:	PACP 7.0
Pipe Length (ft):	211.9	Owner:	City of Hobart	Pre Clean:	Heavy Cleaning
P.O.#:	YES502259	Surveyor:	S. Bucklin	PSR:	M-504-111.1_M-504-111
Customer:	City of Hobart	Clean Date:	08/26/2021	Shape:	C

Street:	North Colorado Street	Flow Control:	Not Controlled
City:	Hobart, IN	Year Renewed:	
Location:	Alley	Tape/Media #:	
Purpose:	Routine Assessment	Dia/Height:	12"
Use:	Sanitary Sewage Pipe	Material:	VCP
Drain Area:		Lining:	None
Category:	NA		
Comment:

Location Details:		Direction of Survey:	Downstream
US MH:	M-504-111.1	DS MH:	M-504-111
		Total Length Surveyed (ft):	211.9

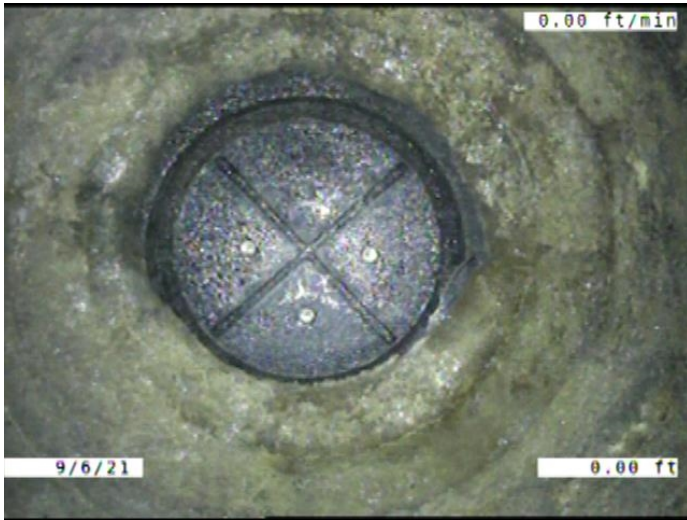
Code: **AMH**
Description: **Manhole**

Distance (ft): **.0**
Structural Grade: **0**
O&M Grade: **0**
Clock Start/From:
Clock To:
1st Value:
2nd Value:
Value Percent:
Continuous Index:
Within 8" of Joint: **NO**
Remarks: **M-504-111.1**

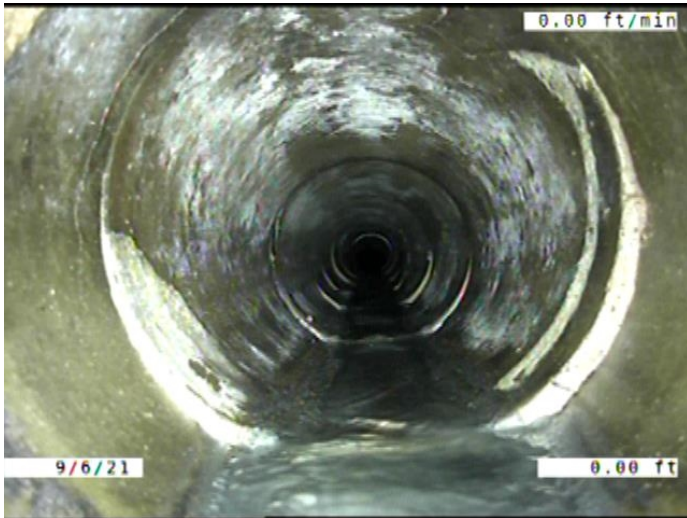
Code: **MWL**
Description: **Miscellaneous Water Level**

Distance (ft): **.0**
Structural Grade: **0**
O&M Grade: **0**
Clock Start/From:
Clock To:
1st Value:
2nd Value:
Value Percent: **5.000**
Continuous Index:
Within 8" of Joint: **NO**
Remarks:

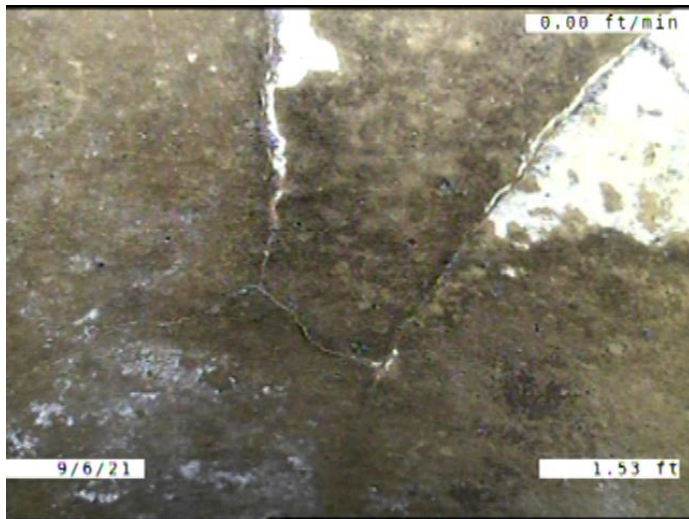
Code: **CM**
 Description: **Crack Multiple**

Distance (ft): **1.5**
 Structural Grade: **3**
 O&M Grade: **0**
 Clock Start/From: **11**
 Clock To: **5**
 1st Value:
 2nd Value:
 Value Percent:
 Continuous Index:
 Within 8" of Joint: **YES**
 Remarks:

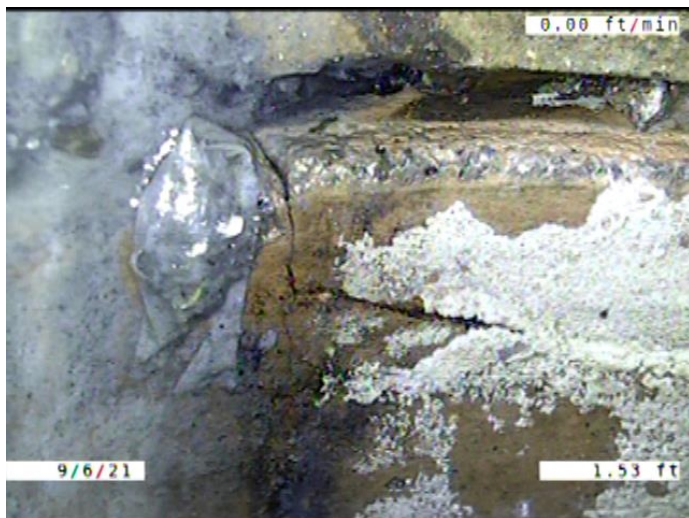
Code: **CM**
 Description: **Crack Multiple**

Distance (ft): **1.5**
 Structural Grade: **3**
 O&M Grade: **0**
 Clock Start/From: **7**
 Clock To: **9**
 1st Value:
 2nd Value:
 Value Percent:
 Continuous Index:
 Within 8" of Joint: **YES**
 Remarks:

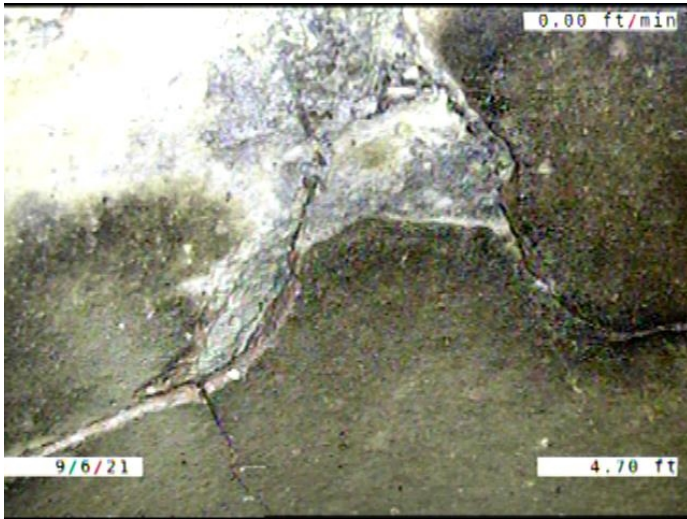
Code: **B**
Description: **Broken**

Distance (ft): **4.7**
Structural Grade: **4**
O&M Grade: **0**
Clock Start/From: **8**
Clock To: **12**
1st Value:
2nd Value:
Value Percent:
Continuous Index:
Within 8" of Joint: **YES**
Remarks:

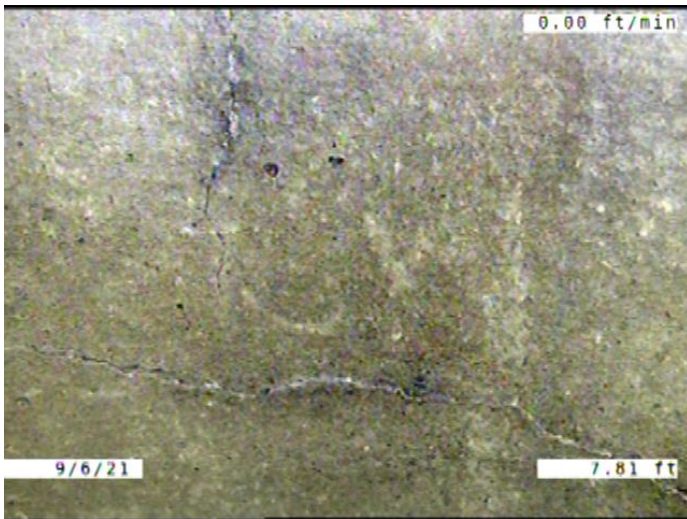
Code: **CM**
Description: **Crack Multiple**

Distance (ft): **7.8**
Structural Grade: **3**
O&M Grade: **0**
Clock Start/From: **12**
Clock To: **3**
1st Value:
2nd Value:
Value Percent:
Continuous Index:
Within 8" of Joint: **YES**
Remarks:

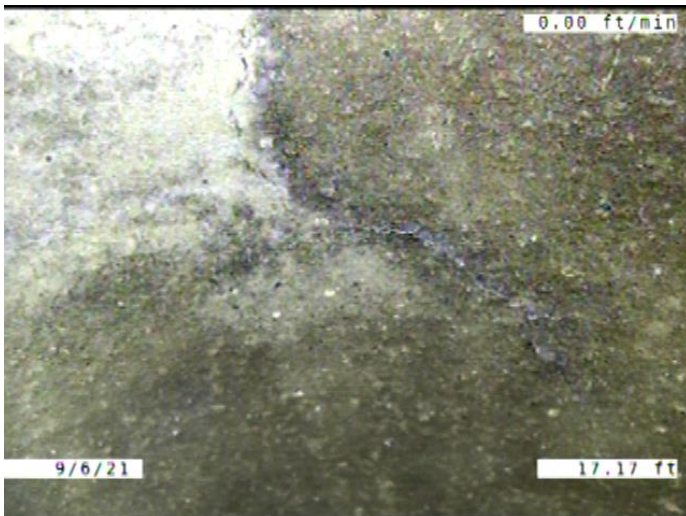
Code: **CS**
 Description: **Crack Spiral**

Distance (ft): **17.2**
 Structural Grade: **2**
 O&M Grade: **0**
 Clock Start/From: **11**
 Clock To: **12**
 1st Value:
 2nd Value:
 Value Percent:
 Continuous Index:
 Within 8" of Joint: **YES**
 Remarks:

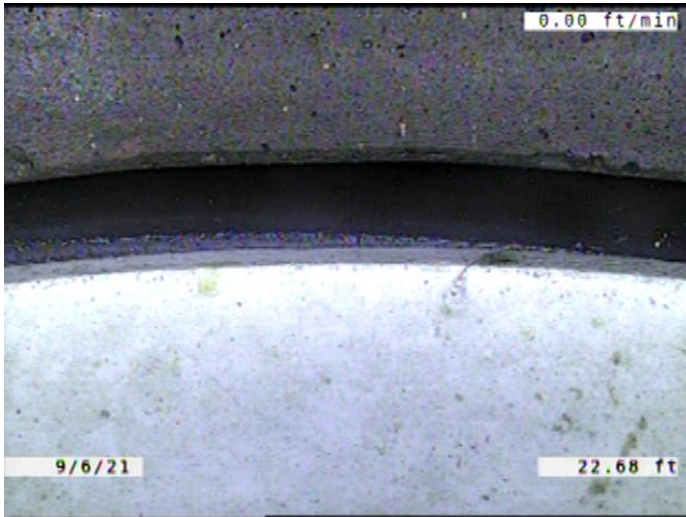
Code: **MMC**
 Description: **Miscellaneous Material Change**

Distance (ft): **22.7**
 Structural Grade: **0**
 O&M Grade: **0**
 Clock Start/From:
 Clock To:
 1st Value:
 2nd Value:
 Value Percent:
 Continuous Index:
 Within 8" of Joint: **NO**
 Remarks: **VCP TO PVC**

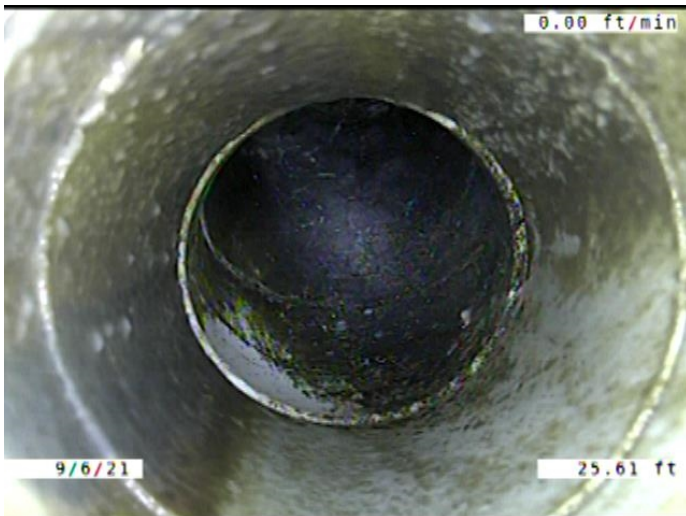
Code: **TF**
 Description: **Tap Factory**

Distance (ft): **25.6**
 Structural Grade: **0**
 O&M Grade: **0**
 Clock Start/From: **12**
 Clock To:
 1st Value: **4.000**
 2nd Value:
 Value Percent:
 Continuous Index:
 Within 8" of Joint: **YES**
 Remarks:

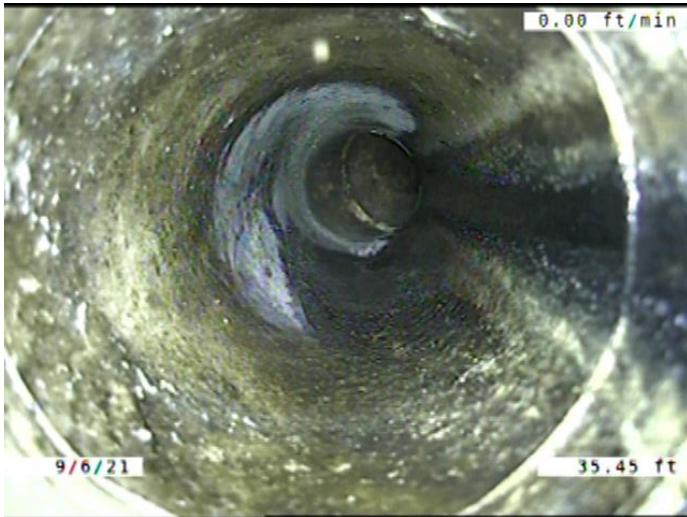
Code: **TF**
 Description: **Tap Factory**

Distance (ft): **35.5**
 Structural Grade: **0**
 O&M Grade: **0**
 Clock Start/From: **1**
 Clock To:
 1st Value: **4.000**
 2nd Value:
 Value Percent:
 Continuous Index:
 Within 8" of Joint: **YES**
 Remarks:

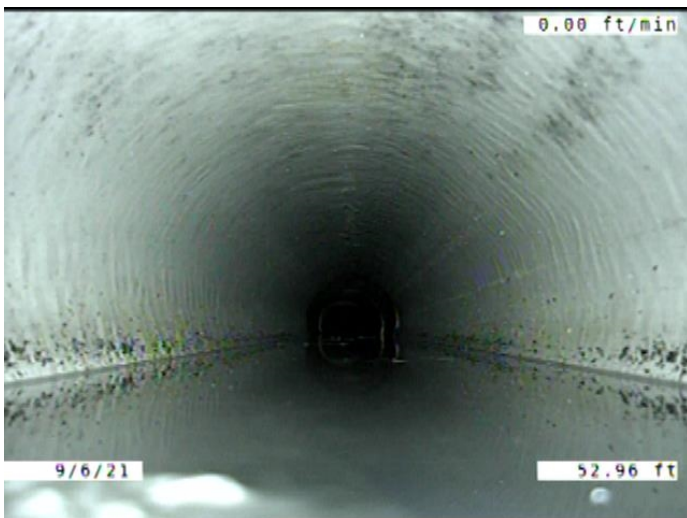
Code: **DSF**
 Description: **Deposits Settled Fine**

Distance (ft): **53.0**
 Structural Grade: **0**
 O&M Grade: **2**
 Clock Start/From: **5**
 Clock To: **7**
 1st Value:
 2nd Value:
 Value Percent: **5.000**
 Continuous Index: **S01**
 Within 8" of Joint: **YES**
 Remarks:

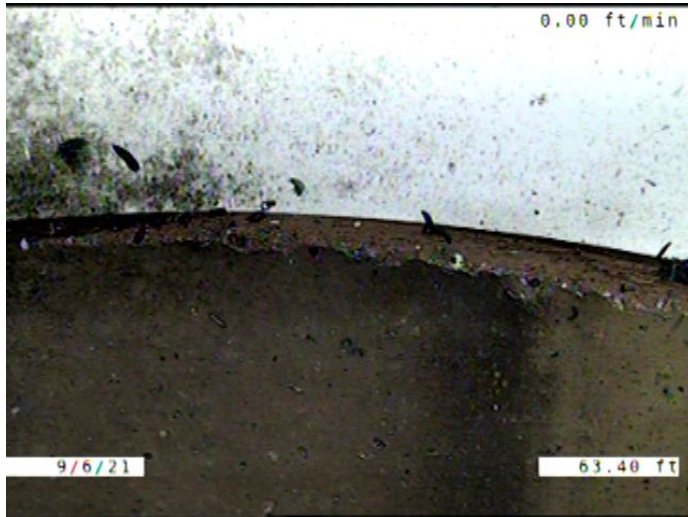
Code: **MMC**
 Description: **Miscellaneous Material Change**

Distance (ft): **63.4**
 Structural Grade: **0**
 O&M Grade: **0**
 Clock Start/From:
 Clock To:
 1st Value:
 2nd Value:
 Value Percent:
 Continuous Index:
 Within 8" of Joint: **NO**
 Remarks: **PVC TO VCP**

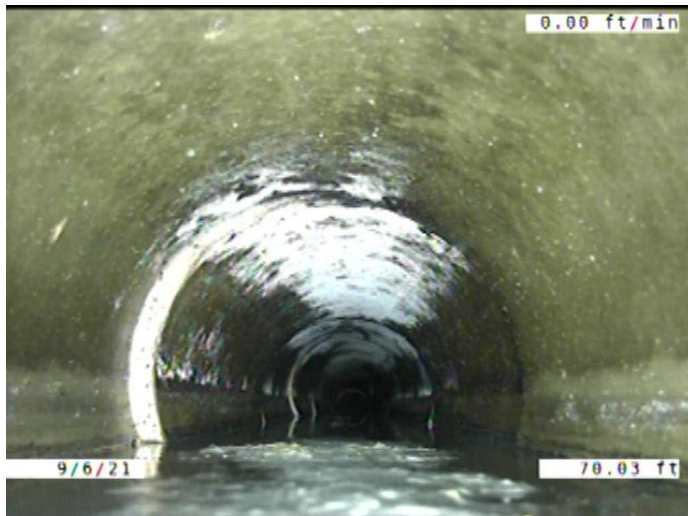
Code: **MWL**
 Description: **Miscellaneous Water Level**

Distance (ft): **70.0**
 Structural Grade: **0**
 O&M Grade: **0**
 Clock Start/From:
 Clock To:
 1st Value:
 2nd Value:
 Value Percent: **15.000**
 Continuous Index:
 Within 8" of Joint: **NO**
 Remarks:

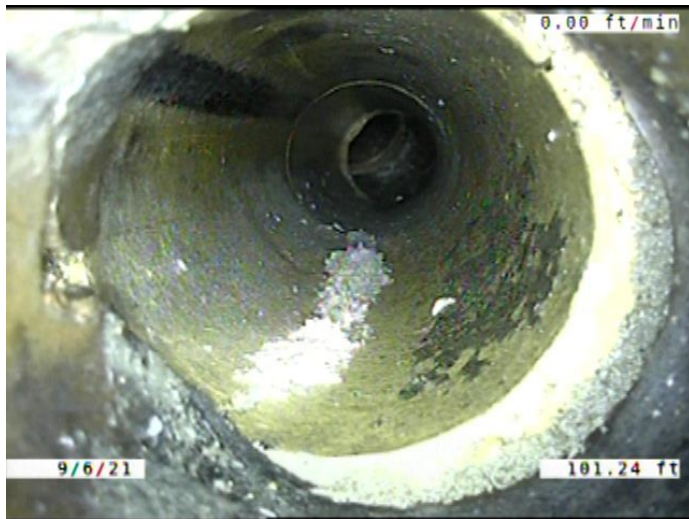
Code: **TFD**
Description: **Tap Factory Defective**

Distance (ft): **101.2**
Structural Grade: **0**
O&M Grade: **3**
Clock Start/From: **11**
Clock To:
1st Value: **4.000**
2nd Value:
Value Percent:
Continuous Index:
Within 8" of Joint: **YES**
Remarks: **Defective**

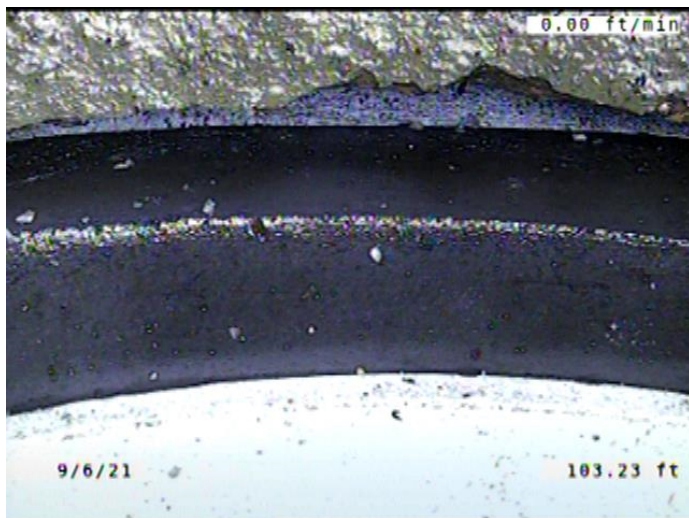
Code: **MMC**
Description: **Miscellaneous Material Change**

Distance (ft): **103.2**
Structural Grade: **0**
O&M Grade: **0**
Clock Start/From:
Clock To:
1st Value:
2nd Value:
Value Percent:
Continuous Index:
Within 8" of Joint: **NO**
Remarks: **VCP TO PVC**

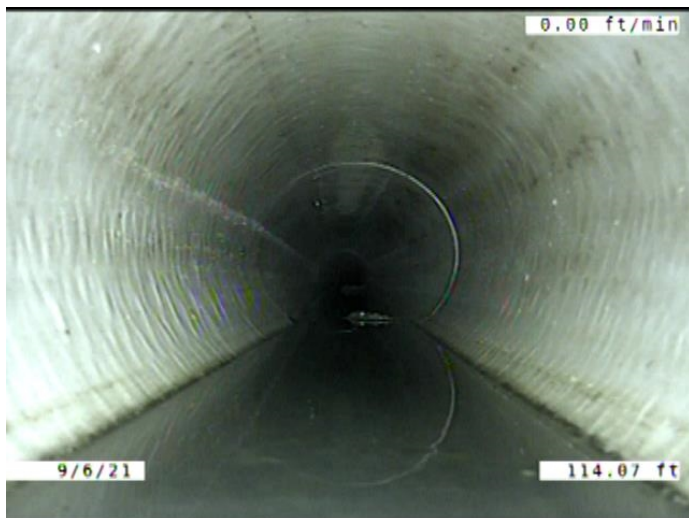
Code:	MWL
Description:	Miscellaneous Water Level
Distance (ft):	114.1
Structural Grade:	0
O&M Grade:	0
Clock Start/From:	
Clock To:	
1st Value:	
2nd Value:	
Value Percent:	5.000
Continuous Index:	
Within 8" of Joint:	NO
Remarks:

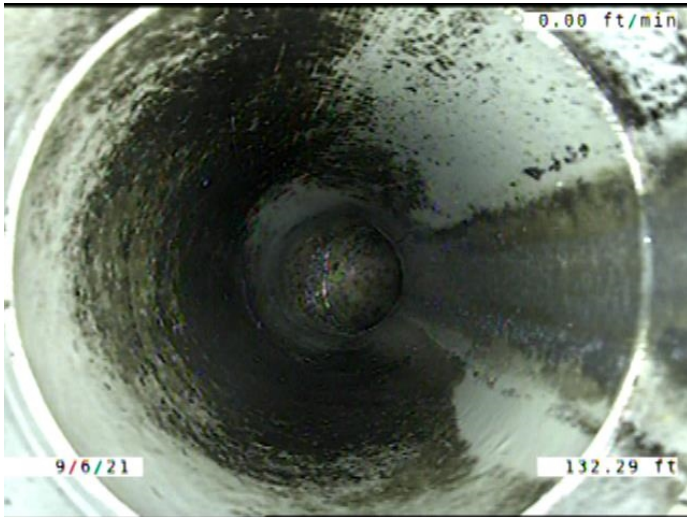
Code: **TF**
 Description: **Tap Factory**

Distance (ft): **132.3**
 Structural Grade: **0**
 O&M Grade: **0**
 Clock Start/From: **1**
 Clock To:
 1st Value: **4.000**
 2nd Value:
 Value Percent:
 Continuous Index:
 Within 8" of Joint: **YES**
 Remarks:

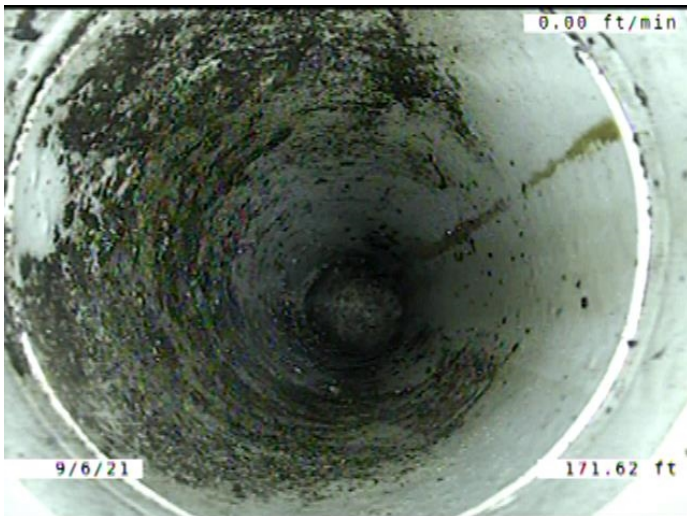
Code: **TF**
 Description: **Tap Factory**

Distance (ft): **171.6**
 Structural Grade: **0**
 O&M Grade: **0**
 Clock Start/From: **1**
 Clock To:
 1st Value: **4.000**
 2nd Value:
 Value Percent:
 Continuous Index:
 Within 8" of Joint: **YES**
 Remarks:

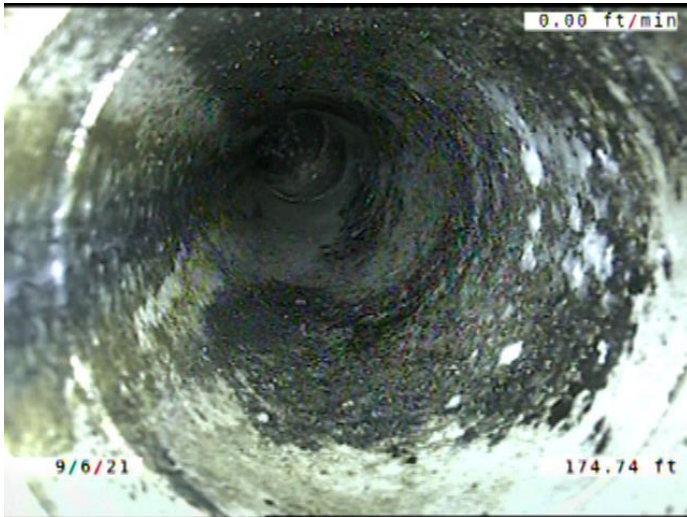
Code: **TF**
Description: **Tap Factory**

Distance (ft): **174.7**
Structural Grade: **0**
O&M Grade: **0**
Clock Start/From: **11**
Clock To:
1st Value: **4.000**
2nd Value:
Value Percent:
Continuous Index:
Within 8" of Joint: **YES**
Remarks:

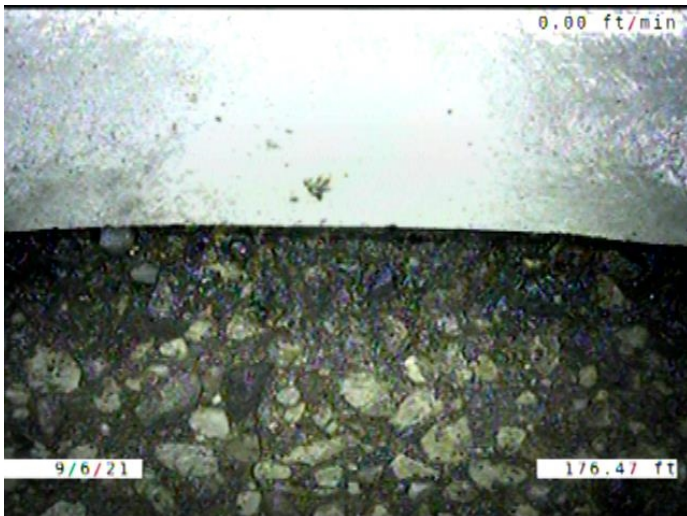
Code: **MMC**
Description: **Miscellaneous Material Change**

Distance (ft): **176.5**
Structural Grade: **0**
O&M Grade: **0**
Clock Start/From:
Clock To:
1st Value:
2nd Value:
Value Percent:
Continuous Index:
Within 8" of Joint: **NO**
Remarks: **PVC TO CONCRETE**

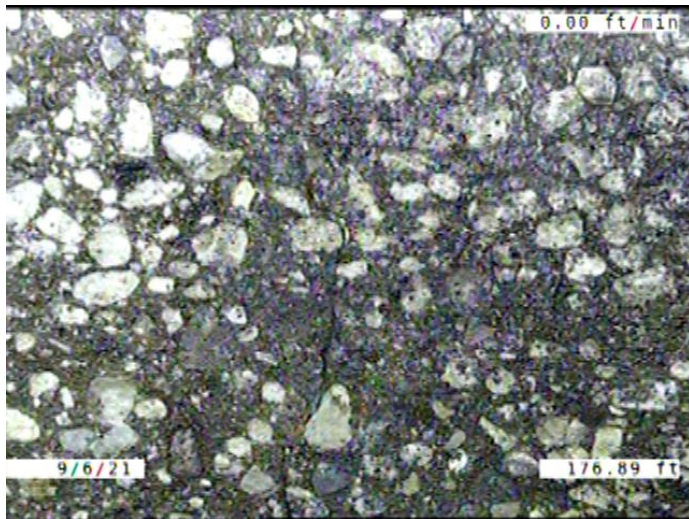
Code: **CL**
 Description: **Crack Longitudinal**

Distance (ft): **176.9**
 Structural Grade: **2**
 O&M Grade: **0**
 Clock Start/From: **12**
 Clock To:
 1st Value:
 2nd Value:
 Value Percent:
 Continuous Index:
 Within 8" of Joint: **YES**
 Remarks:

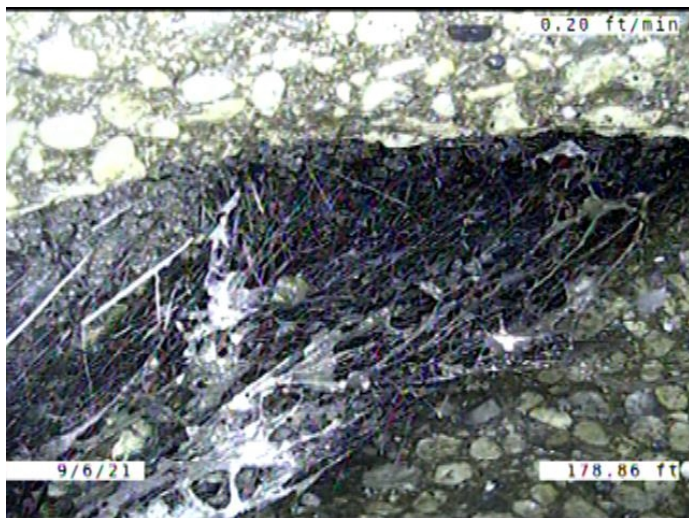
Code: **RMJ**
 Description: **Roots Medium Joint**

Distance (ft): **178.9**
 Structural Grade: **0**
 O&M Grade: **3**
 Clock Start/From: **8**
 Clock To: **4**
 1st Value:
 2nd Value:
 Value Percent: **5.000**
 Continuous Index:
 Within 8" of Joint: **YES**
 Remarks:

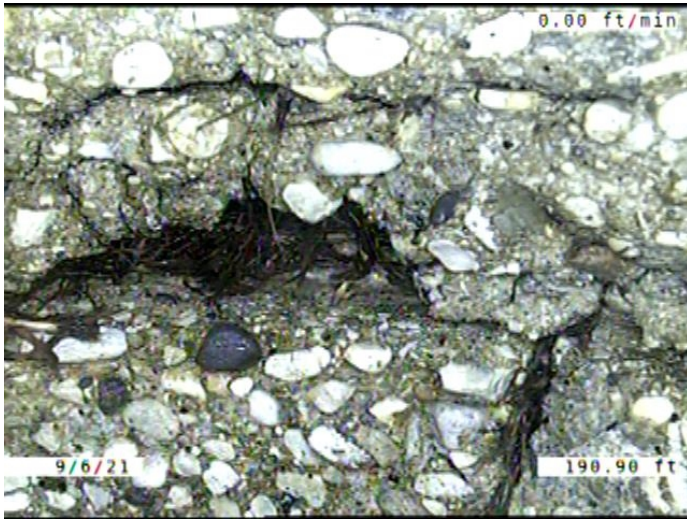
Code: **FM**
Description: **Fracture Multiple**

Distance (ft): **190.9**
Structural Grade: **4**
O&M Grade: **0**
Clock Start/From: **12**
Clock To: **3**
1st Value:
2nd Value:
Value Percent:
Continuous Index:
Within 8" of Joint: **YES**
Remarks:

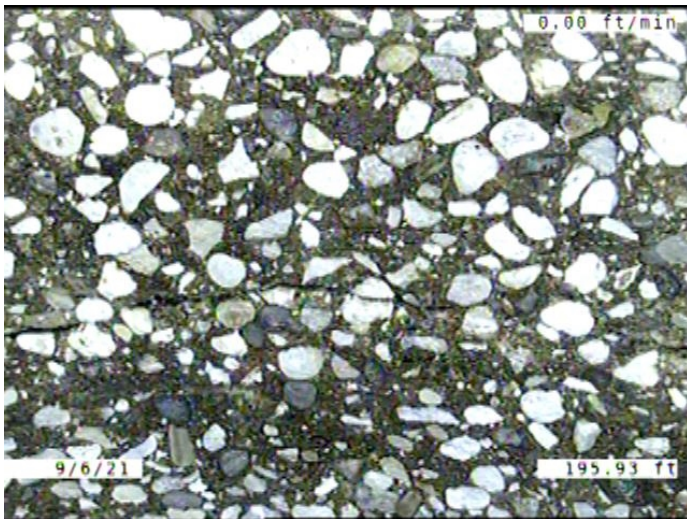
Code: **FS**
Description: **Fracture Spiral**

Distance (ft): **195.9**
Structural Grade: **3**
O&M Grade: **0**
Clock Start/From: **10**
Clock To: **2**
1st Value:
2nd Value:
Value Percent:
Continuous Index:
Within 8" of Joint: **YES**
Remarks:

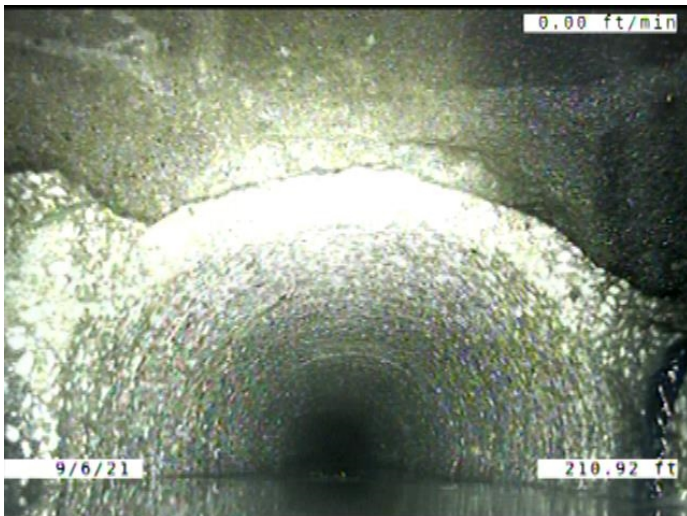
Code: **DSF**
 Description: **Deposits Settled Fine**

Distance (ft): **210.9**
 Structural Grade: **0**
 O&M Grade: **2**
 Clock Start/From: **5**
 Clock To: **7**
 1st Value:
 2nd Value:
 Value Percent: **5.000**
 Continuous Index: **F01**
 Within 8" of Joint: **YES**
 Remarks:

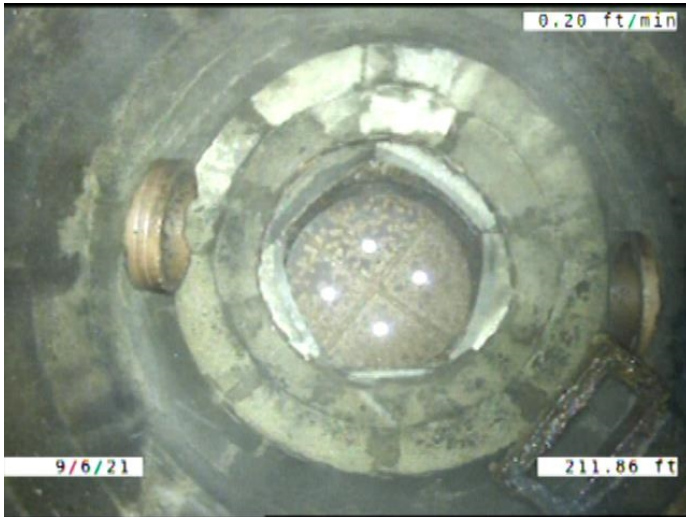
Code:	AMH
Description:	Manhole
Distance (ft):	211.9
Structural Grade:	0
O&M Grade:	0
Clock Start/From:	
Clock To:	
1st Value:	
2nd Value:	
Value Percent:	
Continuous Index:	
Within 8" of Joint:	NO
Remarks:	M-504-111
