Profile/Photo Observation Report

Date:	09/06/2021	Weather:		Coding:	PACP 7.0
Pipe Length (ft):	211.9	Owner:	City of Hobart	Pre Clean:	Heavy Cleaning
P.O.#:	YES502259	Surveyor:	S. Bucklin	PSR:	M-504-111.1_M-504-111
Customer:	City of Hobart	Clean Date:	08/26/2021	Shape:	C

Street:	North Colorado Street	Flow Control:	Not Controlled
City:	Hobart, IN	Year Renewed:	
Location:	Alley	Tape/Media #:	
Purpose:	Routine Assessment	Dia/Height:	12"
Use:	Sanitary Sewage Pipe	Material:	VCP
Drain Area:		Lining:	None
Category:	NA		
Comment:

Location Details:		Direction of Survey:	Downstream
US MH:	M-504-111.1	DS MH:	M-504-111
		Total Length Surveyed (ft):	211.9

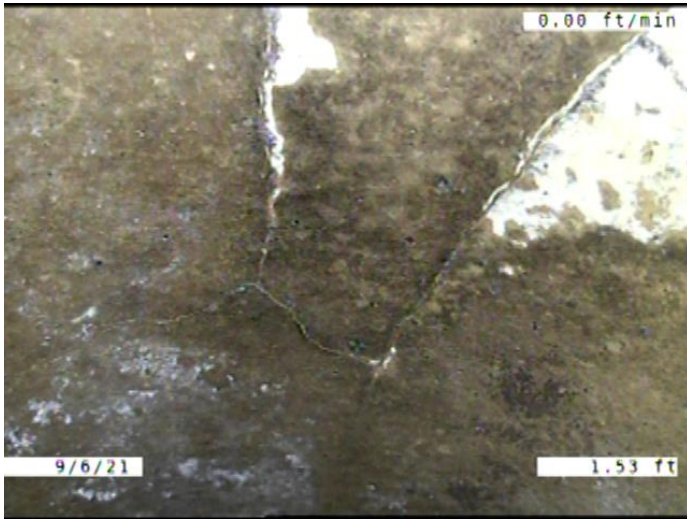
Code: **CM**
 Description: **Crack Multiple**

Distance (ft): **1.5**
 Structural Grade: **3**
 O&M Grade: **0**
 Clock Start/From: **11**
 Clock To: **5**
 1st Value:
 2nd Value:
 Value Percent:
 Continuous Index:
 Within 8" of Joint: **YES**
 Remarks:

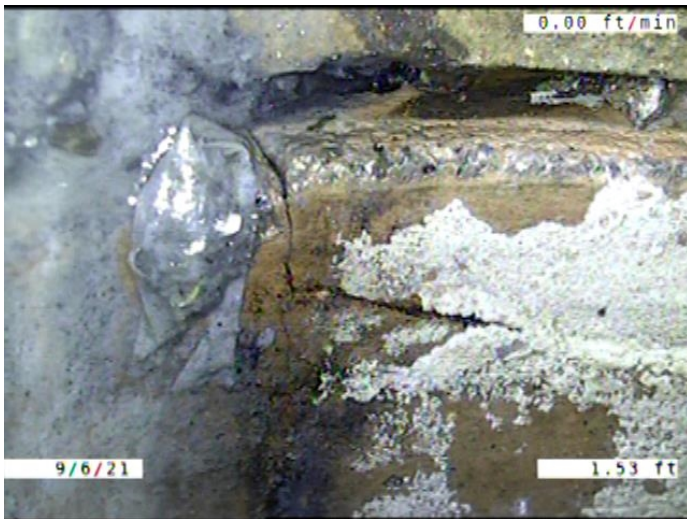
Code: **CM**
 Description: **Crack Multiple**

Distance (ft): **1.5**
 Structural Grade: **3**
 O&M Grade: **0**
 Clock Start/From: **7**
 Clock To: **9**
 1st Value:
 2nd Value:
 Value Percent:
 Continuous Index:
 Within 8" of Joint: **YES**
 Remarks:

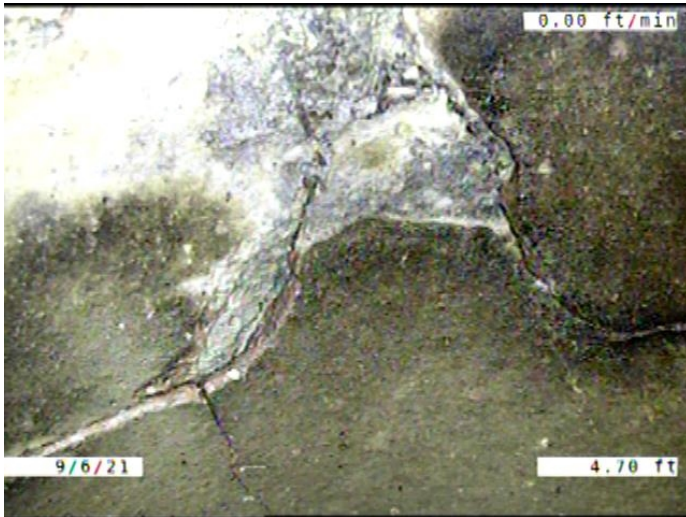
Code: **B**
 Description: **Broken**

Distance (ft): **4.7**
 Structural Grade: **4**
 O&M Grade: **0**
 Clock Start/From: **8**
 Clock To: **12**
 1st Value:
 2nd Value:
 Value Percent:
 Continuous Index:
 Within 8" of Joint: **YES**
 Remarks:

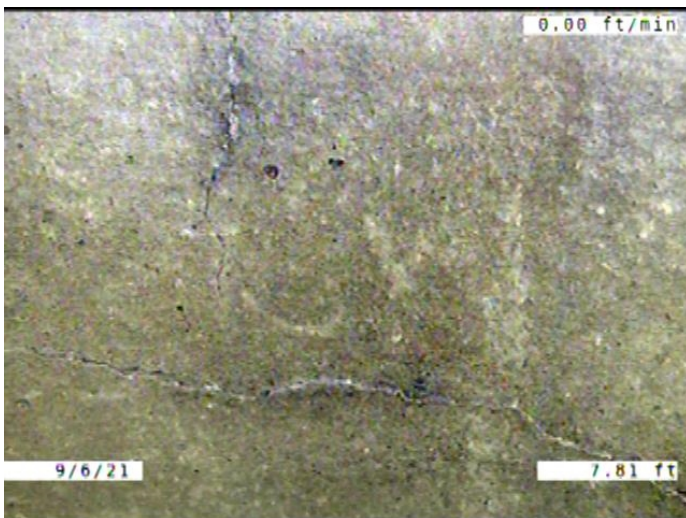
Code: **CM**
 Description: **Crack Multiple**

Distance (ft): **7.8**
 Structural Grade: **3**
 O&M Grade: **0**
 Clock Start/From: **12**
 Clock To: **3**
 1st Value:
 2nd Value:
 Value Percent:
 Continuous Index:
 Within 8" of Joint: **YES**
 Remarks:

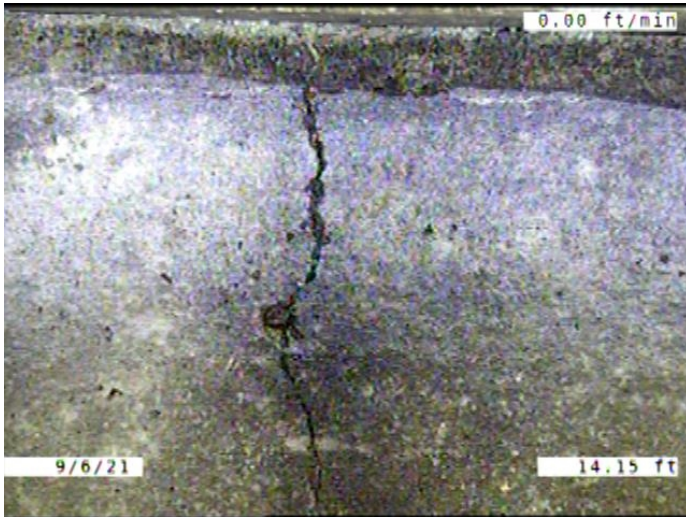
Code: **CM**
 Description: **Crack Multiple**

Distance (ft): **14.2**
 Structural Grade: **3**
 O&M Grade: **0**
 Clock Start/From: **11**
 Clock To: **2**
 1st Value:
 2nd Value:
 Value Percent:
 Continuous Index:
 Within 8" of Joint: **YES**
 Remarks:

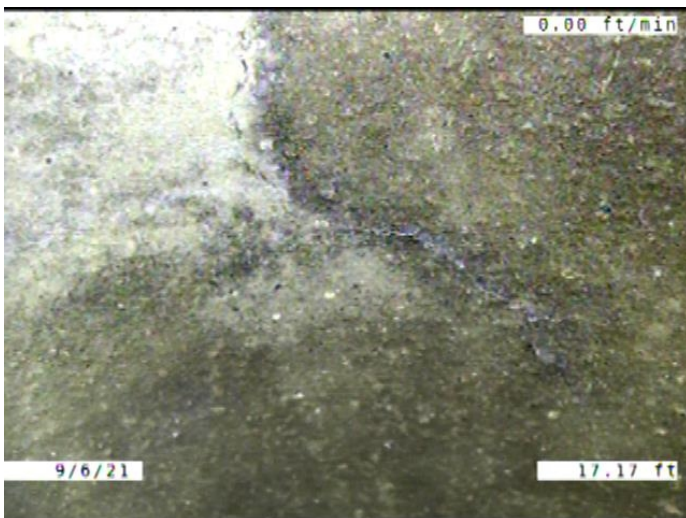
Code: **CS**
 Description: **Crack Spiral**

Distance (ft): **17.2**
 Structural Grade: **2**
 O&M Grade: **0**
 Clock Start/From: **11**
 Clock To: **12**
 1st Value:
 2nd Value:
 Value Percent:
 Continuous Index:
 Within 8" of Joint: **YES**
 Remarks:

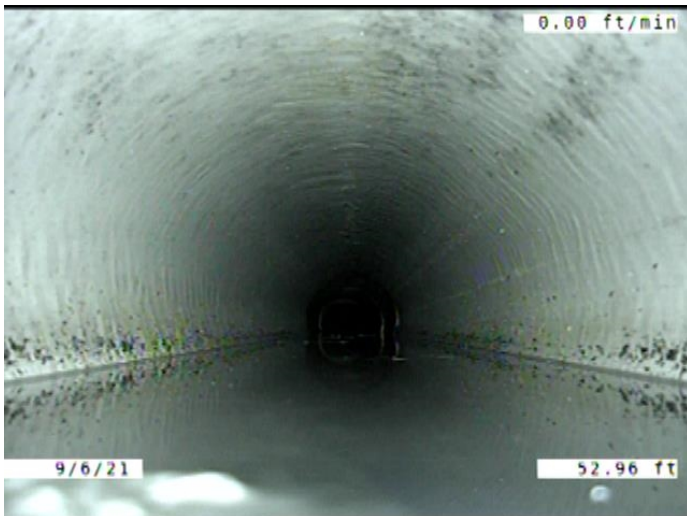
Code: **DSF**
 Description: **Deposits Settled Fine**

Distance (ft): **53.0**
 Structural Grade: **0**
 O&M Grade: **2**
 Clock Start/From: **5**
 Clock To: **7**
 1st Value:
 2nd Value:
 Value Percent: **5.000**
 Continuous Index: **S01**
 Within 8" of Joint: **YES**
 Remarks:

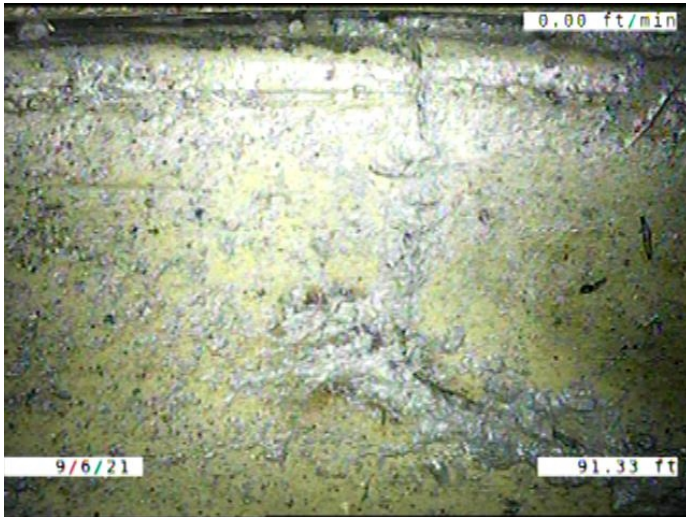
Code: **FM**
 Description: **Fracture Multiple**

Distance (ft): **91.3**
 Structural Grade: **4**
 O&M Grade: **0**
 Clock Start/From: **10**
 Clock To: **1**
 1st Value:
 2nd Value:
 Value Percent:
 Continuous Index:
 Within 8" of Joint: **YES**
 Remarks:

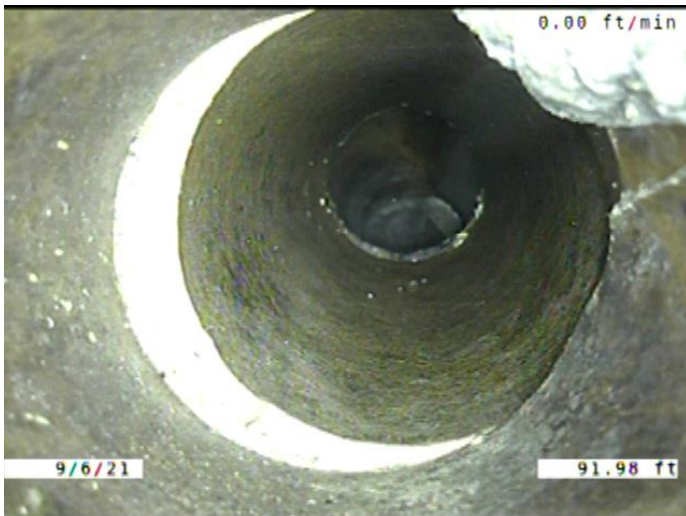
Code: **TFD**
 Description: **Tap Factory Defective**

Distance (ft): **92.0**
 Structural Grade: **0**
 O&M Grade: **3**
 Clock Start/From: **1**
 Clock To:
 1st Value: **4.000**
 2nd Value:
 Value Percent:
 Continuous Index:
 Within 8" of Joint: **YES**
 Remarks: **Defective**

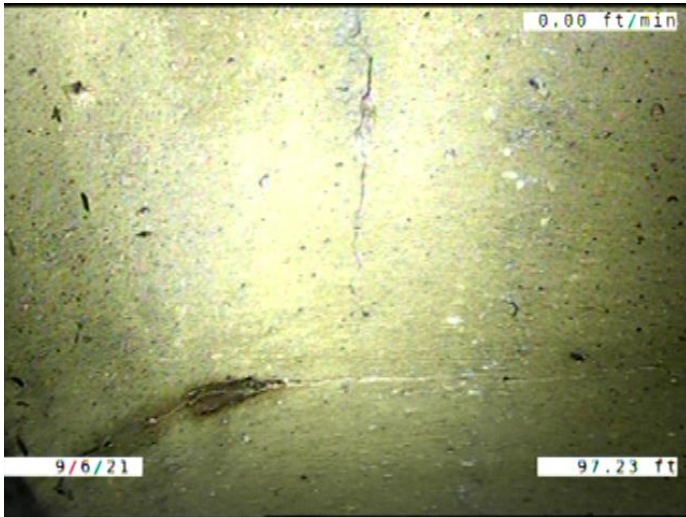
Code: **CM**
 Description: **Crack Multiple**

Distance (ft): **97.2**
 Structural Grade: **3**
 O&M Grade: **0**
 Clock Start/From: **8**
 Clock To: **12**
 1st Value:
 2nd Value:
 Value Percent:
 Continuous Index:
 Within 8" of Joint: **YES**
 Remarks:

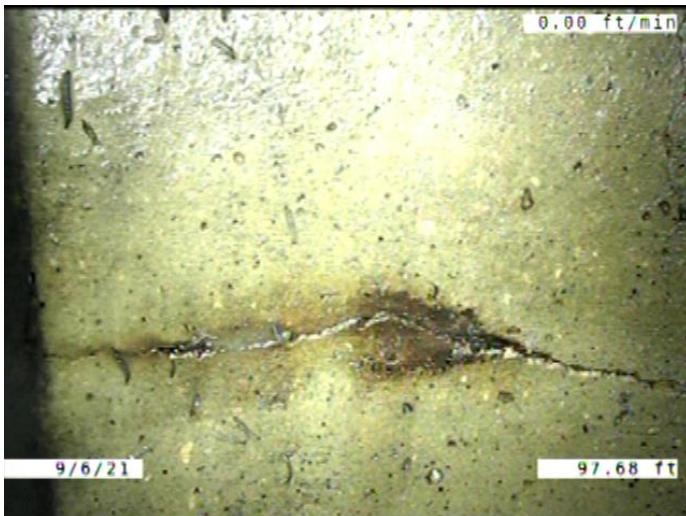
Code: **ISB**
 Description: **Infiltration Stain Barrel**

Distance (ft): **97.7**
 Structural Grade: **0**
 O&M Grade: **1**
 Clock Start/From: **8**
 Clock To: **9**
 1st Value:
 2nd Value:
 Value Percent:
 Continuous Index:
 Within 8" of Joint: **YES**
 Remarks:

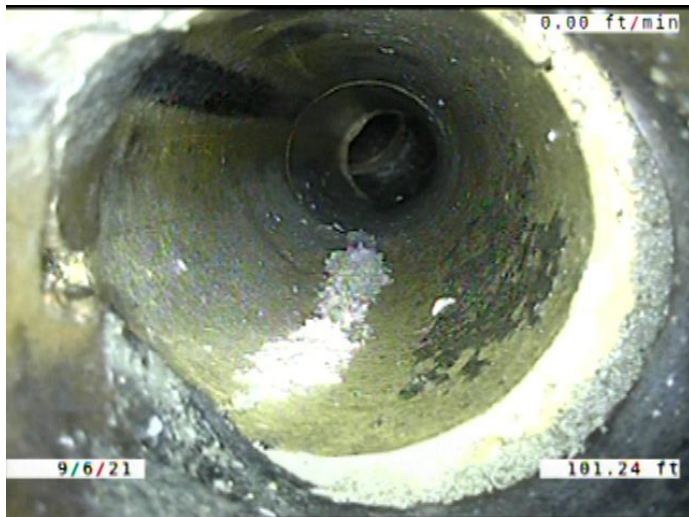
Code: **TFD**
 Description: **Tap Factory Defective**

Distance (ft): **101.2**
 Structural Grade: **0**
 O&M Grade: **3**
 Clock Start/From: **11**
 Clock To:
 1st Value: **4.000**
 2nd Value:
 Value Percent:
 Continuous Index:
 Within 8" of Joint: **YES**
 Remarks: **Defective**

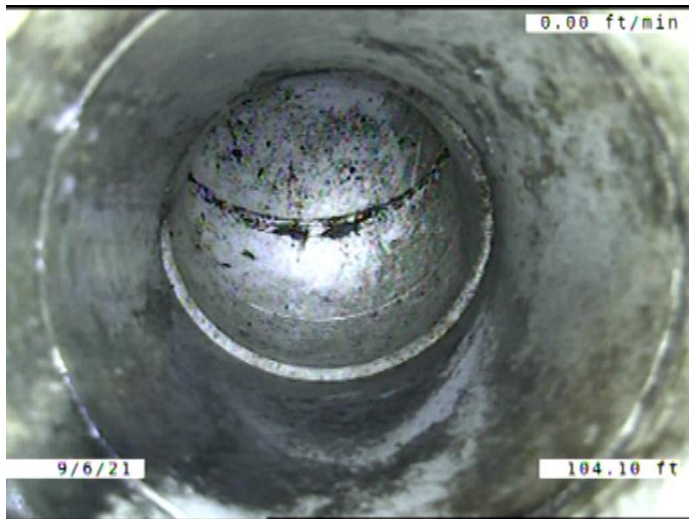
Code:	TF
Description:	Tap Factory
Distance (ft):	104.1
Structural Grade:	0
O&M Grade:	0
Clock Start/From:	11
Clock To:	
1st Value:	4.000
2nd Value:	
Value Percent:	
Continuous Index:	
Within 8" of Joint:	YES
Remarks:	CONSTANTLY RUNNING WATER

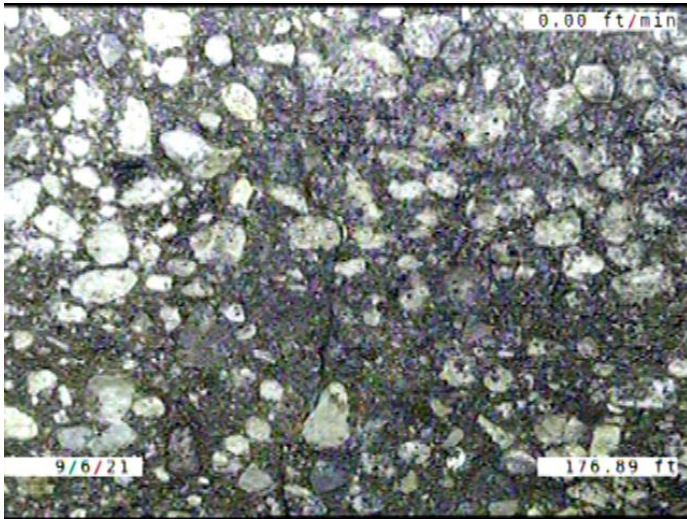
Code: **CL**
 Description: **Crack Longitudinal**

Distance (ft): **176.9**
 Structural Grade: **2**
 O&M Grade: **0**
 Clock Start/From: **12**
 Clock To:
 1st Value:
 2nd Value:
 Value Percent:
 Continuous Index:
 Within 8" of Joint: **YES**
 Remarks:

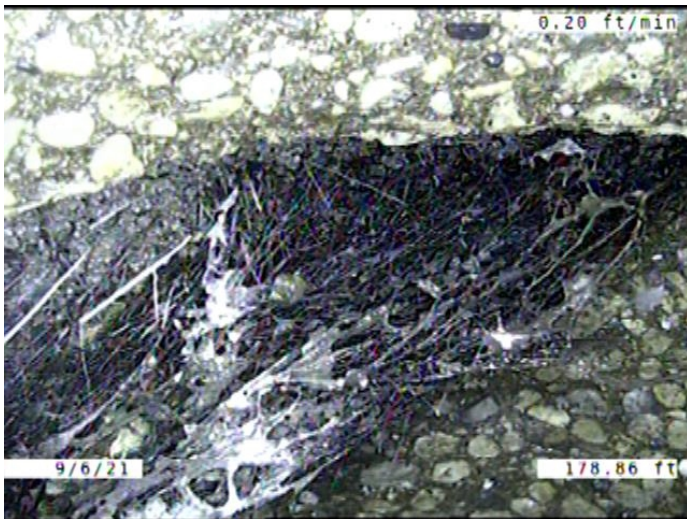
Code: **RMJ**
 Description: **Roots Medium Joint**

Distance (ft): **178.9**
 Structural Grade: **0**
 O&M Grade: **3**
 Clock Start/From: **8**
 Clock To: **4**
 1st Value:
 2nd Value:
 Value Percent: **5.000**
 Continuous Index:
 Within 8" of Joint: **YES**
 Remarks:

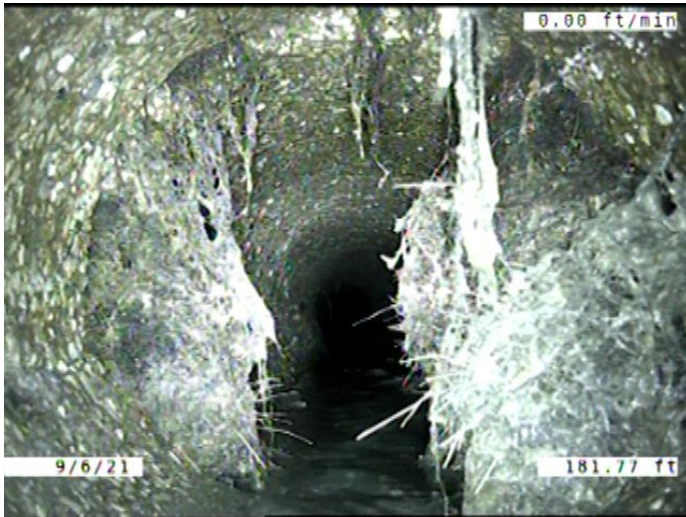
Code: **RMJ**
 Description: **Roots Medium Joint**

Distance (ft): **181.8**
 Structural Grade: **0**
 O&M Grade: **3**
 Clock Start/From: **7**
 Clock To: **5**
 1st Value:
 2nd Value:
 Value Percent: **40.000**
 Continuous Index:
 Within 8" of Joint: **YES**
 Remarks:

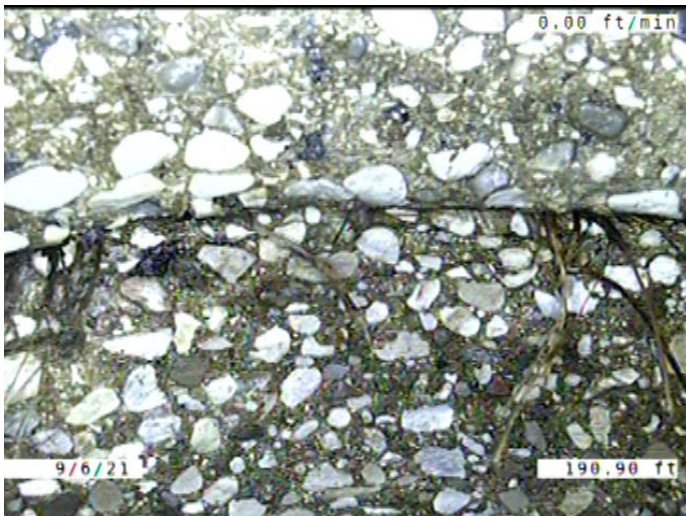
Code: **RFJ**
 Description: **Roots Fine Joint**

Distance (ft): **190.9**
 Structural Grade: **0**
 O&M Grade: **1**
 Clock Start/From: **9**
 Clock To: **3**
 1st Value:
 2nd Value:
 Value Percent:
 Continuous Index:
 Within 8" of Joint: **YES**
 Remarks:

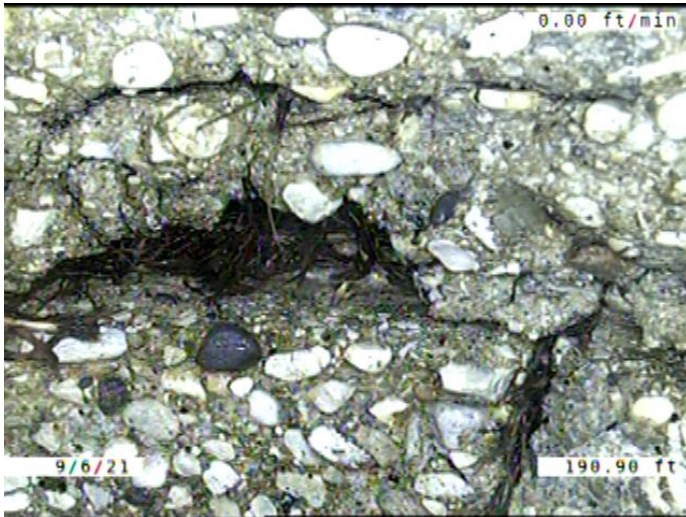
Code: **FM**
 Description: **Fracture Multiple**

Distance (ft): **190.9**
 Structural Grade: **4**
 O&M Grade: **0**
 Clock Start/From: **12**
 Clock To: **3**
 1st Value:
 2nd Value:
 Value Percent:
 Continuous Index:
 Within 8" of Joint: **YES**
 Remarks:

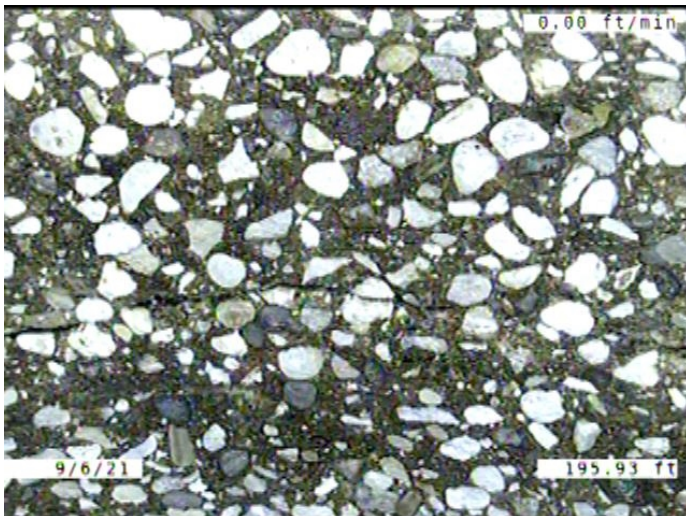
Code: **FS**
 Description: **Fracture Spiral**

Distance (ft): **195.9**
 Structural Grade: **3**
 O&M Grade: **0**
 Clock Start/From: **10**
 Clock To: **2**
 1st Value:
 2nd Value:
 Value Percent:
 Continuous Index:
 Within 8" of Joint: **YES**
 Remarks:

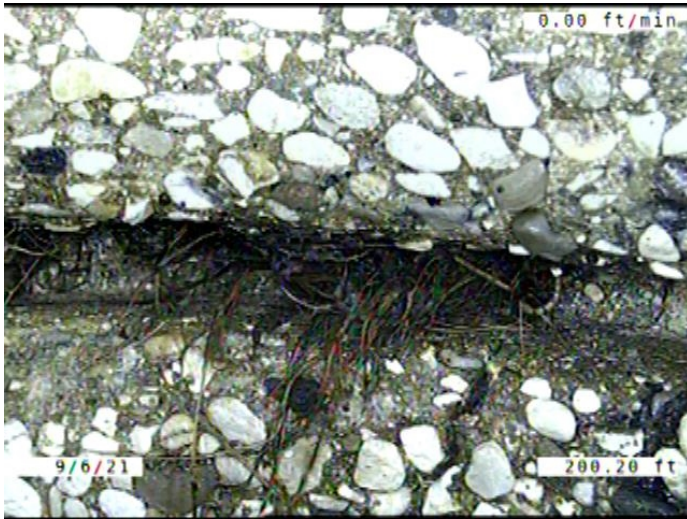
Code: **RFJ**
 Description: **Roots Fine Joint**

Distance (ft): **200.2**
 Structural Grade: **0**
 O&M Grade: **1**
 Clock Start/From: **10**
 Clock To: **3**
 1st Value:
 2nd Value:
 Value Percent:
 Continuous Index:
 Within 8" of Joint: **YES**
 Remarks:

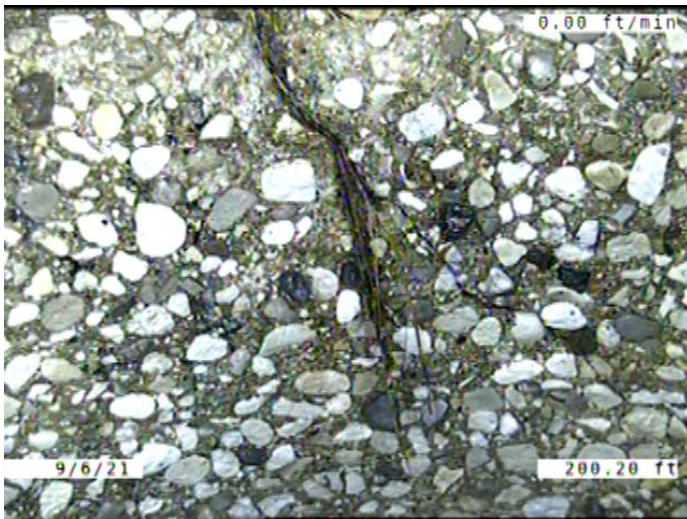
Code: **FM**
 Description: **Fracture Multiple**

Distance (ft): **200.2**
 Structural Grade: **4**
 O&M Grade: **0**
 Clock Start/From: **10**
 Clock To: **3**
 1st Value:
 2nd Value:
 Value Percent:
 Continuous Index:
 Within 8" of Joint: **YES**
 Remarks:

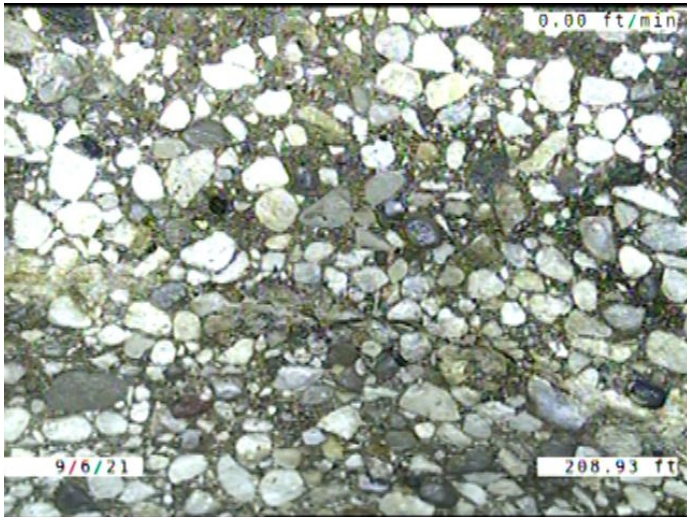
Code: **CS**
 Description: **Crack Spiral**

Distance (ft): **208.9**
 Structural Grade: **2**
 O&M Grade: **0**
 Clock Start/From: **10**
 Clock To: **2**
 1st Value:
 2nd Value:
 Value Percent:
 Continuous Index:
 Within 8" of Joint: **NO**
 Remarks:

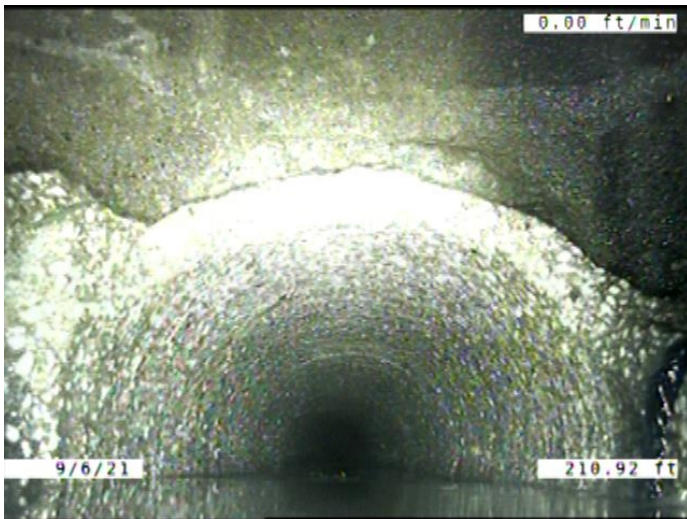
Code: **DSF**
 Description: **Deposits Settled Fine**

Distance (ft): **210.9**
 Structural Grade: **0**
 O&M Grade: **2**
 Clock Start/From: **5**
 Clock To: **7**
 1st Value:
 2nd Value:
 Value Percent: **5.000**
 Continuous Index: **F01**
 Within 8" of Joint: **YES**
 Remarks:
