## Profile/Photo Observation Report

Street:	<b>W 42ND AVE</b>	Flow Control:	<b>Not Controlled</b>
City:	<b>Hobart, IN</b>	Year Renewed:	
Location:	<b>Light Highway</b>	Tape/Media #:	
Purpose:	<b>Not Known</b>	Dia/Height:	<b>12"</b>
Use:	<b>Sanitary</b>	Material:	<b>CP</b>
Drain Area:	<b>NA</b>	Lining:	
Category:	<b>NA</b>		
Comment:

Location Details:		Direction of Survey:	<b>Downstream</b>
US MH:	<b>M-504-104</b>	DS MH:	<b>M-504-111</b>
		Total Length Surveyed (ft):	<b>20.3</b>

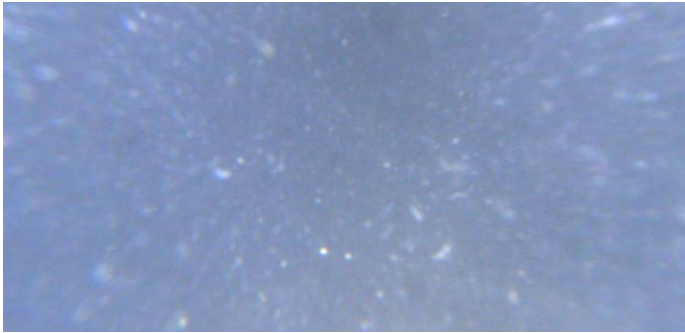
Code:	<b>MWL</b>
Description:	<b>Water Level</b>

Distance (ft):	<b>.0</b>
Structural Grade:	<b>0</b>
O&M Grade:	<b>0</b>
Clock Start/From:	
Clock To:	
1st Value:	
2nd Value:	
Value Percent:	<b>100.000</b>
Continuous Index:	
Within 8" of Joint:	<b>NO</b>
Remarks:

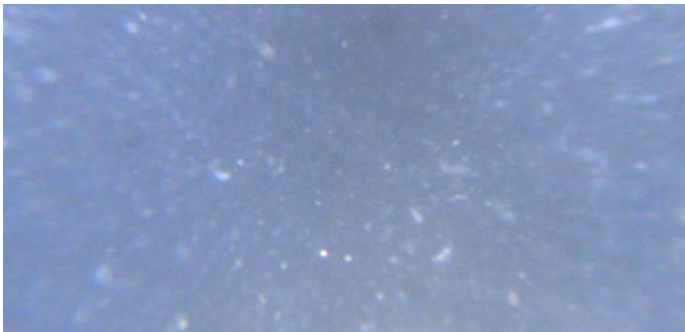
Code:	<b>MCU</b>
Description:	<b>Camera Underwater</b>

Distance (ft):	<b>.0</b>
Structural Grade:	<b>0</b>
O&M Grade:	<b>4</b>
Clock Start/From:	
Clock To:	
1st Value:	
2nd Value:	
Value Percent:	
Continuous Index:	
Within 8" of Joint:	<b>NO</b>
Remarks:

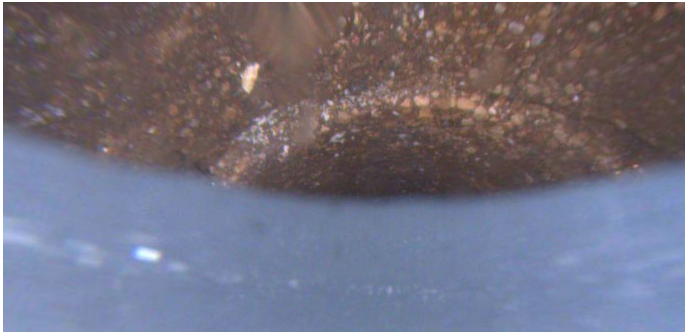
Code: **SAP**  
Description: **Surface Aggregate Projecting**

Distance (ft): **3.7**  
Structural Grade: **3**  
O&M Grade: **0**  
Clock Start/From: **8**  
Clock To: **4**  
1st Value:  
2nd Value:  
Value Percent:  
Continuous Index: **S01**  
Within 8" of Joint:  
Remarks:

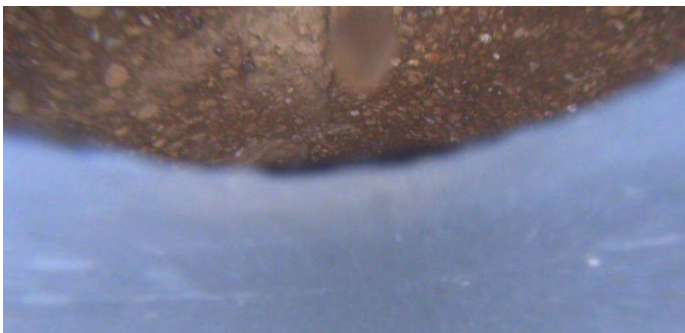
Code: **FL**  
Description: **Fracture Longitudinal**

Distance (ft): **14.7**  
Structural Grade: **3**  
O&M Grade: **0**  
Clock Start/From: **12**  
Clock To:  
1st Value:  
2nd Value:  
Value Percent:  
Continuous Index:  
Within 8" of Joint: **YES**  
Remarks:

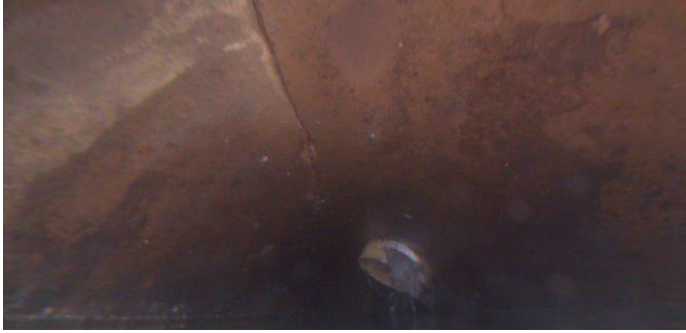
Code: **MMC**  
Description: **Material Change**

Distance (ft): **16.1**  
Structural Grade: **0**  
O&M Grade: **0**  
Clock Start/From:  
Clock To:  
1st Value:  
2nd Value:  
Value Percent:  
Continuous Index:  
Within 8" of Joint: **NO**  
Remarks: **vcp**

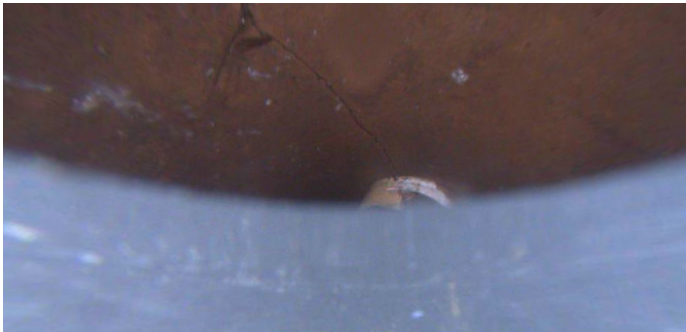
Code: **RFB**  
Description: **Roots Fine Barrel**

Distance (ft): **16.9**  
Structural Grade: **0**  
O&M Grade: **2**  
Clock Start/From: **12**  
Clock To:  
1st Value:  
2nd Value:  
Value Percent:  
Continuous Index:  
Within 8" of Joint: **NO**  
Remarks:

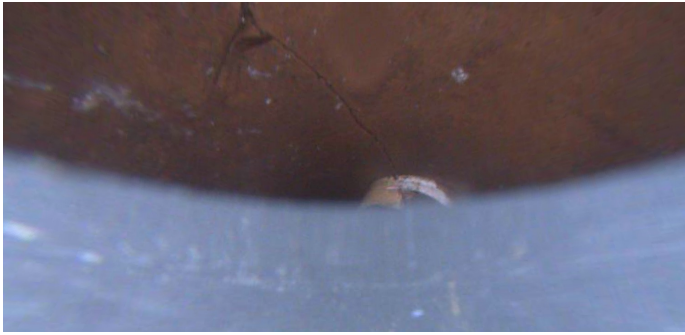
Code: **FM**  
Description: **Fracture Multiple**

Distance (ft): **16.9**  
Structural Grade: **4**  
O&M Grade: **0**  
Clock Start/From: **11**  
Clock To: **1**  
1st Value:  
2nd Value:  
Value Percent:  
Continuous Index:  
Within 8" of Joint:  
Remarks:

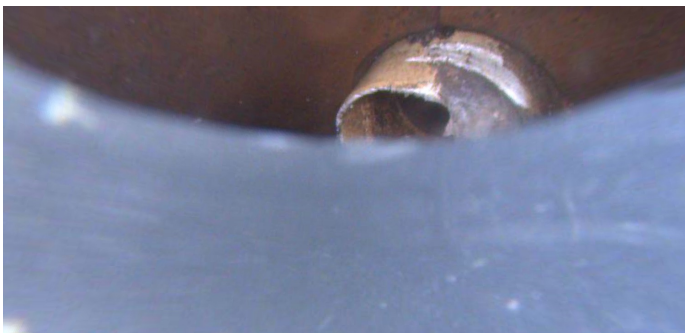
Code: **TBI**  
Description: **Tap Break-in Intruding**

Distance (ft): **17.6**  
Structural Grade: **0**  
O&M Grade: **2**  
Clock Start/From: **1**  
Clock To:  
1st Value: **4.000**  
2nd Value: **1.000**  
Value Percent:  
Continuous Index:  
Within 8" of Joint:  
Remarks:
