## Profile/Photo Observation Report

Street:	<b>Summerlin</b>	Flow Control:	<b>Not Controlled</b>
City:	<b>Hobart, IN</b>	Year Renewed:	
Location:	<b>Light Highway</b>	Tape/Media #:	
Purpose:	<b>Not Known</b>	Dia/Height:	<b>12"</b>
Use:	<b>Sanitary</b>	Material:	<b>CP</b>
Drain Area:	<b>NA</b>	Lining:	
Category:	<b>NA</b>		
Comment:

Location Details:		Direction of Survey:	<b>Downstream</b>
US MH:	<b>M-504-104</b>	DS MH:	<b>M-504-111</b>
		Total Length Surveyed (ft):	<b>20.3</b>

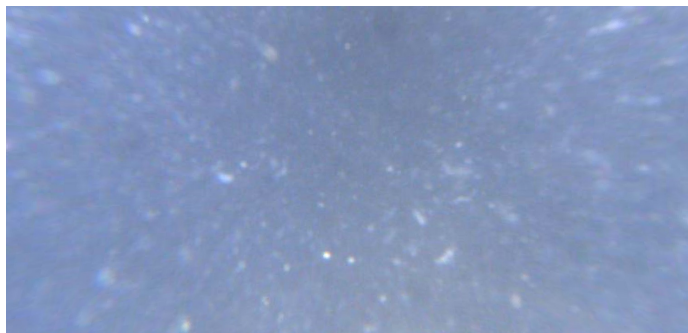
Code: **AMH**  
Description: **Manhole**

Distance (ft): **.0**  
Structural Grade: **0**  
O&M Grade: **0**  
Clock Start/From:  
Clock To:  
1st Value:  
2nd Value:  
Value Percent:  
Continuous Index:  
Within 8" of Joint: **NO**  
Remarks: **M-504-104**

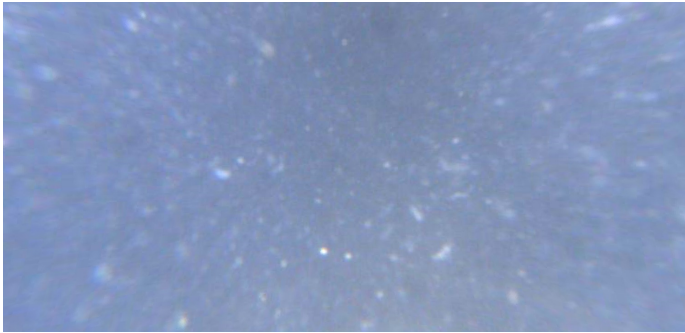
Code:	<b>MWL</b>
Description:	<b>Water Level</b>

Distance (ft):	<b>.0</b>
Structural Grade:	<b>0</b>
O&M Grade:	<b>0</b>
Clock Start/From:	
Clock To:	
1st Value:	
2nd Value:	
Value Percent:	<b>100.000</b>
Continuous Index:	
Within 8" of Joint:	<b>NO</b>
Remarks:

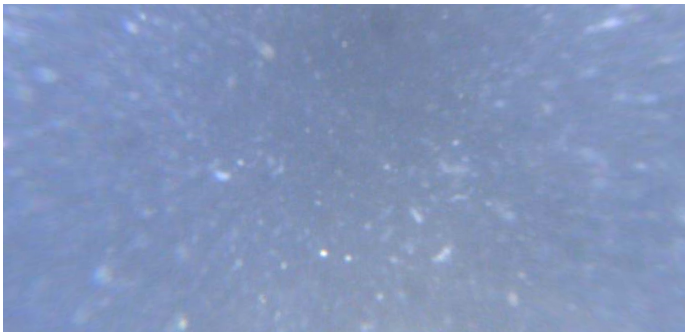
Code:	<b>MCU</b>
Description:	<b>Camera Underwater</b>

Distance (ft):	<b>.0</b>
Structural Grade:	<b>0</b>
O&M Grade:	<b>4</b>
Clock Start/From:	
Clock To:	
1st Value:	
2nd Value:	
Value Percent:	
Continuous Index:	
Within 8" of Joint:	<b>NO</b>
Remarks:

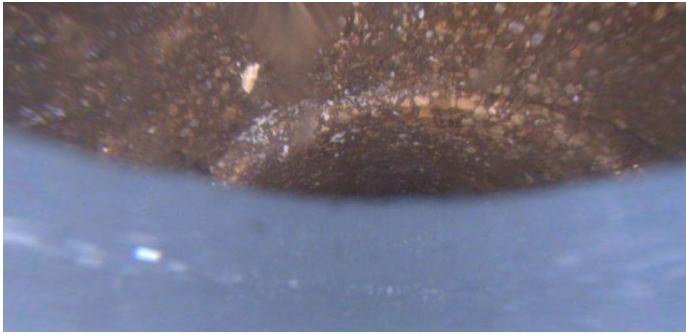
Code: **SAP**  
Description: **Surface Aggregate Projecting**

Distance (ft): **3.7**  
Structural Grade: **3**  
O&M Grade: **0**  
Clock Start/From: **8**  
Clock To: **4**  
1st Value:  
2nd Value:  
Value Percent:  
Continuous Index: **S01**  
Within 8" of Joint:  
Remarks:

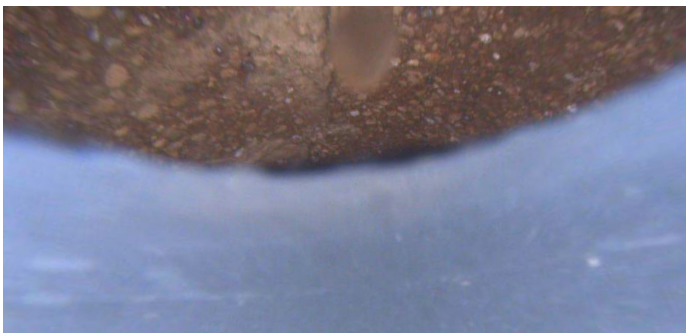
Code: **FL**  
Description: **Fracture Longitudinal**

Distance (ft): **14.7**  
Structural Grade: **3**  
O&M Grade: **0**  
Clock Start/From: **12**  
Clock To:  
1st Value:  
2nd Value:  
Value Percent:  
Continuous Index:  
Within 8" of Joint: **YES**  
Remarks:

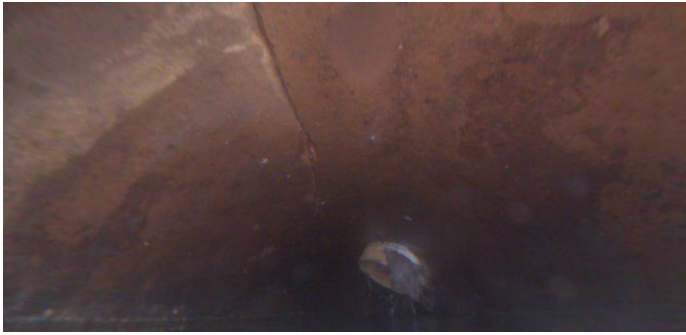
Code: **MMC**  
Description: **Material Change**

Distance (ft): **16.1**  
Structural Grade: **0**  
O&M Grade: **0**  
Clock Start/From:  
Clock To:  
1st Value:  
2nd Value:  
Value Percent:  
Continuous Index:  
Within 8" of Joint: **NO**  
Remarks: **vcp**

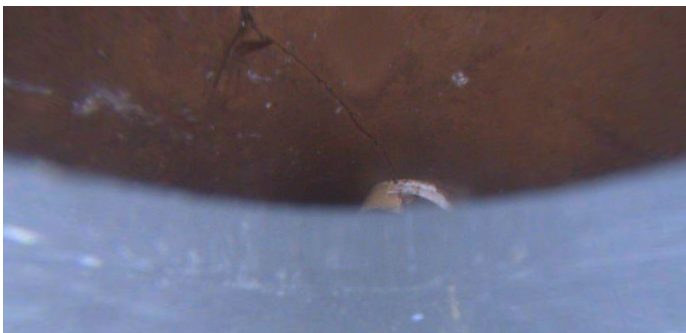
Code: **RFB**  
Description: **Roots Fine Barrel**

Distance (ft): **16.9**  
Structural Grade: **0**  
O&M Grade: **2**  
Clock Start/From: **12**  
Clock To:  
1st Value:  
2nd Value:  
Value Percent:  
Continuous Index:  
Within 8" of Joint: **NO**  
Remarks:

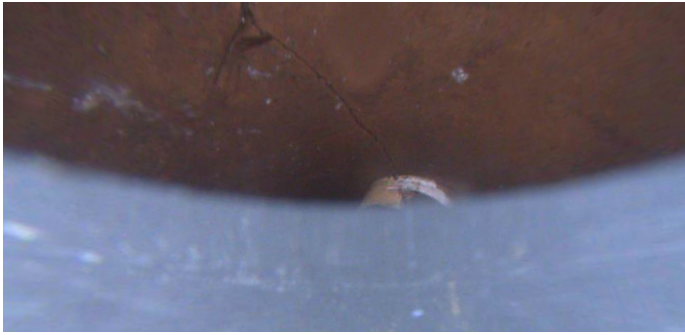
Code: **FM**  
Description: **Fracture Multiple**

Distance (ft): **16.9**  
Structural Grade: **4**  
O&M Grade: **0**  
Clock Start/From: **11**  
Clock To: **1**  
1st Value:  
2nd Value:  
Value Percent:  
Continuous Index:  
Within 8" of Joint:  
Remarks:

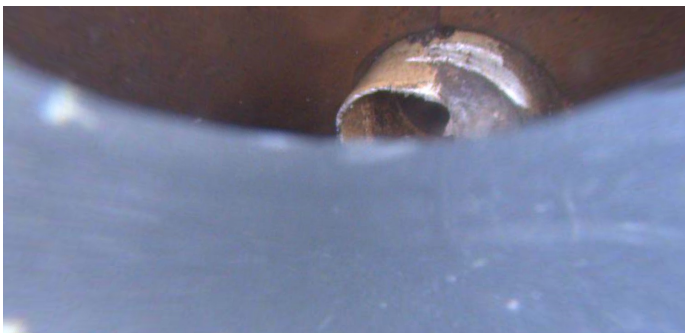
Code: **TBI**  
Description: **Tap Break-in Intruding**

Distance (ft): **17.6**  
Structural Grade: **0**  
O&M Grade: **2**  
Clock Start/From: **1**  
Clock To:  
1st Value: **4.000**  
2nd Value: **1.000**  
Value Percent:  
Continuous Index:  
Within 8" of Joint:  
Remarks:
