Profile/Photo Observation Report

Date:	09/11/2021	Weather:		Coding:	PACP 7.0
Pipe Length (ft):	260.0	Owner:	City of Hobart	Pre Clean:	Heavy Cleaning
P.O.#:	YES502259	Surveyor:	S. Bucklin	PSR:	P-504-111-104
Customer:	City of Hobart	Clean Date:	09/11/2021	Shape:	C

Street:	North Colorado Street	Flow Control:	Not Controlled
City:	Hobart, IN	Year Renewed:	
Location:	Alley	Tape/Media #:	
Purpose:	Routine Assessment	Dia/Height:	12"
Use:	Sanitary Sewage Pipe	Material:	CP
Drain Area:		Lining:	None
Category:	NA		
Comment:

Location Details:		Direction of Survey:	Downstream
US MH:	M-504-104	DS MH:	M-504-111
		Total Length Surveyed (ft):	65.9

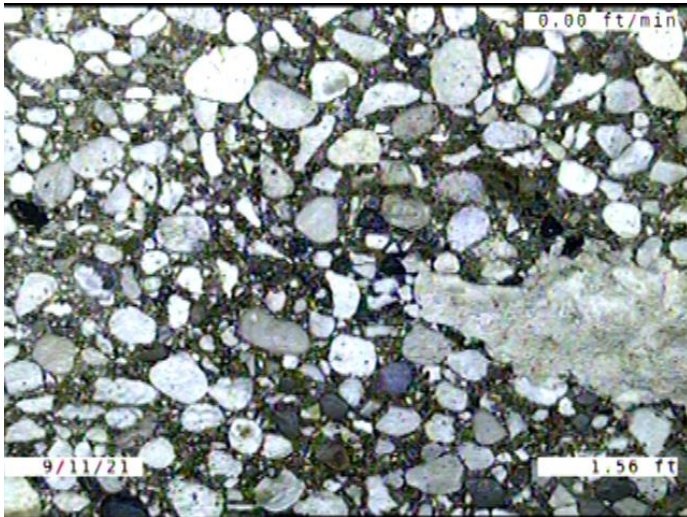
Code: **CS**
 Description: **Crack Spiral**

Distance (ft): **1.6**
 Structural Grade: **2**
 O&M Grade: **0**
 Clock Start/From: **10**
 Clock To: **1**
 1st Value:
 2nd Value:
 Value Percent:
 Continuous Index:
 Within 8" of Joint: **NO**
 Remarks:

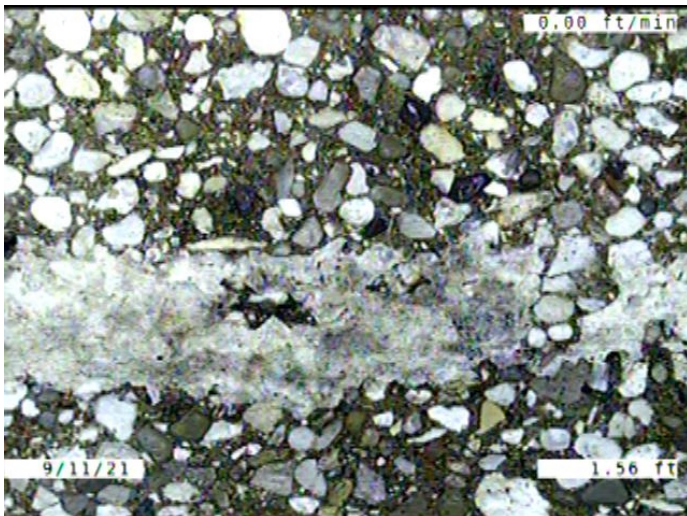
Code: **DAE**
 Description: **Deposits Attached Encrustation**

Distance (ft): **1.6**
 Structural Grade: **0**
 O&M Grade: **2**
 Clock Start/From: **11**
 Clock To: **1**
 1st Value:
 2nd Value:
 Value Percent: **5.000**
 Continuous Index:
 Within 8" of Joint: **YES**
 Remarks:

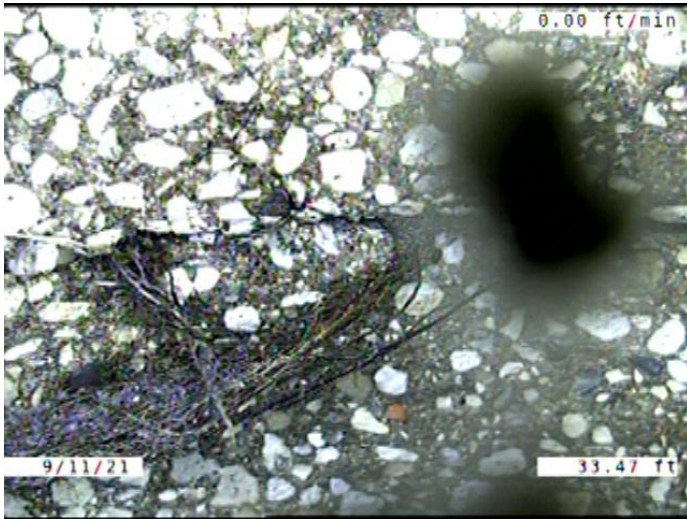
Code: **RFJ**
 Description: **Roots Fine Joint**

Distance (ft): **33.5**
 Structural Grade: **0**
 O&M Grade: **1**
 Clock Start/From: **9**
 Clock To: **11**
 1st Value:
 2nd Value:
 Value Percent:
 Continuous Index:
 Within 8" of Joint: **YES**
 Remarks:

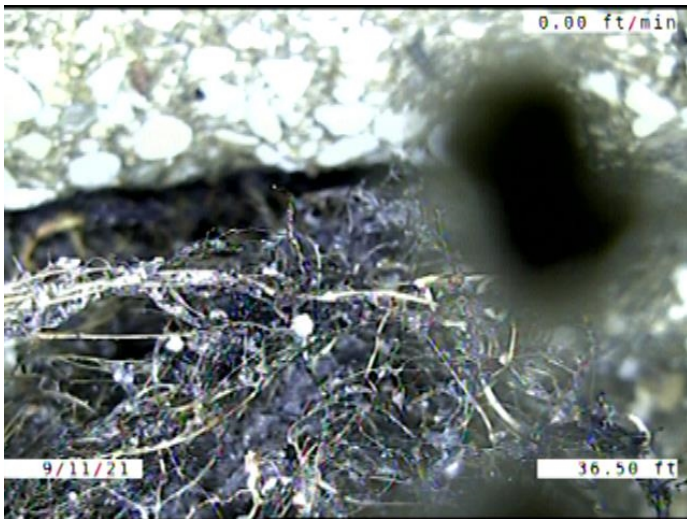
Code: **RMJ**
 Description: **Roots Medium Joint**

Distance (ft): **36.5**
 Structural Grade: **0**
 O&M Grade: **3**
 Clock Start/From: **10**
 Clock To: **11**
 1st Value:
 2nd Value:
 Value Percent: **5.000**
 Continuous Index:
 Within 8" of Joint: **YES**
 Remarks:

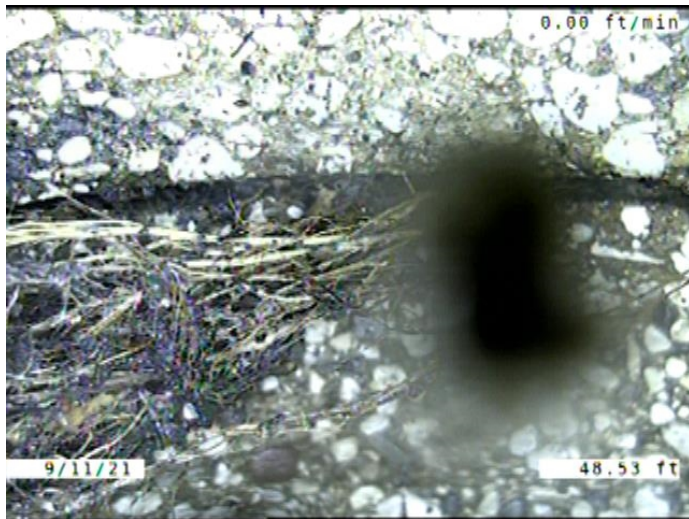
Code: **RMJ**
 Description: **Roots Medium Joint**

Distance (ft): **48.5**
 Structural Grade: **0**
 O&M Grade: **3**
 Clock Start/From: **10**
 Clock To: **11**
 1st Value:
 2nd Value:
 Value Percent: **5.000**
 Continuous Index:
 Within 8" of Joint: **YES**
 Remarks:

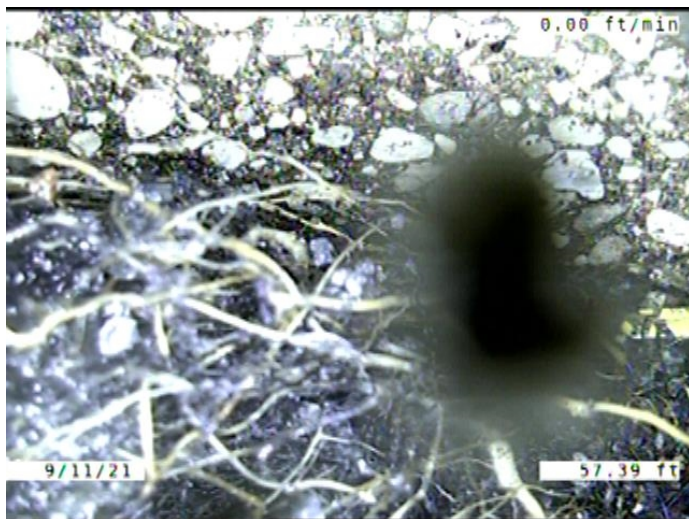
Code: **RMJ**
 Description: **Roots Medium Joint**

Distance (ft): **57.4**
 Structural Grade: **0**
 O&M Grade: **3**
 Clock Start/From: **9**
 Clock To: **3**
 1st Value:
 2nd Value:
 Value Percent: **20.000**
 Continuous Index:
 Within 8" of Joint: **YES**
 Remarks:

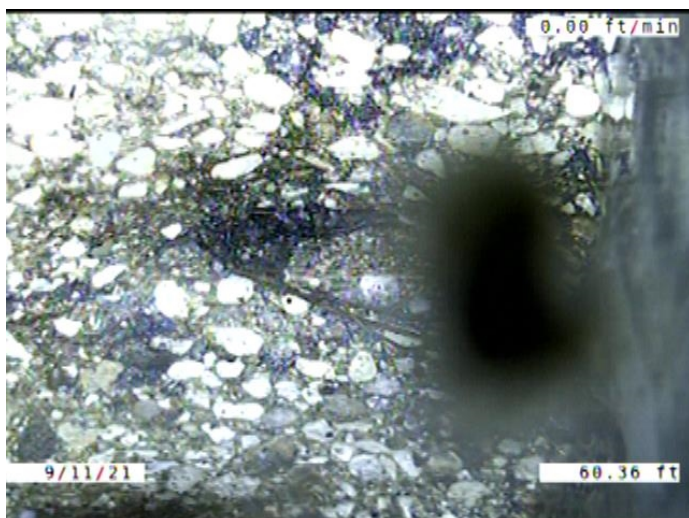
Code: **RFJ**
 Description: **Roots Fine Joint**

Distance (ft): **60.4**
 Structural Grade: **0**
 O&M Grade: **1**
 Clock Start/From: **9**
 Clock To: **3**
 1st Value:
 2nd Value:
 Value Percent:
 Continuous Index:
 Within 8" of Joint: **YES**
 Remarks:

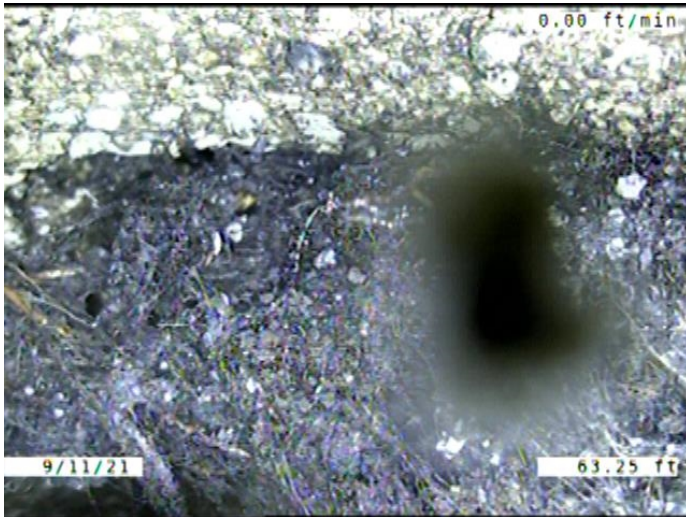
Code: **RMJ**
 Description: **Roots Medium Joint**

Distance (ft): **63.3**
 Structural Grade: **0**
 O&M Grade: **3**
 Clock Start/From: **9**
 Clock To: **3**
 1st Value:
 2nd Value:
 Value Percent: **20.000**
 Continuous Index:
 Within 8" of Joint: **YES**
 Remarks:

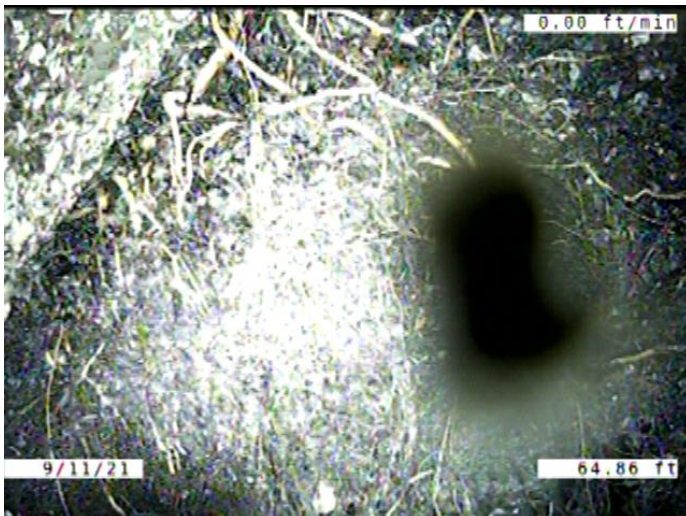
Code: **RBJ**
 Description: **Roots Ball Joint**

Distance (ft): **64.9**
 Structural Grade: **0**
 O&M Grade: **4**
 Clock Start/From: **8**
 Clock To: **4**
 1st Value:
 2nd Value:
 Value Percent: **65.000**
 Continuous Index:
 Within 8" of Joint: **YES**
 Remarks:

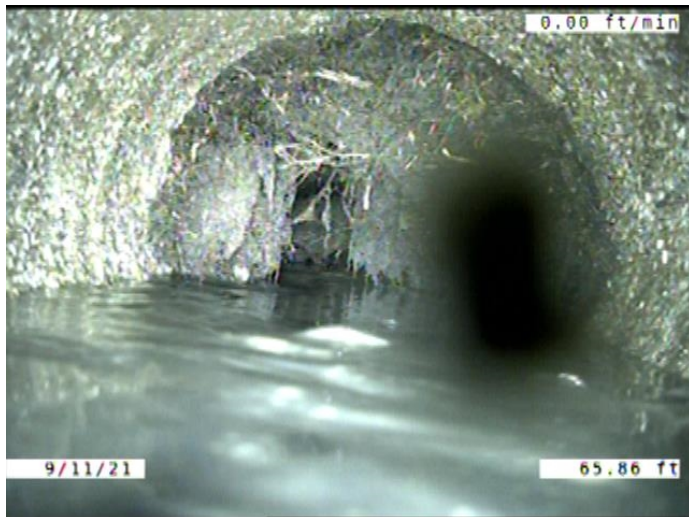
Code: **FM**
 Description: **Fracture Multiple**

Distance (ft): **65.9**
 Structural Grade: **4**
 O&M Grade: **0**
 Clock Start/From: **11**
 Clock To: **1**
 1st Value:
 2nd Value:
 Value Percent:
 Continuous Index: **F01**
 Within 8" of Joint: **YES**
 Remarks:

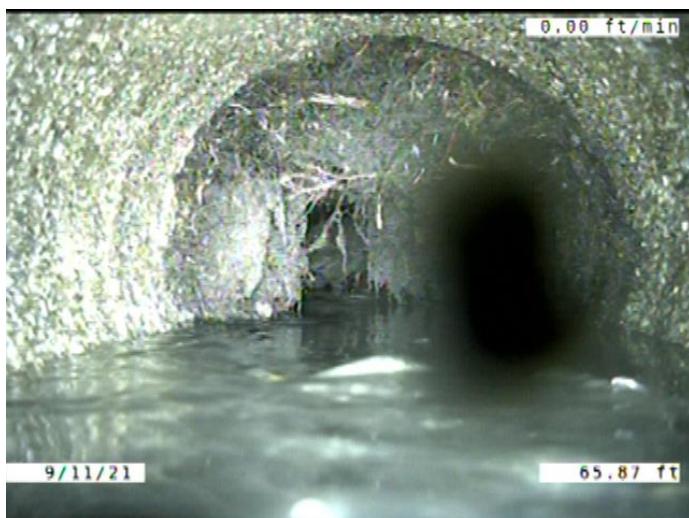
Code: **MSA**
 Description: **Miscellaneous Survey Abandoned**

Distance (ft): **65.9**
 Structural Grade: **0**
 O&M Grade: **0**
 Clock Start/From:
 Clock To:
 1st Value:
 2nd Value:
 Value Percent:
 Continuous Index:
 Within 8" of Joint: **NO**
 Remarks: **CAMERA CANT MAKE IT PAST ROOTS.**
