Profile/Photo Observation Report

Date:	09/11/2021	Weather:		Coding:	PACP 7.0
Pipe Length (ft):	260.0	Owner:	City of Hobart	Pre Clean:	Heavy Cleaning
P.O.#:	YES502259	Surveyor:	S. Bucklin	PSR:	P-504-111-104
Customer:	City of Hobart	Clean Date:	09/11/2021	Shape:	C

Street:	North Colorado Street	Flow Control:	Not Controlled
City:	Hobart, IN	Year Renewed:	
Location:	Alley	Tape/Media #:	
Purpose:	Routine Assessment	Dia/Height:	12"
Use:	Sanitary Sewage Pipe	Material:	CP
Drain Area:		Lining:	None
Category:	NA		
Comment:

Location Details:		Direction of Survey:	Downstream
US MH:	M-504-104	DS MH:	M-504-111
		Total Length Surveyed (ft):	65.9

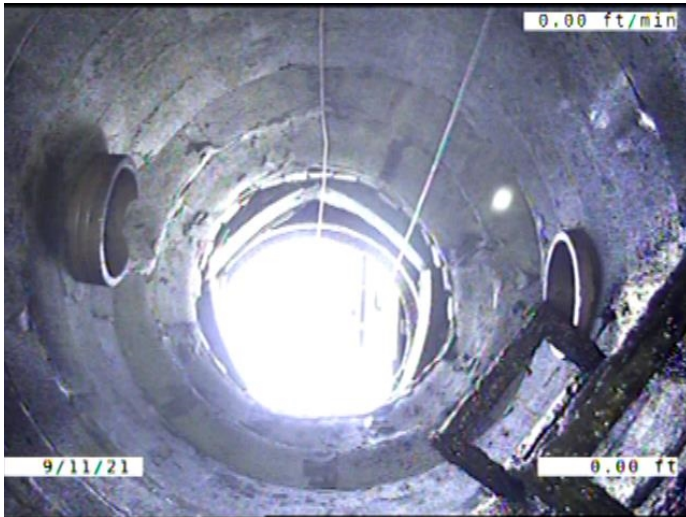
Code: **AMH**
 Description: **Manhole**

Distance (ft): **.0**
 Structural Grade: **0**
 O&M Grade: **0**
 Clock Start/From:
 Clock To:
 1st Value:
 2nd Value:
 Value Percent:
 Continuous Index:
 Within 8" of Joint: **NO**
 Remarks: **M-504-104**

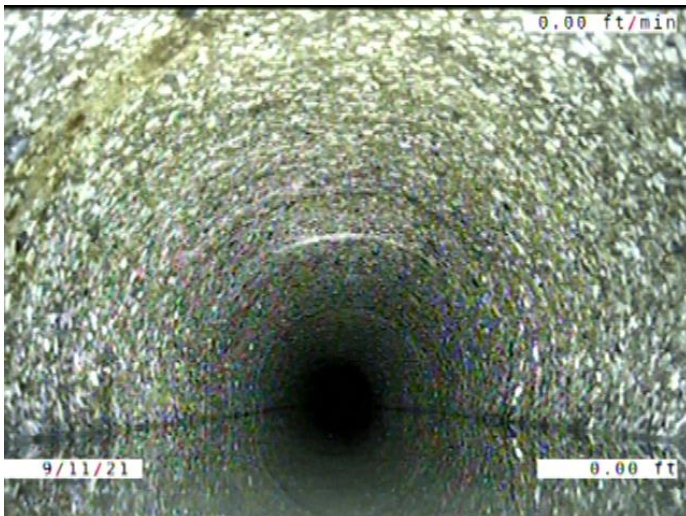
Code: **MWL**
 Description: **Miscellaneous Water Level**

Distance (ft): **.0**
 Structural Grade: **0**
 O&M Grade: **0**
 Clock Start/From:
 Clock To:
 1st Value:
 2nd Value:
 Value Percent: **15.000**
 Continuous Index:
 Within 8" of Joint: **NO**
 Remarks:

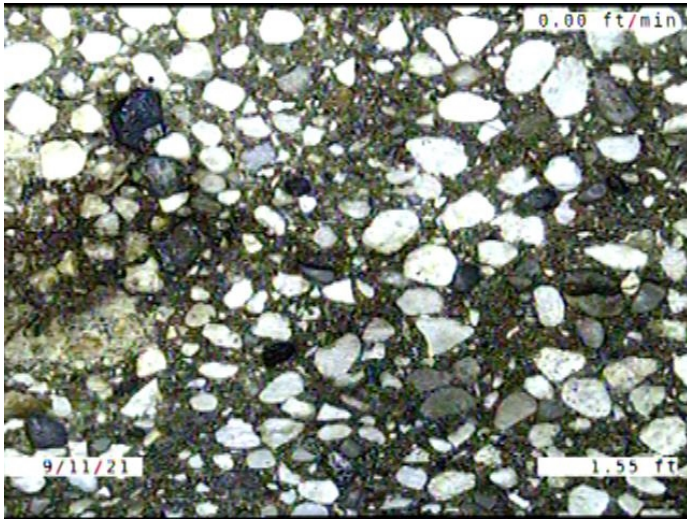
Code: **CS**
Description: **Crack Spiral**

Distance (ft): **1.5**
Structural Grade: **2**
O&M Grade: **0**
Clock Start/From: **10**
Clock To: **1**
1st Value:
2nd Value:
Value Percent:
Continuous Index:
Within 8" of Joint: **NO**
Remarks:

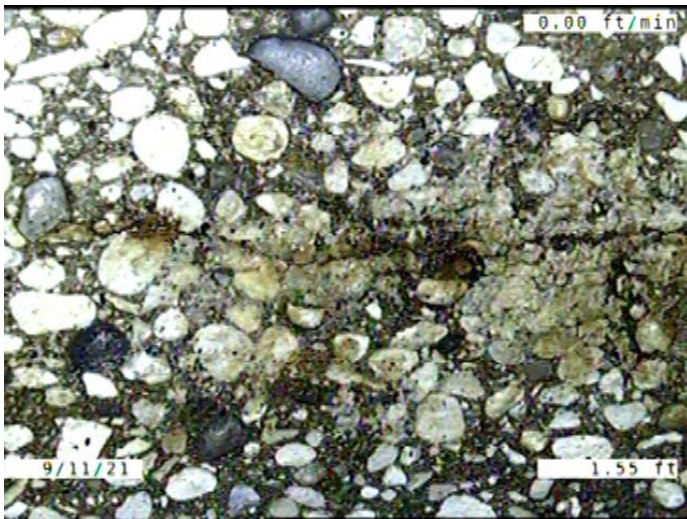
Code: **ISB**
Description: **Infiltration Stain Barrel**

Distance (ft): **1.6**
Structural Grade: **0**
O&M Grade: **1**
Clock Start/From: **10**
Clock To: **1**
1st Value:
2nd Value:
Value Percent:
Continuous Index:
Within 8" of Joint: **NO**
Remarks:

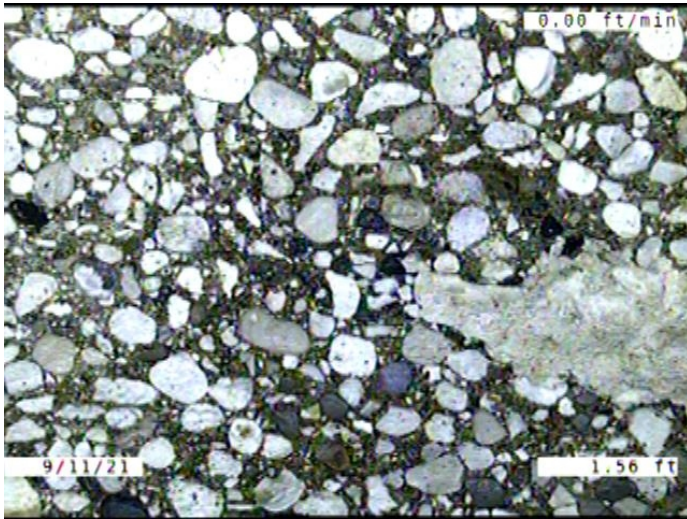
Code: **CS**
 Description: **Crack Spiral**

Distance (ft): **1.6**
 Structural Grade: **2**
 O&M Grade: **0**
 Clock Start/From: **10**
 Clock To: **1**
 1st Value:
 2nd Value:
 Value Percent:
 Continuous Index:
 Within 8" of Joint: **NO**
 Remarks:

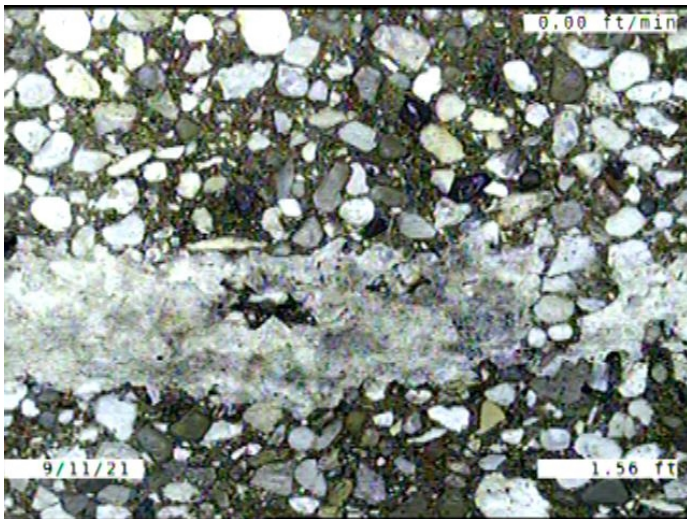
Code: **DAE**
 Description: **Deposits Attached Encrustation**

Distance (ft): **1.6**
 Structural Grade: **0**
 O&M Grade: **2**
 Clock Start/From: **11**
 Clock To: **1**
 1st Value:
 2nd Value:
 Value Percent: **5.000**
 Continuous Index:
 Within 8" of Joint: **YES**
 Remarks:

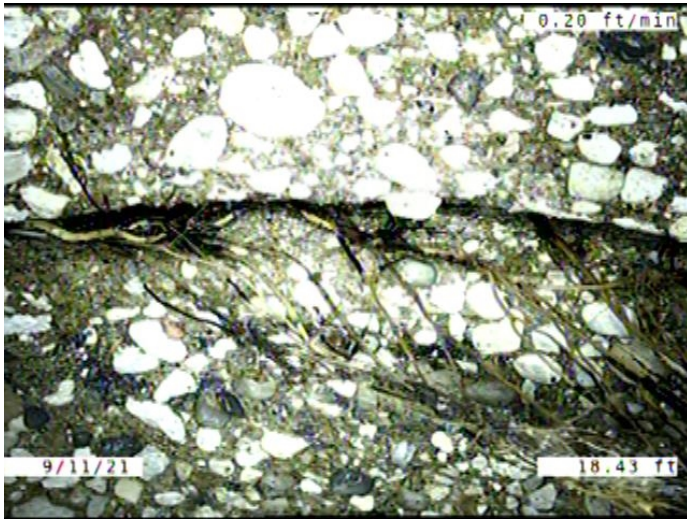
Code: **RFJ**
 Description: **Roots Fine Joint**

Distance (ft): **18.4**
 Structural Grade: **0**
 O&M Grade: **1**
 Clock Start/From: **1**
 Clock To: **3**
 1st Value:
 2nd Value:
 Value Percent:
 Continuous Index:
 Within 8" of Joint: **YES**
 Remarks:

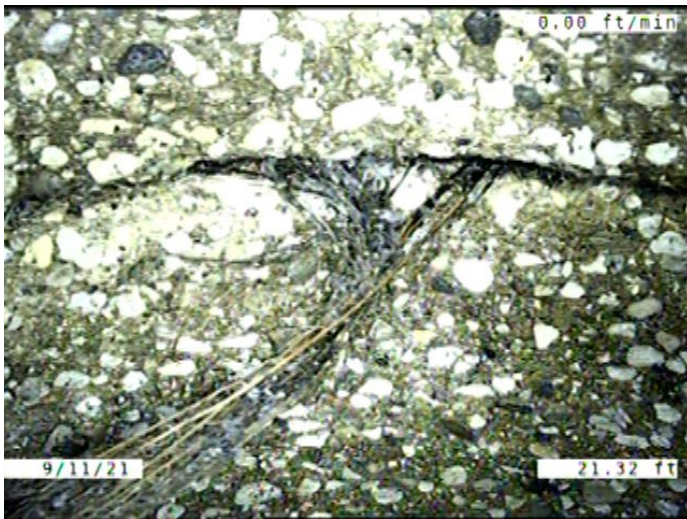
Code: **RMJ**
 Description: **Roots Medium Joint**

Distance (ft): **21.3**
 Structural Grade: **0**
 O&M Grade: **3**
 Clock Start/From: **10**
 Clock To: **12**
 1st Value:
 2nd Value:
 Value Percent: **5.000**
 Continuous Index:
 Within 8" of Joint: **YES**
 Remarks:

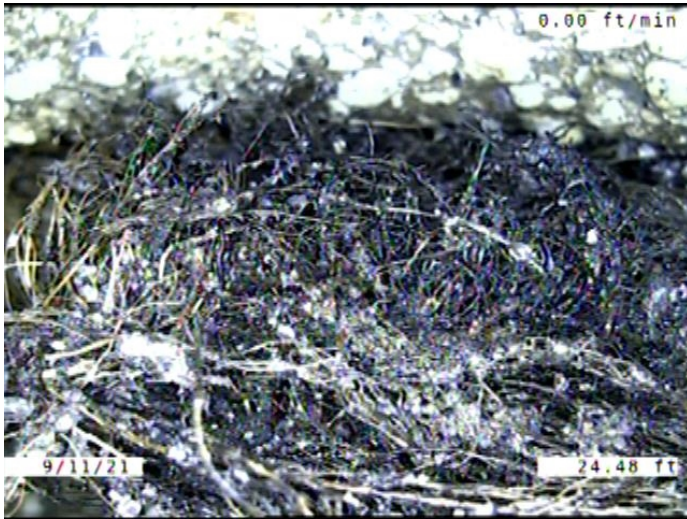
Code: **RMJ**
 Description: **Roots Medium Joint**

Distance (ft): **24.5**
 Structural Grade: **0**
 O&M Grade: **3**
 Clock Start/From: **9**
 Clock To: **2**
 1st Value:
 2nd Value:
 Value Percent: **10.000**
 Continuous Index:
 Within 8" of Joint: **YES**
 Remarks:

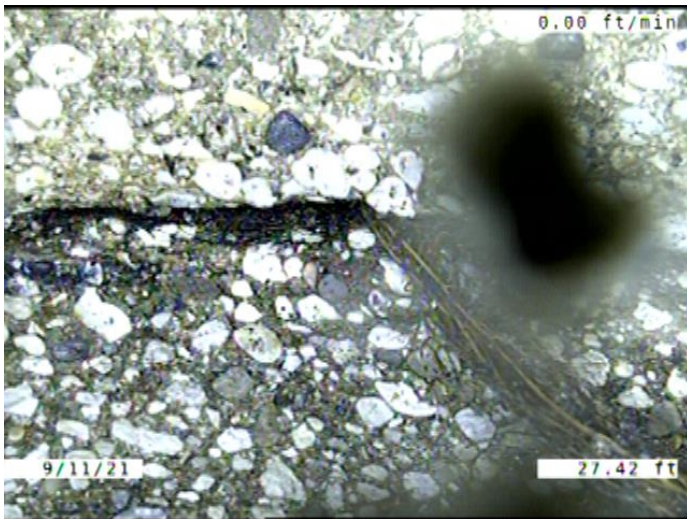
Code: **RMJ**
 Description: **Roots Medium Joint**

Distance (ft): **27.4**
 Structural Grade: **0**
 O&M Grade: **3**
 Clock Start/From: **1**
 Clock To: **2**
 1st Value:
 2nd Value:
 Value Percent: **5.000**
 Continuous Index:
 Within 8" of Joint: **YES**
 Remarks:

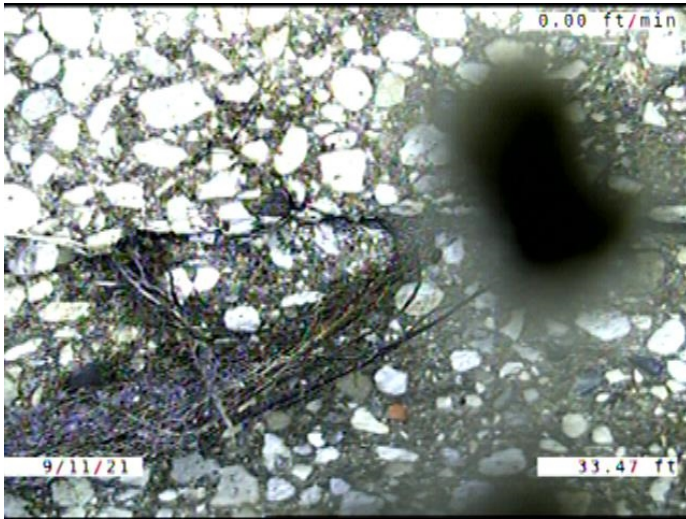
Code: **RFJ**
 Description: **Roots Fine Joint**

Distance (ft): **33.5**
 Structural Grade: **0**
 O&M Grade: **1**
 Clock Start/From: **9**
 Clock To: **11**
 1st Value:
 2nd Value:
 Value Percent:
 Continuous Index:
 Within 8" of Joint: **YES**
 Remarks:

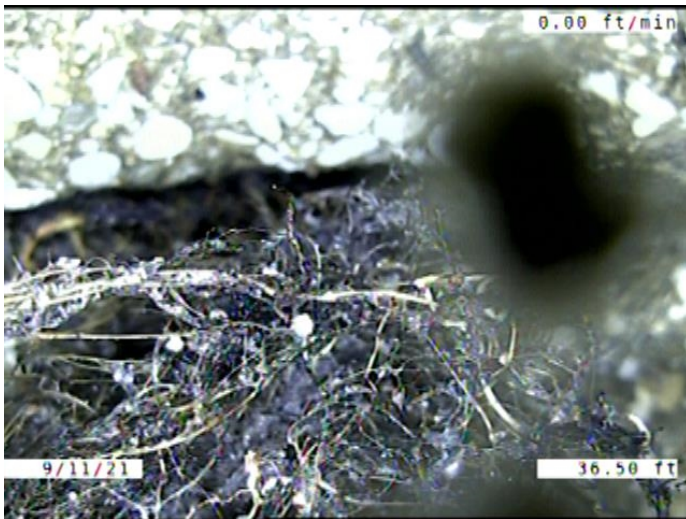
Code: **RMJ**
 Description: **Roots Medium Joint**

Distance (ft): **36.5**
 Structural Grade: **0**
 O&M Grade: **3**
 Clock Start/From: **10**
 Clock To: **11**
 1st Value:
 2nd Value:
 Value Percent: **5.000**
 Continuous Index:
 Within 8" of Joint: **YES**
 Remarks:

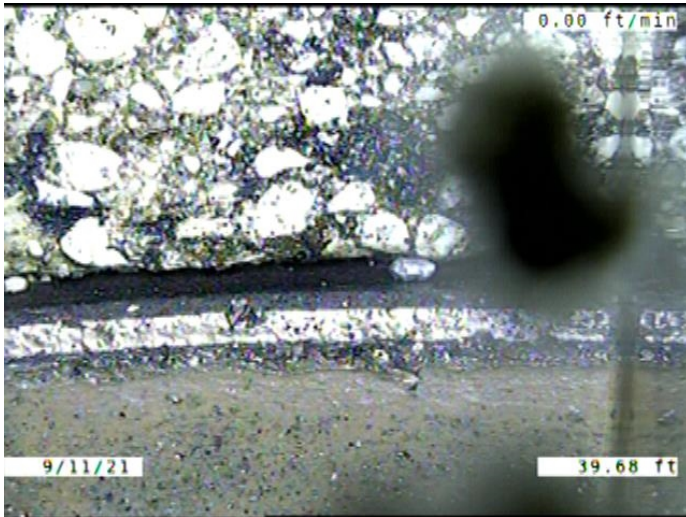
Code: **MMC**
 Description: **Miscellaneous Material Change**

Distance (ft): **39.7**
 Structural Grade: **0**
 O&M Grade: **0**
 Clock Start/From:
 Clock To:
 1st Value:
 2nd Value:
 Value Percent:
 Continuous Index:
 Within 8" of Joint: **NO**
 Remarks: **CONCRETE TO VCP**

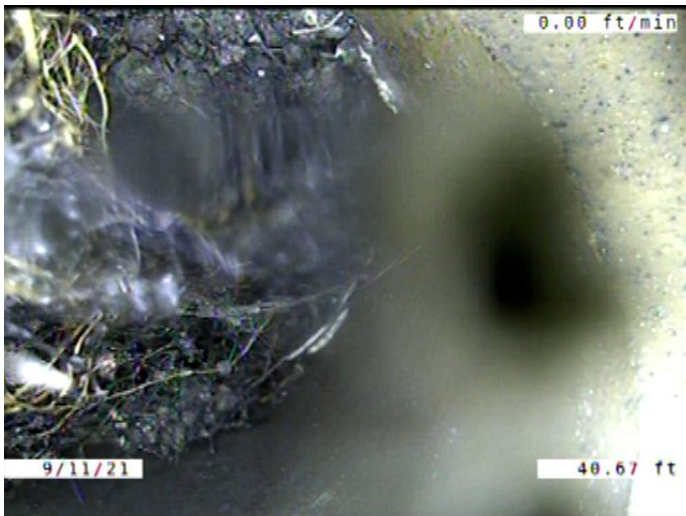
Code: **TFD**
 Description: **Tap Factory Defective**

Distance (ft): **40.7**
 Structural Grade: **0**
 O&M Grade: **3**
 Clock Start/From: **11**
 Clock To:
 1st Value: **4.000**
 2nd Value:
 Value Percent:
 Continuous Index:
 Within 8" of Joint: **YES**
 Remarks: **Defective**

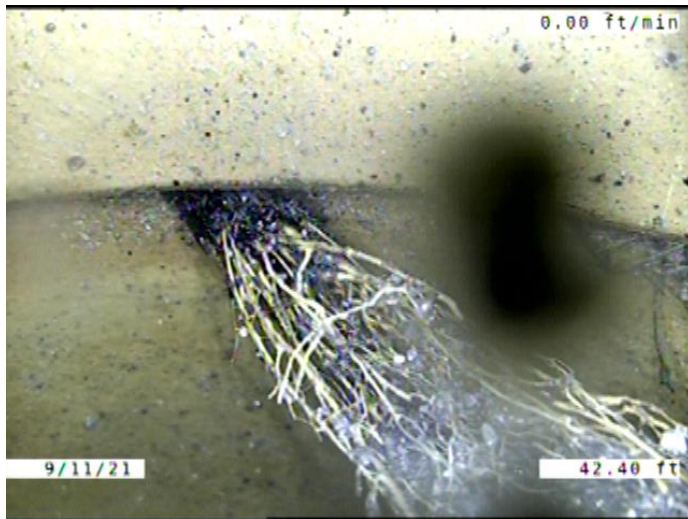
Code: **RMJ**
 Description: **Roots Medium Joint**

Distance (ft): **42.4**
 Structural Grade: **0**
 O&M Grade: **3**
 Clock Start/From: **9**
 Clock To: **3**
 1st Value:
 2nd Value:
 Value Percent: **5.000**
 Continuous Index:
 Within 8" of Joint: **YES**
 Remarks:

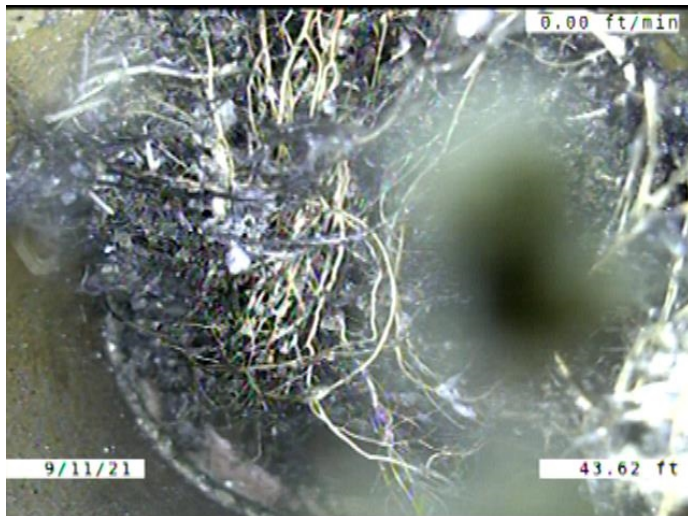
Code: **TFD**
 Description: **Tap Factory Defective**

Distance (ft): **43.6**
 Structural Grade: **0**
 O&M Grade: **3**
 Clock Start/From: **1**
 Clock To:
 1st Value: **4.000**
 2nd Value:
 Value Percent:
 Continuous Index:
 Within 8" of Joint: **YES**
 Remarks: **Defective**

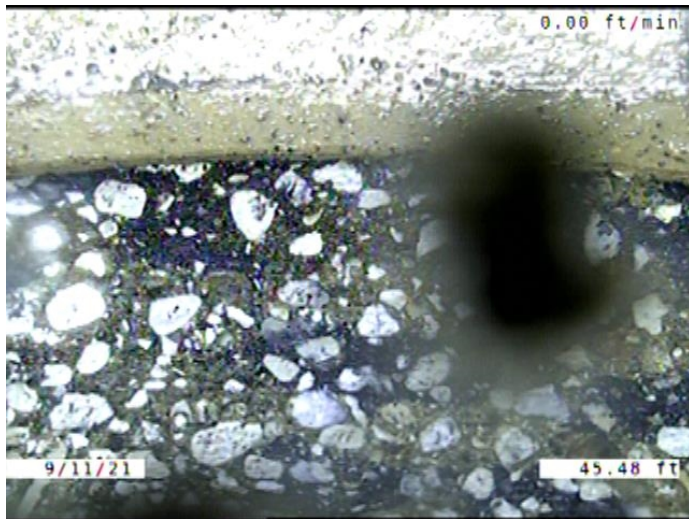
Code: **MMC**
 Description: **Miscellaneous Material Change**

Distance (ft): **45.5**
 Structural Grade: **0**
 O&M Grade: **0**
 Clock Start/From:
 Clock To:
 1st Value:
 2nd Value:
 Value Percent:
 Continuous Index:
 Within 8" of Joint: **NO**
 Remarks: **VCP TO CONCRETE**

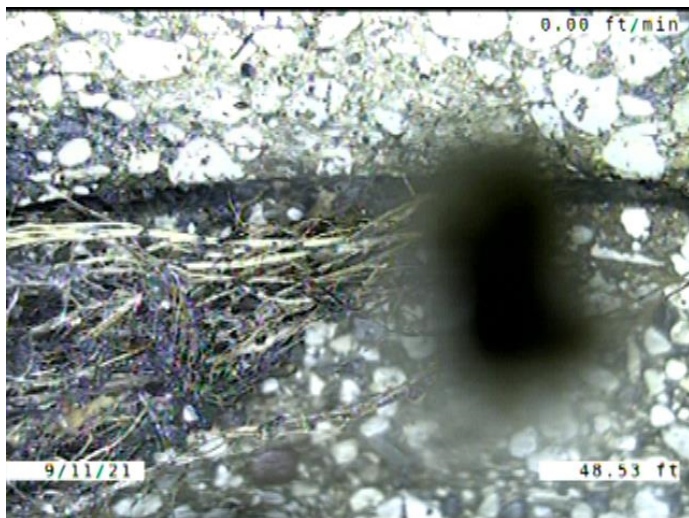
Code: **RMJ**
 Description: **Roots Medium Joint**

Distance (ft): **48.5**
 Structural Grade: **0**
 O&M Grade: **3**
 Clock Start/From: **10**
 Clock To: **11**
 1st Value:
 2nd Value:
 Value Percent: **5.000**
 Continuous Index:
 Within 8" of Joint: **YES**
 Remarks:

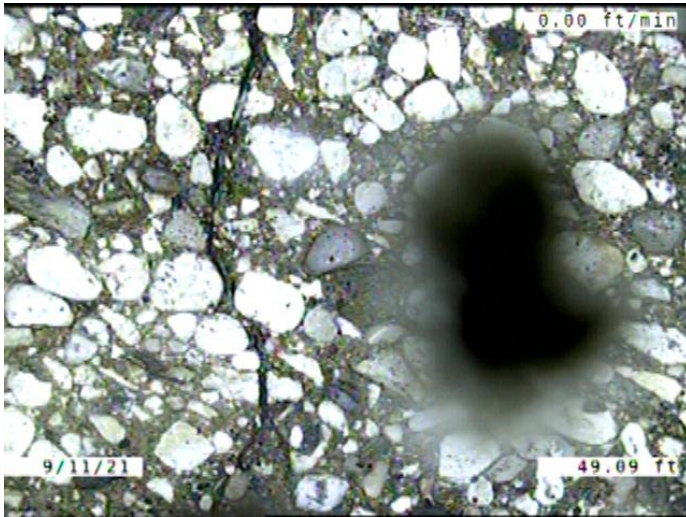
Code: **FM**
 Description: **Fracture Multiple**

Distance (ft): **49.1**
 Structural Grade: **4**
 O&M Grade: **0**
 Clock Start/From: **11**
 Clock To: **1**
 1st Value:
 2nd Value:
 Value Percent:
 Continuous Index: **S01**
 Within 8" of Joint: **YES**
 Remarks:

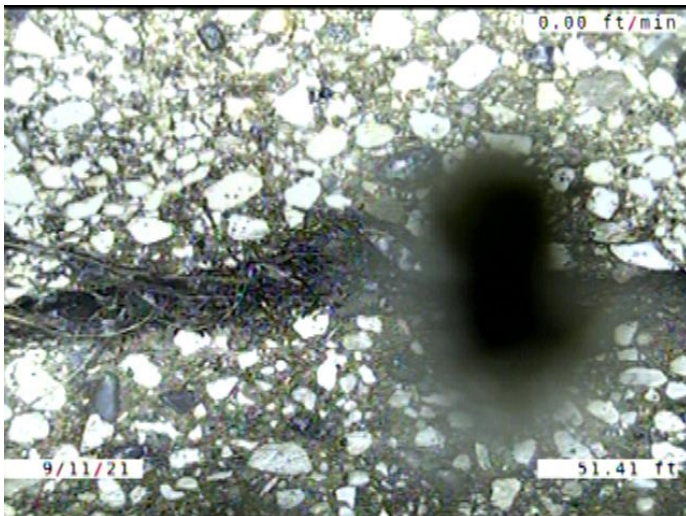
Code: **RFJ**
 Description: **Roots Fine Joint**

Distance (ft): **51.4**
 Structural Grade: **0**
 O&M Grade: **1**
 Clock Start/From: **9**
 Clock To: **3**
 1st Value:
 2nd Value:
 Value Percent:
 Continuous Index:
 Within 8" of Joint: **YES**
 Remarks:

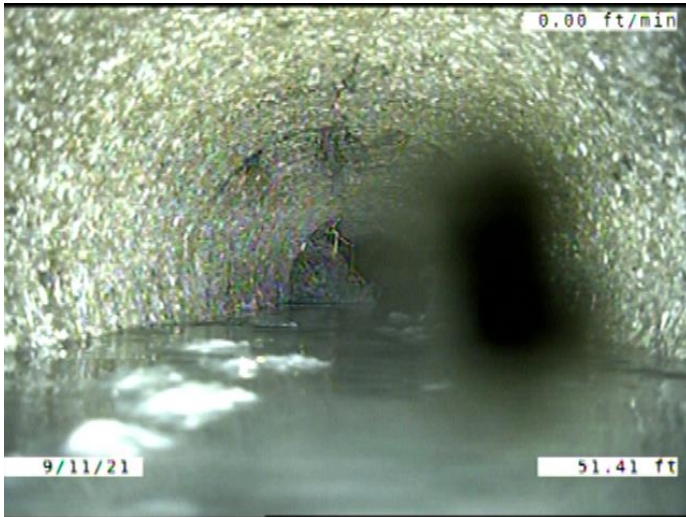
Code: **DSF**
 Description: **Deposits Settled Fine**

Distance (ft): **51.4**
 Structural Grade: **0**
 O&M Grade: **2**
 Clock Start/From: **4**
 Clock To: **8**
 1st Value:
 2nd Value:
 Value Percent: **5.000**
 Continuous Index:
 Within 8" of Joint: **YES**
 Remarks:

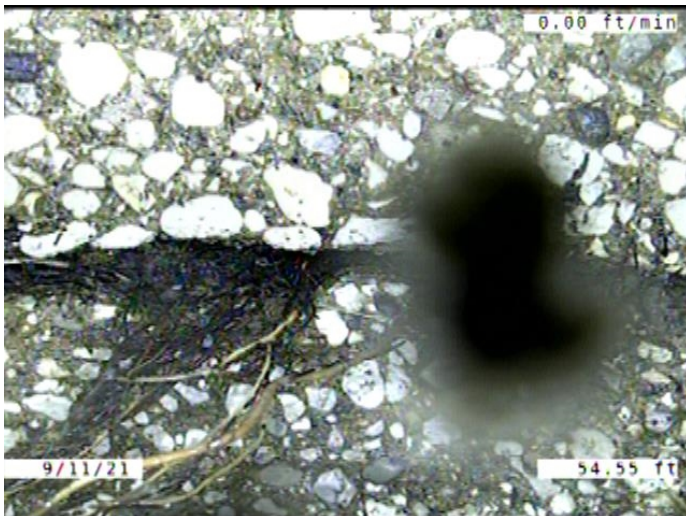
Code: **RMJ**
 Description: **Roots Medium Joint**

Distance (ft): **54.6**
 Structural Grade: **0**
 O&M Grade: **3**
 Clock Start/From: **9**
 Clock To: **3**
 1st Value:
 2nd Value:
 Value Percent: **10.000**
 Continuous Index:
 Within 8" of Joint: **YES**
 Remarks:

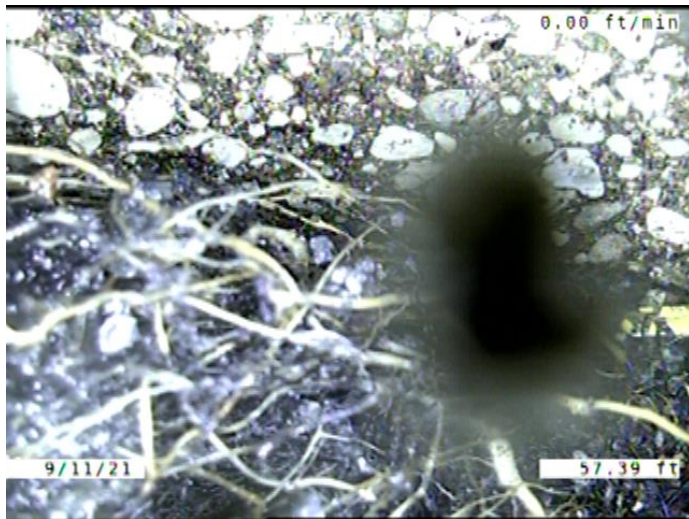
Code: **RMJ**
 Description: **Roots Medium Joint**

Distance (ft): **57.4**
 Structural Grade: **0**
 O&M Grade: **3**
 Clock Start/From: **9**
 Clock To: **3**
 1st Value:
 2nd Value:
 Value Percent: **20.000**
 Continuous Index:
 Within 8" of Joint: **YES**
 Remarks:

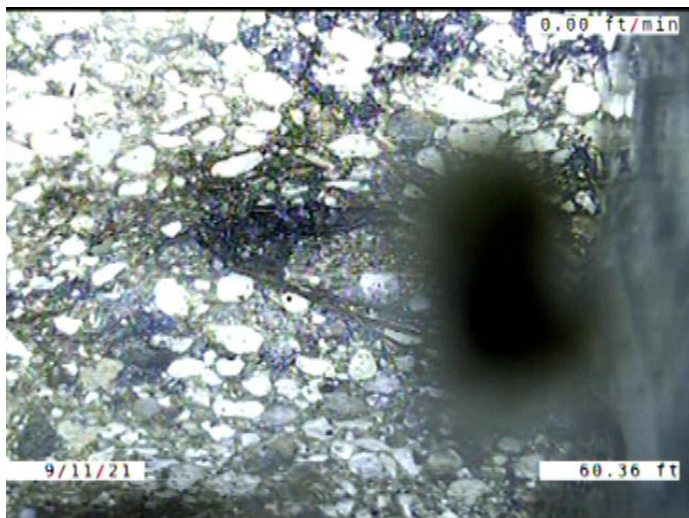
Code: **RFJ**
 Description: **Roots Fine Joint**

Distance (ft): **60.4**
 Structural Grade: **0**
 O&M Grade: **1**
 Clock Start/From: **9**
 Clock To: **3**
 1st Value:
 2nd Value:
 Value Percent:
 Continuous Index:
 Within 8" of Joint: **YES**
 Remarks:

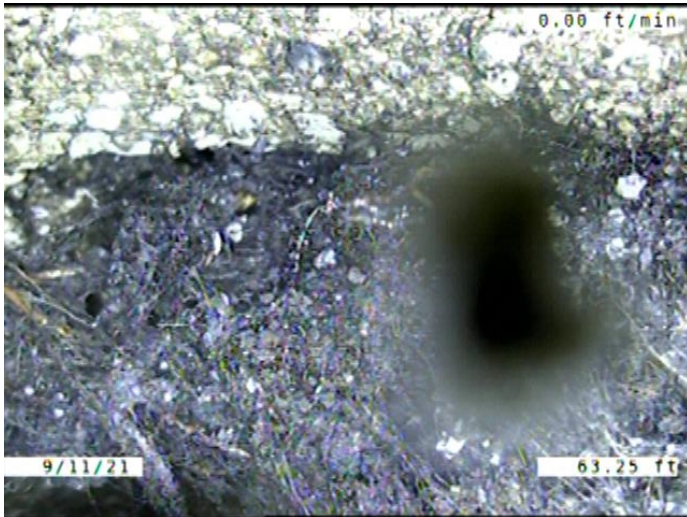
Code: **RMJ**
 Description: **Roots Medium Joint**

Distance (ft): **63.3**
 Structural Grade: **0**
 O&M Grade: **3**
 Clock Start/From: **9**
 Clock To: **3**
 1st Value:
 2nd Value:
 Value Percent: **20.000**
 Continuous Index:
 Within 8" of Joint: **YES**
 Remarks:

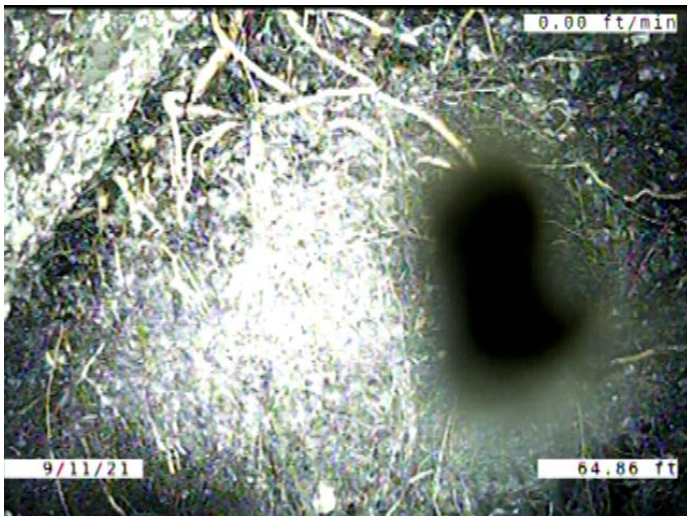
Code: **RBJ**
 Description: **Roots Ball Joint**

Distance (ft): **64.9**
 Structural Grade: **0**
 O&M Grade: **4**
 Clock Start/From: **8**
 Clock To: **4**
 1st Value:
 2nd Value:
 Value Percent: **65.000**
 Continuous Index:
 Within 8" of Joint: **YES**
 Remarks:

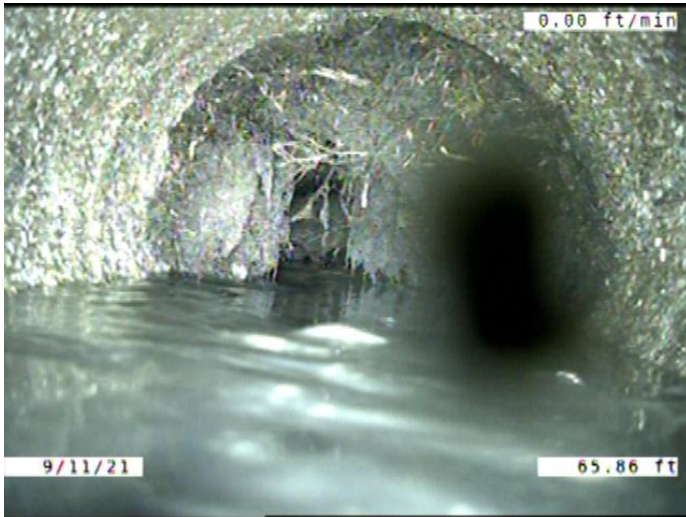
Code: **FM**
 Description: **Fracture Multiple**

Distance (ft): **65.9**
 Structural Grade: **4**
 O&M Grade: **0**
 Clock Start/From: **11**
 Clock To: **1**
 1st Value:
 2nd Value:
 Value Percent:
 Continuous Index: **F01**
 Within 8" of Joint: **YES**
 Remarks:

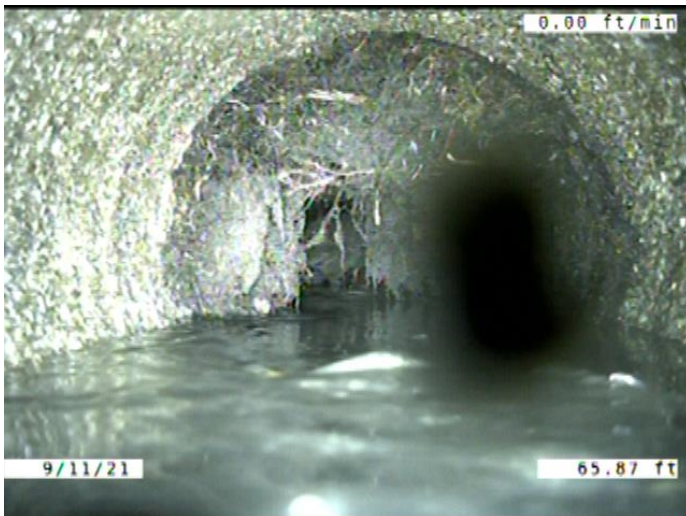
Code: **MSA**
 Description: **Miscellaneous Survey Abandoned**

Distance (ft): **65.9**
 Structural Grade: **0**
 O&M Grade: **0**
 Clock Start/From:
 Clock To:
 1st Value:
 2nd Value:
 Value Percent:
 Continuous Index:
 Within 8" of Joint: **NO**
 Remarks: **CAMERA CANT MAKE IT PAST ROOTS.**
