Profile/Photo Observation Report

Date:	10/21/2021	Weather:		Coding:	PACP 7.0
Pipe Length (ft):	260.0	Owner:	City of Hobart	Pre Clean:	Heavy Cleaning
P.O.#:	YES502259	Surveyor:	S. Bucklin	PSR:	P-504-111-104
Customer:	City of Hobart	Clean Date:	09/11/2021	Shape:	C

Street:	North Colorado Street	Flow Control:	Not Controlled
City:	Hobart, IN	Year Renewed:	
Location:	Alley	Tape/Media #:	
Purpose:	Routine Assessment	Dia/Height:	12"
Use:	Sanitary Sewage Pipe	Material:	CP
Drain Area:		Lining:	None
Category:	NA		
Comment:			
Location Details:		Direction of Survey:	Upstream
US MH:	M-504-104	DS MH:	M-504-111
		Total Length Surveyed (ft):	22.9

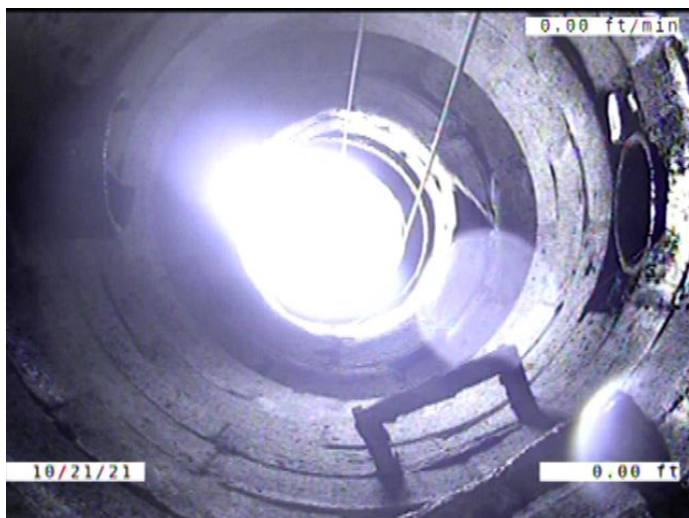
Code: **AMH**
Description: **Manhole**

Distance (ft): **.0**
Structural Grade: **0**
O&M Grade: **0**
Clock Start/From:
Clock To:
1st Value:
2nd Value:
Value Percent:
Continuous Index:
Within 8" of Joint: **NO**
Remarks: **M-504-111**

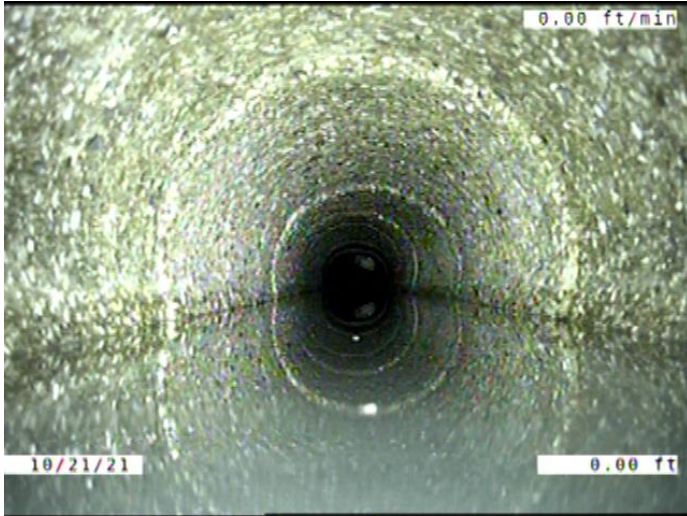
Code: **MWL**
Description: **Miscellaneous Water Level**

Distance (ft): **.0**
Structural Grade: **0**
O&M Grade: **0**
Clock Start/From:
Clock To:
1st Value:
2nd Value:
Value Percent: **15.000**
Continuous Index:
Within 8" of Joint: **NO**
Remarks:

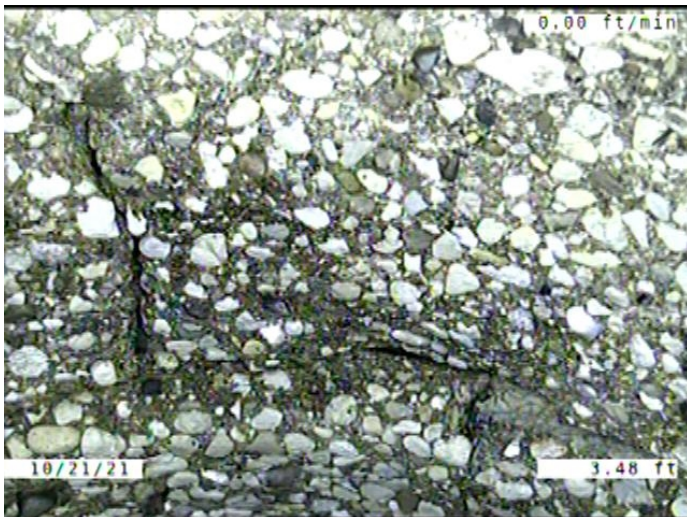
Code: **FM**
Description: **Fracture Multiple**

Distance (ft): **3.5**
Structural Grade: **4**
O&M Grade: **0**
Clock Start/From: **1**
Clock To: **2**
1st Value:
2nd Value:
Value Percent:
Continuous Index:
Within 8" of Joint: **YES**
Remarks:

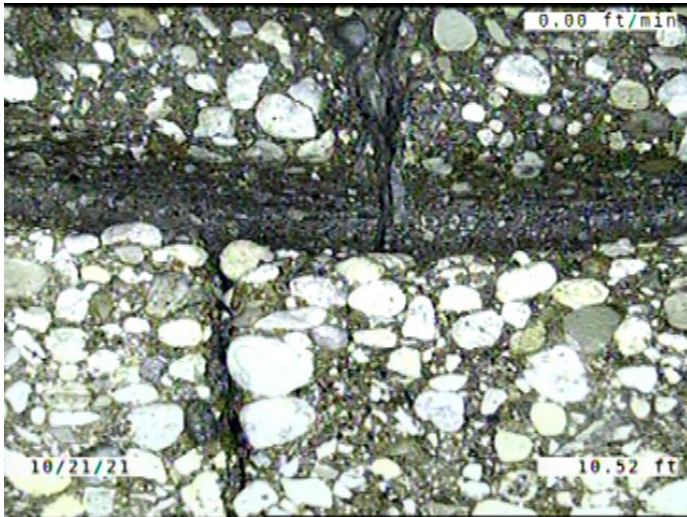
Code: **FM**
Description: **Fracture Multiple**

Distance (ft): **10.5**
Structural Grade: **4**
O&M Grade: **0**
Clock Start/From: **8**
Clock To: **4**
1st Value:
2nd Value:
Value Percent:
Continuous Index: **S01**
Within 8" of Joint: **YES**
Remarks:

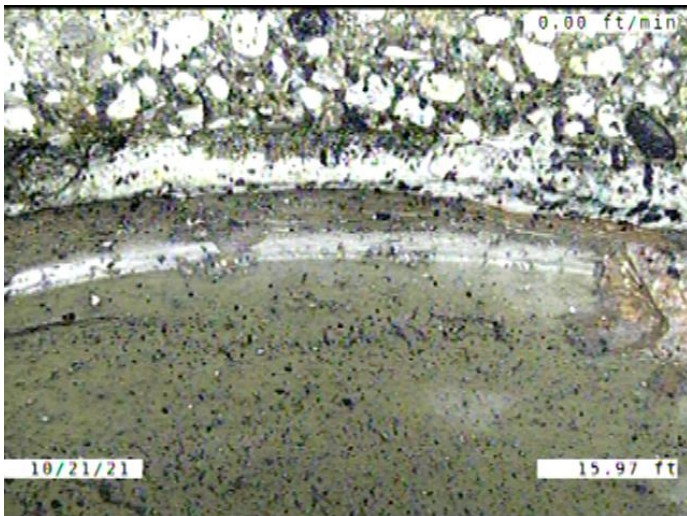
Code: **MMC**
Description: **Miscellaneous Material Change**

Distance (ft): **16.0**
Structural Grade: **0**
O&M Grade: **0**
Clock Start/From:
Clock To:
1st Value:
2nd Value:
Value Percent:
Continuous Index:
Within 8" of Joint: **NO**
Remarks: **CONCRETE TO VCP**

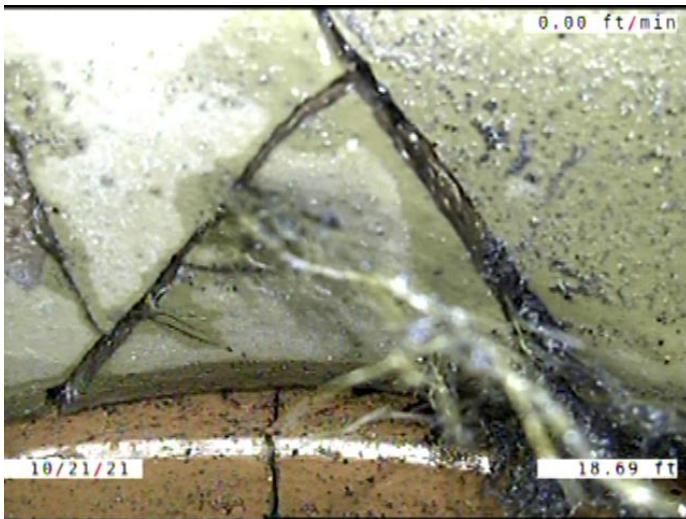
Code: **RFB**
 Description: **Roots Fine Barrel**

Distance (ft): **18.7**
 Structural Grade: **0**
 O&M Grade: **2**
 Clock Start/From: **12**
 Clock To: **2**
 1st Value:
 2nd Value:
 Value Percent:
 Continuous Index:
 Within 8" of Joint: **NO**
 Remarks:

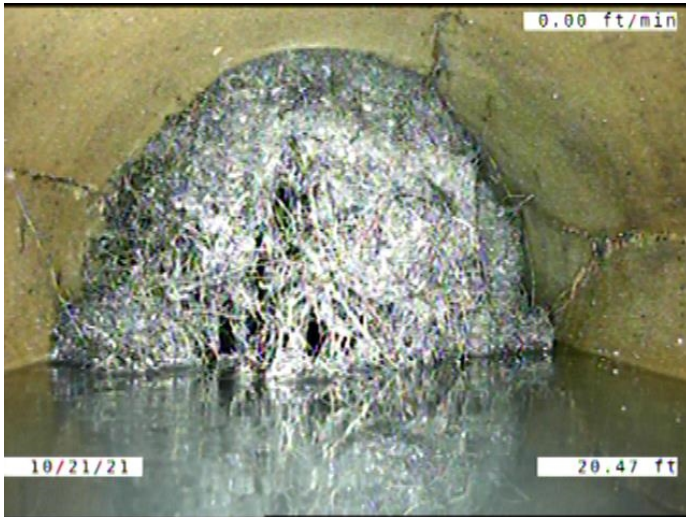
Code: **RBB**
Description: **Roots Ball Barrel**

Distance (ft): **20.5**
Structural Grade: **0**
O&M Grade: **5**
Clock Start/From: **8**
Clock To: **4**
1st Value:
2nd Value:
Value Percent: **70.000**
Continuous Index:
Within 8" of Joint: **NO**
Remarks:

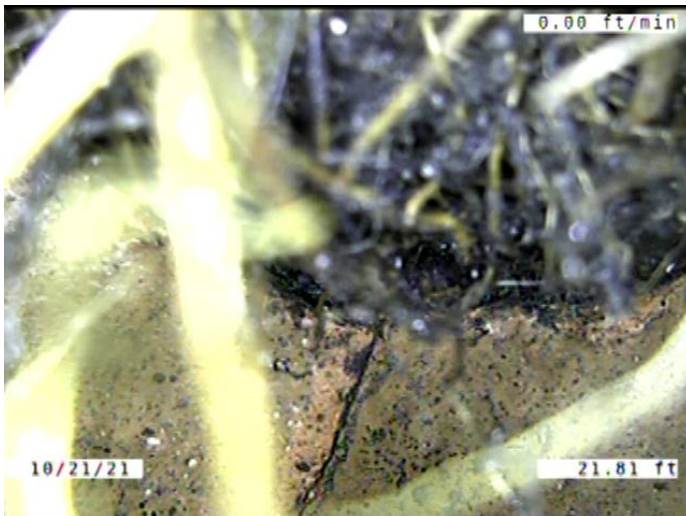
Code: **TFD**
Description: **Tap Factory Defective**

Distance (ft): **21.8**
Structural Grade: **0**
O&M Grade: **3**
Clock Start/From: **11**
Clock To:
1st Value: **4.000**
2nd Value:
Value Percent:
Continuous Index:
Within 8" of Joint: **YES**
Remarks: **LOOKS TO BE 100% PLUGGED WITH ROOTS**
