Profile/Photo Observation Report

Date:	10/21/2021	Weather:		Coding:	PACP 7.0
Pipe Length (ft):	260.0	Owner:	City of Hobart	Pre Clean:	Heavy Cleaning
P.O.#:	YES502259	Surveyor:	S. Bucklin	PSR:	P-504-111-104
Customer:	City of Hobart	Clean Date:	09/11/2021	Shape:	C

Street:	North Colorado Street	Flow Control:	Not Controlled
City:	Hobart, IN	Year Renewed:	
Location:	Alley	Tape/Media #:	
Purpose:	Routine Assessment	Dia/Height:	12"
Use:	Sanitary Sewage Pipe	Material:	CP
Drain Area:		Lining:	None
Category:	NA		
Comment:

Location Details:		Direction of Survey:	Upstream
US MH:	M-504-104	DS MH:	M-504-111
		Total Length Surveyed (ft):	22.9

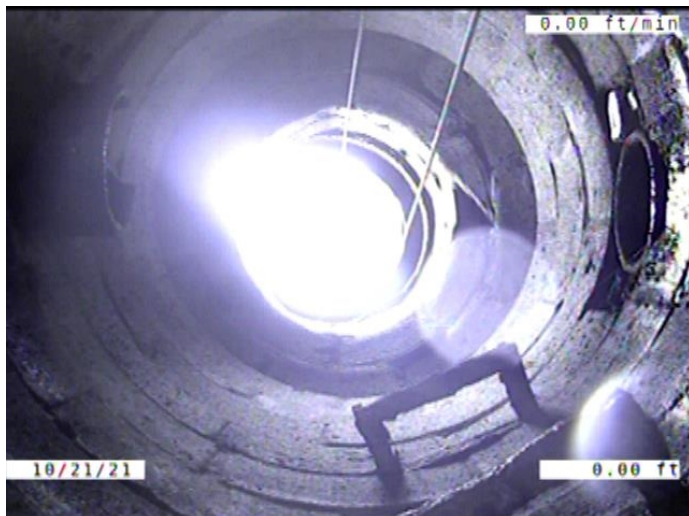
Code: **AMH**
Description: **Manhole**

Distance (ft): **.0**
Structural Grade: **0**
O&M Grade: **0**
Clock Start/From:
Clock To:
1st Value:
2nd Value:
Value Percent:
Continuous Index:
Within 8" of Joint: **NO**
Remarks: **M-504-111**

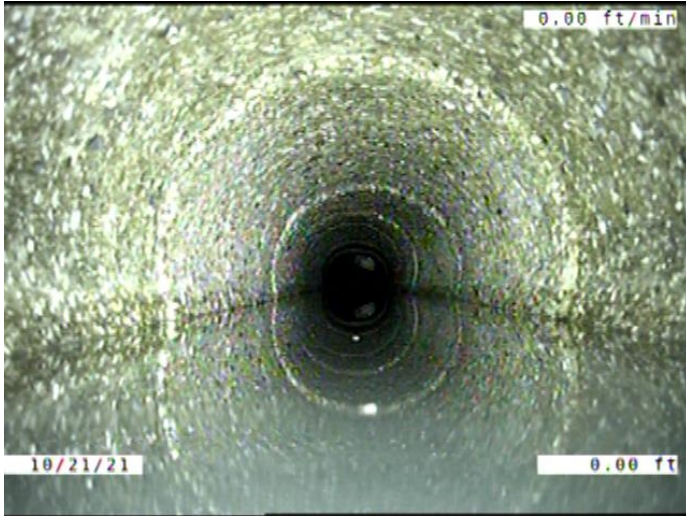
Code: **MWL**
Description: **Miscellaneous Water Level**

Distance (ft): **.0**
Structural Grade: **0**
O&M Grade: **0**
Clock Start/From:
Clock To:
1st Value:
2nd Value:
Value Percent: **15.000**
Continuous Index:
Within 8" of Joint: **NO**
Remarks:

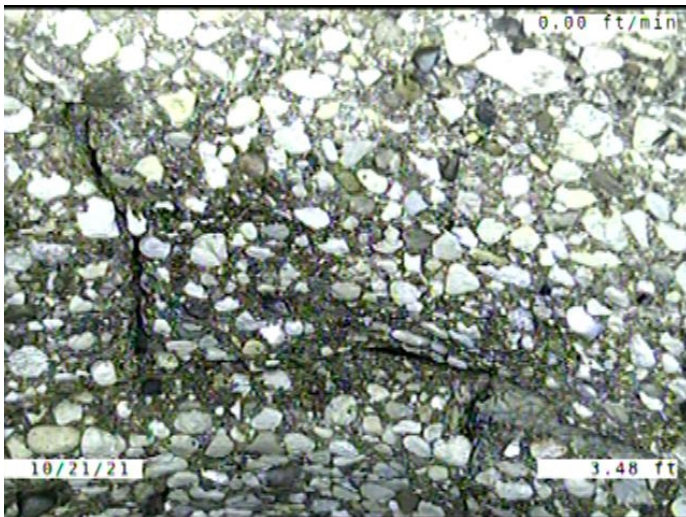
Code: **FM**
Description: **Fracture Multiple**

Distance (ft): **3.5**
Structural Grade: **4**
O&M Grade: **0**
Clock Start/From: **1**
Clock To: **2**
1st Value:
2nd Value:
Value Percent:
Continuous Index:
Within 8" of Joint: **YES**
Remarks:

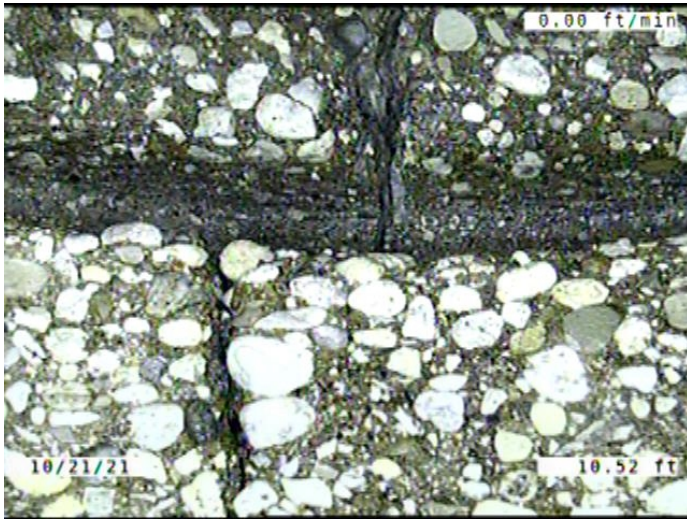
Code: **FM**
 Description: **Fracture Multiple**

Distance (ft): **10.5**
 Structural Grade: **4**
 O&M Grade: **0**
 Clock Start/From: **8**
 Clock To: **4**
 1st Value:
 2nd Value:
 Value Percent:
 Continuous Index: **S01**
 Within 8" of Joint: **YES**
 Remarks:

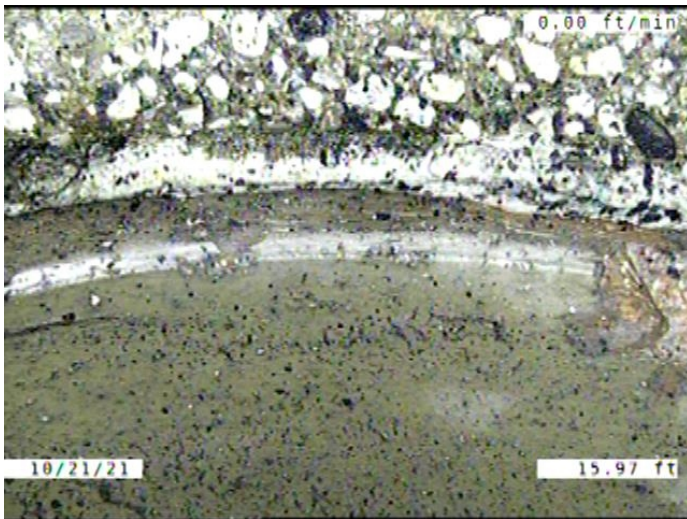
Code: **MMC**
 Description: **Miscellaneous Material Change**

Distance (ft): **16.0**
 Structural Grade: **0**
 O&M Grade: **0**
 Clock Start/From:
 Clock To:
 1st Value:
 2nd Value:
 Value Percent:
 Continuous Index:
 Within 8" of Joint: **NO**
 Remarks: **CONCRETE TO VCP**

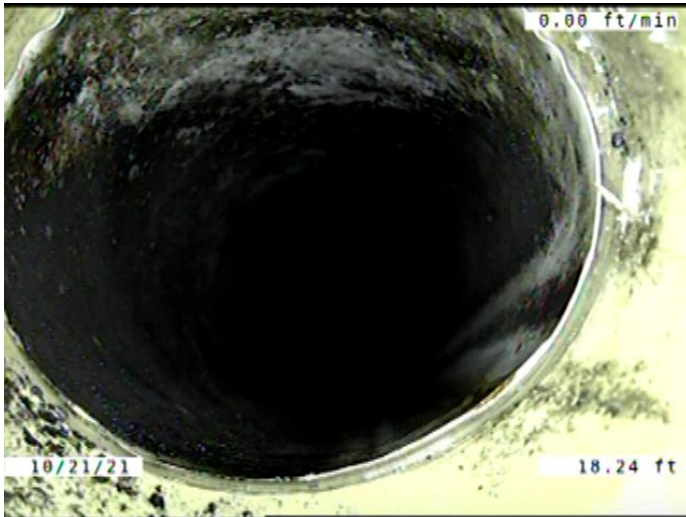
Code: **TFI**
 Description: **Tap Factory Intruding**

Distance (ft): **18.2**
 Structural Grade: **0**
 O&M Grade: **2**
 Clock Start/From: **1**
 Clock To:
 1st Value: **4.000**
 2nd Value: **2.000**
 Value Percent:
 Continuous Index:
 Within 8" of Joint: **YES**
 Remarks:

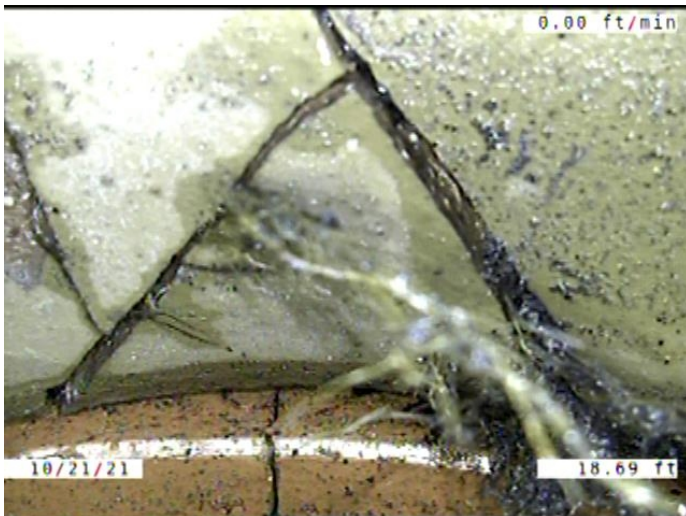
Code: **RFB**
 Description: **Roots Fine Barrel**

Distance (ft): **18.7**
 Structural Grade: **0**
 O&M Grade: **2**
 Clock Start/From: **12**
 Clock To: **2**
 1st Value:
 2nd Value:
 Value Percent:
 Continuous Index:
 Within 8" of Joint: **NO**
 Remarks:

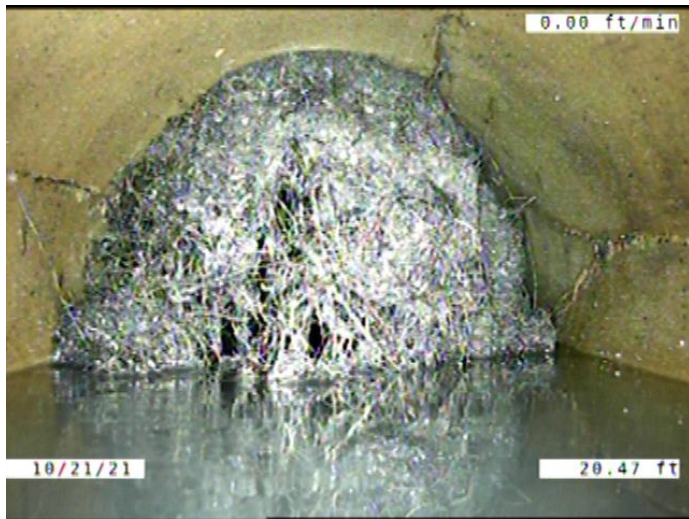
Code: **RBB**
 Description: **Roots Ball Barrel**

Distance (ft): **20.5**
 Structural Grade: **0**
 O&M Grade: **5**
 Clock Start/From: **8**
 Clock To: **4**
 1st Value:
 2nd Value:
 Value Percent: **70.000**
 Continuous Index:
 Within 8" of Joint: **NO**
 Remarks:

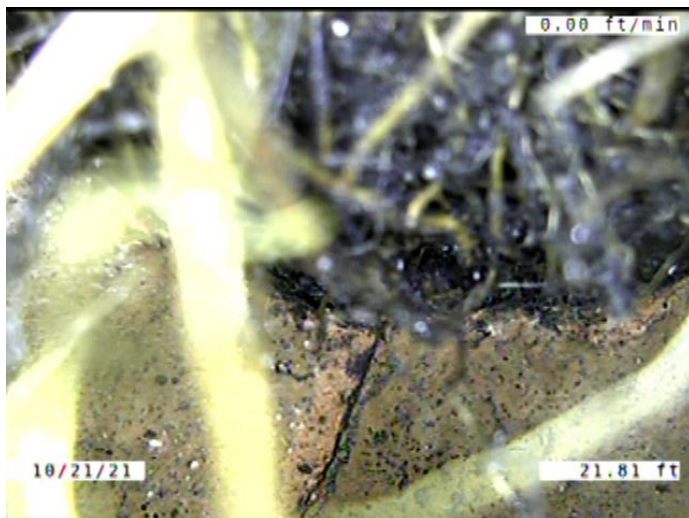
Code: **TFD**
 Description: **Tap Factory Defective**

Distance (ft): **21.8**
 Structural Grade: **0**
 O&M Grade: **3**
 Clock Start/From: **11**
 Clock To:
 1st Value: **4.000**
 2nd Value:
 Value Percent:
 Continuous Index:
 Within 8" of Joint: **YES**
 Remarks: **LOOKS TO BE 100% PLUGGED WITH ROOTS**

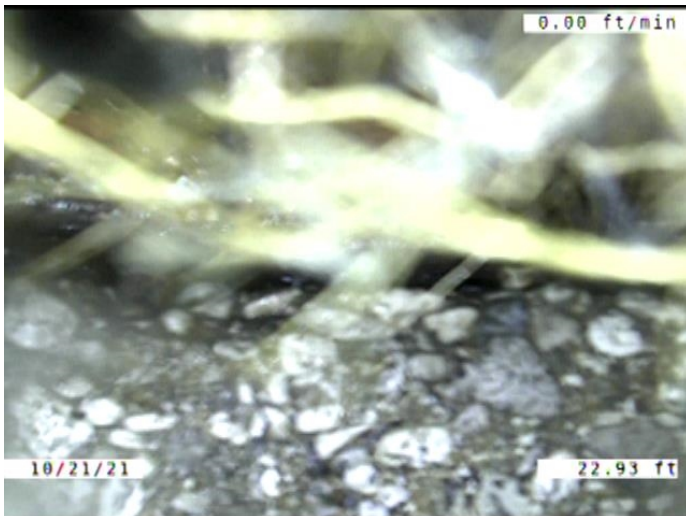
Code: **MMC**
 Description: **Miscellaneous Material Change**

Distance (ft): **22.9**
 Structural Grade: **0**
 O&M Grade: **0**
 Clock Start/From:
 Clock To:
 1st Value:
 2nd Value:
 Value Percent:
 Continuous Index:
 Within 8" of Joint: **NO**
 Remarks: **VCP TO CONCRETE**

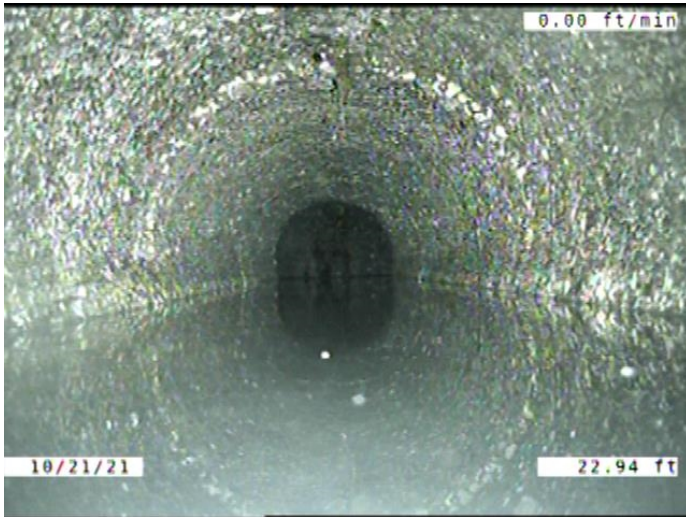
MSA

Miscellaneous Survey Abandoned

CAMERA CANT MAKE IT PAST ROOTS
