RedZone
ROBOTICS

Street:	41st Avenue	Flow Control:	Not Controlled
City:	Hobart, IN	Year Renewed:	
Location:	Alley	Tape/Media #:	
Purpose:	Routine Assessment	Dia/Height:	10"
Use:	Sanitary Sewage Pipe	Material:	CP
Drain Area:		Lining:	None
Category:	NA		
Comment:			
Location Details:		Direction of Survey:	Upstream
US MH:	M-503-032	DS MH:	M-504-112
		Total Length Surveyed (ft):	160.2

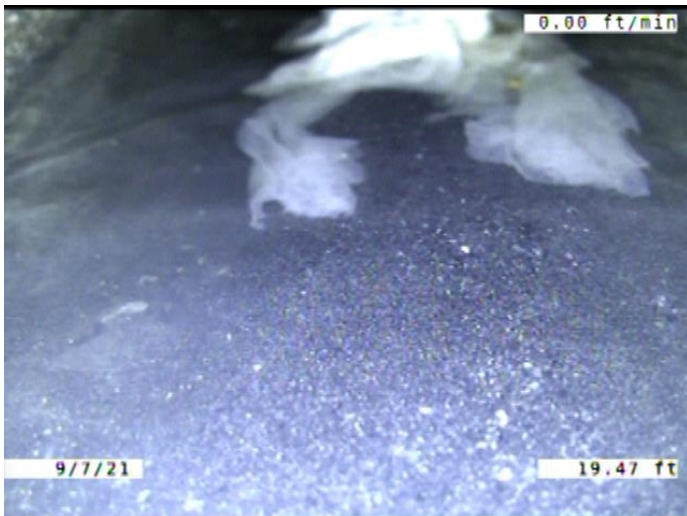
Code: **DSF**
 Description: **Deposits Settled Fine**

Distance (ft): **19.5**
 Structural Grade: **0**
 O&M Grade: **2**
 Clock Start/From: **5**
 Clock To: **7**
 1st Value:
 2nd Value:
 Value Percent: **5.000**
 Continuous Index: **S01**
 Within 8" of Joint: **YES**
 Remarks:

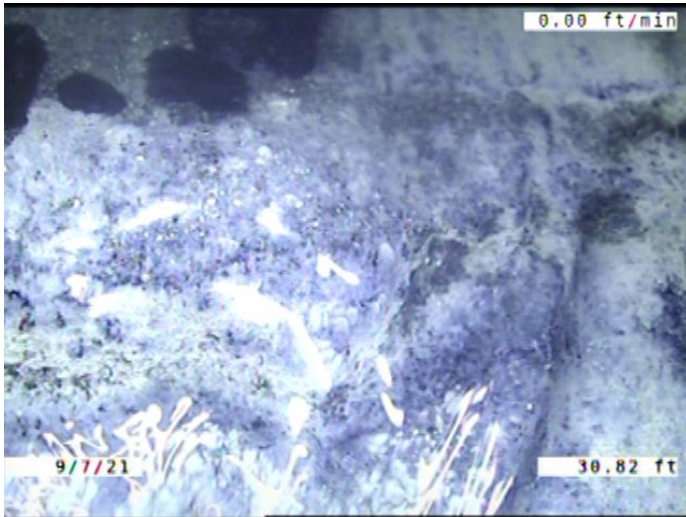
Code: **DAE**
 Description: **Deposits Attached Encrustation**

Distance (ft): **30.8**
 Structural Grade: **0**
 O&M Grade: **2**
 Clock Start/From: **5**
 Clock To: **7**
 1st Value:
 2nd Value:
 Value Percent: **5.000**
 Continuous Index:
 Within 8" of Joint: **YES**
 Remarks:

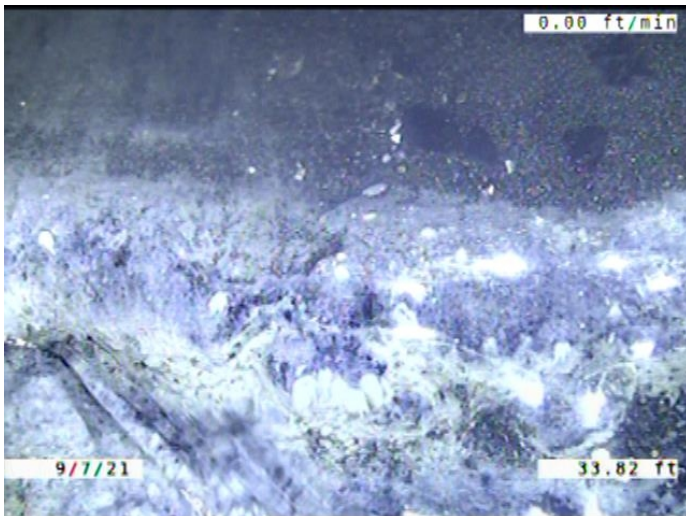
Code: **DAE**
 Description: **Deposits Attached Encrustation**

Distance (ft): **33.8**
 Structural Grade: **0**
 O&M Grade: **2**
 Clock Start/From: **5**
 Clock To: **7**
 1st Value:
 2nd Value:
 Value Percent: **5.000**
 Continuous Index:
 Within 8" of Joint: **YES**
 Remarks:

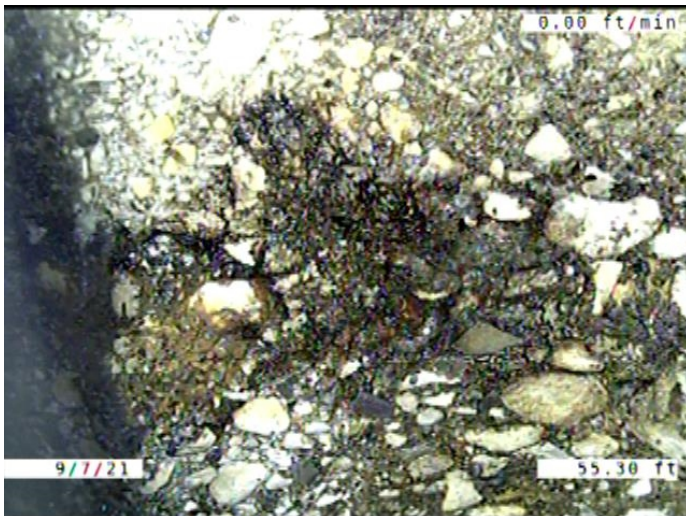
Code: **ISB**
Description: **Infiltration Stain Barrel**

Distance (ft): **55.3**
Structural Grade: **0**
O&M Grade: **1**
Clock Start/From: **9**
Clock To:
1st Value:
2nd Value:
Value Percent:
Continuous Index:
Within 8" of Joint: **NO**
Remarks:

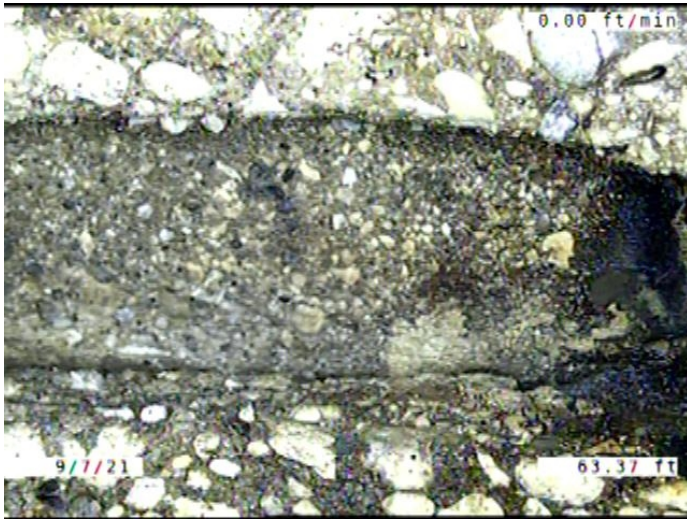
Code: **JAM**
 Description: **Joint Angular Medium**

Distance (ft): **63.4**
 Structural Grade: **3**
 O&M Grade: **0**
 Clock Start/From:
 Clock To:
 1st Value:
 2nd Value:
 Value Percent:
 Continuous Index:
 Within 8" of Joint: **NO**
 Remarks:

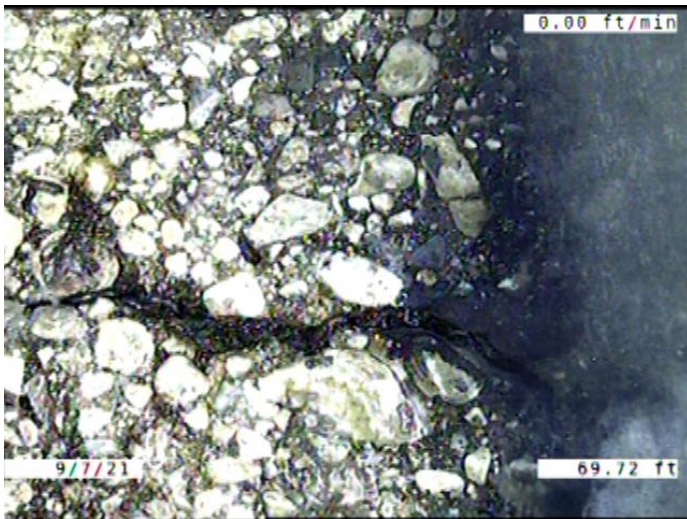
Code: **FS**
 Description: **Fracture Spiral**

Distance (ft): **69.7**
 Structural Grade: **3**
 O&M Grade: **0**
 Clock Start/From: **2**
 Clock To: **10**
 1st Value:
 2nd Value:
 Value Percent:
 Continuous Index:
 Within 8" of Joint: **YES**
 Remarks:

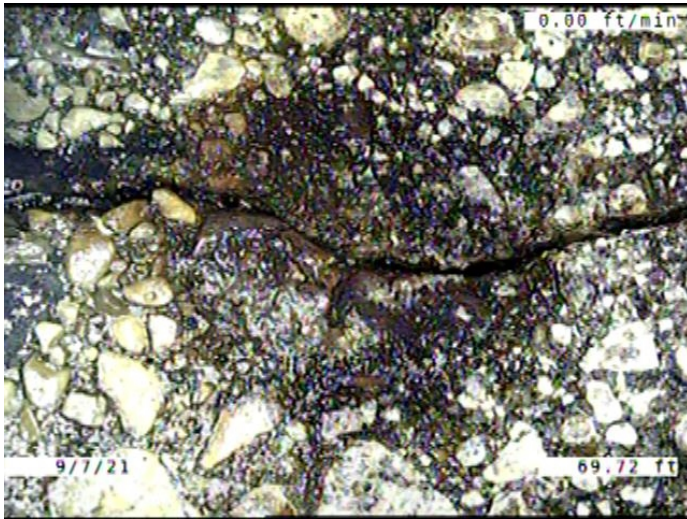
Code: **ISB**
 Description: **Infiltration Stain Barrel**

Distance (ft): **69.7**
 Structural Grade: **0**
 O&M Grade: **1**
 Clock Start/From: **4**
 Clock To: **5**
 1st Value:
 2nd Value:
 Value Percent:
 Continuous Index:
 Within 8" of Joint: **YES**
 Remarks:

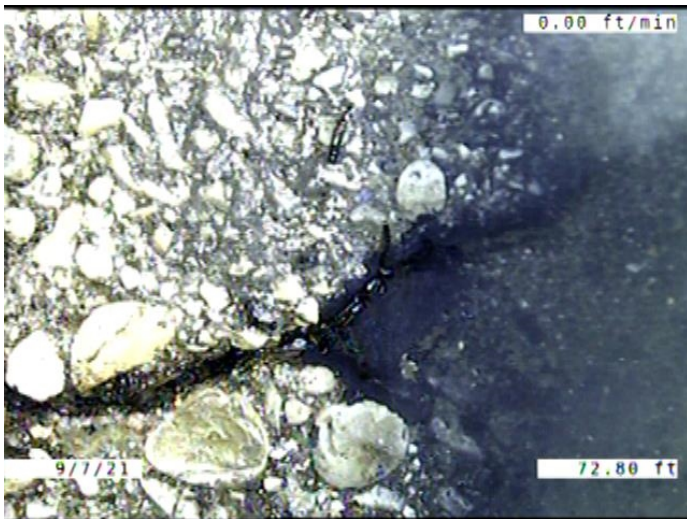
Code: **FM**
 Description: **Fracture Multiple**

Distance (ft): **72.8**
 Structural Grade: **4**
 O&M Grade: **0**
 Clock Start/From: **7**
 Clock To: **5**
 1st Value:
 2nd Value:
 Value Percent:
 Continuous Index:
 Within 8" of Joint: **YES**
 Remarks:

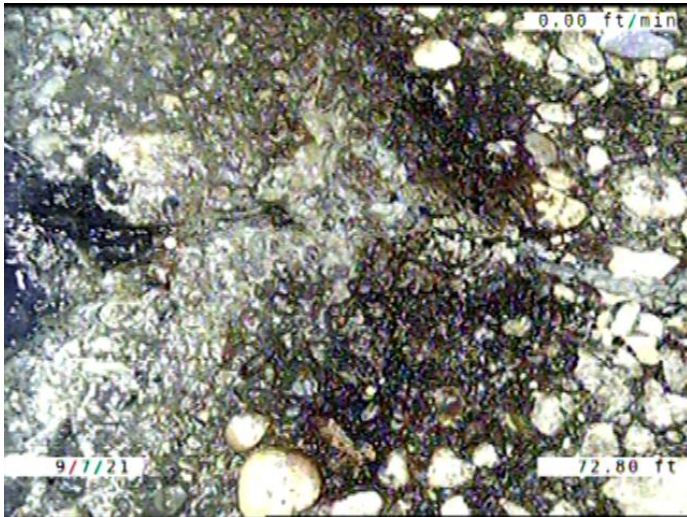
Code: **ISB**
 Description: **Infiltration Stain Barrel**

Distance (ft): **72.8**
 Structural Grade: **0**
 O&M Grade: **1**
 Clock Start/From: **4**
 Clock To:
 1st Value:
 2nd Value:
 Value Percent:
 Continuous Index:
 Within 8" of Joint: **YES**
 Remarks:

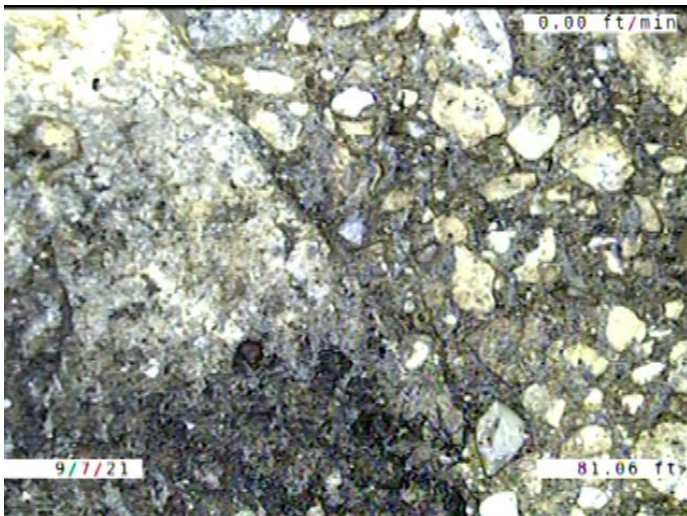
Code: **CS**
 Description: **Crack Spiral**

Distance (ft): **81.1**
 Structural Grade: **2**
 O&M Grade: **0**
 Clock Start/From: **9**
 Clock To: **11**
 1st Value:
 2nd Value:
 Value Percent:
 Continuous Index:
 Within 8" of Joint: **YES**
 Remarks:

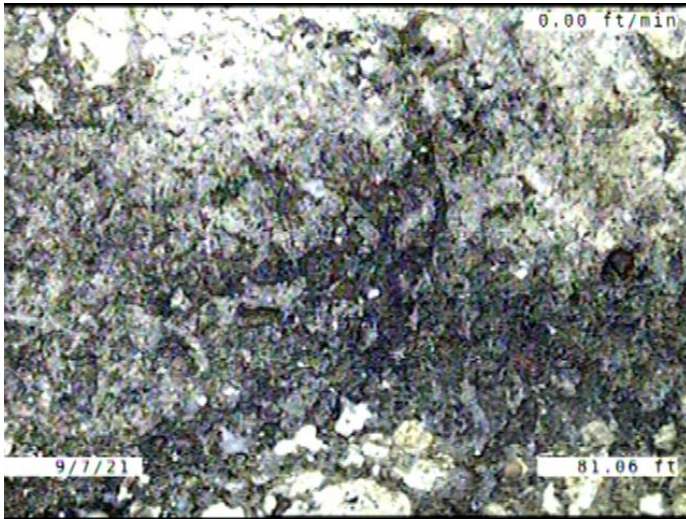
Code: **ISB**
 Description: **Infiltration Stain Barrel**

Distance (ft): **81.1**
 Structural Grade: **0**
 O&M Grade: **1**
 Clock Start/From: **8**
 Clock To: **10**
 1st Value:
 2nd Value:
 Value Percent:
 Continuous Index:
 Within 8" of Joint: **YES**
 Remarks:

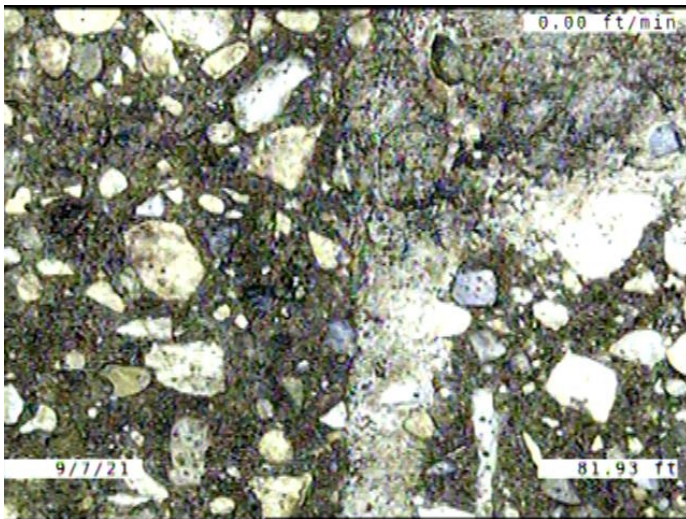
Code: **CM**
 Description: **Crack Multiple**

Distance (ft): **81.9**
 Structural Grade: **3**
 O&M Grade: **0**
 Clock Start/From: **1**
 Clock To: **3**
 1st Value:
 2nd Value:
 Value Percent:
 Continuous Index:
 Within 8" of Joint: **YES**
 Remarks:

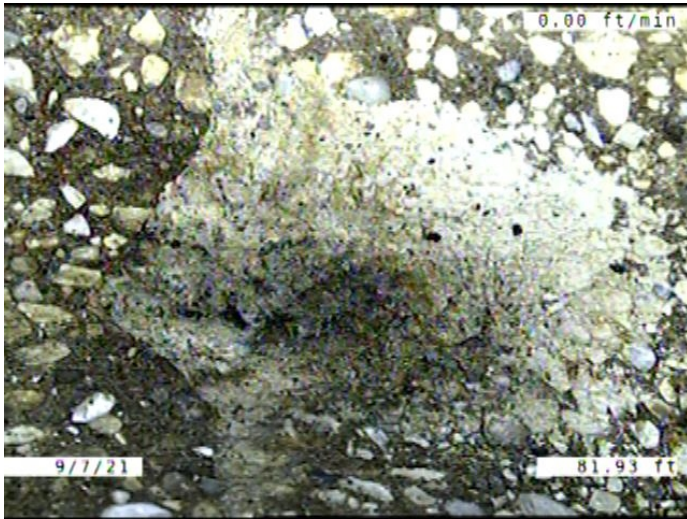
Code: **ISB**
 Description: **Infiltration Stain Barrel**

Distance (ft): **81.9**
 Structural Grade: **0**
 O&M Grade: **1**
 Clock Start/From: **1**
 Clock To: **4**
 1st Value:
 2nd Value:
 Value Percent:
 Continuous Index:
 Within 8" of Joint: **YES**
 Remarks:

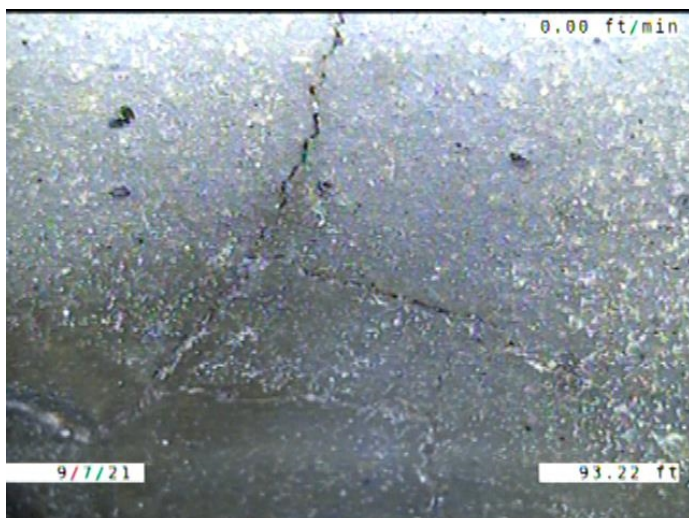
Code: **FM**
 Description: **Fracture Multiple**

Distance (ft): **93.2**
 Structural Grade: **4**
 O&M Grade: **0**
 Clock Start/From: **7**
 Clock To: **5**
 1st Value:
 2nd Value:
 Value Percent:
 Continuous Index:
 Within 8" of Joint: **YES**
 Remarks:

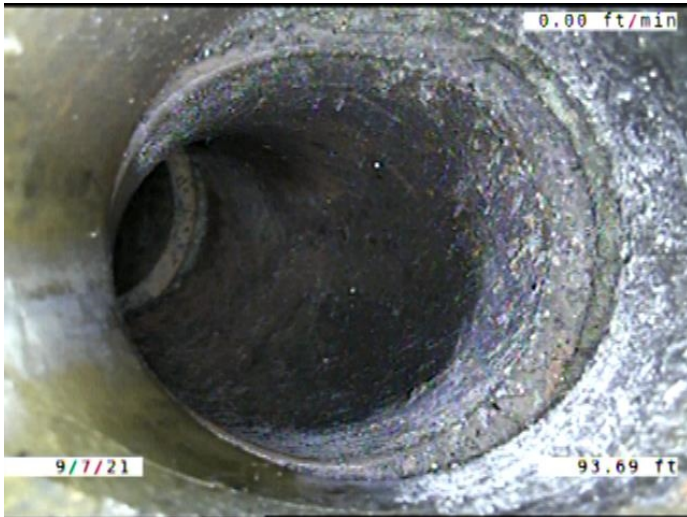
Code: **TFD**
 Description: **Tap Factory Defective**

Distance (ft): **93.7**
 Structural Grade: **0**
 O&M Grade: **3**
 Clock Start/From: **10**
 Clock To:
 1st Value: **4.000**
 2nd Value:
 Value Percent:
 Continuous Index:
 Within 8" of Joint: **YES**
 Remarks: **Defective**

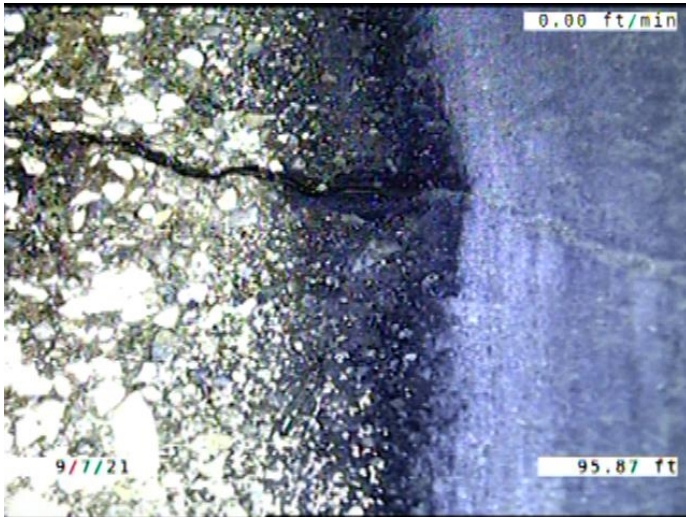
Code: **FM**
 Description: **Fracture Multiple**

Distance (ft): **95.9**
 Structural Grade: **4**
 O&M Grade: **0**
 Clock Start/From: **12**
 Clock To: **12**
 1st Value:
 2nd Value:
 Value Percent:
 Continuous Index:
 Within 8" of Joint: **NO**
 Remarks:

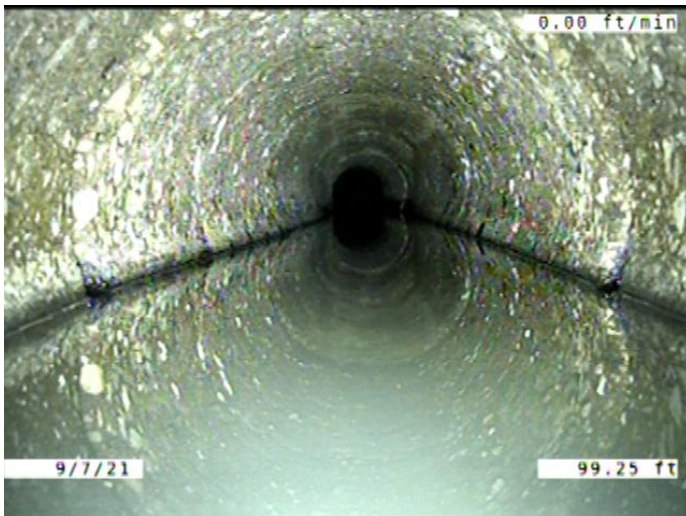
Code: **MWLS**
 Description: **Miscellaneous Water Level Sag**

Distance (ft): **99.2**
 Structural Grade: **2**
 O&M Grade: **0**
 Clock Start/From:
 Clock To:
 1st Value:
 2nd Value:
 Value Percent: **15.000**
 Continuous Index: **S02**
 Within 8" of Joint: **NO**
 Remarks:

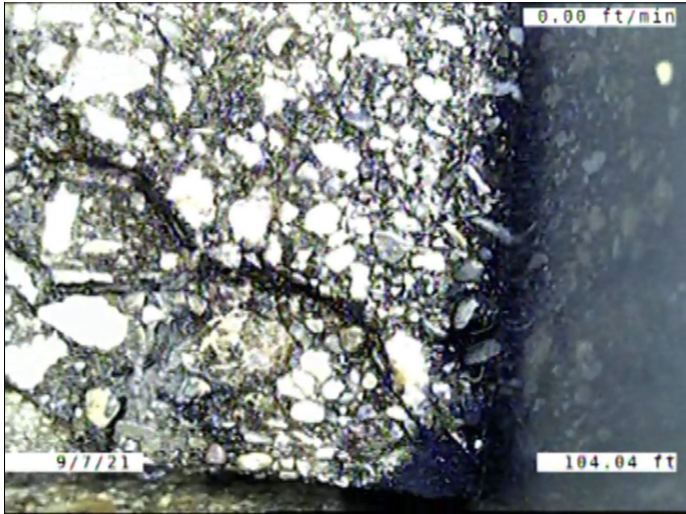
Code: **FM**
 Description: **Fracture Multiple**

Distance (ft): **104.0**
 Structural Grade: **4**
 O&M Grade: **0**
 Clock Start/From: **7**
 Clock To: **5**
 1st Value:
 2nd Value:
 Value Percent:
 Continuous Index:
 Within 8" of Joint: **YES**
 Remarks:

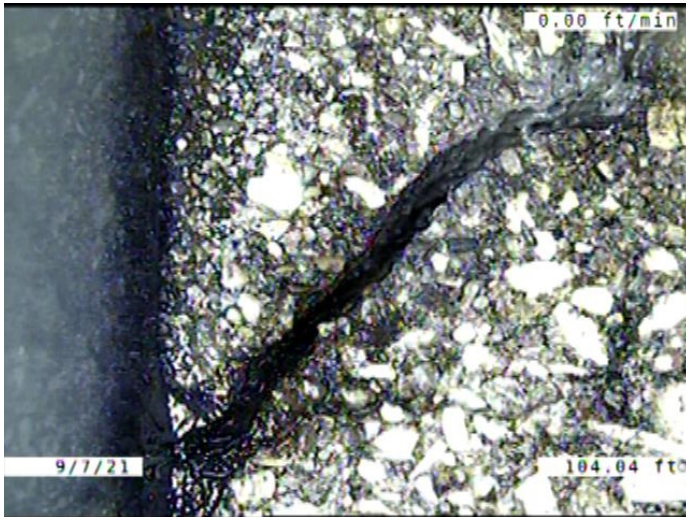
Code: **B**
 Description: **Broken**

Distance (ft): **104.0**
 Structural Grade: **4**
 O&M Grade: **0**
 Clock Start/From: **3**
 Clock To: **12**
 1st Value:
 2nd Value:
 Value Percent:
 Continuous Index:
 Within 8" of Joint: **YES**
 Remarks:

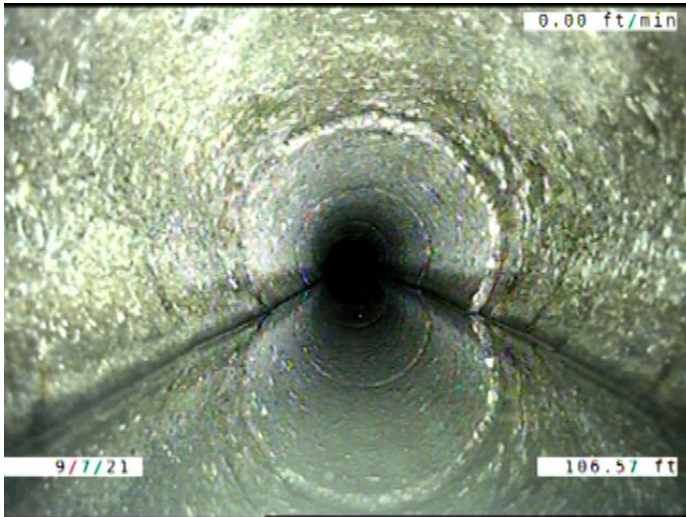
Code: **MWLS**
 Description: **Miscellaneous Water Level Sag**

Distance (ft): **106.6**
 Structural Grade: **2**
 O&M Grade: **0**
 Clock Start/From:
 Clock To:
 1st Value:
 2nd Value:
 Value Percent: **15.000**
 Continuous Index: **F02**
 Within 8" of Joint: **NO**
 Remarks:

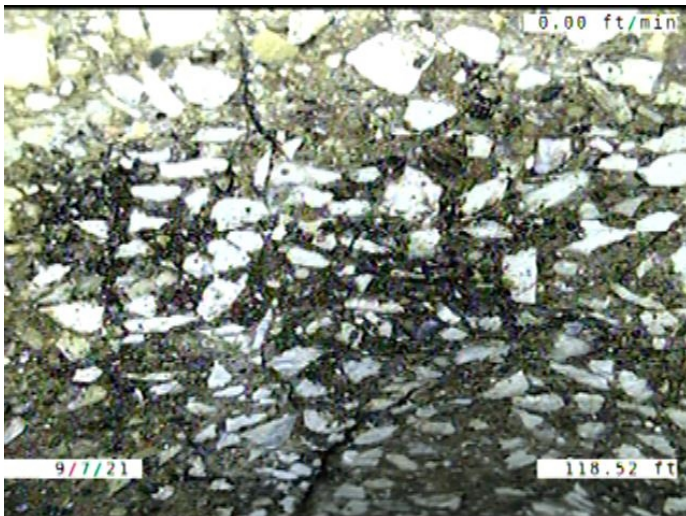
Code: **FM**
 Description: **Fracture Multiple**

Distance (ft): **118.5**
 Structural Grade: **4**
 O&M Grade: **0**
 Clock Start/From: **8**
 Clock To: **4**
 1st Value:
 2nd Value:
 Value Percent:
 Continuous Index: **S04**
 Within 8" of Joint: **YES**
 Remarks:

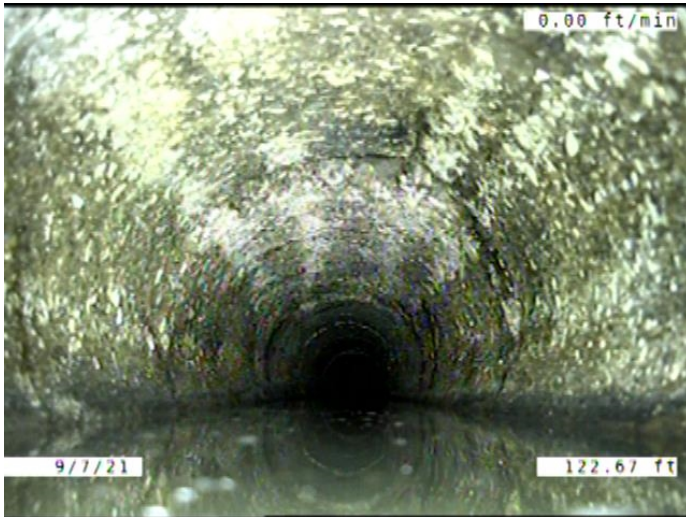
Code: **MWLS**
 Description: **Miscellaneous Water Level Sag**

Distance (ft): **122.7**
 Structural Grade: **2**
 O&M Grade: **0**
 Clock Start/From:
 Clock To:
 1st Value:
 2nd Value:
 Value Percent: **15.000**
 Continuous Index:
 Within 8" of Joint: **NO**
 Remarks:

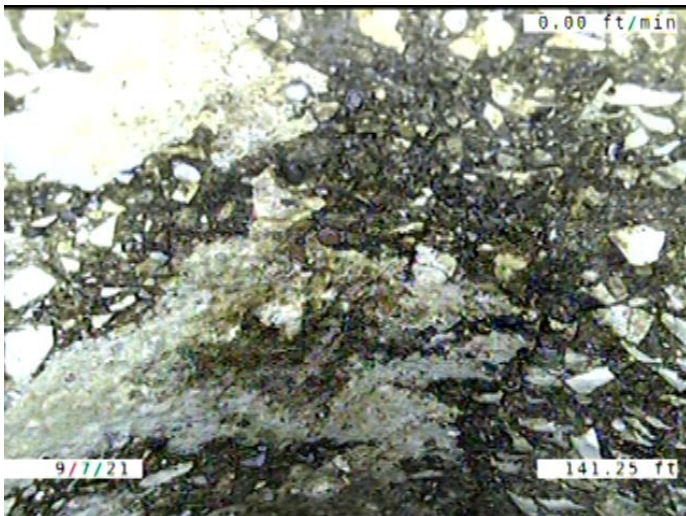
Code: **ISB**
 Description: **Infiltration Stain Barrel**

Distance (ft): **141.2**
 Structural Grade: **0**
 O&M Grade: **1**
 Clock Start/From: **8**
 Clock To: **11**
 1st Value:
 2nd Value:
 Value Percent:
 Continuous Index:
 Within 8" of Joint: **YES**
 Remarks:

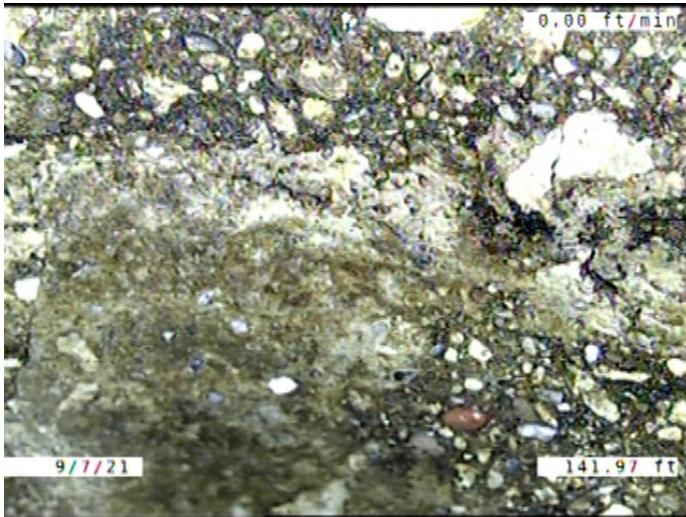
Code: **ISB**
 Description: **Infiltration Stain Barrel**

Distance (ft): **142.0**
 Structural Grade: **0**
 O&M Grade: **1**
 Clock Start/From: **2**
 Clock To: **5**
 1st Value:
 2nd Value:
 Value Percent:
 Continuous Index:
 Within 8" of Joint: **YES**
 Remarks:

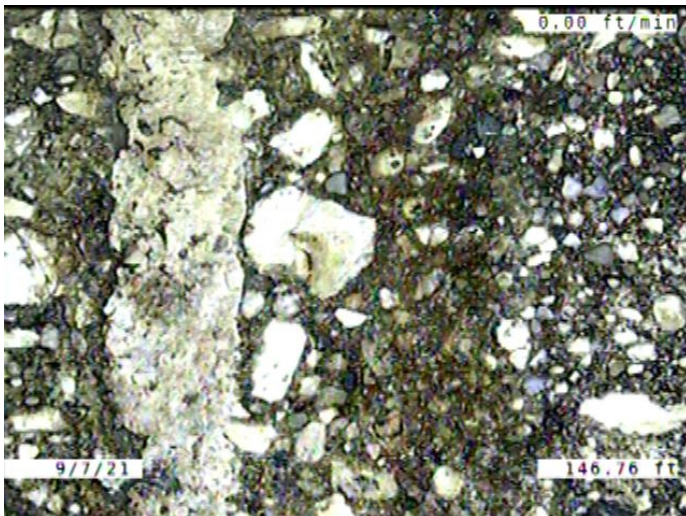
Code: **DAE**
 Description: **Deposits Attached Encrustation**

Distance (ft): **146.8**
 Structural Grade: **0**
 O&M Grade: **2**
 Clock Start/From: **7**
 Clock To: **9**
 1st Value:
 2nd Value:
 Value Percent: **5.000**
 Continuous Index:
 Within 8" of Joint: **YES**
 Remarks:

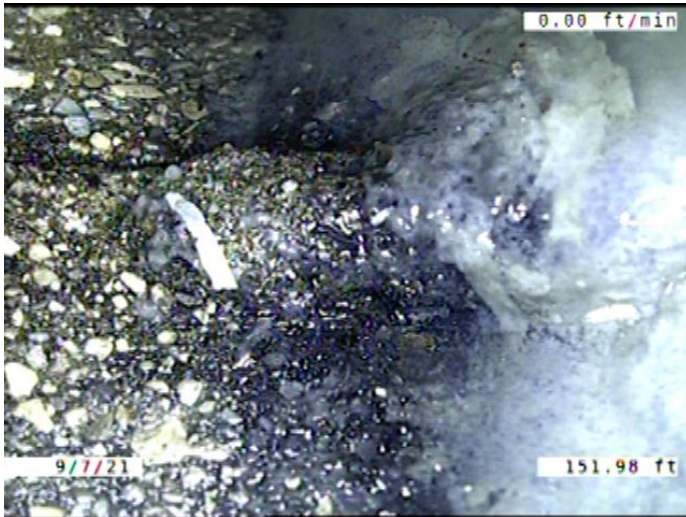
Code: **DAE**
 Description: **Deposits Attached Encrustation**

Distance (ft): **152.0**
 Structural Grade: **0**
 O&M Grade: **2**
 Clock Start/From: **4**
 Clock To: **8**
 1st Value:
 2nd Value:
 Value Percent: **5.000**
 Continuous Index:
 Within 8" of Joint: **YES**
 Remarks:

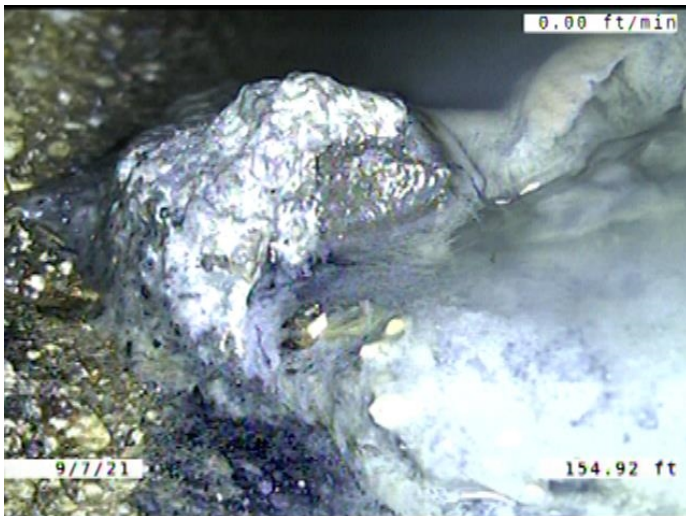
Code: **DAE**
 Description: **Deposits Attached Encrustation**

Distance (ft): **154.9**
 Structural Grade: **0**
 O&M Grade: **2**
 Clock Start/From: **5**
 Clock To: **8**
 1st Value:
 2nd Value:
 Value Percent: **5.000**
 Continuous Index:
 Within 8" of Joint: **YES**
 Remarks:

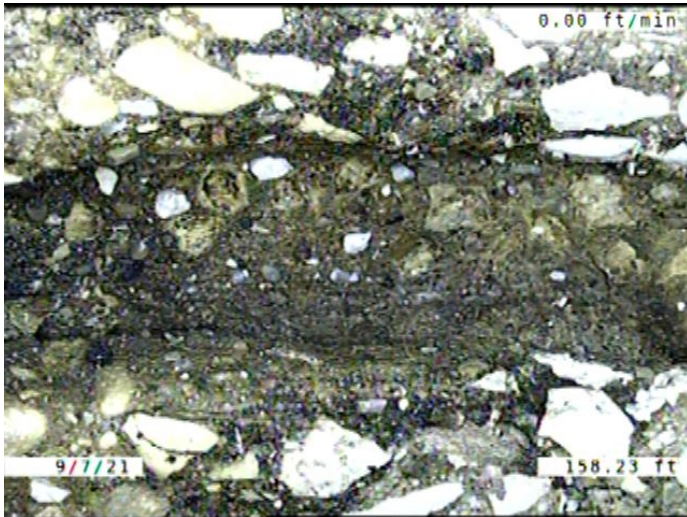
Code: **JAM**
 Description: **Joint Angular Medium**

Distance (ft): **158.2**
 Structural Grade: **3**
 O&M Grade: **0**
 Clock Start/From:
 Clock To:
 1st Value:
 2nd Value:
 Value Percent:
 Continuous Index:
 Within 8" of Joint: **NO**
 Remarks:

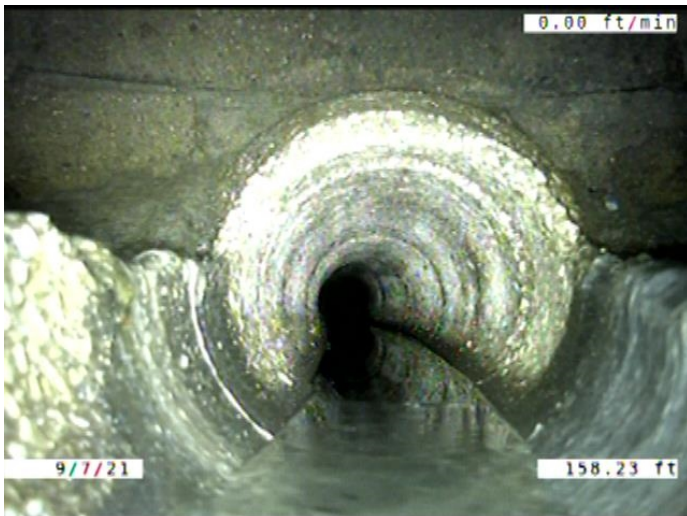
Code: **FM**
 Description: **Fracture Multiple**

Distance (ft): **158.2**
 Structural Grade: **4**
 O&M Grade: **0**
 Clock Start/From: **8**
 Clock To: **4**
 1st Value:
 2nd Value:
 Value Percent:
 Continuous Index: **F04**
 Within 8" of Joint: **YES**
 Remarks:

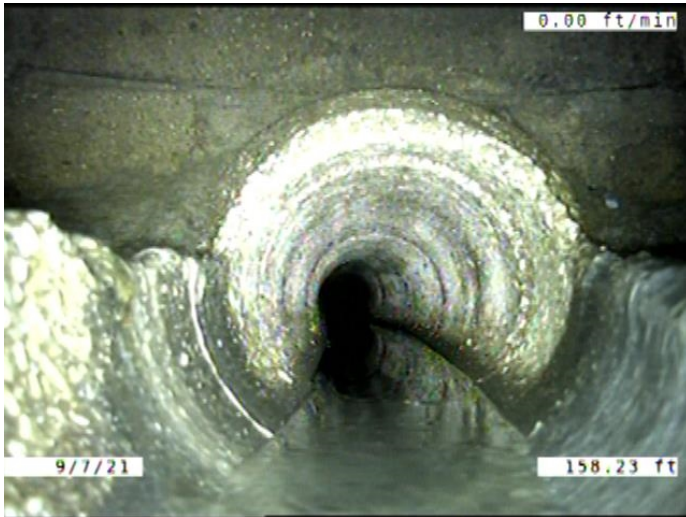
Code: **DSF**
 Description: **Deposits Settled Fine**

Distance (ft): **158.2**
 Structural Grade: **0**
 O&M Grade: **2**
 Clock Start/From: **5**
 Clock To: **7**
 1st Value:
 2nd Value:
 Value Percent: **5.000**
 Continuous Index: **F01**
 Within 8" of Joint: **YES**
 Remarks:
