Profile/Photo Observation Report

Date:	04/09/2018	Weather:		Coding:	PACP 6.0
Pipe Length (ft):	78.7	Owner:	NA	Pre Clean:	Not Known
P.O.#:		Surveyor:	Jen Costello	PSR:	P-503-032-113
Customer:		Clean Date:	01/01/1900	Shape:	C

Street:	W 40th ave	Flow Control:	Not Controlled
City:	Hobart, IN	Year Renewed:	
Location:	Other	Tape/Media #:	
Purpose:	Not Known	Dia/Height:	10"
Use:	Sanitary	Material:	CP
Drain Area:	NA	Lining:	
Category:	NA		
Comment:			
Location Details:		Direction of Survey:	Downstream
US MH:	M-503-032	DS MH:	M-504-113
		Total Length Surveyed (ft):	14.6

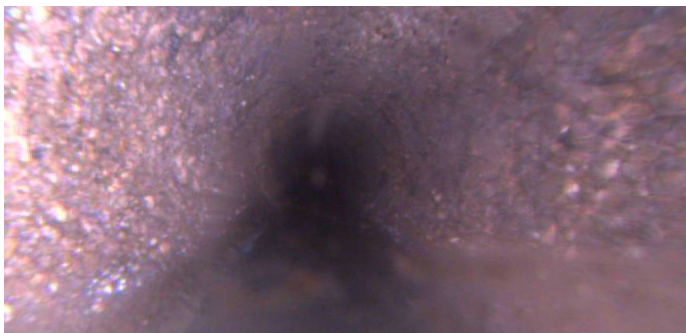
Code: **AMH**
Description: **Manhole**

Distance (ft): **.0**
Structural Grade: **0**
O&M Grade: **0**
Clock Start/From:
Clock To:
1st Value:
2nd Value:
Value Percent:
Continuous Index:
Within 8" of Joint: **NO**
Remarks: **M-503-032**

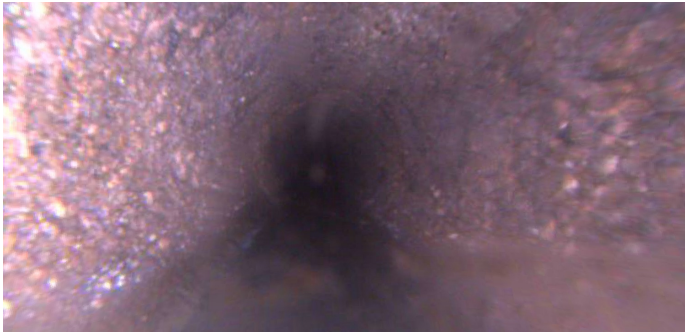
Code:	MWL
Description:	Water Level

Distance (ft):	.0
Structural Grade:	0
O&M Grade:	0
Clock Start/From:	
Clock To:	
1st Value:	
2nd Value:	
Value Percent:	5.000
Continuous Index:	
Within 8" of Joint:	NO
Remarks:

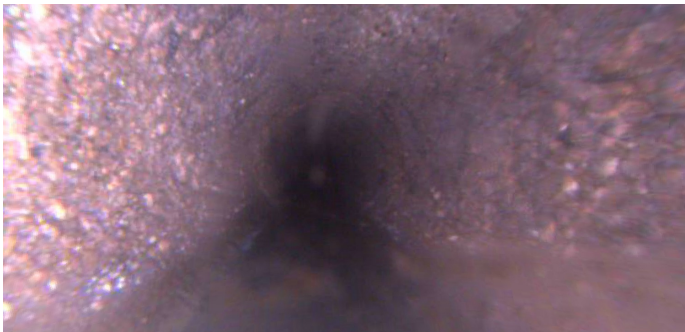
Code:	SAP
Description:	Surface Aggregate Projecting

Distance (ft):	.0
Structural Grade:	3
O&M Grade:	0
Clock Start/From:	8
Clock To:	4
1st Value:	
2nd Value:	
Value Percent:	
Continuous Index:	S01
Within 8" of Joint:	
Remarks:

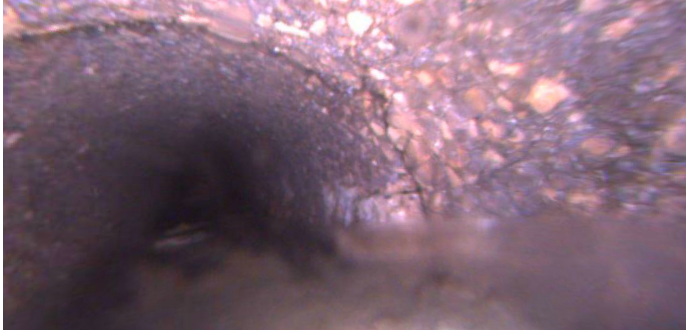
Code: **FL**
Description: **Fracture Longitudinal**

Distance (ft): **8.5**
Structural Grade: **3**
O&M Grade: **0**
Clock Start/From: **3**
Clock To:
1st Value:
2nd Value:
Value Percent:
Continuous Index:
Within 8" of Joint: **YES**
Remarks:

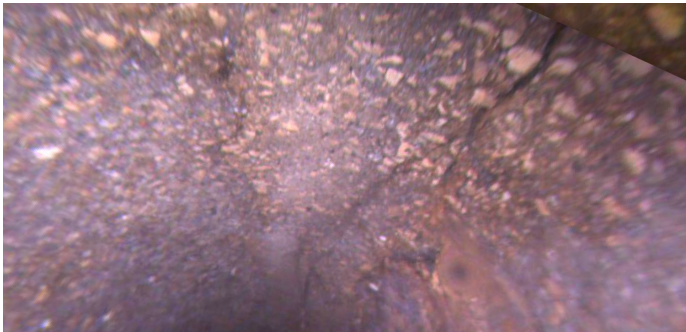
Code: **FM**
Description: **Fracture Multiple**

Distance (ft): **12.0**
Structural Grade: **4**
O&M Grade: **0**
Clock Start/From: **12**
Clock To: **1**
1st Value:
2nd Value:
Value Percent:
Continuous Index:
Within 8" of Joint: **YES**
Remarks:

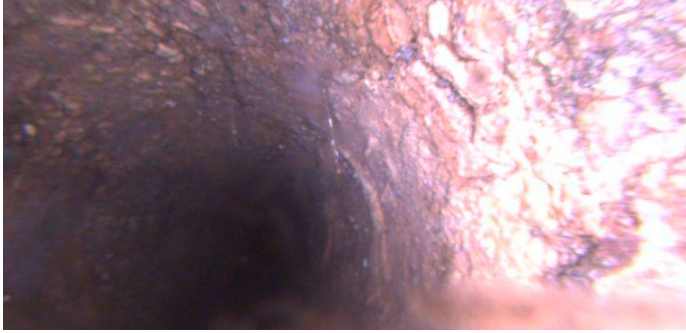
Code: **SAP**
Description: **Surface Aggregate Projecting**

Distance (ft): **14.6**
Structural Grade: **3**
O&M Grade: **0**
Clock Start/From: **8**
Clock To: **4**
1st Value:
2nd Value:
Value Percent:
Continuous Index: **F01**
Within 8" of Joint:
Remarks:

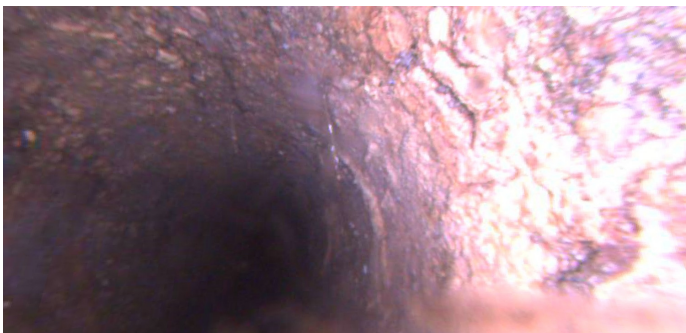
Code: **MSA**
Description: **Abandoned Survey**

Distance (ft): **14.6**
Structural Grade: **0**
O&M Grade: **0**
Clock Start/From:
Clock To:
1st Value:
2nd Value:
Value Percent:
Continuous Index:
Within 8" of Joint: **NO**
Remarks: **DEBRIS UNDER WATER**
