Profile/Photo Observation Report

Date:	04/09/2018	Weather:		Coding:	PACP 6.0
Pipe Length (ft):	78.7	Owner:	NA	Pre Clean:	Not Known
P.O.#:		Surveyor:	Jen Costello	PSR:	P-503-032-113
Customer:		Clean Date:	01/01/1900	Shape:	C

Street:	W 40th ave	Flow Control:	Not Controlled
City:	Hobart, IN	Year Renewed:	
Location:	Other	Tape/Media #:	
Purpose:	Not Known	Dia/Height:	10"
Use:	Sanitary	Material:	CP
Drain Area:	NA	Lining:	
Category:	NA		
Comment:

Location Details:		Direction of Survey:	Downstream
US MH:	M-503-032	DS MH:	M-504-113
		Total Length Surveyed (ft):	14.6

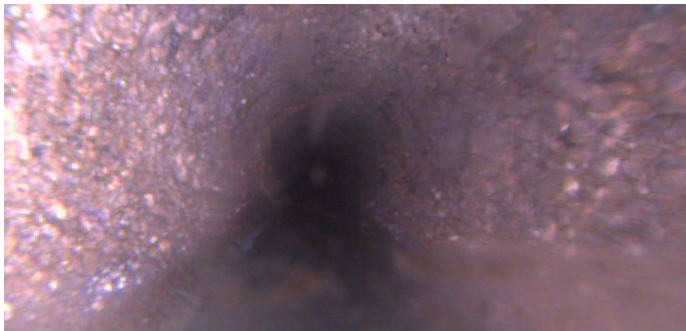
Code: **AMH**
Description: **Manhole**

Distance (ft): **.0**
Structural Grade: **0**
O&M Grade: **0**
Clock Start/From:
Clock To:
1st Value:
2nd Value:
Value Percent:
Continuous Index:
Within 8" of Joint: **NO**
Remarks: **M-503-032**

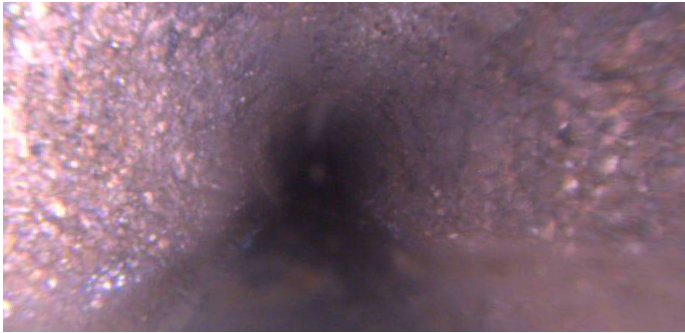
Code:	MWL
Description:	Water Level

Distance (ft):	.0
Structural Grade:	0
O&M Grade:	0
Clock Start/From:	
Clock To:	
1st Value:	
2nd Value:	
Value Percent:	5.000
Continuous Index:	
Within 8" of Joint:	NO
Remarks:

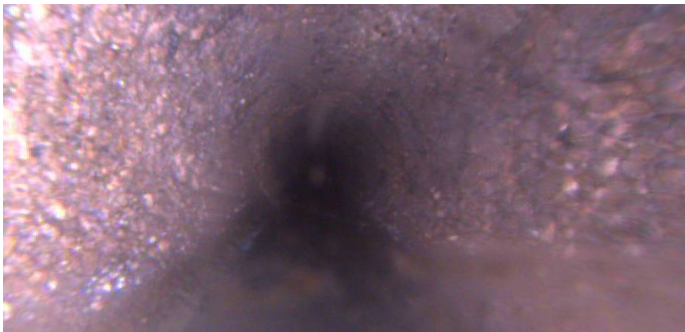
Code:	SAP
Description:	Surface Aggregate Projecting

Distance (ft):	.0
Structural Grade:	3
O&M Grade:	0
Clock Start/From:	8
Clock To:	4
1st Value:	
2nd Value:	
Value Percent:	
Continuous Index:	S01
Within 8" of Joint:	
Remarks:

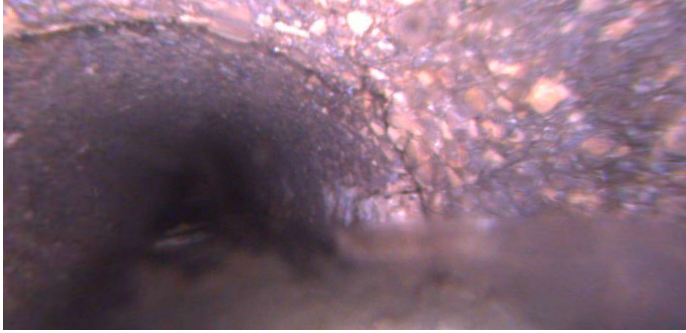
Code: **FL**
Description: **Fracture Longitudinal**

Distance (ft): **8.5**
Structural Grade: **3**
O&M Grade: **0**
Clock Start/From: **3**
Clock To:
1st Value:
2nd Value:
Value Percent:
Continuous Index:
Within 8" of Joint: **YES**
Remarks:

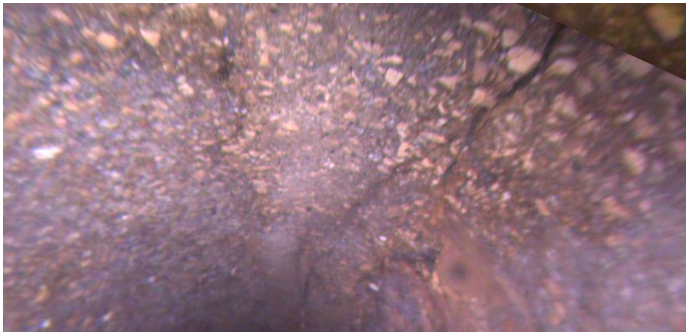
Code: **FM**
Description: **Fracture Multiple**

Distance (ft): **12.0**
Structural Grade: **4**
O&M Grade: **0**
Clock Start/From: **12**
Clock To: **1**
1st Value:
2nd Value:
Value Percent:
Continuous Index:
Within 8" of Joint: **YES**
Remarks:

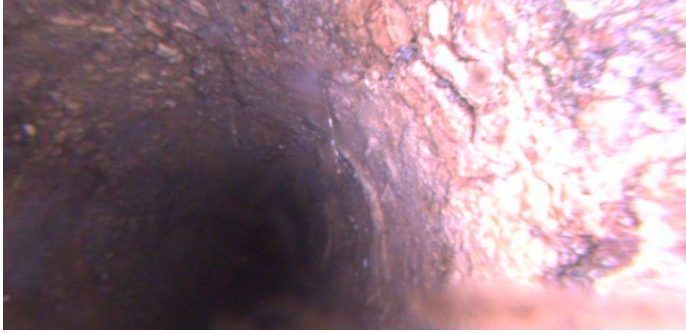
Code: **SAP**
Description: **Surface Aggregate Projecting**

Distance (ft): **14.6**
Structural Grade: **3**
O&M Grade: **0**
Clock Start/From: **8**
Clock To: **4**
1st Value:
2nd Value:
Value Percent:
Continuous Index: **F01**
Within 8" of Joint:
Remarks:

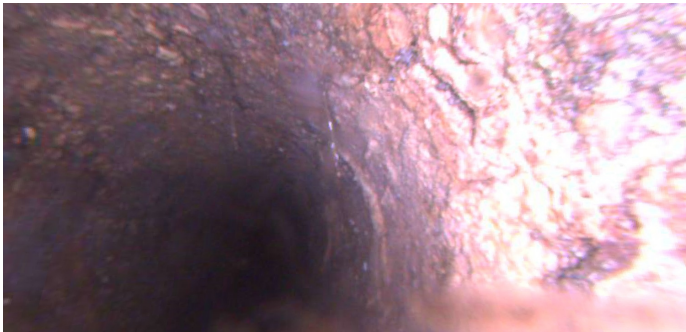
Code: **MSA**
Description: **Abandoned Survey**

Distance (ft): **14.6**
Structural Grade: **0**
O&M Grade: **0**
Clock Start/From:
Clock To:
1st Value:
2nd Value:
Value Percent:
Continuous Index:
Within 8" of Joint: **NO**
Remarks: **DEBRIS UNDER WATER**
