Profile/Photo Observation Report

Street:	W 42ND AVE	Flow Control:	Not Controlled
City:	Hobart, IN	Year Renewed:	
Location:	Light Highway	Tape/Media #:	
Purpose:	Not Known	Dia/Height:	12"
Use:	Sanitary	Material:	VCP
Drain Area:	NA	Lining:	
Category:	NA		
Comment:

Location Details:		Direction of Survey:	Upstream
US MH:	M-504-117	DS MH:	M-504-118
		Total Length Surveyed (ft):	13.8

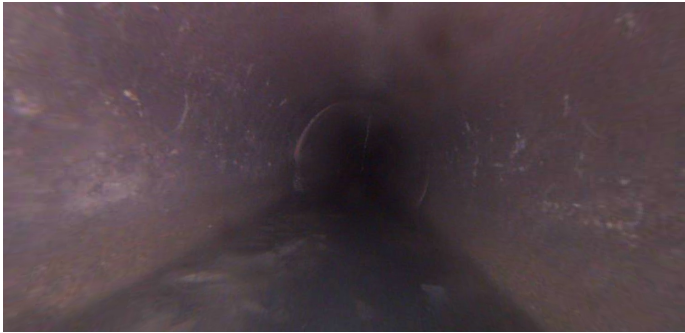
Code:	MWL
Description:	Water Level

Distance (ft):	.0
Structural Grade:	0
O&M Grade:	0
Clock Start/From:	
Clock To:	
1st Value:	
2nd Value:	
Value Percent:	10.000
Continuous Index:	
Within 8" of Joint:	NO
Remarks:

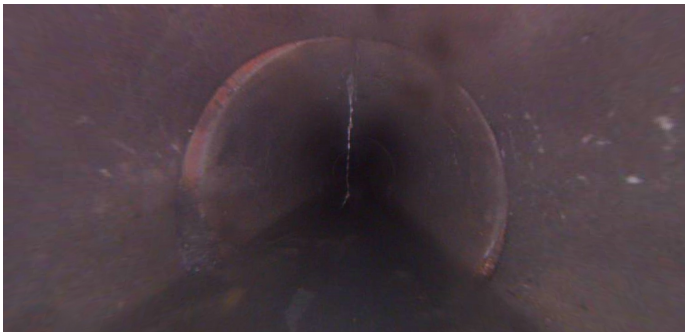
Code:	RFJ
Description:	Roots Fine Joint

Distance (ft):	2.2
Structural Grade:	0
O&M Grade:	1
Clock Start/From:	8
Clock To:	4
1st Value:	
2nd Value:	
Value Percent:	
Continuous Index:	
Within 8" of Joint:	YES
Remarks:

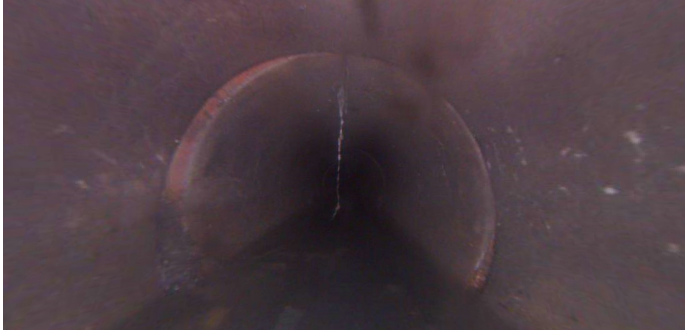
Code: **CM**
Description: **Crack Multiple**

Distance (ft): **2.2**
Structural Grade: **3**
O&M Grade: **0**
Clock Start/From: **9**
Clock To: **12**
1st Value:
2nd Value:
Value Percent:
Continuous Index:
Within 8" of Joint: **YES**
Remarks:

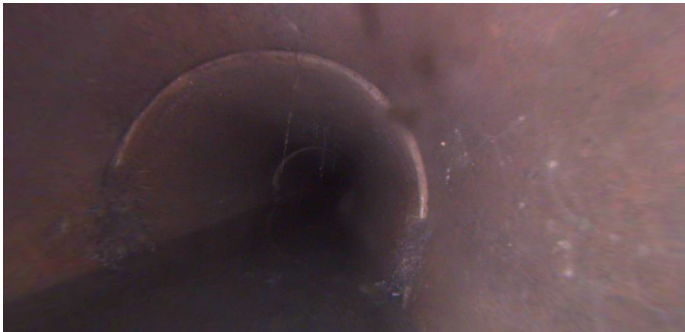
Code: **RMJ**
Description: **Roots Medium Joint**

Distance (ft): **4.1**
Structural Grade: **0**
O&M Grade: **3**
Clock Start/From: **8**
Clock To: **4**
1st Value:
2nd Value:
Value Percent: **5.000**
Continuous Index: **S01**
Within 8" of Joint: **YES**
Remarks:

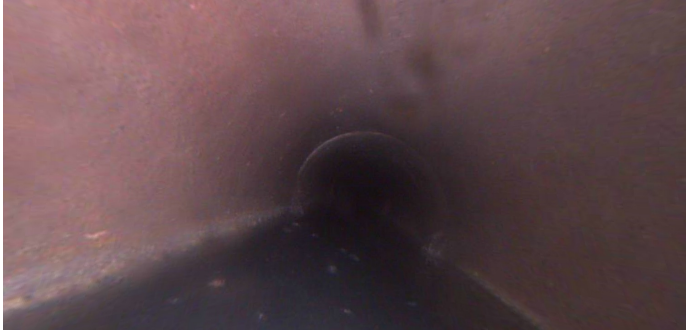
Code: **RMJ**
Description: **Roots Medium Joint**

Distance (ft): **13.8**
Structural Grade: **0**
O&M Grade: **3**
Clock Start/From: **8**
Clock To: **4**
1st Value:
2nd Value:
Value Percent: **5.000**
Continuous Index: **F01**
Within 8" of Joint: **YES**
Remarks:

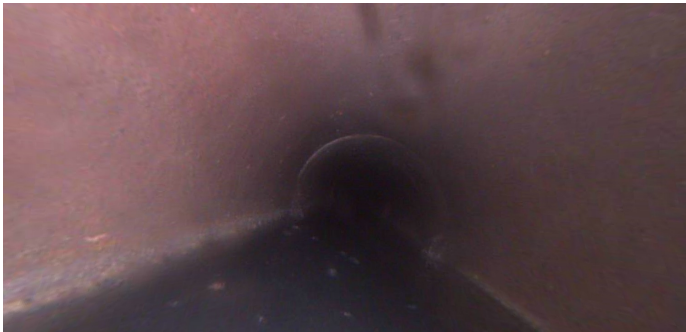
Code: **MSA**
Description: **Abandoned Survey**

Distance (ft): **13.8**
Structural Grade: **0**
O&M Grade: **0**
Clock Start/From:
Clock To:
1st Value:
2nd Value:
Value Percent:
Continuous Index:
Within 8" of Joint: **NO**
Remarks: **debris under water**
