Profile/Photo Observation Report

Date:	04/17/2018	Weather:		Coding:	PACP 6.0
Pipe Length (ft):	208.8	Owner:	NA	Pre Clean:	Not Known
P.O.#:		Surveyor:	Jen Costello	PSR:	P-504-118-117
Customer:		Clean Date:	01/01/1900	Shape:	C

Street:	Summerlin	Flow Control:	Not Controlled
City:	Hobart, IN	Year Renewed:	
Location:	Light Highway	Tape/Media #:	
Purpose:	Not Known	Dia/Height:	12"
Use:	Sanitary	Material:	VCP
Drain Area:	NA	Lining:	
Category:	NA		
Comment:

Location Details:		Direction of Survey:	Upstream
US MH:	M-504-117	DS MH:	M-504-118
		Total Length Surveyed (ft):	13.8

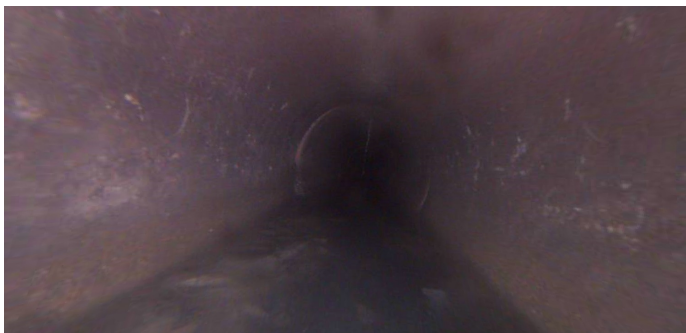
Code: **AMH**
Description: **Manhole**

Distance (ft): **.0**
Structural Grade: **0**
O&M Grade: **0**
Clock Start/From:
Clock To:
1st Value:
2nd Value:
Value Percent:
Continuous Index:
Within 8" of Joint: **NO**
Remarks: **M-504-117**

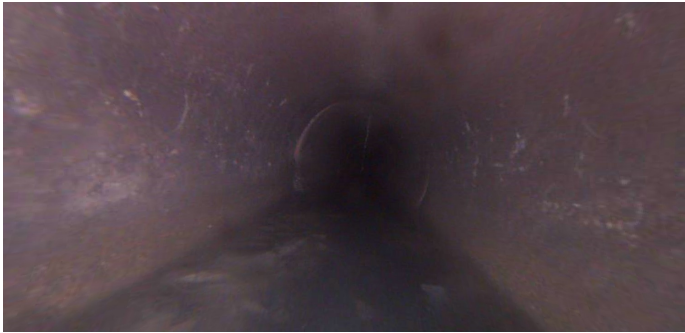
Code:	MWL
Description:	Water Level

Distance (ft):	.0
Structural Grade:	0
O&M Grade:	0
Clock Start/From:	
Clock To:	
1st Value:	
2nd Value:	
Value Percent:	10.000
Continuous Index:	
Within 8" of Joint:	NO
Remarks:

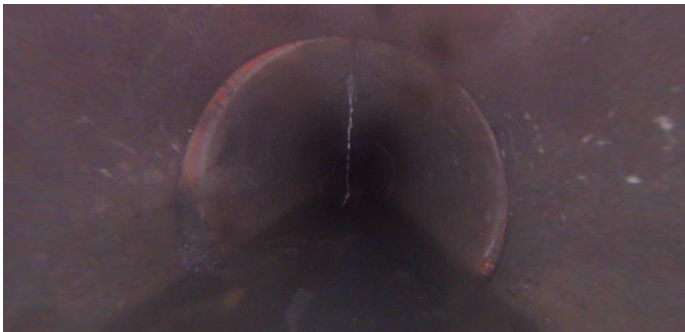
Code:	RFJ
Description:	Roots Fine Joint

Distance (ft):	2.2
Structural Grade:	0
O&M Grade:	1
Clock Start/From:	8
Clock To:	4
1st Value:	
2nd Value:	
Value Percent:	
Continuous Index:	
Within 8" of Joint:	YES
Remarks:

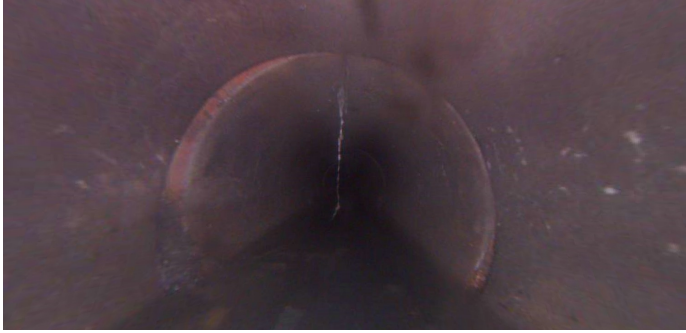
Code: **CM**
Description: **Crack Multiple**

Distance (ft): **2.2**
Structural Grade: **3**
O&M Grade: **0**
Clock Start/From: **9**
Clock To: **12**
1st Value:
2nd Value:
Value Percent:
Continuous Index:
Within 8" of Joint: **YES**
Remarks:

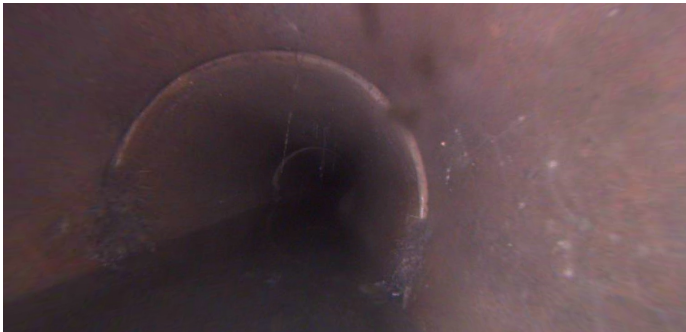
Code: **RMJ**
Description: **Roots Medium Joint**

Distance (ft): **4.1**
Structural Grade: **0**
O&M Grade: **3**
Clock Start/From: **8**
Clock To: **4**
1st Value:
2nd Value:
Value Percent: **5.000**
Continuous Index: **S01**
Within 8" of Joint: **YES**
Remarks:

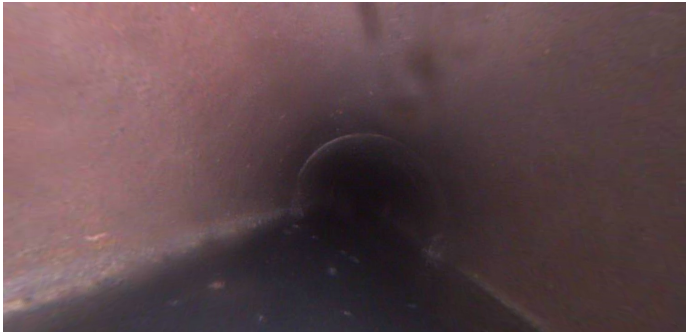
Code: **RMJ**
Description: **Roots Medium Joint**

Distance (ft): **13.8**
Structural Grade: **0**
O&M Grade: **3**
Clock Start/From: **8**
Clock To: **4**
1st Value:
2nd Value:
Value Percent: **5.000**
Continuous Index: **F01**
Within 8" of Joint: **YES**
Remarks:

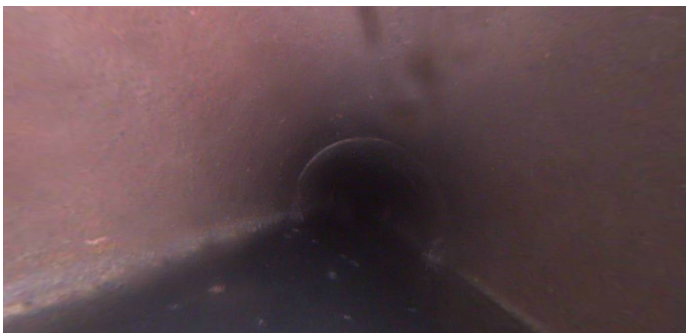
Code: **MSA**
Description: **Abandoned Survey**

Distance (ft): **13.8**
Structural Grade: **0**
O&M Grade: **0**
Clock Start/From:
Clock To:
1st Value:
2nd Value:
Value Percent:
Continuous Index:
Within 8" of Joint: **NO**
Remarks: **debris under water**
