Profile/Photo Observation Report

Date:	09/06/2021	Weather:		Coding:	PACP 7.0
Pipe Length (ft):	205.3	Owner:	City of Hobart	Pre Clean:	Heavy Cleaning
P.O.#:	YES502259	Surveyor:	S. Bucklin	PSR:	P-504-118-117
Customer:	City of Hobart	Clean Date:	09/03/2021	Shape:	C

Street:	42nd Avenue	Flow Control:	Not Controlled
City:	Hobart, IN	Year Renewed:	
Location:	Alley	Tape/Media #:	
Purpose:	Routine Assessment	Dia/Height:	12"
Use:	Sanitary Sewage Pipe	Material:	VCP
Drain Area:		Lining:	None
Category:	NA		
Comment:			
Location Details:		Direction of Survey:	Upstream
US MH:	M-504-117	DS MH:	M-504-118
		Total Length Surveyed (ft):	205.3

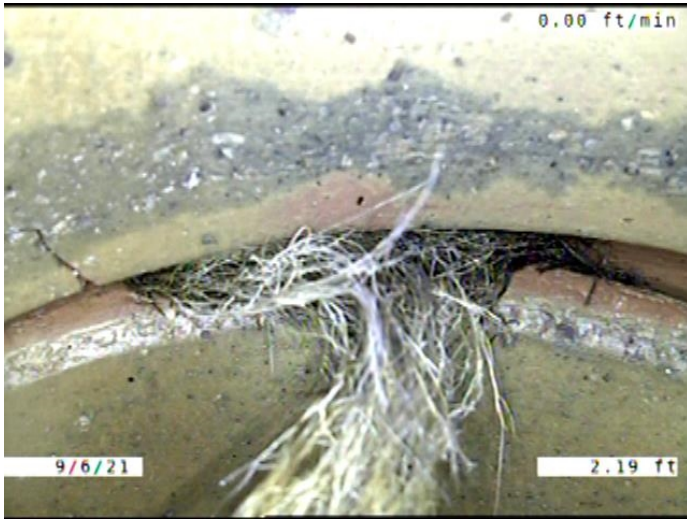
Code: **RFJ**
Description: **Roots Fine Joint**

Distance (ft): **2.2**
Structural Grade: **0**
O&M Grade: **1**
Clock Start/From: **10**
Clock To: **3**
1st Value:
2nd Value:
Value Percent:
Continuous Index: **S01**
Within 8" of Joint: **YES**
Remarks:

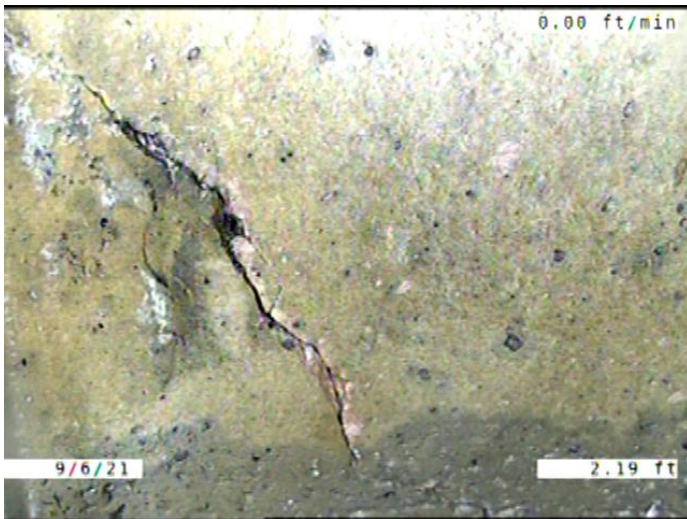
Code: **FM**
Description: **Fracture Multiple**

Distance (ft): **2.2**
Structural Grade: **4**
O&M Grade: **0**
Clock Start/From: **9**
Clock To: **10**
1st Value:
2nd Value:
Value Percent:
Continuous Index:
Within 8" of Joint: **YES**
Remarks:

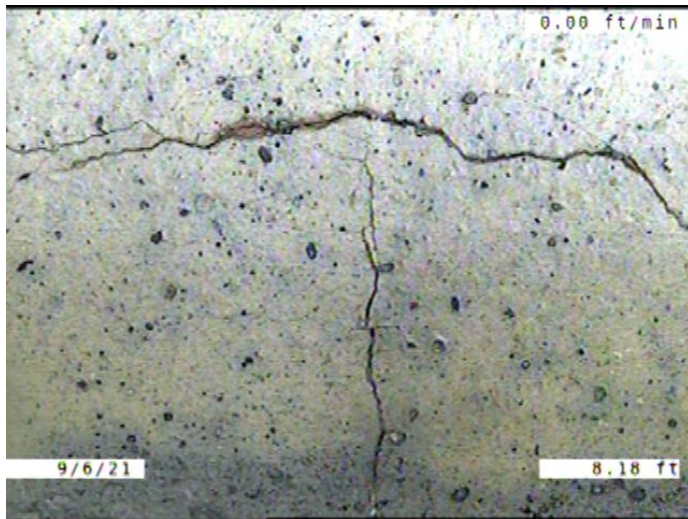
Code: **CM**
 Description: **Crack Multiple**

Distance (ft): **8.2**
 Structural Grade: **3**
 O&M Grade: **0**
 Clock Start/From: **12**
 Clock To: **3**
 1st Value:
 2nd Value:
 Value Percent:
 Continuous Index:
 Within 8" of Joint: **YES**
 Remarks:

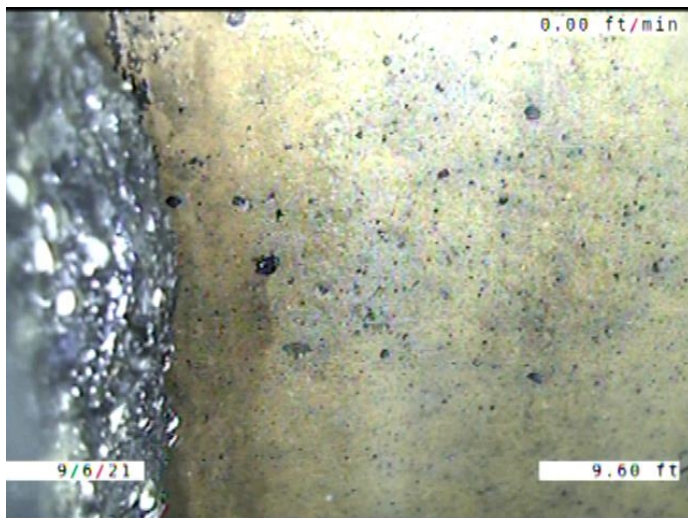
Code: **OBN**
 Description: **Obstruction Construction Debris**

Distance (ft): **9.6**
 Structural Grade: **0**
 O&M Grade: **2**
 Clock Start/From: **7**
 Clock To: **8**
 1st Value:
 2nd Value:
 Value Percent: **5.000**
 Continuous Index:
 Within 8" of Joint: **NO**
 Remarks:

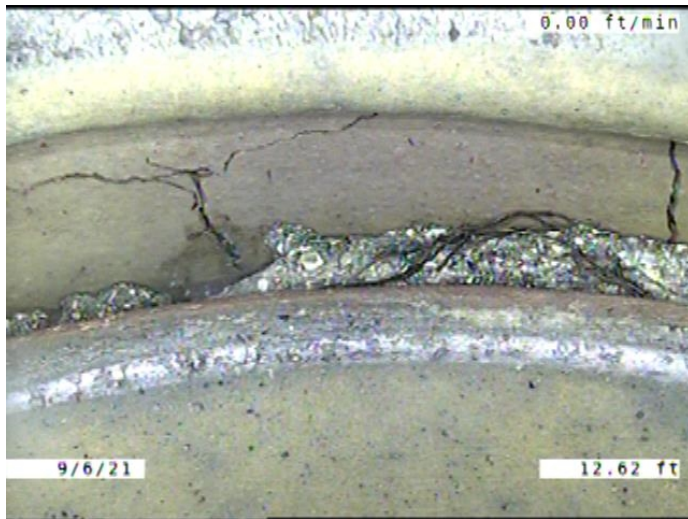
Code: **JOM**
 Description: **Joint Offset Medium**

Distance (ft): **12.6**
 Structural Grade: **3**
 O&M Grade: **0**
 Clock Start/From:
 Clock To:
 1st Value:
 2nd Value:
 Value Percent:
 Continuous Index:
 Within 8" of Joint: **NO**
 Remarks:

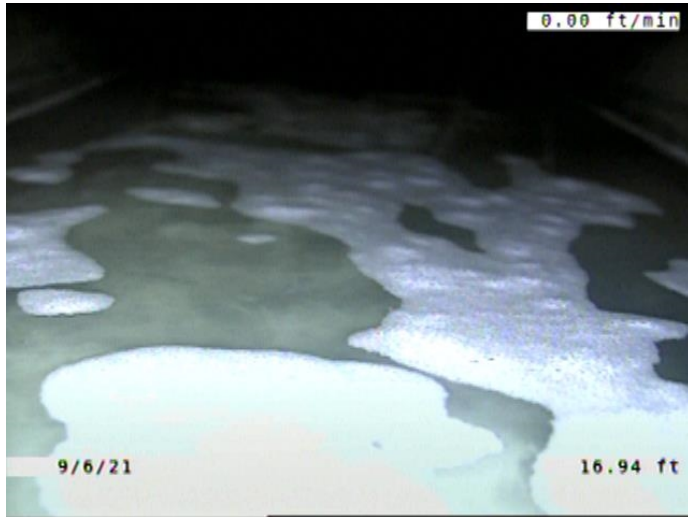
Code: **DSF**
 Description: **Deposits Settled Fine**

Distance (ft): **16.9**
 Structural Grade: **0**
 O&M Grade: **2**
 Clock Start/From: **5**
 Clock To: **7**
 1st Value:
 2nd Value:
 Value Percent: **5.000**
 Continuous Index: **S02**
 Within 8" of Joint: **YES**
 Remarks:

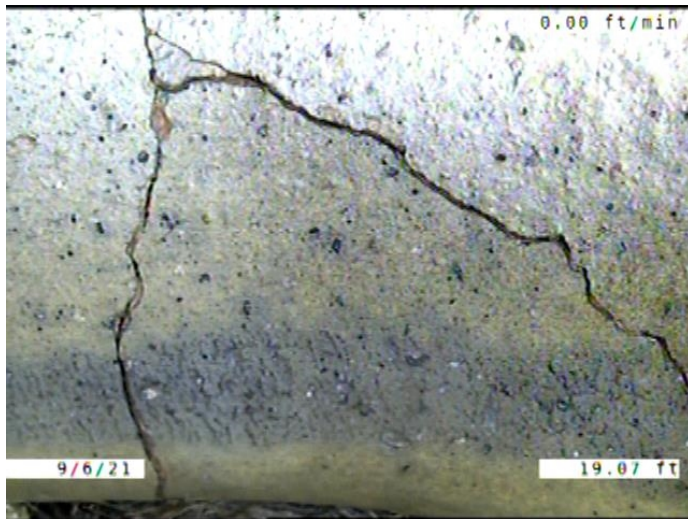
Code: **FM**
 Description: **Fracture Multiple**

Distance (ft): **19.1**
 Structural Grade: **4**
 O&M Grade: **0**
 Clock Start/From: **10**
 Clock To: **3**
 1st Value:
 2nd Value:
 Value Percent:
 Continuous Index:
 Within 8" of Joint: **YES**
 Remarks:

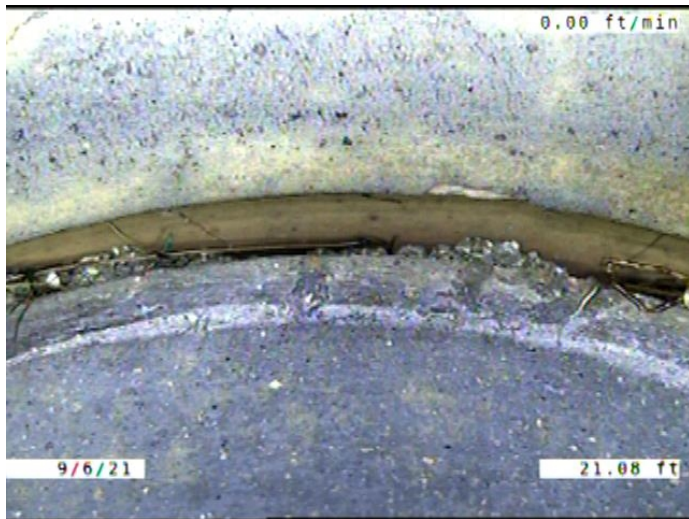
Code: **JOM**
 Description: **Joint Offset Medium**

Distance (ft): **21.1**
 Structural Grade: **3**
 O&M Grade: **0**
 Clock Start/From:
 Clock To:
 1st Value:
 2nd Value:
 Value Percent:
 Continuous Index:
 Within 8" of Joint: **NO**
 Remarks:

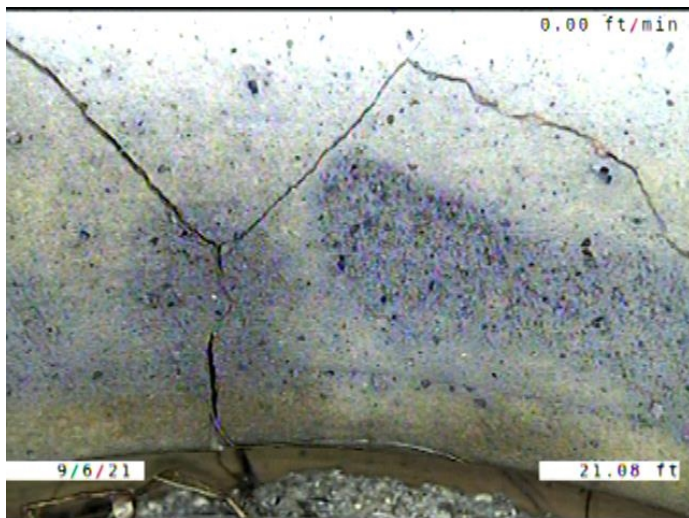
Code: **FM**
 Description: **Fracture Multiple**

Distance (ft): **21.1**
 Structural Grade: **4**
 O&M Grade: **0**
 Clock Start/From: **10**
 Clock To: **2**
 1st Value:
 2nd Value:
 Value Percent:
 Continuous Index:
 Within 8" of Joint: **YES**
 Remarks:

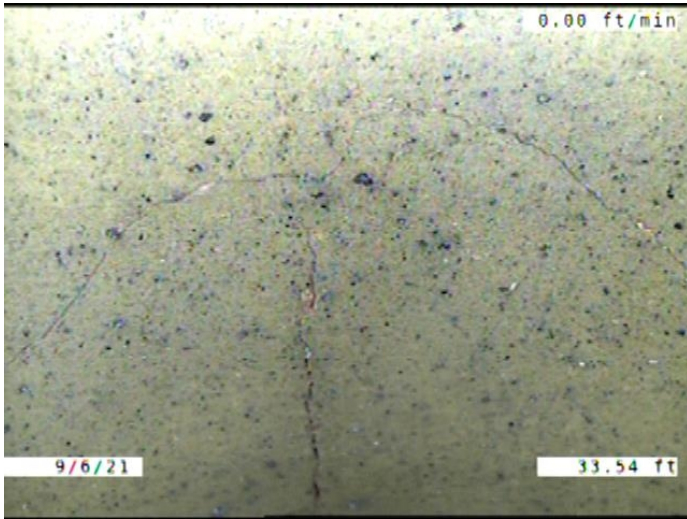
Code: **CM**
Description: **Crack Multiple**

Distance (ft): **33.5**
Structural Grade: **3**
O&M Grade: **0**
Clock Start/From: **8**
Clock To: **1**
1st Value:
2nd Value:
Value Percent:
Continuous Index:
Within 8" of Joint: **YES**
Remarks:

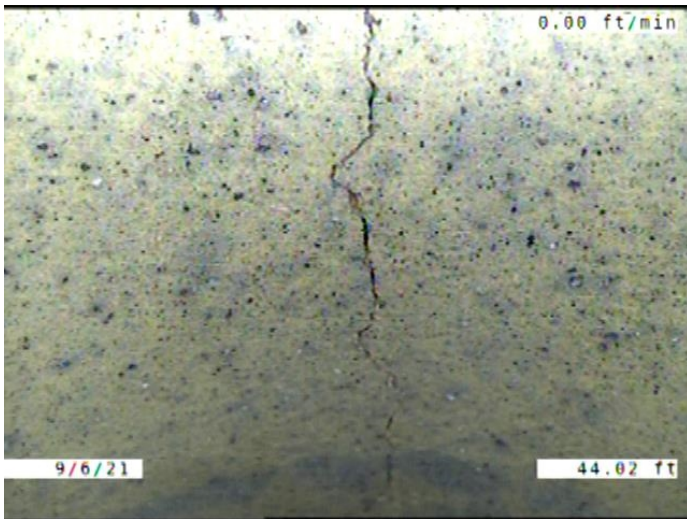
Code: **FL**
Description: **Fracture Longitudinal**

Distance (ft): **44.0**
Structural Grade: **3**
O&M Grade: **0**
Clock Start/From: **12**
Clock To:
1st Value:
2nd Value:
Value Percent:
Continuous Index:
Within 8" of Joint: **YES**
Remarks:

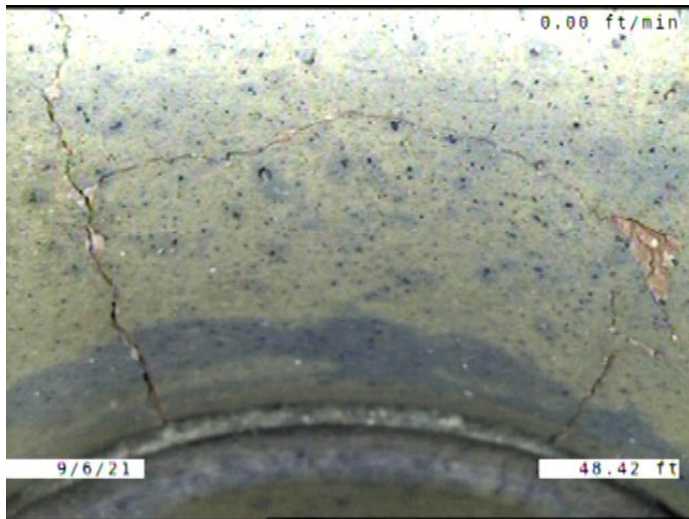
Code: **FM**
 Description: **Fracture Multiple**

Distance (ft): **48.4**
 Structural Grade: **4**
 O&M Grade: **0**
 Clock Start/From: **10**
 Clock To: **3**
 1st Value:
 2nd Value:
 Value Percent:
 Continuous Index: **S03**
 Within 8" of Joint: **YES**
 Remarks:

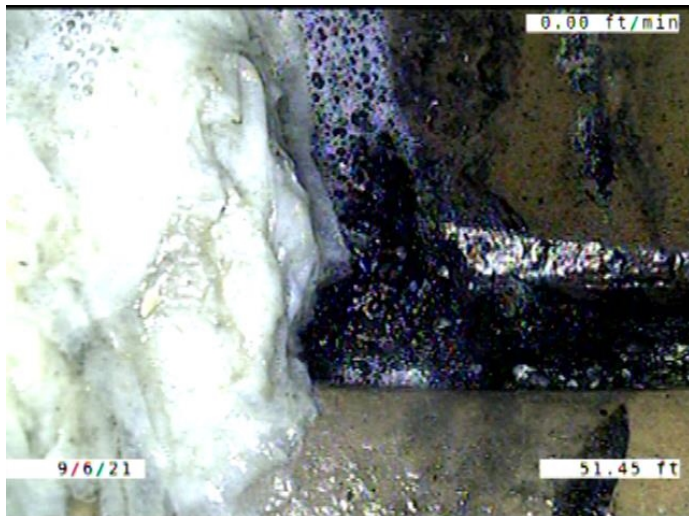
Code: **DAE**
 Description: **Deposits Attached Encrustation**

Distance (ft): **51.4**
 Structural Grade: **0**
 O&M Grade: **2**
 Clock Start/From: **4**
 Clock To: **8**
 1st Value:
 2nd Value:
 Value Percent: **5.000**
 Continuous Index:
 Within 8" of Joint: **YES**
 Remarks:

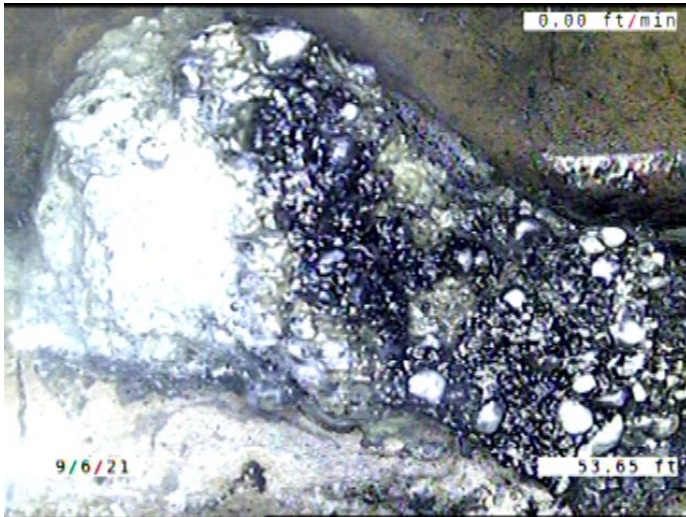
Code: **DAE**
 Description: **Deposits Attached Encrustation**

Distance (ft): **53.6**
 Structural Grade: **0**
 O&M Grade: **2**
 Clock Start/From: **4**
 Clock To: **9**
 1st Value:
 2nd Value:
 Value Percent: **5.000**
 Continuous Index:
 Within 8" of Joint: **YES**
 Remarks:

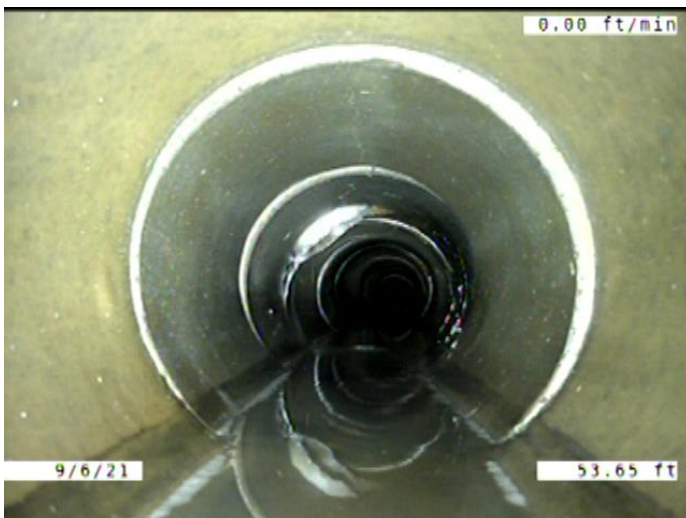
Code: **RFJ**
 Description: **Roots Fine Joint**

Distance (ft): **53.7**
 Structural Grade: **0**
 O&M Grade: **1**
 Clock Start/From: **10**
 Clock To: **3**
 1st Value:
 2nd Value:
 Value Percent:
 Continuous Index: **F01**
 Within 8" of Joint: **YES**
 Remarks:

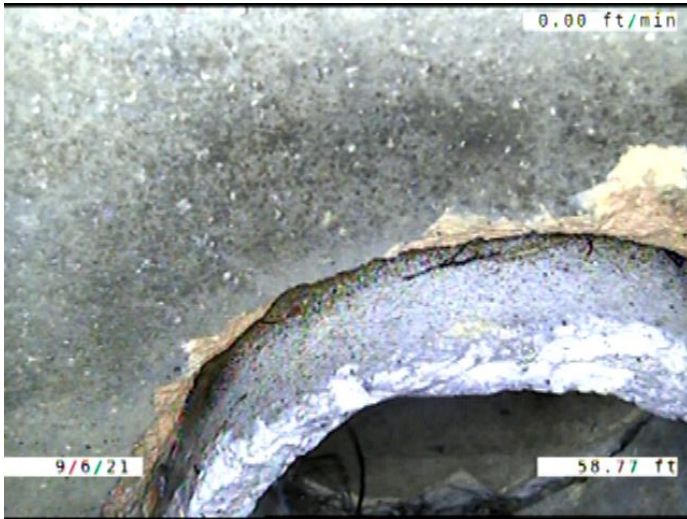
Code: **SSS**
Description: **Surface Damage Surface Spalling**

Distance (ft): **58.8**
Structural Grade: **2**
O&M Grade: **0**
Clock Start/From: **10**
Clock To: **12**
1st Value:
2nd Value:
Value Percent:
Continuous Index:
Within 8" of Joint: **YES**
Remarks:

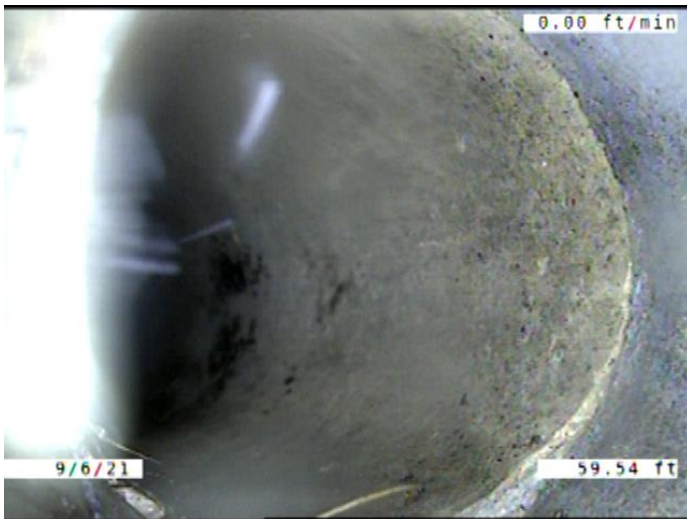
Code: **TBI**
Description: **Tap Break-in Intruding**

Distance (ft): **59.5**
Structural Grade: **0**
O&M Grade: **2**
Clock Start/From: **11**
Clock To:
1st Value: **6.000**
2nd Value: **1.000**
Value Percent:
Continuous Index:
Within 8" of Joint: **YES**
Remarks: **CONSTANTLY RUNNING WATER**

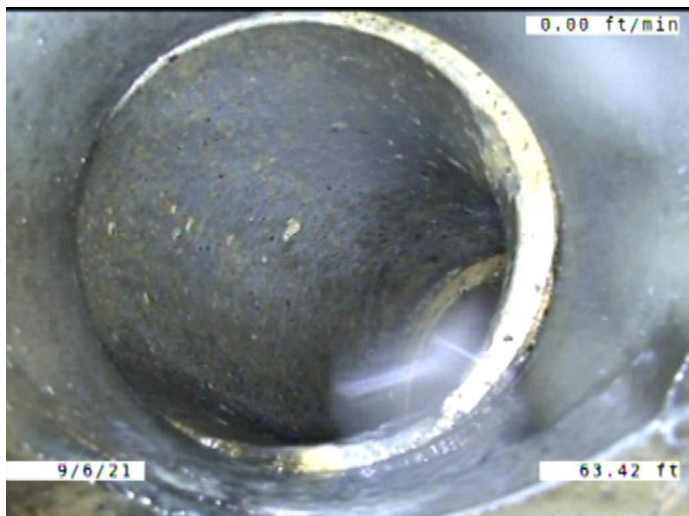
Code: **TFD**
Description: **Tap Factory Defective**

Distance (ft): **63.4**
Structural Grade: **0**
O&M Grade: **3**
Clock Start/From: **1**
Clock To:
1st Value: **6.000**
2nd Value:
Value Percent:
Continuous Index:
Within 8" of Joint: **YES**
Remarks: **CONSTANTLY RUNNING WATER**

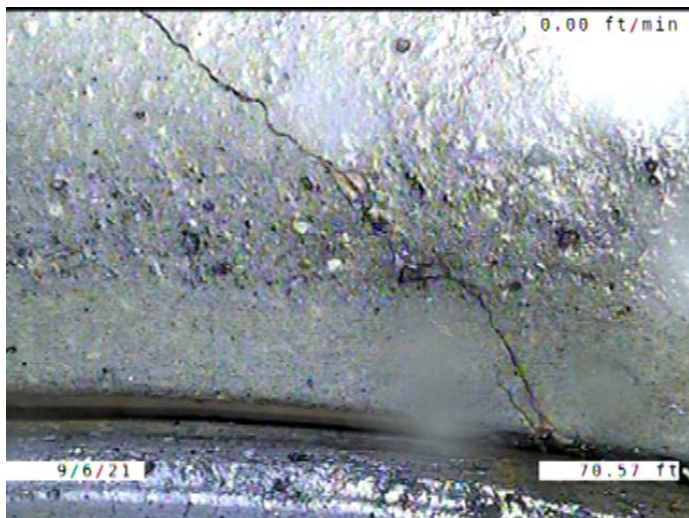
Code: **CS**
Description: **Crack Spiral**

Distance (ft): **70.6**
Structural Grade: **2**
O&M Grade: **0**
Clock Start/From: **2**
Clock To: **4**
1st Value:
2nd Value:
Value Percent:
Continuous Index:
Within 8" of Joint: **YES**
Remarks:

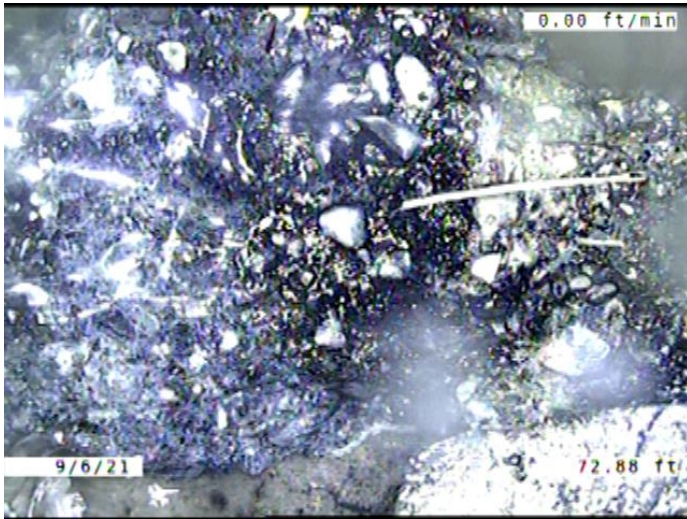
Code:	DAE
Description:	Deposits Attached Encrustation
Distance (ft):	72.9
Structural Grade:	0
O&M Grade:	2
Clock Start/From:	3
Clock To:	9
1st Value:	
2nd Value:	
Value Percent:	5.000
Continuous Index:	
Within 8" of Joint:	YES
Remarks:

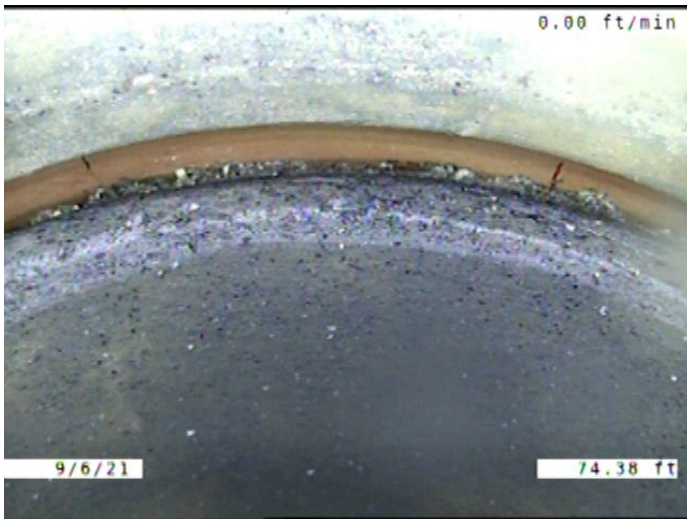
Code:	JOM
Description:	Joint Offset Medium
Distance (ft):	74.4
Structural Grade:	3
O&M Grade:	0
Clock Start/From:	
Clock To:	
1st Value:	
2nd Value:	
Value Percent:	
Continuous Index:	
Within 8" of Joint:	NO
Remarks:

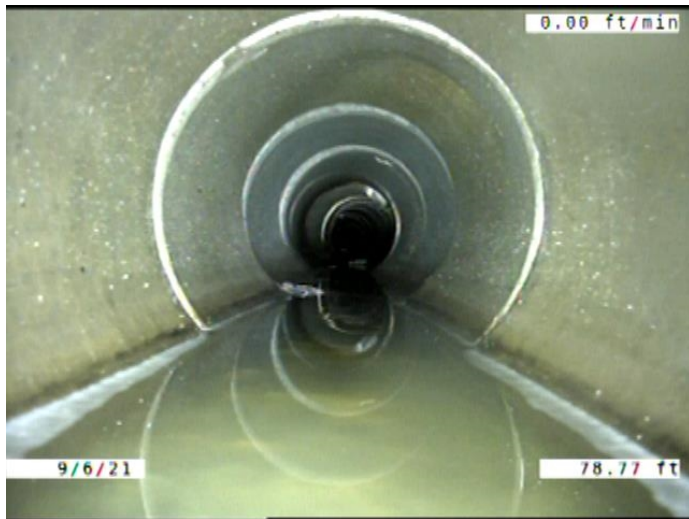
Code: **MWLS**
Description: **Miscellaneous Water Level Sag**

Distance (ft): **78.8**
Structural Grade: **2**
O&M Grade: **0**
Clock Start/From:
Clock To:
1st Value:
2nd Value:
Value Percent: **5.000**
Continuous Index:
Within 8" of Joint: **NO**
Remarks:

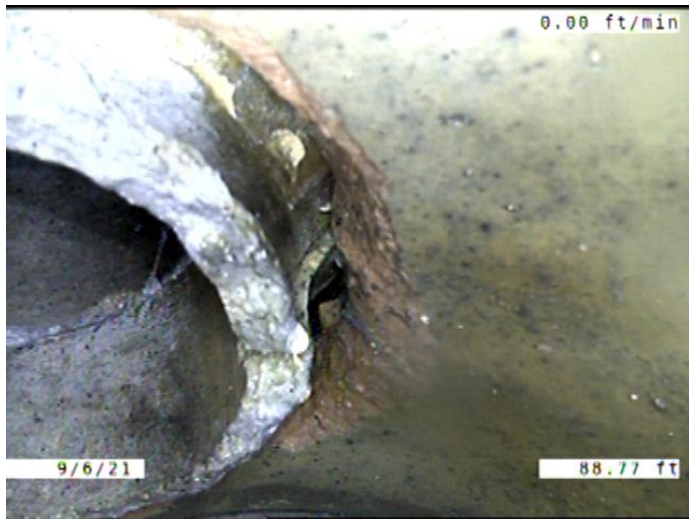
Code:	SSS
Description:	Surface Damage Surface Spalling
Distance (ft):	88.8
Structural Grade:	2
O&M Grade:	0
Clock Start/From:	12
Clock To:	2
1st Value:	
2nd Value:	
Value Percent:	
Continuous Index:	
Within 8" of Joint:	YES
Remarks:

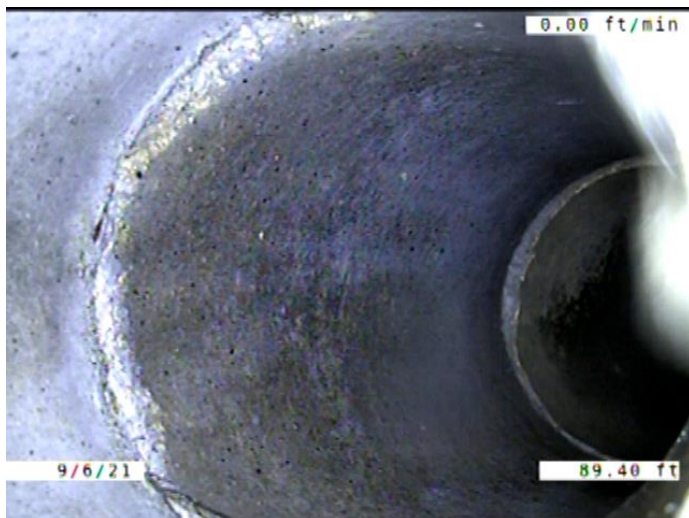
Code:	TBI
Description:	Tap Break-in Intruding
Distance (ft):	89.4
Structural Grade:	0
O&M Grade:	2
Clock Start/From:	1
Clock To:	
1st Value:	6.000
2nd Value:	2.000
Value Percent:	
Continuous Index:	
Within 8" of Joint:	YES
Remarks:

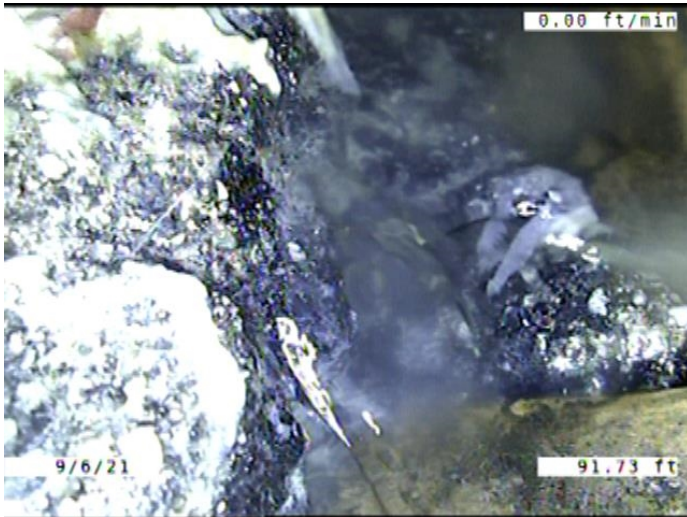
Code: **DAE**
 Description: **Deposits Attached Encrustation**

Distance (ft): **91.7**
 Structural Grade: **0**
 O&M Grade: **2**
 Clock Start/From: **4**
 Clock To: **7**
 1st Value:
 2nd Value:
 Value Percent: **5.000**
 Continuous Index:
 Within 8" of Joint: **YES**
 Remarks:

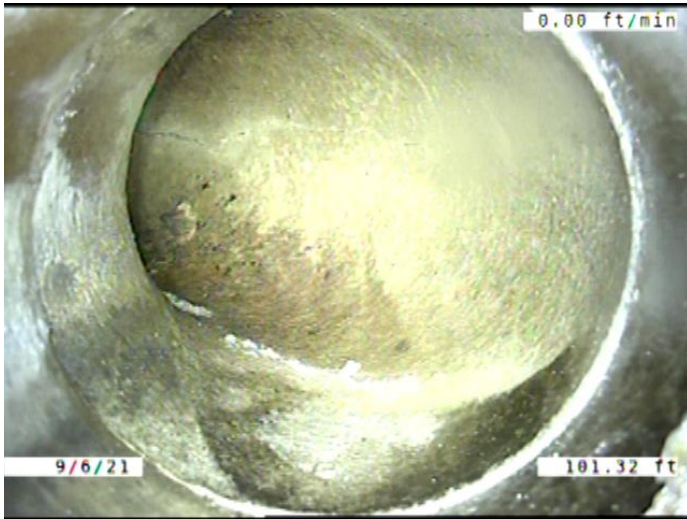
Code: **TBD**
 Description: **Tap Break-in/Hammer Defective**

Distance (ft): **101.3**
 Structural Grade: **0**
 O&M Grade: **3**
 Clock Start/From: **11**
 Clock To:
 1st Value: **6.000**
 2nd Value:
 Value Percent:
 Continuous Index:
 Within 8" of Joint: **YES**
 Remarks: **Defective**

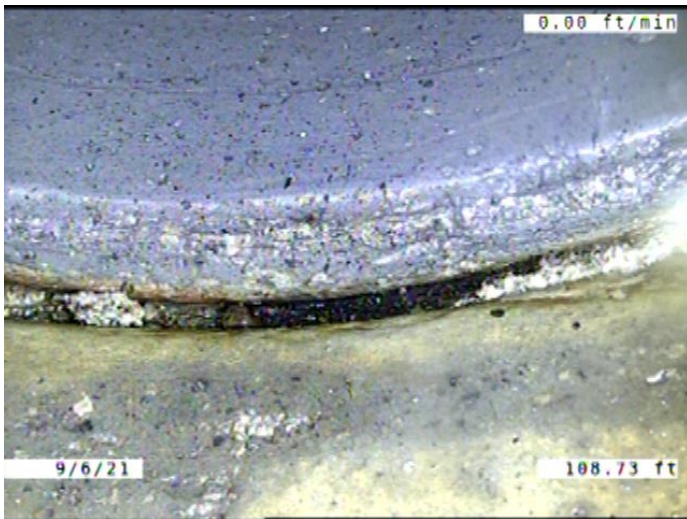
Code: **JOM**
 Description: **Joint Offset Medium**

Distance (ft): **108.7**
 Structural Grade: **3**
 O&M Grade: **0**
 Clock Start/From:
 Clock To:
 1st Value:
 2nd Value:
 Value Percent:
 Continuous Index:
 Within 8" of Joint: **NO**
 Remarks:

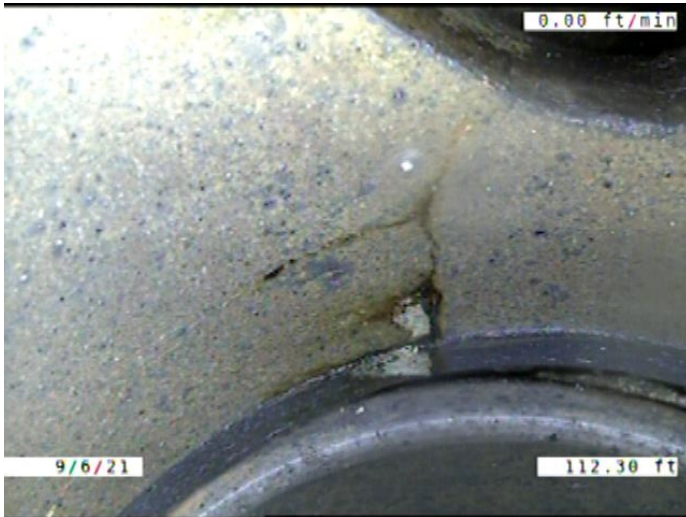
Code: **CM**
Description: **Crack Multiple**

Distance (ft): **112.3**
Structural Grade: **3**
O&M Grade: **0**
Clock Start/From: **10**
Clock To: **11**
1st Value:
2nd Value:
Value Percent:
Continuous Index:
Within 8" of Joint: **YES**
Remarks:

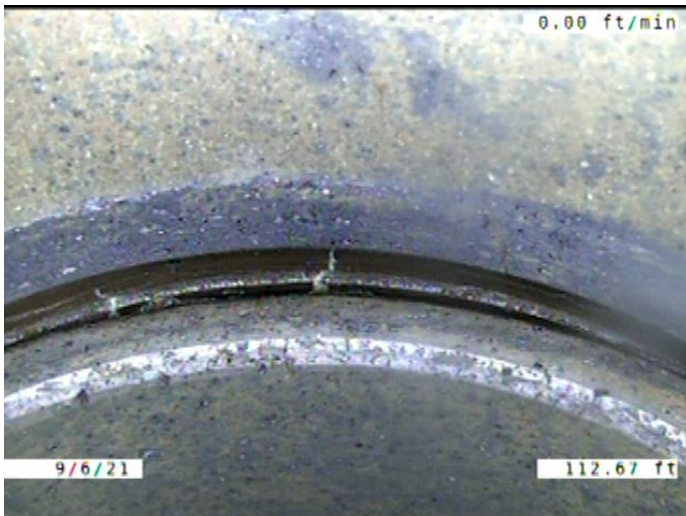
Code: **JOM**
Description: **Joint Offset Medium**

Distance (ft): **112.7**
Structural Grade: **3**
O&M Grade: **0**
Clock Start/From:
Clock To:
1st Value:
2nd Value:
Value Percent:
Continuous Index:
Within 8" of Joint: **NO**
Remarks:

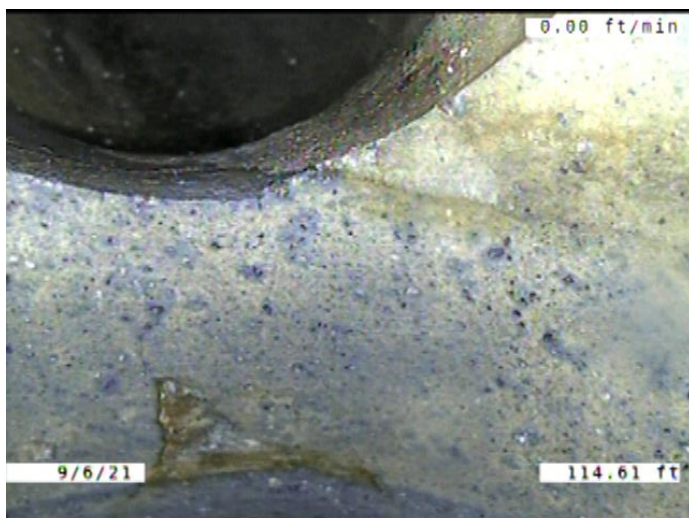
Code: **CM**
 Description: **Crack Multiple**

Distance (ft): **114.6**
 Structural Grade: **3**
 O&M Grade: **0**
 Clock Start/From: **1**
 Clock To: **3**
 1st Value:
 2nd Value:
 Value Percent:
 Continuous Index:
 Within 8" of Joint: **YES**
 Remarks:

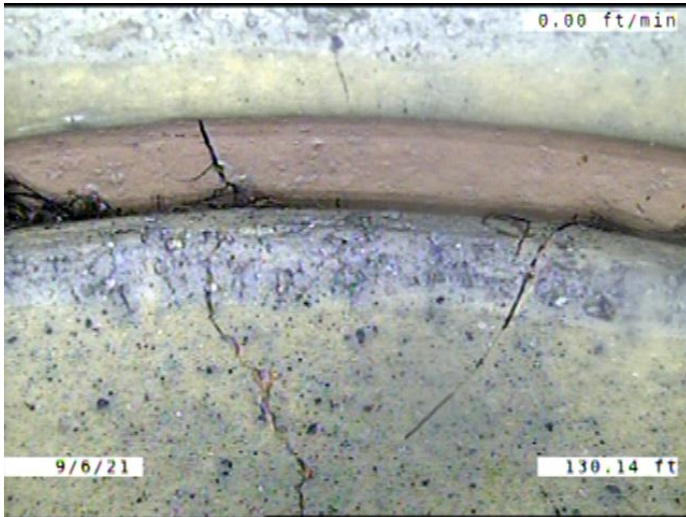
Code: **FM**
Description: **Fracture Multiple**

Distance (ft): **130.1**
Structural Grade: **4**
O&M Grade: **0**
Clock Start/From: **10**
Clock To: **3**
1st Value:
2nd Value:
Value Percent:
Continuous Index: **S05**
Within 8" of Joint: **YES**
Remarks:

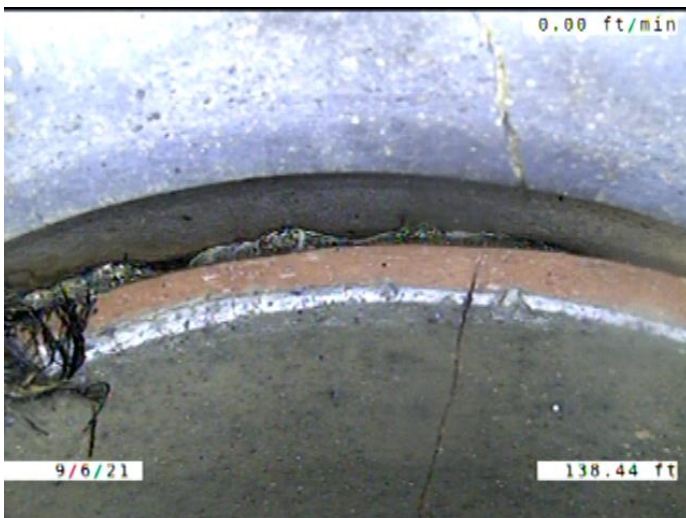
Code: **JOM**
Description: **Joint Offset Medium**

Distance (ft): **138.4**
Structural Grade: **3**
O&M Grade: **0**
Clock Start/From:
Clock To:
1st Value:
2nd Value:
Value Percent:
Continuous Index:
Within 8" of Joint: **NO**
Remarks:

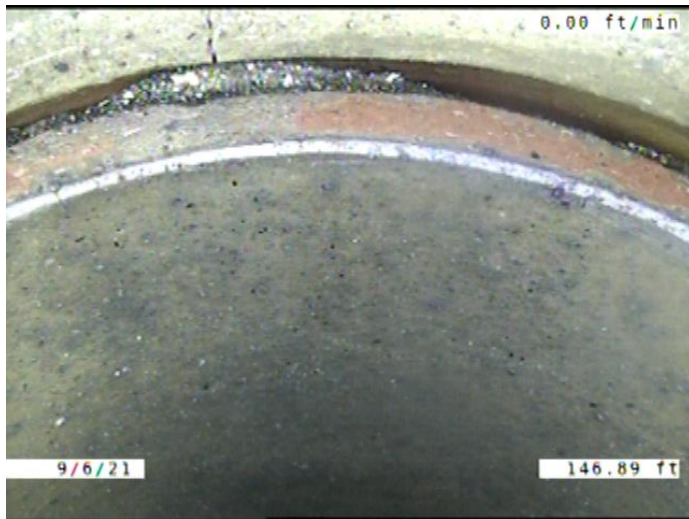
Code: **JOM**
 Description: **Joint Offset Medium**

Distance (ft): **146.9**
 Structural Grade: **3**
 O&M Grade: **0**
 Clock Start/From:
 Clock To:
 1st Value:
 2nd Value:
 Value Percent:
 Continuous Index:
 Within 8" of Joint: **NO**
 Remarks:

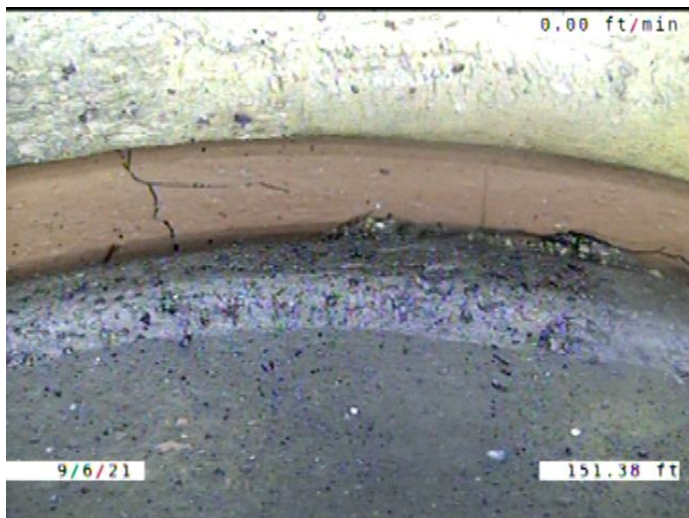
Code: **JOM**
 Description: **Joint Offset Medium**

Distance (ft): **151.4**
 Structural Grade: **3**
 O&M Grade: **0**
 Clock Start/From:
 Clock To:
 1st Value:
 2nd Value:
 Value Percent:
 Continuous Index:
 Within 8" of Joint: **NO**
 Remarks:

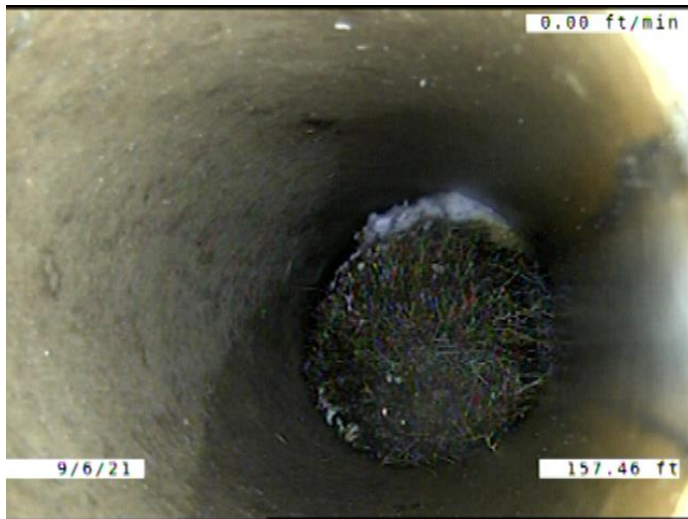
Code:	TBI
Description:	Tap Break-in Intruding
Distance (ft):	157.5
Structural Grade:	0
O&M Grade:	2
Clock Start/From:	2
Clock To:	
1st Value:	6.000
2nd Value:	1.000
Value Percent:	
Continuous Index:	
Within 8" of Joint:	YES
Remarks:	CONSTANTLY RUNNING WATER. TAP LOOKS TO BE 90%+ PLUGGED WITH

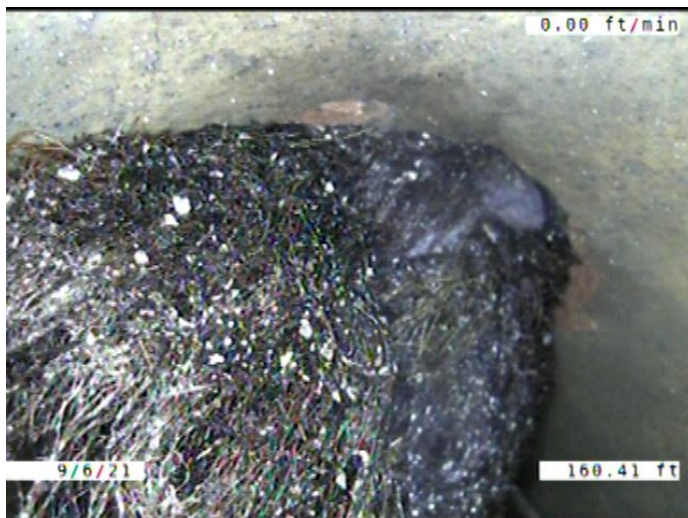
Code:	RML
Description:	Roots Medium Lateral
Distance (ft):	160.4
Structural Grade:	0
O&M Grade:	3
Clock Start/From:	9
Clock To:	12
1st Value:	
2nd Value:	
Value Percent:	40.000
Continuous Index:	
Within 8" of Joint:	NO
Remarks:

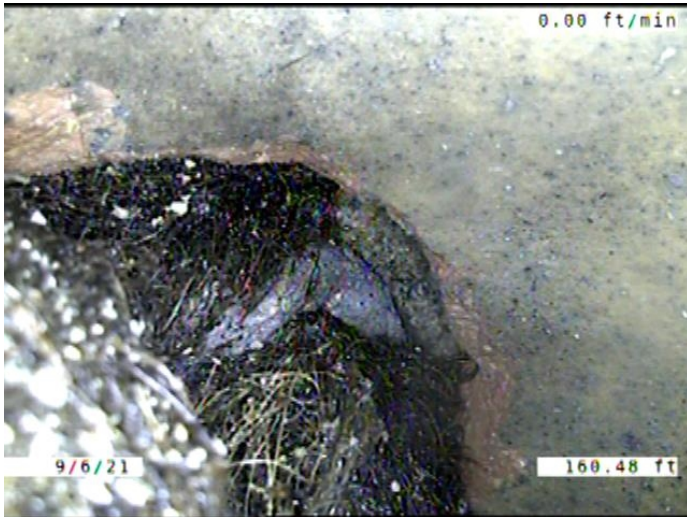
Code:	SSS
Description:	Surface Damage Surface Spalling
Distance (ft):	160.5
Structural Grade:	2
O&M Grade:	0
Clock Start/From:	10
Clock To:	12
1st Value:	
2nd Value:	
Value Percent:	
Continuous Index:	
Within 8" of Joint:	YES
Remarks:

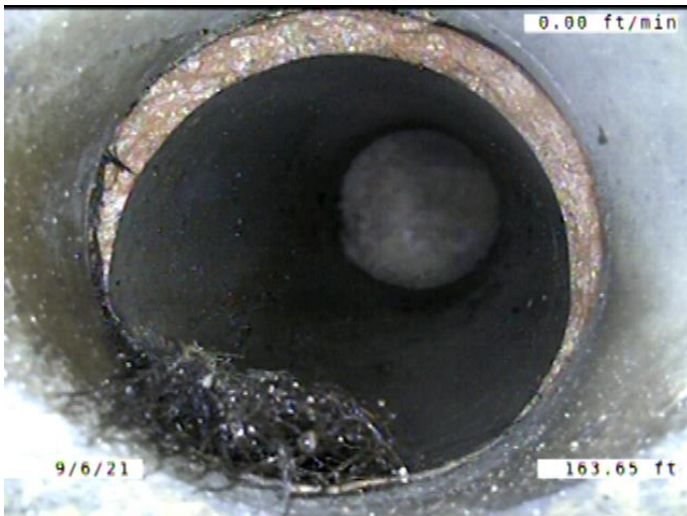
Code:	TFD
Description:	Tap Factory Defective
Distance (ft):	163.7
Structural Grade:	0
O&M Grade:	3
Clock Start/From:	11
Clock To:	
1st Value:	6.000
2nd Value:	
Value Percent:	
Continuous Index:	
Within 8" of Joint:	YES
Remarks:	ROOTS GROWING IN THE JOINT

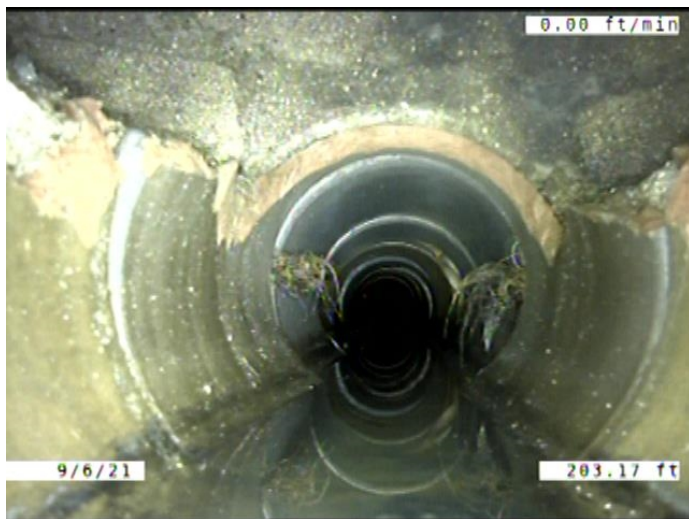
Code: **RMJ**
 Description: **Roots Medium Joint**

Distance (ft): **203.2**
 Structural Grade: **0**
 O&M Grade: **3**
 Clock Start/From: **8**
 Clock To: **4**
 1st Value:
 2nd Value:
 Value Percent: **5.000**
 Continuous Index: **F04**
 Within 8" of Joint: **YES**
 Remarks:

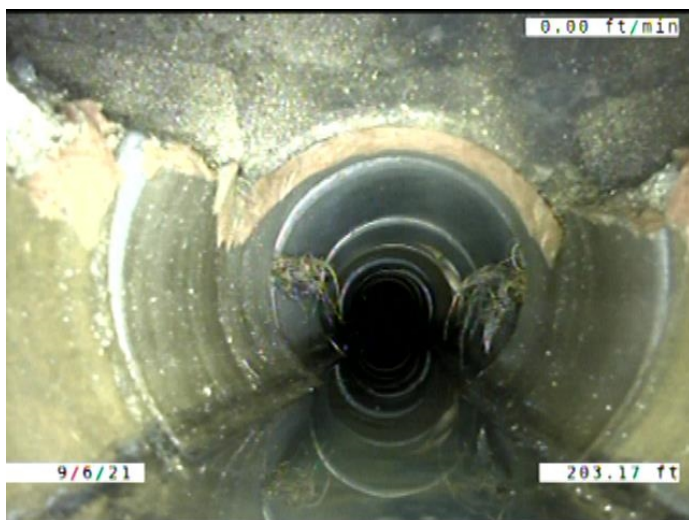
Code: **DSF**
 Description: **Deposits Settled Fine**

Distance (ft): **203.2**
 Structural Grade: **0**
 O&M Grade: **2**
 Clock Start/From: **5**
 Clock To: **7**
 1st Value:
 2nd Value:
 Value Percent: **5.000**
 Continuous Index: **F02**
 Within 8" of Joint: **YES**
 Remarks:
