Profile/Photo Observation Report

Date:	09/06/2021	Weather:		Coding:	PACP 7.0
Pipe Length (ft):	205.3	Owner:	City of Hobart	Pre Clean:	Heavy Cleaning
P.O.#:	YES502259	Surveyor:	S. Bucklin	PSR:	P-504-118-117
Customer:	City of Hobart	Clean Date:	09/03/2021	Shape:	C

Street:	42nd Avenue	Flow Control:	Not Controlled
City:	Hobart, IN	Year Renewed:	
Location:	Alley	Tape/Media #:	
Purpose:	Routine Assessment	Dia/Height:	12"
Use:	Sanitary Sewage Pipe	Material:	VCP
Drain Area:		Lining:	None
Category:	NA		
Comment:			
Location Details:		Direction of Survey:	Upstream
US MH:	M-504-117	DS MH:	M-504-118
		Total Length Surveyed (ft):	205.3

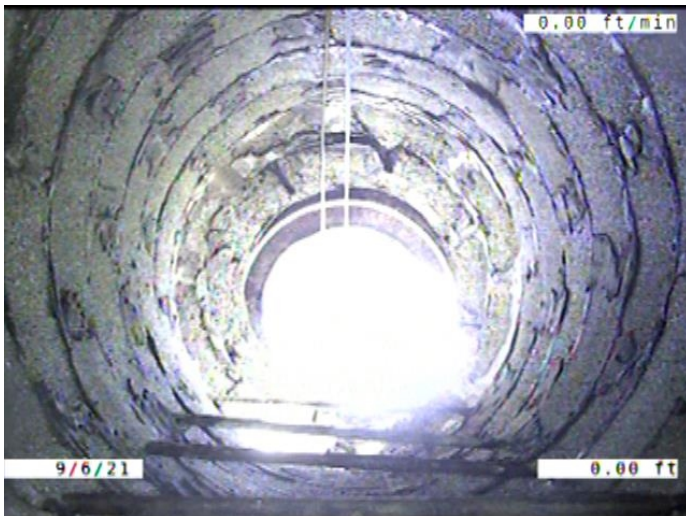
Code: **AMH**
Description: **Manhole**

Distance (ft): **.0**
Structural Grade: **0**
O&M Grade: **0**
Clock Start/From:
Clock To:
1st Value:
2nd Value:
Value Percent:
Continuous Index:
Within 8" of Joint: **NO**
Remarks: **M-504-118**

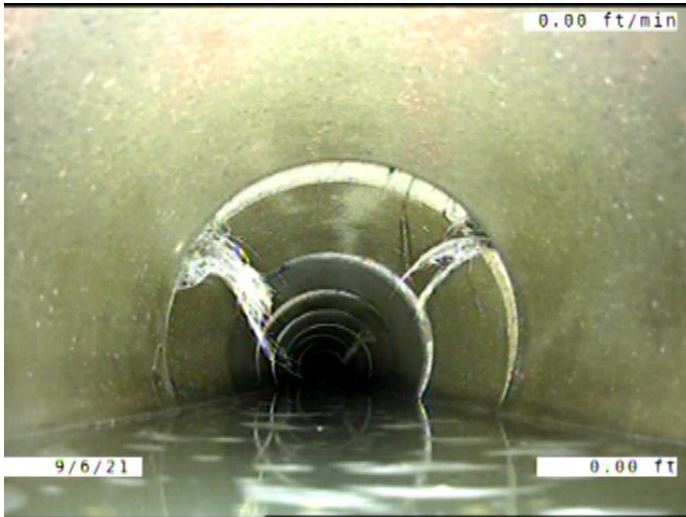
Code: **MWL**
Description: **Miscellaneous Water Level**

Distance (ft): **.0**
Structural Grade: **0**
O&M Grade: **0**
Clock Start/From:
Clock To:
1st Value:
2nd Value:
Value Percent: **10.000**
Continuous Index:
Within 8" of Joint: **NO**
Remarks:

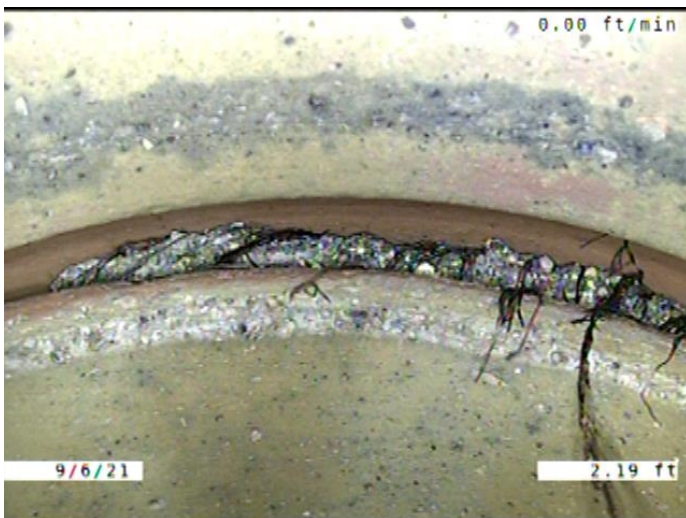
Code: **JOM**
Description: **Joint Offset Medium**

Distance (ft): **2.2**
Structural Grade: **3**
O&M Grade: **0**
Clock Start/From:
Clock To:
1st Value:
2nd Value:
Value Percent:
Continuous Index:
Within 8" of Joint: **NO**
Remarks:

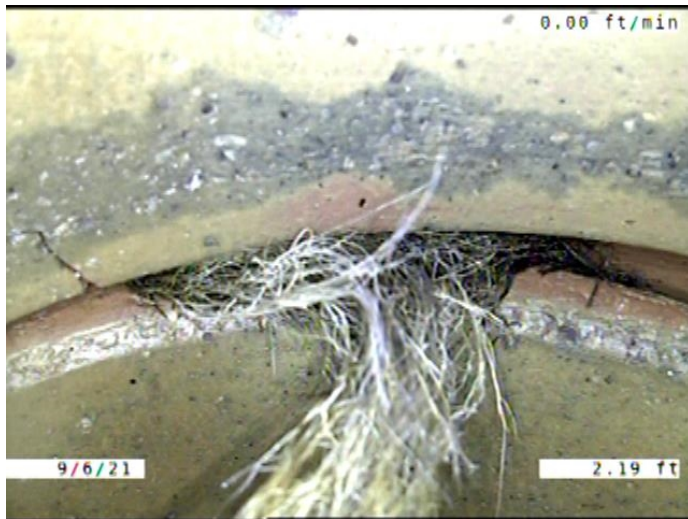
Code: **RFJ**
 Description: **Roots Fine Joint**

Distance (ft): **2.2**
 Structural Grade: **0**
 O&M Grade: **1**
 Clock Start/From: **10**
 Clock To: **3**
 1st Value:
 2nd Value:
 Value Percent:
 Continuous Index: **S01**
 Within 8" of Joint: **YES**
 Remarks:

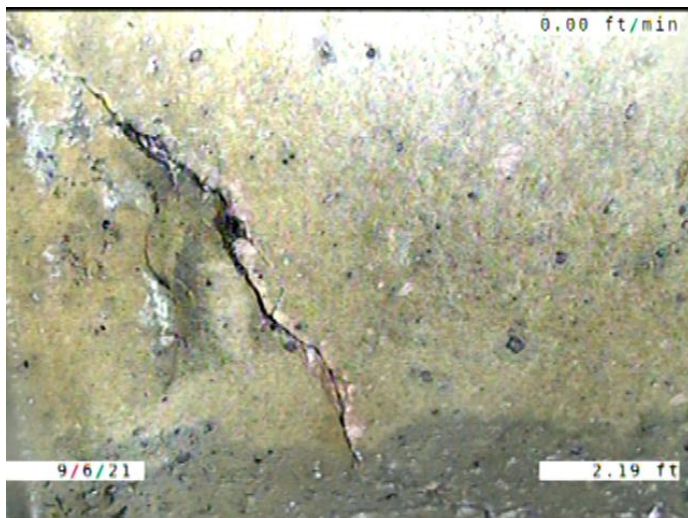
Code: **FM**
 Description: **Fracture Multiple**

Distance (ft): **2.2**
 Structural Grade: **4**
 O&M Grade: **0**
 Clock Start/From: **9**
 Clock To: **10**
 1st Value:
 2nd Value:
 Value Percent:
 Continuous Index:
 Within 8" of Joint: **YES**
 Remarks:

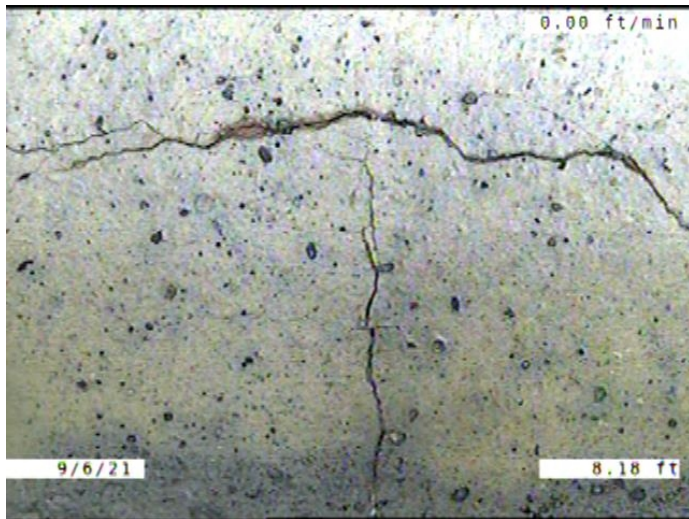
Code: **CM**
 Description: **Crack Multiple**

Distance (ft): **8.2**
 Structural Grade: **3**
 O&M Grade: **0**
 Clock Start/From: **12**
 Clock To: **3**
 1st Value:
 2nd Value:
 Value Percent:
 Continuous Index:
 Within 8" of Joint: **YES**
 Remarks:

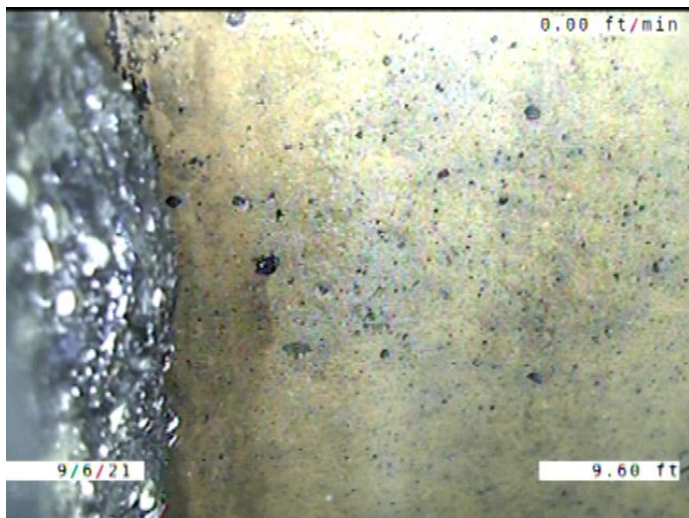
Code: **OBN**
 Description: **Obstruction Construction Debris**

Distance (ft): **9.6**
 Structural Grade: **0**
 O&M Grade: **2**
 Clock Start/From: **7**
 Clock To: **8**
 1st Value:
 2nd Value:
 Value Percent: **5.000**
 Continuous Index:
 Within 8" of Joint: **NO**
 Remarks:

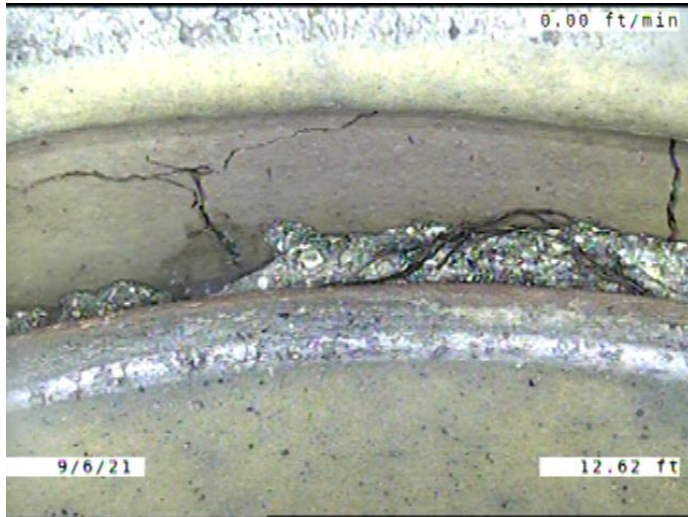
Code: **JOM**
 Description: **Joint Offset Medium**

Distance (ft): **12.6**
 Structural Grade: **3**
 O&M Grade: **0**
 Clock Start/From:
 Clock To:
 1st Value:
 2nd Value:
 Value Percent:
 Continuous Index:
 Within 8" of Joint: **NO**
 Remarks:

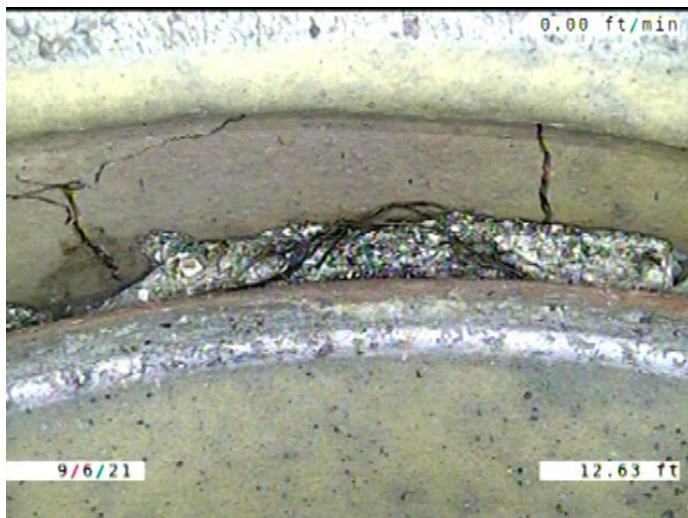
Code: **FM**
 Description: **Fracture Multiple**

Distance (ft): **12.6**
 Structural Grade: **4**
 O&M Grade: **0**
 Clock Start/From: **9**
 Clock To: **1**
 1st Value:
 2nd Value:
 Value Percent:
 Continuous Index:
 Within 8" of Joint: **YES**
 Remarks:

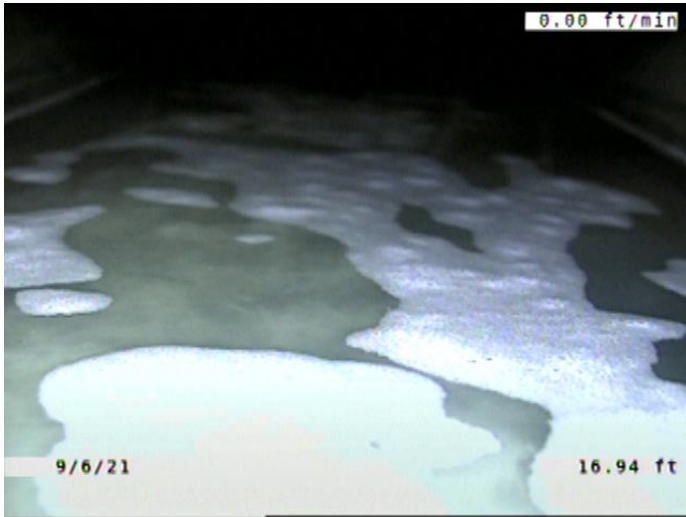
Code: **DSF**
 Description: **Deposits Settled Fine**

Distance (ft): **16.9**
 Structural Grade: **0**
 O&M Grade: **2**
 Clock Start/From: **5**
 Clock To: **7**
 1st Value:
 2nd Value:
 Value Percent: **5.000**
 Continuous Index: **S02**
 Within 8" of Joint: **YES**
 Remarks:

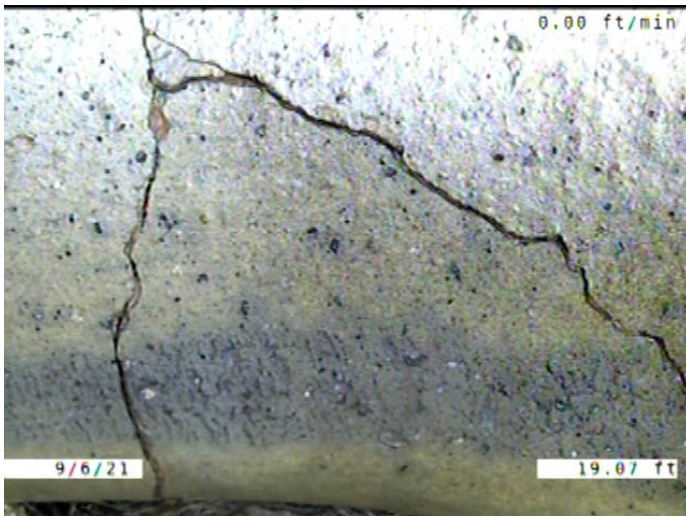
Code: **FM**
 Description: **Fracture Multiple**

Distance (ft): **19.1**
 Structural Grade: **4**
 O&M Grade: **0**
 Clock Start/From: **10**
 Clock To: **3**
 1st Value:
 2nd Value:
 Value Percent:
 Continuous Index:
 Within 8" of Joint: **YES**
 Remarks:

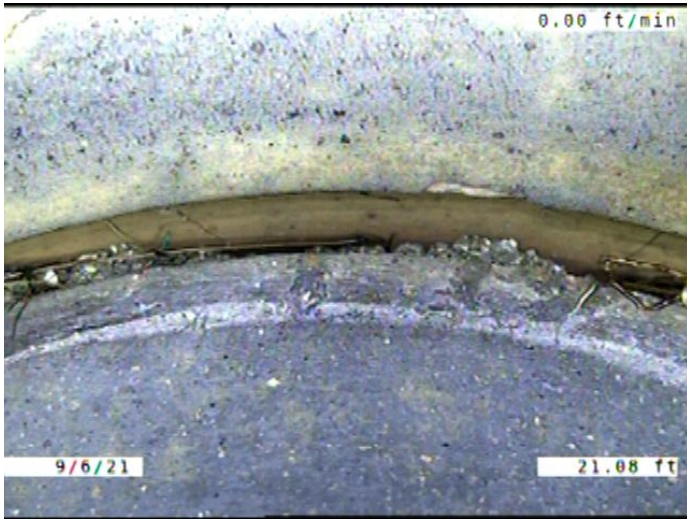
Code: **JOM**
 Description: **Joint Offset Medium**

Distance (ft): **21.1**
 Structural Grade: **3**
 O&M Grade: **0**
 Clock Start/From:
 Clock To:
 1st Value:
 2nd Value:
 Value Percent:
 Continuous Index:
 Within 8" of Joint: **NO**
 Remarks:

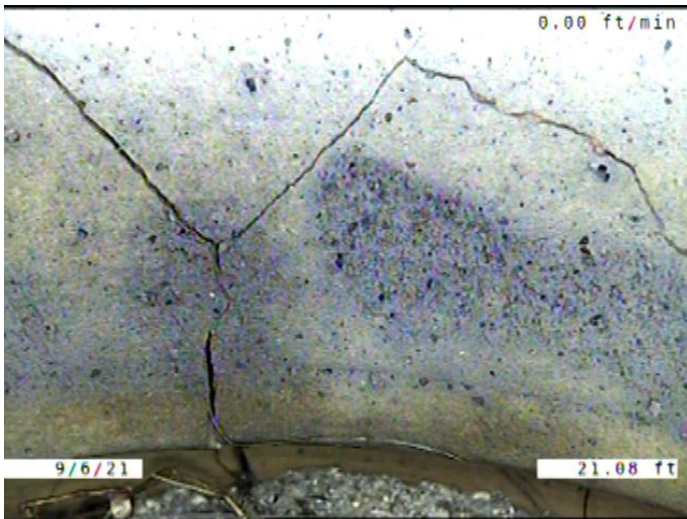
Code: **FM**
 Description: **Fracture Multiple**

Distance (ft): **21.1**
 Structural Grade: **4**
 O&M Grade: **0**
 Clock Start/From: **10**
 Clock To: **2**
 1st Value:
 2nd Value:
 Value Percent:
 Continuous Index:
 Within 8" of Joint: **YES**
 Remarks:

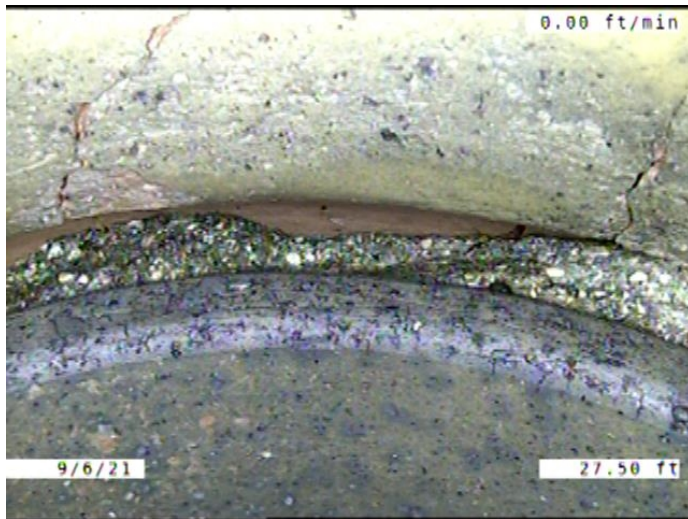
Code: **JOM**
 Description: **Joint Offset Medium**

Distance (ft): **27.5**
 Structural Grade: **3**
 O&M Grade: **0**
 Clock Start/From:
 Clock To:
 1st Value:
 2nd Value:
 Value Percent:
 Continuous Index:
 Within 8" of Joint: **NO**
 Remarks:

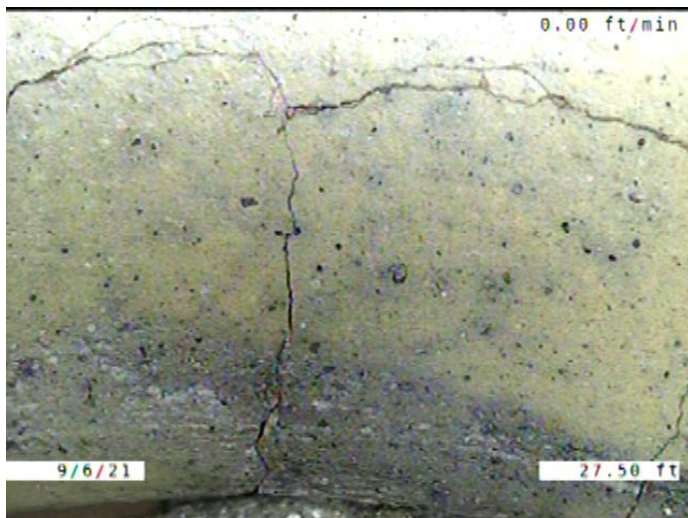
Code: **CM**
 Description: **Crack Multiple**

Distance (ft): **27.5**
 Structural Grade: **3**
 O&M Grade: **0**
 Clock Start/From: **12**
 Clock To: **4**
 1st Value:
 2nd Value:
 Value Percent:
 Continuous Index:
 Within 8" of Joint: **YES**
 Remarks:

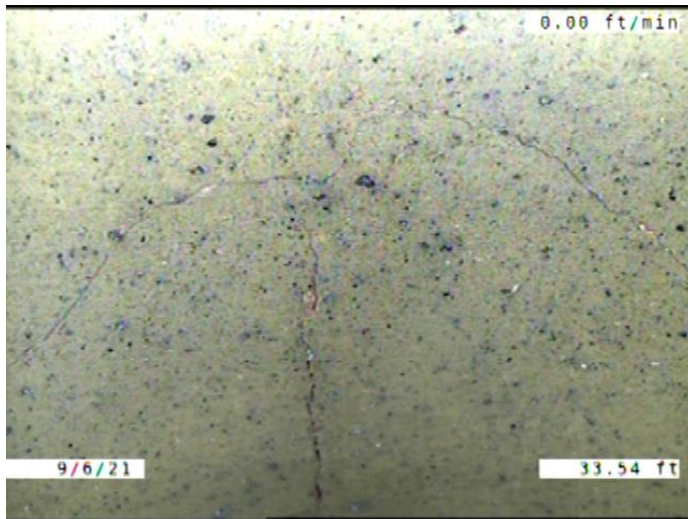
Code: **CM**
 Description: **Crack Multiple**

Distance (ft): **33.5**
 Structural Grade: **3**
 O&M Grade: **0**
 Clock Start/From: **8**
 Clock To: **1**
 1st Value:
 2nd Value:
 Value Percent:
 Continuous Index:
 Within 8" of Joint: **YES**
 Remarks:

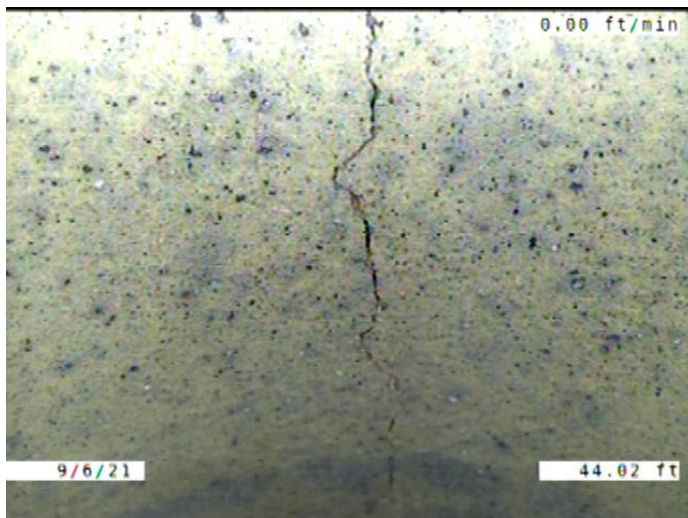
Code: **FL**
 Description: **Fracture Longitudinal**

Distance (ft): **44.0**
 Structural Grade: **3**
 O&M Grade: **0**
 Clock Start/From: **12**
 Clock To:
 1st Value:
 2nd Value:
 Value Percent:
 Continuous Index:
 Within 8" of Joint: **YES**
 Remarks:

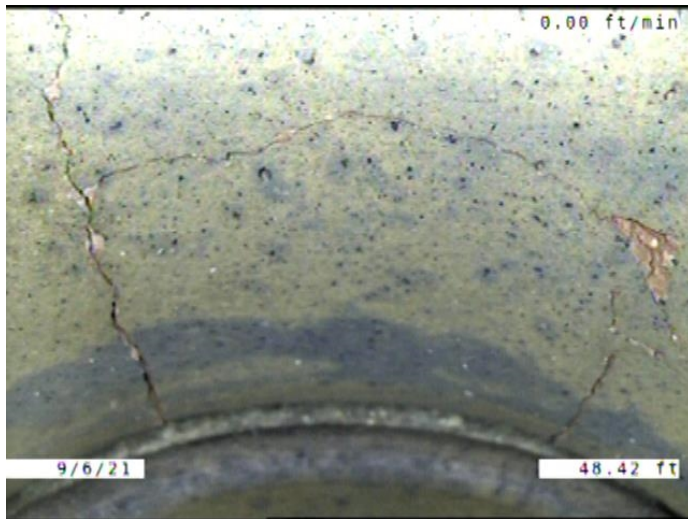
Code: **FM**
 Description: **Fracture Multiple**

Distance (ft): **48.4**
 Structural Grade: **4**
 O&M Grade: **0**
 Clock Start/From: **10**
 Clock To: **3**
 1st Value:
 2nd Value:
 Value Percent:
 Continuous Index: **S03**
 Within 8" of Joint: **YES**
 Remarks:

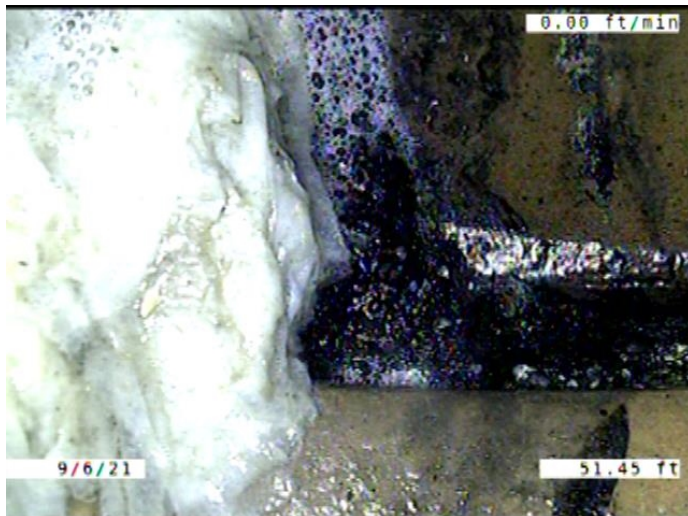
Code: **DAE**
 Description: **Deposits Attached Encrustation**

Distance (ft): **51.4**
 Structural Grade: **0**
 O&M Grade: **2**
 Clock Start/From: **4**
 Clock To: **8**
 1st Value:
 2nd Value:
 Value Percent: **5.000**
 Continuous Index:
 Within 8" of Joint: **YES**
 Remarks:

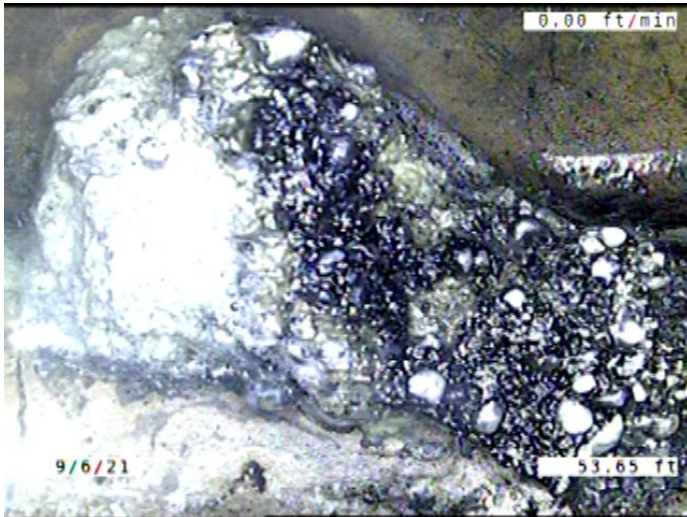
Code: **DAE**
 Description: **Deposits Attached Encrustation**

Distance (ft): **53.6**
 Structural Grade: **0**
 O&M Grade: **2**
 Clock Start/From: **4**
 Clock To: **9**
 1st Value:
 2nd Value:
 Value Percent: **5.000**
 Continuous Index:
 Within 8" of Joint: **YES**
 Remarks:

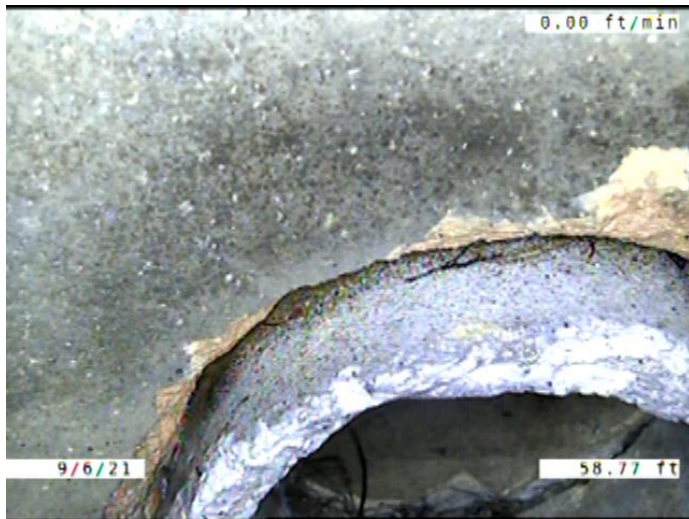
Code: **SSS**
 Description: **Surface Damage Surface Spalling**

Distance (ft): **58.8**
 Structural Grade: **2**
 O&M Grade: **0**
 Clock Start/From: **10**
 Clock To: **12**
 1st Value:
 2nd Value:
 Value Percent:
 Continuous Index:
 Within 8" of Joint: **YES**
 Remarks:

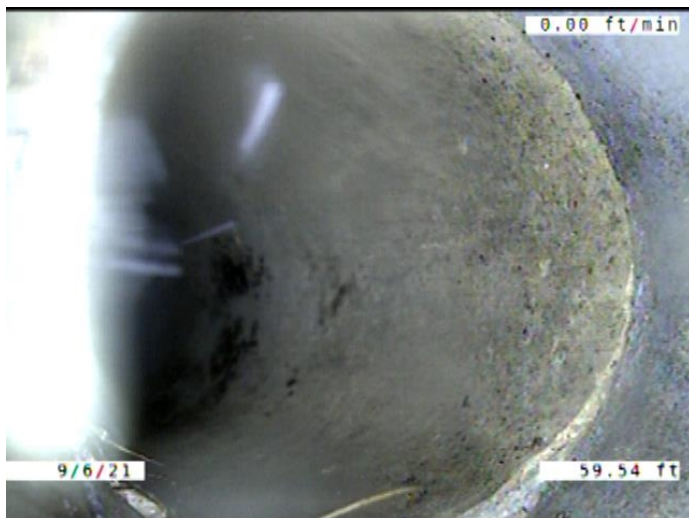
Code: **TBI**
 Description: **Tap Break-in Intruding**

Distance (ft): **59.5**
 Structural Grade: **0**
 O&M Grade: **2**
 Clock Start/From: **11**
 Clock To:
 1st Value: **6.000**
 2nd Value: **1.000**
 Value Percent:
 Continuous Index:
 Within 8" of Joint: **YES**
 Remarks: **CONSTANTLY RUNNING WATER**

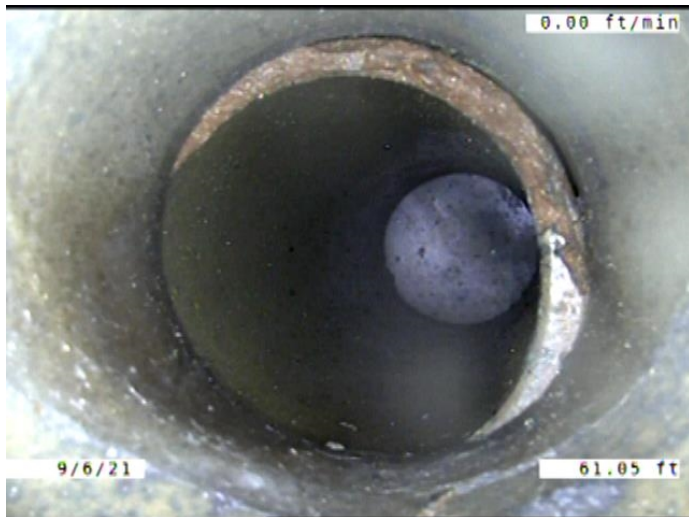
Code: **TFD**
Description: **Tap Factory Defective**

Distance (ft): **61.0**
Structural Grade: **0**
O&M Grade: **3**
Clock Start/From: **11**
Clock To:
1st Value: **6.000**
2nd Value:
Value Percent:
Continuous Index:
Within 8" of Joint: **YES**
Remarks: **CAPPED**

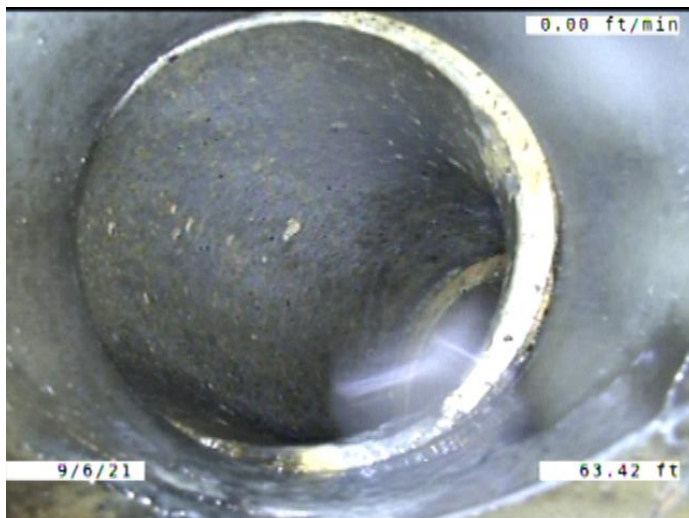
Code: **TFD**
Description: **Tap Factory Defective**

Distance (ft): **63.4**
Structural Grade: **0**
O&M Grade: **3**
Clock Start/From: **1**
Clock To:
1st Value: **6.000**
2nd Value:
Value Percent:
Continuous Index:
Within 8" of Joint: **YES**
Remarks: **CONSTANTLY RUNNING WATER**

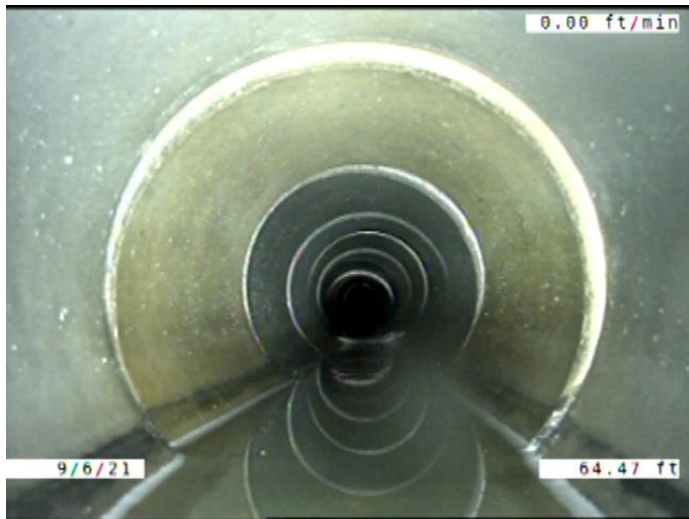
Code: **FM**
 Description: **Fracture Multiple**

Distance (ft): **64.5**
 Structural Grade: **4**
 O&M Grade: **0**
 Clock Start/From: **10**
 Clock To: **3**
 1st Value:
 2nd Value:
 Value Percent:
 Continuous Index: **F03**
 Within 8" of Joint: **YES**
 Remarks:

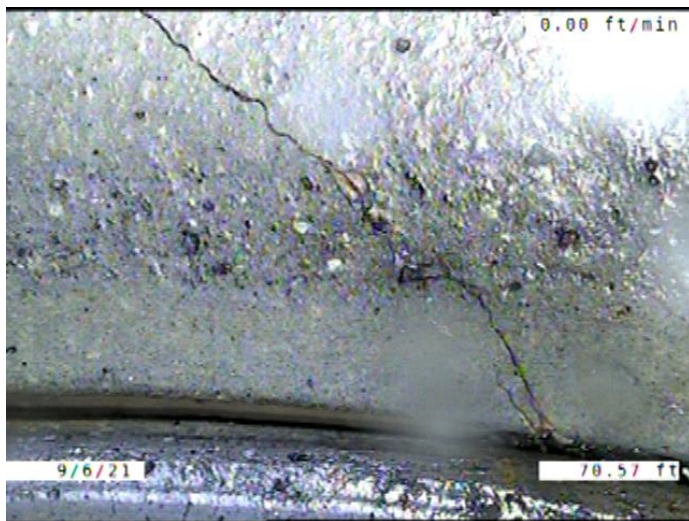
Code: **CS**
 Description: **Crack Spiral**

Distance (ft): **70.6**
 Structural Grade: **2**
 O&M Grade: **0**
 Clock Start/From: **2**
 Clock To: **4**
 1st Value:
 2nd Value:
 Value Percent:
 Continuous Index:
 Within 8" of Joint: **YES**
 Remarks:

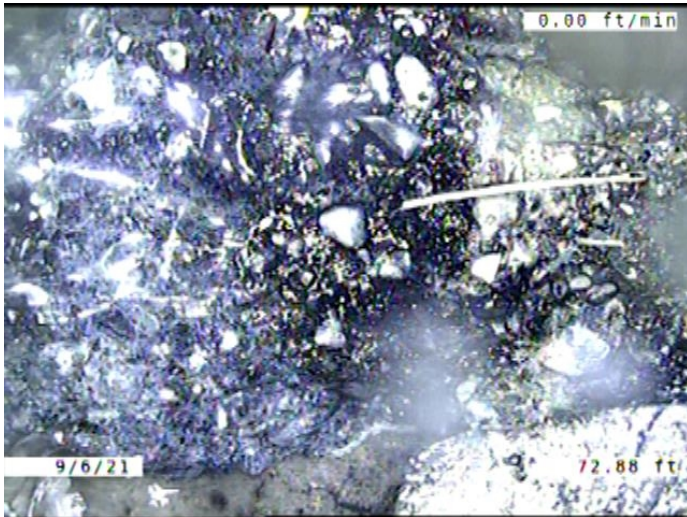
Code:	DAE
Description:	Deposits Attached Encrustation
Distance (ft):	72.9
Structural Grade:	0
O&M Grade:	2
Clock Start/From:	3
Clock To:	9
1st Value:	
2nd Value:	
Value Percent:	5.000
Continuous Index:	
Within 8" of Joint:	YES
Remarks:

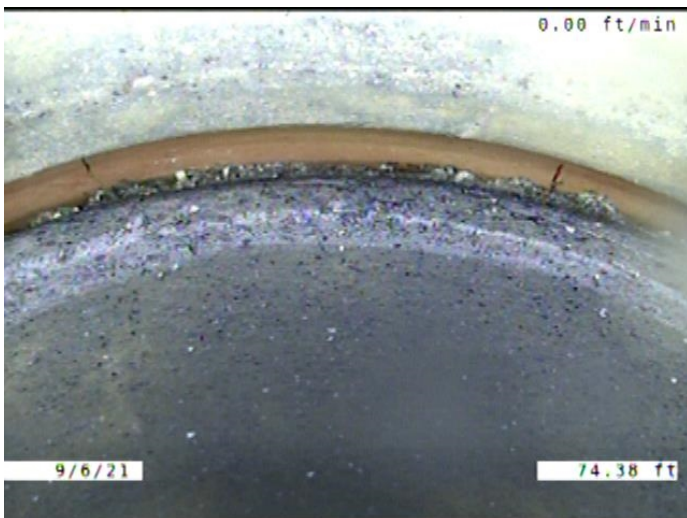
Code:	JOM
Description:	Joint Offset Medium
Distance (ft):	74.4
Structural Grade:	3
O&M Grade:	0
Clock Start/From:	
Clock To:	
1st Value:	
2nd Value:	
Value Percent:	
Continuous Index:	
Within 8" of Joint:	NO
Remarks:

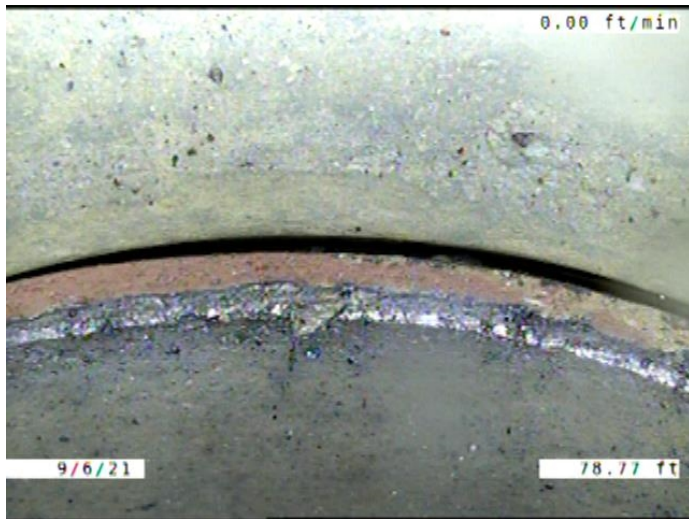
Code: **JOM**
 Description: **Joint Offset Medium**

Distance (ft): **78.8**
 Structural Grade: **3**
 O&M Grade: **0**
 Clock Start/From:
 Clock To:
 1st Value:
 2nd Value:
 Value Percent:
 Continuous Index:
 Within 8" of Joint: **NO**
 Remarks:

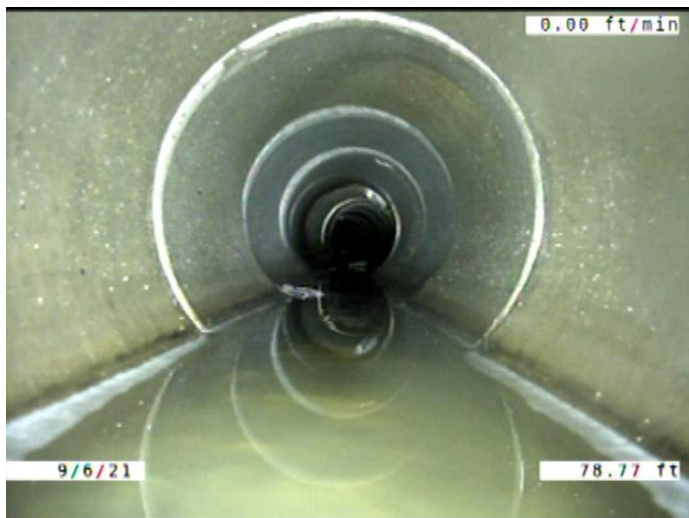
Code: **MWLS**
 Description: **Miscellaneous Water Level Sag**

Distance (ft): **78.8**
 Structural Grade: **2**
 O&M Grade: **0**
 Clock Start/From:
 Clock To:
 1st Value:
 2nd Value:
 Value Percent: **5.000**
 Continuous Index:
 Within 8" of Joint: **NO**
 Remarks:

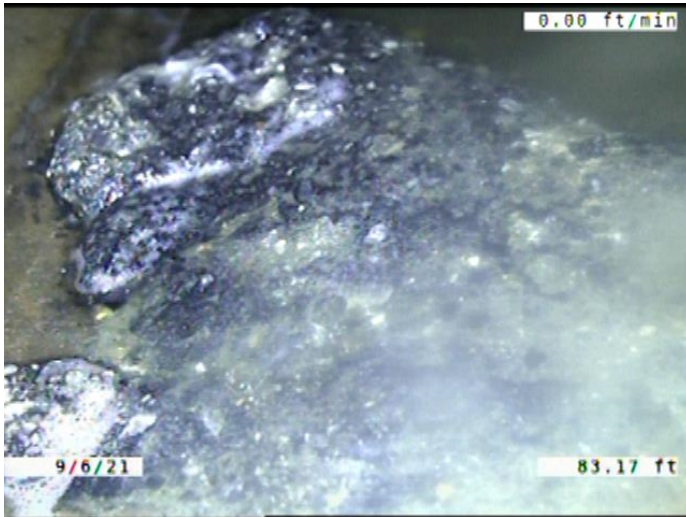
Code: **DAE**
 Description: **Deposits Attached Encrustation**

Distance (ft): **83.2**
 Structural Grade: **0**
 O&M Grade: **2**
 Clock Start/From: **4**
 Clock To: **8**
 1st Value:
 2nd Value:
 Value Percent: **5.000**
 Continuous Index:
 Within 8" of Joint: **YES**
 Remarks:

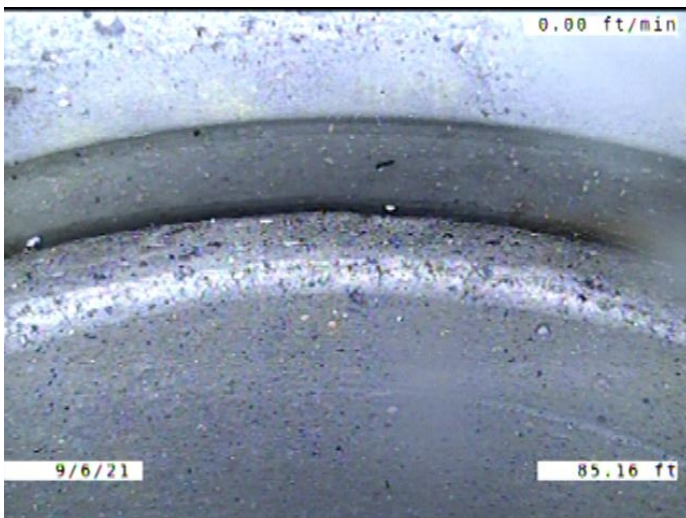
Code: **JOM**
 Description: **Joint Offset Medium**

Distance (ft): **85.2**
 Structural Grade: **3**
 O&M Grade: **0**
 Clock Start/From:
 Clock To:
 1st Value:
 2nd Value:
 Value Percent:
 Continuous Index:
 Within 8" of Joint: **NO**
 Remarks:

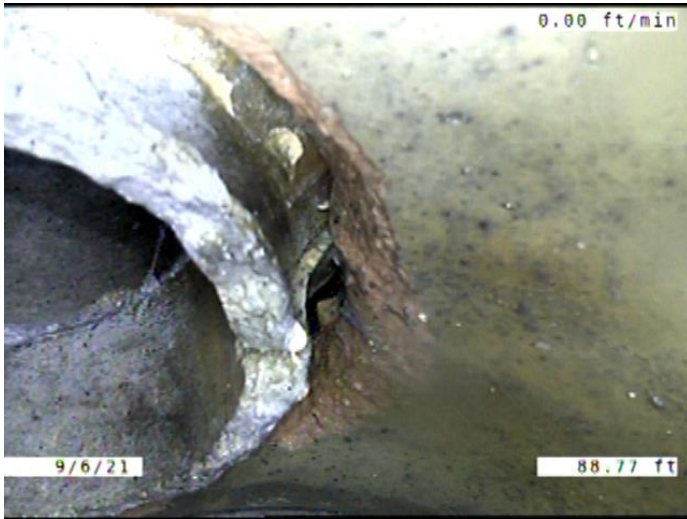
Code:	SSS
Description:	Surface Damage Surface Spalling
Distance (ft):	88.8
Structural Grade:	2
O&M Grade:	0
Clock Start/From:	12
Clock To:	2
1st Value:	
2nd Value:	
Value Percent:	
Continuous Index:	
Within 8" of Joint:	YES
Remarks:

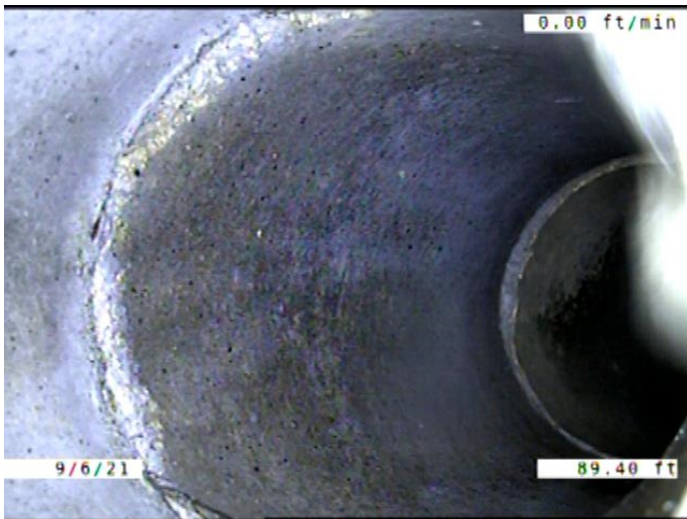
Code:	TBI
Description:	Tap Break-in Intruding
Distance (ft):	89.4
Structural Grade:	0
O&M Grade:	2
Clock Start/From:	1
Clock To:	
1st Value:	6.000
2nd Value:	2.000
Value Percent:	
Continuous Index:	
Within 8" of Joint:	YES
Remarks:

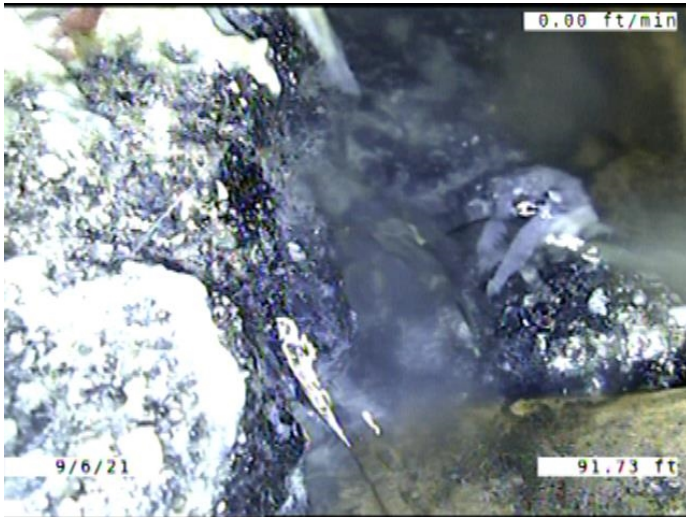
Code: **DAE**
 Description: **Deposits Attached Encrustation**

Distance (ft): **91.7**
 Structural Grade: **0**
 O&M Grade: **2**
 Clock Start/From: **4**
 Clock To: **7**
 1st Value:
 2nd Value:
 Value Percent: **5.000**
 Continuous Index:
 Within 8" of Joint: **YES**
 Remarks:

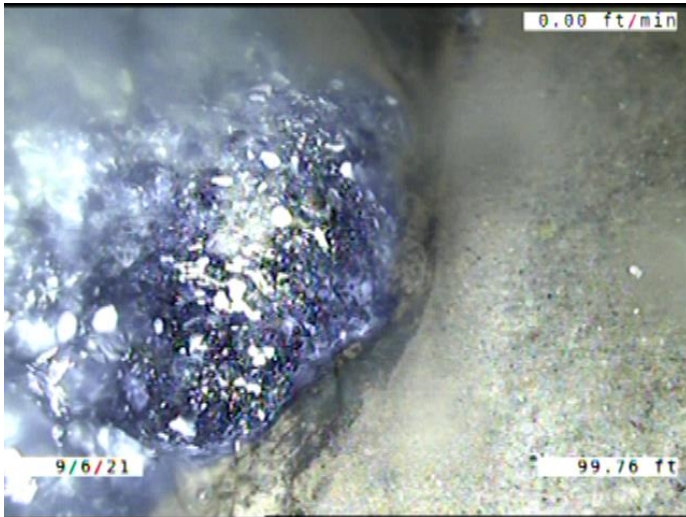
Code: **OBN**
 Description: **Obstruction Construction Debris**

Distance (ft): **99.8**
 Structural Grade: **0**
 O&M Grade: **2**
 Clock Start/From: **5**
 Clock To: **8**
 1st Value:
 2nd Value:
 Value Percent: **5.000**
 Continuous Index:
 Within 8" of Joint: **YES**
 Remarks:

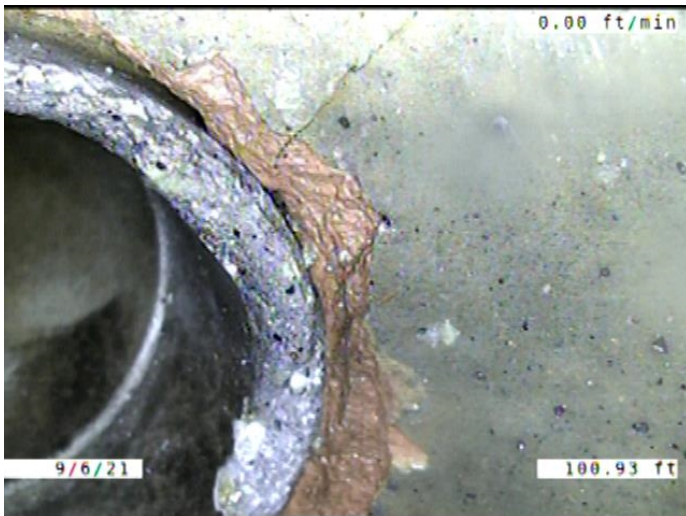
Code: **CM**
 Description: **Crack Multiple**

Distance (ft): **100.9**
 Structural Grade: **3**
 O&M Grade: **0**
 Clock Start/From: **11**
 Clock To: **1**
 1st Value:
 2nd Value:
 Value Percent:
 Continuous Index:
 Within 8" of Joint: **YES**
 Remarks:

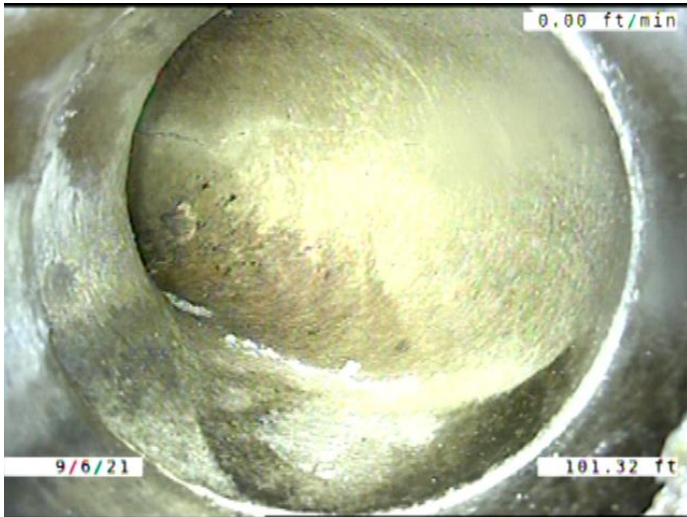
Code: **TBD**
 Description: **Tap Break-in/Hammer Defective**

Distance (ft): **101.3**
 Structural Grade: **0**
 O&M Grade: **3**
 Clock Start/From: **11**
 Clock To:
 1st Value: **6.000**
 2nd Value:
 Value Percent:
 Continuous Index:
 Within 8" of Joint: **YES**
 Remarks: **Defective**

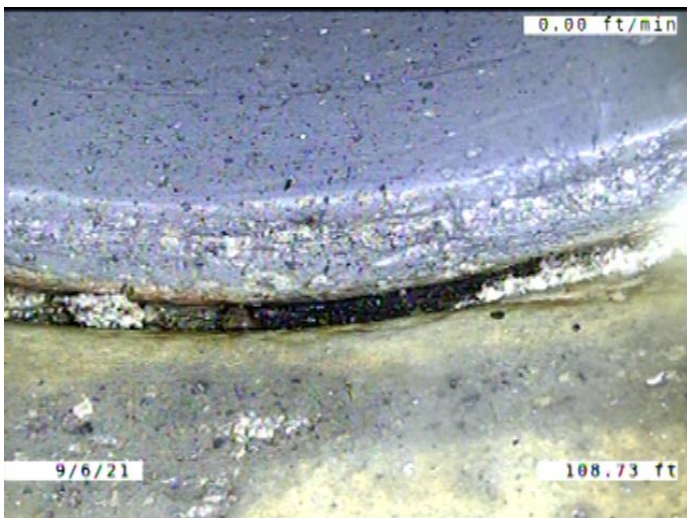
Code: **JOM**
 Description: **Joint Offset Medium**

Distance (ft): **108.7**
 Structural Grade: **3**
 O&M Grade: **0**
 Clock Start/From:
 Clock To:
 1st Value:
 2nd Value:
 Value Percent:
 Continuous Index:
 Within 8" of Joint: **NO**
 Remarks:

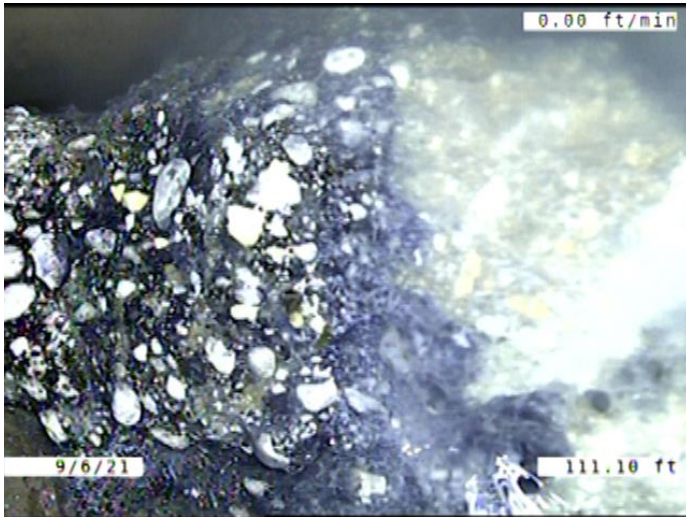
Code: **DAE**
Description: **Deposits Attached Encrustation**

Distance (ft): **111.1**
Structural Grade: **0**
O&M Grade: **2**
Clock Start/From: **3**
Clock To: **9**
1st Value:
2nd Value:
Value Percent: **5.000**
Continuous Index:
Within 8" of Joint: **YES**
Remarks:

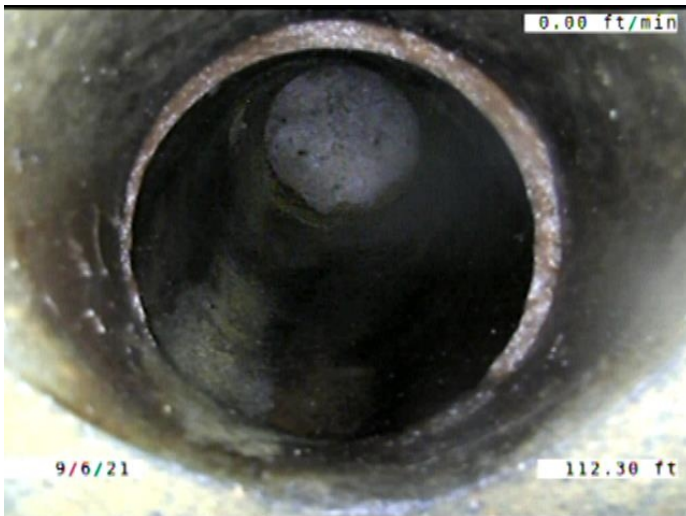
Code: **TFD**
Description: **Tap Factory Defective**

Distance (ft): **112.3**
Structural Grade: **0**
O&M Grade: **3**
Clock Start/From: **11**
Clock To:
1st Value: **6.000**
2nd Value:
Value Percent:
Continuous Index:
Within 8" of Joint: **YES**
Remarks: **CAPPED**

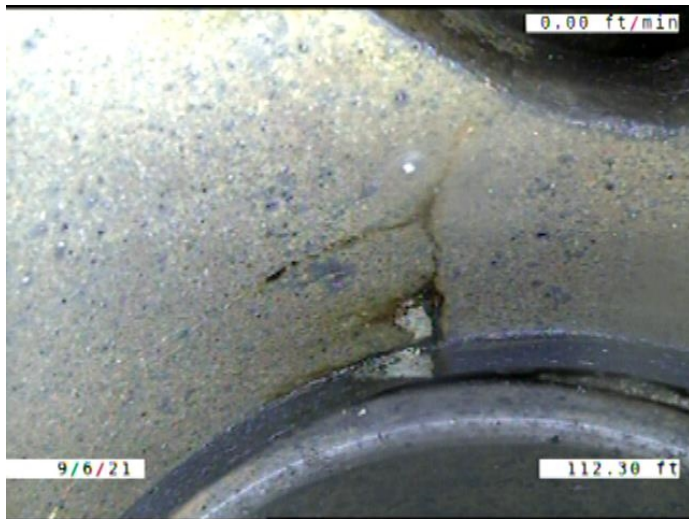
Code: **CM**
 Description: **Crack Multiple**

Distance (ft): **112.3**
 Structural Grade: **3**
 O&M Grade: **0**
 Clock Start/From: **10**
 Clock To: **11**
 1st Value:
 2nd Value:
 Value Percent:
 Continuous Index:
 Within 8" of Joint: **YES**
 Remarks:

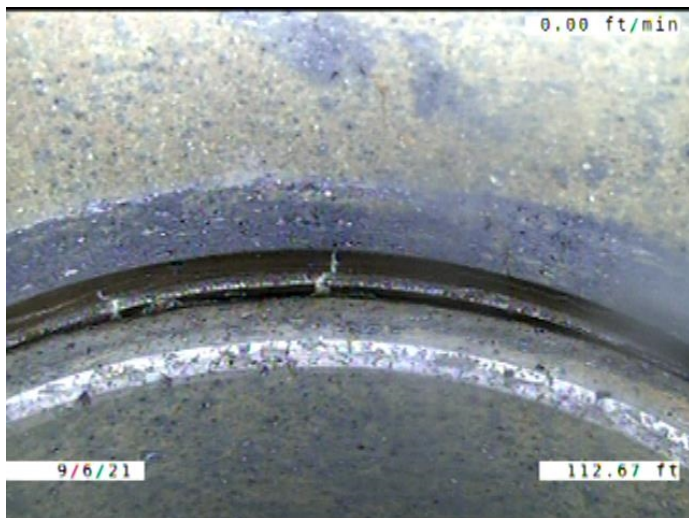
Code: **JOM**
 Description: **Joint Offset Medium**

Distance (ft): **112.7**
 Structural Grade: **3**
 O&M Grade: **0**
 Clock Start/From:
 Clock To:
 1st Value:
 2nd Value:
 Value Percent:
 Continuous Index:
 Within 8" of Joint: **NO**
 Remarks:

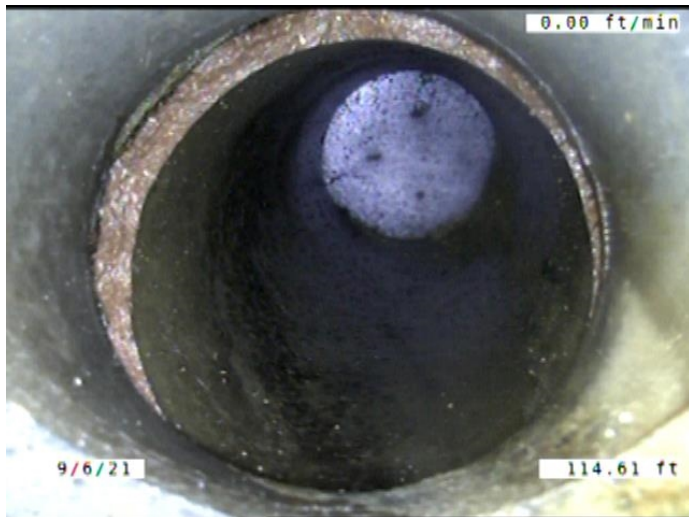
Code: **TFD**
 Description: **Tap Factory Defective**

Distance (ft): **114.6**
 Structural Grade: **0**
 O&M Grade: **3**
 Clock Start/From: **1**
 Clock To:
 1st Value: **6.000**
 2nd Value:
 Value Percent:
 Continuous Index:
 Within 8" of Joint: **YES**
 Remarks: **CAPPED**

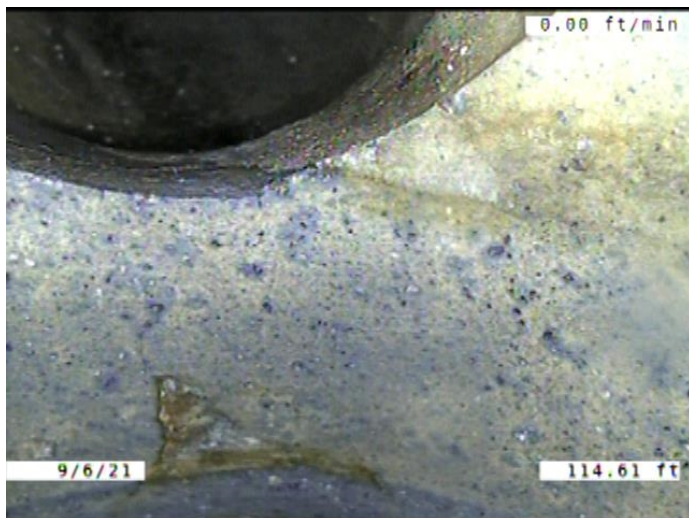
Code: **CM**
 Description: **Crack Multiple**

Distance (ft): **114.6**
 Structural Grade: **3**
 O&M Grade: **0**
 Clock Start/From: **1**
 Clock To: **3**
 1st Value:
 2nd Value:
 Value Percent:
 Continuous Index:
 Within 8" of Joint: **YES**
 Remarks:

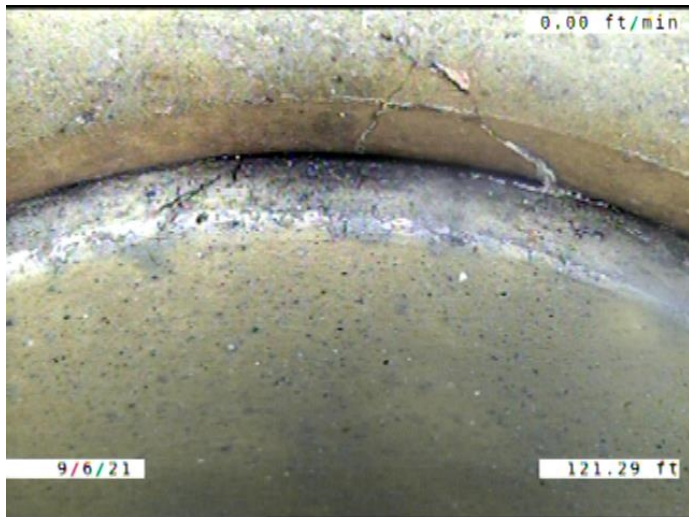
Code: **JOM**
 Description: **Joint Offset Medium**

Distance (ft): **121.3**
 Structural Grade: **3**
 O&M Grade: **0**
 Clock Start/From:
 Clock To:
 1st Value:
 2nd Value:
 Value Percent:
 Continuous Index:
 Within 8" of Joint: **NO**
 Remarks:

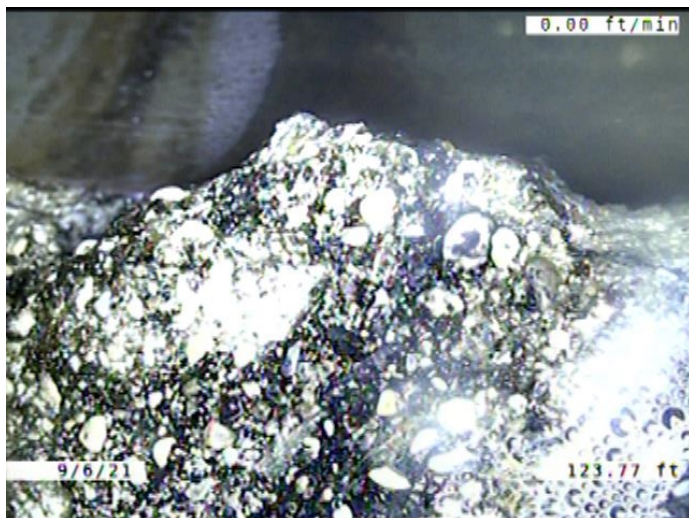
Code: **DAE**
 Description: **Deposits Attached Encrustation**

Distance (ft): **123.8**
 Structural Grade: **0**
 O&M Grade: **2**
 Clock Start/From: **4**
 Clock To: **8**
 1st Value:
 2nd Value:
 Value Percent: **5.000**
 Continuous Index:
 Within 8" of Joint: **YES**
 Remarks:

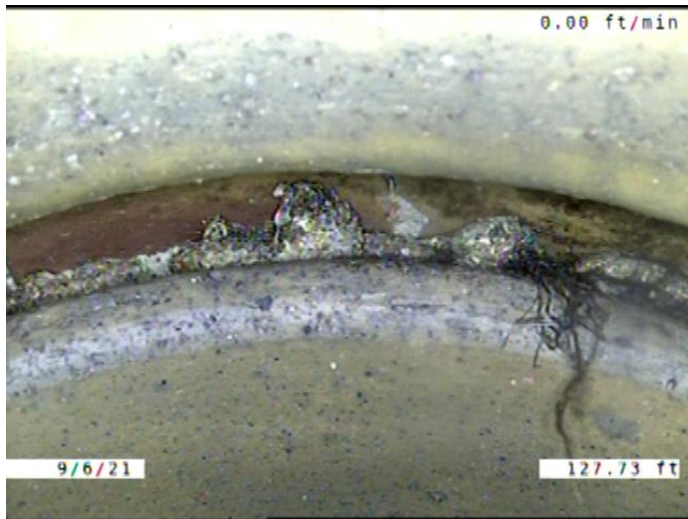
Code: **JOM**
 Description: **Joint Offset Medium**

Distance (ft): **127.7**
 Structural Grade: **3**
 O&M Grade: **0**
 Clock Start/From:
 Clock To:
 1st Value:
 2nd Value:
 Value Percent:
 Continuous Index:
 Within 8" of Joint: **NO**
 Remarks:

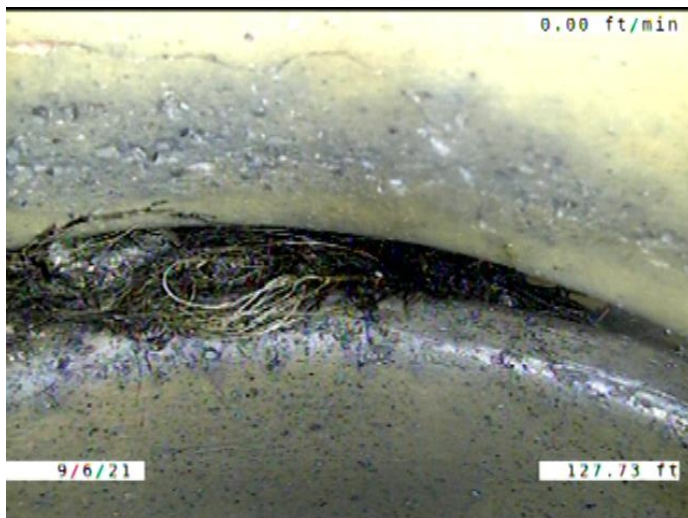
Code: **RFJ**
 Description: **Roots Fine Joint**

Distance (ft): **127.7**
 Structural Grade: **0**
 O&M Grade: **1**
 Clock Start/From: **12**
 Clock To: **3**
 1st Value:
 2nd Value:
 Value Percent:
 Continuous Index:
 Within 8" of Joint: **YES**
 Remarks:

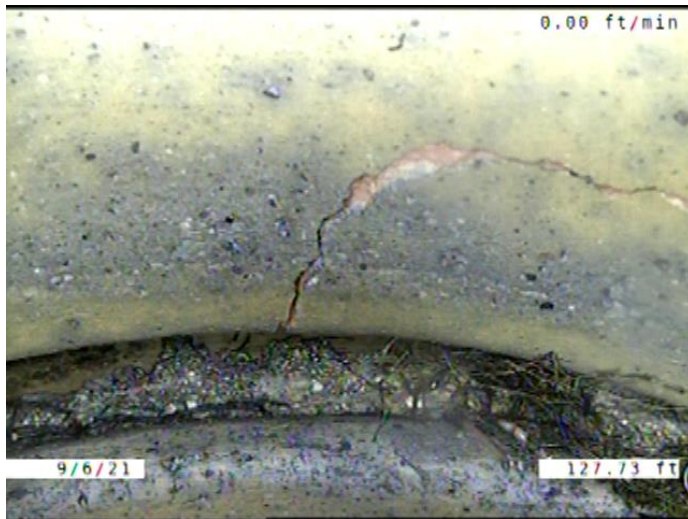
Code: **FS**
 Description: **Fracture Spiral**

Distance (ft): **127.7**
 Structural Grade: **3**
 O&M Grade: **0**
 Clock Start/From: **1**
 Clock To: **3**
 1st Value:
 2nd Value:
 Value Percent:
 Continuous Index:
 Within 8" of Joint: **YES**
 Remarks:

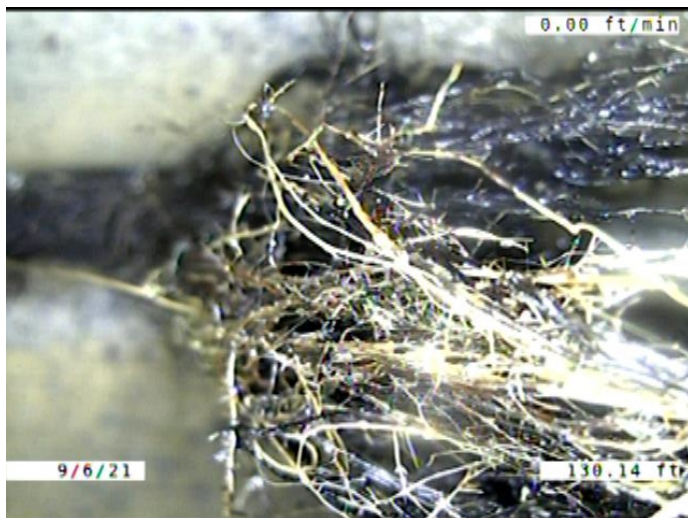
Code: **RMJ**
 Description: **Roots Medium Joint**

Distance (ft): **130.1**
 Structural Grade: **0**
 O&M Grade: **3**
 Clock Start/From: **8**
 Clock To: **4**
 1st Value:
 2nd Value:
 Value Percent: **5.000**
 Continuous Index: **S04**
 Within 8" of Joint: **YES**
 Remarks:

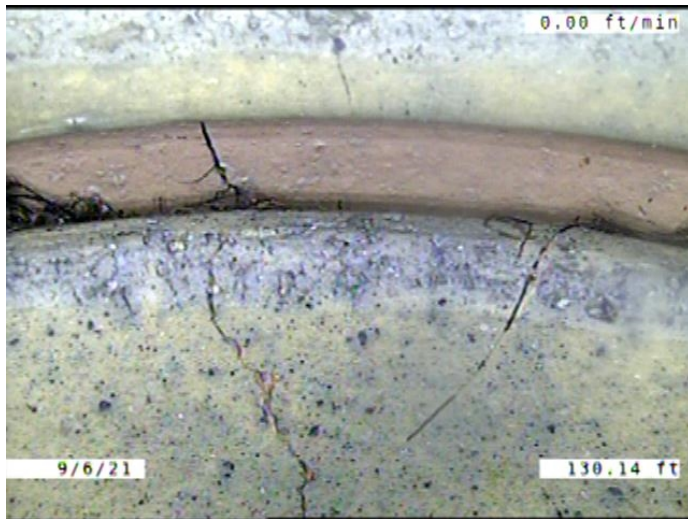
Code: **FM**
 Description: **Fracture Multiple**

Distance (ft): **130.1**
 Structural Grade: **4**
 O&M Grade: **0**
 Clock Start/From: **10**
 Clock To: **3**
 1st Value:
 2nd Value:
 Value Percent:
 Continuous Index: **S05**
 Within 8" of Joint: **YES**
 Remarks:

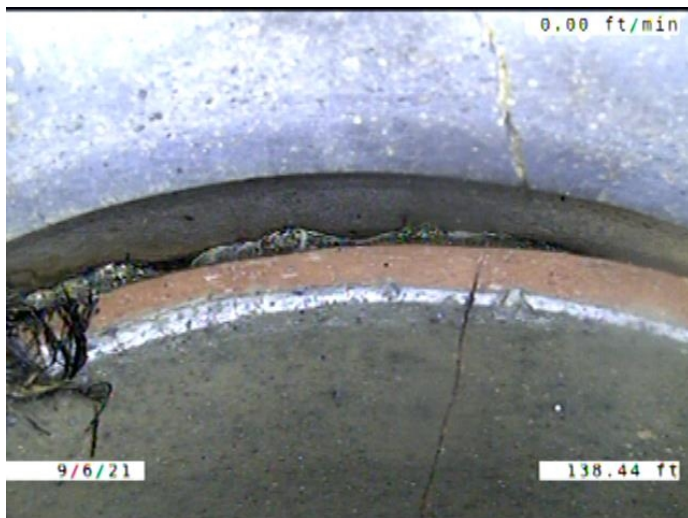
Code: **JOM**
 Description: **Joint Offset Medium**

Distance (ft): **138.4**
 Structural Grade: **3**
 O&M Grade: **0**
 Clock Start/From:
 Clock To:
 1st Value:
 2nd Value:
 Value Percent:
 Continuous Index:
 Within 8" of Joint: **NO**
 Remarks:
