Profile/Photo Observation Report

Date:	09/06/2021	Weather:		Coding:	PACP 7.0
Pipe Length (ft):	205.3	Owner:	City of Hobart	Pre Clean:	Heavy Cleaning
P.O.#:	YES502259	Surveyor:	S. Bucklin	PSR:	P-504-118-117
Customer:	City of Hobart	Clean Date:	09/03/2021	Shape:	C

Street:	42nd Avenue	Flow Control:	Not Controlled
City:	Hobart, IN	Year Renewed:	
Location:	Alley	Tape/Media #:	
Purpose:	Routine Assessment	Dia/Height:	12"
Use:	Sanitary Sewage Pipe	Material:	VCP
Drain Area:		Lining:	None
Category:	NA		
Comment:			
Location Details:		Direction of Survey:	Upstream
US MH:	M-504-117	DS MH:	M-504-118
		Total Length Surveyed (ft):	205.3

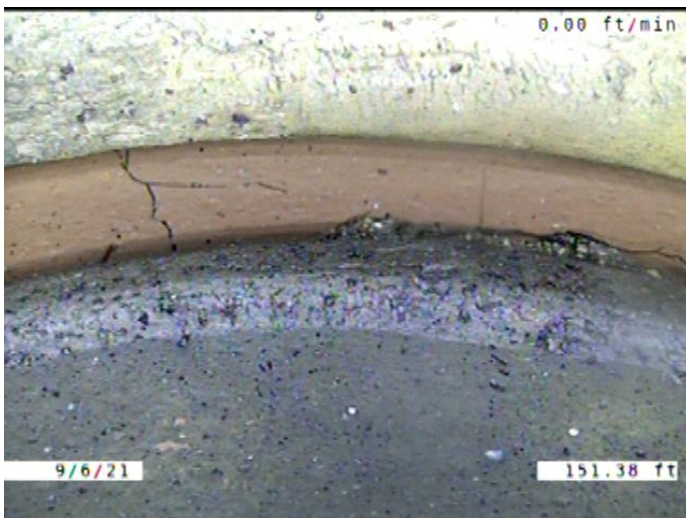
Code: **JOM**
 Description: **Joint Offset Medium**

Distance (ft): **151.4**
 Structural Grade: **3**
 O&M Grade: **0**
 Clock Start/From:
 Clock To:
 1st Value:
 2nd Value:
 Value Percent:
 Continuous Index:
 Within 8" of Joint: **NO**
 Remarks:

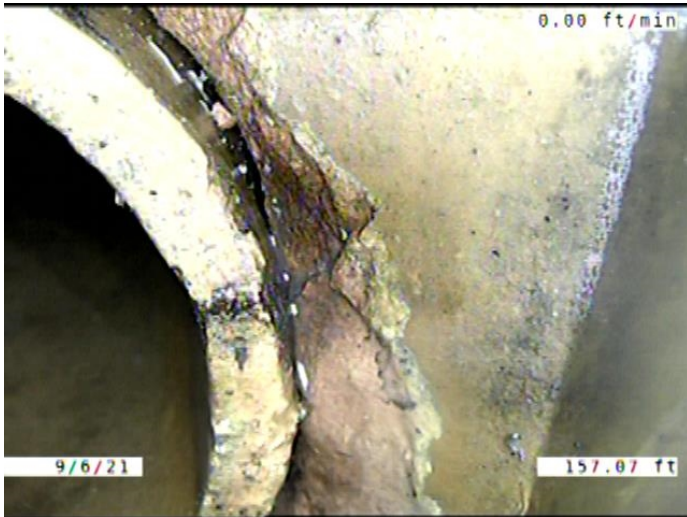
Code: **SSS**
 Description: **Surface Damage Surface Spalling**

Distance (ft): **157.1**
 Structural Grade: **2**
 O&M Grade: **0**
 Clock Start/From: **1**
 Clock To: **3**
 1st Value:
 2nd Value:
 Value Percent:
 Continuous Index:
 Within 8" of Joint: **YES**
 Remarks:

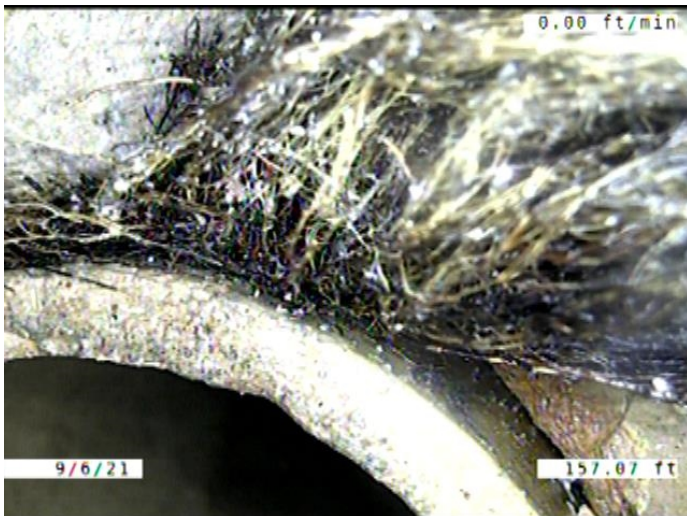
Code: **RML**
 Description: **Roots Medium Lateral**

Distance (ft): **157.1**
 Structural Grade: **0**
 O&M Grade: **3**
 Clock Start/From: **1**
 Clock To: **2**
 1st Value:
 2nd Value:
 Value Percent: **5.000**
 Continuous Index:
 Within 8" of Joint: **NO**
 Remarks:

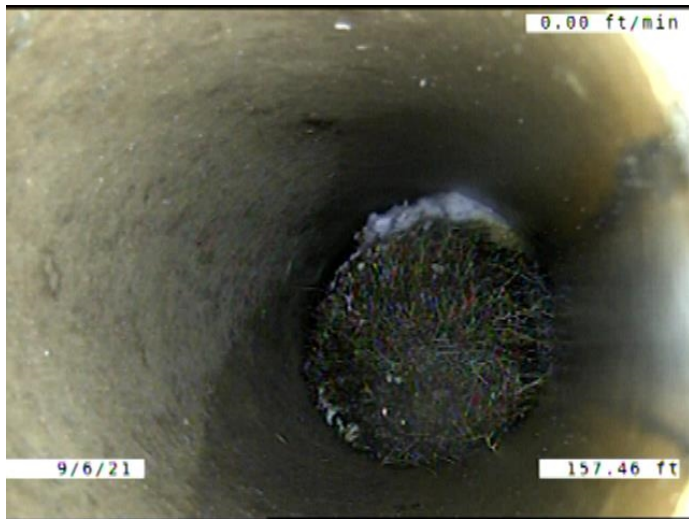
Code:	TBI
Description:	Tap Break-in Intruding
Distance (ft):	157.5
Structural Grade:	0
O&M Grade:	2
Clock Start/From:	2
Clock To:	
1st Value:	6.000
2nd Value:	1.000
Value Percent:	
Continuous Index:	
Within 8" of Joint:	YES
Remarks:	CONSTANTLY RUNNING WATER. TAP LOOKS TO BE 90%+ PLUGGED WITH

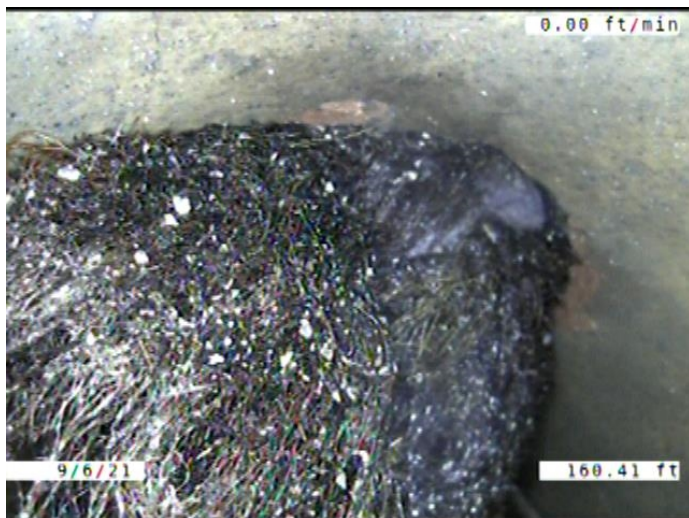
Code:	RML
Description:	Roots Medium Lateral
Distance (ft):	160.4
Structural Grade:	0
O&M Grade:	3
Clock Start/From:	9
Clock To:	12
1st Value:	
2nd Value:	
Value Percent:	40.000
Continuous Index:	
Within 8" of Joint:	NO
Remarks:

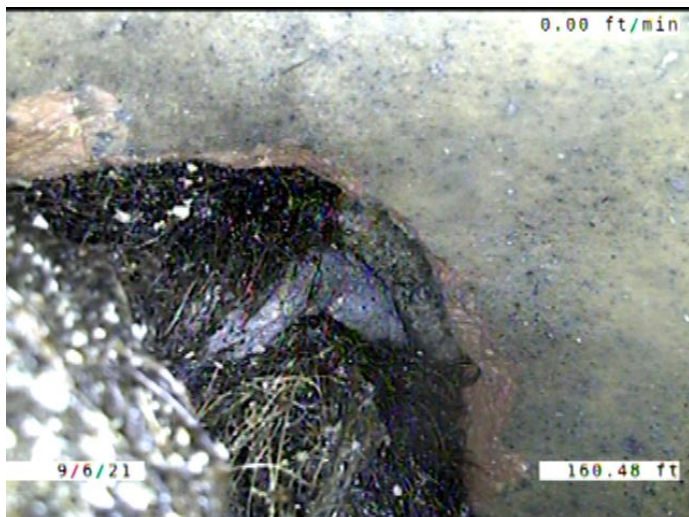
Code: **SSS**
 Description: **Surface Damage Surface Spalling**

Distance (ft): **160.5**
 Structural Grade: **2**
 O&M Grade: **0**
 Clock Start/From: **10**
 Clock To: **12**
 1st Value:
 2nd Value:
 Value Percent:
 Continuous Index:
 Within 8" of Joint: **YES**
 Remarks:

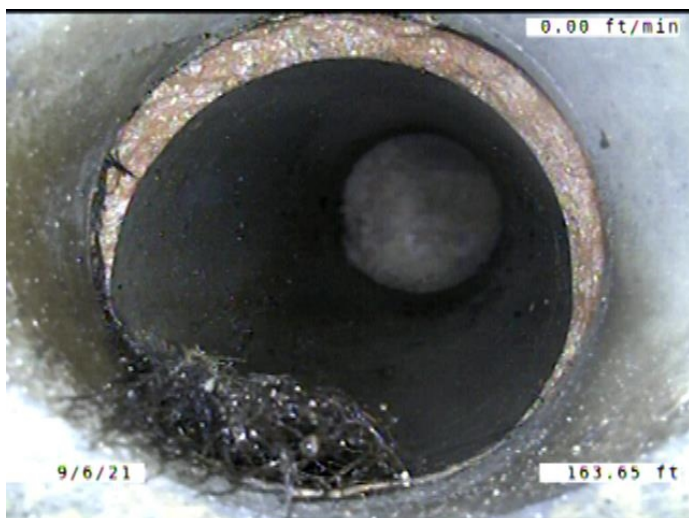
Code: **TFD**
 Description: **Tap Factory Defective**

Distance (ft): **163.7**
 Structural Grade: **0**
 O&M Grade: **3**
 Clock Start/From: **11**
 Clock To:
 1st Value: **6.000**
 2nd Value:
 Value Percent:
 Continuous Index:
 Within 8" of Joint: **YES**
 Remarks: **ROOTS GROWING IN THE JOINT**

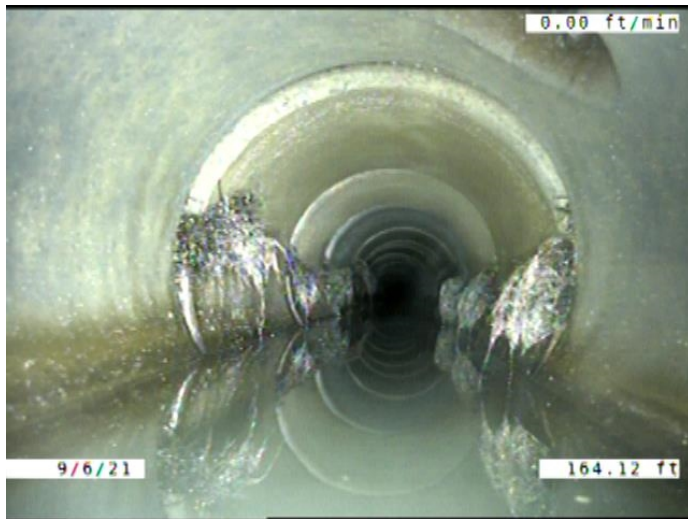
Code: **FM**
 Description: **Fracture Multiple**

Distance (ft): **164.1**
 Structural Grade: **4**
 O&M Grade: **0**
 Clock Start/From: **10**
 Clock To: **3**
 1st Value:
 2nd Value:
 Value Percent:
 Continuous Index: **F05**
 Within 8" of Joint: **YES**
 Remarks:

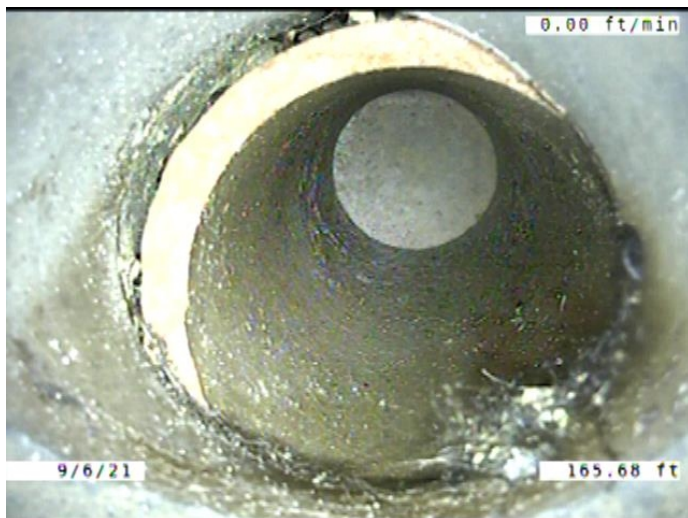
Code: **TFD**
 Description: **Tap Factory Defective**

Distance (ft): **165.7**
 Structural Grade: **0**
 O&M Grade: **3**
 Clock Start/From: **1**
 Clock To:
 1st Value: **6.000**
 2nd Value:
 Value Percent:
 Continuous Index:
 Within 8" of Joint: **YES**
 Remarks: **CAPPED. ROOTS GROWING IN THE JOINT**

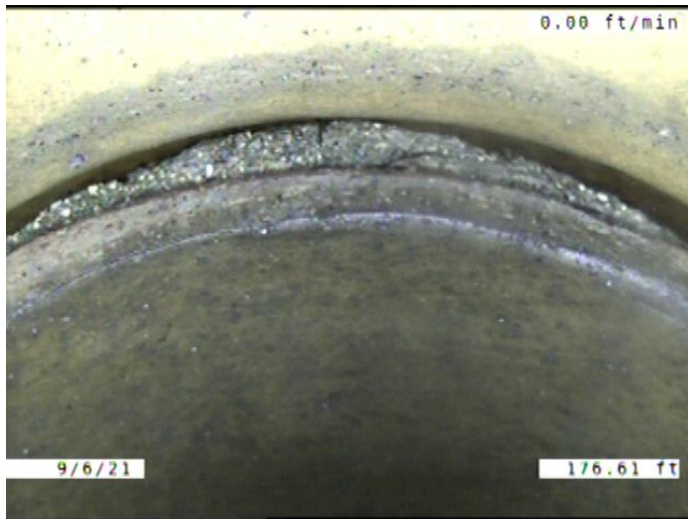
Code: **JOM**
 Description: **Joint Offset Medium**

Distance (ft): **176.6**
 Structural Grade: **3**
 O&M Grade: **0**
 Clock Start/From:
 Clock To:
 1st Value:
 2nd Value:
 Value Percent:
 Continuous Index:
 Within 8" of Joint: **NO**
 Remarks:

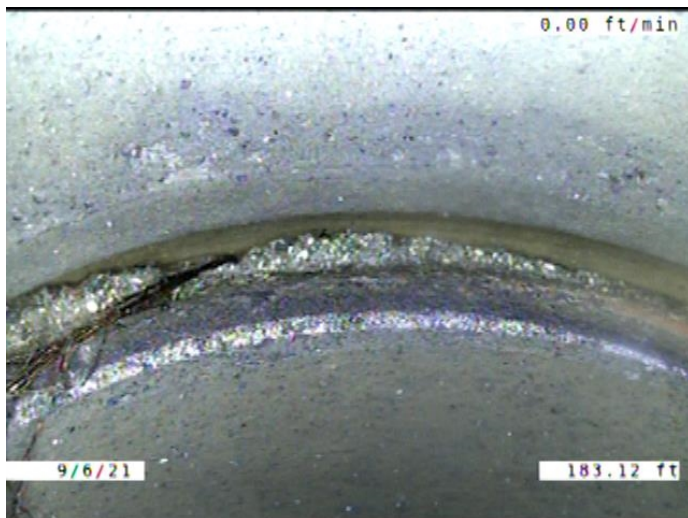
Code: **JOM**
 Description: **Joint Offset Medium**

Distance (ft): **183.1**
 Structural Grade: **3**
 O&M Grade: **0**
 Clock Start/From:
 Clock To:
 1st Value:
 2nd Value:
 Value Percent:
 Continuous Index:
 Within 8" of Joint: **NO**
 Remarks:

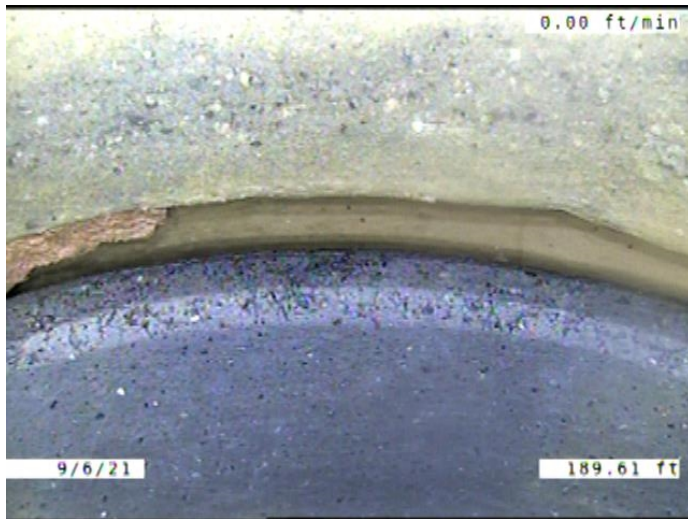
Code: **JOM**
 Description: **Joint Offset Medium**

Distance (ft): **189.6**
 Structural Grade: **3**
 O&M Grade: **0**
 Clock Start/From:
 Clock To:
 1st Value:
 2nd Value:
 Value Percent:
 Continuous Index:
 Within 8" of Joint: **NO**
 Remarks:

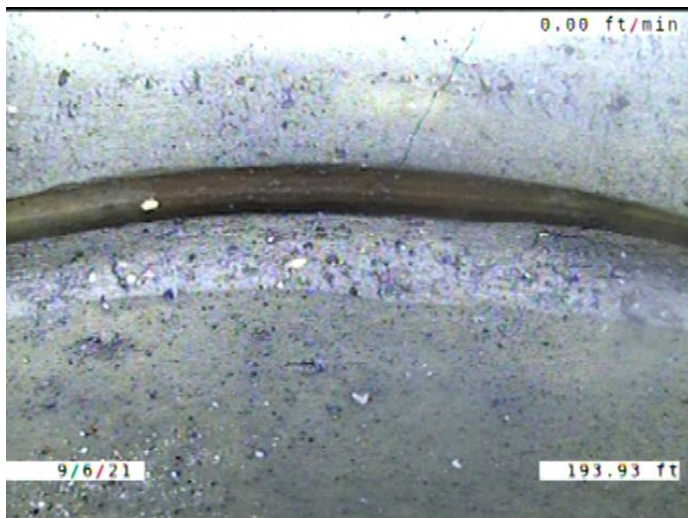
Code: **JOM**
 Description: **Joint Offset Medium**

Distance (ft): **193.9**
 Structural Grade: **3**
 O&M Grade: **0**
 Clock Start/From:
 Clock To:
 1st Value:
 2nd Value:
 Value Percent:
 Continuous Index:
 Within 8" of Joint: **NO**
 Remarks:

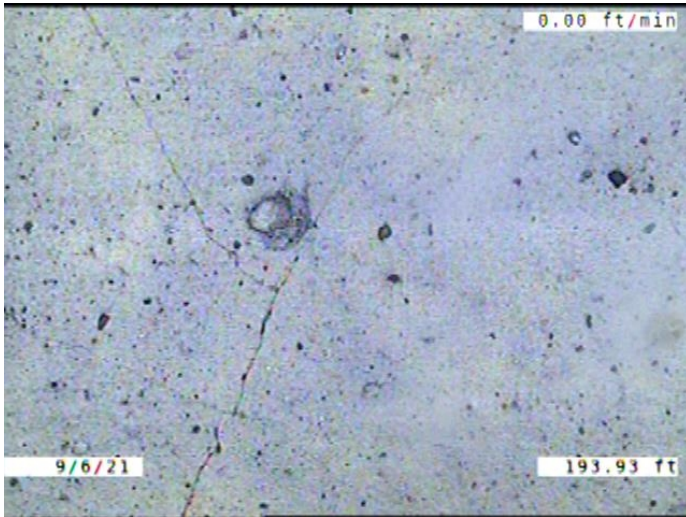
Code: **FM**
 Description: **Fracture Multiple**

Distance (ft): **193.9**
 Structural Grade: **4**
 O&M Grade: **0**
 Clock Start/From: **10**
 Clock To: **3**
 1st Value:
 2nd Value:
 Value Percent:
 Continuous Index: **S06**
 Within 8" of Joint: **YES**
 Remarks:

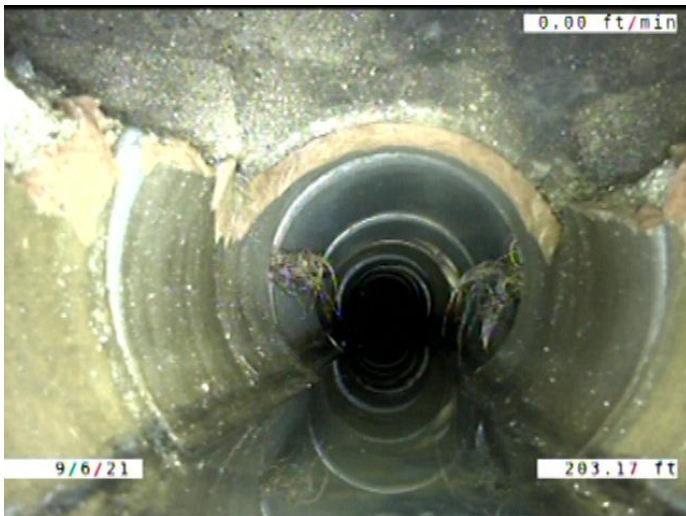
Code: **FM**
 Description: **Fracture Multiple**

Distance (ft): **203.2**
 Structural Grade: **4**
 O&M Grade: **0**
 Clock Start/From: **10**
 Clock To: **3**
 1st Value:
 2nd Value:
 Value Percent:
 Continuous Index: **F06**
 Within 8" of Joint: **YES**
 Remarks:

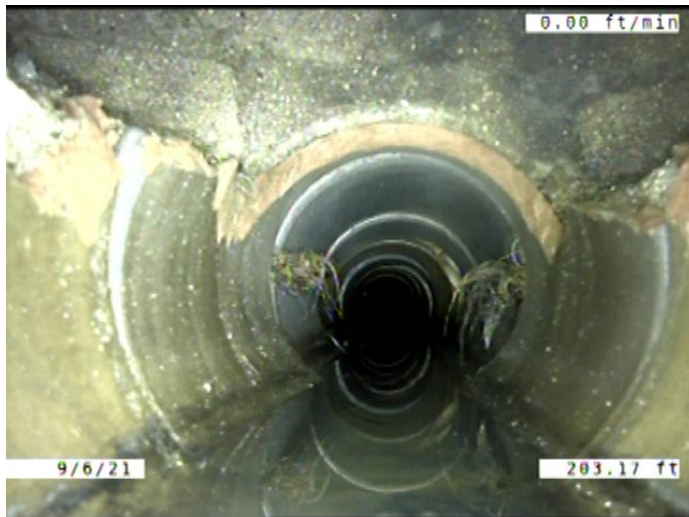
Code: **RMJ**
 Description: **Roots Medium Joint**

Distance (ft): **203.2**
 Structural Grade: **0**
 O&M Grade: **3**
 Clock Start/From: **8**
 Clock To: **4**
 1st Value:
 2nd Value:
 Value Percent: **5.000**
 Continuous Index: **F04**
 Within 8" of Joint: **YES**
 Remarks:

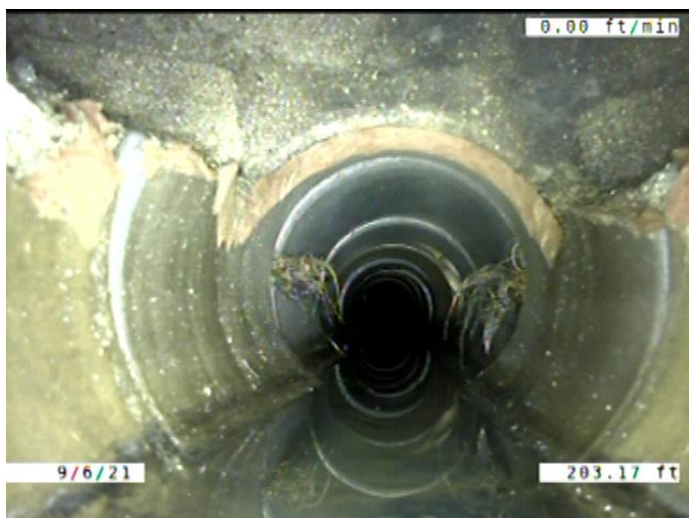
Code: **DSF**
 Description: **Deposits Settled Fine**

Distance (ft): **203.2**
 Structural Grade: **0**
 O&M Grade: **2**
 Clock Start/From: **5**
 Clock To: **7**
 1st Value:
 2nd Value:
 Value Percent: **5.000**
 Continuous Index: **F02**
 Within 8" of Joint: **YES**
 Remarks:
