Profile/Photo Observation Report

Date:	04/17/2018	Weather:		Coding:	PACP 6.0
Pipe Length (ft):	202.7	Owner:	NA	Pre Clean:	Not Known
P.O.#:		Surveyor:	Jen Costello	PSR:	P-504-119-118
Customer:		Clean Date:	01/01/1900	Shape:	C

Street:	ALLEY BETWEEN N COLORADO ST &	Flow Control:	Not Controlled
City:	Hobart, IN	Year Renewed:	
Location:	Light Highway	Tape/Media #:	
Purpose:	Not Known	Dia/Height:	12"
Use:	Sanitary	Material:	VCP
Drain Area:	NA	Lining:	
Category:	NA		
Comment:

Location Details:		Direction of Survey:	Downstream
US MH:	M-504-118	DS MH:	M-504-119
		Total Length Surveyed (ft):	15.1

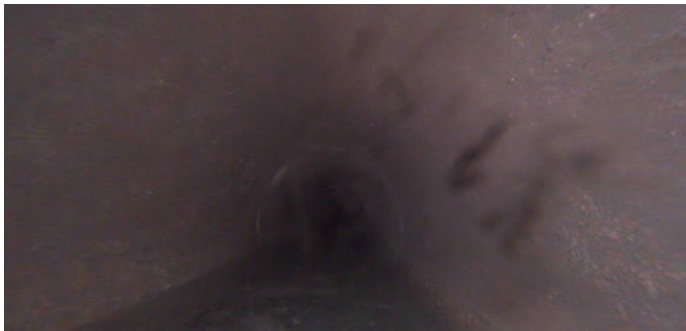
Code: **AMH**
Description: **Manhole**

Distance (ft): **.0**
Structural Grade: **0**
O&M Grade: **0**
Clock Start/From:
Clock To:
1st Value:
2nd Value:
Value Percent:
Continuous Index:
Within 8" of Joint: **NO**
Remarks: **M-504-118**

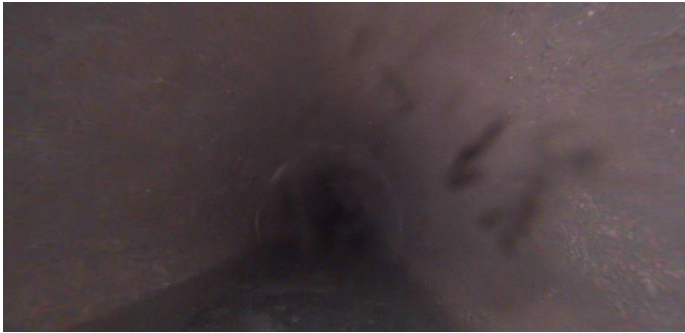
Code:	MWL
Description:	Water Level

Distance (ft):	.0
Structural Grade:	0
O&M Grade:	0
Clock Start/From:	
Clock To:	
1st Value:	
2nd Value:	
Value Percent:	10.000
Continuous Index:	
Within 8" of Joint:	NO
Remarks:

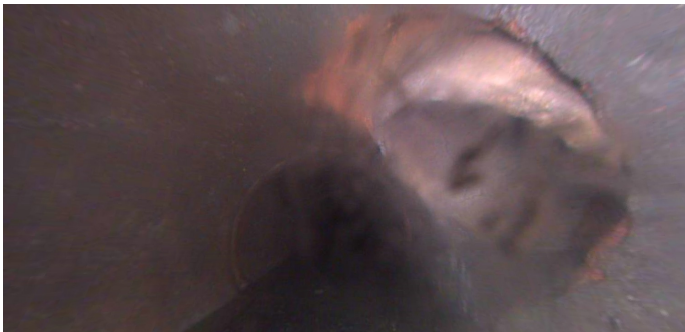
Code:	TBI
Description:	Tap Break-in Intruding

Distance (ft):	2.5
Structural Grade:	0
O&M Grade:	2
Clock Start/From:	1
Clock To:	
1st Value:	4.000
2nd Value:	1.000
Value Percent:	
Continuous Index:	
Within 8" of Joint:	
Remarks:

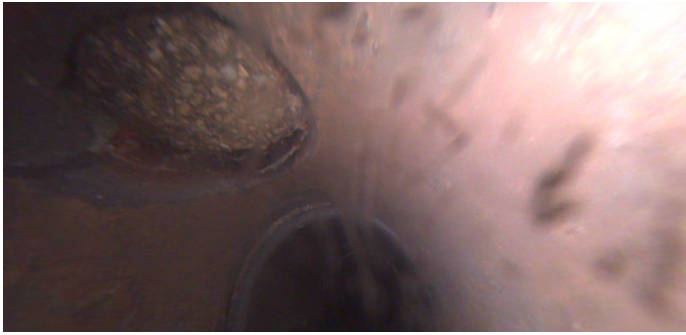
Code: **TFC**
Description: **Tap Factory Capped**

Distance (ft): **4.6**
Structural Grade: **0**
O&M Grade: **0**
Clock Start/From: **11**
Clock To:
1st Value: **4.000**
2nd Value:
Value Percent:
Continuous Index:
Within 8" of Joint:
Remarks:

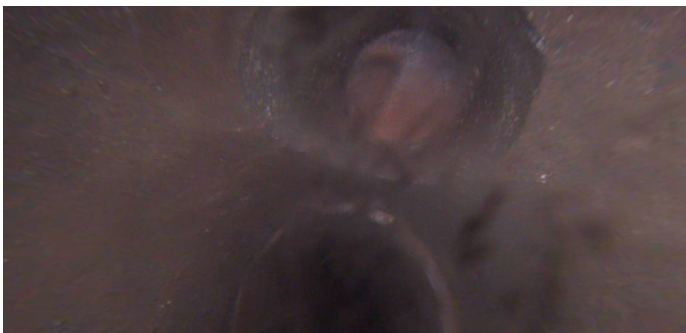
Code: **TFC**
Description: **Tap Factory Capped**

Distance (ft): **6.6**
Structural Grade: **0**
O&M Grade: **0**
Clock Start/From: **12**
Clock To:
1st Value: **4.000**
2nd Value:
Value Percent:
Continuous Index:
Within 8" of Joint:
Remarks:

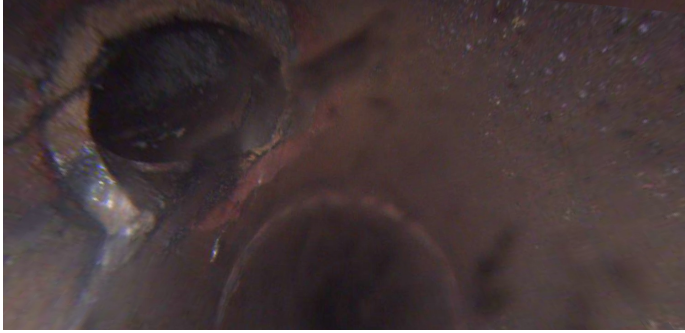
Code: **TBI**
Description: **Tap Break-in Intruding**

Distance (ft): **12.7**
Structural Grade: **0**
O&M Grade: **2**
Clock Start/From: **10**
Clock To:
1st Value: **4.000**
2nd Value: **1.000**
Value Percent:
Continuous Index:
Within 8" of Joint:
Remarks: **rfl**

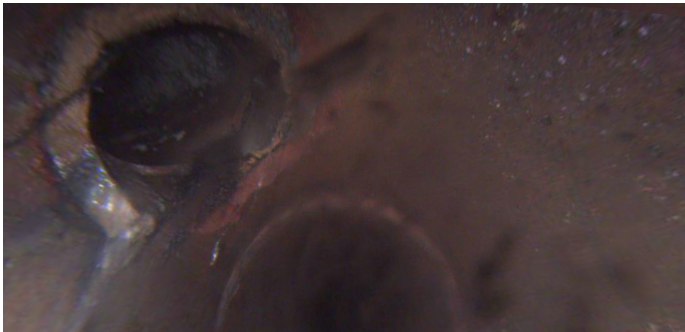
Code: **RFL**
Description: **Roots Fine Lateral**

Distance (ft): **12.7**
Structural Grade: **0**
O&M Grade: **1**
Clock Start/From: **9**
Clock To: **10**
1st Value:
2nd Value:
Value Percent:
Continuous Index:
Within 8" of Joint: **NO**
Remarks:

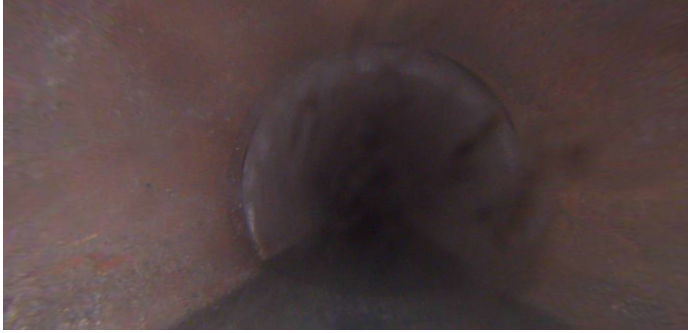
Code:	MSA
Description:	Abandoned Survey
Distance (ft):	15.1
Structural Grade:	0
O&M Grade:	0
Clock Start/From:	
Clock To:	
1st Value:	
2nd Value:	
Value Percent:	
Continuous Index:	
Within 8" of Joint:	NO
Remarks:	unknown
