Profile/Photo Observation Report

Street:	Summerlin	Flow Control:	Not Controlled		
City:	Hobart, IN	Year Renewed:			
Location:	Light Highway	Tape/Media #:			
Purpose:	Not Known	Dia/Height:	12"		
Use:	Sanitary	Material:	VCP		
Drain Area:	NA	Lining:			
Category:	NA				
Comment:					
Location Details:		Direction of Survey:	Downstream		
US MH:	M-504-118	DS MH:	M-504-119	Total Length Surveyed (ft):	15.1

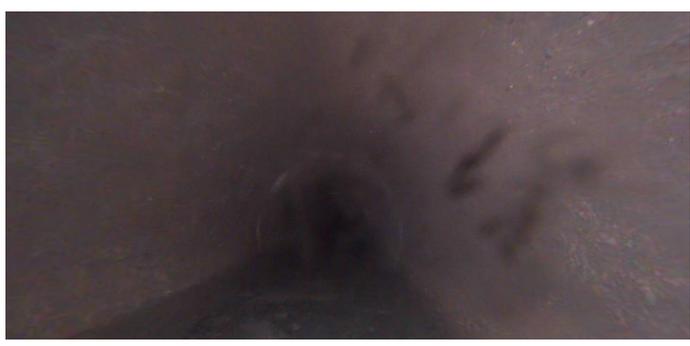
Code: **AMH**
 Description: **Manhole**
 Distance (ft): **.0**
 Structural Grade: **0**
 O&M Grade: **0**
 Clock Start/From:
 Clock To:
 1st Value:
 2nd Value:
 Value Percent:
 Continuous Index:
 Within 8" of Joint: **NO**
 Remarks: **M-504-118**

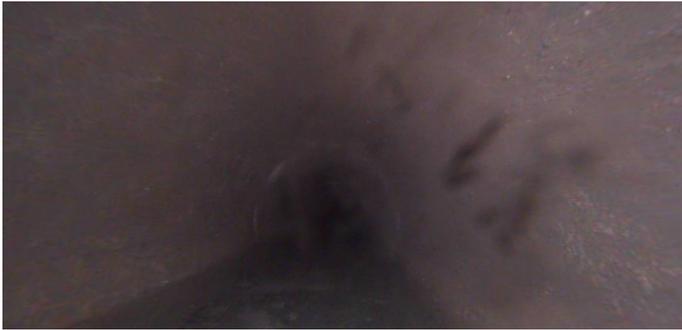
Code: **MWL**
Description: **Water Level**

Distance (ft): **.0**
Structural Grade: **0**
O&M Grade: **0**
Clock Start/From:
Clock To:
1st Value:
2nd Value:
Value Percent: **10.000**
Continuous Index:
Within 8" of Joint: **NO**
Remarks:

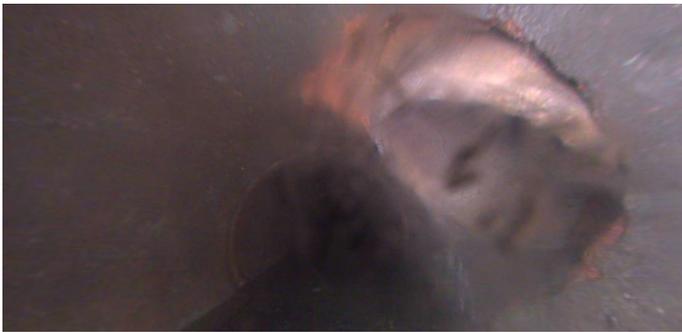
Code: **TBI**
Description: **Tap Break-in Intruding**

Distance (ft): **2.5**
Structural Grade: **0**
O&M Grade: **2**
Clock Start/From: **1**
Clock To:
1st Value: **4.000**
2nd Value: **1.000**
Value Percent:
Continuous Index:
Within 8" of Joint:
Remarks:

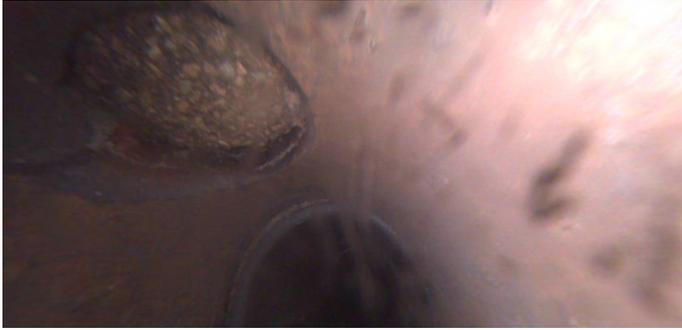
Code: **TFC**
Description: **Tap Factory Capped**

Distance (ft): **4.6**
Structural Grade: **0**
O&M Grade: **0**
Clock Start/From: **11**
Clock To:
1st Value: **4.000**
2nd Value:
Value Percent:
Continuous Index:
Within 8" of Joint:
Remarks:

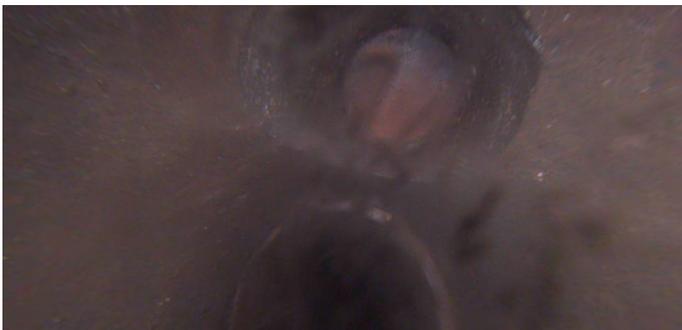
Code: **TFC**
Description: **Tap Factory Capped**

Distance (ft): **6.6**
Structural Grade: **0**
O&M Grade: **0**
Clock Start/From: **12**
Clock To:
1st Value: **4.000**
2nd Value:
Value Percent:
Continuous Index:
Within 8" of Joint:
Remarks:

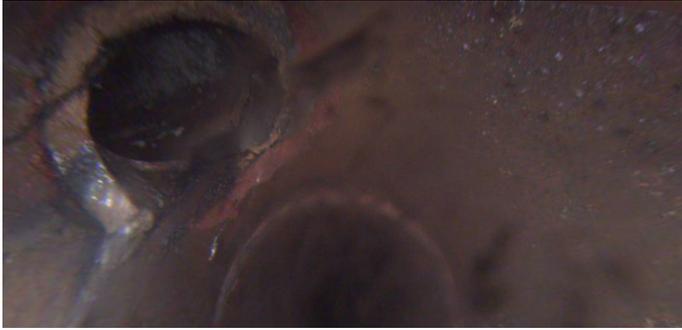
Code: **TBI**
Description: **Tap Break-in Intruding**

Distance (ft): **12.7**
Structural Grade: **0**
O&M Grade: **2**
Clock Start/From: **10**
Clock To:
1st Value: **4.000**
2nd Value: **1.000**
Value Percent:
Continuous Index:
Within 8" of Joint:
Remarks: **rfl**

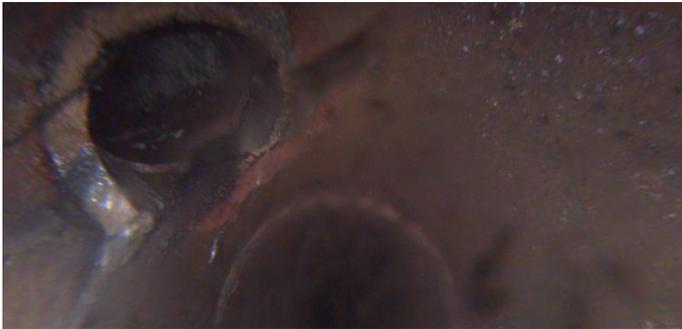
Code: **RFL**
Description: **Roots Fine Lateral**

Distance (ft): **12.7**
Structural Grade: **0**
O&M Grade: **1**
Clock Start/From: **9**
Clock To: **10**
1st Value:
2nd Value:
Value Percent:
Continuous Index:
Within 8" of Joint: **NO**
Remarks:

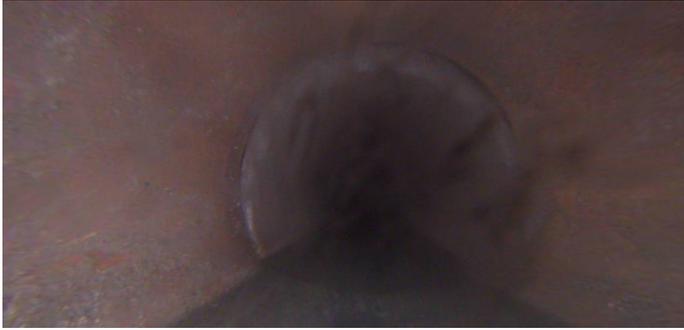
Code: **MSA**
Description: **Abandoned Survey**

Distance (ft): **15.1**
Structural Grade: **0**
O&M Grade: **0**
Clock Start/From:
Clock To:
1st Value:
2nd Value:
Value Percent:
Continuous Index:
Within 8" of Joint: **NO**
Remarks: **unknown**
