## Profile/Photo Observation Report

Date:	<b>04/17/2018</b>	Weather:		Coding:	<b>PACP 6.0</b>
Pipe Length (ft):	<b>202.7</b>	Owner:	<b>NA</b>	Pre Clean:	<b>Not Known</b>
P.O.#:		Surveyor:	<b>Jen Costello</b>	PSR:	<b>P-504-119-118</b>
Customer:		Clean Date:	<b>01/01/1900</b>	Shape:	<b>C</b>

Street:	<b>Summerlin</b>	Flow Control:	<b>Not Controlled</b>
City:	<b>Hobart, IN</b>	Year Renewed:	
Location:	<b>Light Highway</b>	Tape/Media #:	
Purpose:	<b>Not Known</b>	Dia/Height:	<b>12"</b>
Use:	<b>Sanitary</b>	Material:	<b>VCP</b>
Drain Area:	<b>NA</b>	Lining:	
Category:	<b>NA</b>		
Comment:

Location Details:		Direction of Survey:	<b>Upstream</b>
US MH:	<b>M-504-118</b>	DS MH:	<b>M-504-119</b>
		Total Length Surveyed (ft):	<b>19.9</b>

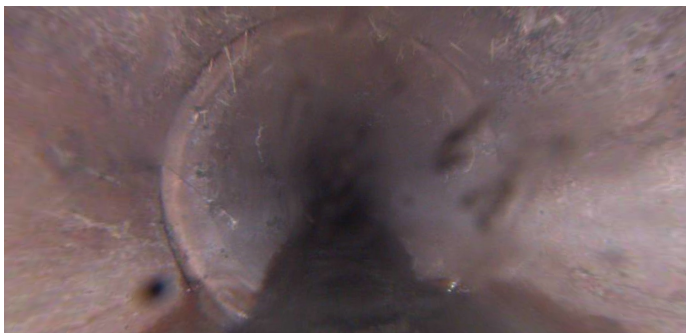
Code: **AMH**  
Description: **Manhole**

Distance (ft): **.0**  
Structural Grade: **0**  
O&M Grade: **0**  
Clock Start/From:  
Clock To:  
1st Value:  
2nd Value:  
Value Percent:  
Continuous Index:  
Within 8" of Joint: **NO**  
Remarks: **M-504-118**

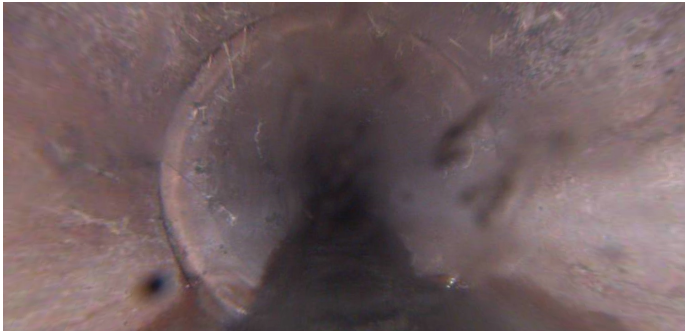
Code:	<b>MWL</b>
Description:	<b>Water Level</b>

Distance (ft):	<b>.0</b>
Structural Grade:	<b>0</b>
O&M Grade:	<b>0</b>
Clock Start/From:	
Clock To:	
1st Value:	
2nd Value:	
Value Percent:	<b>5.000</b>
Continuous Index:	
Within 8" of Joint:	<b>NO</b>
Remarks:

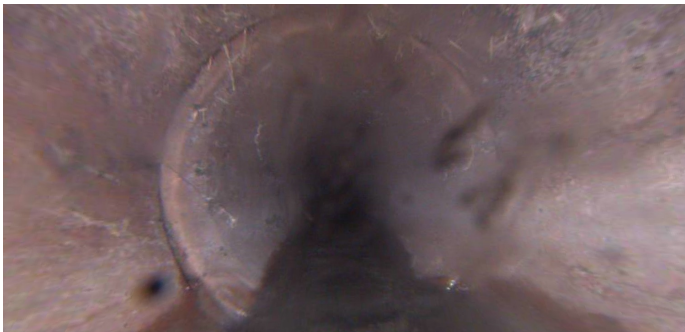
Code:	<b>RFJ</b>
Description:	<b>Roots Fine Joint</b>

Distance (ft):	<b>.0</b>
Structural Grade:	<b>0</b>
O&M Grade:	<b>1</b>
Clock Start/From:	<b>8</b>
Clock To:	<b>4</b>
1st Value:	
2nd Value:	
Value Percent:	
Continuous Index:	<b>S01</b>
Within 8" of Joint:	<b>YES</b>
Remarks:

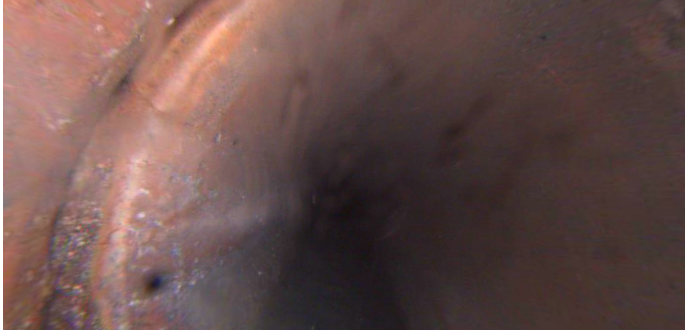
Code: **CM**  
Description: **Crack Multiple**

Distance (ft): **19.9**  
Structural Grade: **3**  
O&M Grade: **0**  
Clock Start/From: **9**  
Clock To: **10**  
1st Value:  
2nd Value:  
Value Percent:  
Continuous Index:  
Within 8" of Joint: **YES**  
Remarks:

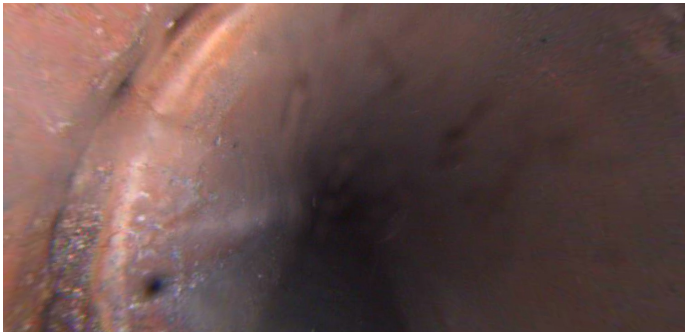
Code: **MSA**  
Description: **Abandoned Survey**

Distance (ft): **19.9**  
Structural Grade: **0**  
O&M Grade: **0**  
Clock Start/From:  
Clock To:  
1st Value:  
2nd Value:  
Value Percent:  
Continuous Index:  
Within 8" of Joint: **NO**  
Remarks: **unknown**

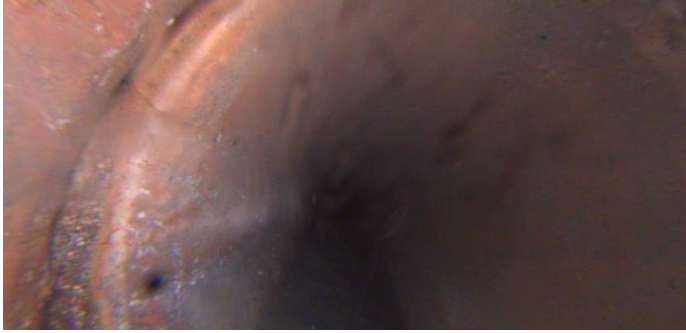
Code:	<b>RFJ</b>
Description:	<b>Roots Fine Joint</b>
Distance (ft):	<b>19.9</b>
Structural Grade:	<b>0</b>
O&M Grade:	<b>1</b>
Clock Start/From:	<b>8</b>
Clock To:	<b>4</b>
1st Value:	
2nd Value:	
Value Percent:	
Continuous Index:	<b>F01</b>
Within 8" of Joint:	<b>YES</b>
Remarks:
