## **Profile/Photo Observation Report**

Customer: City of Hobart Clean Date: 09/03/2021 Shape: C

Street: 41st Avenue Flow Control: Not Controlled

US MH: M-504-118 DS MH: M-504-119 Total Length Surveyed (ft): 201.0

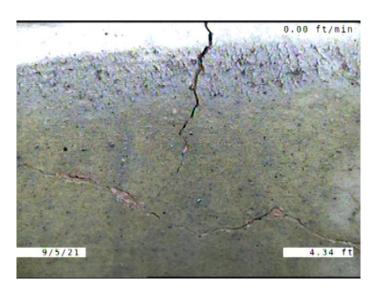
Code: FM

Description: Fracture Multiple

Distance (ft): 4.3
Structural Grade: 4

Continuous Index: **S03** Within 8" of Joint: **YES**

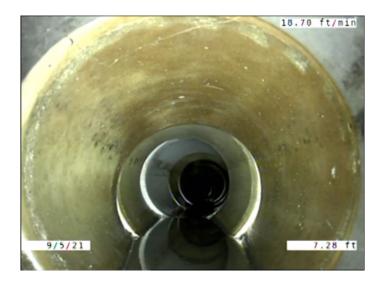
Code: FM
Description: Fracture Multiple

Distance (ft): 7.3
Structural Grade: 4

Continuous Index: F03
Within 8" of Joint: YES

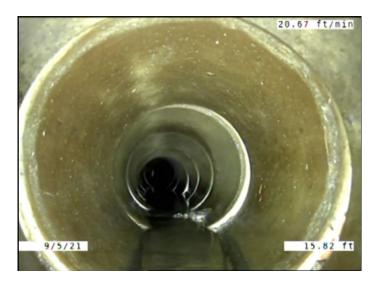
Code: CM

Description: Crack Multiple

Distance (ft): 15.8 Structural Grade: 3 O&M Grade: 0 Clock Start/From: 8 Clock To: 4 1st Value: 2nd Value: Value Percent: Continuous Index: Within 8" of Joint: YES

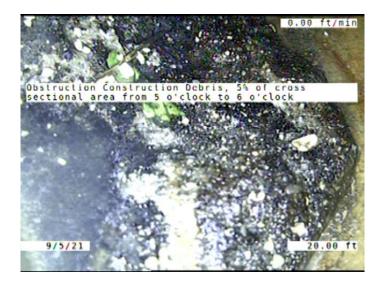
Code: OBN

Description: Obstruction Construction Debris

Distance (ft): 20.0
Structural Grade: 0
O&M Grade: 2
Clock Start/From: 5
Clock To: 6

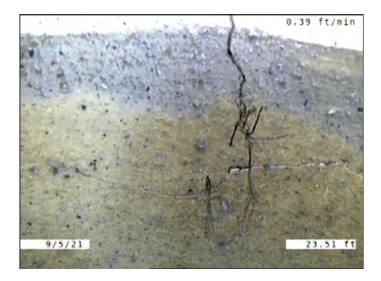
Code: FM

Description: Fracture Multiple

Distance (ft): 23.5
Structural Grade: 4
O&M Grade: 0
Clock Start/From: 11
Clock To: 1
1st Value:
2nd Value:

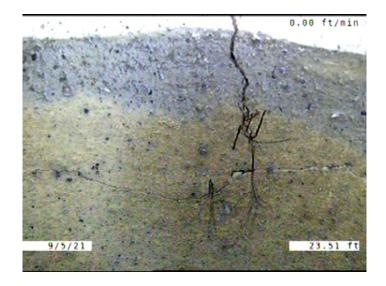
Code: **RFB**

Description: **Roots Fine Barrel**

Distance (ft): 23.5 Structural Grade: 0 O&M Grade: 2 Clock Start/From: 12

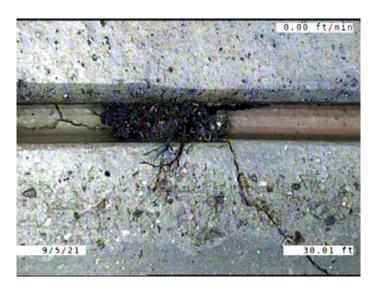
Code: RFJ

Description: **Roots Fine Joint**

Distance (ft): 30.0 Structural Grade: 0 O&M Grade: 1 Clock Start/From: 10 Clock To:

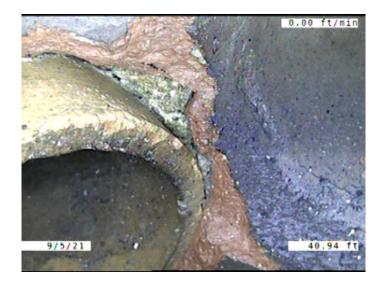
Code: SSS

Description: **Surface Damage Surface Spalling**

Distance (ft): 40.9 Structural Grade: 2 O&M Grade: 0 Clock Start/From: 9 Clock To: 11

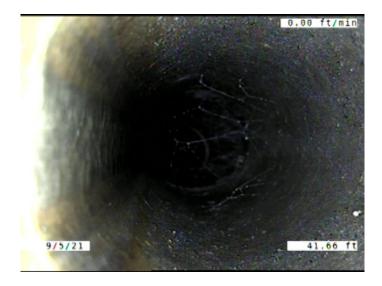
Code: TBI

Description: Tap Break-in Intruding

Distance (ft): 41.7
Structural Grade: 0
O&M Grade: 2
Clock Start/From: 10

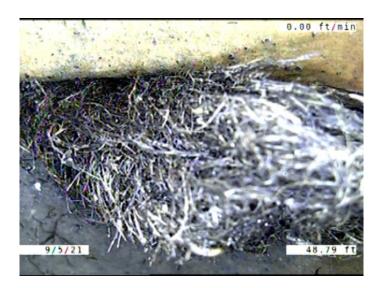
Code: RMJ

Description: Roots Medium Joint

Distance (ft): 48.8
Structural Grade: 0

O&M Grade: 3

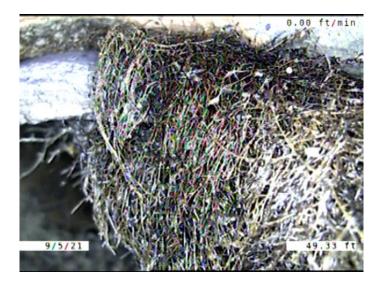
Code: RML

Description: Roots Medium Lateral

Distance (ft): 49.3
Structural Grade: 0
O&M Grade: 3
Clock Start/From: 1
Clock To: 3

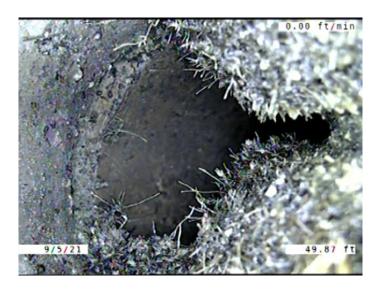
Code: **TBD**

Description: Tap Break-in/Hammer Defective

Distance (ft): 49.9
Structural Grade: 0
O&M Grade: 3
Clock Start/From: 2

Remarks: **Defective**

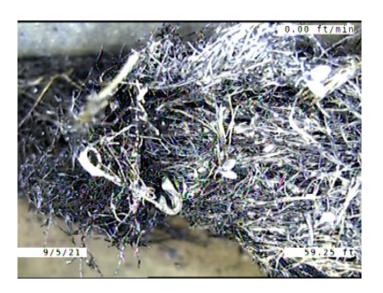
Code: RMJ

Description: **Roots Medium Joint**

Distance (ft): 59.3 Structural Grade: 0 O&M Grade: 3 Clock Start/From: 2 5 Clock To: 1st Value:

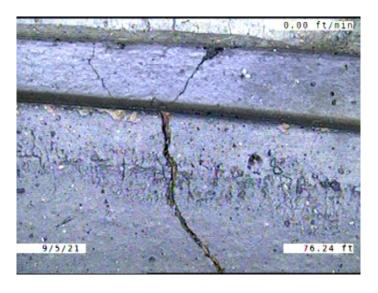
Code: FM

Description: Fracture Multiple

Distance (ft): 76.2
Structural Grade: 4

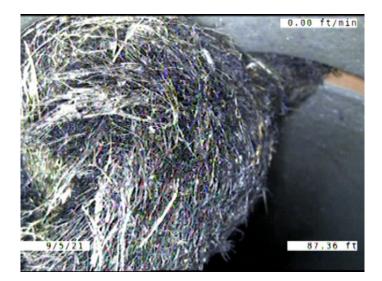
Code: RMJ

Description: Roots Medium Joint

Distance (ft): 87.4
Structural Grade: 0

O&M Grade: 3

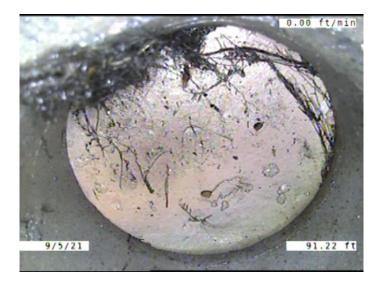
Code: **TFD**

Description: Tap Factory Defective

Distance (ft): 91.2
Structural Grade: 0
O&M Grade: 3
Clock Start/From: 11

Remarks: CAPPED

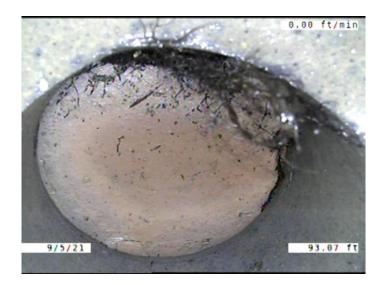
Code: TFC

Description: **Tap Factory Capped**

Remarks: **ROOTS GROWING AROUND THE CAP**

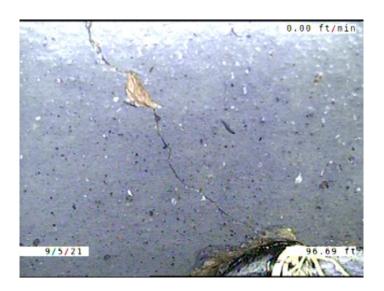
Code: FΜ

Description: **Fracture Multiple**

Distance (ft): 96.7 Structural Grade: 4 O&M Grade: 0 Clock Start/From: 9 Clock To: 3 1st Value: 2nd Value: Value Percent: Continuous Index: Within 8" of Joint: YES

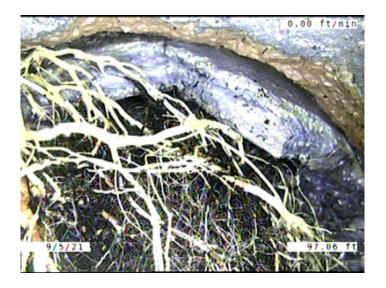
Code: TBI

Description: Tap Break-in Intruding

Distance (ft): 97.1
Structural Grade: 0
O&M Grade: 2
Clock Start/From: 2

Remarks: LOOKS TO BE 100% PLUGGED WITH

ROOTS

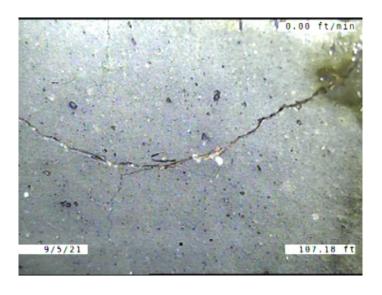
Code: FM

Description: Fracture Multiple

Distance (ft): 107.2
Structural Grade: 4
O&M Grade: 0
Clock Start/From: 1
Clock To: 4
1st Value:
2nd Value:

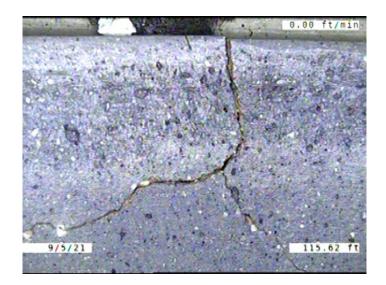
Code: FM
Description: Fracture Multiple

Distance (ft): 115.6
Structural Grade: 4
O&M Grade: 0
Clock Start/From: 9
Clock To: 3
1st Value:
2nd Value:

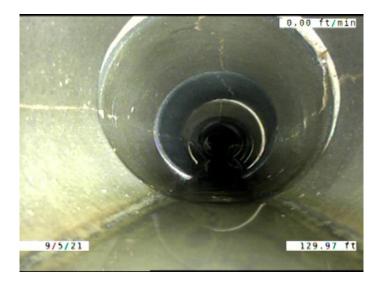
Code: FH4

Description: Fracture Longitudinal Hinge, 4

Distance (ft): 130.0
Structural Grade: 4

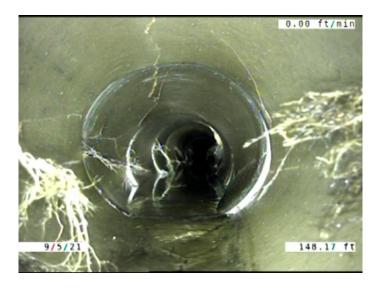
Code: FH4

Description: Fracture Longitudinal Hinge, 4

Distance (ft): 148.2
Structural Grade: 4
O&M Grade: 0
Clock Start/From: 12
Clock To: 12

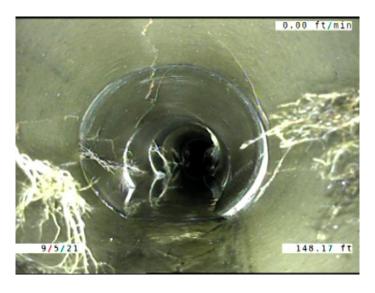
Code: FM

Description: Fracture Multiple

Distance (ft): 148.2
Structural Grade: 4
O&M Grade: 0
Clock Start/From: 12
Clock To: 12

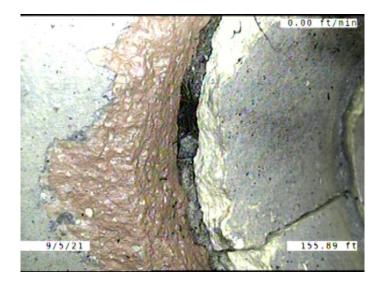
Code: B
Description: Broken

Distance (ft): 155.9

Structural Grade: 4

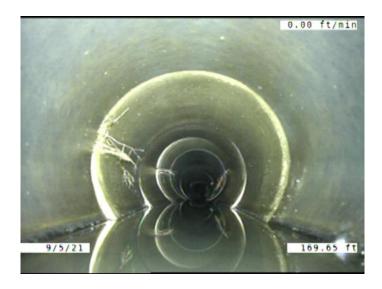
Code: **FM**

Description: Fracture Multiple

Distance (ft): 169.6
Structural Grade: 4

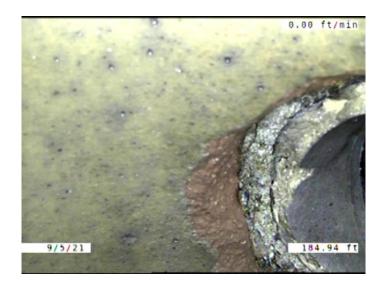
Code: FM

Description: Fracture Multiple

Distance (ft): 184.9 Structural Grade: 4

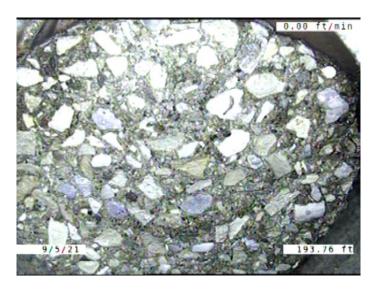
Code: **TFD**

Description: Tap Factory Defective

Distance (ft): 193.8
Structural Grade: 0
O&M Grade: 3
Clock Start/From: 1

Remarks: LOOKS LIKE SOMEONE TRIED TO

PLUG IT/ CAP IT.
