RedZone
ROBOTICS

Street:	41st Avenue	Flow Control:	Not Controlled
City:	Hobart, IN	Year Renewed:	
Location:	Alley	Tape/Media #:	
Purpose:	Routine Assessment	Dia/Height:	12"
Use:	Sanitary Sewage Pipe	Material:	VCP
Drain Area:		Lining:	None
Category:	NA		
Comment:			
Location Details:		Direction of Survey:	Downstream
US MH:	M-504-118	DS MH:	M-504-119
		Total Length Surveyed (ft):	201.0

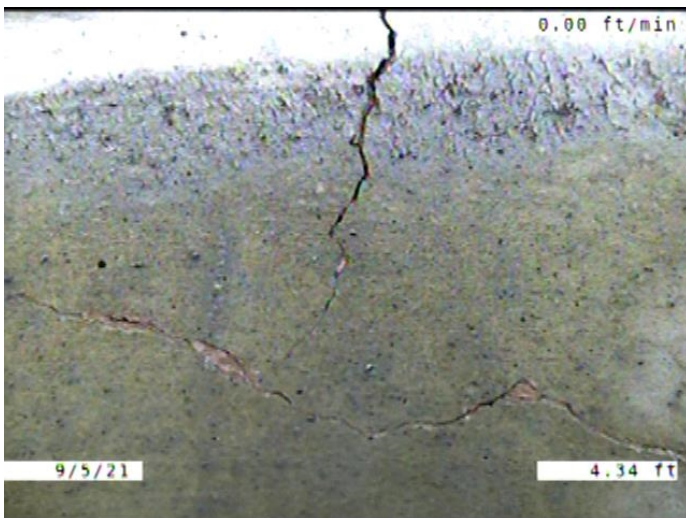
Code: **FM**
 Description: **Fracture Multiple**

Distance (ft): **4.3**
 Structural Grade: **4**
 O&M Grade: **0**
 Clock Start/From: **8**
 Clock To: **4**
 1st Value:
 2nd Value:
 Value Percent:
 Continuous Index: **S03**
 Within 8" of Joint: **YES**
 Remarks:

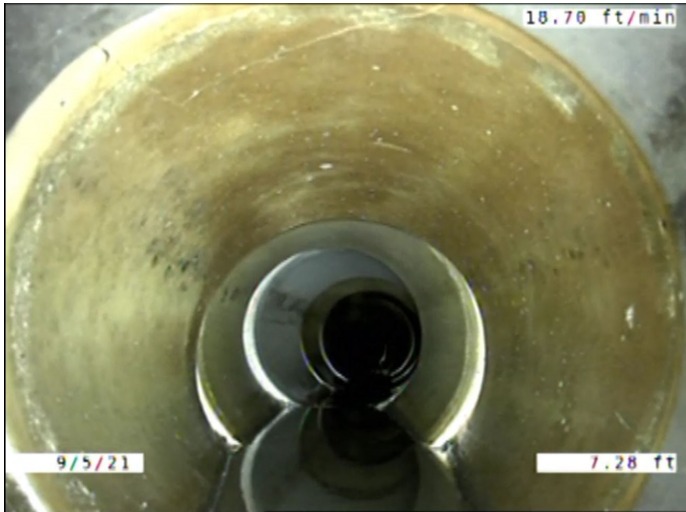
Code: **FM**
Description: **Fracture Multiple**

Distance (ft): **7.3**
Structural Grade: **4**
O&M Grade: **0**
Clock Start/From: **8**
Clock To: **4**
1st Value:
2nd Value:
Value Percent:
Continuous Index: **F03**
Within 8" of Joint: **YES**
Remarks:

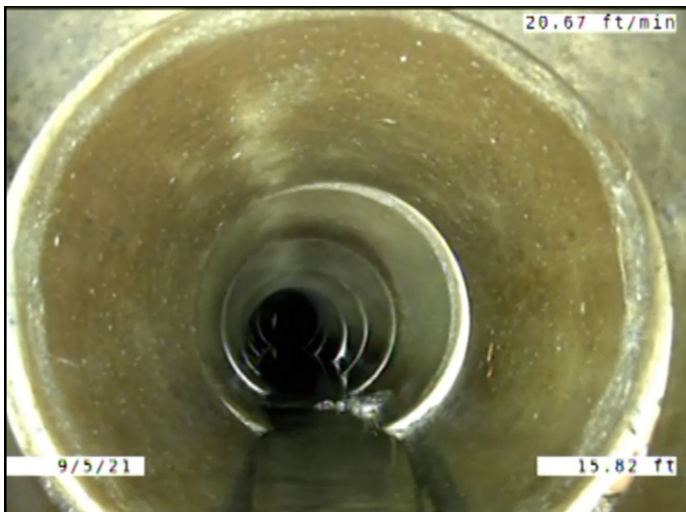
Code: **CM**
Description: **Crack Multiple**

Distance (ft): **15.8**
Structural Grade: **3**
O&M Grade: **0**
Clock Start/From: **8**
Clock To: **4**
1st Value:
2nd Value:
Value Percent:
Continuous Index:
Within 8" of Joint: **YES**
Remarks:

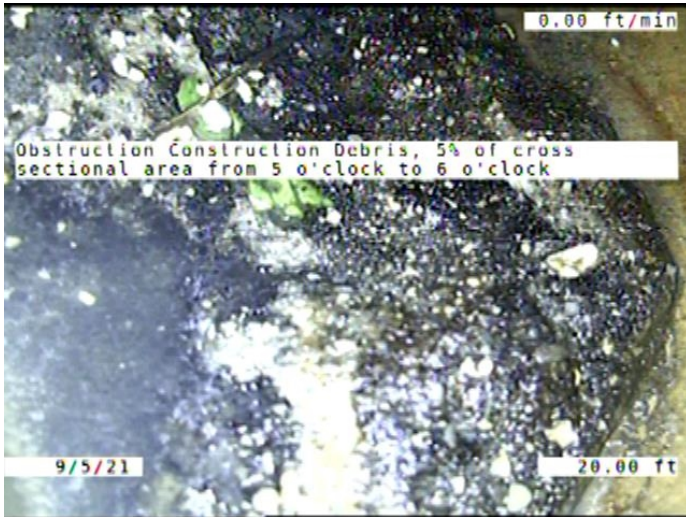
Code:	OBN
Description:	Obstruction Construction Debris
Distance (ft):	20.0
Structural Grade:	0
O&M Grade:	2
Clock Start/From:	5
Clock To:	6
1st Value:	
2nd Value:	
Value Percent:	5.000
Continuous Index:	
Within 8" of Joint:	NO
Remarks:

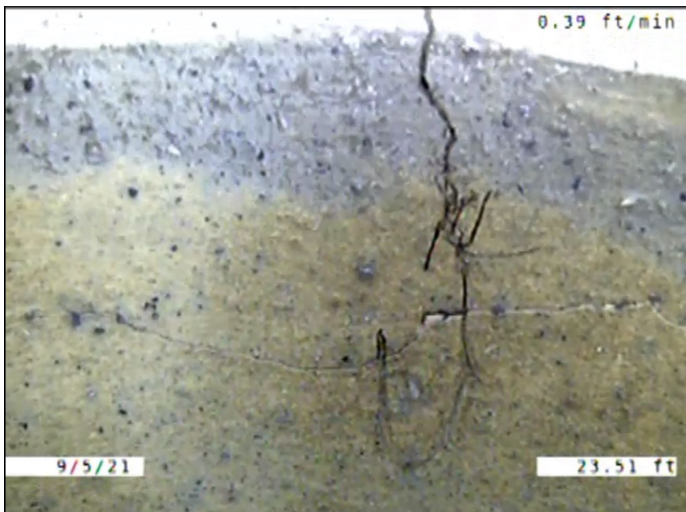
Code:	FM
Description:	Fracture Multiple
Distance (ft):	23.5
Structural Grade:	4
O&M Grade:	0
Clock Start/From:	11
Clock To:	1
1st Value:	
2nd Value:	
Value Percent:	
Continuous Index:	
Within 8" of Joint:	YES
Remarks:

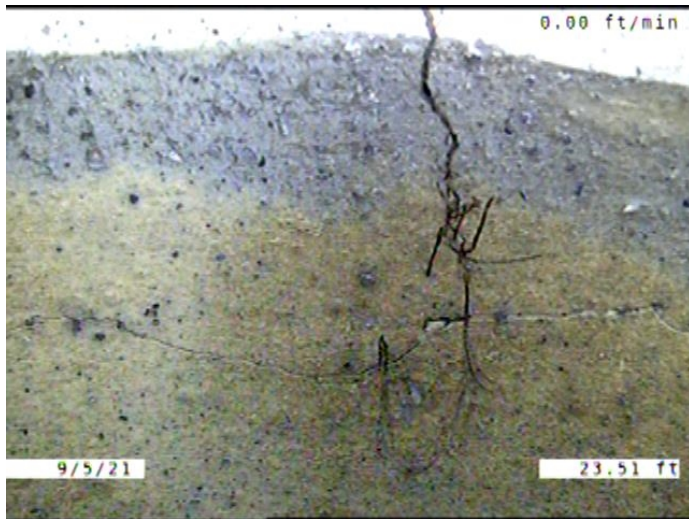
Code: **RFB**
 Description: **Roots Fine Barrel**

Distance (ft): **23.5**
 Structural Grade: **0**
 O&M Grade: **2**
 Clock Start/From: **12**
 Clock To:
 1st Value:
 2nd Value:
 Value Percent:
 Continuous Index:
 Within 8" of Joint: **NO**
 Remarks:

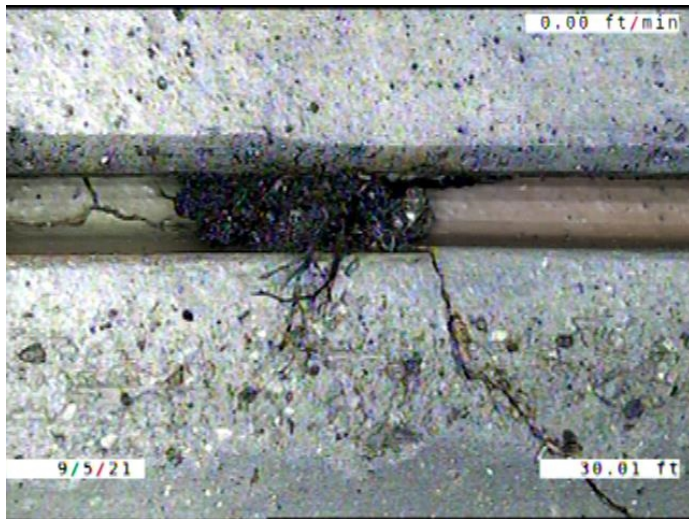
Code: **RFJ**
 Description: **Roots Fine Joint**

Distance (ft): **30.0**
 Structural Grade: **0**
 O&M Grade: **1**
 Clock Start/From: **10**
 Clock To:
 1st Value:
 2nd Value:
 Value Percent:
 Continuous Index:
 Within 8" of Joint: **YES**
 Remarks:

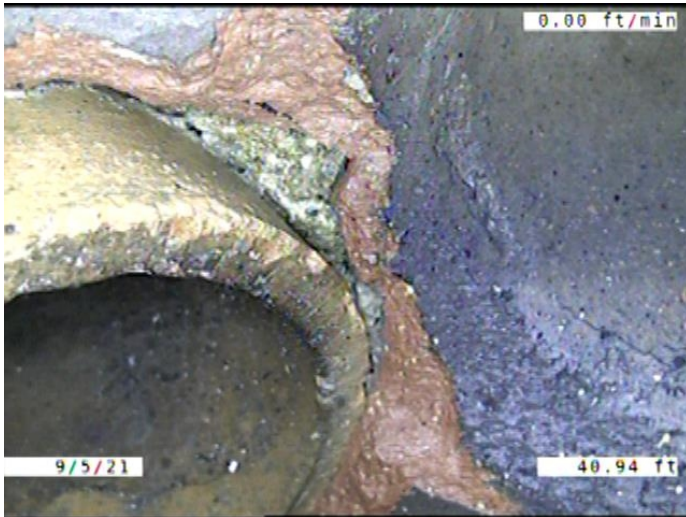
Code: **SSS**
 Description: **Surface Damage Surface Spalling**

Distance (ft): **40.9**
 Structural Grade: **2**
 O&M Grade: **0**
 Clock Start/From: **9**
 Clock To: **11**
 1st Value:
 2nd Value:
 Value Percent:
 Continuous Index:
 Within 8" of Joint: **NO**
 Remarks:

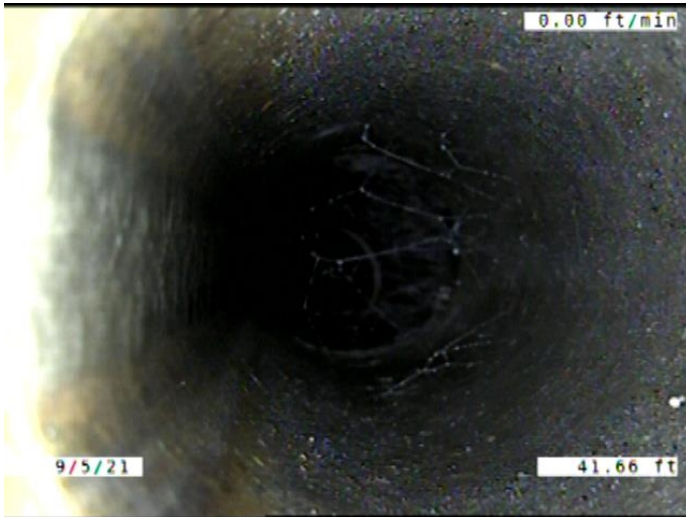
Code: **TBI**
 Description: **Tap Break-in Intruding**

Distance (ft): **41.7**
 Structural Grade: **0**
 O&M Grade: **2**
 Clock Start/From: **10**
 Clock To:
 1st Value: **6.000**
 2nd Value: **1.000**
 Value Percent:
 Continuous Index:
 Within 8" of Joint: **YES**
 Remarks:

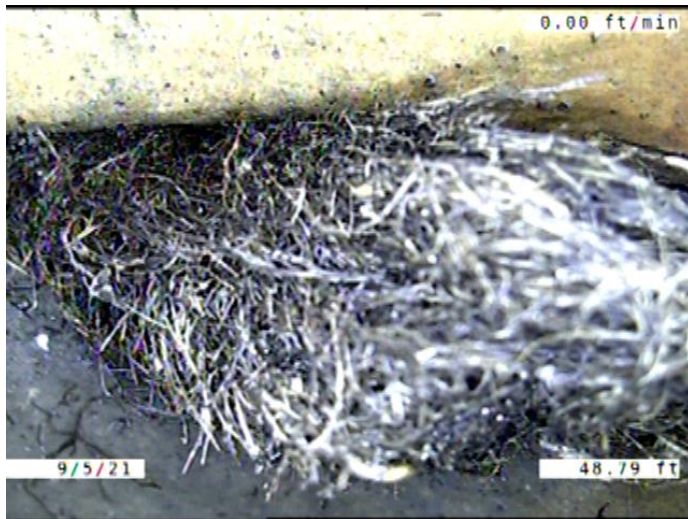
Code: **RMJ**
 Description: **Roots Medium Joint**

Distance (ft): **48.8**
 Structural Grade: **0**
 O&M Grade: **3**
 Clock Start/From: **3**
 Clock To: **5**
 1st Value:
 2nd Value:
 Value Percent: **5.000**
 Continuous Index:
 Within 8" of Joint: **YES**
 Remarks:

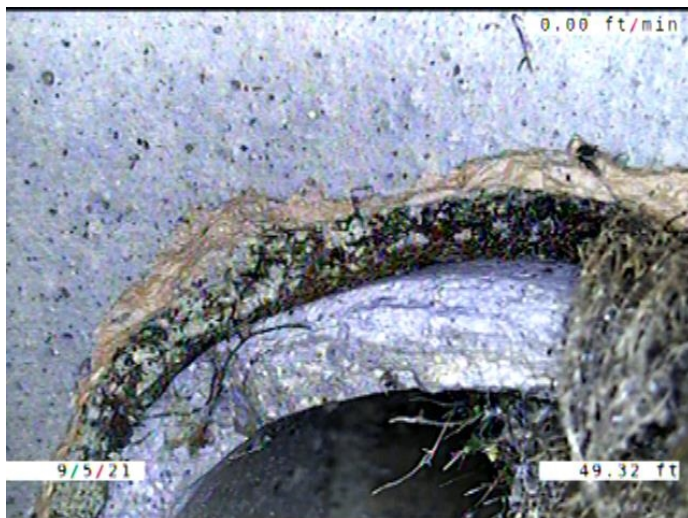
Code: **B**
 Description: **Broken**

Distance (ft): **49.3**
 Structural Grade: **4**
 O&M Grade: **0**
 Clock Start/From: **1**
 Clock To: **3**
 1st Value:
 2nd Value:
 Value Percent:
 Continuous Index:
 Within 8" of Joint: **YES**
 Remarks:

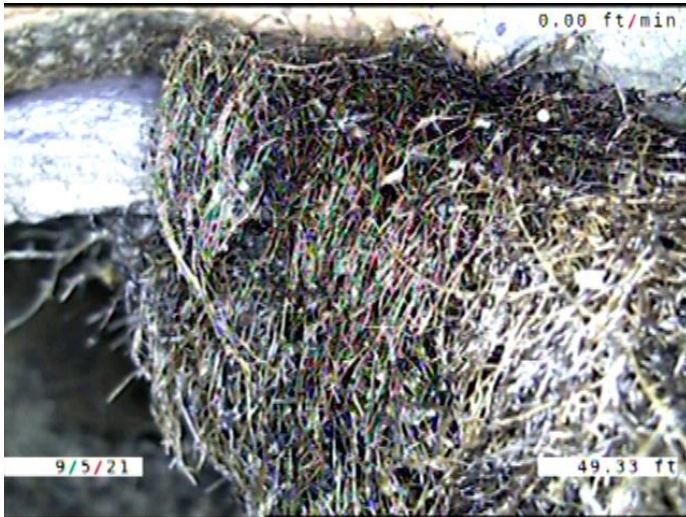
Code: **RML**
 Description: **Roots Medium Lateral**

Distance (ft): **49.3**
 Structural Grade: **0**
 O&M Grade: **3**
 Clock Start/From: **1**
 Clock To: **3**
 1st Value:
 2nd Value:
 Value Percent: **10.000**
 Continuous Index:
 Within 8" of Joint: **NO**
 Remarks:

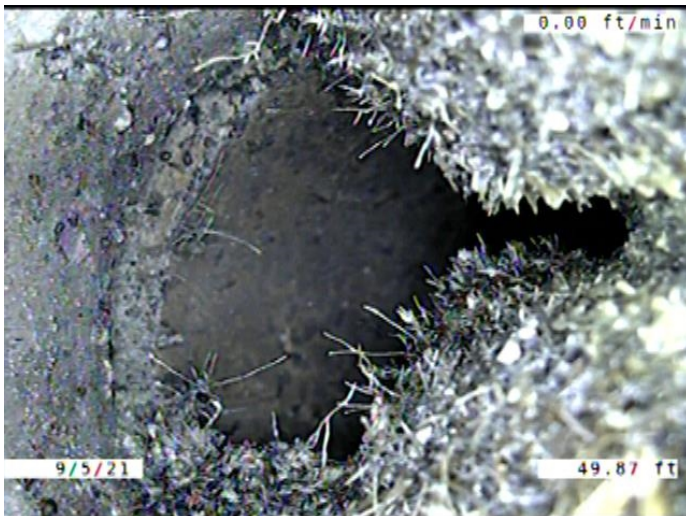
Code: **TBD**
 Description: **Tap Break-in/Hammer Defective**

Distance (ft): **49.9**
 Structural Grade: **0**
 O&M Grade: **3**
 Clock Start/From: **2**
 Clock To:
 1st Value: **6.000**
 2nd Value:
 Value Percent:
 Continuous Index:
 Within 8" of Joint: **YES**
 Remarks: **Defective**

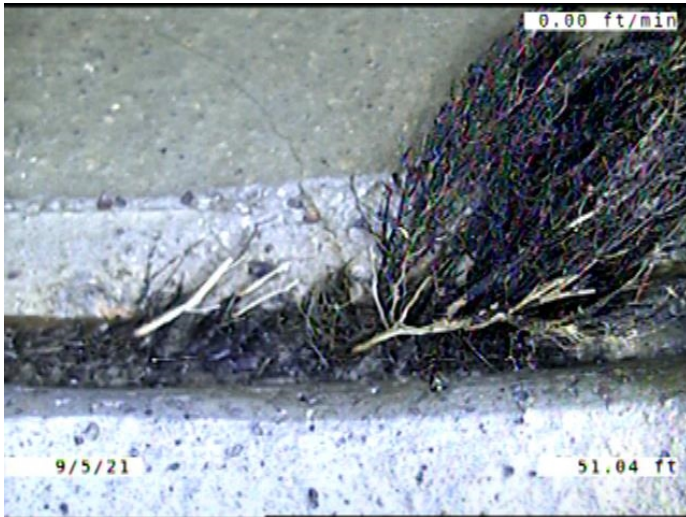
Code: **RFJ**
 Description: **Roots Fine Joint**

Distance (ft): **51.0**
 Structural Grade: **0**
 O&M Grade: **1**
 Clock Start/From: **9**
 Clock To: **10**
 1st Value:
 2nd Value:
 Value Percent:
 Continuous Index:
 Within 8" of Joint: **YES**
 Remarks:

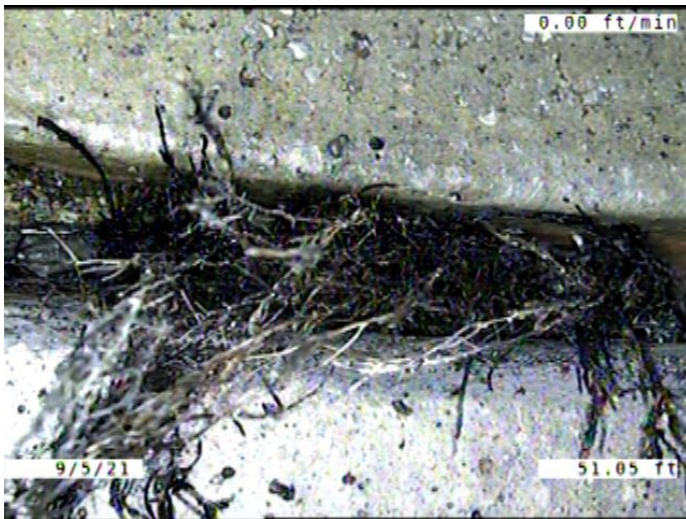
Code: **RFJ**
 Description: **Roots Fine Joint**

Distance (ft): **51.0**
 Structural Grade: **0**
 O&M Grade: **1**
 Clock Start/From: **4**
 Clock To: **5**
 1st Value:
 2nd Value:
 Value Percent:
 Continuous Index:
 Within 8" of Joint: **YES**
 Remarks:

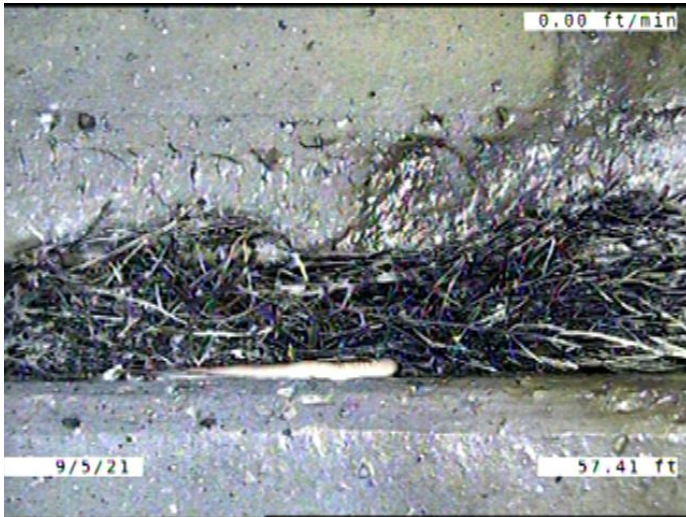
Code: **RFJ**
 Description: **Roots Fine Joint**

Distance (ft): **57.4**
 Structural Grade: **0**
 O&M Grade: **1**
 Clock Start/From: **8**
 Clock To: **9**
 1st Value:
 2nd Value:
 Value Percent:
 Continuous Index:
 Within 8" of Joint: **YES**
 Remarks:

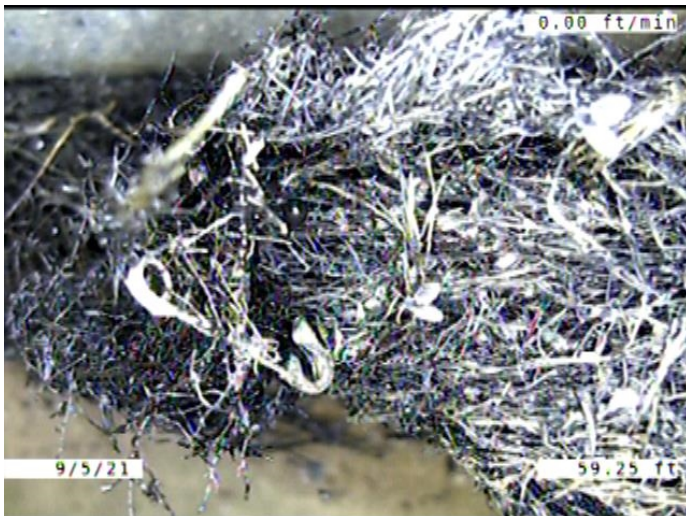
Code: **RMJ**
 Description: **Roots Medium Joint**

Distance (ft): **59.3**
 Structural Grade: **0**
 O&M Grade: **3**
 Clock Start/From: **2**
 Clock To: **5**
 1st Value:
 2nd Value:
 Value Percent: **5.000**
 Continuous Index:
 Within 8" of Joint: **YES**
 Remarks:

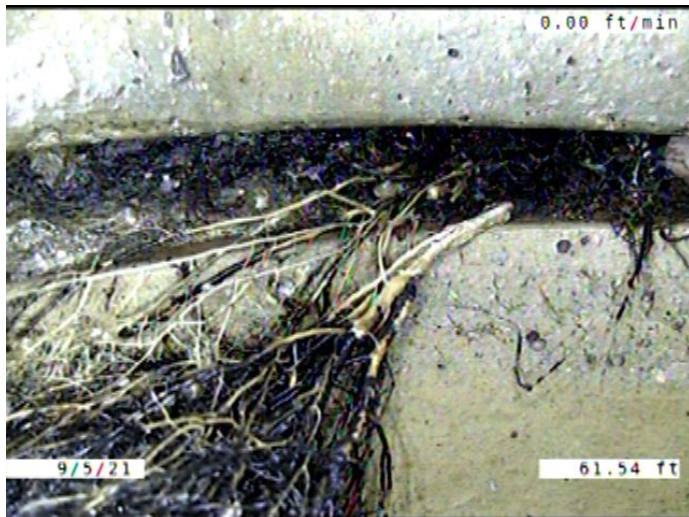
Code: **RMJ**
 Description: **Roots Medium Joint**

Distance (ft): **61.5**
 Structural Grade: **0**
 O&M Grade: **3**
 Clock Start/From: **9**
 Clock To: **10**
 1st Value:
 2nd Value:
 Value Percent: **5.000**
 Continuous Index:
 Within 8" of Joint: **YES**
 Remarks:

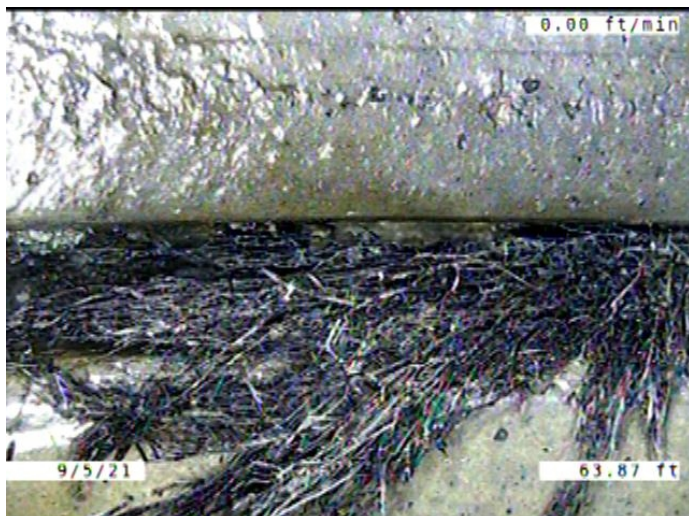
Code: **RMJ**
 Description: **Roots Medium Joint**

Distance (ft): **63.9**
 Structural Grade: **0**
 O&M Grade: **3**
 Clock Start/From: **3**
 Clock To: **5**
 1st Value:
 2nd Value:
 Value Percent: **5.000**
 Continuous Index: **S05**
 Within 8" of Joint: **YES**
 Remarks:

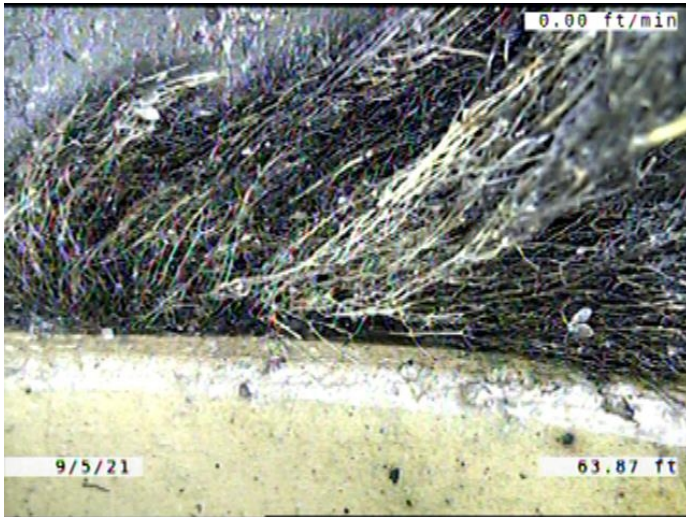
Code: **RMJ**
 Description: **Roots Medium Joint**

Distance (ft): **63.9**
 Structural Grade: **0**
 O&M Grade: **3**
 Clock Start/From: **8**
 Clock To: **10**
 1st Value:
 2nd Value:
 Value Percent: **5.000**
 Continuous Index: **S04**
 Within 8" of Joint: **YES**
 Remarks:

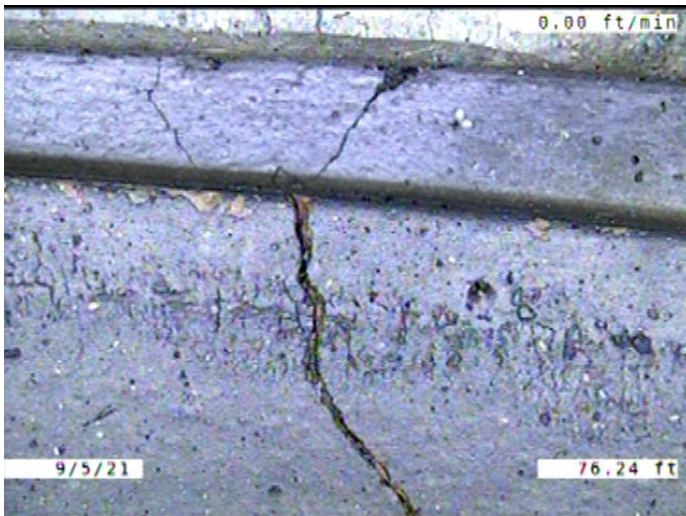
Code: **FM**
 Description: **Fracture Multiple**

Distance (ft): **76.2**
 Structural Grade: **4**
 O&M Grade: **0**
 Clock Start/From: **12**
 Clock To: **3**
 1st Value:
 2nd Value:
 Value Percent:
 Continuous Index:
 Within 8" of Joint: **YES**
 Remarks:

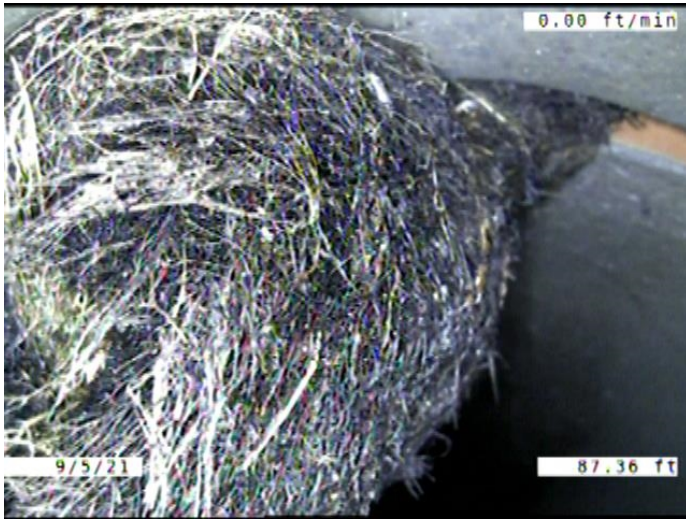
Code: **RMJ**
 Description: **Roots Medium Joint**

Distance (ft): **87.4**
 Structural Grade: **0**
 O&M Grade: **3**
 Clock Start/From: **7**
 Clock To: **11**
 1st Value:
 2nd Value:
 Value Percent: **20.000**
 Continuous Index:
 Within 8" of Joint: **YES**
 Remarks:

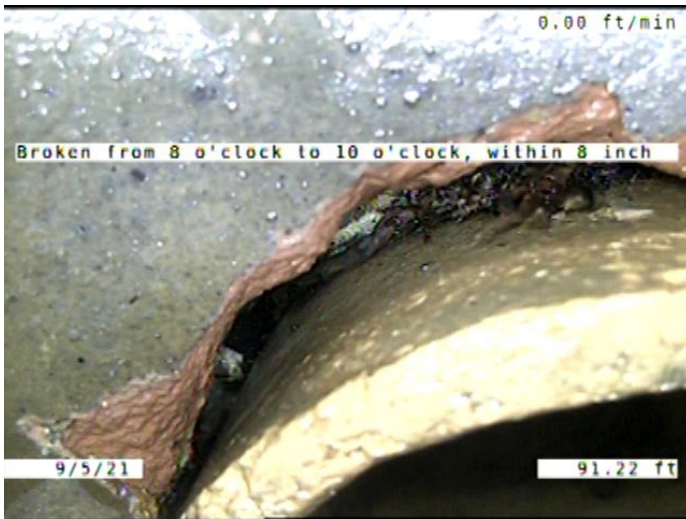
Code: **SSS**
 Description: **Surface Damage Surface Spalling**

Distance (ft): **91.2**
 Structural Grade: **2**
 O&M Grade: **0**
 Clock Start/From: **8**
 Clock To: **10**
 1st Value:
 2nd Value:
 Value Percent:
 Continuous Index:
 Within 8" of Joint: **YES**
 Remarks:

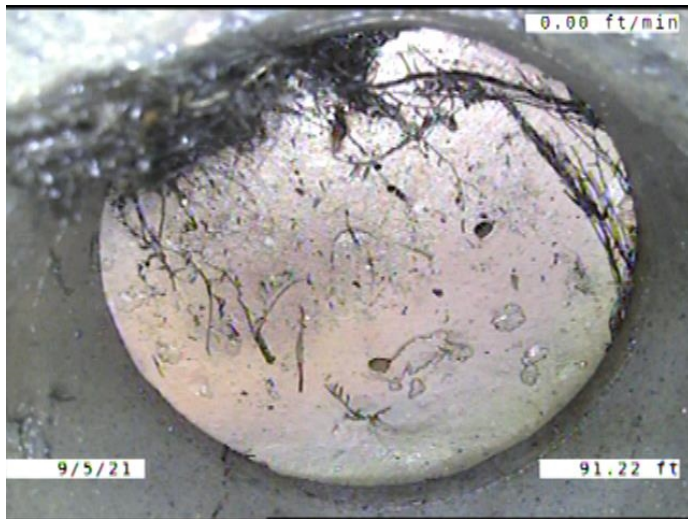
Code: **TFD**
 Description: **Tap Factory Defective**

Distance (ft): **91.2**
 Structural Grade: **0**
 O&M Grade: **3**
 Clock Start/From: **11**
 Clock To:
 1st Value: **6.000**
 2nd Value:
 Value Percent:
 Continuous Index:
 Within 8" of Joint: **YES**
 Remarks: **CAPPED**

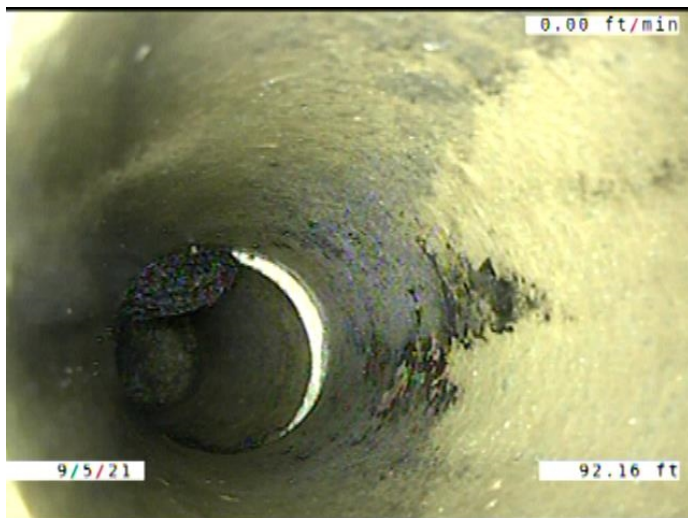
Code: **TBI**
 Description: **Tap Break-in Intruding**

Distance (ft): **92.2**
 Structural Grade: **0**
 O&M Grade: **2**
 Clock Start/From: **10**
 Clock To:
 1st Value: **6.000**
 2nd Value: **2.000**
 Value Percent:
 Continuous Index:
 Within 8" of Joint: **YES**
 Remarks:

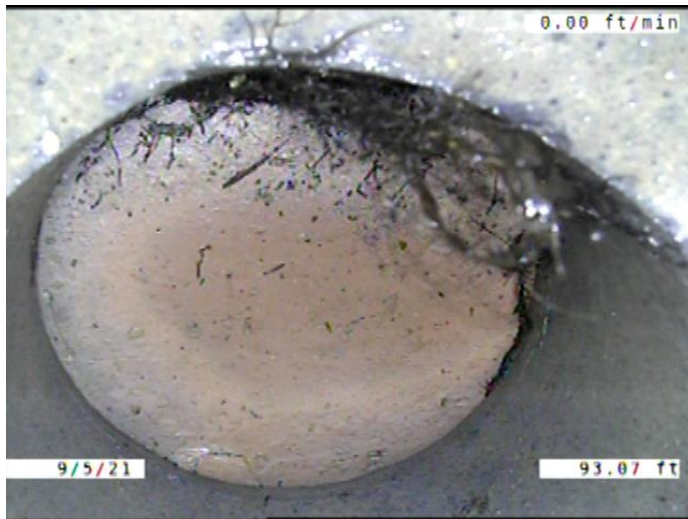
Code:	TFC
Description:	Tap Factory Capped
Distance (ft):	93.1
Structural Grade:	0
O&M Grade:	0
Clock Start/From:	1
Clock To:	
1st Value:	6.000
2nd Value:	
Value Percent:	
Continuous Index:	
Within 8" of Joint:	YES
Remarks:	ROOTS GROWING AROUND THE CAP

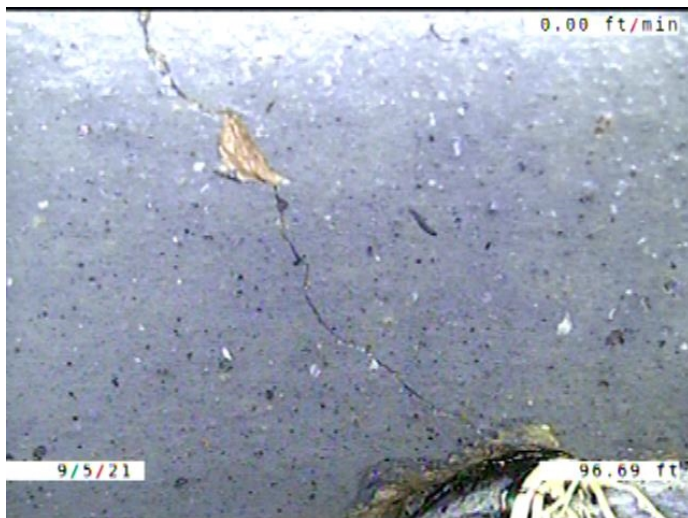
Code:	FM
Description:	Fracture Multiple
Distance (ft):	96.7
Structural Grade:	4
O&M Grade:	0
Clock Start/From:	9
Clock To:	3
1st Value:	
2nd Value:	
Value Percent:	
Continuous Index:	
Within 8" of Joint:	YES
Remarks:

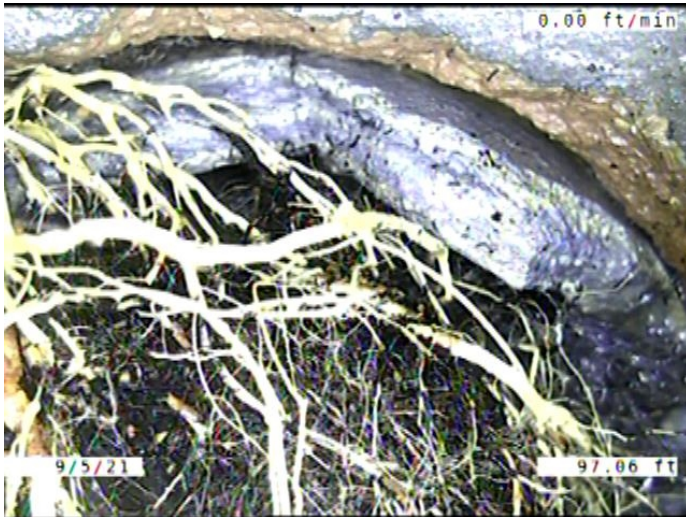
Code:	TBI
Description:	Tap Break-in Intruding
Distance (ft):	97.1
Structural Grade:	0
O&M Grade:	2
Clock Start/From:	2
Clock To:	
1st Value:	6.000
2nd Value:	1.000
Value Percent:	
Continuous Index:	
Within 8" of Joint:	YES
Remarks:	LOOKS TO BE 100% PLUGGED WITH ROOTS

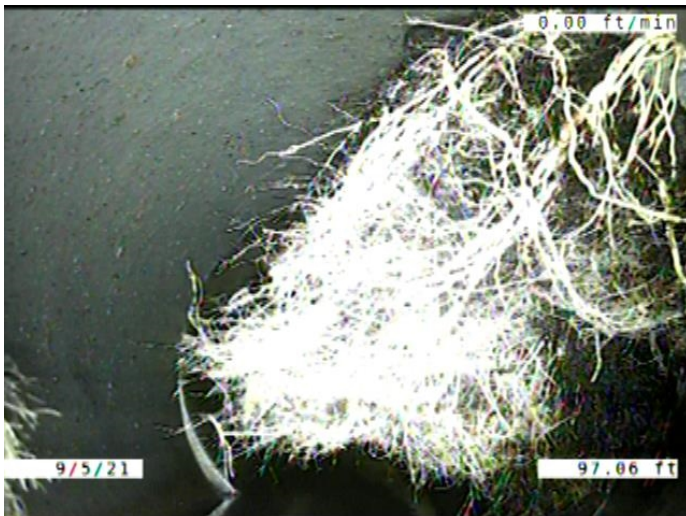
Code:	RML
Description:	Roots Medium Lateral
Distance (ft):	97.1
Structural Grade:	0
O&M Grade:	3
Clock Start/From:	1
Clock To:	5
1st Value:	
2nd Value:	
Value Percent:	40.000
Continuous Index:	
Within 8" of Joint:	NO
Remarks:

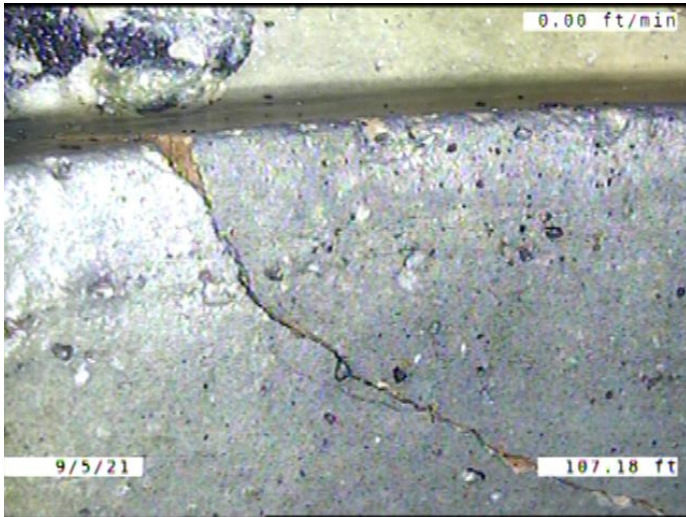
Code: **FC**
 Description: **Fracture Circumferential**

Distance (ft): **107.2**
 Structural Grade: **2**
 O&M Grade: **0**
 Clock Start/From: **8**
 Clock To: **11**
 1st Value:
 2nd Value:
 Value Percent:
 Continuous Index:
 Within 8" of Joint: **YES**
 Remarks:

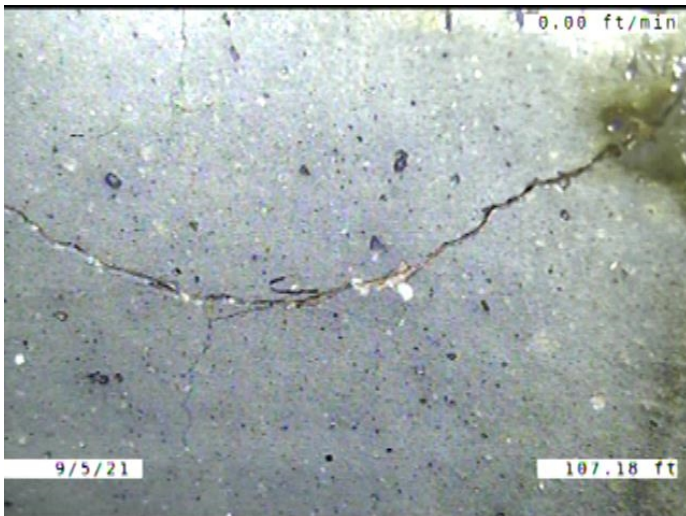
Code: **FM**
 Description: **Fracture Multiple**

Distance (ft): **107.2**
 Structural Grade: **4**
 O&M Grade: **0**
 Clock Start/From: **1**
 Clock To: **4**
 1st Value:
 2nd Value:
 Value Percent:
 Continuous Index:
 Within 8" of Joint: **YES**
 Remarks:

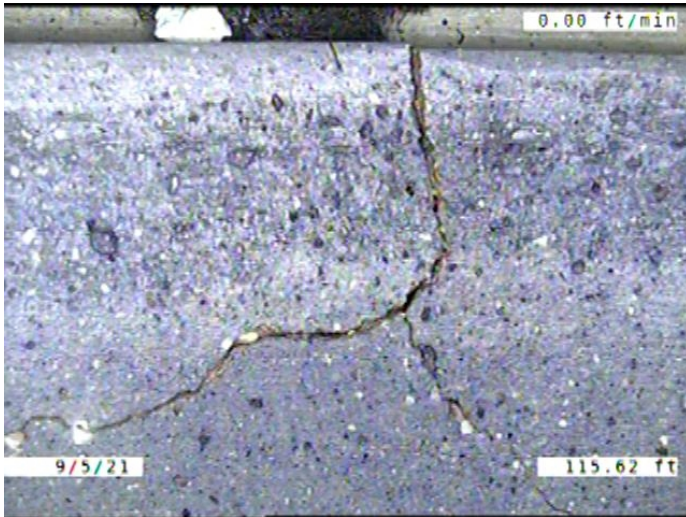
Code: **FM**
 Description: **Fracture Multiple**

Distance (ft): **115.6**
 Structural Grade: **4**
 O&M Grade: **0**
 Clock Start/From: **9**
 Clock To: **3**
 1st Value:
 2nd Value:
 Value Percent:
 Continuous Index:
 Within 8" of Joint: **YES**
 Remarks:

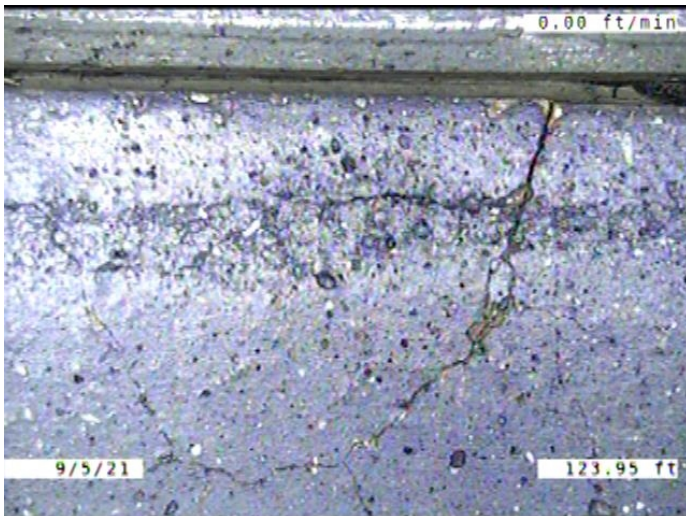
Code: **CM**
 Description: **Crack Multiple**

Distance (ft): **124.0**
 Structural Grade: **3**
 O&M Grade: **0**
 Clock Start/From: **10**
 Clock To: **12**
 1st Value:
 2nd Value:
 Value Percent:
 Continuous Index:
 Within 8" of Joint: **YES**
 Remarks:

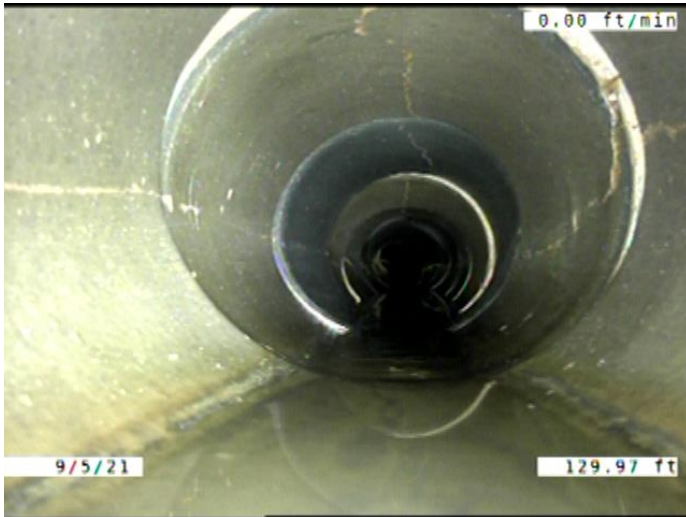
Code: **FH4**
 Description: **Fracture Longitudinal Hinge, 4**

Distance (ft): **130.0**
 Structural Grade: **4**
 O&M Grade: **0**
 Clock Start/From: **12**
 Clock To: **12**
 1st Value:
 2nd Value:
 Value Percent:
 Continuous Index: **S06**
 Within 8" of Joint: **YES**
 Remarks:

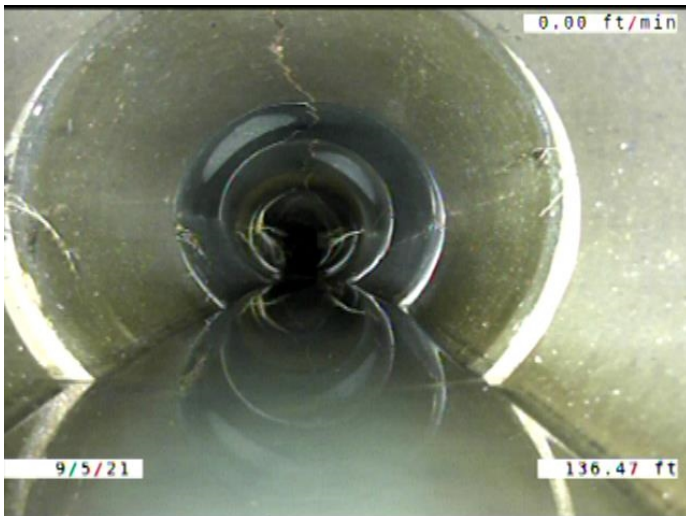
Code: **MWLS**
 Description: **Miscellaneous Water Level Sag**

Distance (ft): **136.5**
 Structural Grade: **2**
 O&M Grade: **0**
 Clock Start/From:
 Clock To:
 1st Value:
 2nd Value:
 Value Percent: **10.000**
 Continuous Index:
 Within 8" of Joint: **NO**
 Remarks:

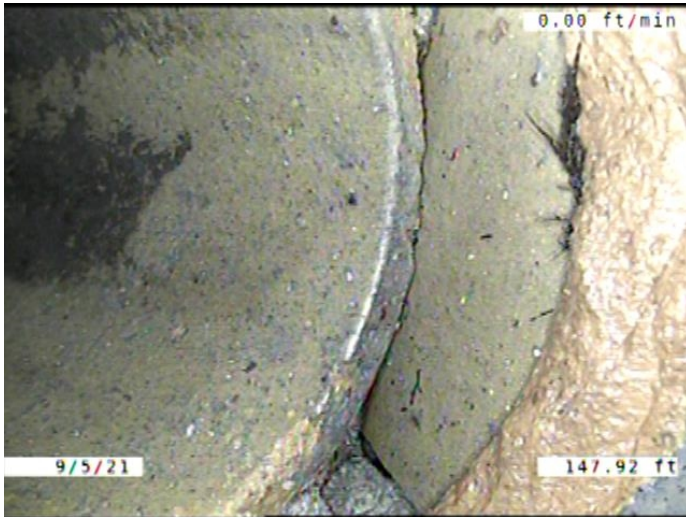
Code: **SSC**
Description: **Surface Spalling of Damage Coating**

Distance (ft): **147.9**
Structural Grade: **1**
O&M Grade: **0**
Clock Start/From: **9**
Clock To: **11**
1st Value:
2nd Value:
Value Percent:
Continuous Index:
Within 8" of Joint: **NO**
Remarks:

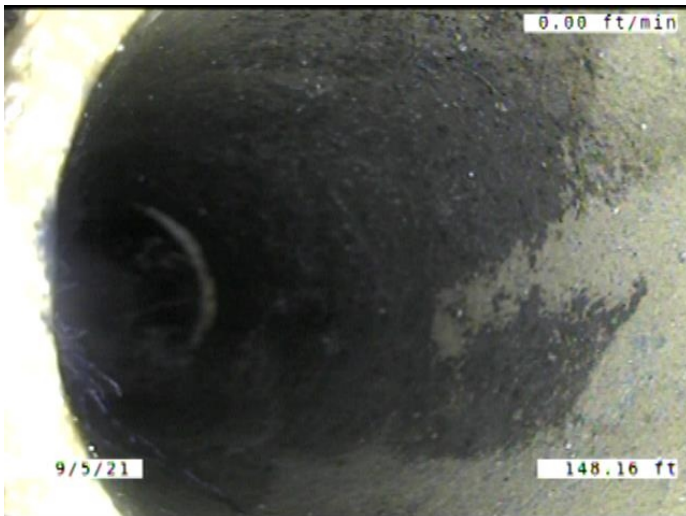
Code: **TBI**
Description: **Tap Break-in Intruding**

Distance (ft): **148.2**
Structural Grade: **0**
O&M Grade: **2**
Clock Start/From: **10**
Clock To:
1st Value: **6.000**
2nd Value: **1.000**
Value Percent:
Continuous Index:
Within 8" of Joint: **NO**
Remarks:

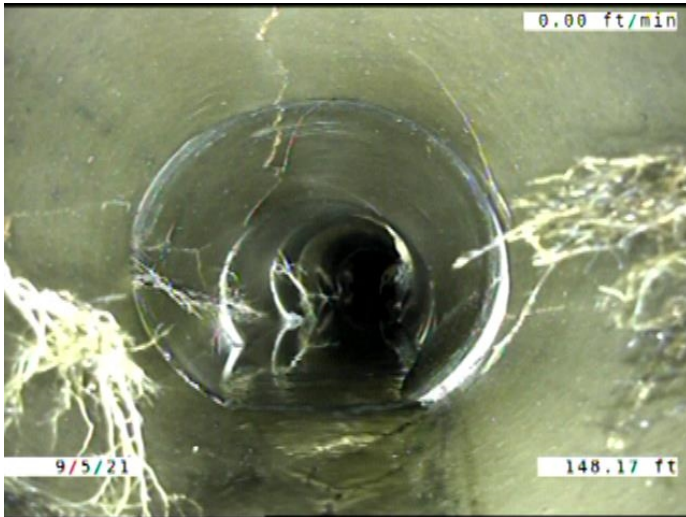
Code: **FH4**
 Description: **Fracture Longitudinal Hinge, 4**

Distance (ft): **148.2**
 Structural Grade: **4**
 O&M Grade: **0**
 Clock Start/From: **12**
 Clock To: **12**
 1st Value:
 2nd Value:
 Value Percent:
 Continuous Index: **F06**
 Within 8" of Joint: **YES**
 Remarks:

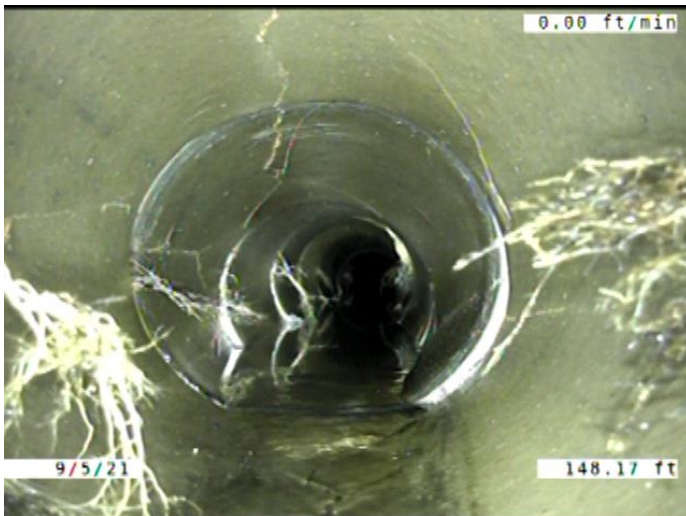
Code: **FM**
 Description: **Fracture Multiple**

Distance (ft): **148.2**
 Structural Grade: **4**
 O&M Grade: **0**
 Clock Start/From: **12**
 Clock To: **12**
 1st Value:
 2nd Value:
 Value Percent:
 Continuous Index: **S07**
 Within 8" of Joint: **YES**
 Remarks:

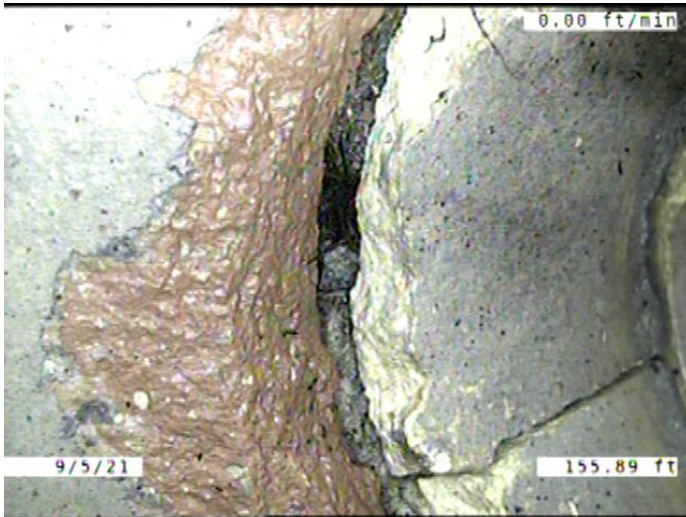
Code: **B**
 Description: **Broken**

Distance (ft): **155.9**
 Structural Grade: **4**
 O&M Grade: **0**
 Clock Start/From: **1**
 Clock To: **2**
 1st Value:
 2nd Value:
 Value Percent:
 Continuous Index:
 Within 8" of Joint: **YES**
 Remarks:

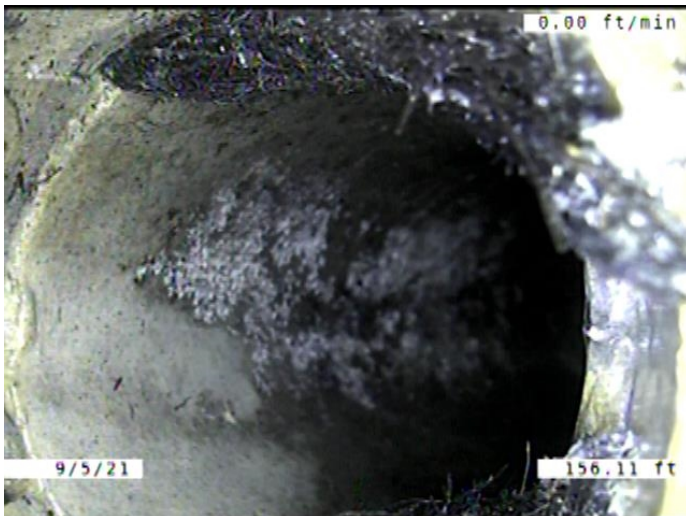
Code: **TBI**
 Description: **Tap Break-in Intruding**

Distance (ft): **156.1**
 Structural Grade: **0**
 O&M Grade: **2**
 Clock Start/From: **2**
 Clock To:
 1st Value: **6.000**
 2nd Value: **1.000**
 Value Percent:
 Continuous Index:
 Within 8" of Joint: **YES**
 Remarks:

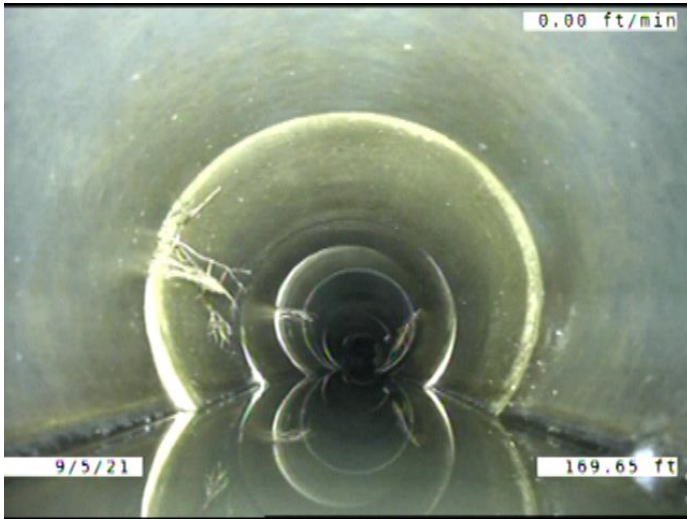
Code: **FM**
 Description: **Fracture Multiple**

Distance (ft): **169.6**
 Structural Grade: **4**
 O&M Grade: **0**
 Clock Start/From: **12**
 Clock To: **12**
 1st Value:
 2nd Value:
 Value Percent:
 Continuous Index: **F07**
 Within 8" of Joint: **YES**
 Remarks:

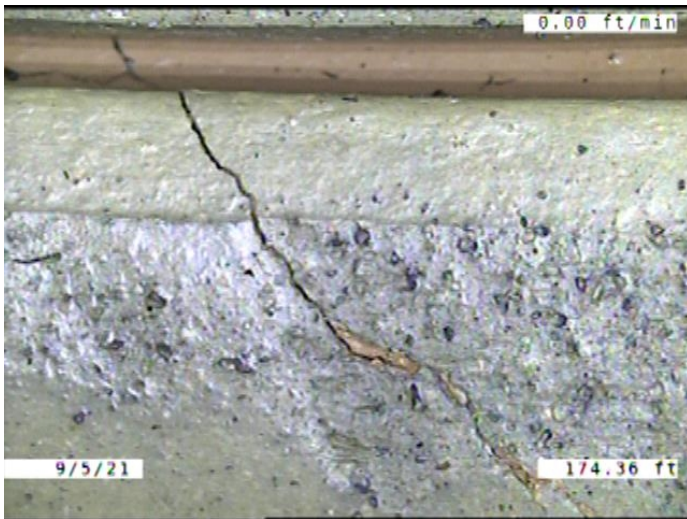
Code: **CM**
 Description: **Crack Multiple**

Distance (ft): **174.4**
 Structural Grade: **3**
 O&M Grade: **0**
 Clock Start/From: **12**
 Clock To: **2**
 1st Value:
 2nd Value:
 Value Percent:
 Continuous Index:
 Within 8" of Joint: **YES**
 Remarks:

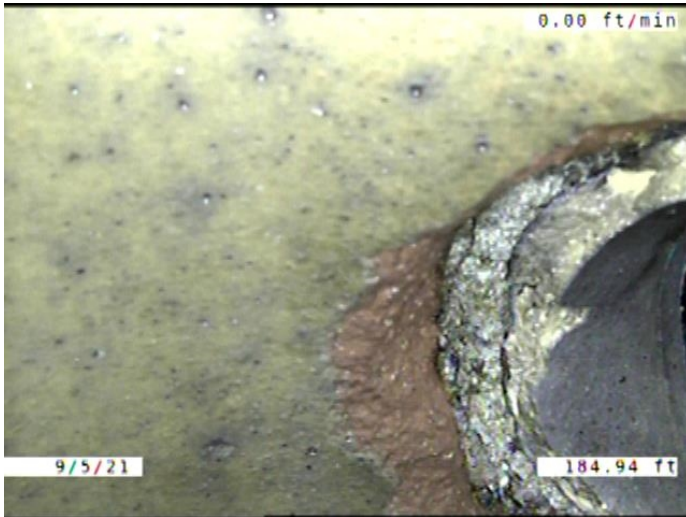
Code: **FM**
 Description: **Fracture Multiple**

Distance (ft): **184.9**
 Structural Grade: **4**
 O&M Grade: **0**
 Clock Start/From: **11**
 Clock To: **4**
 1st Value:
 2nd Value:
 Value Percent:
 Continuous Index:
 Within 8" of Joint: **YES**
 Remarks:

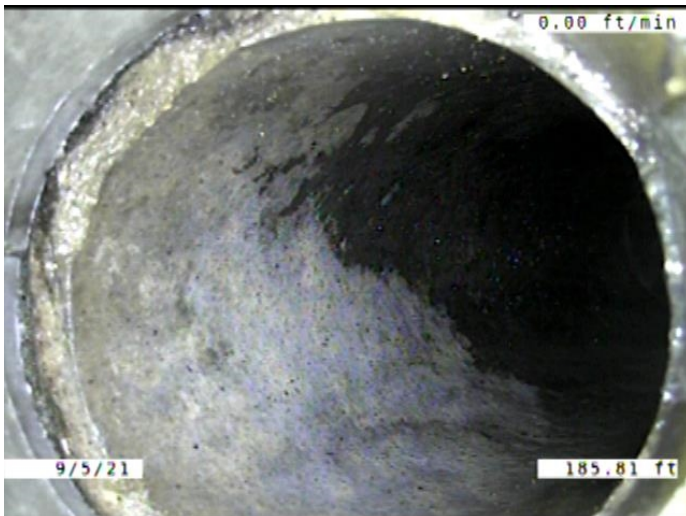
Code: **TBI**
 Description: **Tap Break-in Intruding**

Distance (ft): **185.8**
 Structural Grade: **0**
 O&M Grade: **2**
 Clock Start/From: **2**
 Clock To:
 1st Value: **6.000**
 2nd Value: **1.000**
 Value Percent:
 Continuous Index:
 Within 8" of Joint: **YES**
 Remarks:

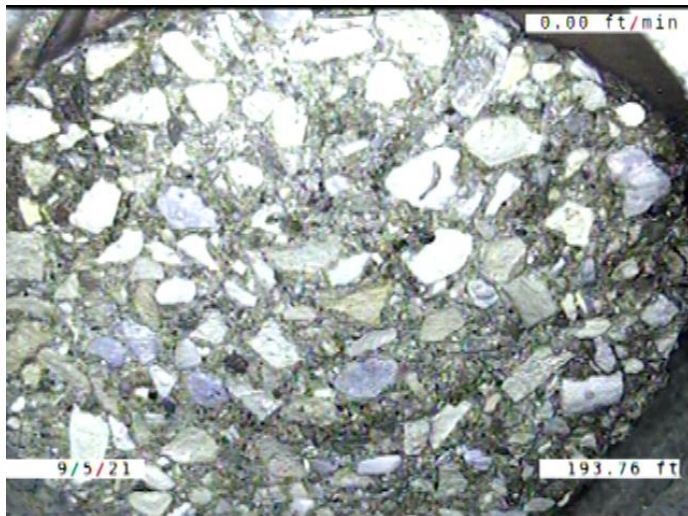
Code: **TFD**
 Description: **Tap Factory Defective**

Distance (ft): **193.8**
 Structural Grade: **0**
 O&M Grade: **3**
 Clock Start/From: **1**
 Clock To:
 1st Value: **6.000**
 2nd Value:
 Value Percent:
 Continuous Index:
 Within 8" of Joint: **YES**
 Remarks: **LOOKS LIKE SOMEONE TRIED TO PLUG IT/ CAP IT.**

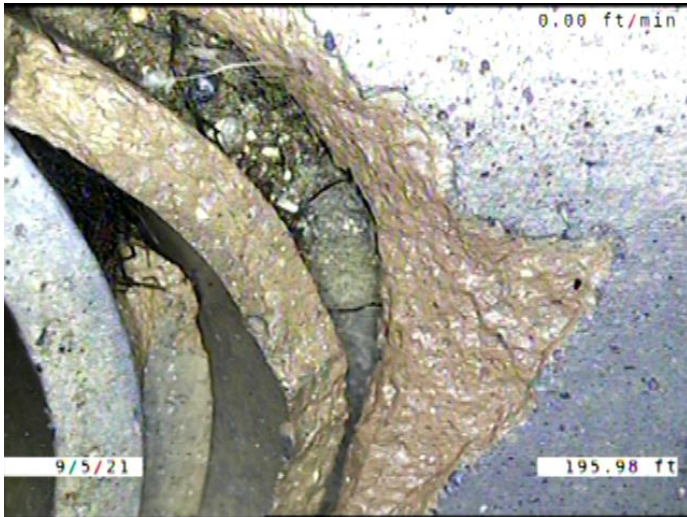
Code: **SSS**
 Description: **Surface Damage Surface Spalling**

Distance (ft): **196.0**
 Structural Grade: **2**
 O&M Grade: **0**
 Clock Start/From: **9**
 Clock To: **11**
 1st Value:
 2nd Value:
 Value Percent:
 Continuous Index:
 Within 8" of Joint: **NO**
 Remarks:

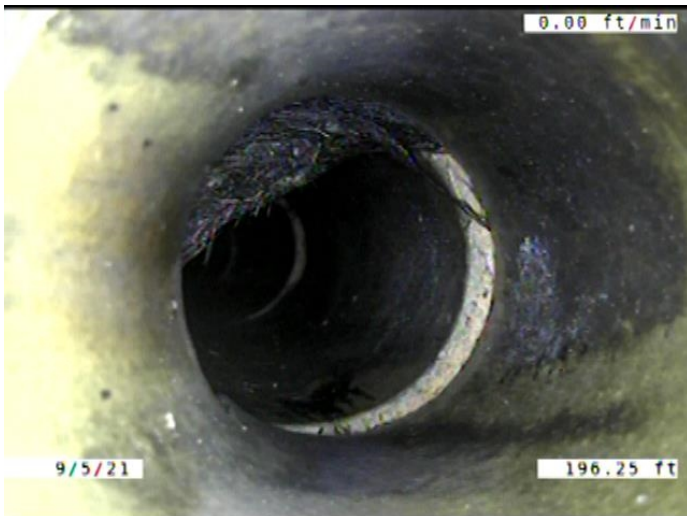
Code: **TBI**
 Description: **Tap Break-in Intruding**

Distance (ft): **196.2**
 Structural Grade: **0**
 O&M Grade: **2**
 Clock Start/From: **10**
 Clock To:
 1st Value: **6.000**
 2nd Value: **1.000**
 Value Percent:
 Continuous Index:
 Within 8" of Joint: **NO**
 Remarks:

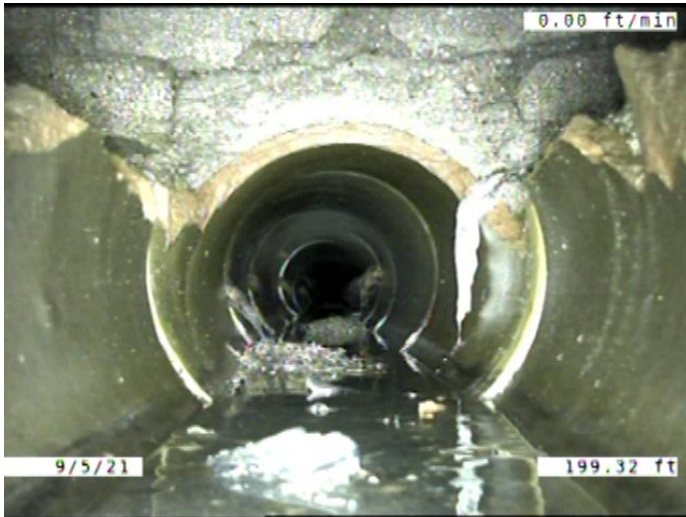
Code: **RMJ**
 Description: **Roots Medium Joint**

Distance (ft): **199.3**
 Structural Grade: **0**
 O&M Grade: **3**
 Clock Start/From: **3**
 Clock To: **5**
 1st Value:
 2nd Value:
 Value Percent: **5.000**
 Continuous Index: **F05**
 Within 8" of Joint: **YES**
 Remarks:

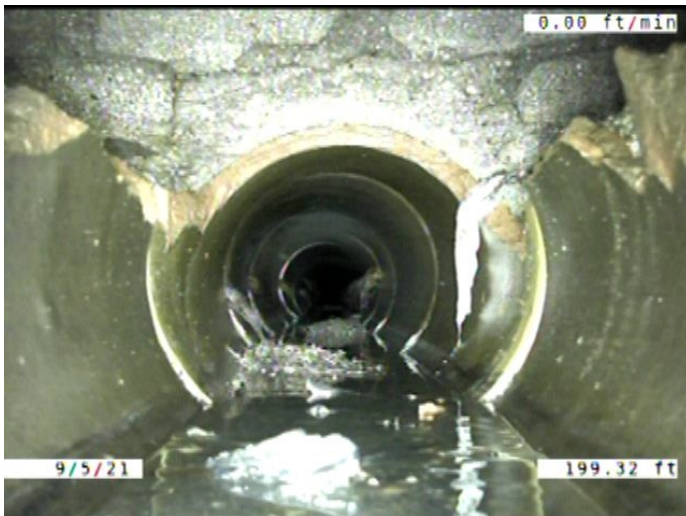
Code: **RMJ**
 Description: **Roots Medium Joint**

Distance (ft): **199.3**
 Structural Grade: **0**
 O&M Grade: **3**
 Clock Start/From: **8**
 Clock To: **10**
 1st Value:
 2nd Value:
 Value Percent: **5.000**
 Continuous Index: **F04**
 Within 8" of Joint: **YES**
 Remarks:

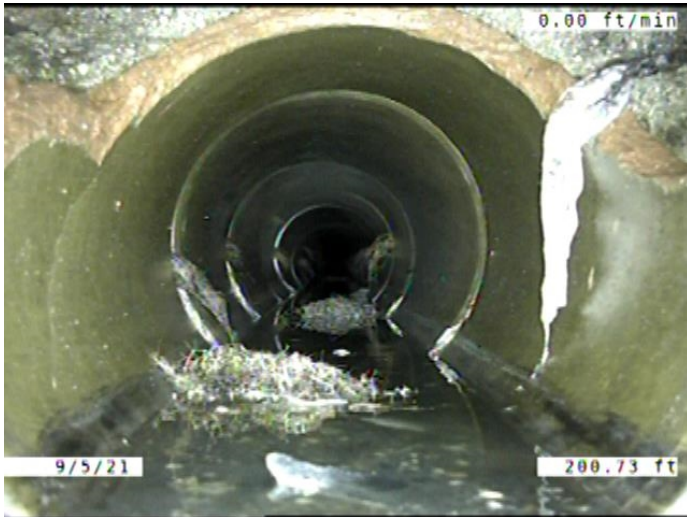
Code: **DSF**
 Description: **Deposits Settled Fine**

Distance (ft): **200.7**
 Structural Grade: **0**
 O&M Grade: **2**
 Clock Start/From: **5**
 Clock To: **7**
 1st Value:
 2nd Value:
 Value Percent: **5.000**
 Continuous Index: **F02**
 Within 8" of Joint: **YES**
 Remarks:
