Profile/Photo Observation Report

Date:	04/17/2018	Weather:		Coding:	PACP 6.0
Pipe Length (ft):	211.6	Owner:	NA	Pre Clean:	Not Known
P.O.#:		Surveyor:	Byrd Fitzgerald	PSR:	P-504-120-119
Customer:		Clean Date:	01/01/1900	Shape:	C

Street:	ALLEY BETWEEN N COLORADO ST &	Flow Control:	Not Controlled
City:	Hobart, IN	Year Renewed:	
Location:	Light Highway	Tape/Media #:	
Purpose:	Not Known	Dia/Height:	12"
Use:	Sanitary	Material:	VCP
Drain Area:	NA	Lining:	
Category:	NA		
Comment:

Location Details:		Direction of Survey:	Upstream
US MH:	M-504-119	DS MH:	M-504-120
		Total Length Surveyed (ft):	56.1

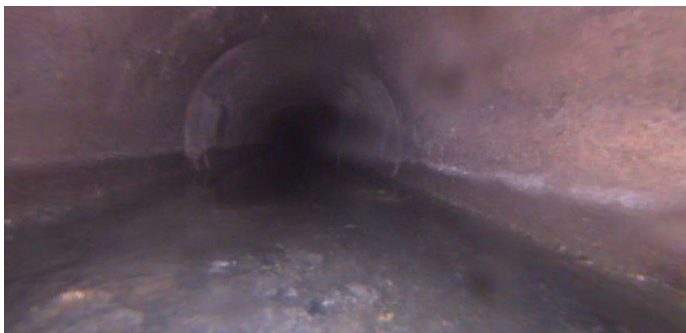
Code: **AMH**
Description: **Manhole**

Distance (ft): **.0**
Structural Grade: **0**
O&M Grade: **0**
Clock Start/From:
Clock To:
1st Value:
2nd Value:
Value Percent:
Continuous Index:
Within 8" of Joint: **NO**
Remarks: **M-504-119**

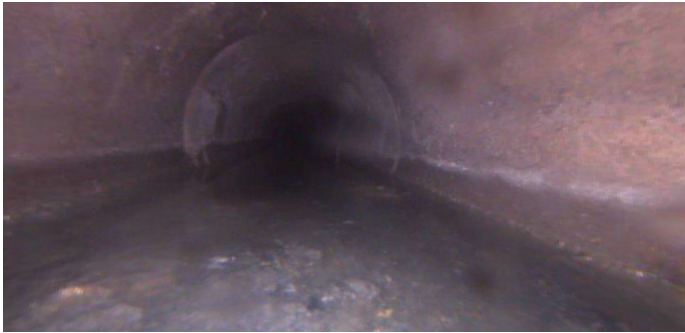
Code:	MWL
Description:	Water Level

Distance (ft):	.0
Structural Grade:	0
O&M Grade:	0
Clock Start/From:	
Clock To:	
1st Value:	
2nd Value:	
Value Percent:	5.000
Continuous Index:	
Within 8" of Joint:	NO
Remarks:

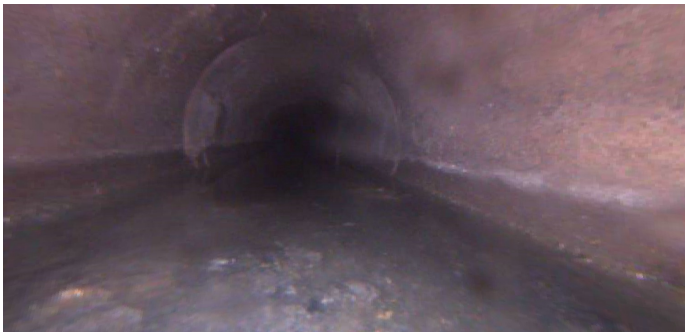
Code:	DSZ
Description:	Deposits Settled Other

Distance (ft):	.0
Structural Grade:	0
O&M Grade:	2
Clock Start/From:	6
Clock To:	
1st Value:	
2nd Value:	
Value Percent:	5.000
Continuous Index:	S01
Within 8" of Joint:	NO
Remarks:	debris/sediments

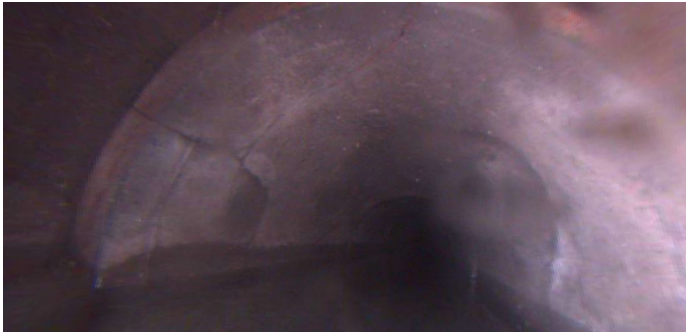
Code: **CM**
Description: **Crack Multiple**

Distance (ft): **2.5**
Structural Grade: **3**
O&M Grade: **0**
Clock Start/From: **7**
Clock To: **12**
1st Value:
2nd Value:
Value Percent:
Continuous Index: **S02**
Within 8" of Joint: **YES**
Remarks: **wandering**

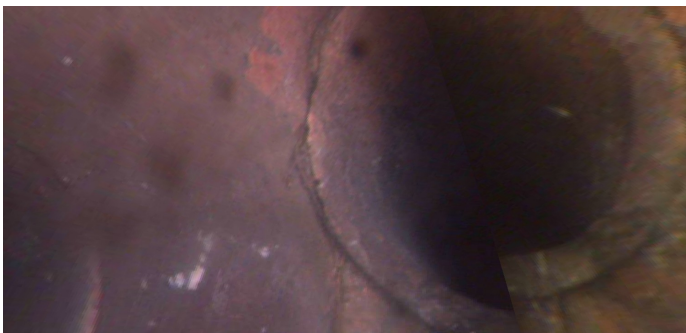
Code: **TB**
Description: **Tap Break-in**

Distance (ft): **19.9**
Structural Grade: **0**
O&M Grade: **0**
Clock Start/From: **2**
Clock To:
1st Value: **4.000**
2nd Value:
Value Percent:
Continuous Index:
Within 8" of Joint:
Remarks:

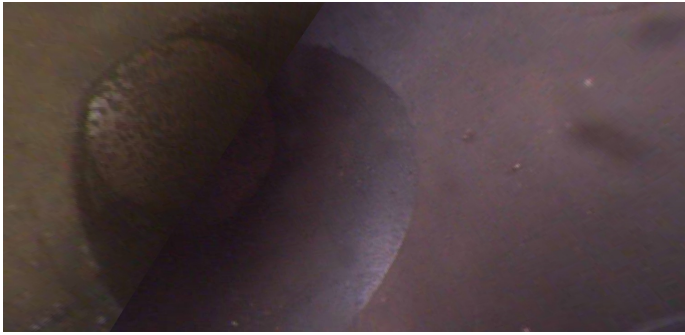
Code: **TFC**
Description: **Tap Factory Capped**

Distance (ft): **48.9**
Structural Grade: **0**
O&M Grade: **0**
Clock Start/From: **10**
Clock To:
1st Value: **4.000**
2nd Value:
Value Percent:
Continuous Index:
Within 8" of Joint: **YES**
Remarks:

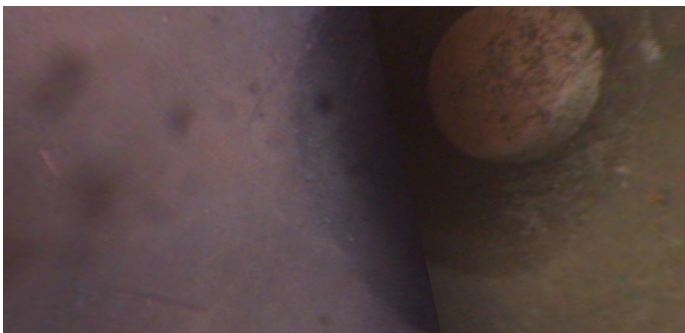
Code: **TFC**
Description: **Tap Factory Capped**

Distance (ft): **51.3**
Structural Grade: **0**
O&M Grade: **0**
Clock Start/From: **2**
Clock To:
1st Value: **4.000**
2nd Value:
Value Percent:
Continuous Index:
Within 8" of Joint: **YES**
Remarks:

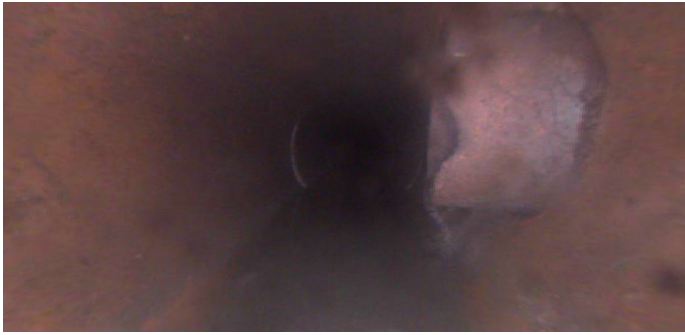
Code: **TBI**
Description: **Tap Break-in Intruding**

Distance (ft): **54.3**
Structural Grade: **0**
O&M Grade: **2**
Clock Start/From: **3**
Clock To:
1st Value: **4.000**
2nd Value: **3.000**
Value Percent:
Continuous Index:
Within 8" of Joint:
Remarks:

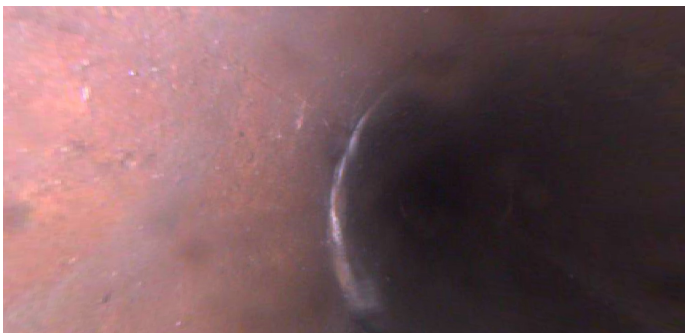
Code: **MSA**
Description: **Abandoned Survey**

Distance (ft): **56.1**
Structural Grade: **0**
O&M Grade: **0**
Clock Start/From:
Clock To:
1st Value:
2nd Value:
Value Percent:
Continuous Index:
Within 8" of Joint: **NO**
Remarks: **tbi**

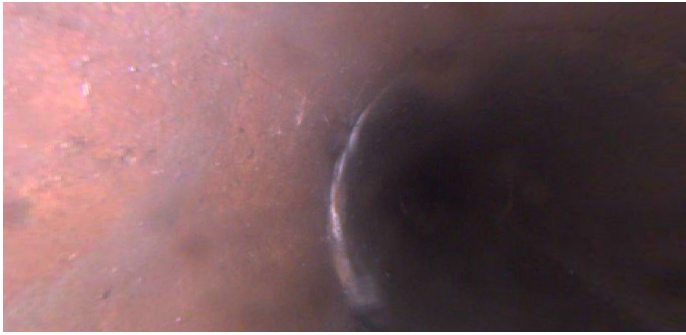
Code: **CM**
Description: **Crack Multiple**

Distance (ft): **56.1**
Structural Grade: **3**
O&M Grade: **0**
Clock Start/From: **7**
Clock To: **12**
1st Value:
2nd Value:
Value Percent:
Continuous Index: **F02**
Within 8" of Joint: **YES**
Remarks: **wandering**

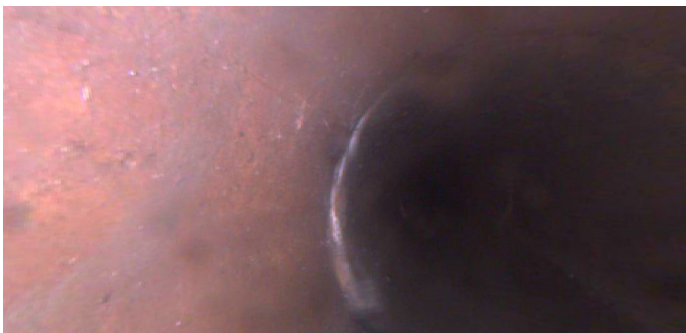
Code: **DSZ**
Description: **Deposits Settled Other**

Distance (ft): **56.1**
Structural Grade: **0**
O&M Grade: **2**
Clock Start/From: **6**
Clock To:
1st Value:
2nd Value:
Value Percent: **5.000**
Continuous Index: **F01**
Within 8" of Joint: **NO**
Remarks: **debris/sediments**
