# Profile/Photo Observation Report

Date:	09/05/2021	Weather:		Coding:	PACP 7.0
Pipe Length (ft):	212.0	Owner:	City of Hobart	Pre Clean:	Heavy Cleaning
P.O.#:	YES502259	Surveyor:	S. Bucklin	PSR:	P-504-120-119
Customer:	City of Hobart	Clean Date:	09/02/2021	Shape:	C

Street:	41st Avenue	Flow Control:	Not Controlled
City:	Hobart, IN	Year Renewed:	
Location:	Alley	Tape/Media #:	
Purpose:	Routine Assessment	Dia/Height:	12"
Use:	Sanitary Sewage Pipe	Material:	VCP
Drain Area:		Lining:	None
Category:	NA		
Comment:			
Location Details:		Direction of Survey:	Upstream
US MH:	M-504-119	DS MH:	M-504-120
		Total Length Surveyed (ft):	148.7

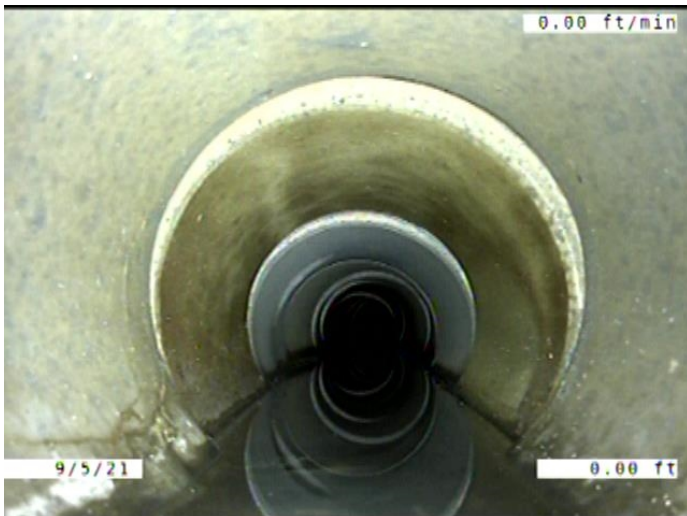
Code: **MWL**  
Description: **Miscellaneous Water Level**

Distance (ft): **.0**  
Structural Grade: **0**  
O&M Grade: **0**  
Clock Start/From:  
Clock To:  
1st Value:  
2nd Value:  
Value Percent: **5.000**  
Continuous Index:  
Within 8" of Joint: **NO**  
Remarks:

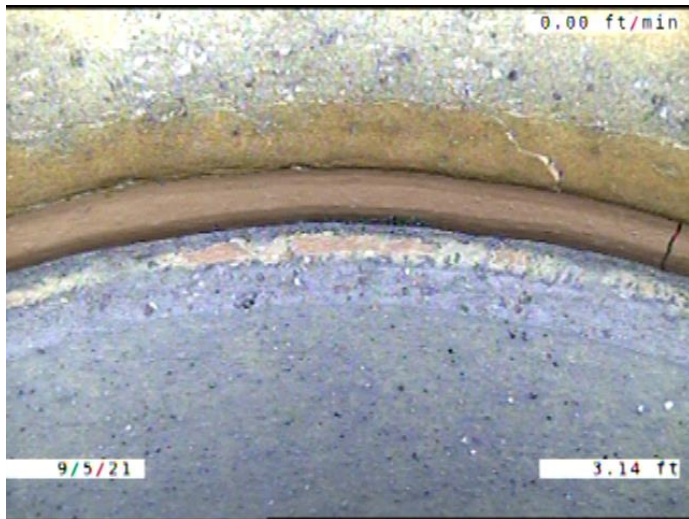
Code: **JOM**  
 Description: **Joint Offset Medium**

Distance (ft): **3.1**  
 Structural Grade: **3**  
 O&M Grade: **0**  
 Clock Start/From:  
 Clock To:  
 1st Value:  
 2nd Value:  
 Value Percent:  
 Continuous Index:  
 Within 8" of Joint: **NO**  
 Remarks:

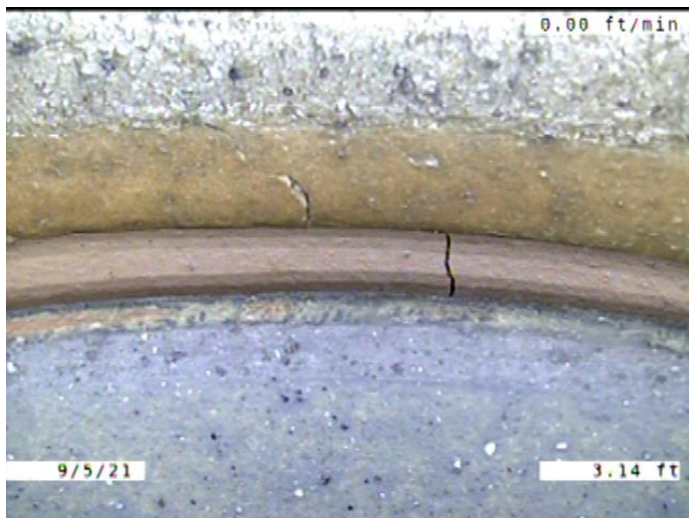
Code: **CM**  
 Description: **Crack Multiple**

Distance (ft): **3.1**  
 Structural Grade: **3**  
 O&M Grade: **0**  
 Clock Start/From: **12**  
 Clock To: **1**  
 1st Value:  
 2nd Value:  
 Value Percent:  
 Continuous Index:  
 Within 8" of Joint: **YES**  
 Remarks:

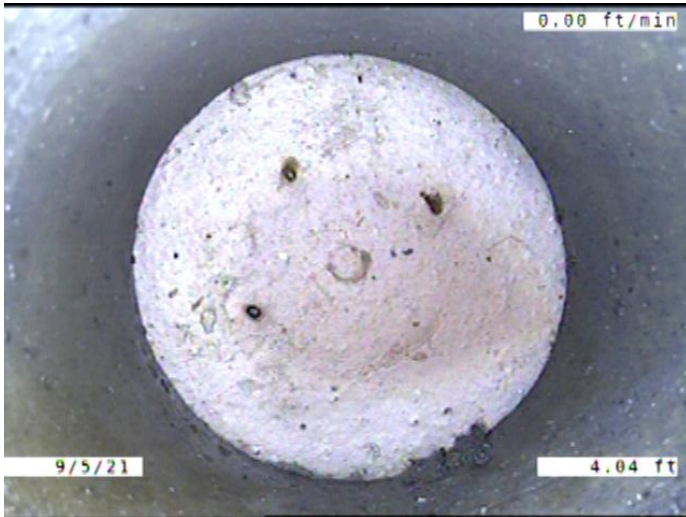
Code: **TFC**  
Description: **Tap Factory Capped**

Distance (ft): **4.0**  
Structural Grade: **0**  
O&M Grade: **0**  
Clock Start/From: **11**  
Clock To:  
1st Value: **6.000**  
2nd Value:  
Value Percent:  
Continuous Index:  
Within 8" of Joint: **YES**  
Remarks:

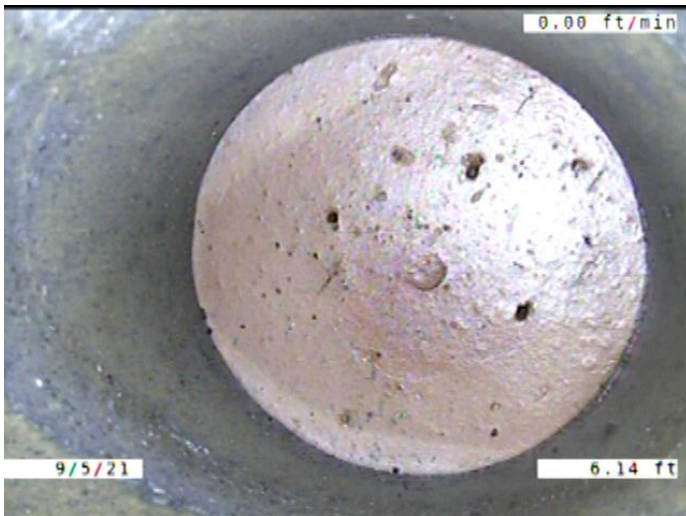
Code: **TFC**  
Description: **Tap Factory Capped**

Distance (ft): **6.1**  
Structural Grade: **0**  
O&M Grade: **0**  
Clock Start/From: **1**  
Clock To:  
1st Value: **6.000**  
2nd Value:  
Value Percent:  
Continuous Index:  
Within 8" of Joint: **YES**  
Remarks:

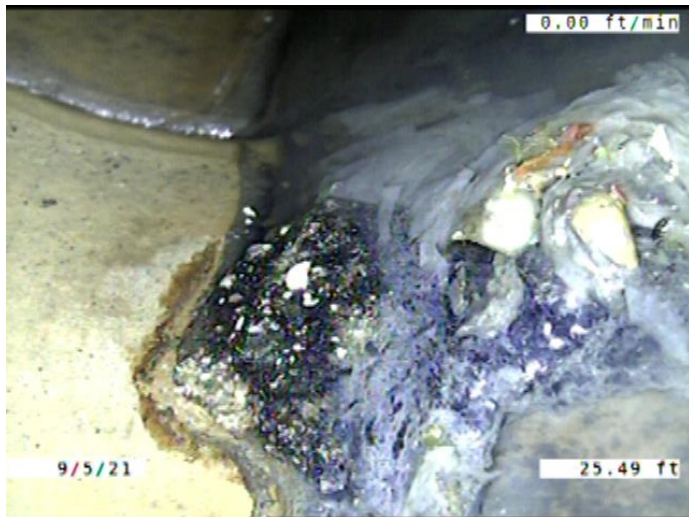
Code: **DAE**  
 Description: **Deposits Attached Encrustation**

Distance (ft): **25.5**  
 Structural Grade: **0**  
 O&M Grade: **2**  
 Clock Start/From: **5**  
 Clock To: **7**  
 1st Value:  
 2nd Value:  
 Value Percent: **5.000**  
 Continuous Index:  
 Within 8" of Joint: **YES**  
 Remarks:

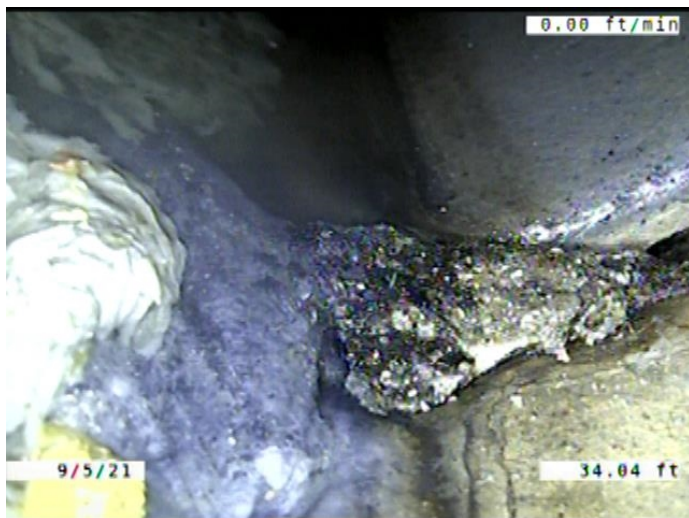
Code: **DAE**  
 Description: **Deposits Attached Encrustation**

Distance (ft): **34.0**  
 Structural Grade: **0**  
 O&M Grade: **2**  
 Clock Start/From: **4**  
 Clock To: **8**  
 1st Value:  
 2nd Value:  
 Value Percent: **5.000**  
 Continuous Index:  
 Within 8" of Joint: **YES**  
 Remarks:

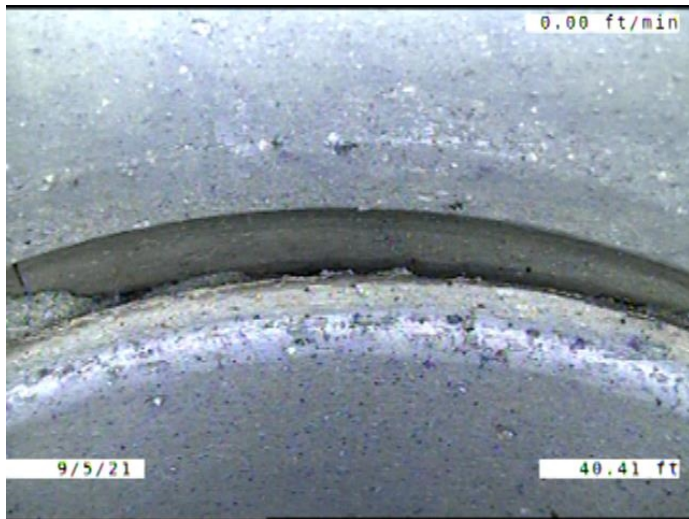
Code: **JOM**  
 Description: **Joint Offset Medium**

Distance (ft): **40.4**  
 Structural Grade: **3**  
 O&M Grade: **0**  
 Clock Start/From:  
 Clock To:  
 1st Value:  
 2nd Value:  
 Value Percent:  
 Continuous Index:  
 Within 8" of Joint: **NO**  
 Remarks:

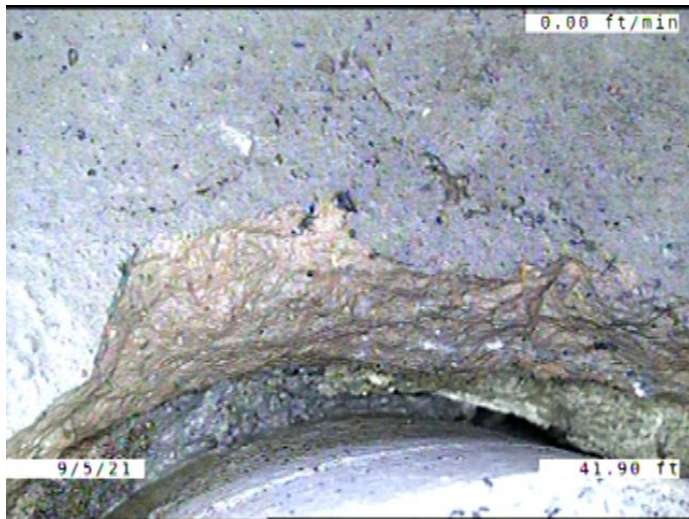
Code: **CM**  
 Description: **Crack Multiple**

Distance (ft): **41.9**  
 Structural Grade: **3**  
 O&M Grade: **0**  
 Clock Start/From: **8**  
 Clock To: **1**  
 1st Value:  
 2nd Value:  
 Value Percent:  
 Continuous Index:  
 Within 8" of Joint: **YES**  
 Remarks:

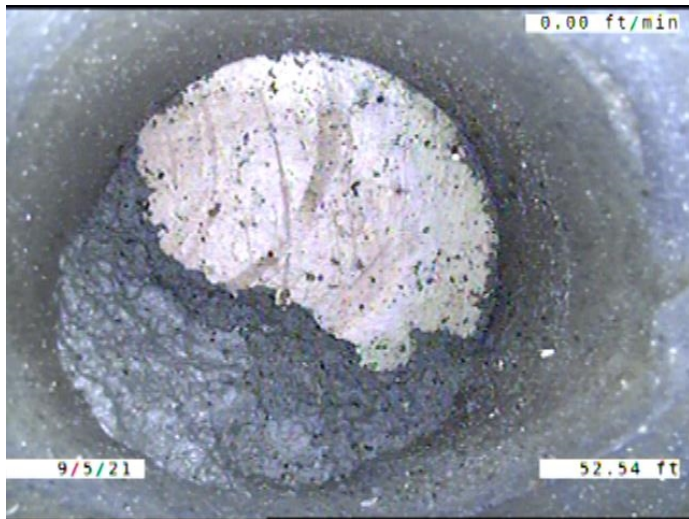
Code: **TFC**  
 Description: **Tap Factory Capped**

Distance (ft): **52.5**  
 Structural Grade: **0**  
 O&M Grade: **0**  
 Clock Start/From: **11**  
 Clock To:  
 1st Value: **6.000**  
 2nd Value:  
 Value Percent:  
 Continuous Index:  
 Within 8" of Joint: **YES**  
 Remarks:

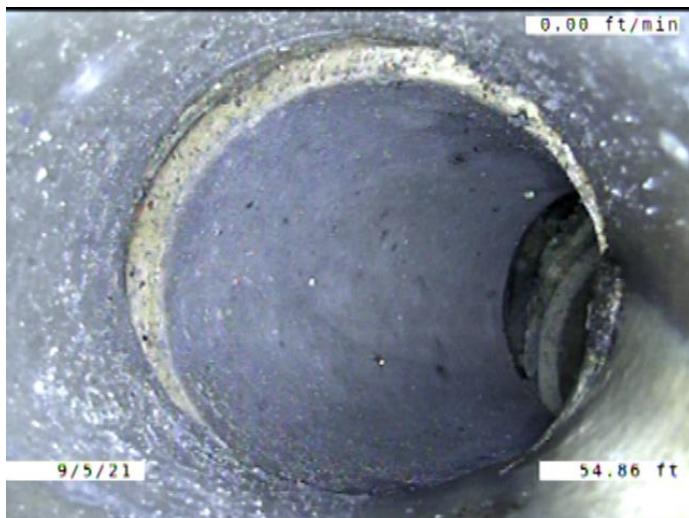
Code: **TFD**  
 Description: **Tap Factory Defective**

Distance (ft): **54.9**  
 Structural Grade: **0**  
 O&M Grade: **3**  
 Clock Start/From: **2**  
 Clock To:  
 1st Value: **6.000**  
 2nd Value:  
 Value Percent:  
 Continuous Index:  
 Within 8" of Joint: **YES**  
 Remarks: **Defective**

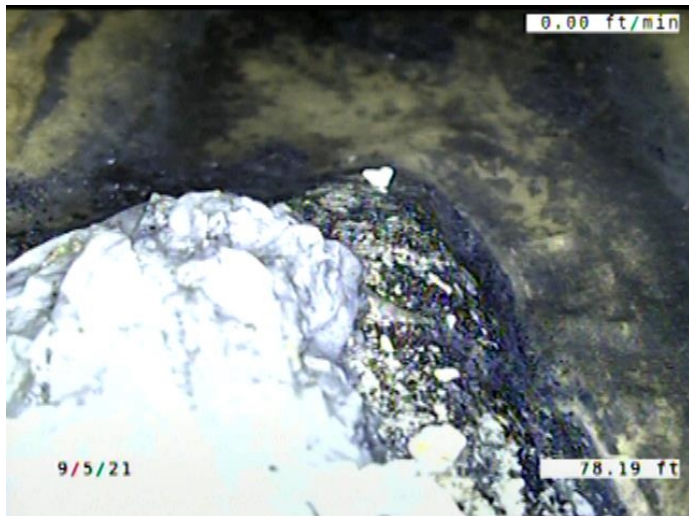
Code: **DSC**  
 Description: **Deposits Settled Hard/Compacted**

Distance (ft): **78.2**  
 Structural Grade: **0**  
 O&M Grade: **2**  
 Clock Start/From: **6**  
 Clock To:  
 1st Value:  
 2nd Value:  
 Value Percent: **5.000**  
 Continuous Index:  
 Within 8" of Joint: **YES**  
 Remarks:

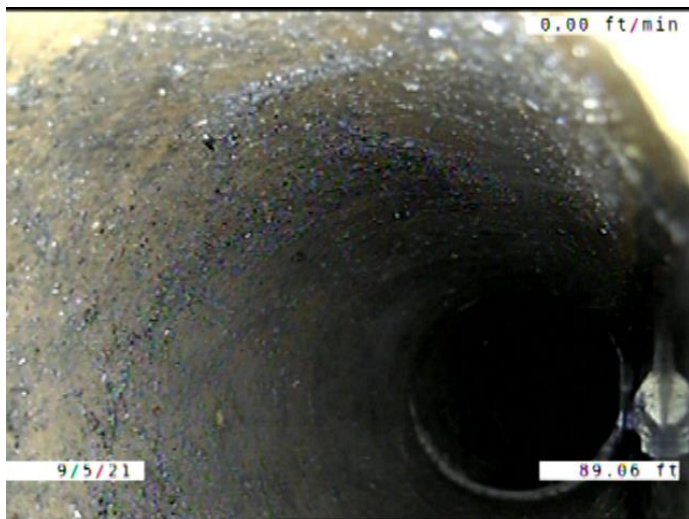
Code: **TBI**  
 Description: **Tap Break-in Intruding**

Distance (ft): **89.1**  
 Structural Grade: **0**  
 O&M Grade: **2**  
 Clock Start/From: **3**  
 Clock To:  
 1st Value: **6.000**  
 2nd Value: **2.000**  
 Value Percent:  
 Continuous Index:  
 Within 8" of Joint: **YES**  
 Remarks:

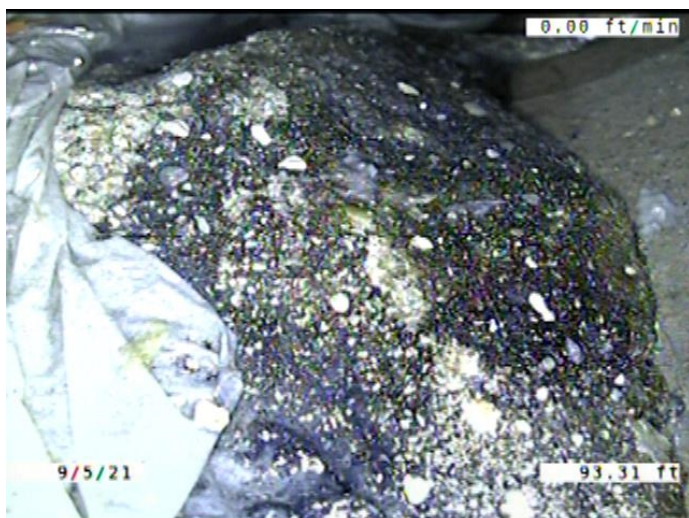
Code: **DSC**  
 Description: **Deposits Settled Hard/Compacted**

Distance (ft): **93.3**  
 Structural Grade: **0**  
 O&M Grade: **2**  
 Clock Start/From: **5**  
 Clock To: **6**  
 1st Value:  
 2nd Value:  
 Value Percent: **5.000**  
 Continuous Index:  
 Within 8" of Joint: **YES**  
 Remarks:

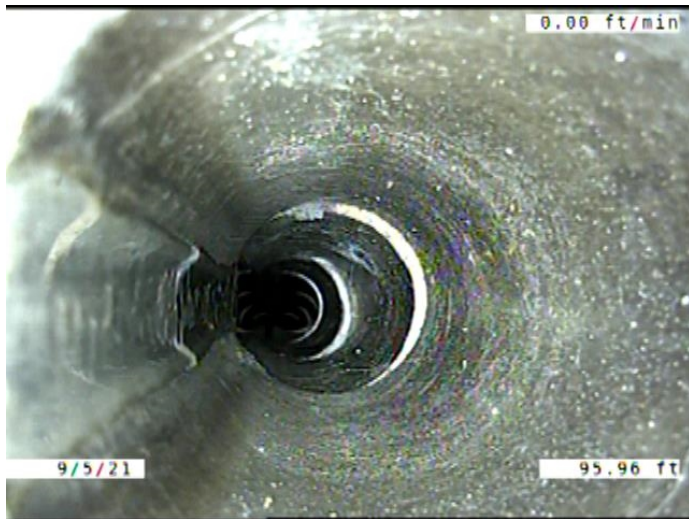
Code: **TBI**  
 Description: **Tap Break-in Intruding**

Distance (ft): **96.0**  
 Structural Grade: **0**  
 O&M Grade: **2**  
 Clock Start/From: **9**  
 Clock To:  
 1st Value: **6.000**  
 2nd Value: **1.000**  
 Value Percent:  
 Continuous Index:  
 Within 8" of Joint: **YES**  
 Remarks:

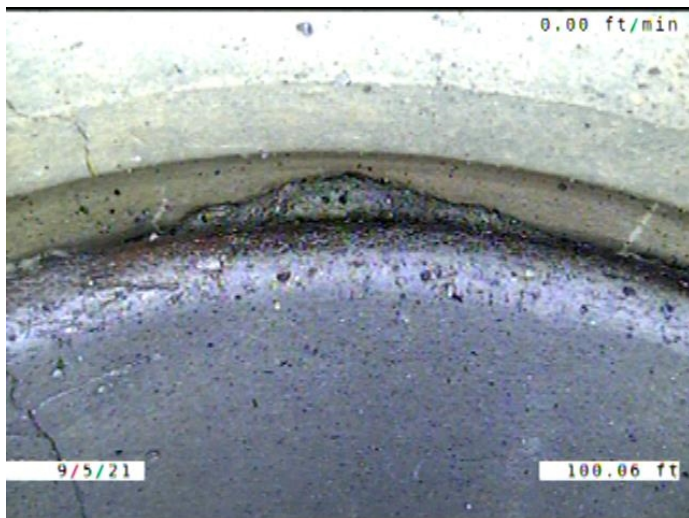
Code: **JOM**  
 Description: **Joint Offset Medium**

Distance (ft): **100.1**  
 Structural Grade: **3**  
 O&M Grade: **0**  
 Clock Start/From:  
 Clock To:  
 1st Value:  
 2nd Value:  
 Value Percent:  
 Continuous Index:  
 Within 8" of Joint: **NO**  
 Remarks:

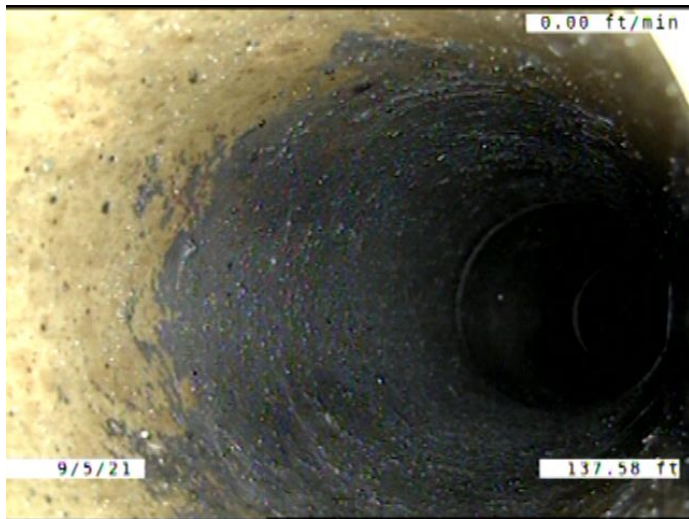
Code: **TBI**  
 Description: **Tap Break-in Intruding**

Distance (ft): **137.6**  
 Structural Grade: **0**  
 O&M Grade: **2**  
 Clock Start/From: **2**  
 Clock To:  
 1st Value: **6.000**  
 2nd Value: **1.000**  
 Value Percent:  
 Continuous Index:  
 Within 8" of Joint: **YES**  
 Remarks:

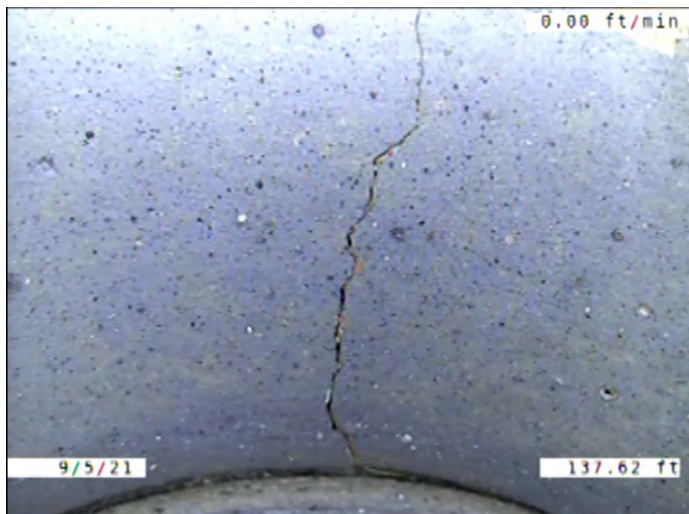
Code: **CL**  
 Description: **Crack Longitudinal**

Distance (ft): **137.6**  
 Structural Grade: **2**  
 O&M Grade: **0**  
 Clock Start/From: **1**  
 Clock To:  
 1st Value:  
 2nd Value:  
 Value Percent:  
 Continuous Index:  
 Within 8" of Joint: **YES**  
 Remarks:

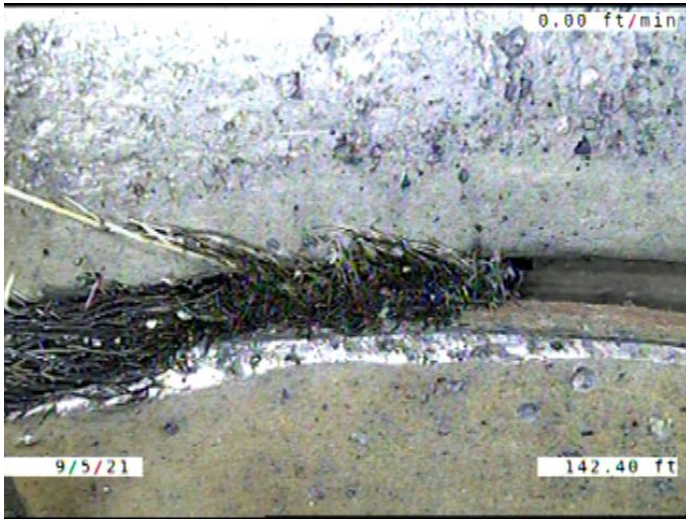
Code: **RFJ**  
Description: **Roots Fine Joint**

Distance (ft): **142.4**  
Structural Grade: **0**  
O&M Grade: **1**  
Clock Start/From: **9**  
Clock To: **10**  
1st Value:  
2nd Value:  
Value Percent:  
Continuous Index: **S04**  
Within 8" of Joint: **YES**  
Remarks:

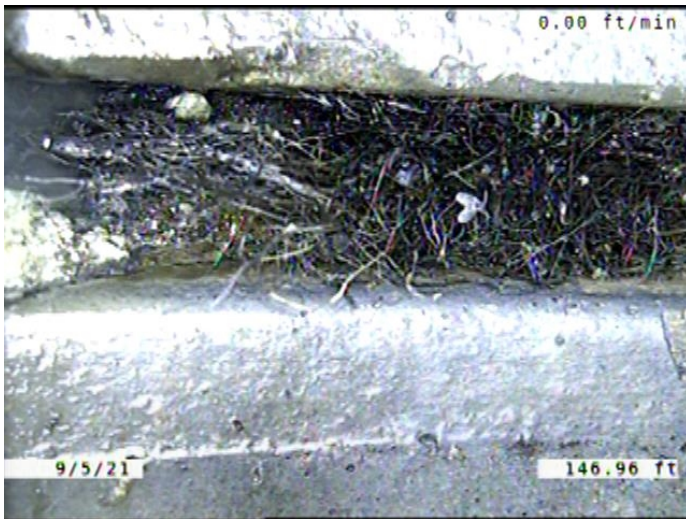
Code: **RFJ**  
Description: **Roots Fine Joint**

Distance (ft): **147.0**  
Structural Grade: **0**  
O&M Grade: **1**  
Clock Start/From: **3**  
Clock To: **4**  
1st Value:  
2nd Value:  
Value Percent:  
Continuous Index:  
Within 8" of Joint: **YES**  
Remarks:

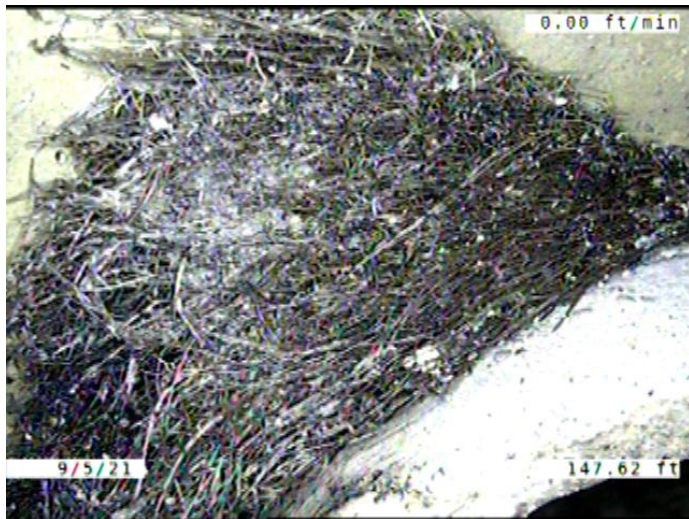
Code: **RML**  
 Description: **Roots Medium Lateral**

Distance (ft): **147.6**  
 Structural Grade: **0**  
 O&M Grade: **3**  
 Clock Start/From: **8**  
 Clock To: **11**  
 1st Value:  
 2nd Value:  
 Value Percent: **10.000**  
 Continuous Index:  
 Within 8" of Joint: **NO**  
 Remarks:

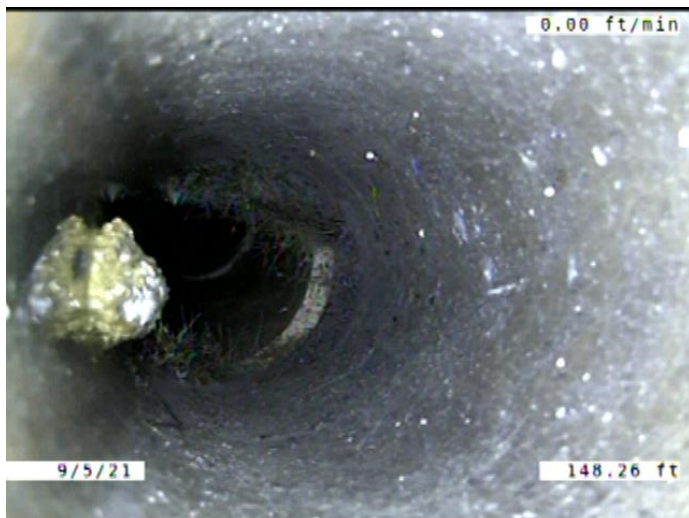
Code: **TBI**  
 Description: **Tap Break-in Intruding**

Distance (ft): **148.3**  
 Structural Grade: **0**  
 O&M Grade: **2**  
 Clock Start/From: **9**  
 Clock To:  
 1st Value: **6.000**  
 2nd Value: **3.000**  
 Value Percent:  
 Continuous Index:  
 Within 8" of Joint: **YES**  
 Remarks:

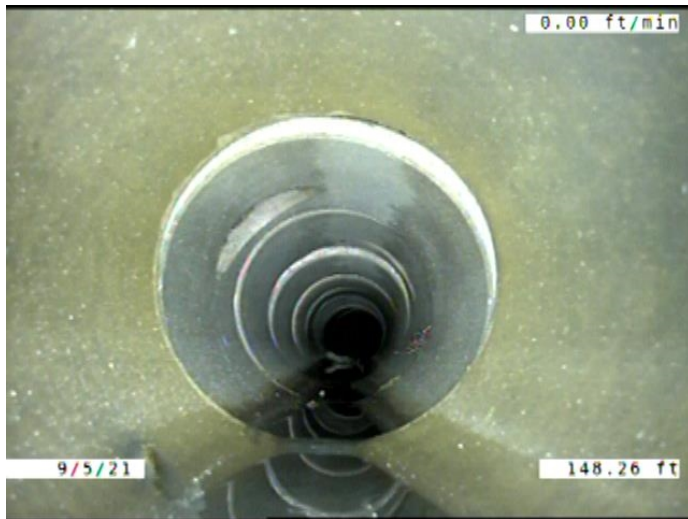
Code: **RFJ**  
 Description: **Roots Fine Joint**

Distance (ft): **148.3**  
 Structural Grade: **0**  
 O&M Grade: **1**  
 Clock Start/From: **9**  
 Clock To: **10**  
 1st Value:  
 2nd Value:  
 Value Percent:  
 Continuous Index: **F04**  
 Within 8" of Joint: **YES**  
 Remarks:

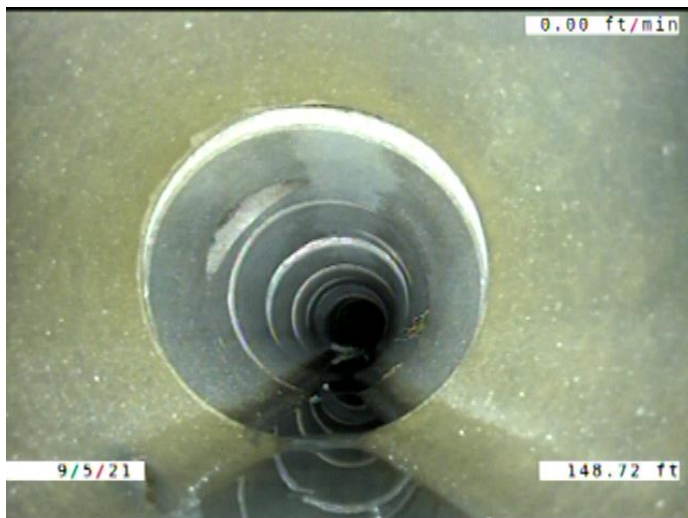
Code: **MWLS**  
 Description: **Miscellaneous Water Level Sag**

Distance (ft): **148.7**  
 Structural Grade: **2**  
 O&M Grade: **0**  
 Clock Start/From:  
 Clock To:  
 1st Value:  
 2nd Value:  
 Value Percent: **15.000**  
 Continuous Index: **F03**  
 Within 8" of Joint: **NO**  
 Remarks:
