# Profile/Photo Observation Report

Date:	<b>09/05/2021</b>	Weather:		Coding:	<b>PACP 7.0</b>
Pipe Length (ft):	<b>212.0</b>	Owner:	<b>City of Hobart</b>	Pre Clean:	<b>Heavy Cleaning</b>
P.O.#:	<b>YES502259</b>	Surveyor:	<b>S. Bucklin</b>	PSR:	<b>P-504-120-119</b>
Customer:	<b>City of Hobart</b>	Clean Date:	<b>09/02/2021</b>	Shape:	<b>C</b>

Street:	<b>41st Avenue</b>	Flow Control:	<b>Not Controlled</b>
City:	<b>Hobart, IN</b>	Year Renewed:	
Location:	<b>Alley</b>	Tape/Media #:	
Purpose:	<b>Routine Assessment</b>	Dia/Height:	<b>12"</b>
Use:	<b>Sanitary Sewage Pipe</b>	Material:	<b>VCP</b>
Drain Area:		Lining:	<b>None</b>
Category:	<b>NA</b>		
Comment:			
Location Details:		Direction of Survey:	<b>Upstream</b>
US MH:	<b>M-504-119</b>	DS MH:	<b>M-504-120</b>
		Total Length Surveyed (ft):	<b>148.7</b>

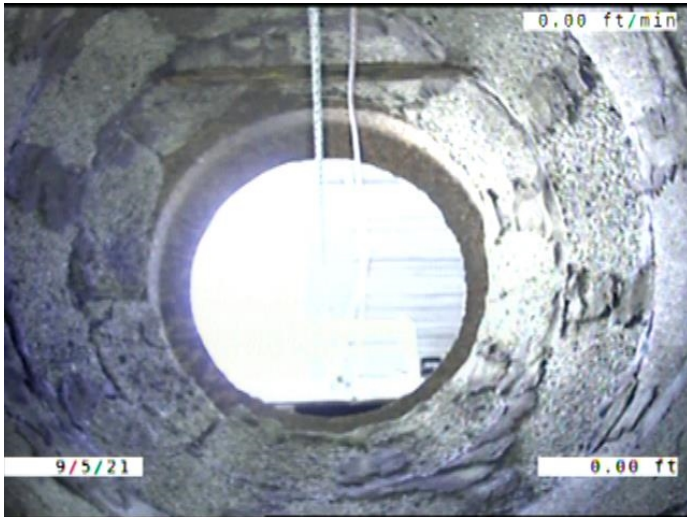
Code: **AMH**  
 Description: **Manhole**

Distance (ft): **.0**  
 Structural Grade: **0**  
 O&M Grade: **0**  
 Clock Start/From:  
 Clock To:  
 1st Value:  
 2nd Value:  
 Value Percent:  
 Continuous Index:  
 Within 8" of Joint: **NO**  
 Remarks: **M-504-120**

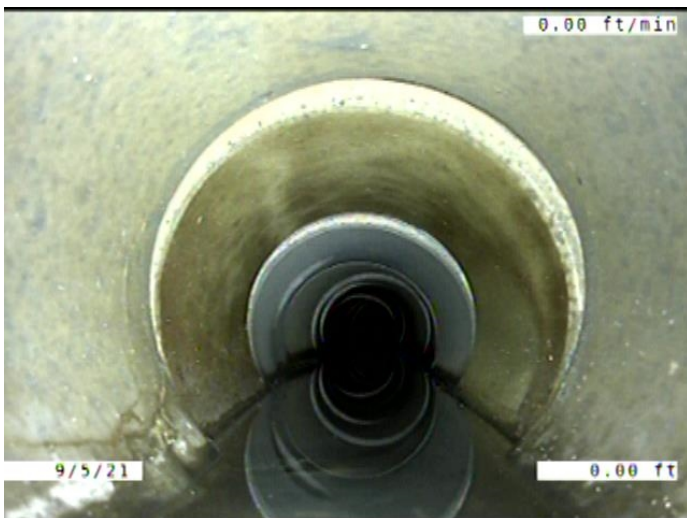
Code: **MWL**  
 Description: **Miscellaneous Water Level**

Distance (ft): **.0**  
 Structural Grade: **0**  
 O&M Grade: **0**  
 Clock Start/From:  
 Clock To:  
 1st Value:  
 2nd Value:  
 Value Percent: **5.000**  
 Continuous Index:  
 Within 8" of Joint: **NO**  
 Remarks:

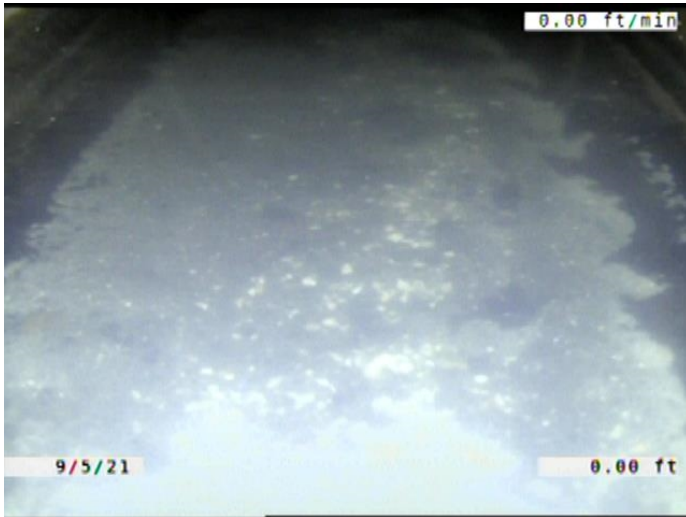
Code: **DSF**  
 Description: **Deposits Settled Fine**

Distance (ft): **.0**  
 Structural Grade: **0**  
 O&M Grade: **2**  
 Clock Start/From: **5**  
 Clock To: **7**  
 1st Value:  
 2nd Value:  
 Value Percent: **5.000**  
 Continuous Index: **S01**  
 Within 8" of Joint: **YES**  
 Remarks:

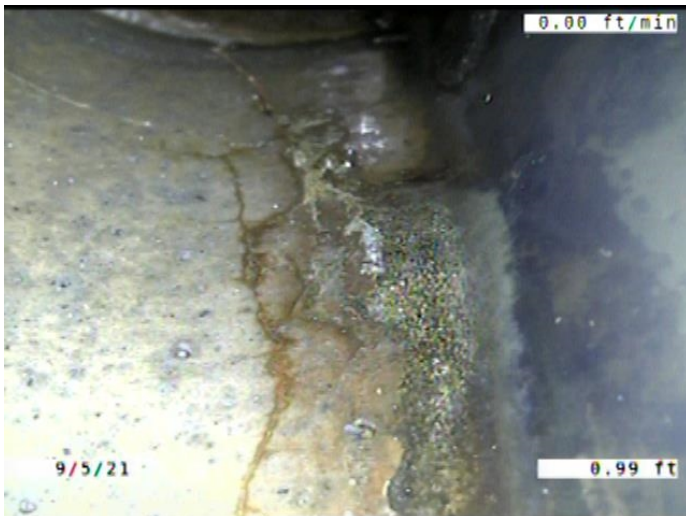
Code: **FM**  
 Description: **Fracture Multiple**

Distance (ft): **1.0**  
 Structural Grade: **4**  
 O&M Grade: **0**  
 Clock Start/From: **4**  
 Clock To: **8**  
 1st Value:  
 2nd Value:  
 Value Percent:  
 Continuous Index:  
 Within 8" of Joint: **YES**  
 Remarks:

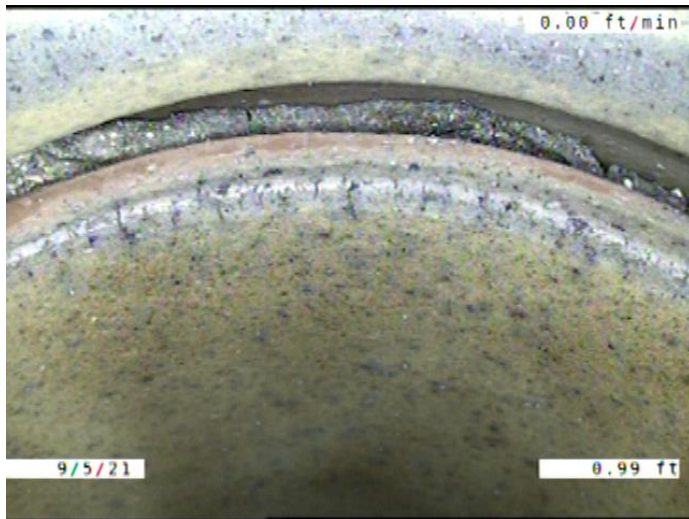
Code: **JOM**  
 Description: **Joint Offset Medium**

Distance (ft): **1.0**  
 Structural Grade: **3**  
 O&M Grade: **0**  
 Clock Start/From:  
 Clock To:  
 1st Value:  
 2nd Value:  
 Value Percent:  
 Continuous Index:  
 Within 8" of Joint: **NO**  
 Remarks:

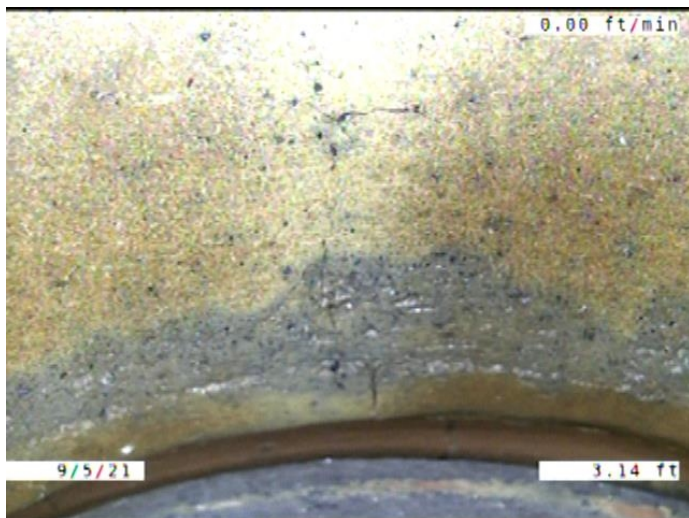
Code: **CM**  
 Description: **Crack Multiple**

Distance (ft): **3.1**  
 Structural Grade: **3**  
 O&M Grade: **0**  
 Clock Start/From: **9**  
 Clock To: **11**  
 1st Value:  
 2nd Value:  
 Value Percent:  
 Continuous Index:  
 Within 8" of Joint: **YES**  
 Remarks:

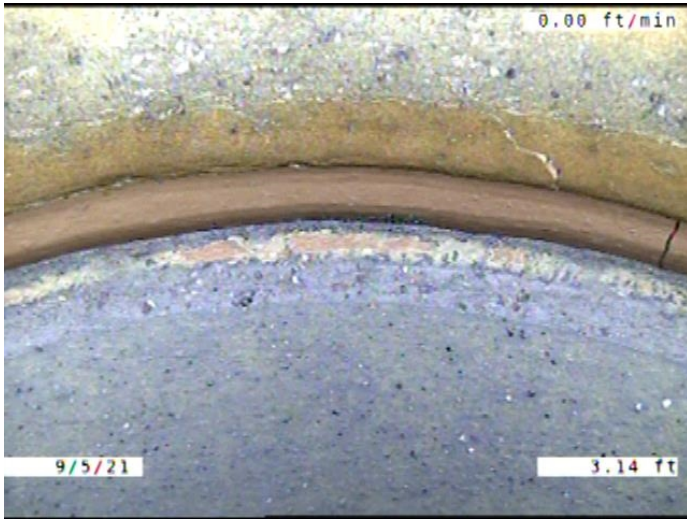
Code: **JOM**  
 Description: **Joint Offset Medium**

Distance (ft): **3.1**  
 Structural Grade: **3**  
 O&M Grade: **0**  
 Clock Start/From:  
 Clock To:  
 1st Value:  
 2nd Value:  
 Value Percent:  
 Continuous Index:  
 Within 8" of Joint: **NO**  
 Remarks:

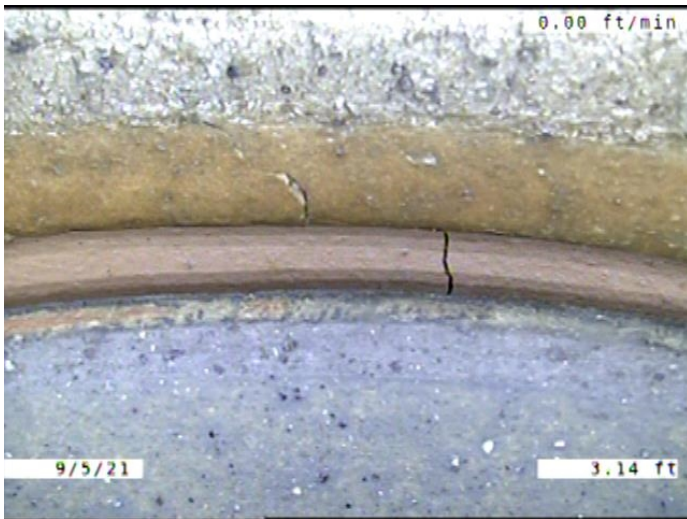
Code: **CM**  
 Description: **Crack Multiple**

Distance (ft): **3.1**  
 Structural Grade: **3**  
 O&M Grade: **0**  
 Clock Start/From: **12**  
 Clock To: **1**  
 1st Value:  
 2nd Value:  
 Value Percent:  
 Continuous Index:  
 Within 8" of Joint: **YES**  
 Remarks:

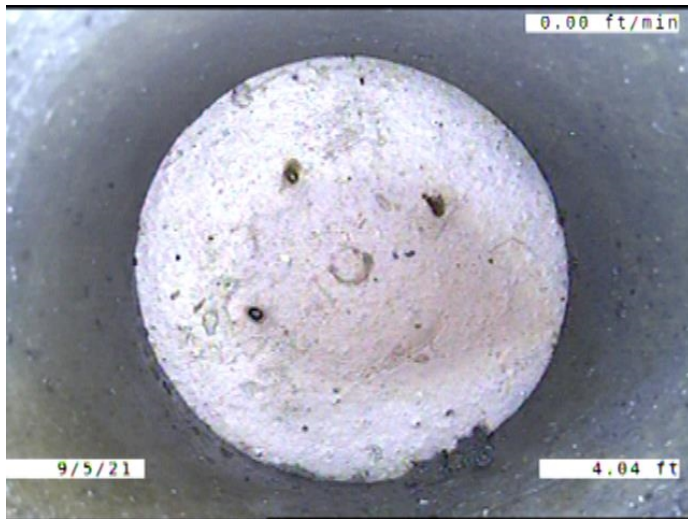
Code: **TFC**  
Description: **Tap Factory Capped**

Distance (ft): **4.0**  
Structural Grade: **0**  
O&M Grade: **0**  
Clock Start/From: **11**  
Clock To:  
1st Value: **6.000**  
2nd Value:  
Value Percent:  
Continuous Index:  
Within 8" of Joint: **YES**  
Remarks:

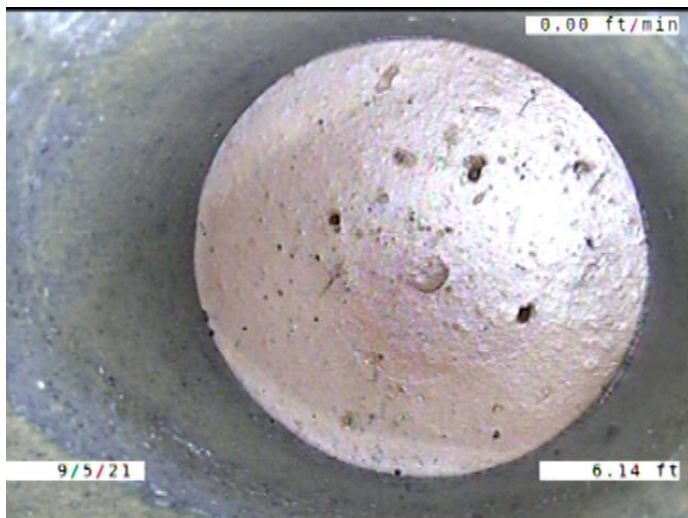
Code: **TFC**  
Description: **Tap Factory Capped**

Distance (ft): **6.1**  
Structural Grade: **0**  
O&M Grade: **0**  
Clock Start/From: **1**  
Clock To:  
1st Value: **6.000**  
2nd Value:  
Value Percent:  
Continuous Index:  
Within 8" of Joint: **YES**  
Remarks:

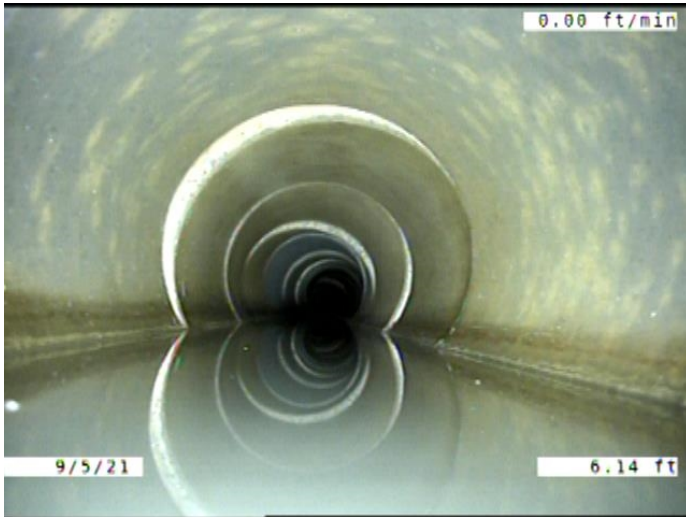
Code: **MWLS**  
Description: **Miscellaneous Water Level Sag**

Distance (ft): **6.1**  
Structural Grade: **2**  
O&M Grade: **0**  
Clock Start/From:  
Clock To:  
1st Value:  
2nd Value:  
Value Percent: **10.000**  
Continuous Index: **S02**  
Within 8" of Joint: **NO**  
Remarks:

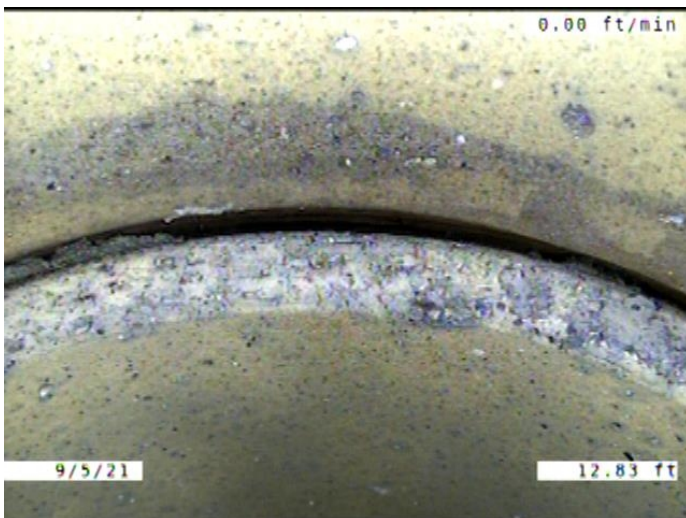
Code: **JOM**  
Description: **Joint Offset Medium**

Distance (ft): **12.8**  
Structural Grade: **3**  
O&M Grade: **0**  
Clock Start/From:  
Clock To:  
1st Value:  
2nd Value:  
Value Percent:  
Continuous Index:  
Within 8" of Joint: **NO**  
Remarks:

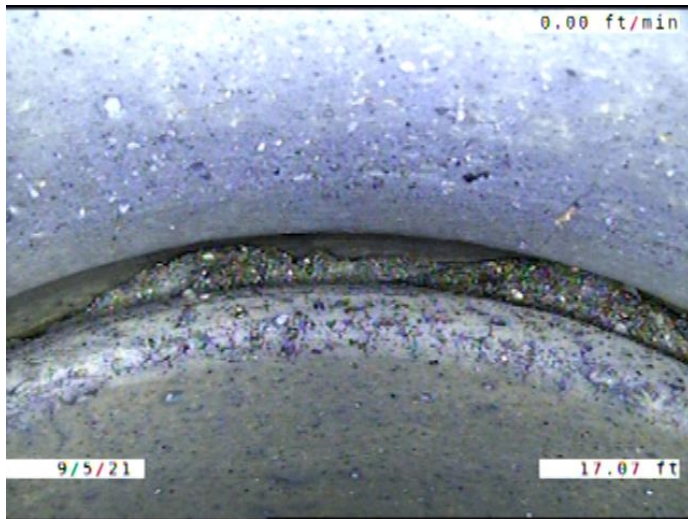
Code: **JOM**  
 Description: **Joint Offset Medium**

Distance (ft): **17.1**  
 Structural Grade: **3**  
 O&M Grade: **0**  
 Clock Start/From:  
 Clock To:  
 1st Value:  
 2nd Value:  
 Value Percent:  
 Continuous Index:  
 Within 8" of Joint: **NO**  
 Remarks:

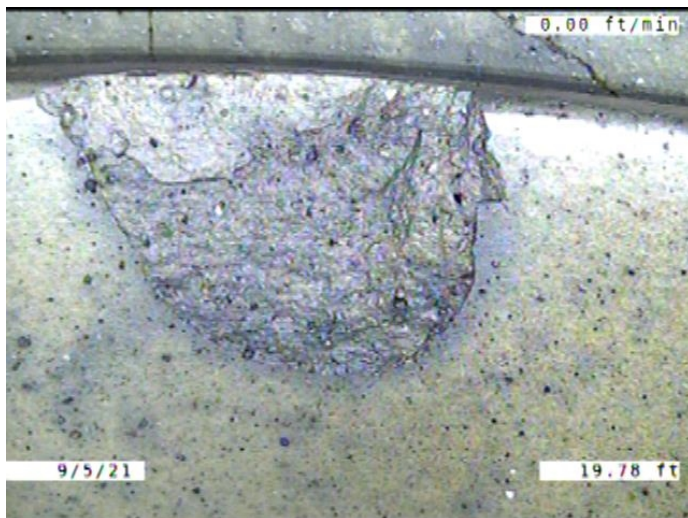
Code: **SSS**  
 Description: **Surface Damage Surface Spalling**

Distance (ft): **19.8**  
 Structural Grade: **2**  
 O&M Grade: **0**  
 Clock Start/From: **3**  
 Clock To:  
 1st Value:  
 2nd Value:  
 Value Percent:  
 Continuous Index:  
 Within 8" of Joint: **YES**  
 Remarks:

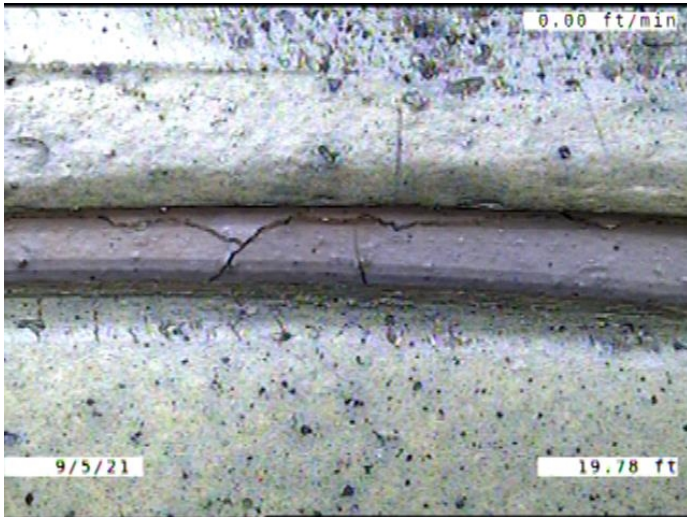
Code: **CM**  
Description: **Crack Multiple**

Distance (ft): **19.8**  
Structural Grade: **3**  
O&M Grade: **0**  
Clock Start/From: **11**  
Clock To: **4**  
1st Value:  
2nd Value:  
Value Percent:  
Continuous Index:  
Within 8" of Joint: **YES**  
Remarks:

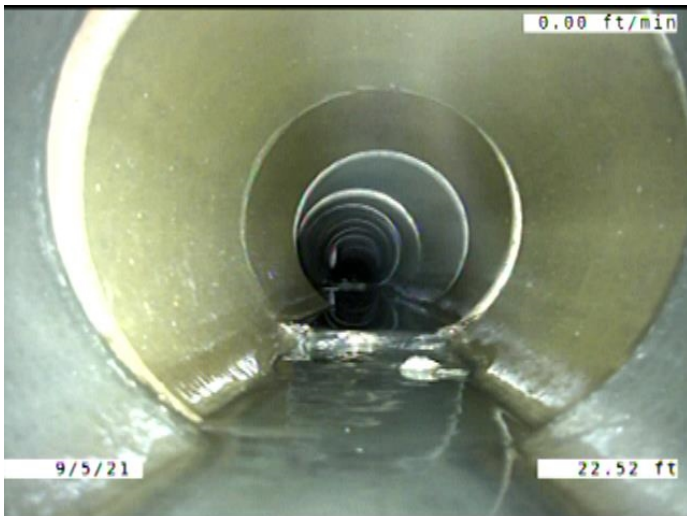
Code: **MWLS**  
Description: **Miscellaneous Water Level Sag**

Distance (ft): **22.5**  
Structural Grade: **2**  
O&M Grade: **0**  
Clock Start/From:  
Clock To:  
1st Value:  
2nd Value:  
Value Percent: **10.000**  
Continuous Index: **F02**  
Within 8" of Joint: **NO**  
Remarks:

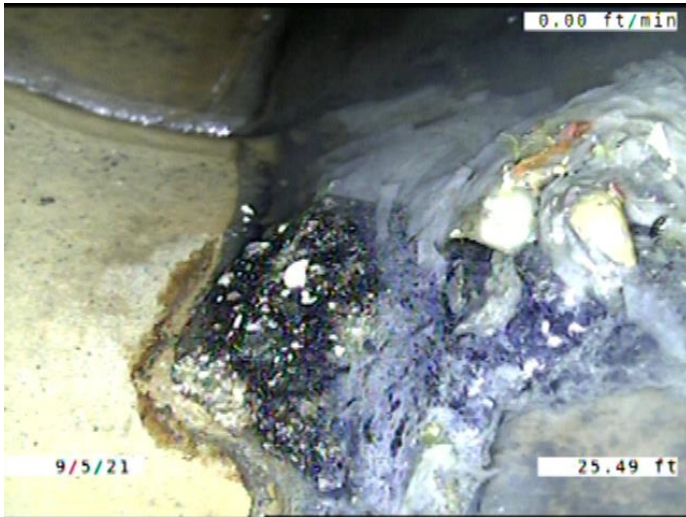
Code: **DAE**  
 Description: **Deposits Attached Encrustation**

Distance (ft): **25.5**  
 Structural Grade: **0**  
 O&M Grade: **2**  
 Clock Start/From: **5**  
 Clock To: **7**  
 1st Value:  
 2nd Value:  
 Value Percent: **5.000**  
 Continuous Index:  
 Within 8" of Joint: **YES**  
 Remarks:

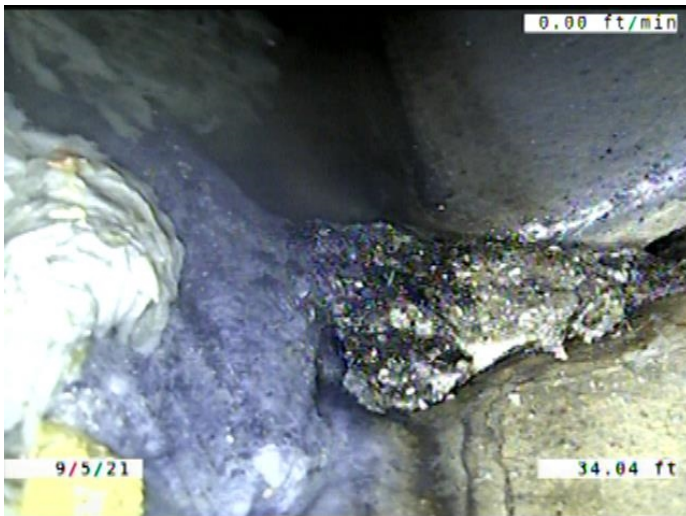
Code: **DAE**  
 Description: **Deposits Attached Encrustation**

Distance (ft): **34.0**  
 Structural Grade: **0**  
 O&M Grade: **2**  
 Clock Start/From: **4**  
 Clock To: **8**  
 1st Value:  
 2nd Value:  
 Value Percent: **5.000**  
 Continuous Index:  
 Within 8" of Joint: **YES**  
 Remarks:

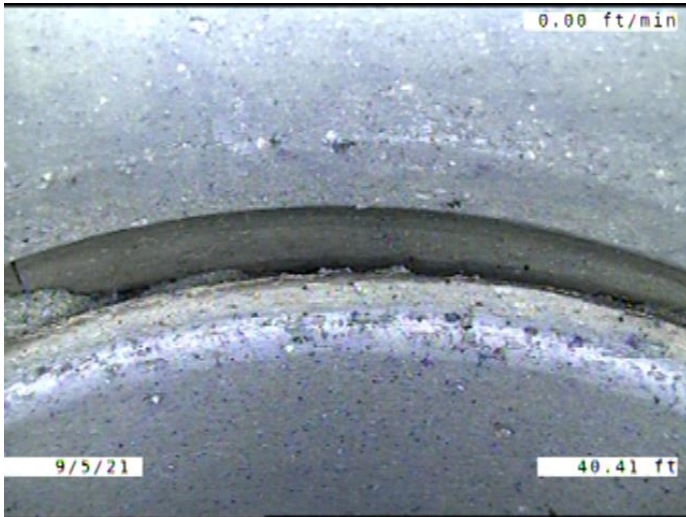
Code: **JOM**  
Description: **Joint Offset Medium**

Distance (ft): **40.4**  
Structural Grade: **3**  
O&M Grade: **0**  
Clock Start/From:  
Clock To:  
1st Value:  
2nd Value:  
Value Percent:  
Continuous Index:  
Within 8" of Joint: **NO**  
Remarks:

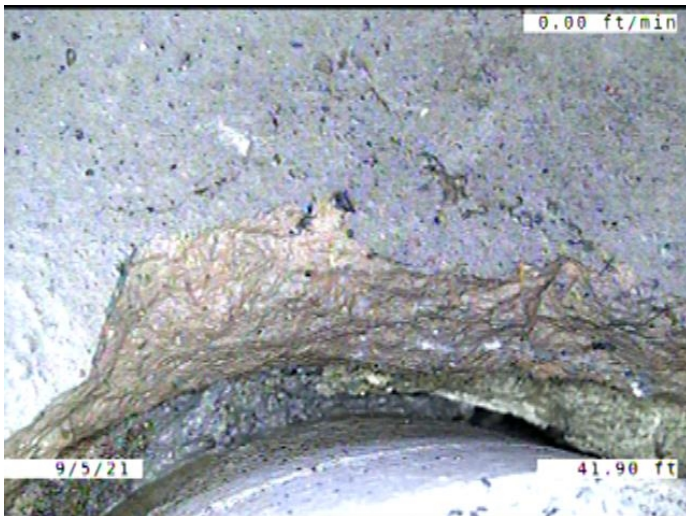
Code: **CM**  
Description: **Crack Multiple**

Distance (ft): **41.9**  
Structural Grade: **3**  
O&M Grade: **0**  
Clock Start/From: **8**  
Clock To: **1**  
1st Value:  
2nd Value:  
Value Percent:  
Continuous Index:  
Within 8" of Joint: **YES**  
Remarks:

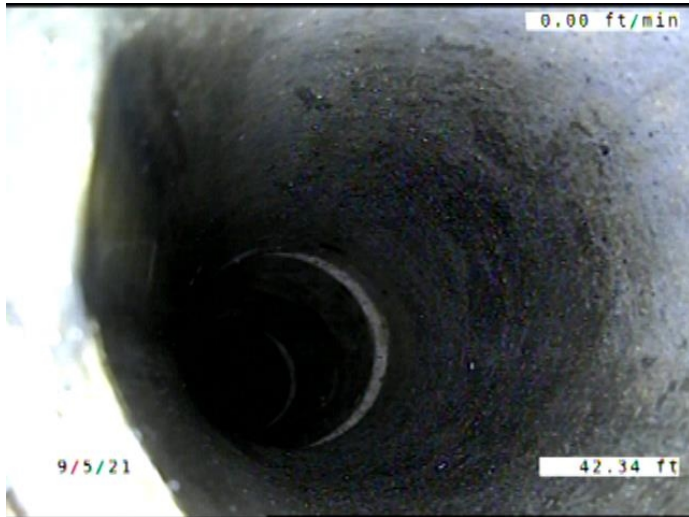
Code: **TBI**  
 Description: **Tap Break-in Intruding**

Distance (ft): **42.3**  
 Structural Grade: **0**  
 O&M Grade: **2**  
 Clock Start/From: **9**  
 Clock To:  
 1st Value: **6.000**  
 2nd Value: **2.000**  
 Value Percent:  
 Continuous Index:  
 Within 8" of Joint: **YES**  
 Remarks:

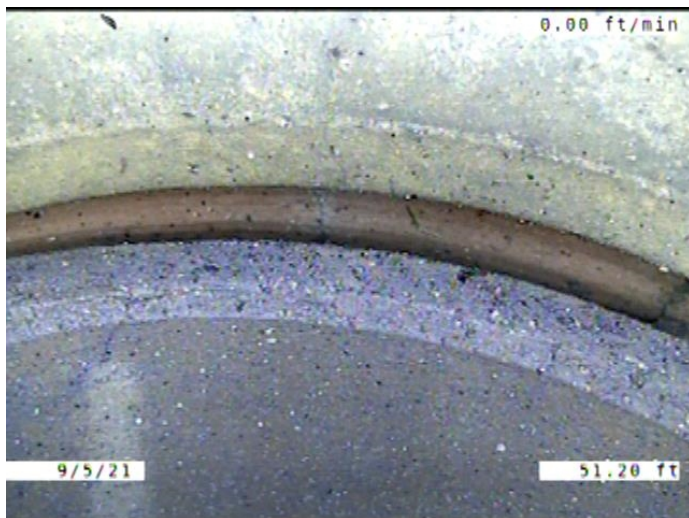
Code: **JOM**  
 Description: **Joint Offset Medium**

Distance (ft): **51.2**  
 Structural Grade: **3**  
 O&M Grade: **0**  
 Clock Start/From:  
 Clock To:  
 1st Value:  
 2nd Value:  
 Value Percent:  
 Continuous Index:  
 Within 8" of Joint: **NO**  
 Remarks:

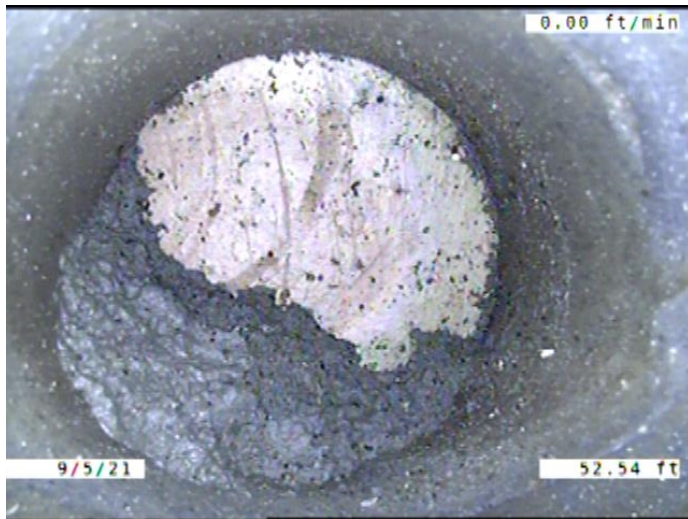
Code: **TFC**  
 Description: **Tap Factory Capped**

Distance (ft): **52.5**  
 Structural Grade: **0**  
 O&M Grade: **0**  
 Clock Start/From: **11**  
 Clock To:  
 1st Value: **6.000**  
 2nd Value:  
 Value Percent:  
 Continuous Index:  
 Within 8" of Joint: **YES**  
 Remarks:

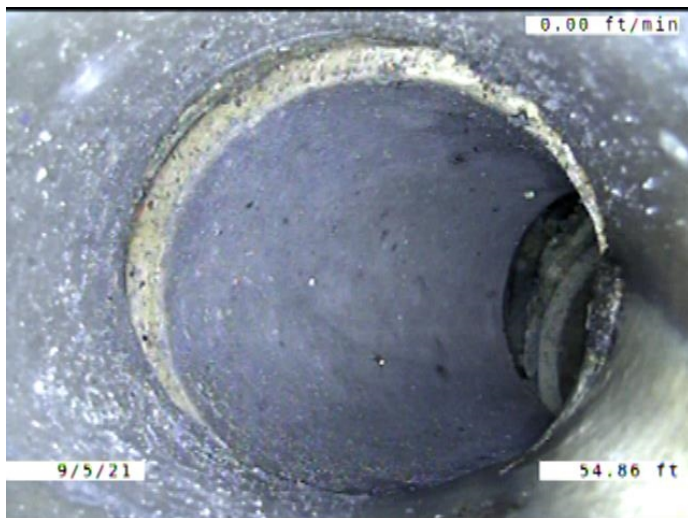
Code: **TFD**  
 Description: **Tap Factory Defective**

Distance (ft): **54.9**  
 Structural Grade: **0**  
 O&M Grade: **3**  
 Clock Start/From: **2**  
 Clock To:  
 1st Value: **6.000**  
 2nd Value:  
 Value Percent:  
 Continuous Index:  
 Within 8" of Joint: **YES**  
 Remarks: **Defective**

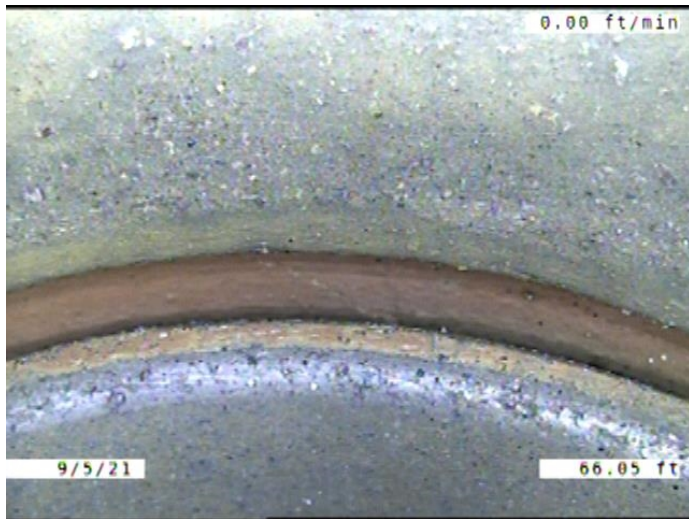
Code: **JOM**  
 Description: **Joint Offset Medium**

Distance (ft): **66.0**  
 Structural Grade: **3**  
 O&M Grade: **0**  
 Clock Start/From:  
 Clock To:  
 1st Value:  
 2nd Value:  
 Value Percent:  
 Continuous Index:  
 Within 8" of Joint: **NO**  
 Remarks:

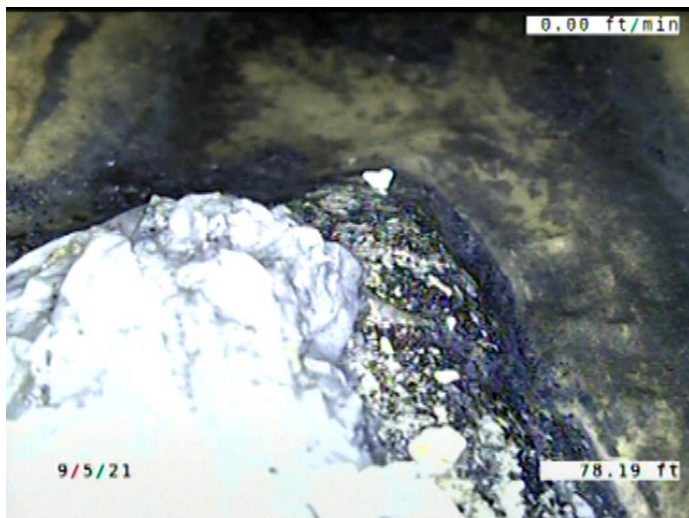
Code: **DSC**  
 Description: **Deposits Settled Hard/Compacted**

Distance (ft): **78.2**  
 Structural Grade: **0**  
 O&M Grade: **2**  
 Clock Start/From: **6**  
 Clock To:  
 1st Value:  
 2nd Value:  
 Value Percent: **5.000**  
 Continuous Index:  
 Within 8" of Joint: **YES**  
 Remarks:

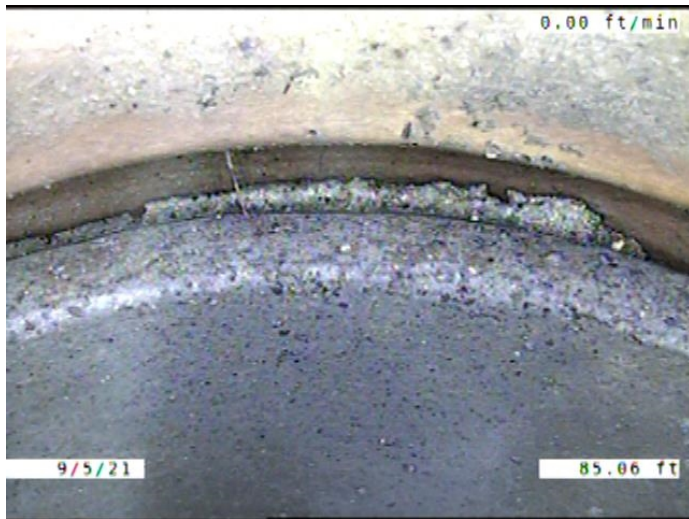
Code: **JOM**  
 Description: **Joint Offset Medium**

Distance (ft): **85.1**  
 Structural Grade: **3**  
 O&M Grade: **0**  
 Clock Start/From:  
 Clock To:  
 1st Value:  
 2nd Value:  
 Value Percent:  
 Continuous Index:  
 Within 8" of Joint: **NO**  
 Remarks:

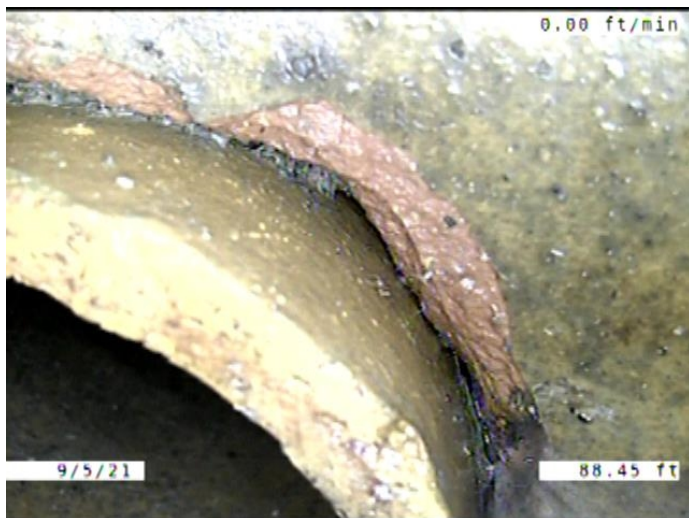
Code: **SSS**  
 Description: **Surface Damage Surface Spalling**

Distance (ft): **88.5**  
 Structural Grade: **2**  
 O&M Grade: **0**  
 Clock Start/From: **1**  
 Clock To: **3**  
 1st Value:  
 2nd Value:  
 Value Percent:  
 Continuous Index:  
 Within 8" of Joint: **YES**  
 Remarks:

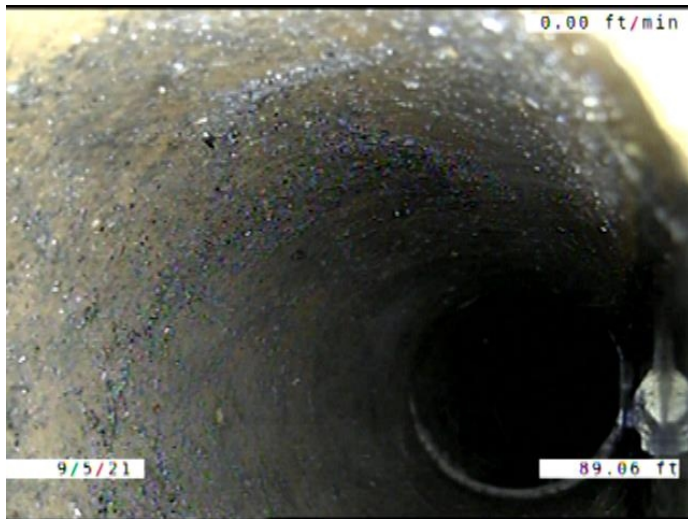
Code: **TBI**  
 Description: **Tap Break-in Intruding**

Distance (ft): **89.1**  
 Structural Grade: **0**  
 O&M Grade: **2**  
 Clock Start/From: **3**  
 Clock To:  
 1st Value: **6.000**  
 2nd Value: **2.000**  
 Value Percent:  
 Continuous Index:  
 Within 8" of Joint: **YES**  
 Remarks:

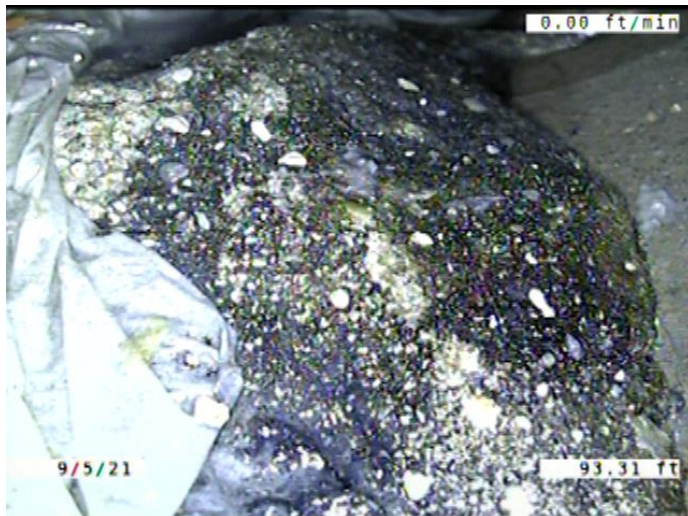
Code: **DSC**  
 Description: **Deposits Settled Hard/Compacted**

Distance (ft): **93.3**  
 Structural Grade: **0**  
 O&M Grade: **2**  
 Clock Start/From: **5**  
 Clock To: **6**  
 1st Value:  
 2nd Value:  
 Value Percent: **5.000**  
 Continuous Index:  
 Within 8" of Joint: **YES**  
 Remarks:

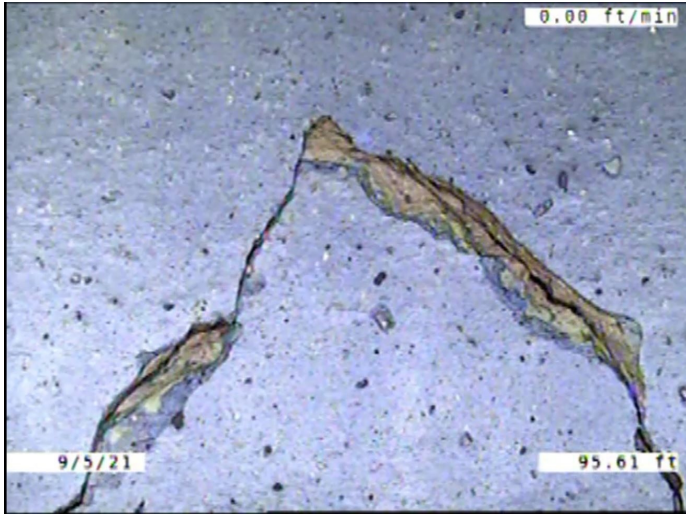
Code: **FS**  
 Description: **Fracture Spiral**

Distance (ft): **95.6**  
 Structural Grade: **3**  
 O&M Grade: **0**  
 Clock Start/From: **11**  
 Clock To: **1**  
 1st Value:  
 2nd Value:  
 Value Percent:  
 Continuous Index:  
 Within 8" of Joint: **YES**  
 Remarks:

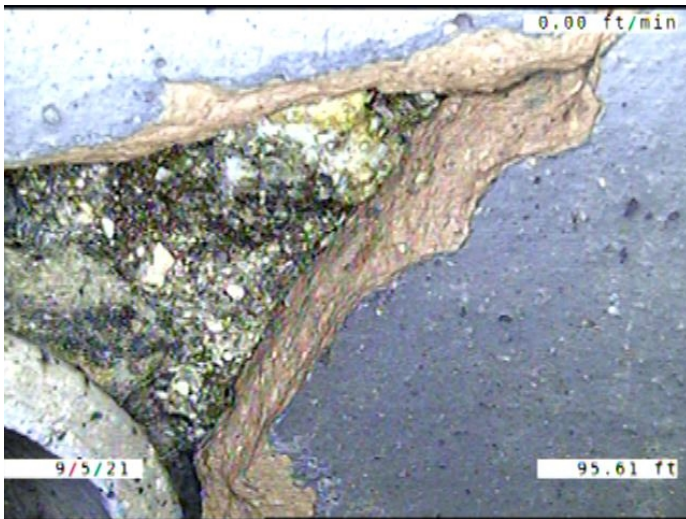
Code: **HSV**  
 Description: **Hole Soil Visible**

Distance (ft): **95.6**  
 Structural Grade: **5**  
 O&M Grade: **0**  
 Clock Start/From: **10**  
 Clock To: **11**  
 1st Value:  
 2nd Value:  
 Value Percent:  
 Continuous Index:  
 Within 8" of Joint: **YES**  
 Remarks:

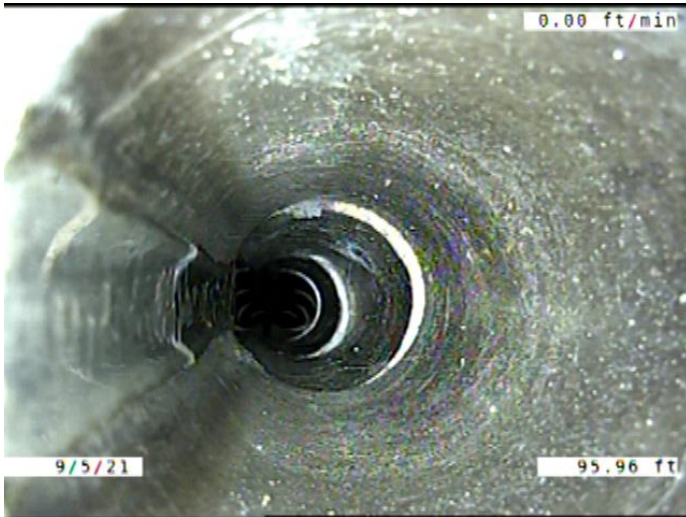
Code: **TBI**  
 Description: **Tap Break-in Intruding**

Distance (ft): **96.0**  
 Structural Grade: **0**  
 O&M Grade: **2**  
 Clock Start/From: **9**  
 Clock To:  
 1st Value: **6.000**  
 2nd Value: **1.000**  
 Value Percent:  
 Continuous Index:  
 Within 8" of Joint: **YES**  
 Remarks:

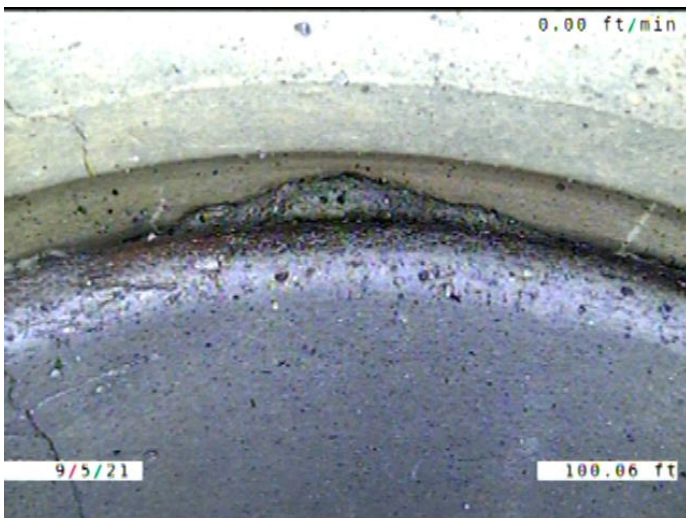
Code: **JOM**  
 Description: **Joint Offset Medium**

Distance (ft): **100.1**  
 Structural Grade: **3**  
 O&M Grade: **0**  
 Clock Start/From:  
 Clock To:  
 1st Value:  
 2nd Value:  
 Value Percent:  
 Continuous Index:  
 Within 8" of Joint: **NO**  
 Remarks:

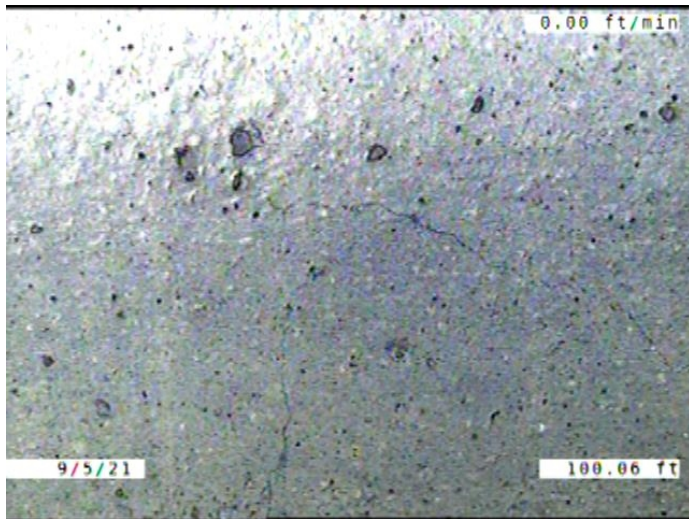
Code: **CM**  
 Description: **Crack Multiple**

Distance (ft): **100.1**  
 Structural Grade: **3**  
 O&M Grade: **0**  
 Clock Start/From: **9**  
 Clock To: **12**  
 1st Value:  
 2nd Value:  
 Value Percent:  
 Continuous Index:  
 Within 8" of Joint: **YES**  
 Remarks:

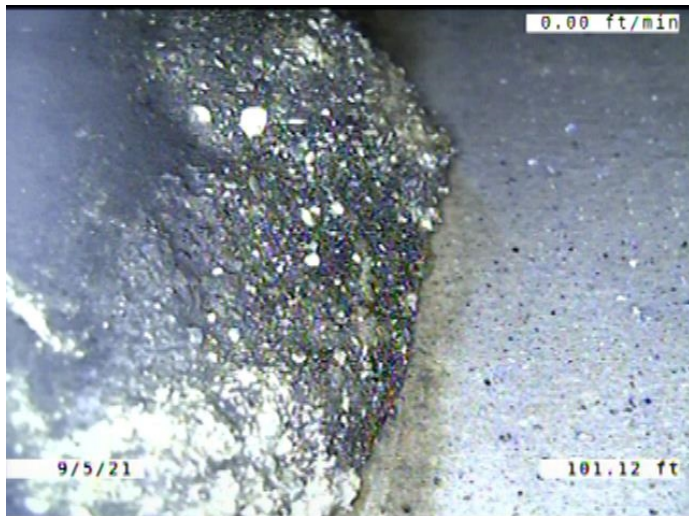
Code: **DSC**  
 Description: **Deposits Settled Hard/Compacted**

Distance (ft): **101.1**  
 Structural Grade: **0**  
 O&M Grade: **2**  
 Clock Start/From: **5**  
 Clock To: **7**  
 1st Value:  
 2nd Value:  
 Value Percent: **5.000**  
 Continuous Index:  
 Within 8" of Joint: **YES**  
 Remarks:

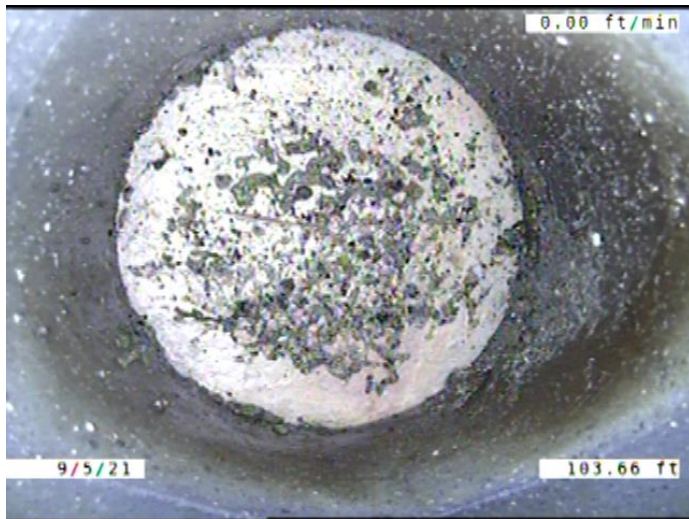
Code: **TFC**  
Description: **Tap Factory Capped**

Distance (ft): **103.7**  
Structural Grade: **0**  
O&M Grade: **0**  
Clock Start/From: **11**  
Clock To:  
1st Value: **6.000**  
2nd Value:  
Value Percent:  
Continuous Index:  
Within 8" of Joint: **YES**  
Remarks:

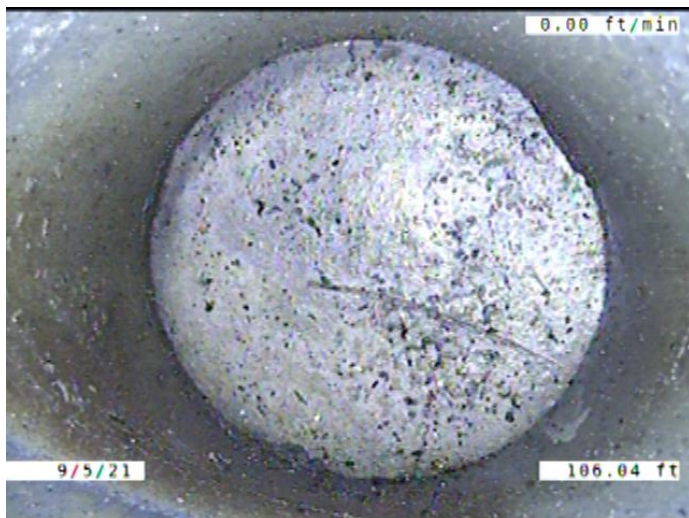
Code: **TFC**  
Description: **Tap Factory Capped**

Distance (ft): **106.0**  
Structural Grade: **0**  
O&M Grade: **0**  
Clock Start/From: **1**  
Clock To:  
1st Value: **6.000**  
2nd Value:  
Value Percent:  
Continuous Index:  
Within 8" of Joint: **YES**  
Remarks:

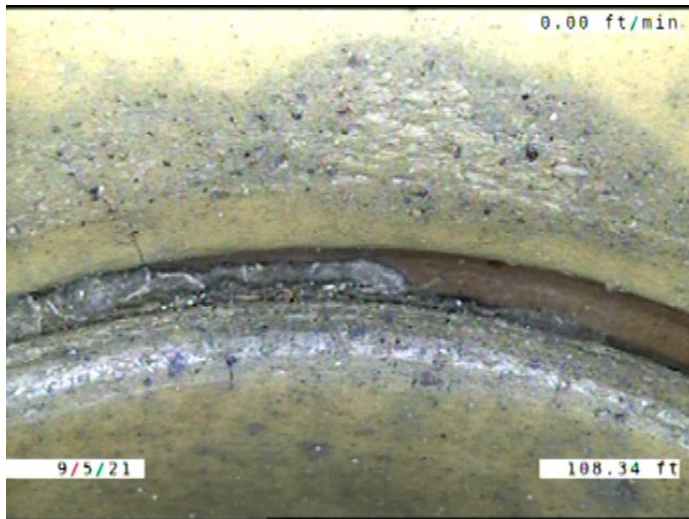
Code: **JOM**  
 Description: **Joint Offset Medium**

Distance (ft): **108.3**  
 Structural Grade: **3**  
 O&M Grade: **0**  
 Clock Start/From:  
 Clock To:  
 1st Value:  
 2nd Value:  
 Value Percent:  
 Continuous Index:  
 Within 8" of Joint: **NO**  
 Remarks:

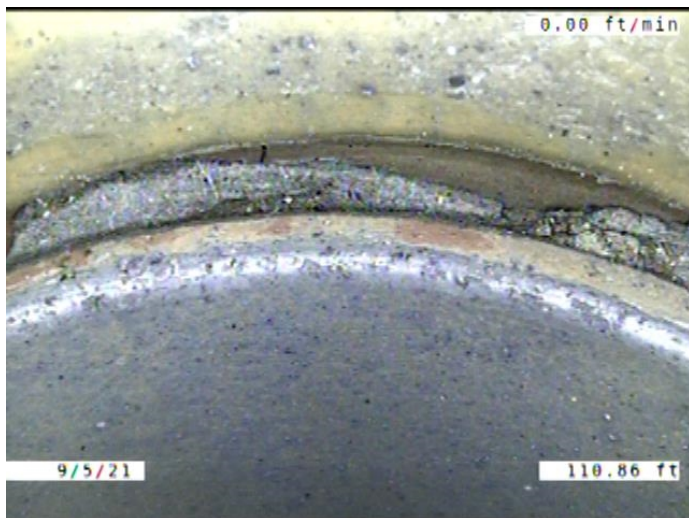
Code: **JOM**  
 Description: **Joint Offset Medium**

Distance (ft): **110.9**  
 Structural Grade: **3**  
 O&M Grade: **0**  
 Clock Start/From:  
 Clock To:  
 1st Value:  
 2nd Value:  
 Value Percent:  
 Continuous Index:  
 Within 8" of Joint: **NO**  
 Remarks:

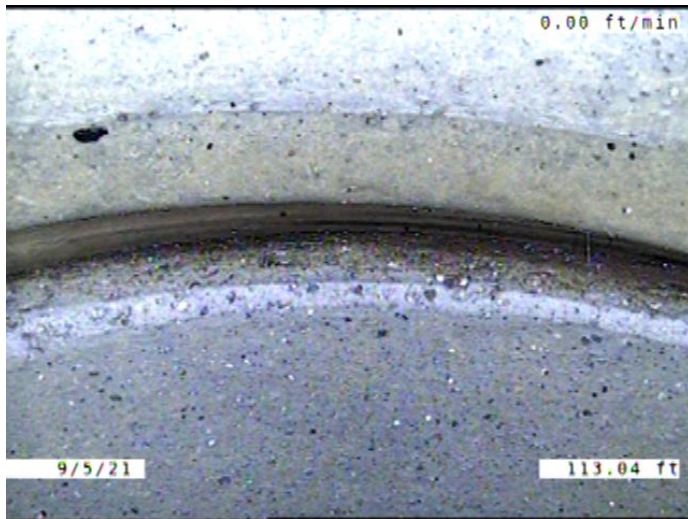
Code: **JOM**  
Description: **Joint Offset Medium**

Distance (ft): **113.0**  
Structural Grade: **3**  
O&M Grade: **0**  
Clock Start/From:  
Clock To:  
1st Value:  
2nd Value:  
Value Percent:  
Continuous Index:  
Within 8" of Joint: **NO**  
Remarks:

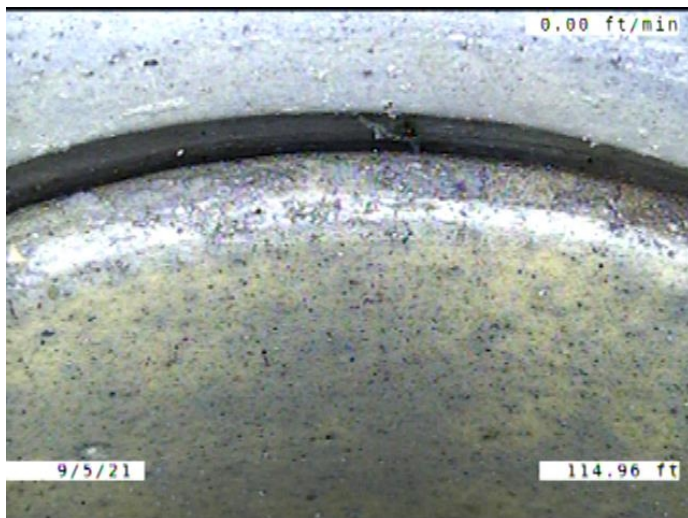
Code: **JOM**  
Description: **Joint Offset Medium**

Distance (ft): **115.0**  
Structural Grade: **3**  
O&M Grade: **0**  
Clock Start/From:  
Clock To:  
1st Value:  
2nd Value:  
Value Percent:  
Continuous Index:  
Within 8" of Joint: **NO**  
Remarks:

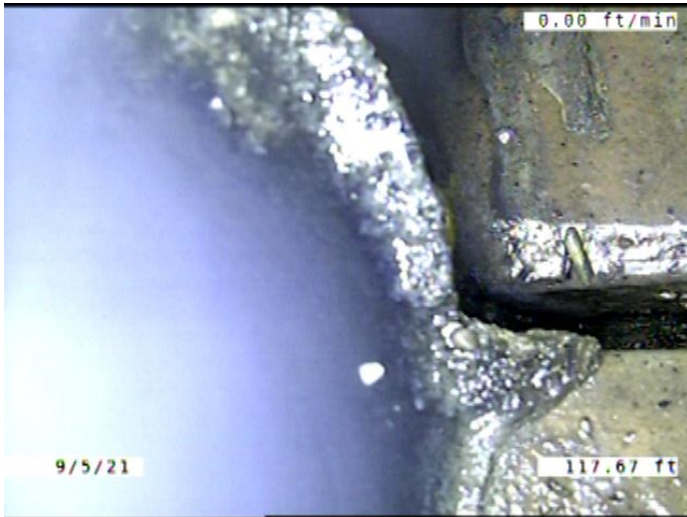
Code: **DAE**  
 Description: **Deposits Attached Encrustation**

Distance (ft): **117.7**  
 Structural Grade: **0**  
 O&M Grade: **2**  
 Clock Start/From: **4**  
 Clock To: **5**  
 1st Value:  
 2nd Value:  
 Value Percent: **5.000**  
 Continuous Index:  
 Within 8" of Joint: **YES**  
 Remarks:

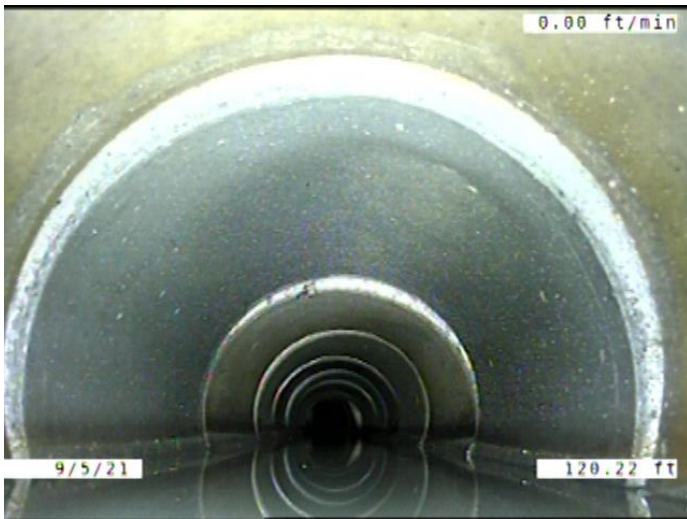
Code: **MWLS**  
 Description: **Miscellaneous Water Level Sag**

Distance (ft): **120.2**  
 Structural Grade: **2**  
 O&M Grade: **0**  
 Clock Start/From:  
 Clock To:  
 1st Value:  
 2nd Value:  
 Value Percent: **15.000**  
 Continuous Index: **S03**  
 Within 8" of Joint: **NO**  
 Remarks:

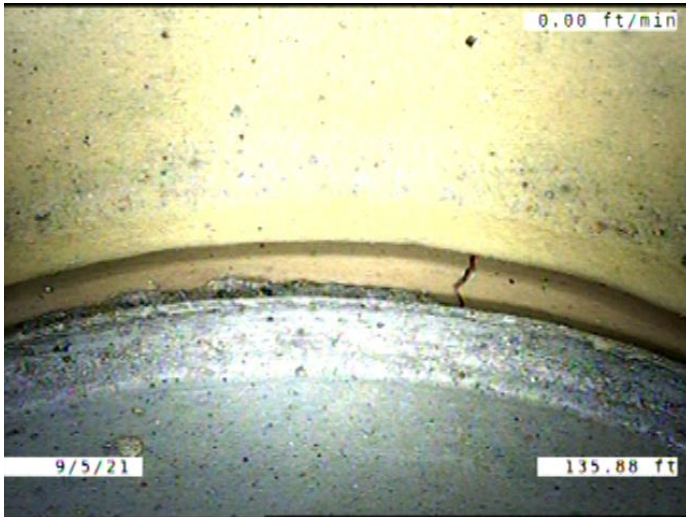
Code: **JOM**  
 Description: **Joint Offset Medium**

Distance (ft): **135.9**  
 Structural Grade: **3**  
 O&M Grade: **0**  
 Clock Start/From:  
 Clock To:  
 1st Value:  
 2nd Value:  
 Value Percent:  
 Continuous Index:  
 Within 8" of Joint: **NO**  
 Remarks:

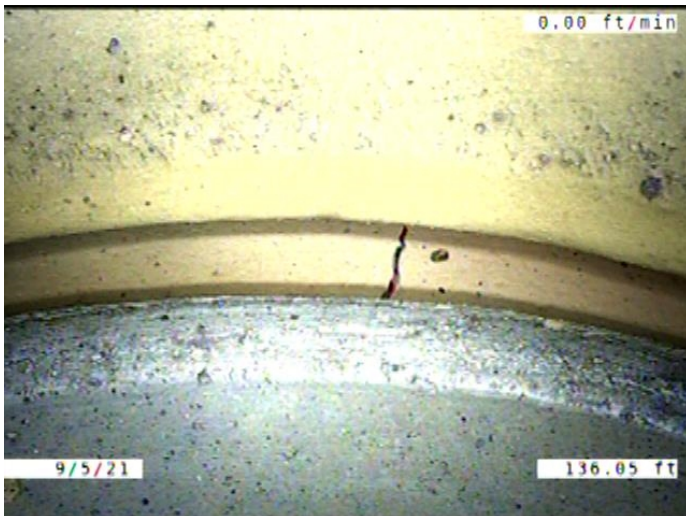
Code: **FM**  
 Description: **Fracture Multiple**

Distance (ft): **136.0**  
 Structural Grade: **4**  
 O&M Grade: **0**  
 Clock Start/From: **11**  
 Clock To: **2**  
 1st Value:  
 2nd Value:  
 Value Percent:  
 Continuous Index:  
 Within 8" of Joint: **YES**  
 Remarks:

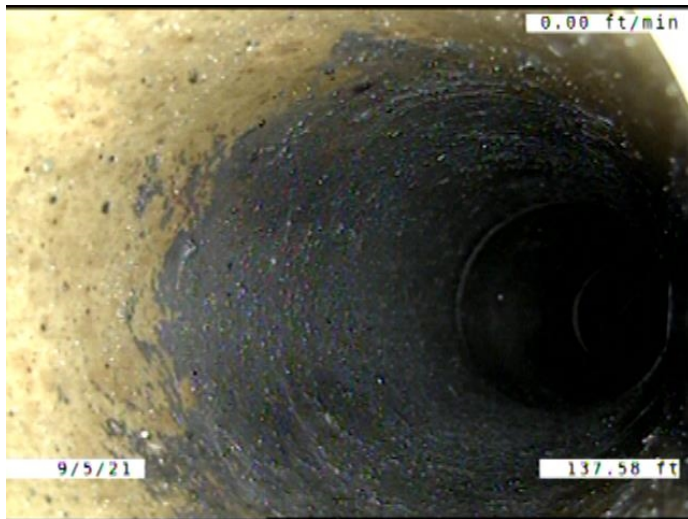
Code: **TBI**  
 Description: **Tap Break-in Intruding**

Distance (ft): **137.6**  
 Structural Grade: **0**  
 O&M Grade: **2**  
 Clock Start/From: **2**  
 Clock To:  
 1st Value: **6.000**  
 2nd Value: **1.000**  
 Value Percent:  
 Continuous Index:  
 Within 8" of Joint: **YES**  
 Remarks:

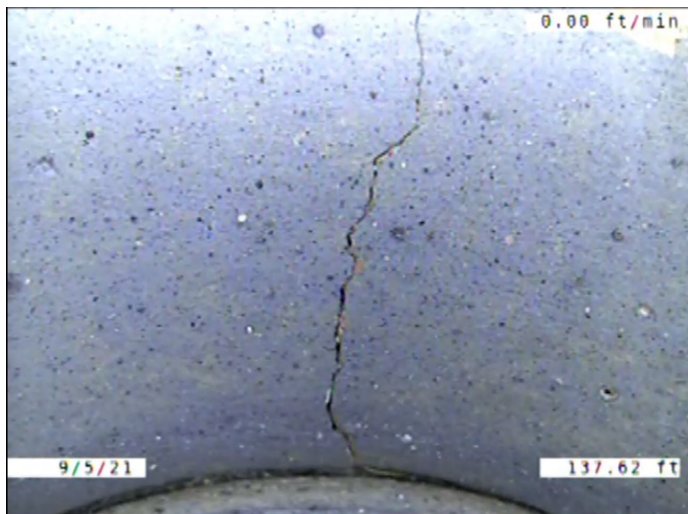
Code: **CL**  
 Description: **Crack Longitudinal**

Distance (ft): **137.6**  
 Structural Grade: **2**  
 O&M Grade: **0**  
 Clock Start/From: **1**  
 Clock To:  
 1st Value:  
 2nd Value:  
 Value Percent:  
 Continuous Index:  
 Within 8" of Joint: **YES**  
 Remarks:

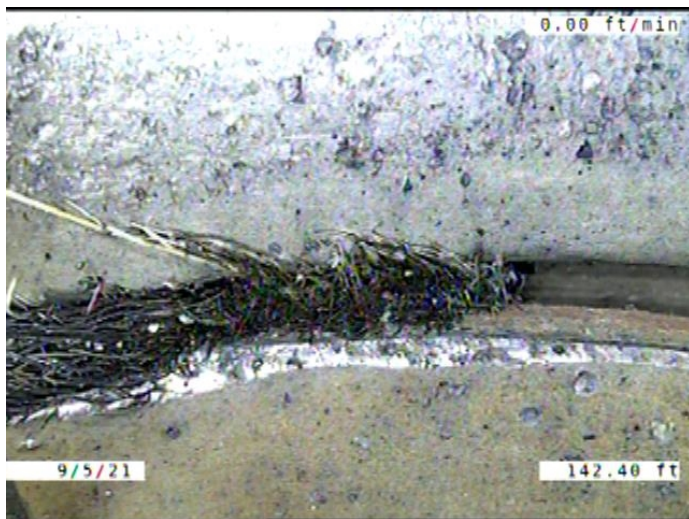
Code: **RFJ**  
 Description: **Roots Fine Joint**

Distance (ft): **142.4**  
 Structural Grade: **0**  
 O&M Grade: **1**  
 Clock Start/From: **9**  
 Clock To: **10**  
 1st Value:  
 2nd Value:  
 Value Percent:  
 Continuous Index: **S04**  
 Within 8" of Joint: **YES**  
 Remarks:

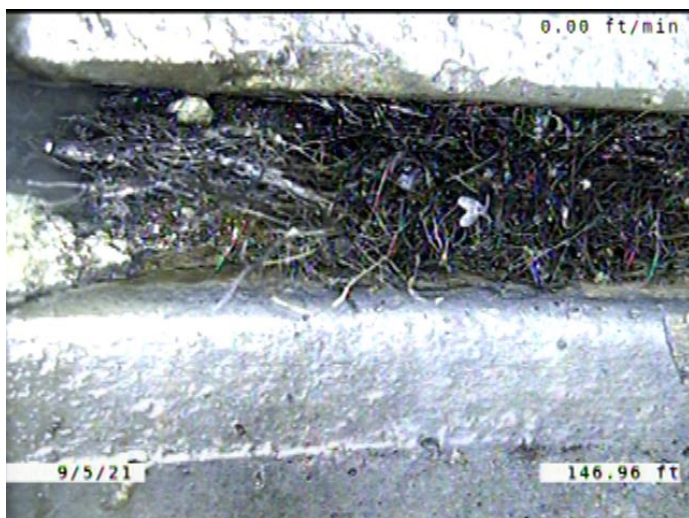
Code: **RFJ**  
 Description: **Roots Fine Joint**

Distance (ft): **147.0**  
 Structural Grade: **0**  
 O&M Grade: **1**  
 Clock Start/From: **3**  
 Clock To: **4**  
 1st Value:  
 2nd Value:  
 Value Percent:  
 Continuous Index:  
 Within 8" of Joint: **YES**  
 Remarks:

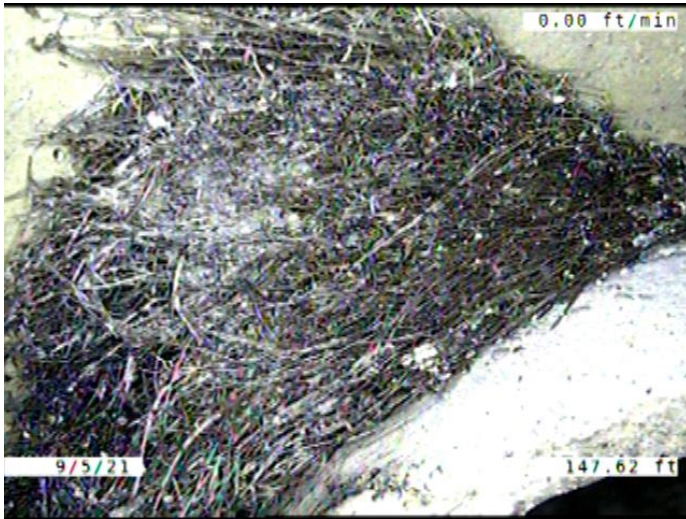
Code: **RML**  
 Description: **Roots Medium Lateral**

Distance (ft): **147.6**  
 Structural Grade: **0**  
 O&M Grade: **3**  
 Clock Start/From: **8**  
 Clock To: **11**  
 1st Value:  
 2nd Value:  
 Value Percent: **10.000**  
 Continuous Index:  
 Within 8" of Joint: **NO**  
 Remarks:

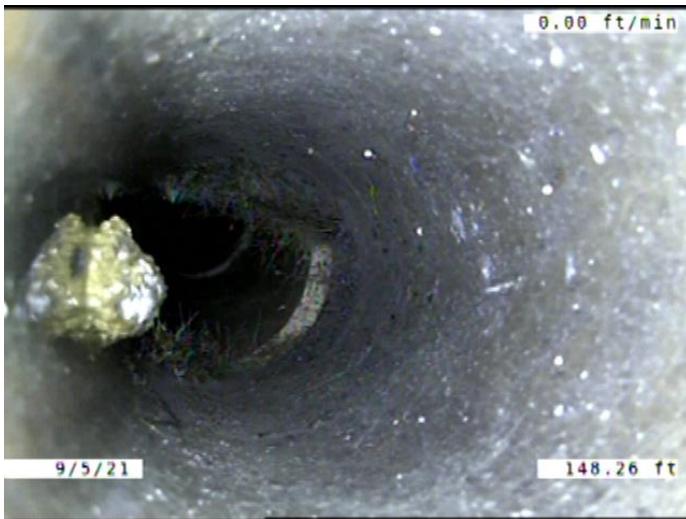
Code: **TBI**  
 Description: **Tap Break-in Intruding**

Distance (ft): **148.3**  
 Structural Grade: **0**  
 O&M Grade: **2**  
 Clock Start/From: **9**  
 Clock To:  
 1st Value: **6.000**  
 2nd Value: **3.000**  
 Value Percent:  
 Continuous Index:  
 Within 8" of Joint: **YES**  
 Remarks:
