# Profile/Photo Observation Report

Date:	<b>09/05/2021</b>	Weather:		Coding:	<b>PACP 7.0</b>
Pipe Length (ft):	<b>212.0</b>	Owner:	<b>City of Hobart</b>	Pre Clean:	<b>Heavy Cleaning</b>
P.O.#:	<b>YES502259</b>	Surveyor:	<b>S. Bucklin</b>	PSR:	<b>P-504-120-119</b>
Customer:	<b>City of Hobart</b>	Clean Date:	<b>09/02/2021</b>	Shape:	<b>C</b>

Street:	<b>41st Avenue</b>	Flow Control:	<b>Not Controlled</b>
City:	<b>Hobart, IN</b>	Year Renewed:	
Location:	<b>Alley</b>	Tape/Media #:	
Purpose:	<b>Routine Assessment</b>	Dia/Height:	<b>12"</b>
Use:	<b>Sanitary Sewage Pipe</b>	Material:	<b>VCP</b>
Drain Area:		Lining:	<b>None</b>
Category:	<b>NA</b>		
Comment:			
Location Details:		Direction of Survey:	<b>Upstream</b>
US MH:	<b>M-504-119</b>	DS MH:	<b>M-504-120</b>
		Total Length Surveyed (ft):	<b>148.7</b>

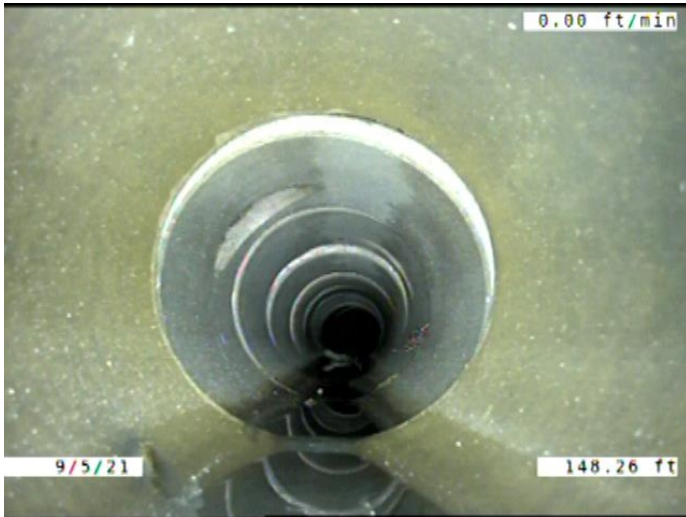
Code: **RFJ**  
Description: **Roots Fine Joint**

Distance (ft): **148.3**  
Structural Grade: **0**  
O&M Grade: **1**  
Clock Start/From: **9**  
Clock To: **10**  
1st Value:  
2nd Value:  
Value Percent:  
Continuous Index: **F04**  
Within 8" of Joint: **YES**  
Remarks:

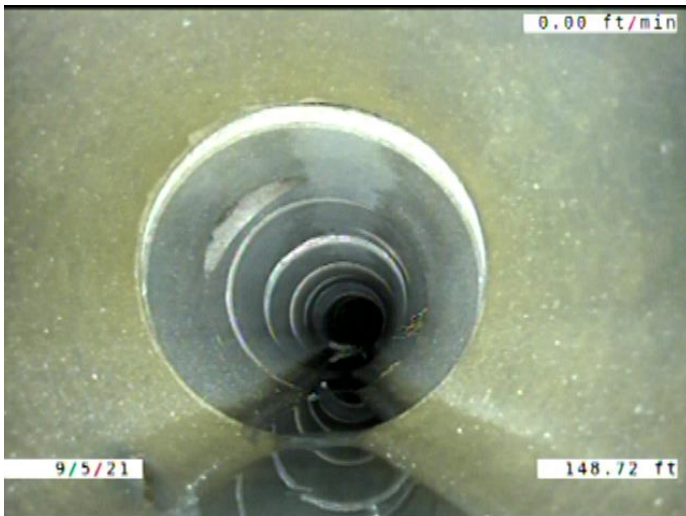
Code: **MWLS**  
Description: **Miscellaneous Water Level Sag**

Distance (ft): **148.7**  
Structural Grade: **2**  
O&M Grade: **0**  
Clock Start/From:  
Clock To:  
1st Value:  
2nd Value:  
Value Percent: **15.000**  
Continuous Index: **F03**  
Within 8" of Joint: **NO**  
Remarks:

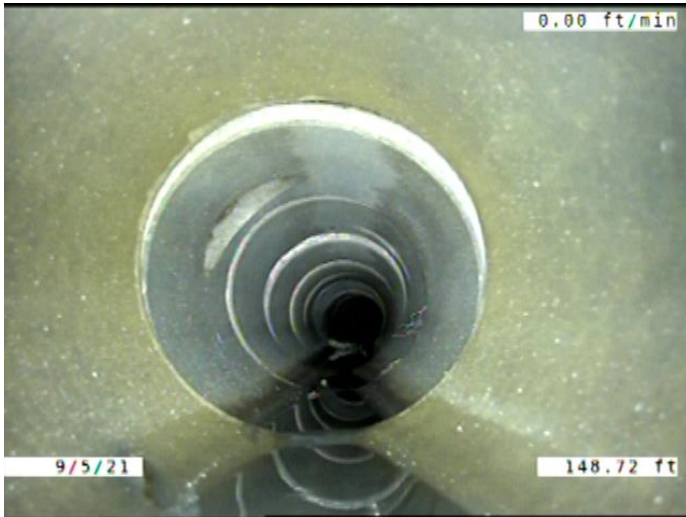
Code: **DSF**  
Description: **Deposits Settled Fine**

Distance (ft): **148.7**  
Structural Grade: **0**  
O&M Grade: **2**  
Clock Start/From: **5**  
Clock To: **7**  
1st Value:  
2nd Value:  
Value Percent: **5.000**  
Continuous Index: **F01**  
Within 8" of Joint: **YES**  
Remarks:

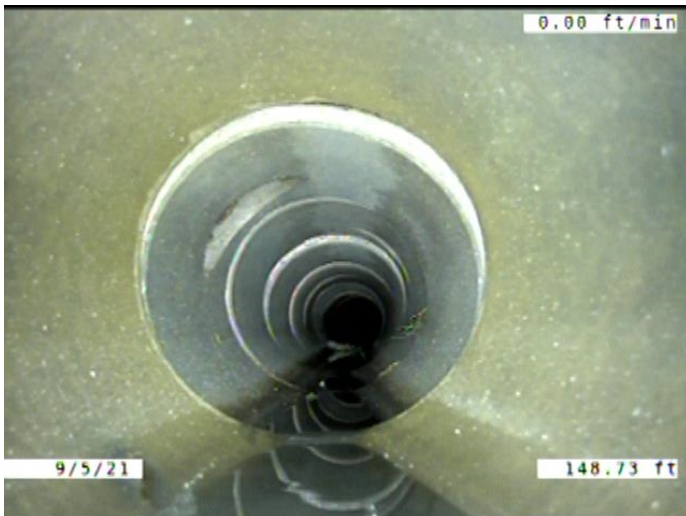
Code: **MSA**  
Description: **Miscellaneous Survey Abandoned**

Distance (ft): **148.7**  
Structural Grade: **0**  
O&M Grade: **0**  
Clock Start/From:  
Clock To:  
1st Value:  
2nd Value:  
Value Percent:  
Continuous Index:  
Within 8" of Joint: **NO**  
Remarks: **CAMERA CANT MAKE IT PAST PROTRUDING TAP.**
