Profile/Photo Observation Report

Date:	09/06/2021	Weather:		Coding:	PACP 7.0
Pipe Length (ft):	212.0	Owner:	City of Hobart	Pre Clean:	Heavy Cleaning
P.O.#:	YES502259	Surveyor:	S. Bucklin	PSR:	P-504-120-119
Customer:	City of Hobart	Clean Date:	09/02/2021	Shape:	C

Street:	41st Avenue	Flow Control:	Not Controlled
City:	Hobart, IN	Year Renewed:	
Location:	Alley	Tape/Media #:	
Purpose:	Routine Assessment	Dia/Height:	12"
Use:	Sanitary Sewage Pipe	Material:	VCP
Drain Area:		Lining:	None
Category:	NA		
Comment:			
Location Details:		Direction of Survey:	Downstream
US MH:	M-504-119	DS MH:	M-504-120
		Total Length Surveyed (ft):	59.9

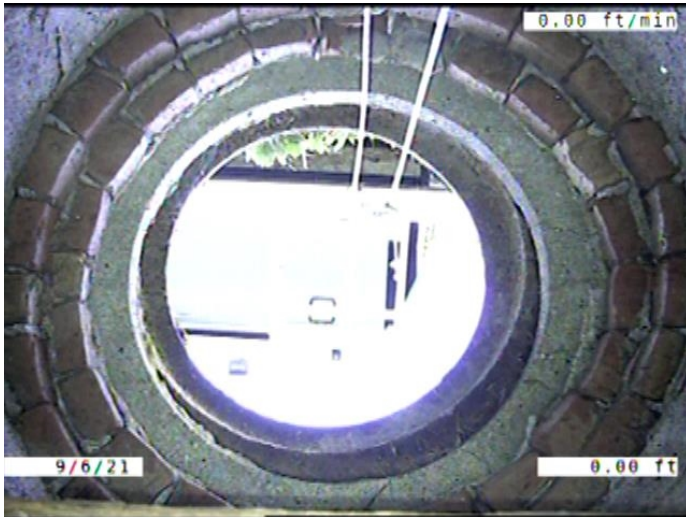
Code: **AMH**
 Description: **Manhole**

Distance (ft): **.0**
 Structural Grade: **0**
 O&M Grade: **0**
 Clock Start/From:
 Clock To:
 1st Value:
 2nd Value:
 Value Percent:
 Continuous Index:
 Within 8" of Joint: **NO**
 Remarks: **M-504-119**

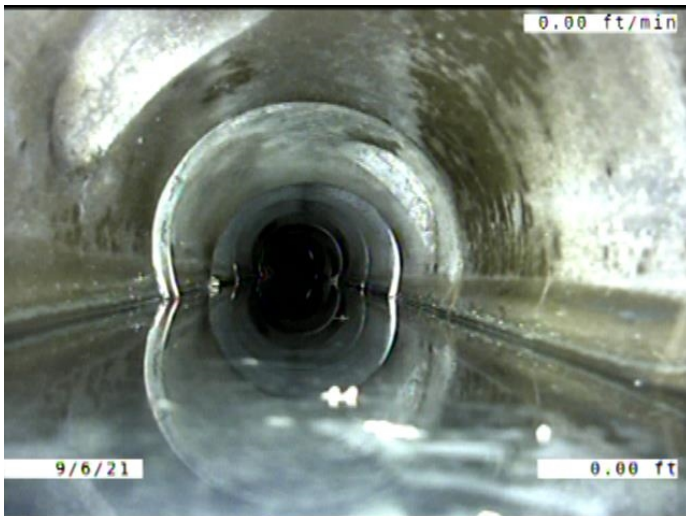
Code: **MWL**
 Description: **Miscellaneous Water Level**

Distance (ft): **.0**
 Structural Grade: **0**
 O&M Grade: **0**
 Clock Start/From:
 Clock To:
 1st Value:
 2nd Value:
 Value Percent: **10.000**
 Continuous Index:
 Within 8" of Joint: **NO**
 Remarks:

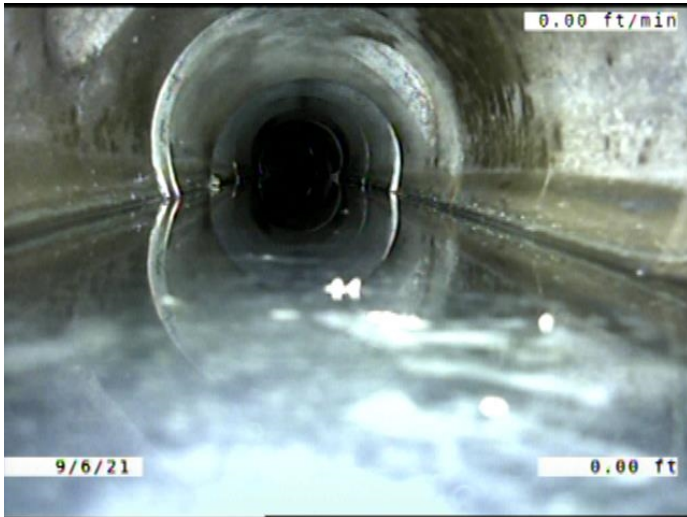
Code: **DSF**
 Description: **Deposits Settled Fine**

Distance (ft): **.0**
 Structural Grade: **0**
 O&M Grade: **2**
 Clock Start/From: **5**
 Clock To: **7**
 1st Value:
 2nd Value:
 Value Percent: **5.000**
 Continuous Index: **S01**
 Within 8" of Joint: **YES**
 Remarks:

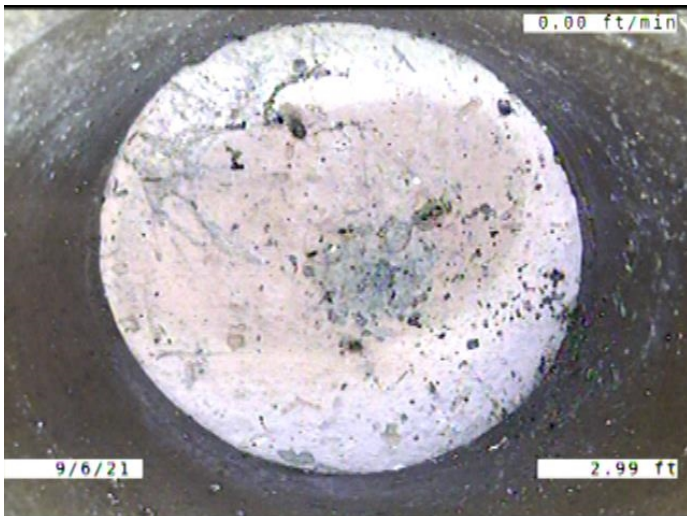
Code: **TFC**
 Description: **Tap Factory Capped**

Distance (ft): **3.0**
 Structural Grade: **0**
 O&M Grade: **0**
 Clock Start/From: **10**
 Clock To:
 1st Value: **6.000**
 2nd Value:
 Value Percent:
 Continuous Index:
 Within 8" of Joint: **YES**
 Remarks:

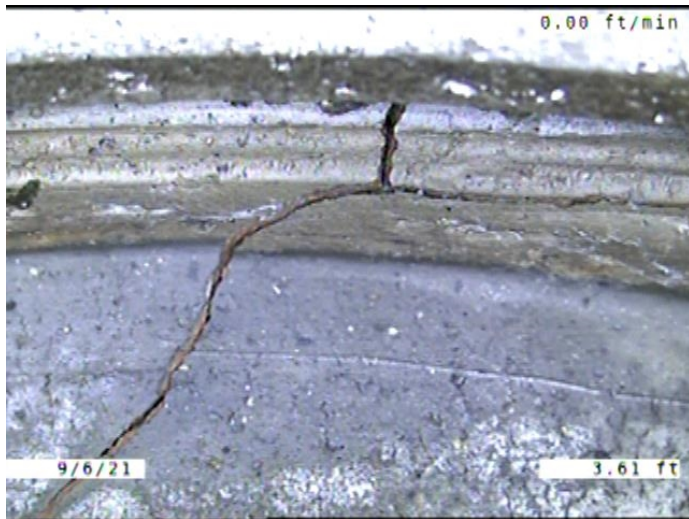
Code: **FM**
 Description: **Fracture Multiple**

Distance (ft): **3.6**
 Structural Grade: **4**
 O&M Grade: **0**
 Clock Start/From: **10**
 Clock To: **3**
 1st Value:
 2nd Value:
 Value Percent:
 Continuous Index:
 Within 8" of Joint: **YES**
 Remarks:

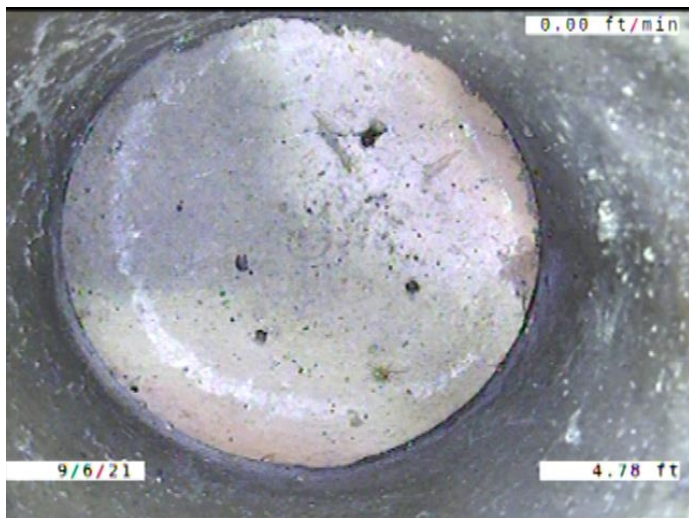
Code: **TFC**
 Description: **Tap Factory Capped**

Distance (ft): **4.8**
 Structural Grade: **0**
 O&M Grade: **0**
 Clock Start/From: **1**
 Clock To:
 1st Value: **6.000**
 2nd Value:
 Value Percent:
 Continuous Index:
 Within 8" of Joint: **YES**
 Remarks:

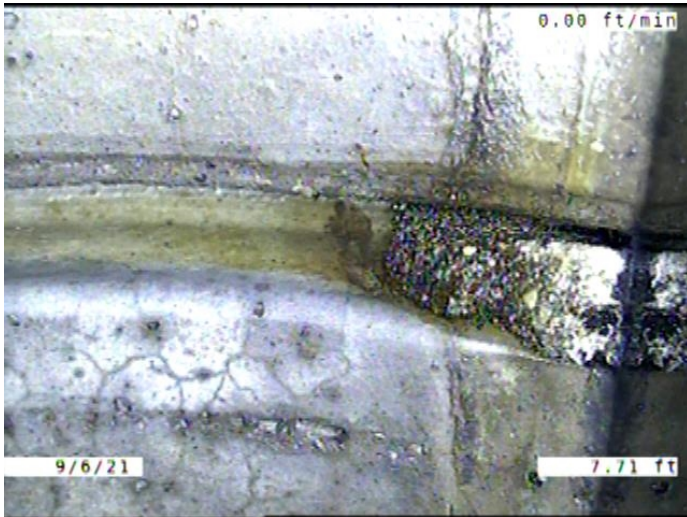
Code: **DAE**
 Description: **Deposits Attached Encrustation**

Distance (ft): **7.7**
 Structural Grade: **0**
 O&M Grade: **2**
 Clock Start/From: **2**
 Clock To: **4**
 1st Value:
 2nd Value:
 Value Percent: **5.000**
 Continuous Index: **S02**
 Within 8" of Joint: **YES**
 Remarks:

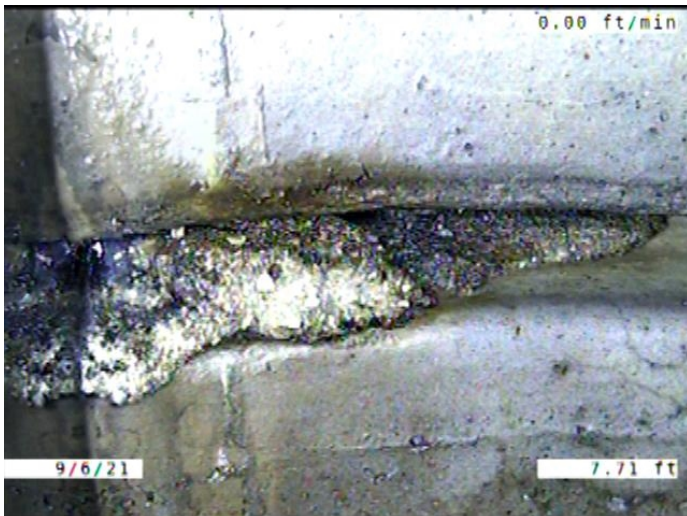
Code: **DAE**
 Description: **Deposits Attached Encrustation**

Distance (ft): **7.7**
 Structural Grade: **0**
 O&M Grade: **2**
 Clock Start/From: **8**
 Clock To: **10**
 1st Value:
 2nd Value:
 Value Percent: **5.000**
 Continuous Index: **S03**
 Within 8" of Joint: **YES**
 Remarks:

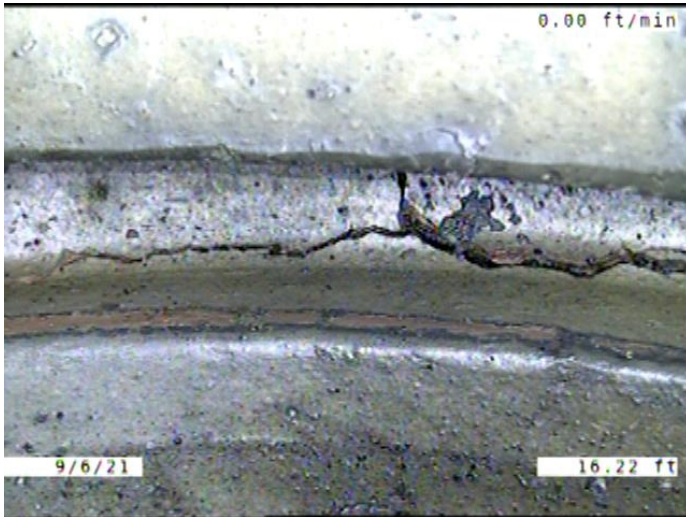
Code: **FM**
 Description: **Fracture Multiple**

Distance (ft): **16.2**
 Structural Grade: **4**
 O&M Grade: **0**
 Clock Start/From: **10**
 Clock To: **3**
 1st Value:
 2nd Value:
 Value Percent:
 Continuous Index:
 Within 8" of Joint: **YES**
 Remarks:

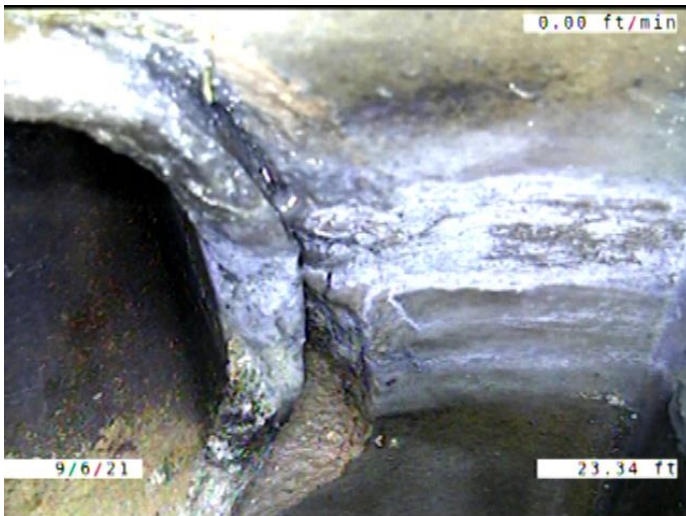
Code: **SSS**
 Description: **Surface Damage Surface Spalling**

Distance (ft): **23.3**
 Structural Grade: **2**
 O&M Grade: **0**
 Clock Start/From: **1**
 Clock To: **3**
 1st Value:
 2nd Value:
 Value Percent:
 Continuous Index:
 Within 8" of Joint: **YES**
 Remarks:

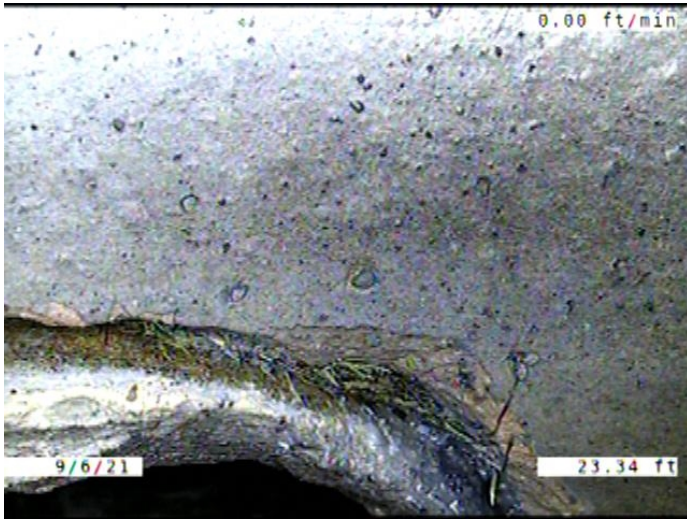
Code: **RFL**
Description: **Roots Fine Lateral**

Distance (ft): **23.3**
Structural Grade: **0**
O&M Grade: **1**
Clock Start/From: **2**
Clock To: **3**
1st Value:
2nd Value:
Value Percent:
Continuous Index:
Within 8" of Joint: **NO**
Remarks:

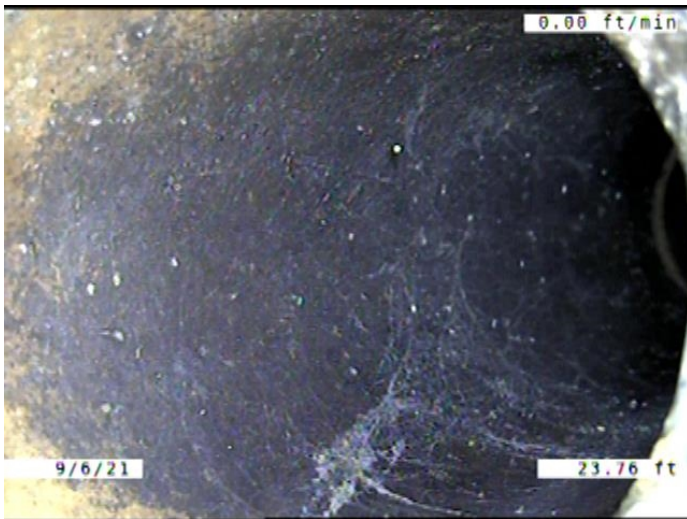
Code: **TBI**
Description: **Tap Break-in Intruding**

Distance (ft): **23.8**
Structural Grade: **0**
O&M Grade: **2**
Clock Start/From: **2**
Clock To:
1st Value: **6.000**
2nd Value: **1.000**
Value Percent:
Continuous Index:
Within 8" of Joint: **YES**
Remarks:

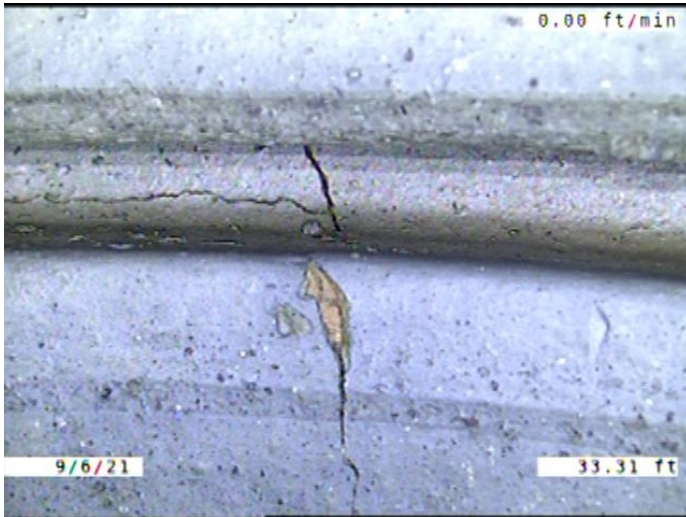
Code: **CM**
Description: **Crack Multiple**

Distance (ft): **33.3**
Structural Grade: **3**
O&M Grade: **0**
Clock Start/From: **10**
Clock To: **3**
1st Value:
2nd Value:
Value Percent:
Continuous Index:
Within 8" of Joint: **YES**
Remarks:

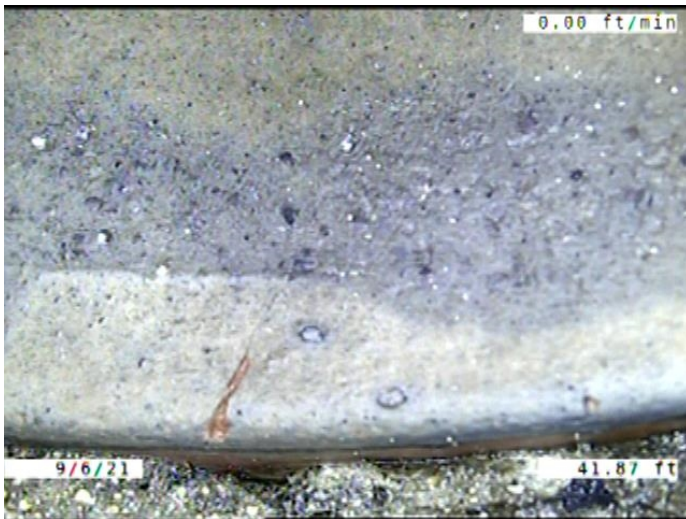
Code: **CL**
Description: **Crack Longitudinal**

Distance (ft): **41.9**
Structural Grade: **2**
O&M Grade: **0**
Clock Start/From: **8**
Clock To:
1st Value:
2nd Value:
Value Percent:
Continuous Index:
Within 8" of Joint: **YES**
Remarks:

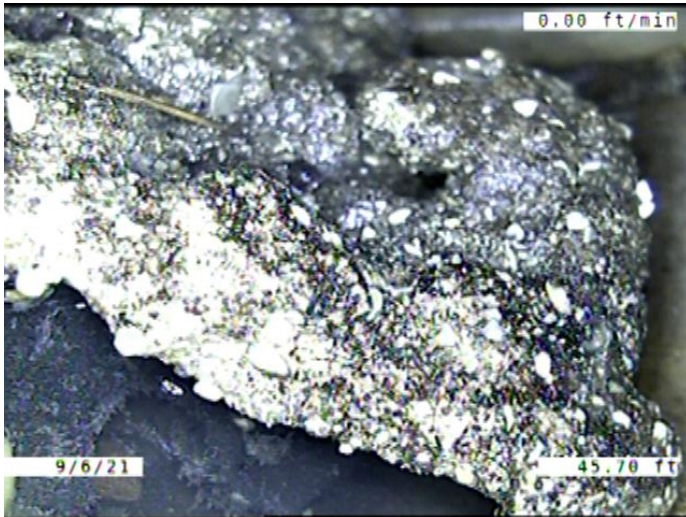
Code: **DSC**
 Description: **Deposits Settled Hard/Compacted**

Distance (ft): **45.7**
 Structural Grade: **0**
 O&M Grade: **2**
 Clock Start/From: **4**
 Clock To: **8**
 1st Value:
 2nd Value:
 Value Percent: **5.000**
 Continuous Index:
 Within 8" of Joint: **YES**
 Remarks:

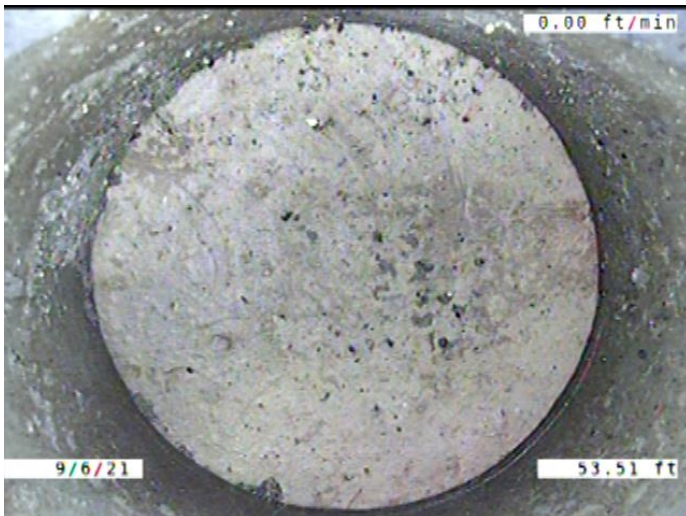
Code: **TFC**
 Description: **Tap Factory Capped**

Distance (ft): **53.5**
 Structural Grade: **0**
 O&M Grade: **0**
 Clock Start/From: **11**
 Clock To:
 1st Value: **6.000**
 2nd Value:
 Value Percent:
 Continuous Index:
 Within 8" of Joint: **YES**
 Remarks:

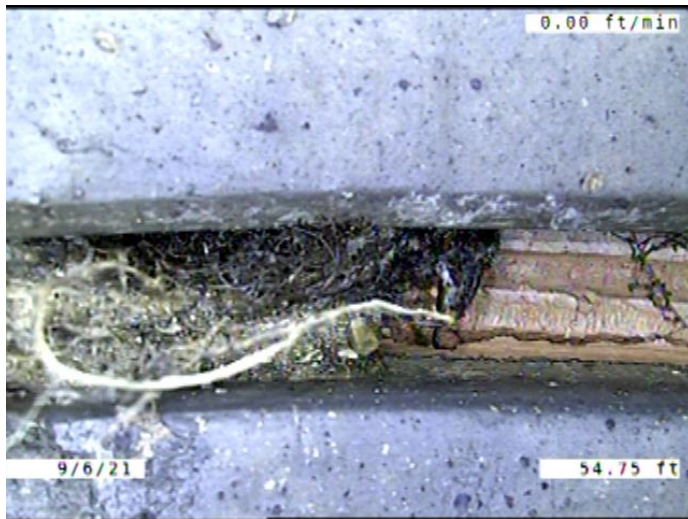
Code: **RFJ**
 Description: **Roots Fine Joint**

Distance (ft): **54.8**
 Structural Grade: **0**
 O&M Grade: **1**
 Clock Start/From: **9**
 Clock To: **10**
 1st Value:
 2nd Value:
 Value Percent:
 Continuous Index:
 Within 8" of Joint: **YES**
 Remarks:

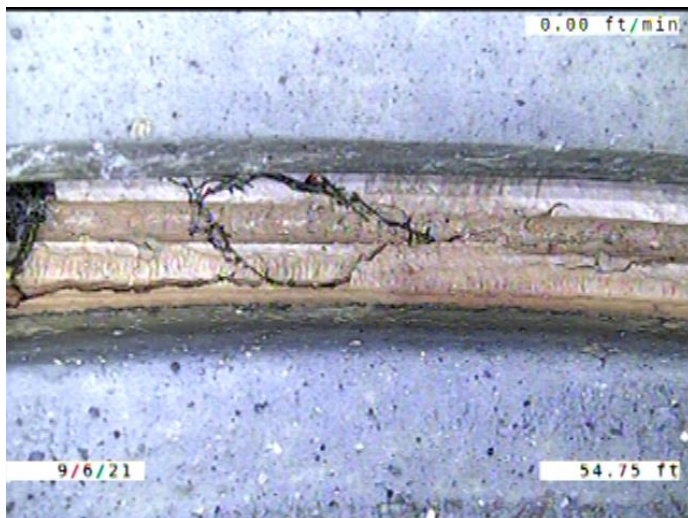
Code: **FM**
 Description: **Fracture Multiple**

Distance (ft): **54.8**
 Structural Grade: **4**
 O&M Grade: **0**
 Clock Start/From: **9**
 Clock To: **3**
 1st Value:
 2nd Value:
 Value Percent:
 Continuous Index:
 Within 8" of Joint: **YES**
 Remarks:

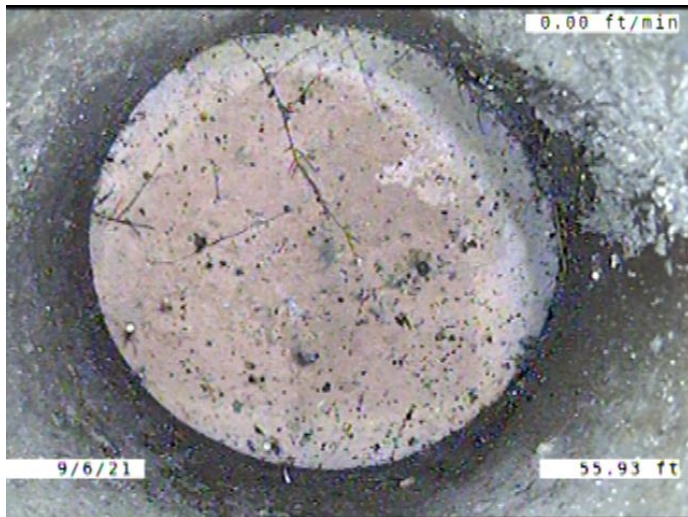
Code: **TFC**
 Description: **Tap Factory Capped**

Distance (ft): **55.9**
 Structural Grade: **0**
 O&M Grade: **0**
 Clock Start/From: **1**
 Clock To:
 1st Value: **6.000**
 2nd Value:
 Value Percent:
 Continuous Index:
 Within 8" of Joint: **YES**
 Remarks:

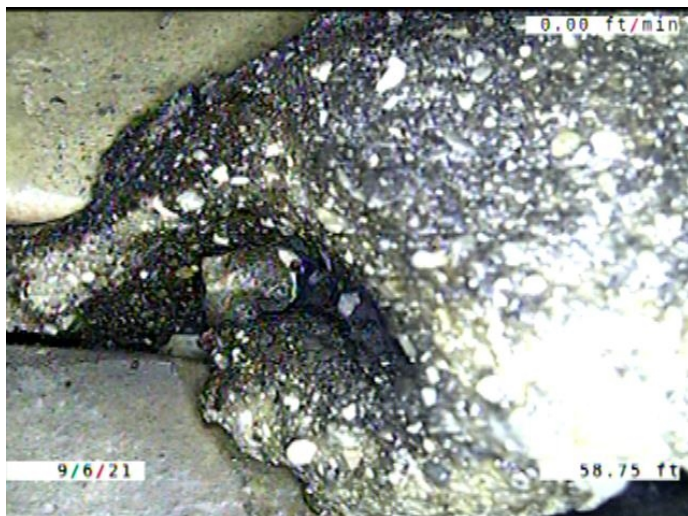
Code: **DAE**
 Description: **Deposits Attached Encrustation**

Distance (ft): **58.7**
 Structural Grade: **0**
 O&M Grade: **2**
 Clock Start/From: **4**
 Clock To: **9**
 1st Value:
 2nd Value:
 Value Percent: **5.000**
 Continuous Index:
 Within 8" of Joint: **YES**
 Remarks:

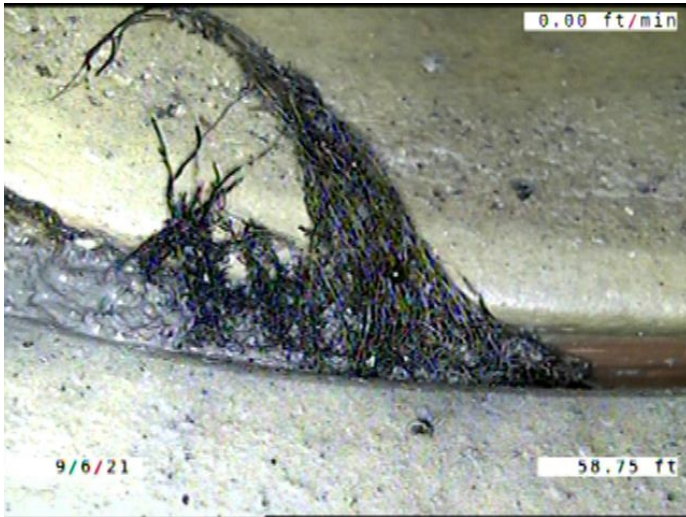
Code: **RFJ**
 Description: **Roots Fine Joint**

Distance (ft): **58.7**
 Structural Grade: **0**
 O&M Grade: **1**
 Clock Start/From: **3**
 Clock To: **4**
 1st Value:
 2nd Value:
 Value Percent:
 Continuous Index:
 Within 8" of Joint: **YES**
 Remarks:

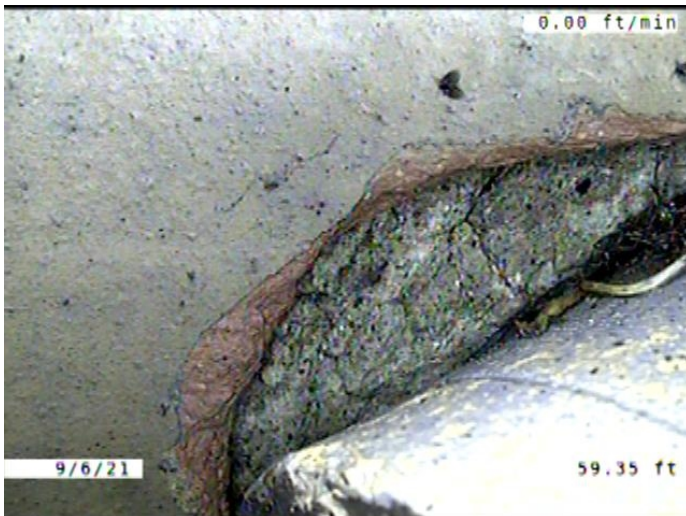
Code: **B**
 Description: **Broken**

Distance (ft): **59.4**
 Structural Grade: **4**
 O&M Grade: **0**
 Clock Start/From: **1**
 Clock To: **4**
 1st Value:
 2nd Value:
 Value Percent:
 Continuous Index:
 Within 8" of Joint: **YES**
 Remarks:

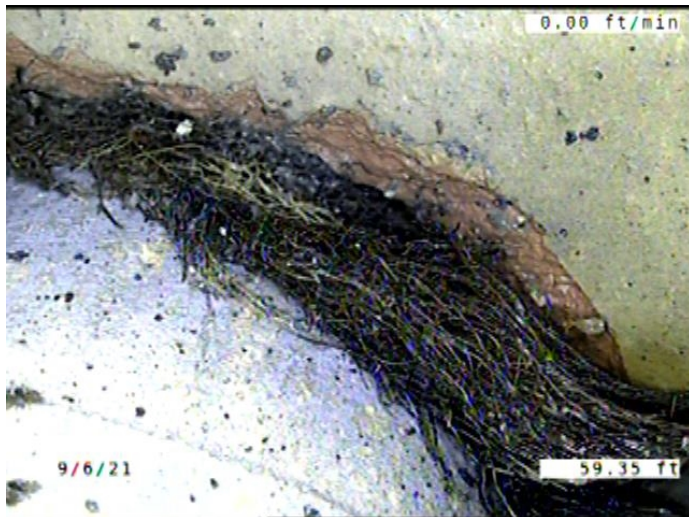
Code: **RML**
 Description: **Roots Medium Lateral**

Distance (ft): **59.4**
 Structural Grade: **0**
 O&M Grade: **3**
 Clock Start/From: **2**
 Clock To: **4**
 1st Value:
 2nd Value:
 Value Percent: **5.000**
 Continuous Index:
 Within 8" of Joint: **NO**
 Remarks:

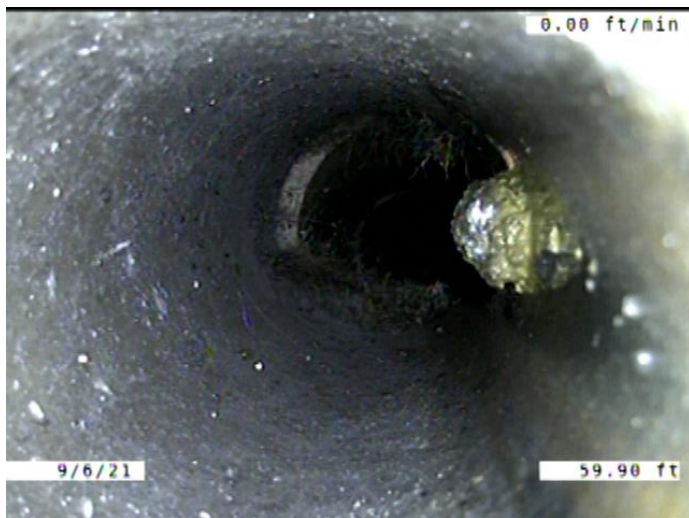
Code: **TBI**
 Description: **Tap Break-in Intruding**

Distance (ft): **59.9**
 Structural Grade: **0**
 O&M Grade: **2**
 Clock Start/From: **3**
 Clock To:
 1st Value: **6.000**
 2nd Value: **3.000**
 Value Percent:
 Continuous Index:
 Within 8" of Joint: **YES**
 Remarks:

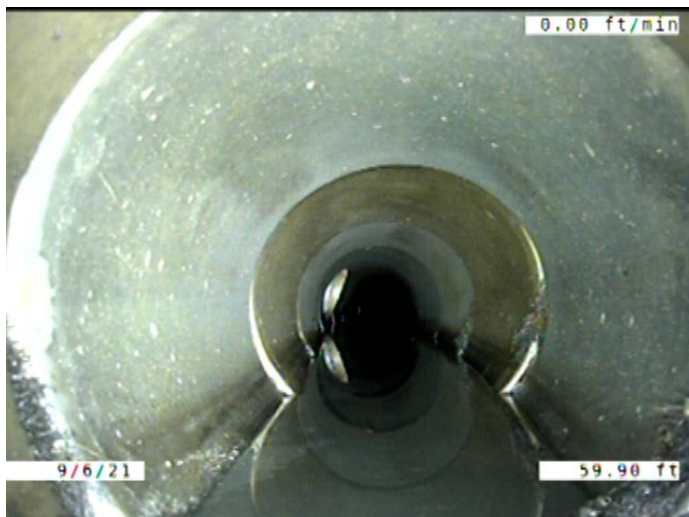
Code: **DSF**
 Description: **Deposits Settled Fine**

Distance (ft): **59.9**
 Structural Grade: **0**
 O&M Grade: **2**
 Clock Start/From: **5**
 Clock To: **7**
 1st Value:
 2nd Value:
 Value Percent: **5.000**
 Continuous Index: **F01**
 Within 8" of Joint: **YES**
 Remarks:

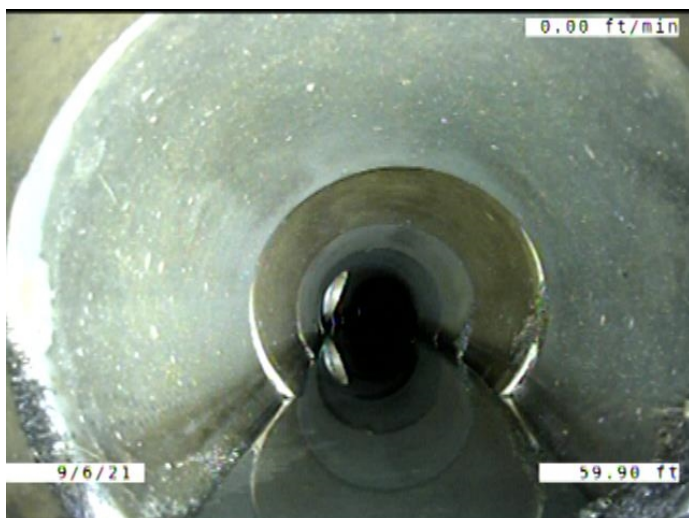
Code: **DAE**
 Description: **Deposits Attached Encrustation**

Distance (ft): **59.9**
 Structural Grade: **0**
 O&M Grade: **2**
 Clock Start/From: **2**
 Clock To: **4**
 1st Value:
 2nd Value:
 Value Percent: **5.000**
 Continuous Index: **F02**
 Within 8" of Joint: **YES**
 Remarks:

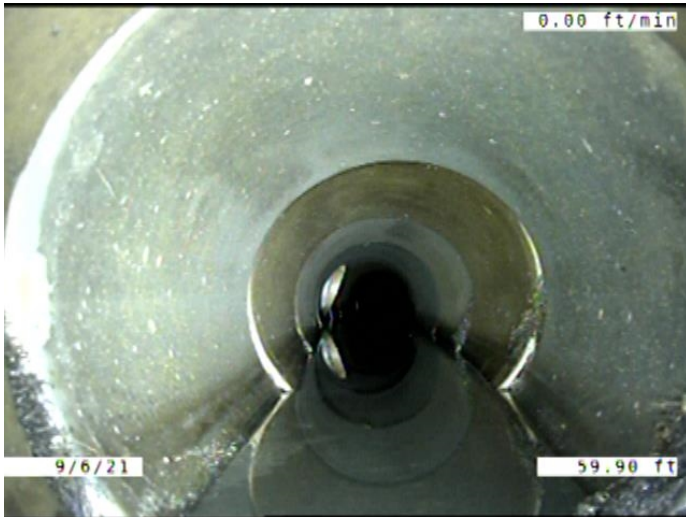
Code: **DAE**
 Description: **Deposits Attached Encrustation**

Distance (ft): **59.9**
 Structural Grade: **0**
 O&M Grade: **2**
 Clock Start/From: **8**
 Clock To: **10**
 1st Value:
 2nd Value:
 Value Percent: **5.000**
 Continuous Index: **F03**
 Within 8" of Joint: **YES**
 Remarks:

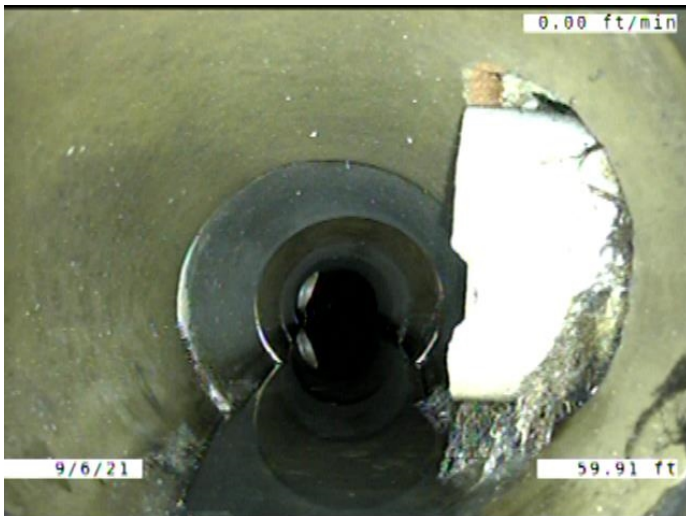
Code: **MSA**
 Description: **Miscellaneous Survey Abandoned**

Distance (ft): **59.9**
 Structural Grade: **0**
 O&M Grade: **0**
 Clock Start/From:
 Clock To:
 1st Value:
 2nd Value:
 Value Percent:
 Continuous Index:
 Within 8" of Joint: **NO**
 Remarks: **CAMERA CANT MAKE IT PAST PROTRUDING TAP. MADE IT TO THE**
