Profile/Photo Observation Report

| Street: | W 42ND AVE | Flow Control: | Not Controlled |
| City: | Hobart, IN | Year Renewed: | |

| US MH: | M-504-122 | DS MH: | M-504-121 |

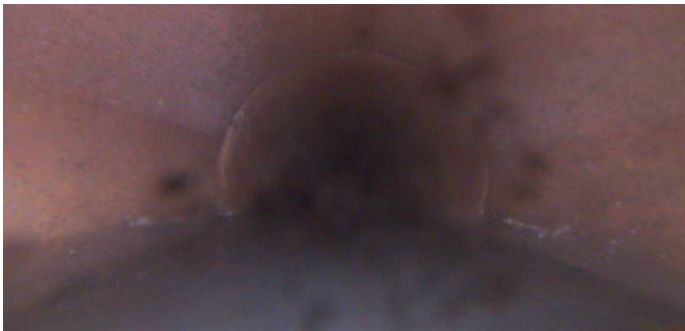
Code: **AMH**
Description: **Manhole**

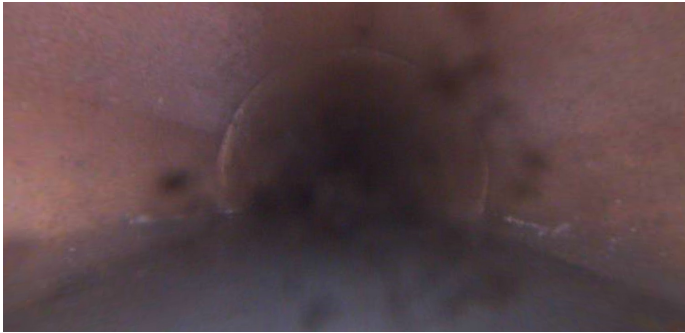
| Code: | MWL |
| Description: | Water Level |

| Distance (ft): | .0 |
| Value Percent: | 40.000 |

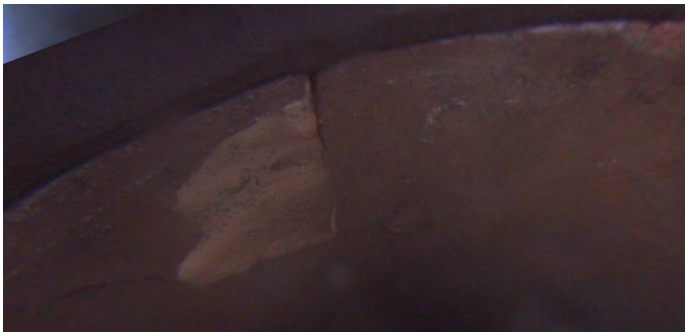
| Code: | FM |
| Description: | Fracture Multiple |

| Distance (ft): | 7.2 |
| Structural Grade: | 4 |
| Clock Start/From: | 10 |
| Clock To: | 2 |
| Within 8" of Joint: | YES |

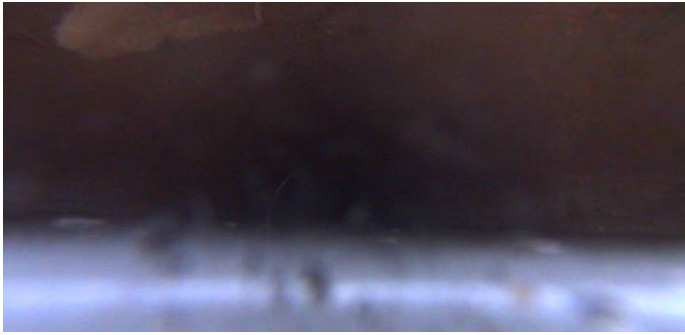
Code: **MWL**
Description: **Water Level**

Distance (ft): **7.2**
Structural Grade: **0**
O&M Grade: **0**
Clock Start/From:
Clock To:
1st Value:
2nd Value:
Value Percent: **40.000**
Continuous Index:
Within 8" of Joint: **NO**
Remarks:

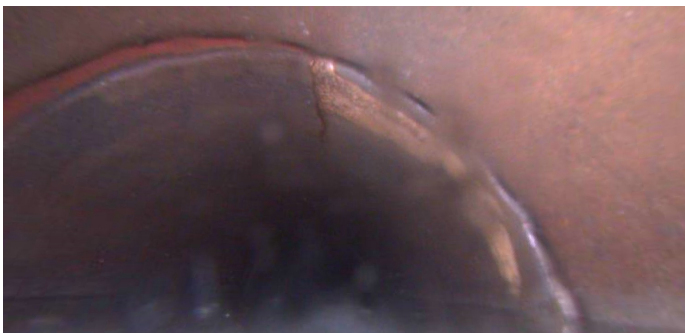
Code: **FL**
Description: **Fracture Longitudinal**

Distance (ft): **9.0**
Structural Grade: **3**
O&M Grade: **0**
Clock Start/From: **12**
Clock To:
1st Value:
2nd Value:
Value Percent:
Continuous Index:
Within 8" of Joint: **YES**
Remarks:

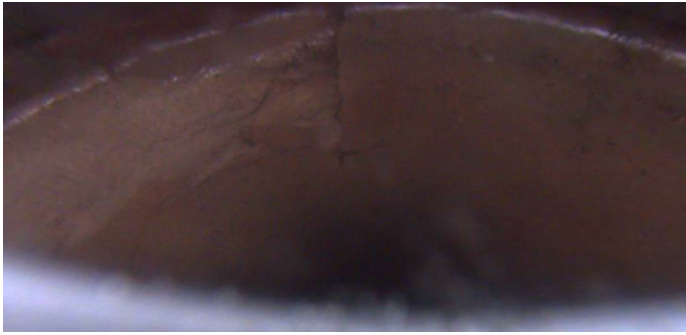
Code: **FM**
Description: **Fracture Multiple**

Distance (ft): **13.4**
Structural Grade: **4**
O&M Grade: **0**
Clock Start/From: **10**
Clock To: **12**
1st Value:
2nd Value:
Value Percent:
Continuous Index:
Within 8" of Joint: **YES**
Remarks:

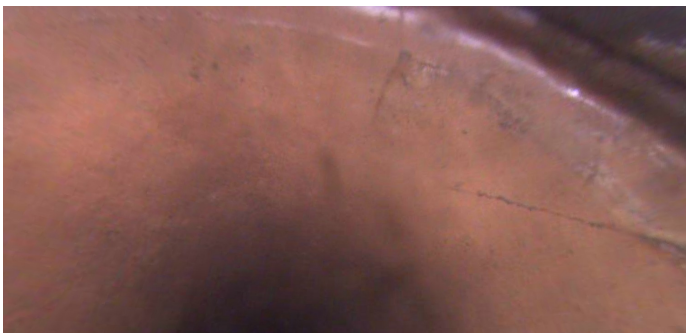
Code: **FM**
Description: **Fracture Multiple**

Distance (ft): **15.6**
Structural Grade: **4**
O&M Grade: **0**
Clock Start/From: **12**
Clock To: **2**
1st Value:
2nd Value:
Value Percent:
Continuous Index:
Within 8" of Joint: **YES**
Remarks:

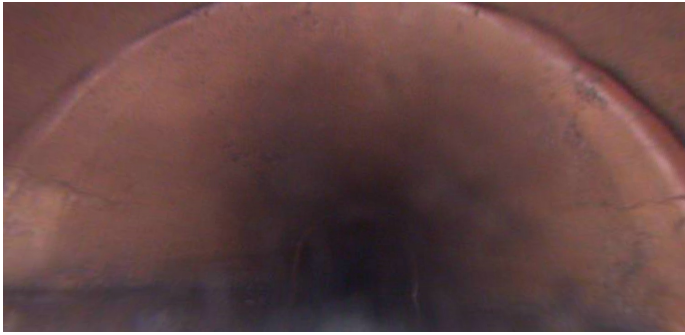
Code: **FM**
Description: **Fracture Multiple**

Distance (ft): **17.4**
Structural Grade: **4**
O&M Grade: **0**
Clock Start/From: **9**
Clock To: **3**
1st Value:
2nd Value:
Value Percent:
Continuous Index:
Within 8" of Joint: **YES**
Remarks:

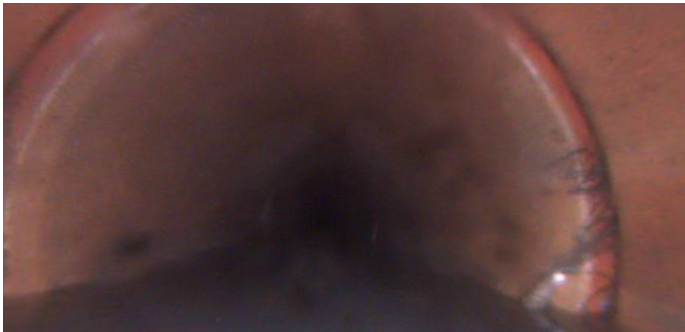
Code: **RFJ**
Description: **Roots Fine Joint**

Distance (ft): **21.5**
Structural Grade: **0**
O&M Grade: **1**
Clock Start/From: **3**
Clock To:
1st Value:
2nd Value:
Value Percent:
Continuous Index:
Within 8" of Joint: **YES**
Remarks:

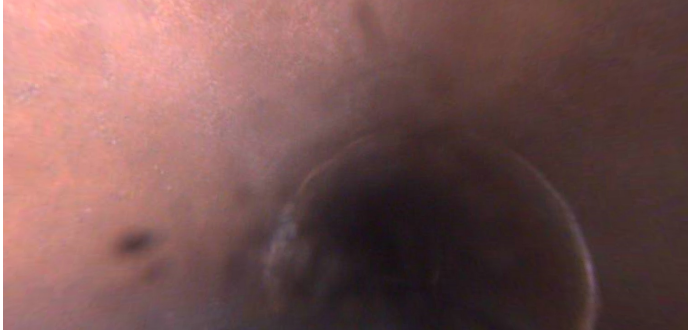
| Code: | MSA |
| Description: | Abandoned Survey |
| Distance (ft): | 23.3 |
| Remarks: | debris under water |
