Profile/Photo Observation Report

Date:	04/17/2018	Weather:		Coding:	PACP 6.0
Pipe Length (ft):	141.5	Owner:	NA	Pre Clean:	Not Known
P.O.#:		Surveyor:	Jen Costello	PSR:	P-504-122-121
Customer:		Clean Date:	01/01/1900	Shape:	C

Street:	Summerlin	Flow Control:	Not Controlled
City:	Hobart, IN	Year Renewed:	
Location:	Light Highway	Tape/Media #:	
Purpose:	Not Known	Dia/Height:	12"
Use:	Sanitary	Material:	VCP
Drain Area:	NA	Lining:	
Category:	NA		
Comment:

Location Details:		Direction of Survey:	Downstream
US MH:	M-504-122	DS MH:	M-504-121
		Total Length Surveyed (ft):	23.3

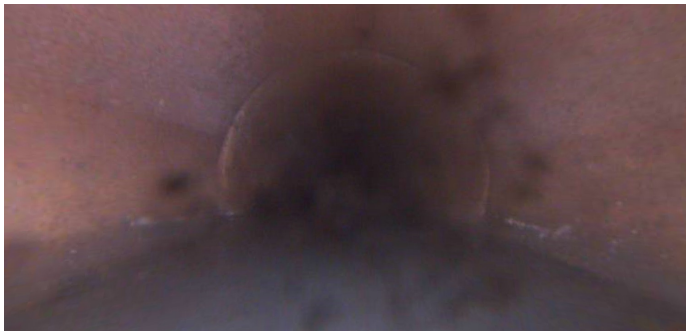
Code: **AMH**
Description: **Manhole**

Distance (ft): **.0**
Structural Grade: **0**
O&M Grade: **0**
Clock Start/From:
Clock To:
1st Value:
2nd Value:
Value Percent:
Continuous Index:
Within 8" of Joint: **NO**
Remarks: **M-504-122**

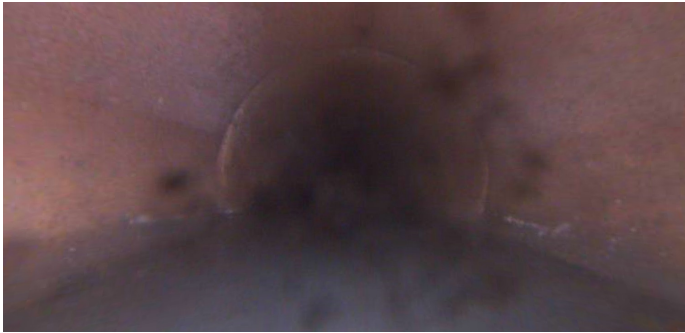
Code:	MWL
Description:	Water Level

Distance (ft):	.0
Structural Grade:	0
O&M Grade:	0
Clock Start/From:	
Clock To:	
1st Value:	
2nd Value:	
Value Percent:	40.000
Continuous Index:	
Within 8" of Joint:	NO
Remarks:

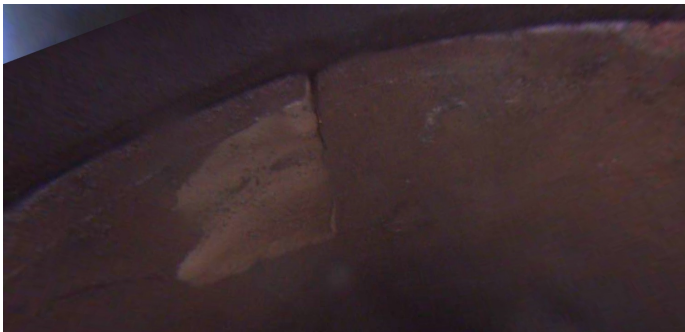
Code:	FM
Description:	Fracture Multiple

Distance (ft):	7.2
Structural Grade:	4
O&M Grade:	0
Clock Start/From:	10
Clock To:	2
1st Value:	
2nd Value:	
Value Percent:	
Continuous Index:	
Within 8" of Joint:	YES
Remarks:

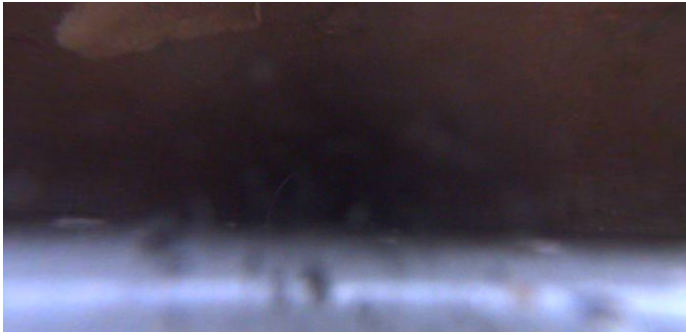
Code: **MWL**
Description: **Water Level**

Distance (ft): **7.2**
Structural Grade: **0**
O&M Grade: **0**
Clock Start/From:
Clock To:
1st Value:
2nd Value:
Value Percent: **40.000**
Continuous Index:
Within 8" of Joint: **NO**
Remarks:

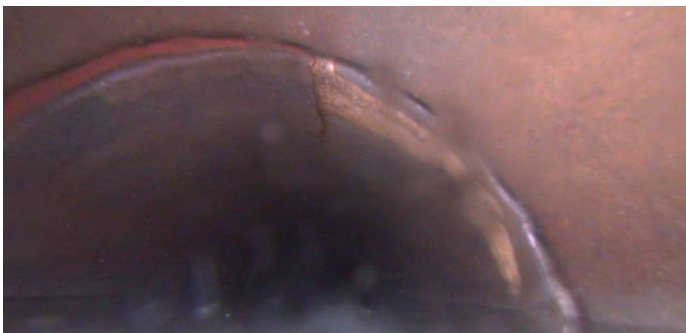
Code: **FL**
Description: **Fracture Longitudinal**

Distance (ft): **9.0**
Structural Grade: **3**
O&M Grade: **0**
Clock Start/From: **12**
Clock To:
1st Value:
2nd Value:
Value Percent:
Continuous Index:
Within 8" of Joint: **YES**
Remarks:

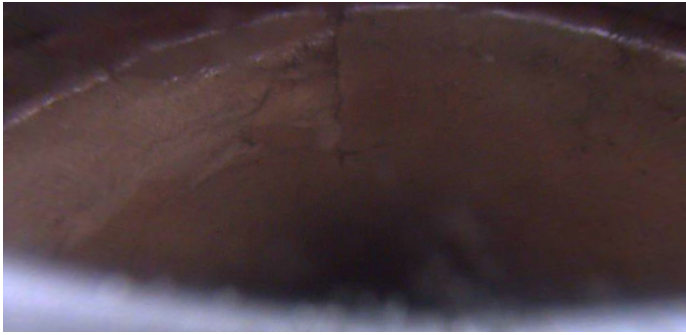
Code: **FM**
Description: **Fracture Multiple**

Distance (ft): **13.4**
Structural Grade: **4**
O&M Grade: **0**
Clock Start/From: **10**
Clock To: **12**
1st Value:
2nd Value:
Value Percent:
Continuous Index:
Within 8" of Joint: **YES**
Remarks:

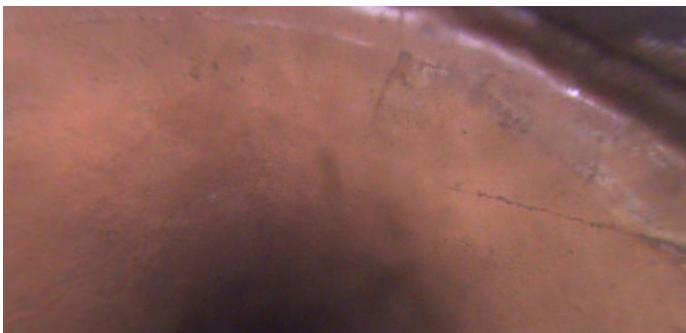
Code: **FM**
Description: **Fracture Multiple**

Distance (ft): **15.6**
Structural Grade: **4**
O&M Grade: **0**
Clock Start/From: **12**
Clock To: **2**
1st Value:
2nd Value:
Value Percent:
Continuous Index:
Within 8" of Joint: **YES**
Remarks:

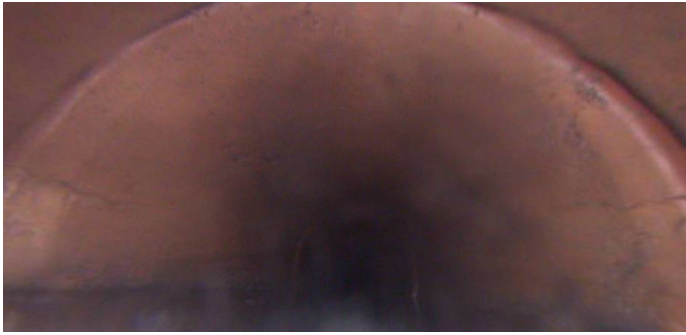
Code: **FM**
Description: **Fracture Multiple**

Distance (ft): **17.4**
Structural Grade: **4**
O&M Grade: **0**
Clock Start/From: **9**
Clock To: **3**
1st Value:
2nd Value:
Value Percent:
Continuous Index:
Within 8" of Joint: **YES**
Remarks:

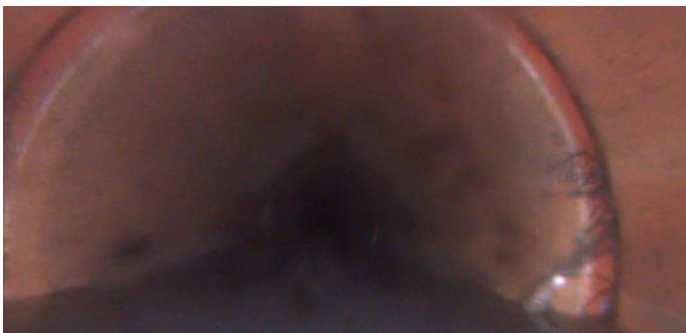
Code: **RFJ**
Description: **Roots Fine Joint**

Distance (ft): **21.5**
Structural Grade: **0**
O&M Grade: **1**
Clock Start/From: **3**
Clock To:
1st Value:
2nd Value:
Value Percent:
Continuous Index:
Within 8" of Joint: **YES**
Remarks:

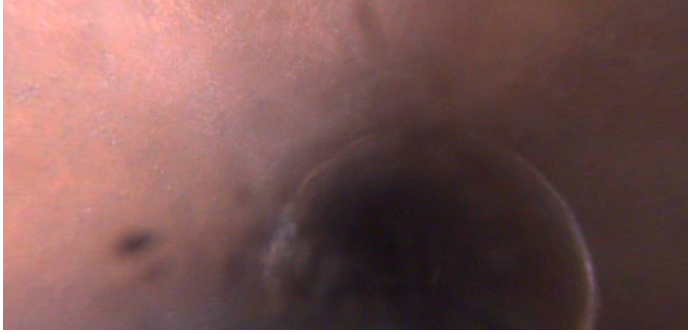
Code:	MSA
Description:	Abandoned Survey
Distance (ft):	23.3
Structural Grade:	0
O&M Grade:	0
Clock Start/From:	
Clock To:	
1st Value:	
2nd Value:	
Value Percent:	
Continuous Index:	
Within 8" of Joint:	NO
Remarks:	debris under water
