# Profile/Photo Observation Report

Date:	09/03/2021	Weather:		Coding:	PACP 7.0
Pipe Length (ft):	140.7	Owner:	City of Hobart	Pre Clean:	Light Cleaning
P.O.#:	YES502259	Surveyor:	S. Bucklin	PSR:	P-504-122-121
Customer:	City of Hobart	Clean Date:	09/02/2021	Shape:	C

Street:	42nd Avenue	Flow Control:	Not Controlled
City:	Hobart, IN	Year Renewed:	
Location:	Alley	Tape/Media #:	
Purpose:	Routine Assessment	Dia/Height:	12"
Use:	Sanitary Sewage Pipe	Material:	VCP
Drain Area:		Lining:	
Category:	NA		
Comment:			
Location Details:		Direction of Survey:	Downstream
US MH:	M-504-122	DS MH:	M-504-121
		Total Length Surveyed (ft):	140.7

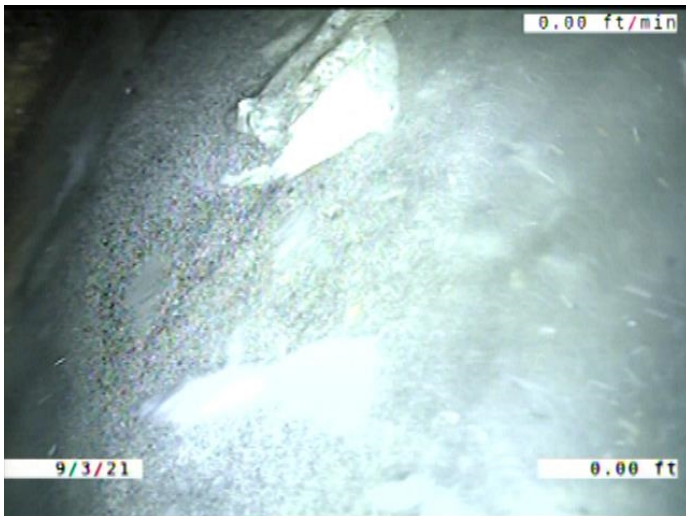
Code: **DSF**  
 Description: **Deposits Settled Fine**

Distance (ft): **.0**  
 Structural Grade: **0**  
 O&M Grade: **2**  
 Clock Start/From: **5**  
 Clock To: **7**  
 1st Value:  
 2nd Value:  
 Value Percent: **5.000**  
 Continuous Index: **S01**  
 Within 8" of Joint: **YES**  
 Remarks:

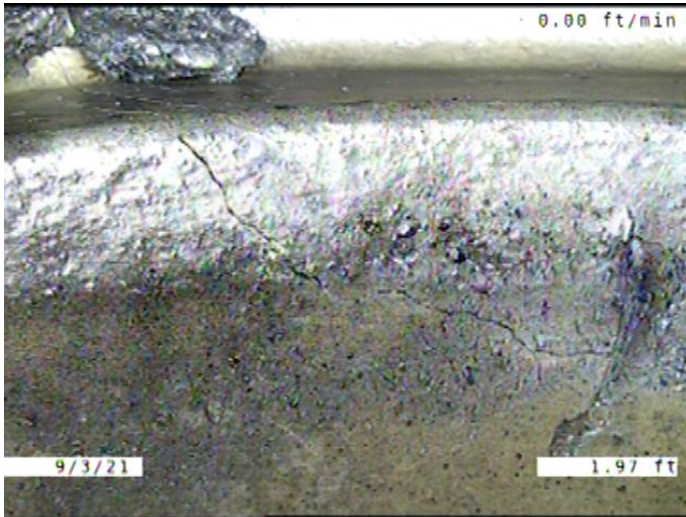
Code: **CM**  
 Description: **Crack Multiple**

Distance (ft): **2.0**  
 Structural Grade: **3**  
 O&M Grade: **0**  
 Clock Start/From: **9**  
 Clock To: **11**  
 1st Value:  
 2nd Value:  
 Value Percent:  
 Continuous Index:  
 Within 8" of Joint: **YES**  
 Remarks:

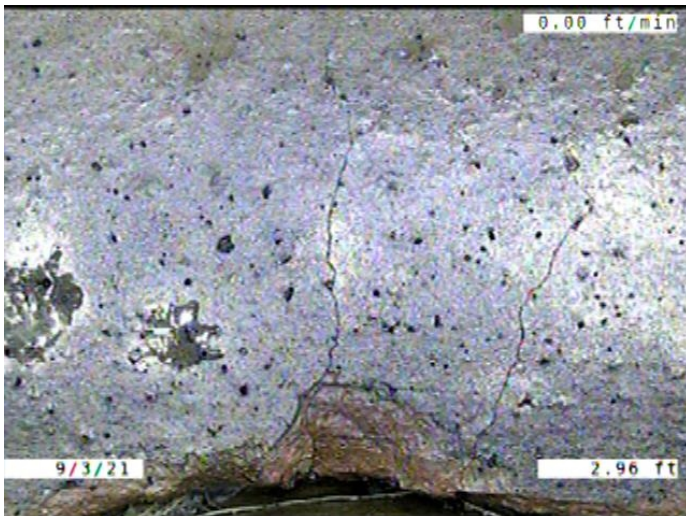
Code: **CM**  
 Description: **Crack Multiple**

Distance (ft): **3.0**  
 Structural Grade: **3**  
 O&M Grade: **0**  
 Clock Start/From: **12**  
 Clock To: **2**  
 1st Value:  
 2nd Value:  
 Value Percent:  
 Continuous Index:  
 Within 8" of Joint: **YES**  
 Remarks:

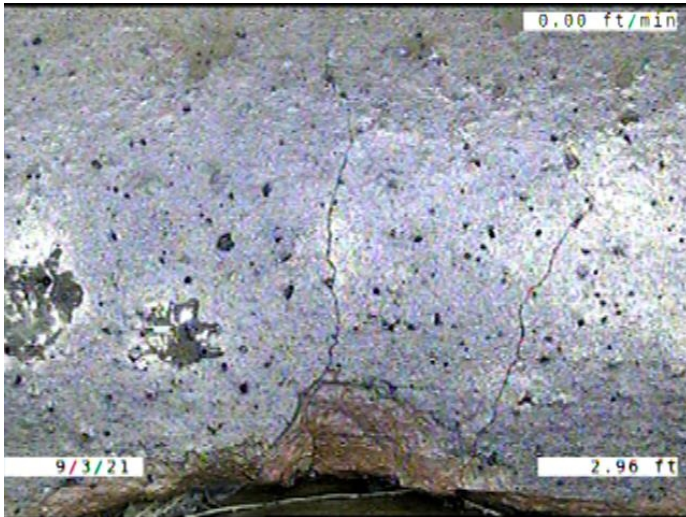
Code: **RFL**  
Description: **Roots Fine Lateral**

Distance (ft): **3.0**  
Structural Grade: **0**  
O&M Grade: **1**  
Clock Start/From: **12**  
Clock To: **2**  
1st Value:  
2nd Value:  
Value Percent:  
Continuous Index:  
Within 8" of Joint: **NO**  
Remarks:

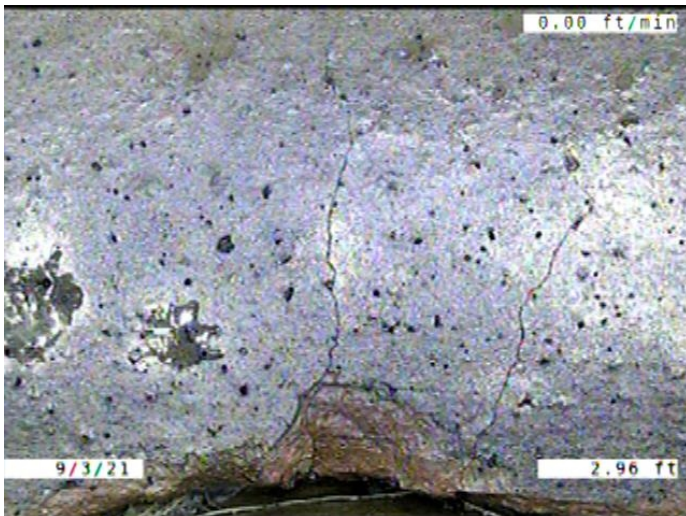
Code: **TBI**  
Description: **Tap Break-in Intruding**

Distance (ft): **3.2**  
Structural Grade: **0**  
O&M Grade: **2**  
Clock Start/From: **1**  
Clock To:  
1st Value: **6.000**  
2nd Value: **1.000**  
Value Percent:  
Continuous Index:  
Within 8" of Joint: **YES**  
Remarks:

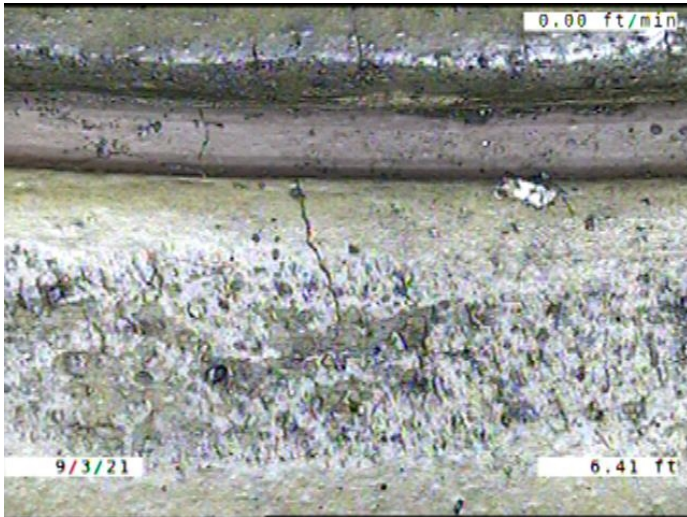
Code: **CM**  
 Description: **Crack Multiple**

Distance (ft): **6.4**  
 Structural Grade: **3**  
 O&M Grade: **0**  
 Clock Start/From: **12**  
 Clock To: **3**  
 1st Value:  
 2nd Value:  
 Value Percent:  
 Continuous Index:  
 Within 8" of Joint: **YES**  
 Remarks:

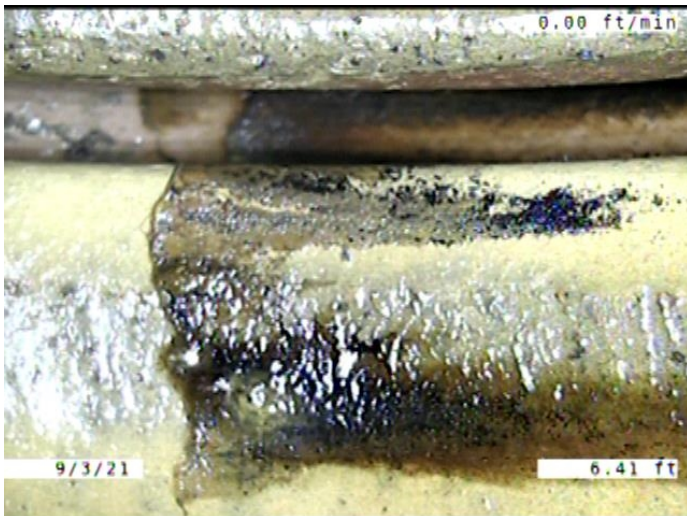
Code: **ISB**  
 Description: **Infiltration Stain Barrel**

Distance (ft): **6.4**  
 Structural Grade: **0**  
 O&M Grade: **1**  
 Clock Start/From: **1**  
 Clock To: **4**  
 1st Value:  
 2nd Value:  
 Value Percent:  
 Continuous Index:  
 Within 8" of Joint: **YES**  
 Remarks:

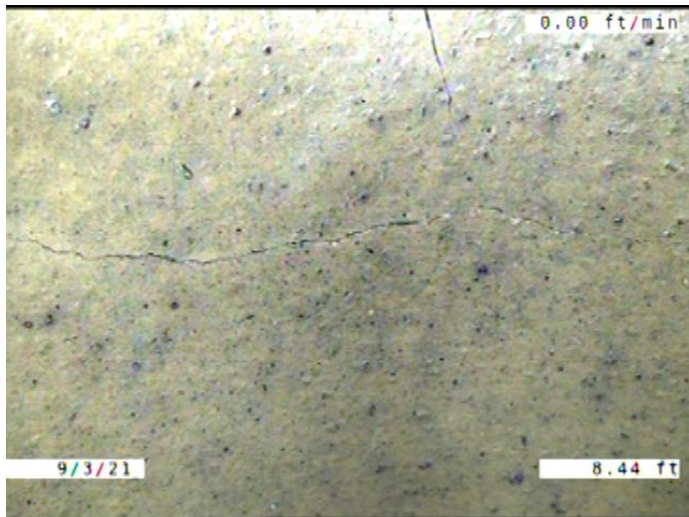
Code: **FM**  
 Description: **Fracture Multiple**

Distance (ft): **8.4**  
 Structural Grade: **4**  
 O&M Grade: **0**  
 Clock Start/From: **8**  
 Clock To: **12**  
 1st Value:  
 2nd Value:  
 Value Percent:  
 Continuous Index:  
 Within 8" of Joint: **YES**  
 Remarks:

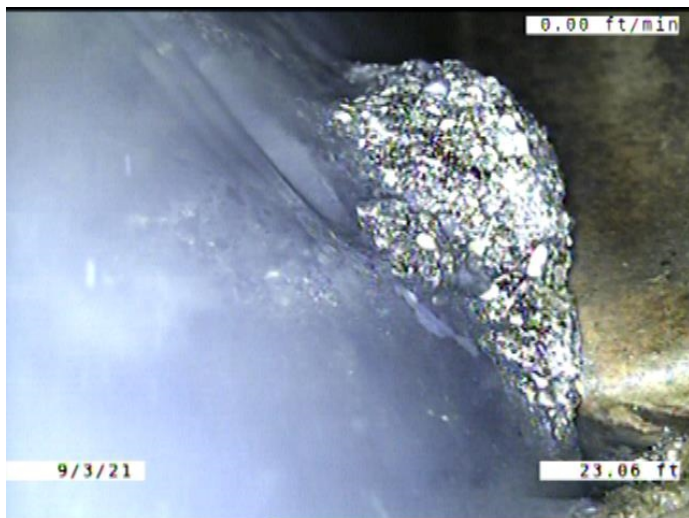
Code: **DAE**  
 Description: **Deposits Attached Encrustation**

Distance (ft): **23.1**  
 Structural Grade: **0**  
 O&M Grade: **2**  
 Clock Start/From: **4**  
 Clock To: **5**  
 1st Value:  
 2nd Value:  
 Value Percent: **5.000**  
 Continuous Index:  
 Within 8" of Joint: **YES**  
 Remarks:

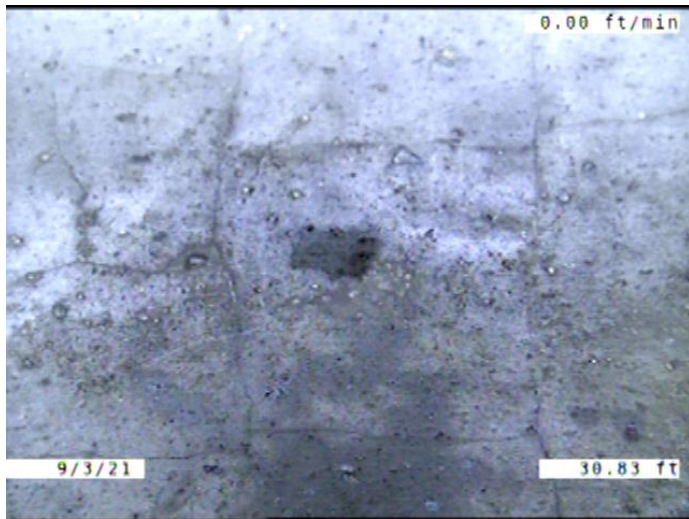
Code: **CM**  
Description: **Crack Multiple**

Distance (ft): **30.8**  
Structural Grade: **3**  
O&M Grade: **0**  
Clock Start/From: **8**  
Clock To: **4**  
1st Value:  
2nd Value:  
Value Percent:  
Continuous Index:  
Within 8" of Joint: **YES**  
Remarks:

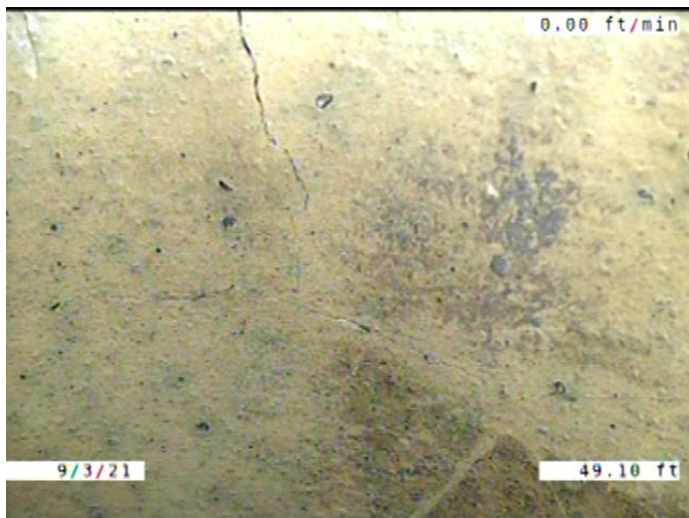
Code: **FM**  
Description: **Fracture Multiple**

Distance (ft): **49.1**  
Structural Grade: **4**  
O&M Grade: **0**  
Clock Start/From: **9**  
Clock To: **4**  
1st Value:  
2nd Value:  
Value Percent:  
Continuous Index:  
Within 8" of Joint: **YES**  
Remarks:

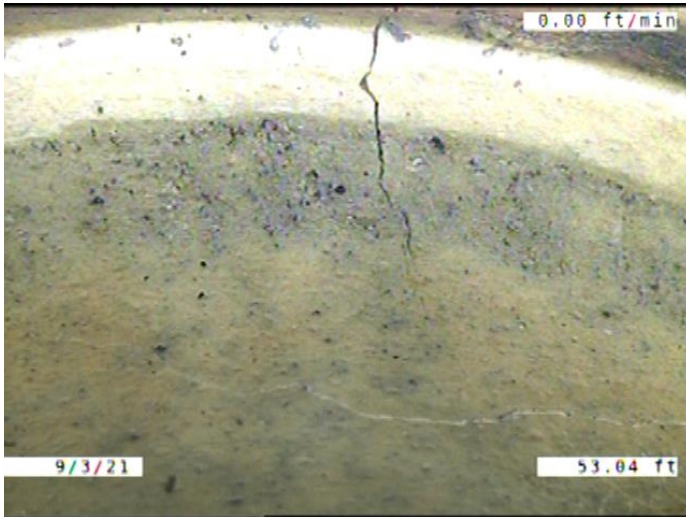
Code: **CM**  
 Description: **Crack Multiple**

Distance (ft): **53.0**  
 Structural Grade: **3**  
 O&M Grade: **0**  
 Clock Start/From: **11**  
 Clock To: **4**  
 1st Value:  
 2nd Value:  
 Value Percent:  
 Continuous Index:  
 Within 8" of Joint: **YES**  
 Remarks:

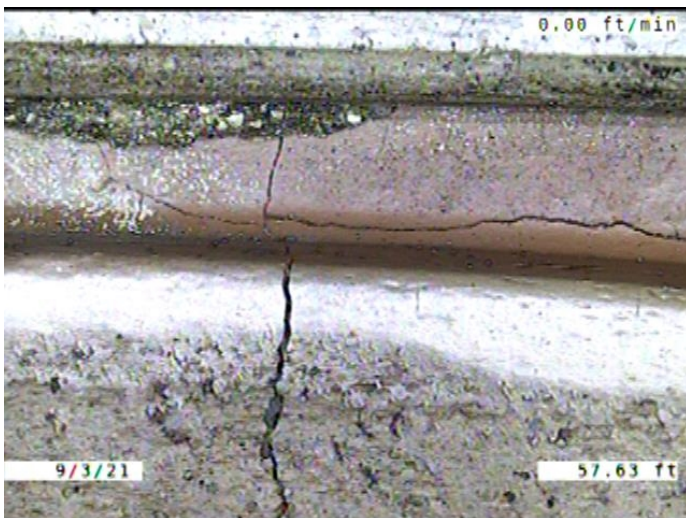
Code: **FM**  
 Description: **Fracture Multiple**

Distance (ft): **57.6**  
 Structural Grade: **4**  
 O&M Grade: **0**  
 Clock Start/From: **12**  
 Clock To: **4**  
 1st Value:  
 2nd Value:  
 Value Percent:  
 Continuous Index:  
 Within 8" of Joint: **NO**  
 Remarks:

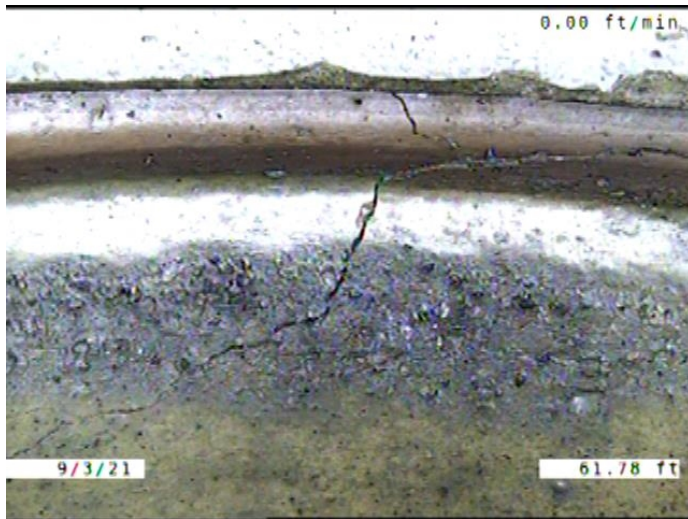
Code: **CM**  
Description: **Crack Multiple**

Distance (ft): **61.8**  
Structural Grade: **3**  
O&M Grade: **0**  
Clock Start/From: **10**  
Clock To: **4**  
1st Value:  
2nd Value:  
Value Percent:  
Continuous Index:  
Within 8" of Joint: **YES**  
Remarks:

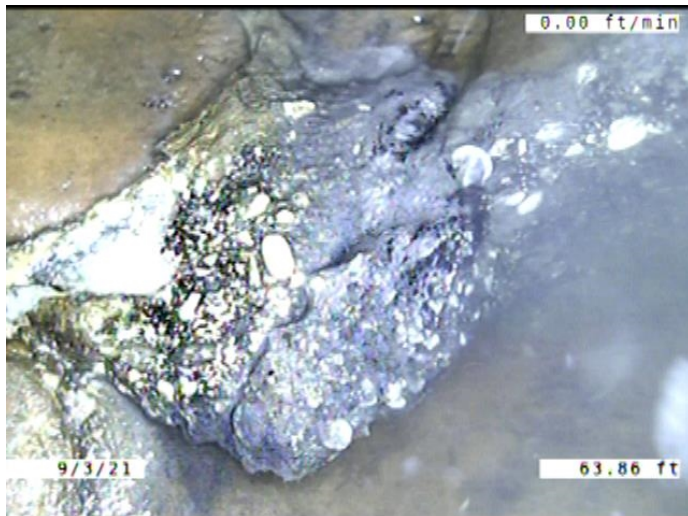
Code: **DAE**  
Description: **Deposits Attached Encrustation**

Distance (ft): **63.9**  
Structural Grade: **0**  
O&M Grade: **2**  
Clock Start/From: **5**  
Clock To: **8**  
1st Value:  
2nd Value:  
Value Percent: **5.000**  
Continuous Index:  
Within 8" of Joint: **YES**  
Remarks:

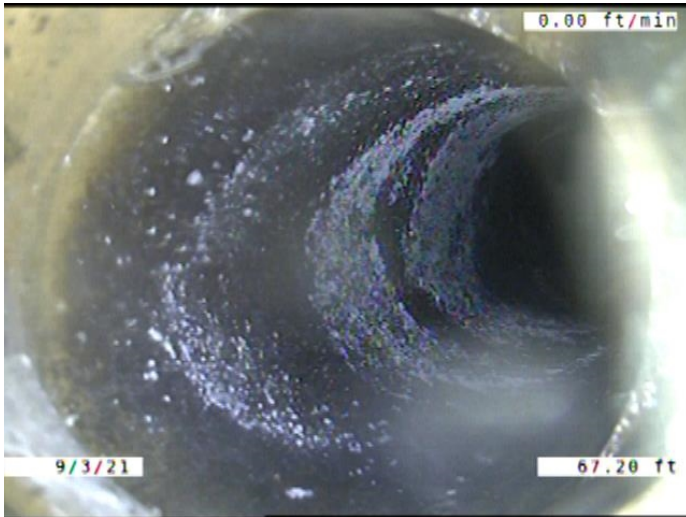
Code: **TBI**  
 Description: **Tap Break-in Intruding**

Distance (ft): **67.2**  
 Structural Grade: **0**  
 O&M Grade: **2**  
 Clock Start/From: **1**  
 Clock To:  
 1st Value: **6.000**  
 2nd Value: **1.000**  
 Value Percent:  
 Continuous Index:  
 Within 8" of Joint: **YES**  
 Remarks: **ROOTS GROWING IN THE TAP.**

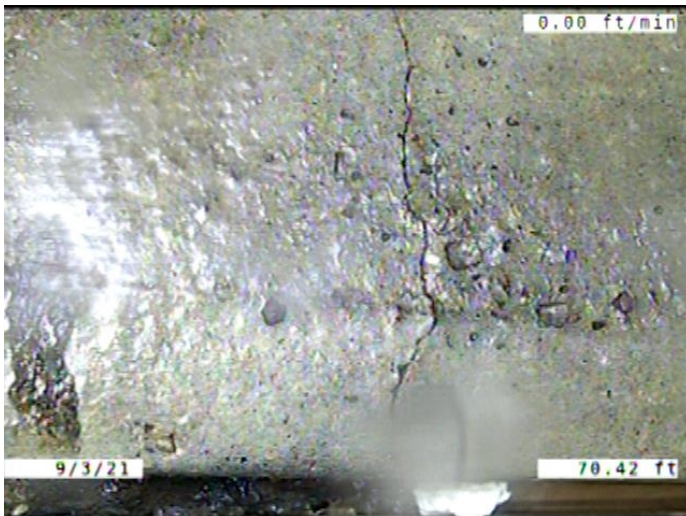
Code: **CM**  
 Description: **Crack Multiple**

Distance (ft): **70.4**  
 Structural Grade: **3**  
 O&M Grade: **0**  
 Clock Start/From: **4**  
 Clock To: **5**  
 1st Value:  
 2nd Value:  
 Value Percent:  
 Continuous Index:  
 Within 8" of Joint: **YES**  
 Remarks:

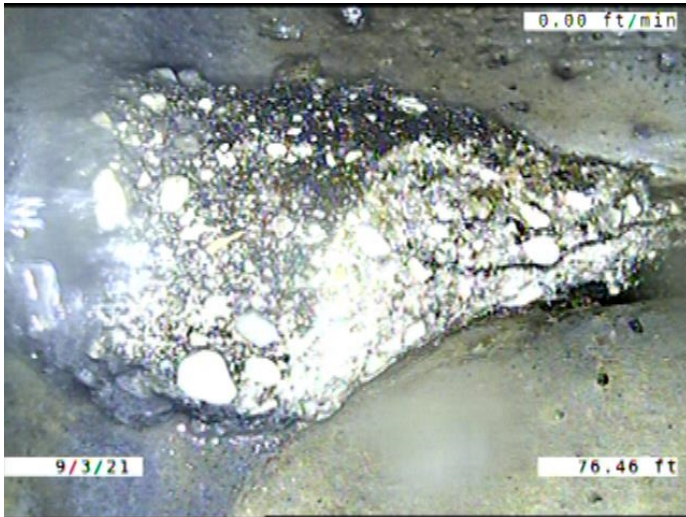
Code: **DAE**  
 Description: **Deposits Attached Encrustation**

Distance (ft): **76.5**  
 Structural Grade: **0**  
 O&M Grade: **2**  
 Clock Start/From: **4**  
 Clock To: **5**  
 1st Value:  
 2nd Value:  
 Value Percent: **5.000**  
 Continuous Index: **S02**  
 Within 8" of Joint: **YES**  
 Remarks:

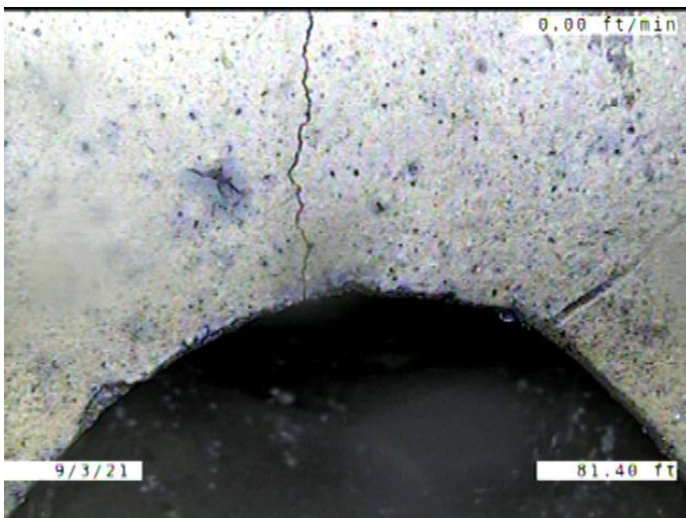
Code: **CL**  
 Description: **Crack Longitudinal**

Distance (ft): **81.4**  
 Structural Grade: **2**  
 O&M Grade: **0**  
 Clock Start/From: **12**  
 Clock To:  
 1st Value:  
 2nd Value:  
 Value Percent:  
 Continuous Index:  
 Within 8" of Joint: **YES**  
 Remarks:

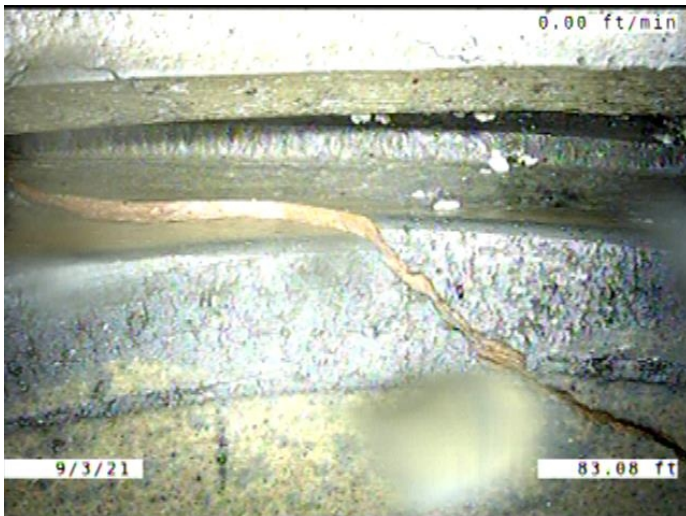
Code: **B**  
Description: **Broken**

Distance (ft): **83.1**  
Structural Grade: **4**  
O&M Grade: **0**  
Clock Start/From: **10**  
Clock To: **4**  
1st Value:  
2nd Value:  
Value Percent:  
Continuous Index:  
Within 8" of Joint: **YES**  
Remarks:

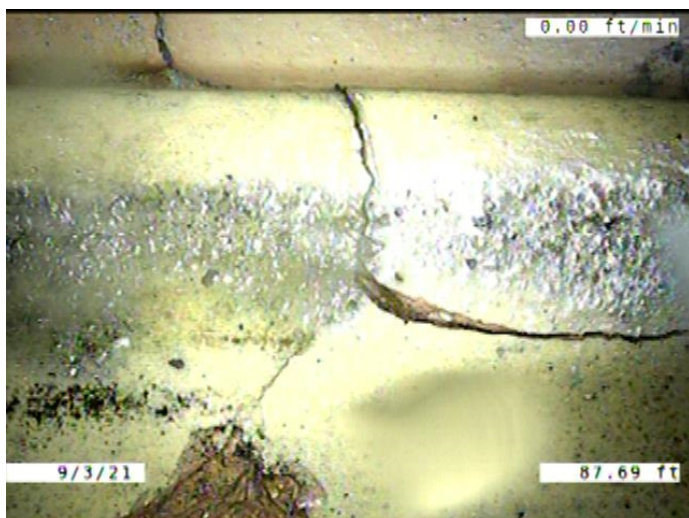
Code: **FM**  
 Description: **Fracture Multiple**

Distance (ft): **87.7**  
 Structural Grade: **4**  
 O&M Grade: **0**  
 Clock Start/From: **10**  
 Clock To: **4**  
 1st Value:  
 2nd Value:  
 Value Percent:  
 Continuous Index:  
 Within 8" of Joint: **YES**  
 Remarks:

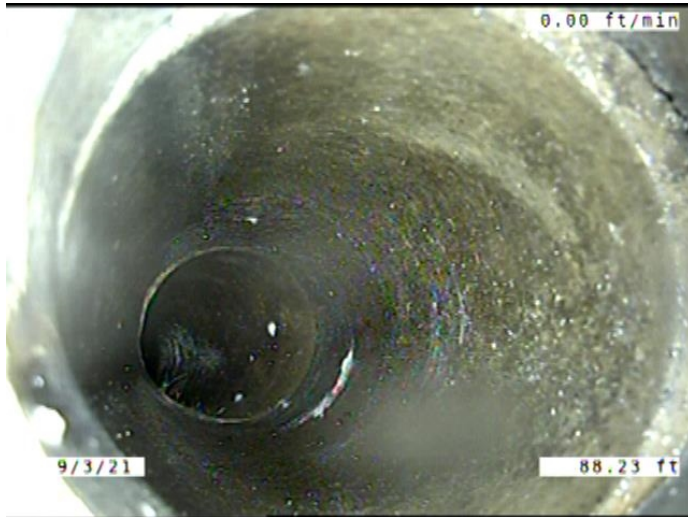
Code: **TBI**  
Description: **Tap Break-in Intruding**

Distance (ft): **88.2**  
Structural Grade: **0**  
O&M Grade: **2**  
Clock Start/From: **11**  
Clock To:  
1st Value: **6.000**  
2nd Value: **1.000**  
Value Percent:  
Continuous Index:  
Within 8" of Joint: **YES**  
Remarks: **CONSTANTLY RUNNING WATER**

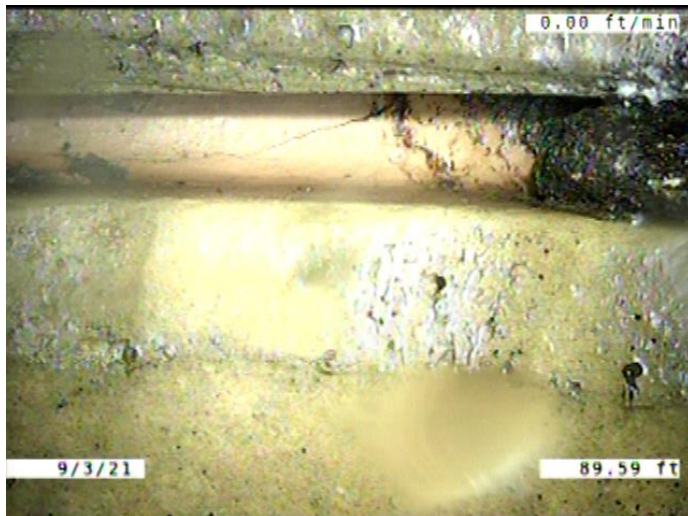
Code: **CM**  
Description: **Crack Multiple**

Distance (ft): **89.6**  
Structural Grade: **3**  
O&M Grade: **0**  
Clock Start/From: **10**  
Clock To: **5**  
1st Value:  
2nd Value:  
Value Percent:  
Continuous Index:  
Within 8" of Joint: **YES**  
Remarks:

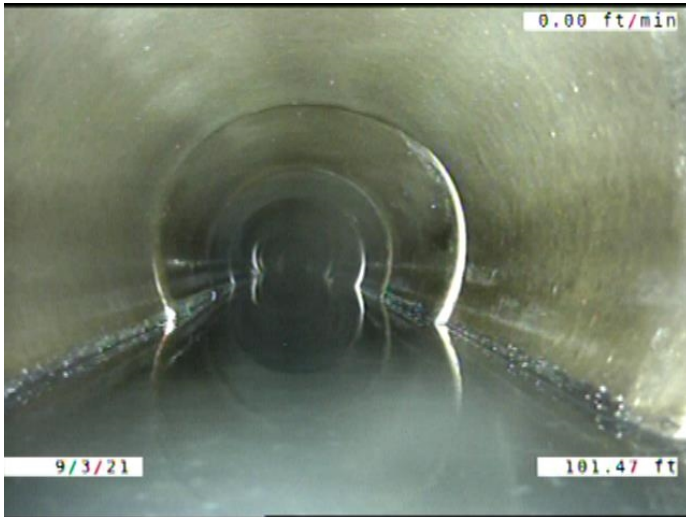
Code: **DAE**  
 Description: **Deposits Attached Encrustation**

Distance (ft): **101.5**  
 Structural Grade: **0**  
 O&M Grade: **2**  
 Clock Start/From: **4**  
 Clock To: **5**  
 1st Value:  
 2nd Value:  
 Value Percent: **5.000**  
 Continuous Index: **F02**  
 Within 8" of Joint: **YES**  
 Remarks:

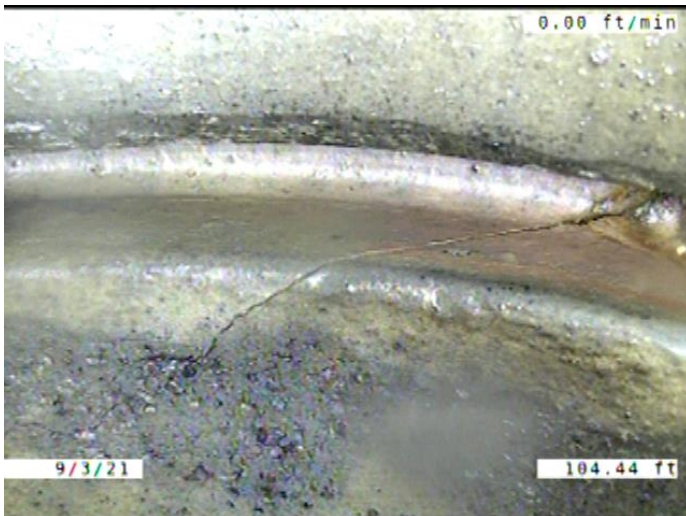
Code: **CM**  
 Description: **Crack Multiple**

Distance (ft): **104.4**  
 Structural Grade: **3**  
 O&M Grade: **0**  
 Clock Start/From: **12**  
 Clock To: **2**  
 1st Value:  
 2nd Value:  
 Value Percent:  
 Continuous Index:  
 Within 8" of Joint: **YES**  
 Remarks:

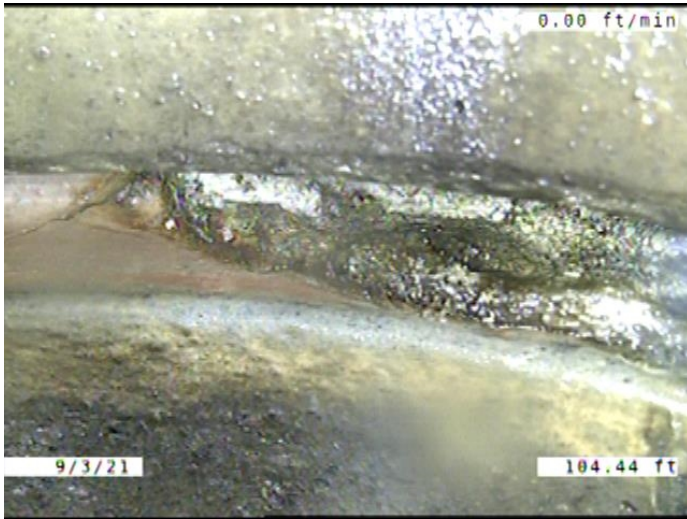
Code: **ISJ**  
Description: **Infiltration Stain Joint**

Distance (ft): **104.4**  
Structural Grade: **0**  
O&M Grade: **1**  
Clock Start/From: **2**  
Clock To: **4**  
1st Value:  
2nd Value:  
Value Percent:  
Continuous Index:  
Within 8" of Joint: **YES**  
Remarks:

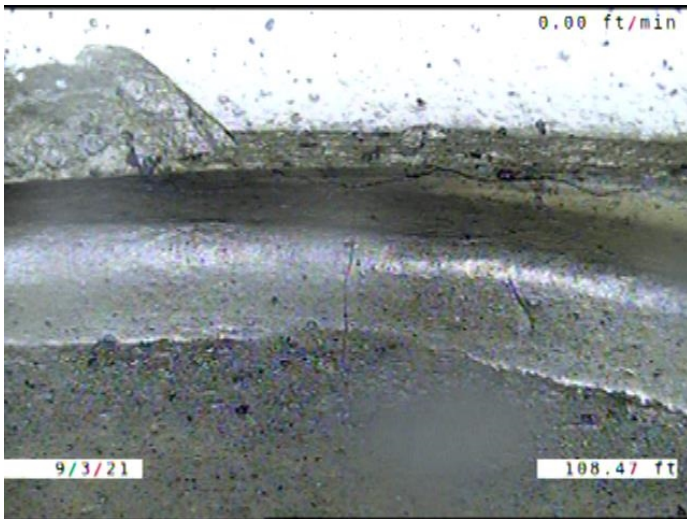
Code: **CM**  
Description: **Crack Multiple**

Distance (ft): **108.5**  
Structural Grade: **3**  
O&M Grade: **0**  
Clock Start/From: **12**  
Clock To: **2**  
1st Value:  
2nd Value:  
Value Percent:  
Continuous Index:  
Within 8" of Joint: **YES**  
Remarks:

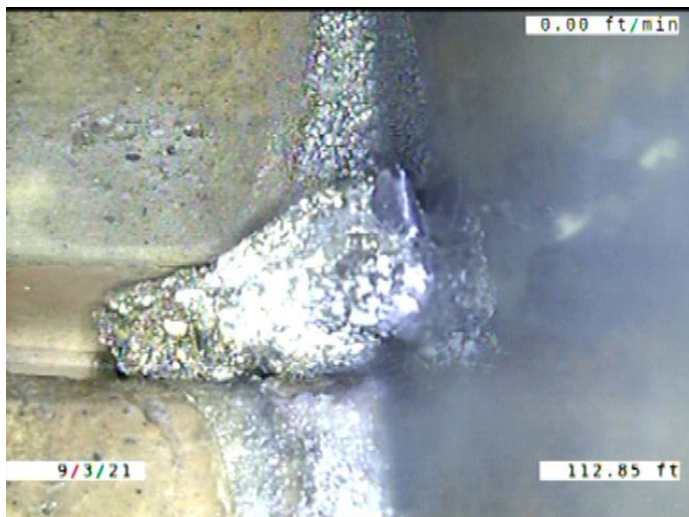
Code:	<b>DAE</b>
Description:	<b>Deposits Attached Encrustation</b>
Distance (ft):	<b>112.8</b>
Structural Grade:	<b>0</b>
O&M Grade:	<b>2</b>
Clock Start/From:	<b>8</b>
Clock To:	<b>9</b>
1st Value:	
2nd Value:	
Value Percent:	<b>5.000</b>
Continuous Index:	
Within 8" of Joint:	<b>YES</b>
Remarks:

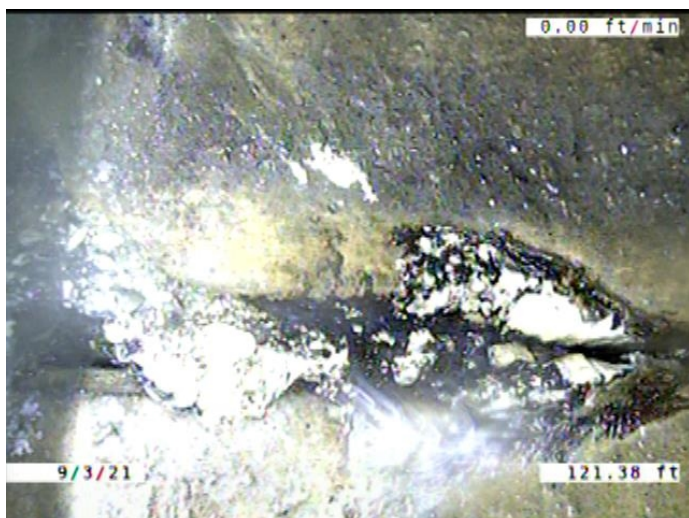
Code:	<b>DAE</b>
Description:	<b>Deposits Attached Encrustation</b>
Distance (ft):	<b>121.4</b>
Structural Grade:	<b>0</b>
O&M Grade:	<b>2</b>
Clock Start/From:	<b>9</b>
Clock To:	<b>3</b>
1st Value:	
2nd Value:	
Value Percent:	<b>5.000</b>
Continuous Index:	
Within 8" of Joint:	<b>YES</b>
Remarks:

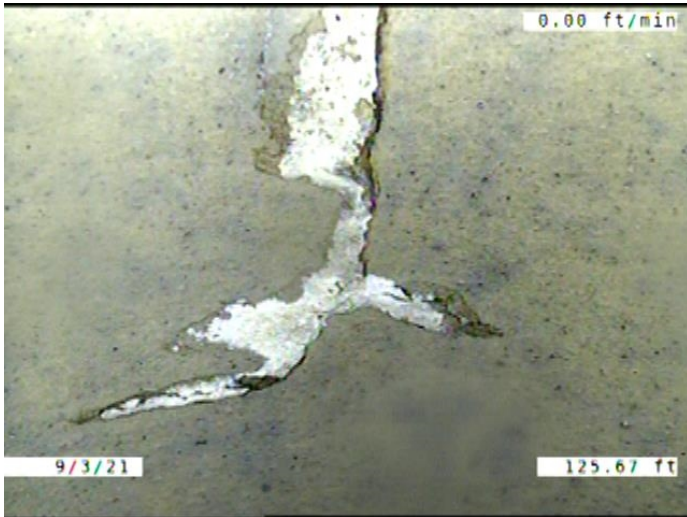
Code: **CM**  
 Description: **Crack Multiple**

Distance (ft): **125.7**  
 Structural Grade: **3**  
 O&M Grade: **0**  
 Clock Start/From: **11**  
 Clock To: **12**  
 1st Value:  
 2nd Value:  
 Value Percent:  
 Continuous Index:  
 Within 8" of Joint: **YES**  
 Remarks:

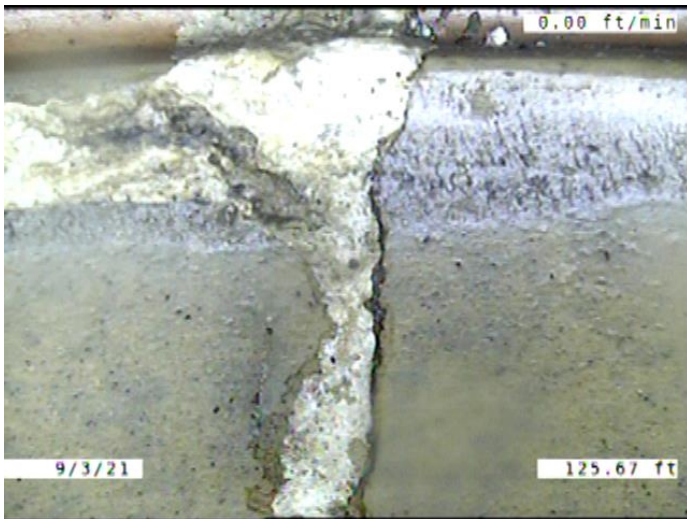
Code: **DAE**  
 Description: **Deposits Attached Encrustation**

Distance (ft): **125.7**  
 Structural Grade: **0**  
 O&M Grade: **2**  
 Clock Start/From: **11**  
 Clock To: **12**  
 1st Value:  
 2nd Value:  
 Value Percent: **5.000**  
 Continuous Index:  
 Within 8" of Joint: **YES**  
 Remarks:

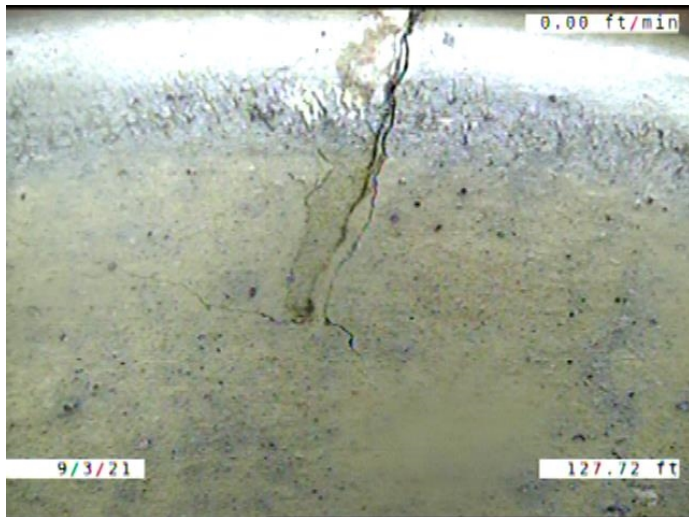
Code: **CM**  
 Description: **Crack Multiple**

Distance (ft): **127.7**  
 Structural Grade: **3**  
 O&M Grade: **0**  
 Clock Start/From: **10**  
 Clock To: **2**  
 1st Value:  
 2nd Value:  
 Value Percent:  
 Continuous Index:  
 Within 8" of Joint: **YES**  
 Remarks:

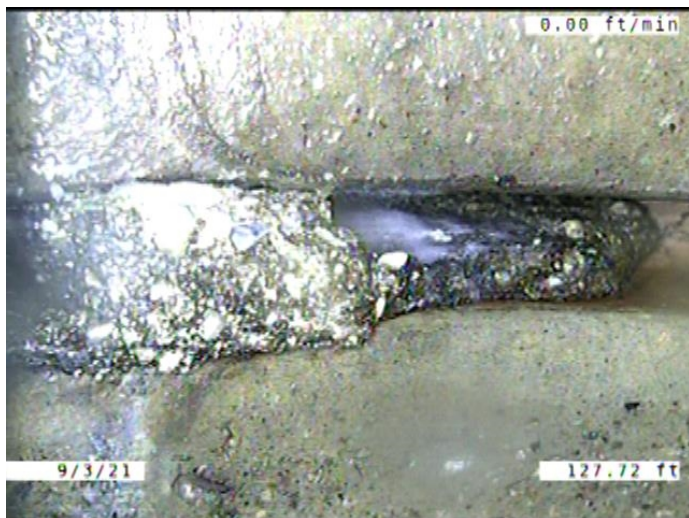
Code: **DAE**  
 Description: **Deposits Attached Encrustation**

Distance (ft): **127.7**  
 Structural Grade: **0**  
 O&M Grade: **2**  
 Clock Start/From: **9**  
 Clock To: **3**  
 1st Value:  
 2nd Value:  
 Value Percent: **5.000**  
 Continuous Index:  
 Within 8" of Joint: **YES**  
 Remarks:

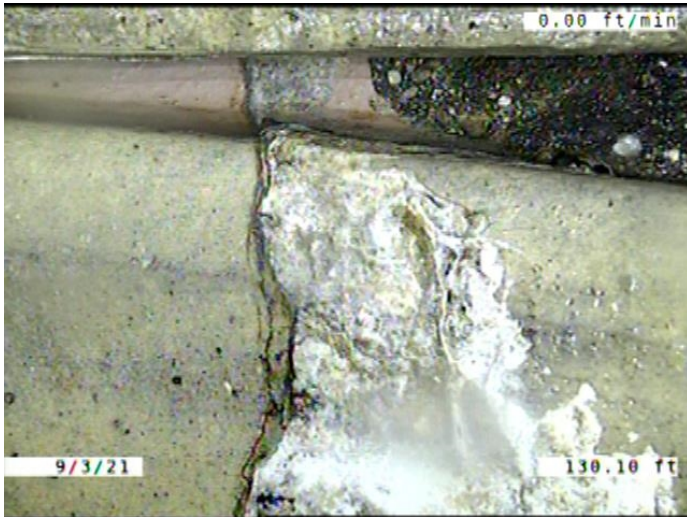
Code: **CL**  
 Description: **Crack Longitudinal**

Distance (ft): **130.1**  
 Structural Grade: **2**  
 O&M Grade: **0**  
 Clock Start/From: **2**  
 Clock To:  
 1st Value:  
 2nd Value:  
 Value Percent:  
 Continuous Index:  
 Within 8" of Joint: **YES**  
 Remarks:

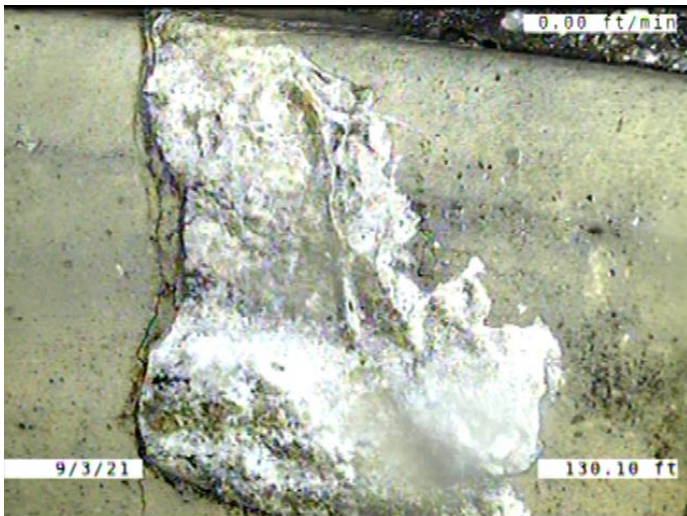
Code: **DAE**  
 Description: **Deposits Attached Encrustation**

Distance (ft): **130.1**  
 Structural Grade: **0**  
 O&M Grade: **2**  
 Clock Start/From: **2**  
 Clock To: **3**  
 1st Value:  
 2nd Value:  
 Value Percent: **5.000**  
 Continuous Index:  
 Within 8" of Joint: **YES**  
 Remarks:

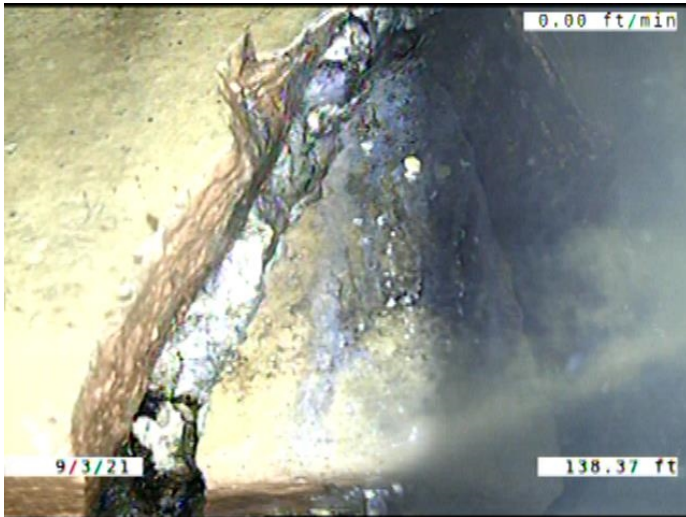
Code: **BSV**  
 Description: **Broken Soil Visible**

Distance (ft): **138.4**  
 Structural Grade: **5**  
 O&M Grade: **0**  
 Clock Start/From: **3**  
 Clock To: **9**  
 1st Value:  
 2nd Value:  
 Value Percent:  
 Continuous Index:  
 Within 8" of Joint: **YES**  
 Remarks:

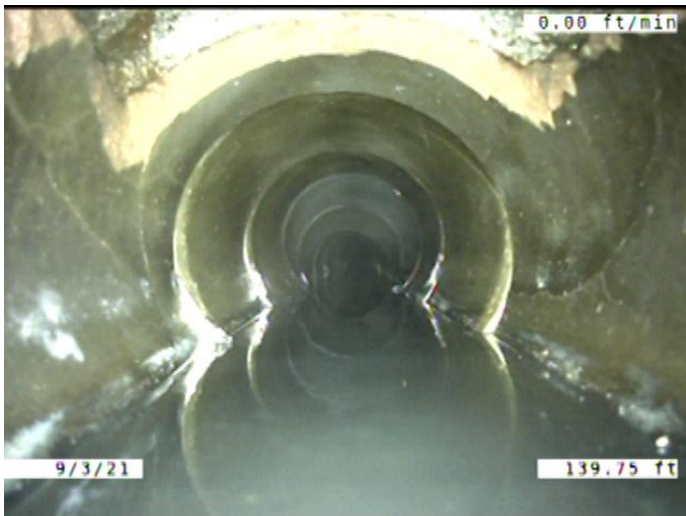
Code: **DSF**  
 Description: **Deposits Settled Fine**

Distance (ft): **139.8**  
 Structural Grade: **0**  
 O&M Grade: **2**  
 Clock Start/From: **5**  
 Clock To: **7**  
 1st Value:  
 2nd Value:  
 Value Percent: **5.000**  
 Continuous Index: **F01**  
 Within 8" of Joint: **YES**  
 Remarks:
