Profile/Photo Observation Report

| Street: | 42nd Avenue | Flow Control: | Not Controlled |
| US MH: | M-504-122 | DS MH: | M-504-121 |

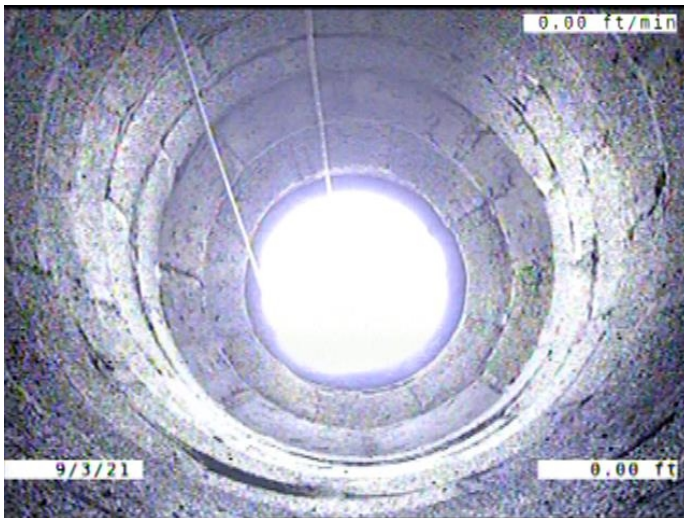
Code: **AMH**
Description: **Manhole**

Distance (ft): **.0**
Structural Grade: **0**
O&M Grade: **0**
Clock Start/From:
Clock To:
1st Value:
2nd Value:
Value Percent:
Continuous Index:
Within 8" of Joint: **NO**
Remarks: **M-504-122**

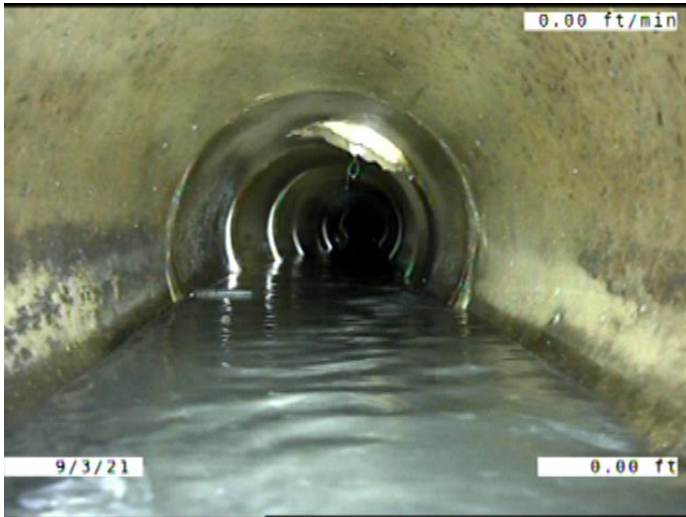
Code: **MWL**
 Description: **Miscellaneous Water Level**

Distance (ft): **.0**
 Structural Grade: **0**
 O&M Grade: **0**
 Clock Start/From:
 Clock To:
 1st Value:
 2nd Value:
 Value Percent: **10.000**
 Continuous Index:
 Within 8" of Joint: **NO**
 Remarks:

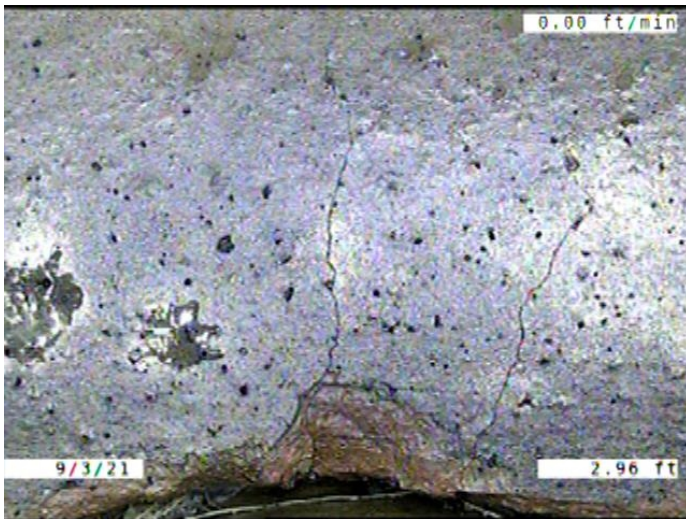
Code: **CM**
 Description: **Crack Multiple**

Distance (ft): **3.0**
 Structural Grade: **3**
 O&M Grade: **0**
 Clock Start/From: **12**
 Clock To: **2**
 1st Value:
 2nd Value:
 Value Percent:
 Continuous Index:
 Within 8" of Joint: **YES**
 Remarks:

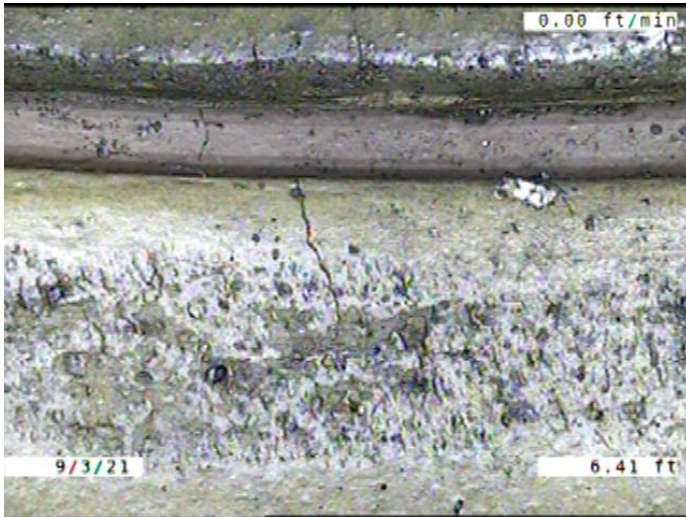
Code: **CM**
 Description: **Crack Multiple**

Distance (ft): **6.4**
 Structural Grade: **3**
 O&M Grade: **0**
 Clock Start/From: **12**
 Clock To: **3**
 1st Value:
 2nd Value:
 Value Percent:
 Continuous Index:
 Within 8" of Joint: **YES**
 Remarks:

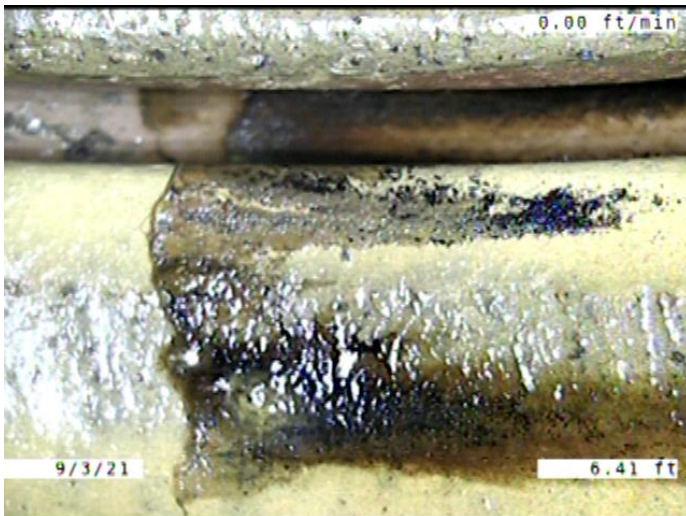
Code: **ISB**
 Description: **Infiltration Stain Barrel**

Distance (ft): **6.4**
 Structural Grade: **0**
 O&M Grade: **1**
 Clock Start/From: **1**
 Clock To: **4**
 1st Value:
 2nd Value:
 Value Percent:
 Continuous Index:
 Within 8" of Joint: **YES**
 Remarks:

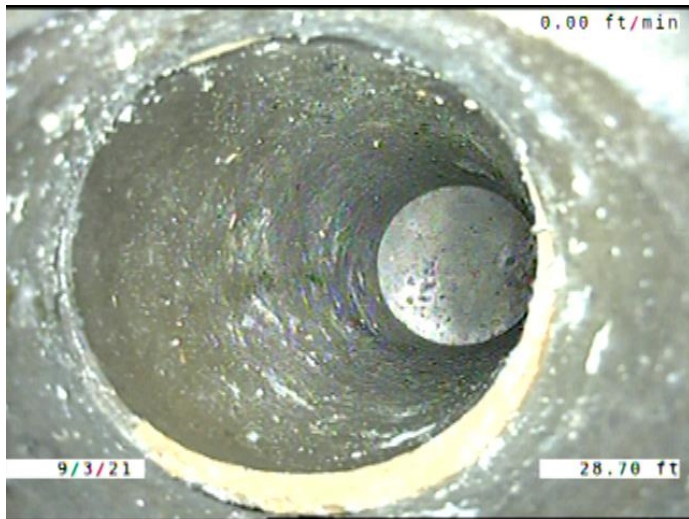
Code: **TFC**
 Description: **Tap Factory Capped**

Distance (ft): **28.7**
 Structural Grade: **0**
 O&M Grade: **0**
 Clock Start/From: **1**
 Clock To:
 1st Value: **6.000**
 2nd Value:
 Value Percent:
 Continuous Index:
 Within 8" of Joint: **YES**
 Remarks:

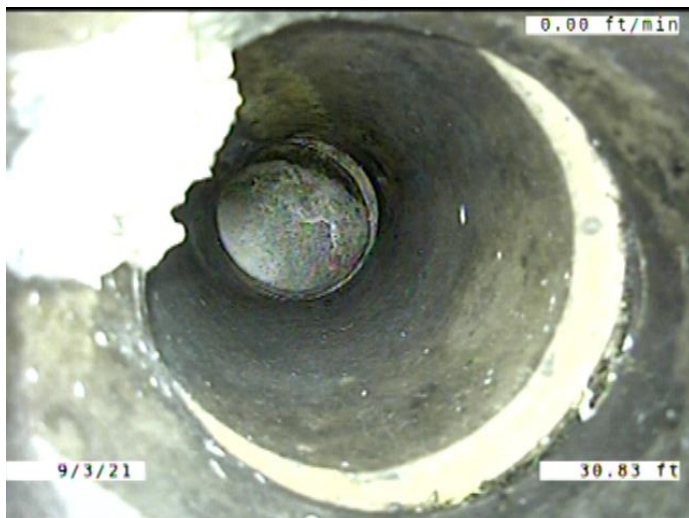
Code: **TF**
 Description: **Tap Factory**

Distance (ft): **30.8**
 Structural Grade: **0**
 O&M Grade: **0**
 Clock Start/From: **11**
 Clock To:
 1st Value: **6.000**
 2nd Value:
 Value Percent:
 Continuous Index:
 Within 8" of Joint: **YES**
 Remarks:

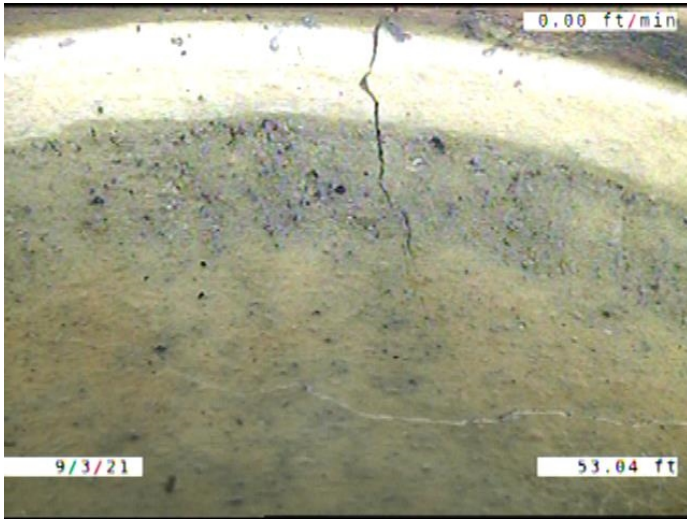
Code: **CM**
 Description: **Crack Multiple**

Distance (ft): **53.0**
 Structural Grade: **3**
 O&M Grade: **0**
 Clock Start/From: **11**
 Clock To: **4**
 1st Value:
 2nd Value:
 Value Percent:
 Continuous Index:
 Within 8" of Joint: **YES**
 Remarks:

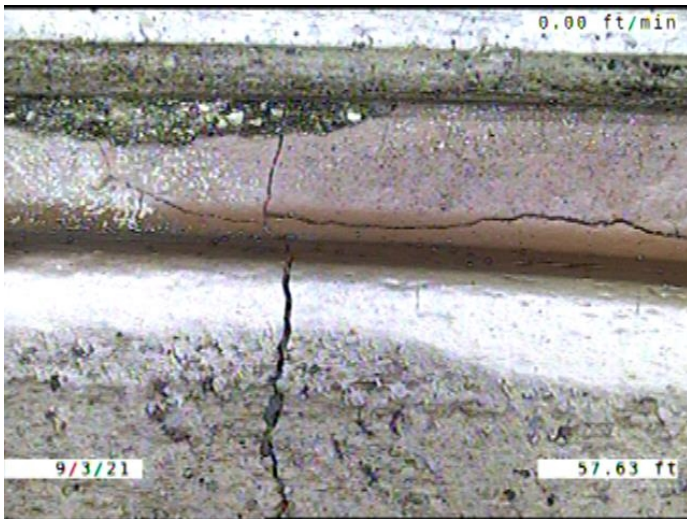
Code: **FM**
 Description: **Fracture Multiple**

Distance (ft): **57.6**
 Structural Grade: **4**
 O&M Grade: **0**
 Clock Start/From: **12**
 Clock To: **4**
 1st Value:
 2nd Value:
 Value Percent:
 Continuous Index:
 Within 8" of Joint: **NO**
 Remarks:

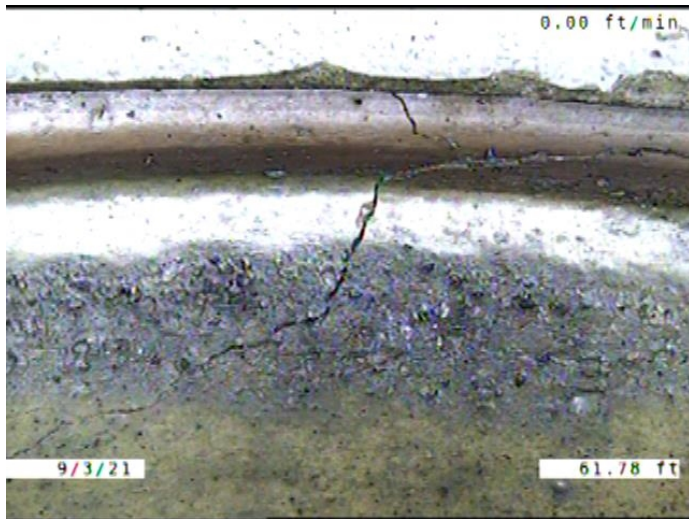
Code: **CM**
 Description: **Crack Multiple**

Distance (ft): **61.8**
 Structural Grade: **3**
 O&M Grade: **0**
 Clock Start/From: **10**
 Clock To: **4**
 1st Value:
 2nd Value:
 Value Percent:
 Continuous Index:
 Within 8" of Joint: **YES**
 Remarks:

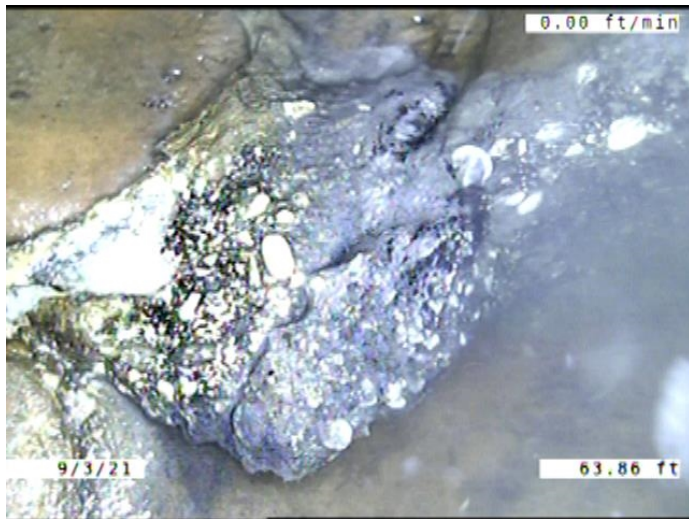
Code: **DAE**
 Description: **Deposits Attached Encrustation**

Distance (ft): **63.9**
 Structural Grade: **0**
 O&M Grade: **2**
 Clock Start/From: **5**
 Clock To: **8**
 1st Value:
 2nd Value:
 Value Percent: **5.000**
 Continuous Index:
 Within 8" of Joint: **YES**
 Remarks:

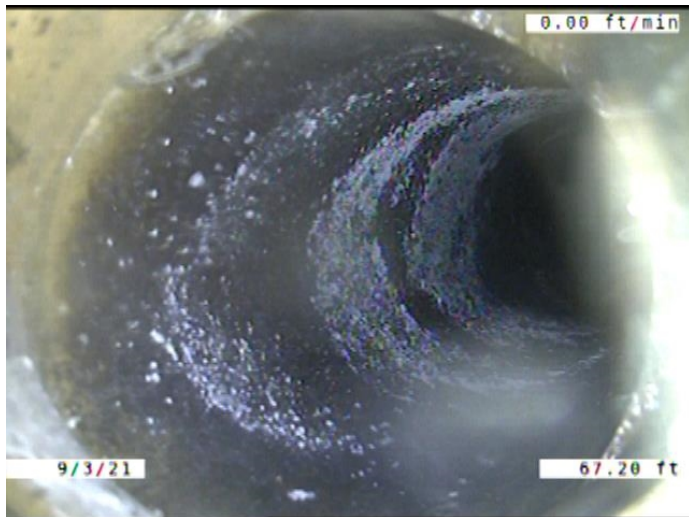
Code: **TBI**
 Description: **Tap Break-in Intruding**

Distance (ft): **67.2**
 Structural Grade: **0**
 O&M Grade: **2**
 Clock Start/From: **1**
 Clock To:
 1st Value: **6.000**
 2nd Value: **1.000**
 Value Percent:
 Continuous Index:
 Within 8" of Joint: **YES**
 Remarks: **ROOTS GROWING IN THE TAP.**

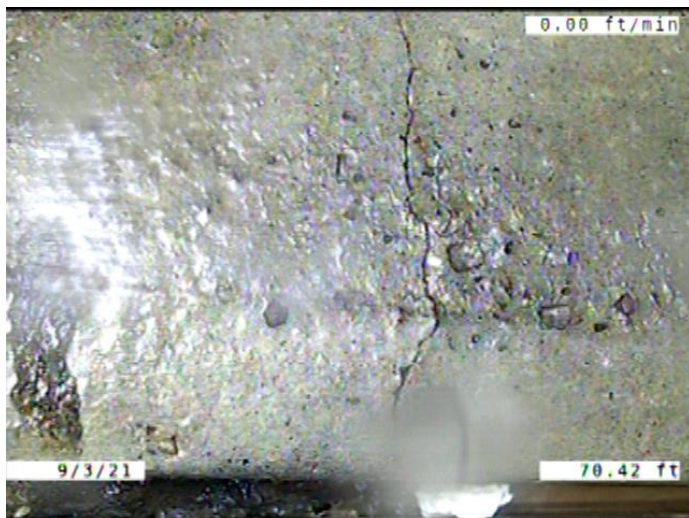
Code: **CM**
 Description: **Crack Multiple**

Distance (ft): **70.4**
 Structural Grade: **3**
 O&M Grade: **0**
 Clock Start/From: **4**
 Clock To: **5**
 1st Value:
 2nd Value:
 Value Percent:
 Continuous Index:
 Within 8" of Joint: **YES**
 Remarks:

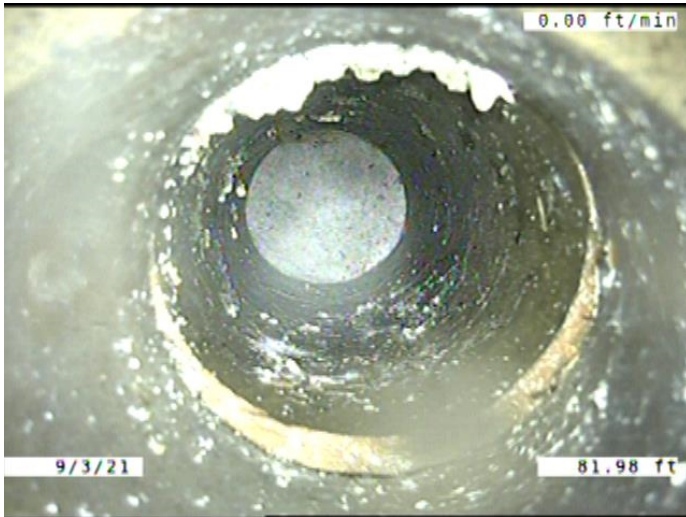
Code: **TFC**
 Description: **Tap Factory Capped**

Distance (ft): **82.0**
 Structural Grade: **0**
 O&M Grade: **0**
 Clock Start/From: **11**
 Clock To:
 1st Value: **6.000**
 2nd Value:
 Value Percent:
 Continuous Index:
 Within 8" of Joint: **YES**
 Remarks:

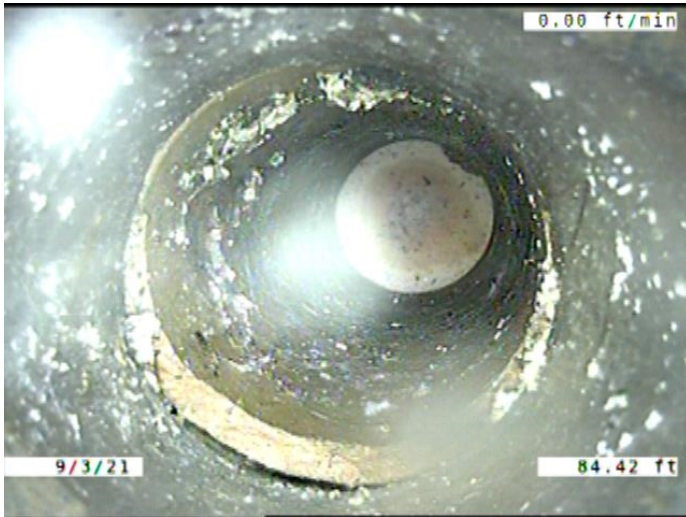
Code: **TFC**
 Description: **Tap Factory Capped**

Distance (ft): **84.4**
 Structural Grade: **0**
 O&M Grade: **0**
 Clock Start/From: **1**
 Clock To:
 1st Value: **6.000**
 2nd Value:
 Value Percent:
 Continuous Index:
 Within 8" of Joint: **YES**
 Remarks:

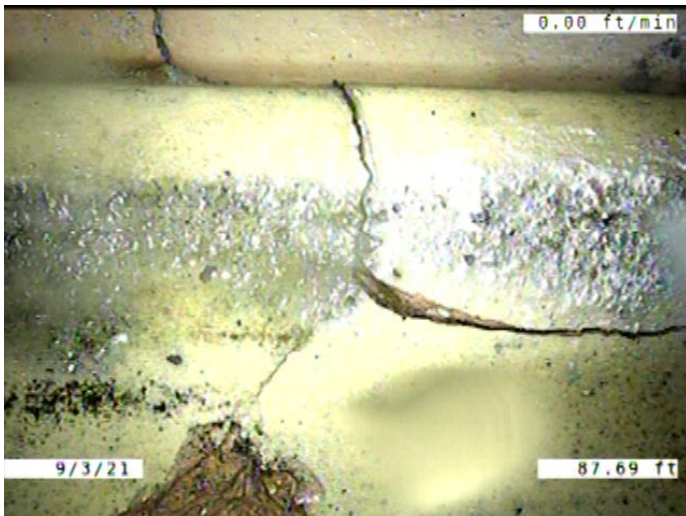
Code: **FM**
 Description: **Fracture Multiple**

Distance (ft): **87.7**
 Structural Grade: **4**
 O&M Grade: **0**
 Clock Start/From: **10**
 Clock To: **4**
 1st Value:
 2nd Value:
 Value Percent:
 Continuous Index:
 Within 8" of Joint: **YES**
 Remarks:

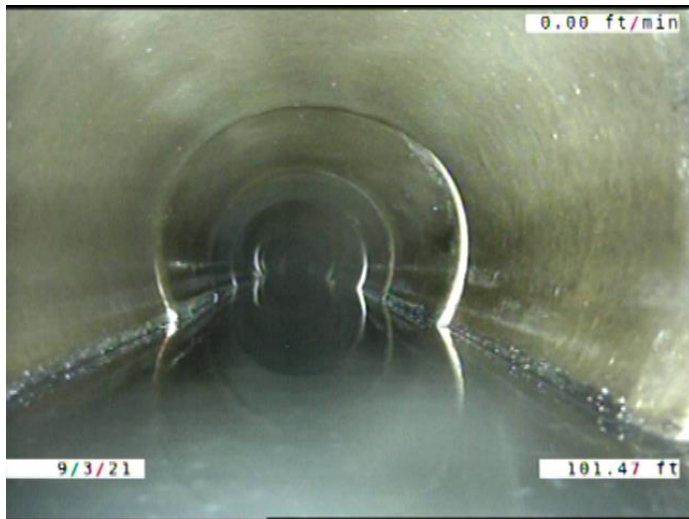
Code: **DAE**
 Description: **Deposits Attached Encrustation**

Distance (ft): **101.5**
 Structural Grade: **0**
 O&M Grade: **2**
 Clock Start/From: **4**
 Clock To: **5**
 1st Value:
 2nd Value:
 Value Percent: **5.000**
 Continuous Index: **F02**
 Within 8" of Joint: **YES**
 Remarks:

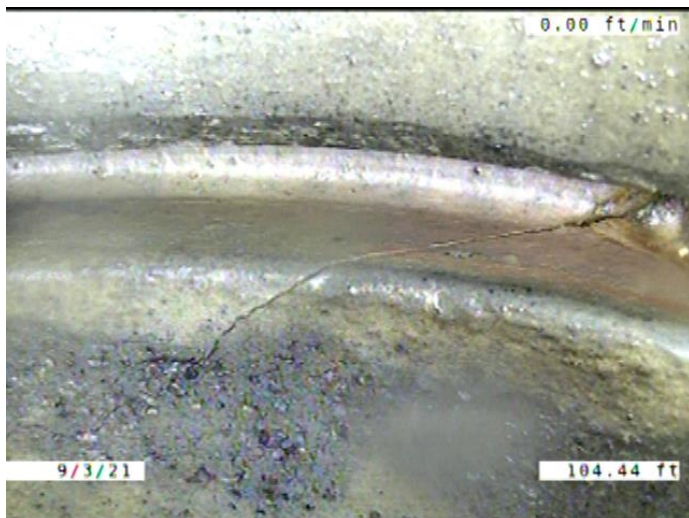
Code: **CM**
 Description: **Crack Multiple**

Distance (ft): **104.4**
 Structural Grade: **3**
 O&M Grade: **0**
 Clock Start/From: **12**
 Clock To: **2**
 1st Value:
 2nd Value:
 Value Percent:
 Continuous Index:
 Within 8" of Joint: **YES**
 Remarks:

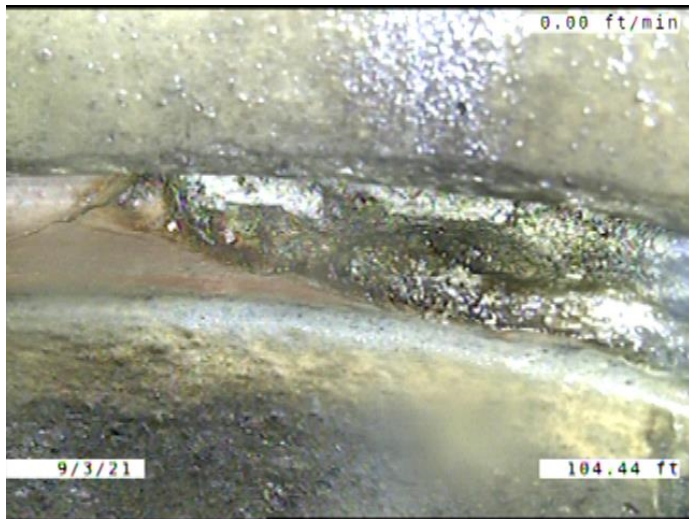
Code: **ISJ**
 Description: **Infiltration Stain Joint**

Distance (ft): **104.4**
 Structural Grade: **0**
 O&M Grade: **1**
 Clock Start/From: **2**
 Clock To: **4**
 1st Value:
 2nd Value:
 Value Percent:
 Continuous Index:
 Within 8" of Joint: **YES**
 Remarks:

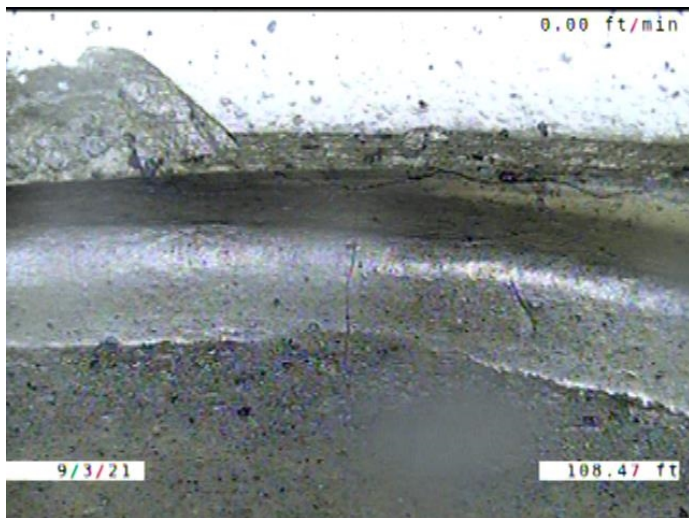
Code: **CM**
 Description: **Crack Multiple**

Distance (ft): **108.5**
 Structural Grade: **3**
 O&M Grade: **0**
 Clock Start/From: **12**
 Clock To: **2**
 1st Value:
 2nd Value:
 Value Percent:
 Continuous Index:
 Within 8" of Joint: **YES**
 Remarks:

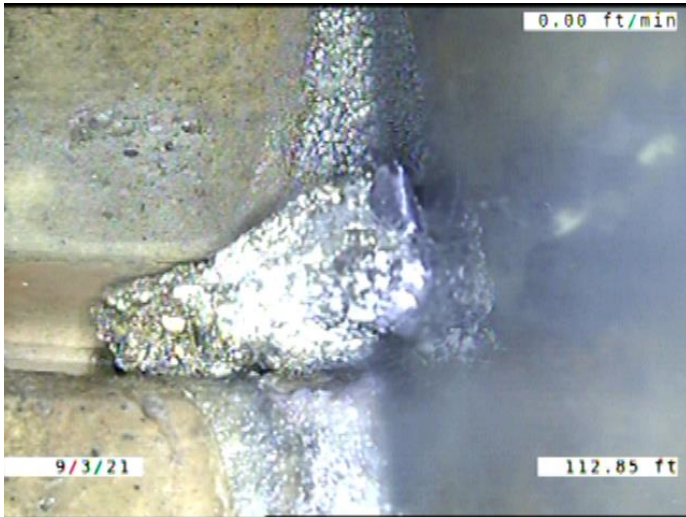
Code: **DAE**
 Description: **Deposits Attached Encrustation**

Distance (ft): **112.8**
 Structural Grade: **0**
 O&M Grade: **2**
 Clock Start/From: **8**
 Clock To: **9**
 1st Value:
 2nd Value:
 Value Percent: **5.000**
 Continuous Index:
 Within 8" of Joint: **YES**
 Remarks:

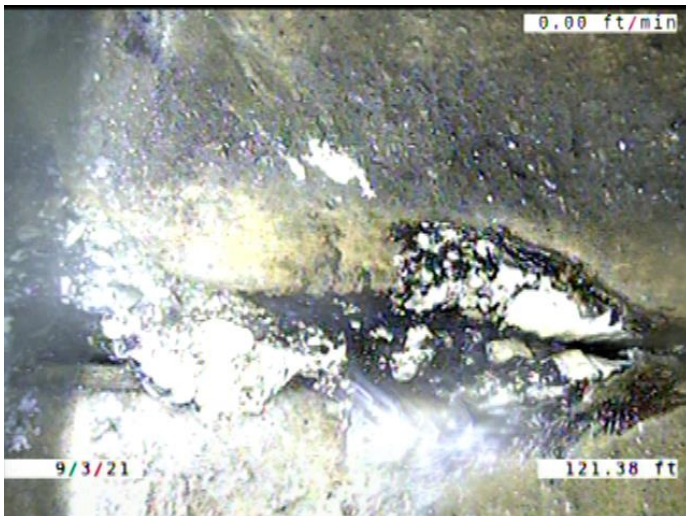
Code: **DAE**
 Description: **Deposits Attached Encrustation**

Distance (ft): **121.4**
 Structural Grade: **0**
 O&M Grade: **2**
 Clock Start/From: **9**
 Clock To: **3**
 1st Value:
 2nd Value:
 Value Percent: **5.000**
 Continuous Index:
 Within 8" of Joint: **YES**
 Remarks:

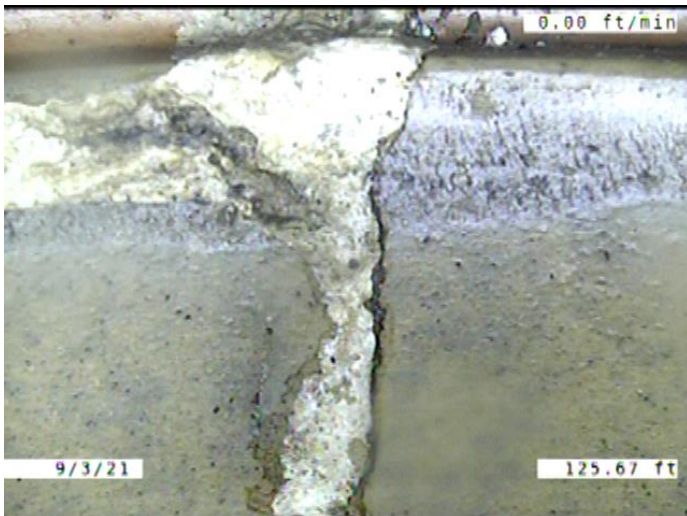
Code: **DAE**
 Description: **Deposits Attached Encrustation**

Distance (ft): **125.7**
 Structural Grade: **0**
 O&M Grade: **2**
 Clock Start/From: **11**
 Clock To: **12**
 1st Value:
 2nd Value:
 Value Percent: **5.000**
 Continuous Index:
 Within 8" of Joint: **YES**
 Remarks:

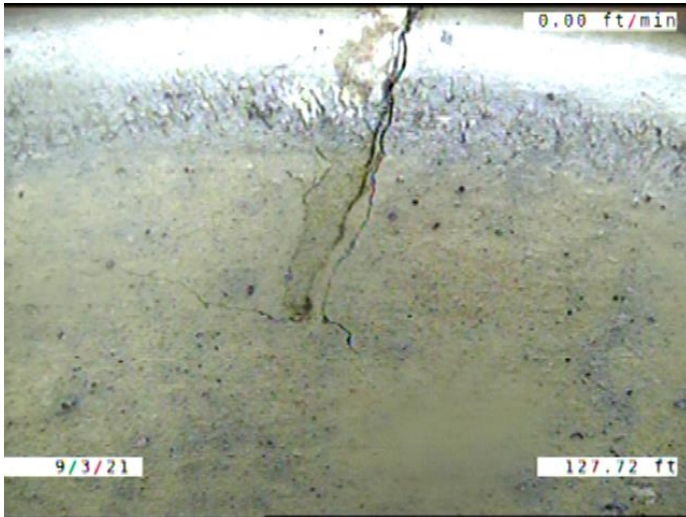
Code: **CM**
 Description: **Crack Multiple**

Distance (ft): **127.7**
 Structural Grade: **3**
 O&M Grade: **0**
 Clock Start/From: **10**
 Clock To: **2**
 1st Value:
 2nd Value:
 Value Percent:
 Continuous Index:
 Within 8" of Joint: **YES**
 Remarks:

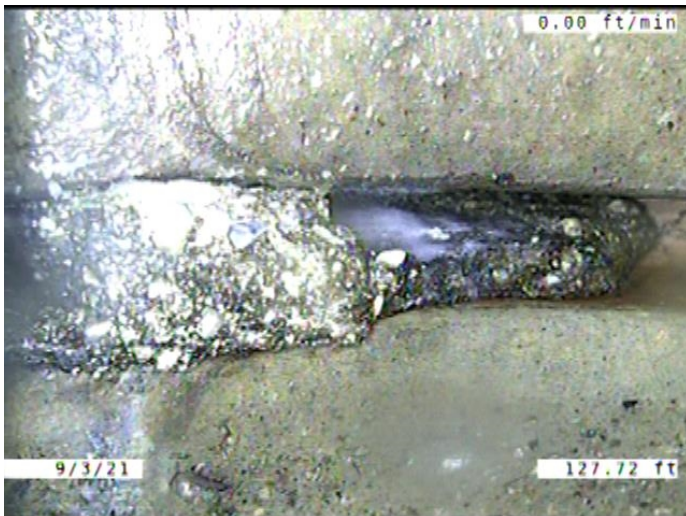
Code: **DAE**
 Description: **Deposits Attached Encrustation**

Distance (ft): **127.7**
 Structural Grade: **0**
 O&M Grade: **2**
 Clock Start/From: **9**
 Clock To: **3**
 1st Value:
 2nd Value:
 Value Percent: **5.000**
 Continuous Index:
 Within 8" of Joint: **YES**
 Remarks:

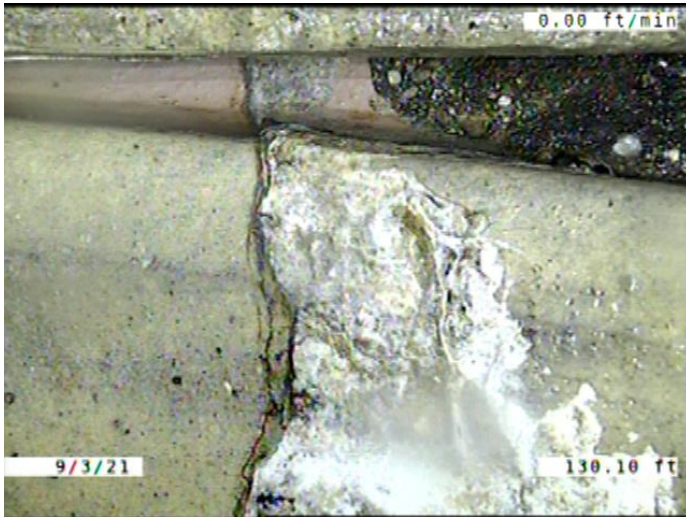
Code: **CL**
 Description: **Crack Longitudinal**

Distance (ft): **130.1**
 Structural Grade: **2**
 O&M Grade: **0**
 Clock Start/From: **2**
 Clock To:
 1st Value:
 2nd Value:
 Value Percent:
 Continuous Index:
 Within 8" of Joint: **YES**
 Remarks:

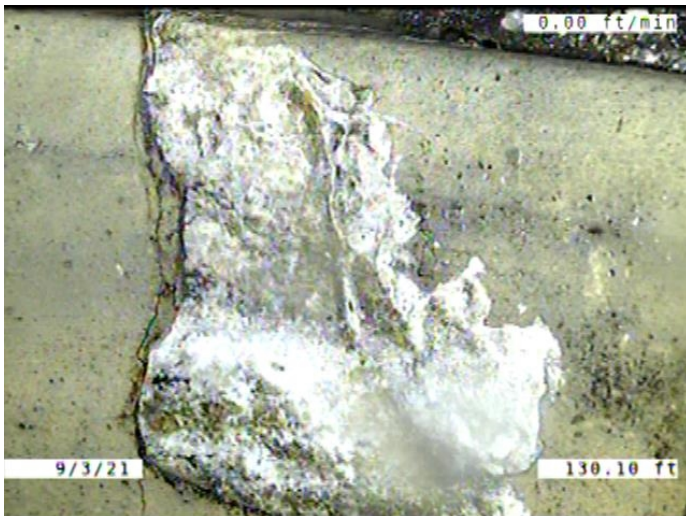
Code: **DAE**
 Description: **Deposits Attached Encrustation**

Distance (ft): **130.1**
 Structural Grade: **0**
 O&M Grade: **2**
 Clock Start/From: **2**
 Clock To: **3**
 1st Value:
 2nd Value:
 Value Percent: **5.000**
 Continuous Index:
 Within 8" of Joint: **YES**
 Remarks:

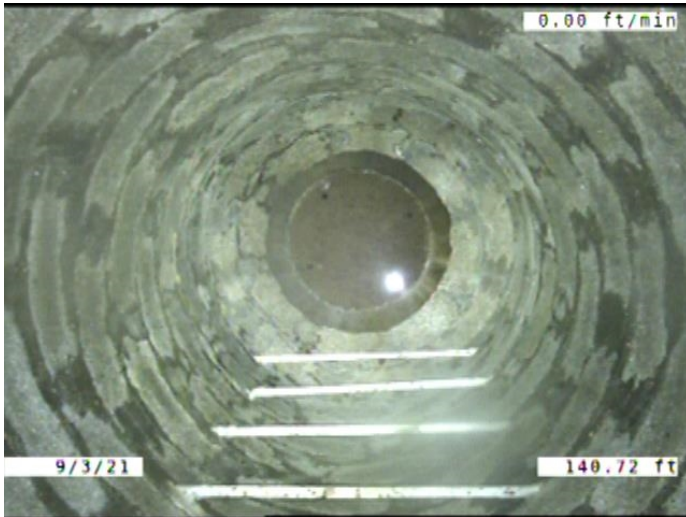
| Code: | AMH |
| Description: | Manhole |
| Distance (ft): | 140.7 |
