# Profile/Photo Observation Report

Street:	<b>ALLEY BETWEEN N GUYER ST &amp; N CA</b>	Flow Control:	<b>Not Controlled</b>
City:	<b>Hobart, IN</b>	Year Renewed:	
Location:	<b>Light Highway</b>	Tape/Media #:	
Purpose:	<b>Not Known</b>	Dia/Height:	<b>12"</b>
Use:	<b>Sanitary</b>	Material:	<b>VCP</b>
Drain Area:	<b>NA</b>	Lining:	
Category:	<b>NA</b>		
Comment:			
Location Details:		Direction of Survey:	<b>Downstream</b>
US MH:	<b>M-504-123</b>	DS MH:	<b>M-504-122</b>
		Total Length Surveyed (ft):	<b>48.7</b>

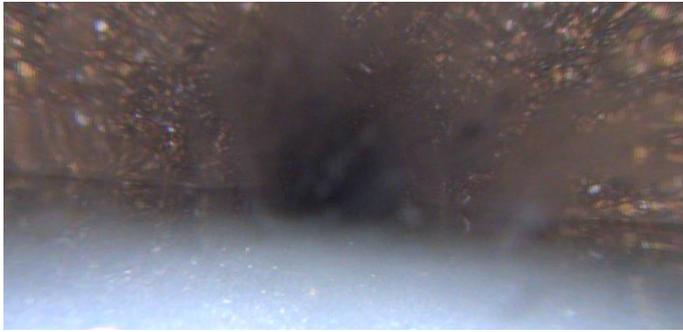
Code: **MCU**  
Description: **Camera Underwater**

Distance (ft): **24.4**  
Structural Grade: **0**  
O&M Grade: **4**  
Clock Start/From:  
Clock To:  
1st Value:  
2nd Value:  
Value Percent:  
Continuous Index: **F01**  
Within 8" of Joint: **NO**  
Remarks: **front and rear**

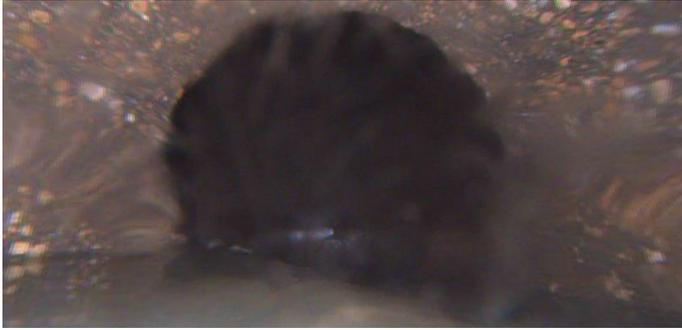
Code: **MCU**  
Description: **Camera Underwater**

Distance (ft): **47.3**  
Structural Grade: **0**  
O&M Grade: **4**  
Clock Start/From:  
Clock To:  
1st Value:  
2nd Value:  
Value Percent:  
Continuous Index: **F02**  
Within 8" of Joint: **NO**  
Remarks:
