Profile/Photo Observation Report

Date:	04/17/2018	Weather:		Coding:	PACP 6.0
Pipe Length (ft):	48.4	Owner:	NA	Pre Clean:	Not Known
P.O.#:		Surveyor:	Byrd Fitzgerald	PSR:	P-504-123-122
Customer:		Clean Date:	01/01/1900	Shape:	C

Location Details:		Direction of Survey:	Downstream
US MH:	M-504-123	DS MH:	M-504-122
		Total Length Surveyed (ft):	48.7

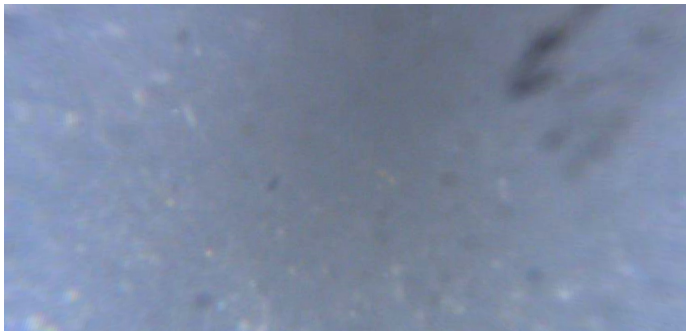
Code: **AMH**
Description: **Manhole**

Distance (ft): **.0**
Structural Grade: **0**
O&M Grade: **0**
Clock Start/From:
Clock To:
1st Value:
2nd Value:
Value Percent:
Continuous Index:
Within 8" of Joint: **NO**
Remarks: **M-504-123**

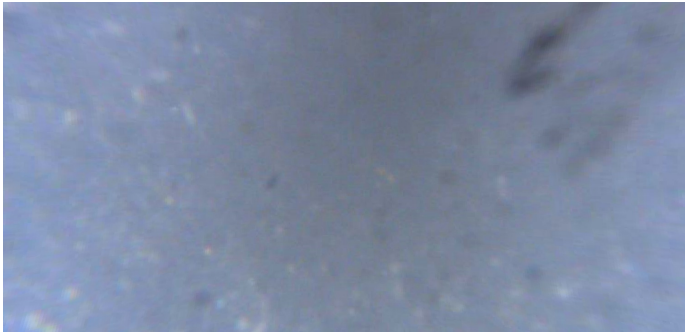
Code:	MWL
Description:	Water Level

Distance (ft):	.0
Structural Grade:	0
O&M Grade:	0
Clock Start/From:	
Clock To:	
1st Value:	
2nd Value:	
Value Percent:	100.000
Continuous Index:	
Within 8" of Joint:	NO
Remarks:	mcu

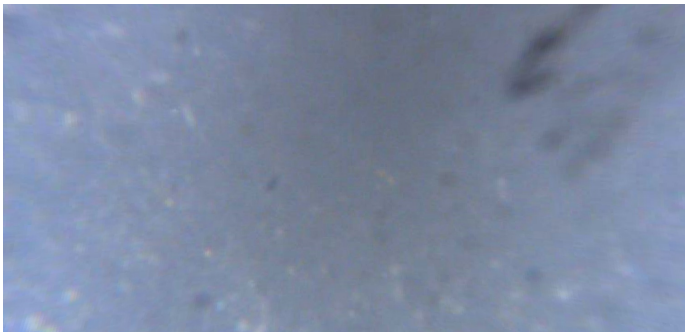
Code:	MCU
Description:	Camera Underwater

Distance (ft):	.0
Structural Grade:	0
O&M Grade:	4
Clock Start/From:	
Clock To:	
1st Value:	
2nd Value:	
Value Percent:	
Continuous Index:	S01
Within 8" of Joint:	NO
Remarks:	front and rear

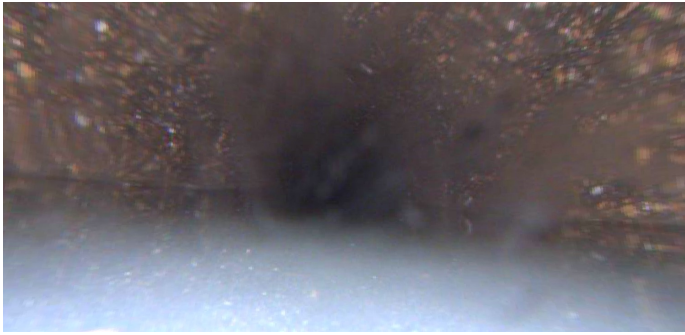
Code: **MCU**
Description: **Camera Underwater**

Distance (ft): **24.4**
Structural Grade: **0**
O&M Grade: **4**
Clock Start/From:
Clock To:
1st Value:
2nd Value:
Value Percent:
Continuous Index: **F01**
Within 8" of Joint: **NO**
Remarks: **front and rear**

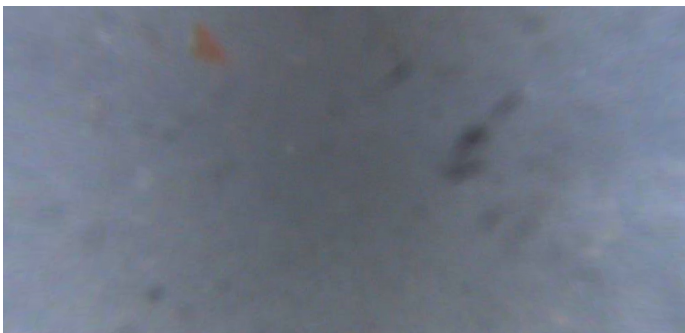
Code: **MCU**
Description: **Camera Underwater**

Distance (ft): **34.2**
Structural Grade: **0**
O&M Grade: **4**
Clock Start/From:
Clock To:
1st Value:
2nd Value:
Value Percent:
Continuous Index: **S02**
Within 8" of Joint: **NO**
Remarks:

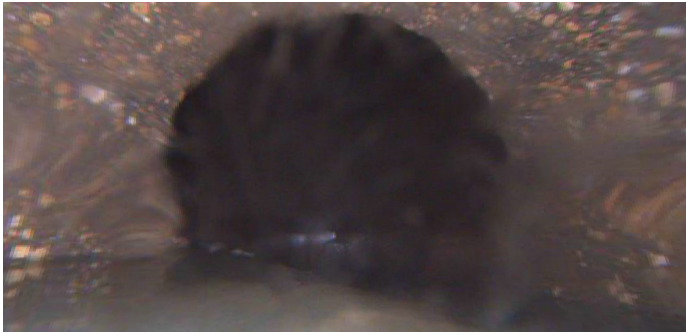
Code: **MCU**
Description: **Camera Underwater**

Distance (ft): **47.3**
Structural Grade: **0**
O&M Grade: **4**
Clock Start/From:
Clock To:
1st Value:
2nd Value:
Value Percent:
Continuous Index: **F02**
Within 8" of Joint: **NO**
Remarks:
