Profile/Photo Observation Report

| Street: | 42nd Avenue | Flow Control: | Not Controlled |
| Purpose: | Routine Assessment | Dia/Height: | 12" |
| Use: | Sanitary Sewage Pipe | Material: | VCP |

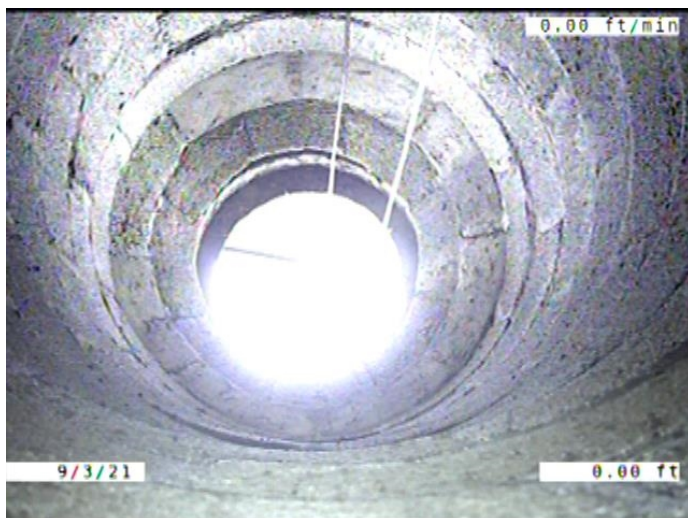
Code: **AMH**
 Description: **Manhole**

Distance (ft): **.0**
 Structural Grade: **0**
 O&M Grade: **0**
 Clock Start/From:
 Clock To:
 1st Value:
 2nd Value:
 Value Percent:
 Continuous Index:
 Within 8" of Joint: **NO**
 Remarks: **M-504-122**

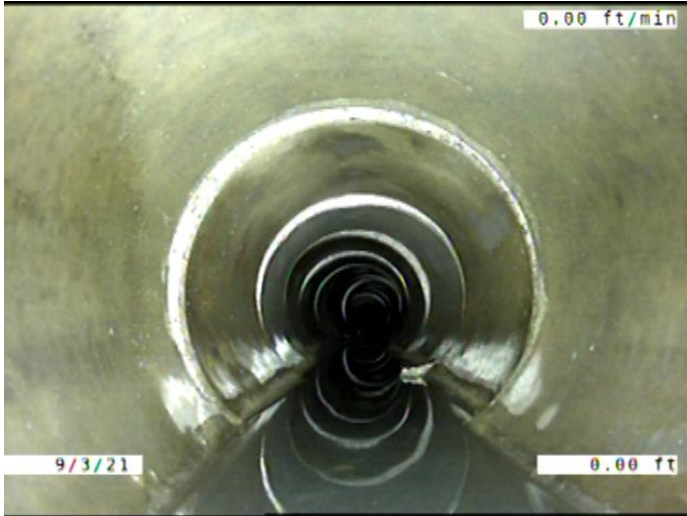
Code: **MWL**
Description: **Miscellaneous Water Level**

Distance (ft): **.0**
Structural Grade: **0**
O&M Grade: **0**
Clock Start/From:
Clock To:
1st Value:
2nd Value:
Value Percent: **5.000**
Continuous Index:
Within 8" of Joint: **NO**
Remarks:

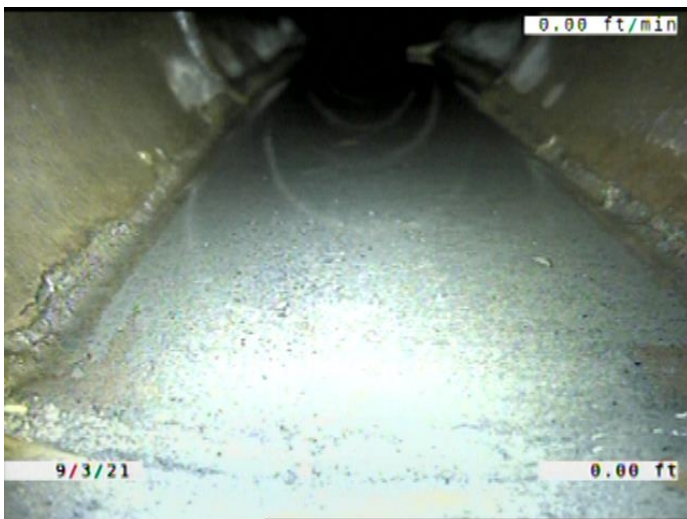
Code: **DSF**
Description: **Deposits Settled Fine**

Distance (ft): **.0**
Structural Grade: **0**
O&M Grade: **2**
Clock Start/From: **5**
Clock To: **7**
1st Value:
2nd Value:
Value Percent: **5.000**
Continuous Index: **S01**
Within 8" of Joint: **YES**
Remarks:

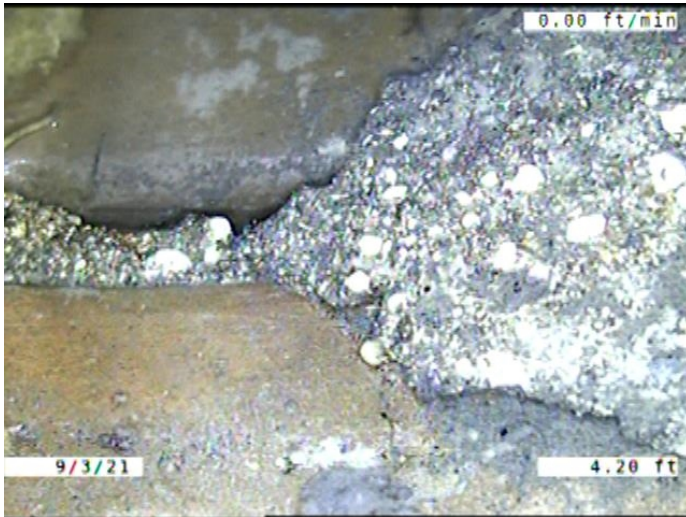
Code: **DAE**
 Description: **Deposits Attached Encrustation**

Distance (ft): **4.2**
 Structural Grade: **0**
 O&M Grade: **2**
 Clock Start/From: **4**
 Clock To: **8**
 1st Value:
 2nd Value:
 Value Percent: **5.000**
 Continuous Index:
 Within 8" of Joint: **YES**
 Remarks:

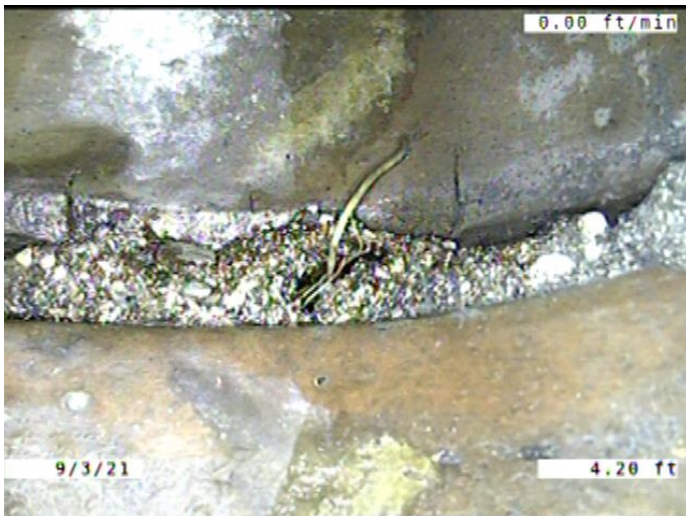
Code: **RFJ**
 Description: **Roots Fine Joint**

Distance (ft): **4.2**
 Structural Grade: **0**
 O&M Grade: **1**
 Clock Start/From: **7**
 Clock To: **8**
 1st Value:
 2nd Value:
 Value Percent:
 Continuous Index:
 Within 8" of Joint: **YES**
 Remarks:

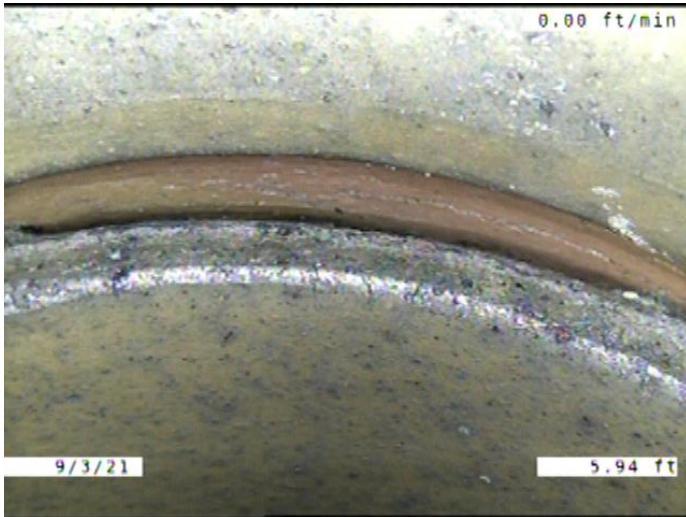
Code: **JOM**
Description: **Joint Offset Medium**

Distance (ft): **5.9**
Structural Grade: **3**
O&M Grade: **0**
Clock Start/From:
Clock To:
1st Value:
2nd Value:
Value Percent:
Continuous Index:
Within 8" of Joint: **NO**
Remarks:

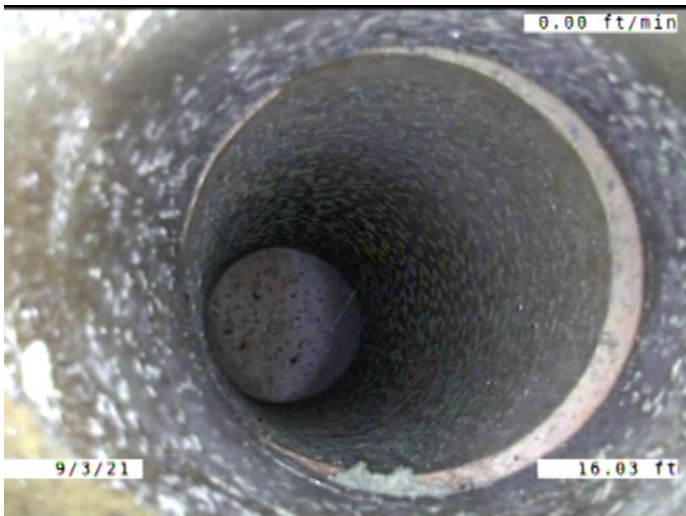
Code: **TFC**
Description: **Tap Factory Capped**

Distance (ft): **16.0**
Structural Grade: **0**
O&M Grade: **0**
Clock Start/From: **11**
Clock To:
1st Value: **6.000**
2nd Value:
Value Percent:
Continuous Index:
Within 8" of Joint: **YES**
Remarks:

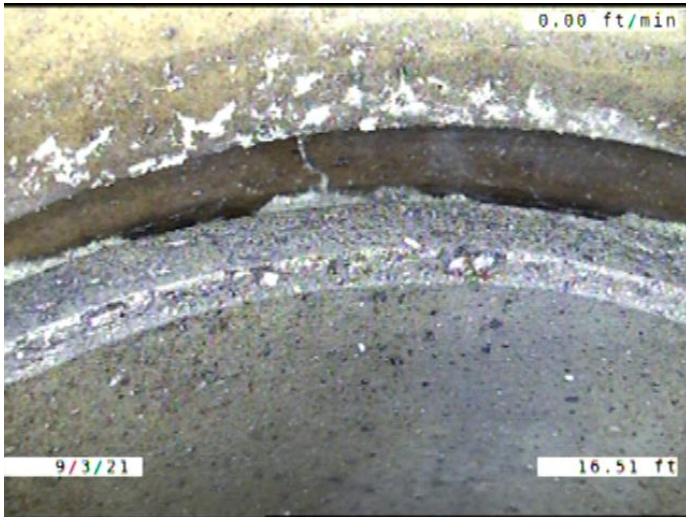
Code: **JOM**
 Description: **Joint Offset Medium**

Distance (ft): **16.5**
 Structural Grade: **3**
 O&M Grade: **0**
 Clock Start/From:
 Clock To:
 1st Value:
 2nd Value:
 Value Percent:
 Continuous Index:
 Within 8" of Joint: **NO**
 Remarks:

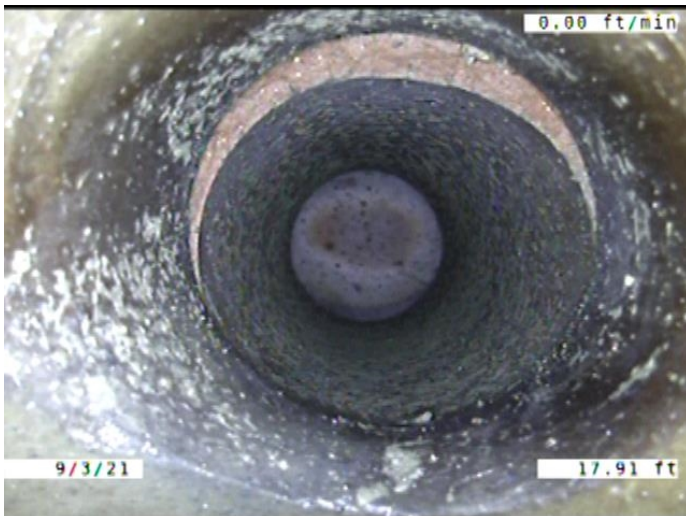
Code: **TFC**
 Description: **Tap Factory Capped**

Distance (ft): **17.9**
 Structural Grade: **0**
 O&M Grade: **0**
 Clock Start/From: **12**
 Clock To:
 1st Value: **6.000**
 2nd Value:
 Value Percent:
 Continuous Index:
 Within 8" of Joint: **YES**
 Remarks:

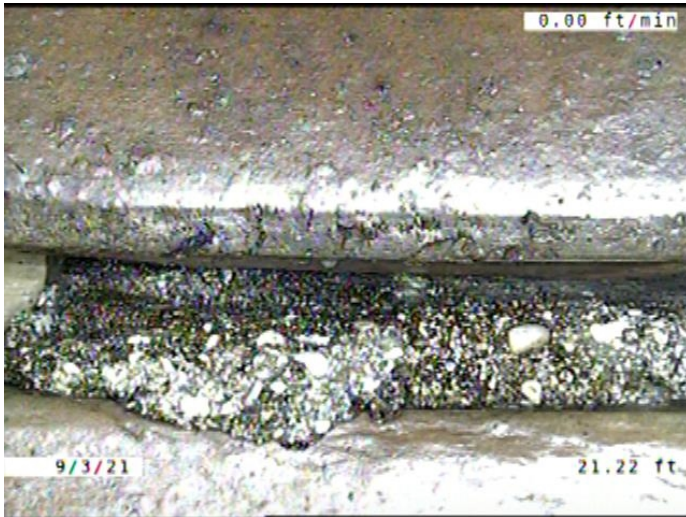
Code: **DAE**
 Description: **Deposits Attached Encrustation**

Distance (ft): **21.2**
 Structural Grade: **0**
 O&M Grade: **2**
 Clock Start/From: **3**
 Clock To: **8**
 1st Value:
 2nd Value:
 Value Percent: **5.000**
 Continuous Index:
 Within 8" of Joint: **YES**
 Remarks:

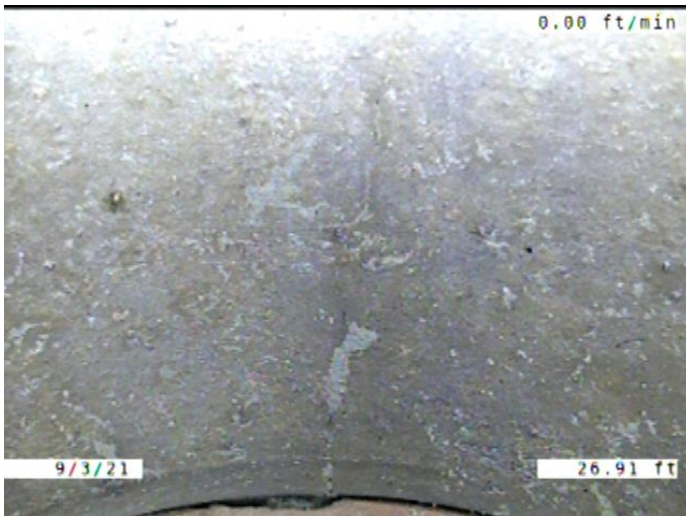
Code: **CL**
 Description: **Crack Longitudinal**

Distance (ft): **26.9**
 Structural Grade: **2**
 O&M Grade: **0**
 Clock Start/From: **12**
 Clock To:
 1st Value:
 2nd Value:
 Value Percent:
 Continuous Index:
 Within 8" of Joint: **YES**
 Remarks:

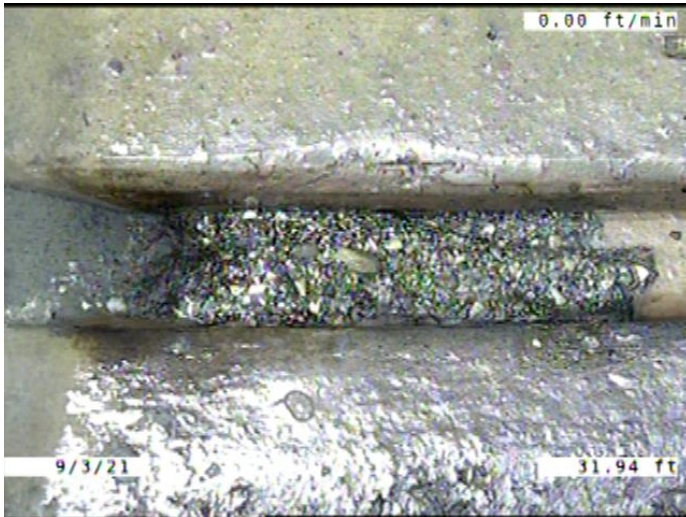
Code: **DAE**
 Description: **Deposits Attached Encrustation**

Distance (ft): **31.9**
 Structural Grade: **0**
 O&M Grade: **2**
 Clock Start/From: **3**
 Clock To: **9**
 1st Value:
 2nd Value:
 Value Percent: **5.000**
 Continuous Index:
 Within 8" of Joint: **YES**
 Remarks:

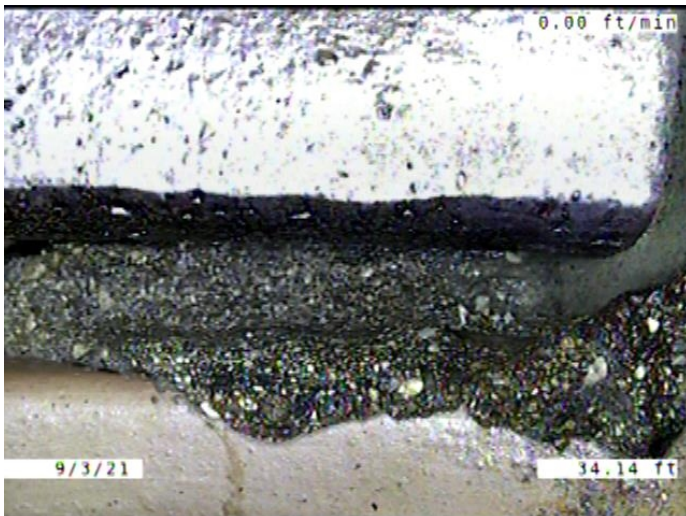
Code: **DAE**
 Description: **Deposits Attached Encrustation**

Distance (ft): **34.1**
 Structural Grade: **0**
 O&M Grade: **2**
 Clock Start/From: **3**
 Clock To: **9**
 1st Value:
 2nd Value:
 Value Percent: **5.000**
 Continuous Index:
 Within 8" of Joint: **YES**
 Remarks:

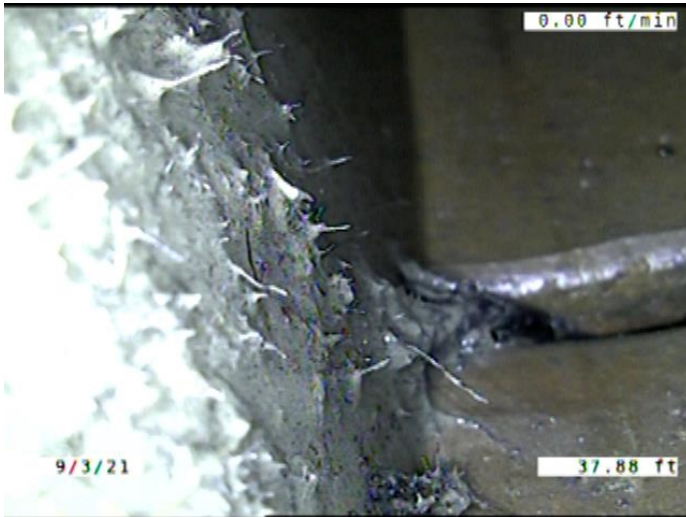
Code: **RMJ**
 Description: **Roots Medium Joint**

Distance (ft): **37.9**
 Structural Grade: **0**
 O&M Grade: **3**
 Clock Start/From: **4**
 Clock To: **8**
 1st Value:
 2nd Value:
 Value Percent: **10.000**
 Continuous Index:
 Within 8" of Joint: **YES**
 Remarks:

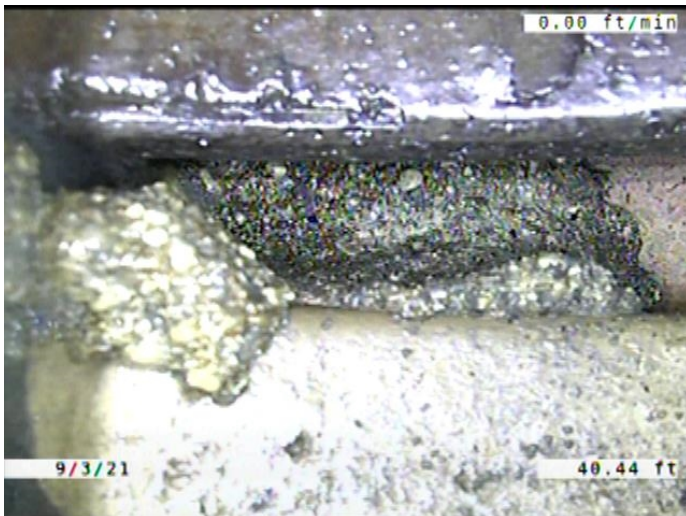
Code: **DAE**
 Description: **Deposits Attached Encrustation**

Distance (ft): **40.4**
 Structural Grade: **0**
 O&M Grade: **2**
 Clock Start/From: **3**
 Clock To:
 1st Value:
 2nd Value:
 Value Percent: **5.000**
 Continuous Index:
 Within 8" of Joint: **YES**
 Remarks:

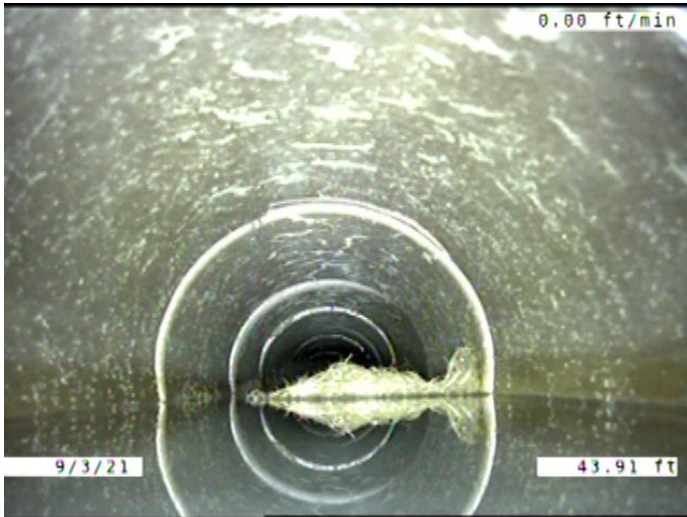
Code: **MWL**
 Description: **Miscellaneous Water Level**

Distance (ft): **43.9**
 Structural Grade: **0**
 O&M Grade: **0**
 Clock Start/From:
 Clock To:
 1st Value:
 2nd Value:
 Value Percent: **15.000**
 Continuous Index:
 Within 8" of Joint: **NO**
 Remarks:

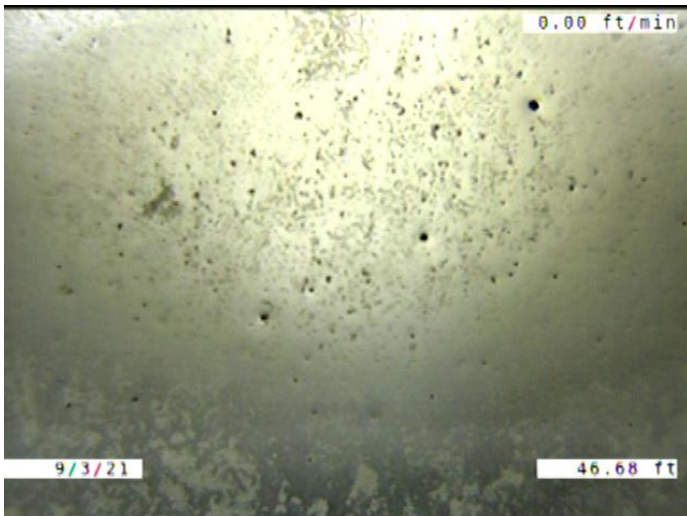
Code: **DSF**
 Description: **Deposits Settled Fine**

Distance (ft): **46.7**
 Structural Grade: **0**
 O&M Grade: **2**
 Clock Start/From: **5**
 Clock To: **7**
 1st Value:
 2nd Value:
 Value Percent: **5.000**
 Continuous Index: **F01**
 Within 8" of Joint: **YES**
 Remarks:

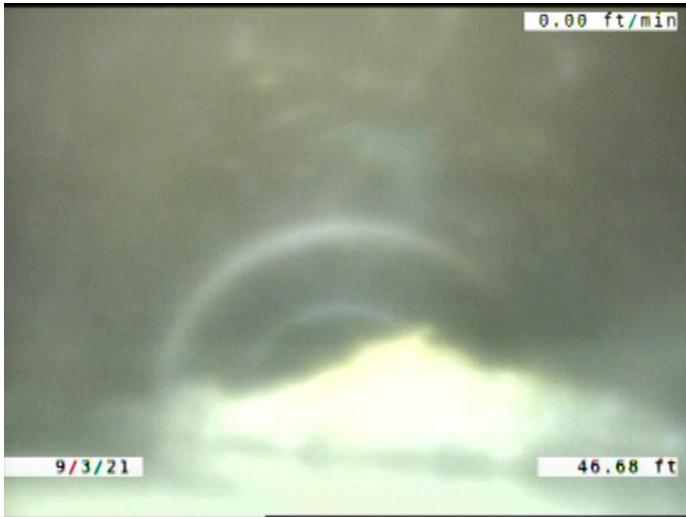
Code: **DSF**
 Description: **Deposits Settled Fine**

Distance (ft): **46.7**
 Structural Grade: **0**
 O&M Grade: **3**
 Clock Start/From: **4**
 Clock To: **8**
 1st Value:
 2nd Value:
 Value Percent: **20.000**
 Continuous Index:
 Within 8" of Joint: **YES**
 Remarks:

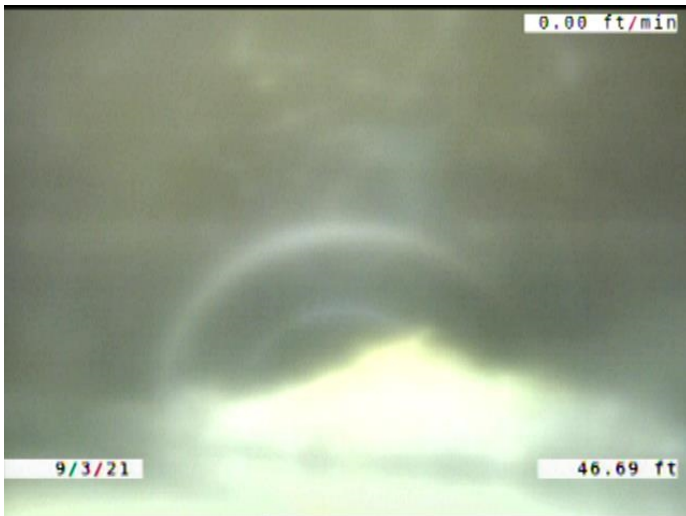
Code: **MSA**
 Description: **Miscellaneous Survey Abandoned**

Distance (ft): **46.7**
 Structural Grade: **0**
 O&M Grade: **0**
 Clock Start/From:
 Clock To:
 1st Value:
 2nd Value:
 Value Percent:
 Continuous Index:
 Within 8" of Joint: **NO**
 Remarks: **CAMERA CANT MAKE IT PAST ROOTS AND DEBRIS**
