Profile/Photo Observation Report

Date:	04/17/2018	Weather:		Coding:	PACP 6.0
Pipe Length (ft):	262.9	Owner:	NA	Pre Clean:	Not Known
P.O.#:		Surveyor:	Byrd Fitzgerald	PSR:	P-504-124-123
Customer:		Clean Date:	01/01/1900	Shape:	C

Street:	ALLEY BETWEEN N GUYER ST & N CA	Flow Control:	Not Controlled
City:	Hobart, IN	Year Renewed:	
Location:	Light Highway	Tape/Media #:	
Purpose:	Not Known	Dia/Height:	12"
Use:	Sanitary	Material:	CP
Drain Area:	NA	Lining:	
Category:	NA		
Comment:

Location Details:		Direction of Survey:	Downstream
US MH:	M-504-124	DS MH:	M-504-123
		Total Length Surveyed (ft):	104.6

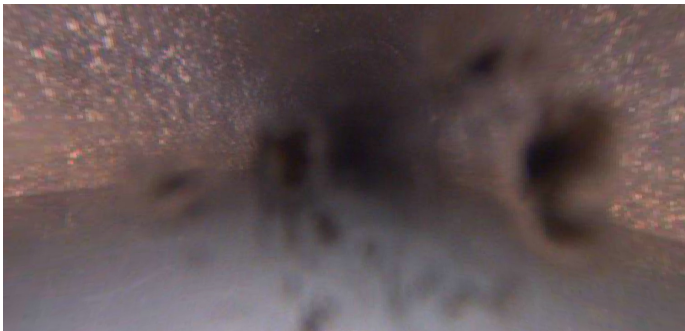
Code: **AMH**
Description: **Manhole**

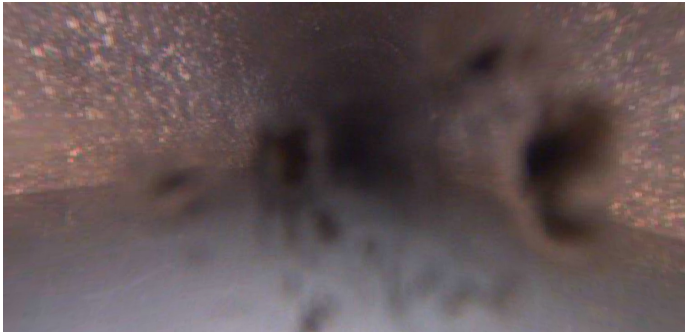
Code:	MWL
Description:	Water Level

Distance (ft):	.0
Structural Grade:	0
O&M Grade:	0
Clock Start/From:	
Clock To:	
1st Value:	
2nd Value:	
Value Percent:	10.000
Continuous Index:	
Within 8" of Joint:	NO
Remarks:

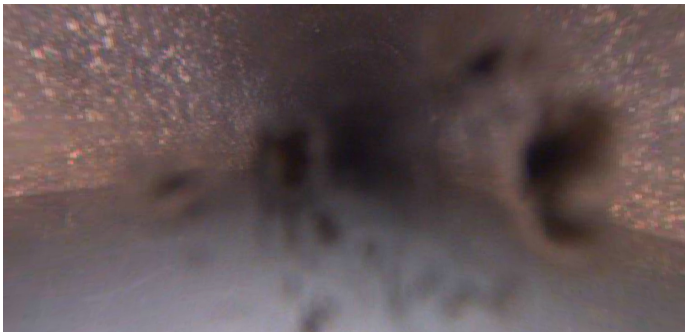
Code:	SAV
Description:	Surface Aggregate Visible

Distance (ft):	.0
Structural Grade:	3
O&M Grade:	0
Clock Start/From:	8
Clock To:	4
1st Value:	
2nd Value:	
Value Percent:	
Continuous Index:	S01
Within 8" of Joint:	
Remarks:

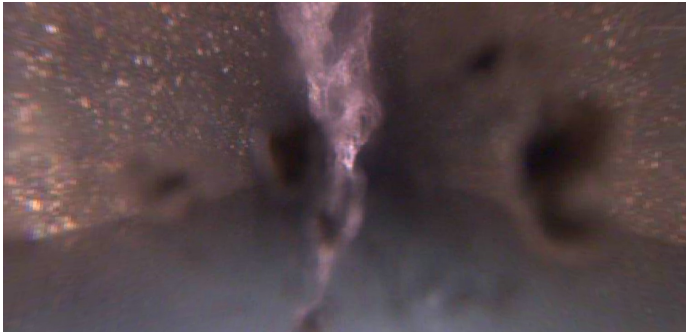
Code: **RFJ**
Description: **Roots Fine Joint**

Distance (ft): **20.8**
Structural Grade: **0**
O&M Grade: **1**
Clock Start/From: **12**
Clock To:
1st Value:
2nd Value:
Value Percent:
Continuous Index:
Within 8" of Joint: **YES**
Remarks:

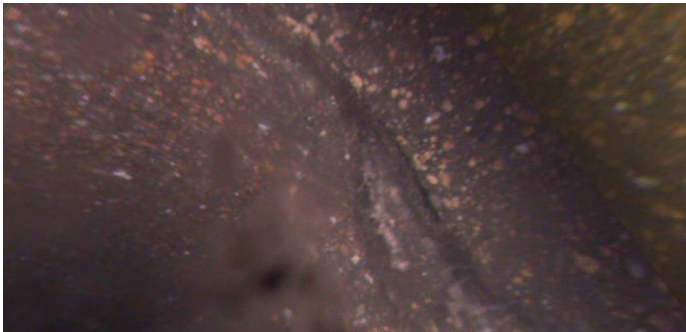
Code: **RFJ**
Description: **Roots Fine Joint**

Distance (ft): **23.8**
Structural Grade: **0**
O&M Grade: **1**
Clock Start/From: **8**
Clock To: **4**
1st Value:
2nd Value:
Value Percent:
Continuous Index: **S02**
Within 8" of Joint: **YES**
Remarks: **wandering**

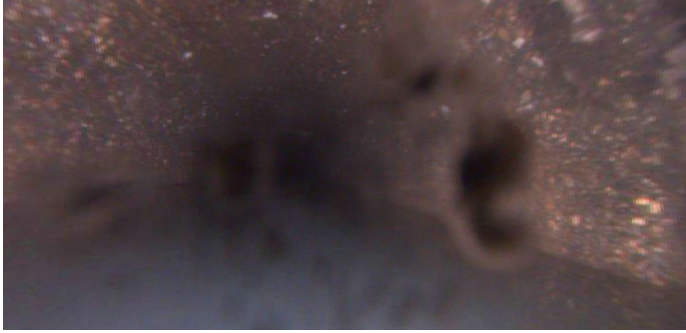
Code: **MWL**
Description: **Water Level**

Distance (ft): **23.8**
Structural Grade: **0**
O&M Grade: **0**
Clock Start/From:
Clock To:
1st Value:
2nd Value:
Value Percent: **25.000**
Continuous Index:
Within 8" of Joint: **NO**
Remarks:

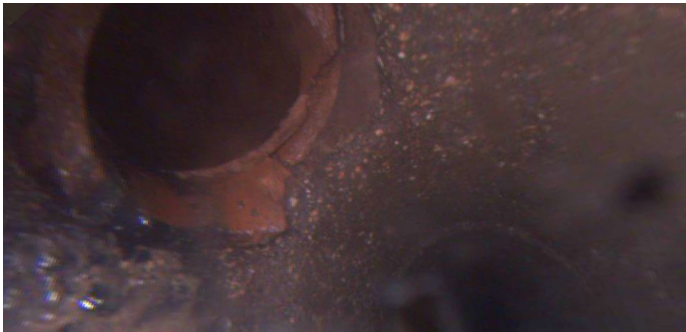
Code: **TB**
Description: **Tap Break-in**

Distance (ft): **52.1**
Structural Grade: **0**
O&M Grade: **0**
Clock Start/From: **11**
Clock To:
1st Value: **6.000**
2nd Value:
Value Percent:
Continuous Index:
Within 8" of Joint:
Remarks:

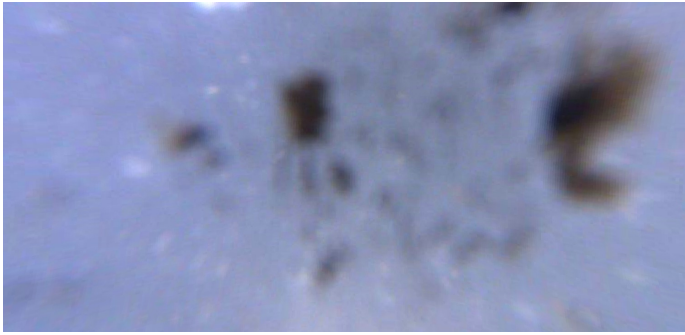
Code: **MCU**
Description: **Camera Underwater**

Distance (ft): **52.6**
Structural Grade: **0**
O&M Grade: **4**
Clock Start/From:
Clock To:
1st Value:
2nd Value:
Value Percent:
Continuous Index:
Within 8" of Joint: **NO**
Remarks:

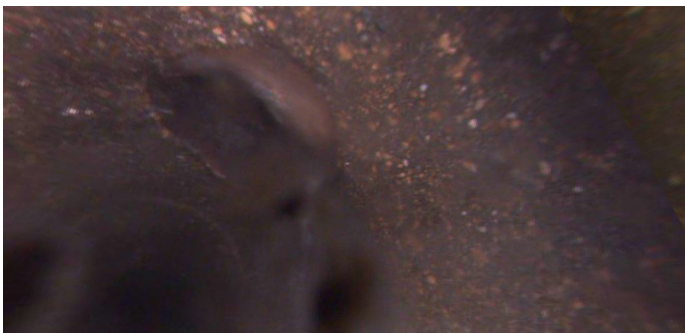
Code: **TB**
Description: **Tap Break-in**

Distance (ft): **60.8**
Structural Grade: **0**
O&M Grade: **0**
Clock Start/From: **1**
Clock To:
1st Value: **4.000**
2nd Value:
Value Percent:
Continuous Index:
Within 8" of Joint:
Remarks:

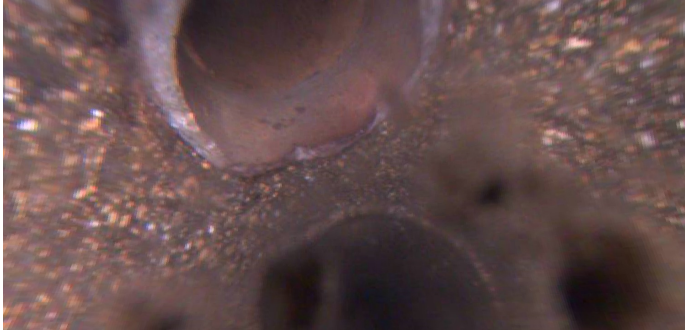
Code: **TB**
Description: **Tap Break-in**

Distance (ft): **64.5**
Structural Grade: **0**
O&M Grade: **0**
Clock Start/From: **1**
Clock To:
1st Value: **6.000**
2nd Value:
Value Percent:
Continuous Index:
Within 8" of Joint: **YES**
Remarks:

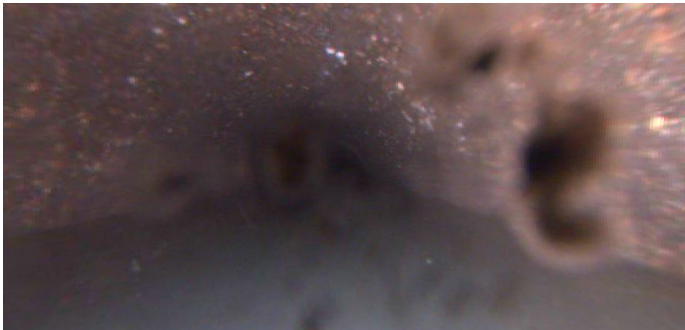
Code: **MWL**
Description: **Water Level**

Distance (ft): **98.2**
Structural Grade: **0**
O&M Grade: **0**
Clock Start/From:
Clock To:
1st Value:
2nd Value:
Value Percent: **50.000**
Continuous Index:
Within 8" of Joint: **NO**
Remarks:

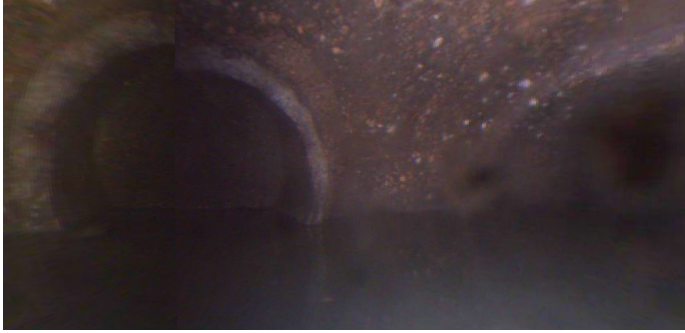
Code: **TBC**
Description: **Tap Break-in Capped**

Distance (ft): **100.4**
Structural Grade: **0**
O&M Grade: **2**
Clock Start/From: **9**
Clock To:
1st Value: **6.000**
2nd Value:
Value Percent:
Continuous Index:
Within 8" of Joint:
Remarks:

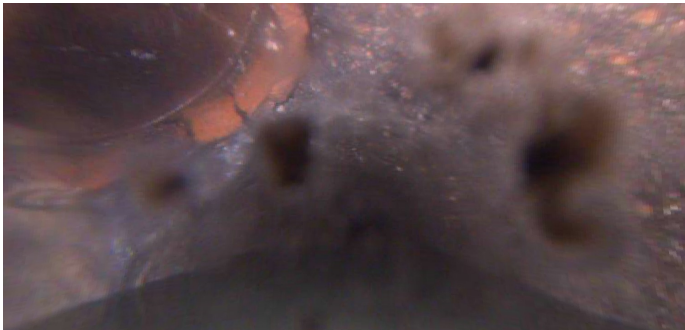
Code: **TB**
Description: **Tap Break-in**

Distance (ft): **104.6**
Structural Grade: **0**
O&M Grade: **0**
Clock Start/From: **11**
Clock To:
1st Value: **6.000**
2nd Value:
Value Percent:
Continuous Index:
Within 8" of Joint:
Remarks:

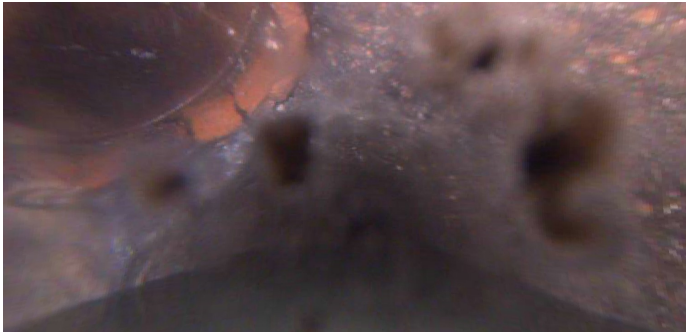
Code: **MSA**
Description: **Abandoned Survey**

Distance (ft): **104.6**
Structural Grade: **0**
O&M Grade: **0**
Clock Start/From:
Clock To:
1st Value:
2nd Value:
Value Percent:
Continuous Index:
Within 8" of Joint: **NO**
Remarks: **no blockage**

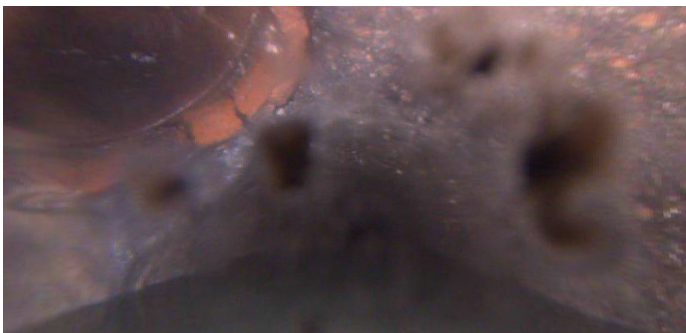
Code: **RFJ**
Description: **Roots Fine Joint**

Distance (ft): **104.6**
Structural Grade: **0**
O&M Grade: **1**
Clock Start/From: **8**
Clock To: **4**
1st Value:
2nd Value:
Value Percent:
Continuous Index: **F02**
Within 8" of Joint: **YES**
Remarks: **wandering**

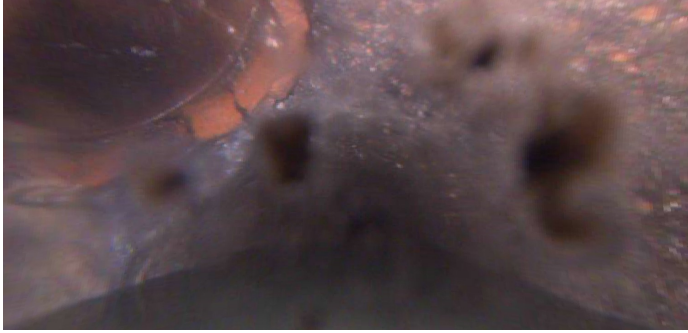
Code:	SAV
Description:	Surface Aggregate Visible
Distance (ft):	104.6
Structural Grade:	3
O&M Grade:	0
Clock Start/From:	8
Clock To:	4
1st Value:	
2nd Value:	
Value Percent:	
Continuous Index:	F01
Within 8" of Joint:	
Remarks:
