Profile/Photo Observation Report

Date:	04/17/2018	Weather:		Coding:	PACP 6.0
Pipe Length (ft):	262.9	Owner:	NA	Pre Clean:	Not Known
P.O.#:		Surveyor:	Byrd Fitzgerald	PSR:	P-504-124-123
Customer:		Clean Date:	01/01/1900	Shape:	C

Street:	Summerlin	Flow Control:	Not Controlled
City:	Hobart, IN	Year Renewed:	
Location:	Light Highway	Tape/Media #:	
Purpose:	Not Known	Dia/Height:	12"
Use:	Sanitary	Material:	CP
Drain Area:	NA	Lining:	
Category:	NA		
Comment:

Location Details:		Direction of Survey:	Downstream
US MH:	M-504-124	DS MH:	M-504-123
		Total Length Surveyed (ft):	104.6

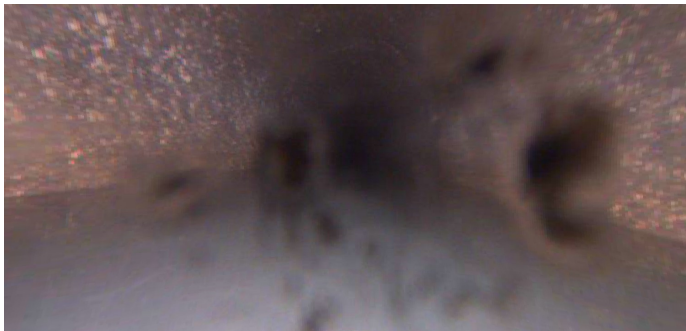
Code: **AMH**
Description: **Manhole**

Distance (ft): **.0**
Structural Grade: **0**
O&M Grade: **0**
Clock Start/From:
Clock To:
1st Value:
2nd Value:
Value Percent:
Continuous Index:
Within 8" of Joint: **NO**
Remarks: **M-504-124**

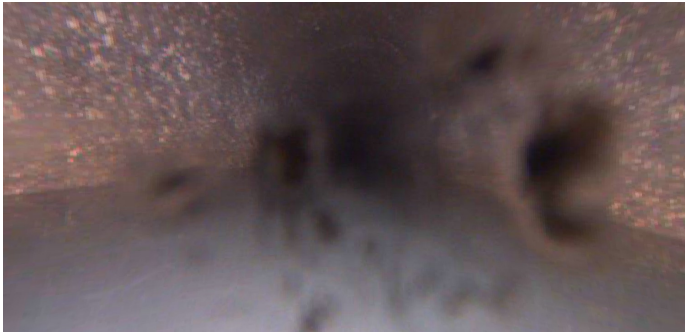
Code:	MWL
Description:	Water Level

Distance (ft):	.0
Structural Grade:	0
O&M Grade:	0
Clock Start/From:	
Clock To:	
1st Value:	
2nd Value:	
Value Percent:	10.000
Continuous Index:	
Within 8" of Joint:	NO
Remarks:

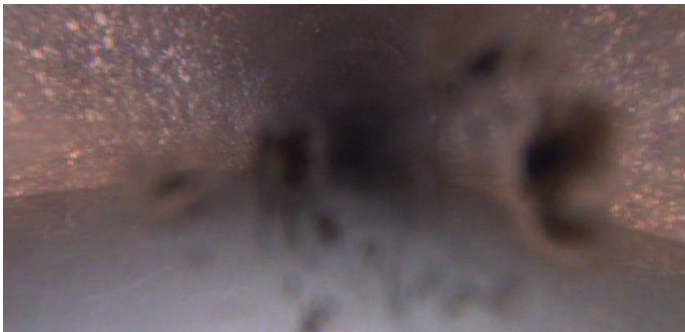
Code:	SAV
Description:	Surface Aggregate Visible

Distance (ft):	.0
Structural Grade:	3
O&M Grade:	0
Clock Start/From:	8
Clock To:	4
1st Value:	
2nd Value:	
Value Percent:	
Continuous Index:	S01
Within 8" of Joint:	
Remarks:

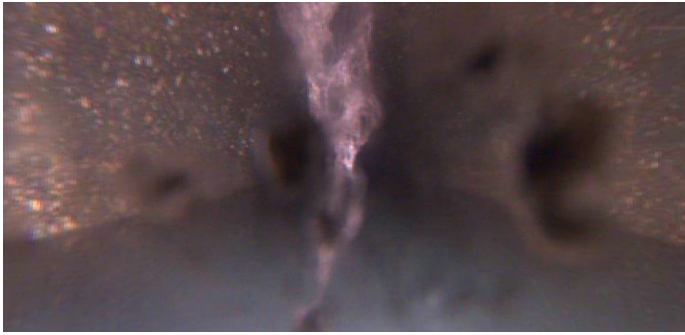
Code: **RFJ**
Description: **Roots Fine Joint**

Distance (ft): **20.8**
Structural Grade: **0**
O&M Grade: **1**
Clock Start/From: **12**
Clock To:
1st Value:
2nd Value:
Value Percent:
Continuous Index:
Within 8" of Joint: **YES**
Remarks:

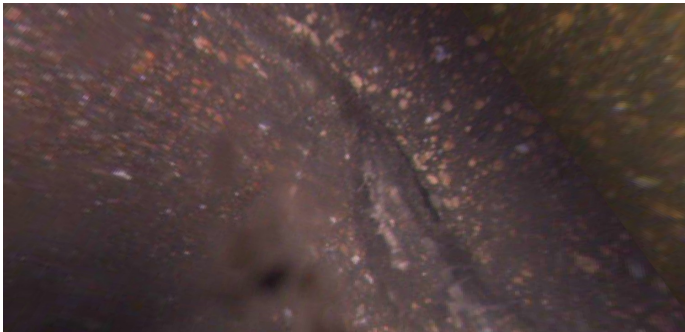
Code: **RFJ**
Description: **Roots Fine Joint**

Distance (ft): **23.8**
Structural Grade: **0**
O&M Grade: **1**
Clock Start/From: **8**
Clock To: **4**
1st Value:
2nd Value:
Value Percent:
Continuous Index: **S02**
Within 8" of Joint: **YES**
Remarks: **wandering**

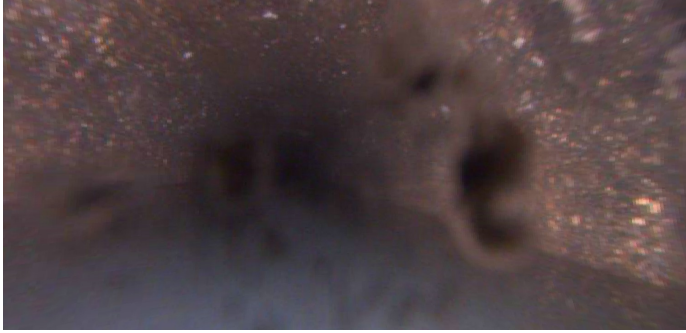
Code: **MWL**
Description: **Water Level**

Distance (ft): **23.8**
Structural Grade: **0**
O&M Grade: **0**
Clock Start/From:
Clock To:
1st Value:
2nd Value:
Value Percent: **25.000**
Continuous Index:
Within 8" of Joint: **NO**
Remarks:

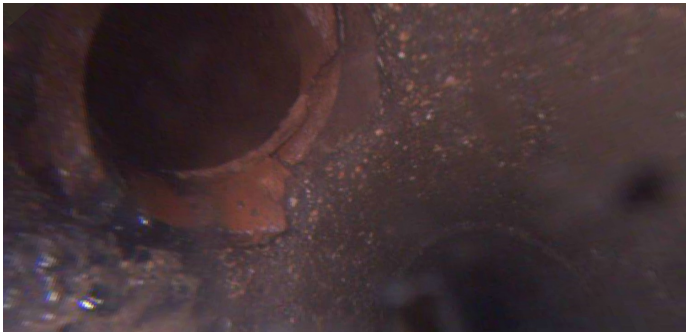
Code: **TB**
Description: **Tap Break-in**

Distance (ft): **52.1**
Structural Grade: **0**
O&M Grade: **0**
Clock Start/From: **11**
Clock To:
1st Value: **6.000**
2nd Value:
Value Percent:
Continuous Index:
Within 8" of Joint:
Remarks:

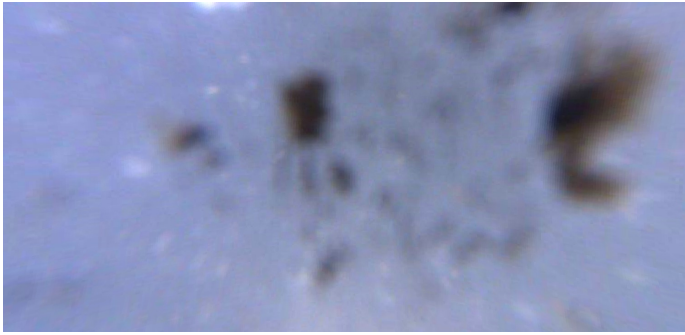
Code: **MCU**
Description: **Camera Underwater**

Distance (ft): **52.6**
Structural Grade: **0**
O&M Grade: **4**
Clock Start/From:
Clock To:
1st Value:
2nd Value:
Value Percent:
Continuous Index:
Within 8" of Joint: **NO**
Remarks:

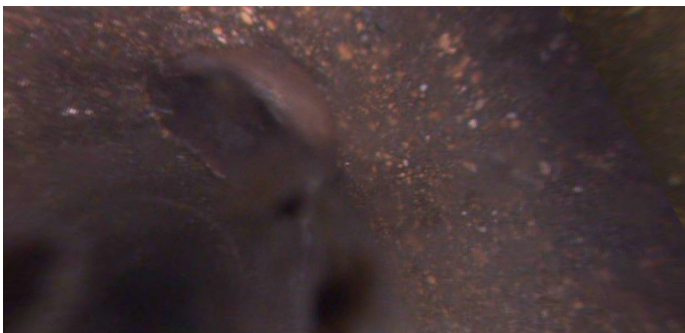
Code: **TB**
Description: **Tap Break-in**

Distance (ft): **60.8**
Structural Grade: **0**
O&M Grade: **0**
Clock Start/From: **1**
Clock To:
1st Value: **4.000**
2nd Value:
Value Percent:
Continuous Index:
Within 8" of Joint:
Remarks:

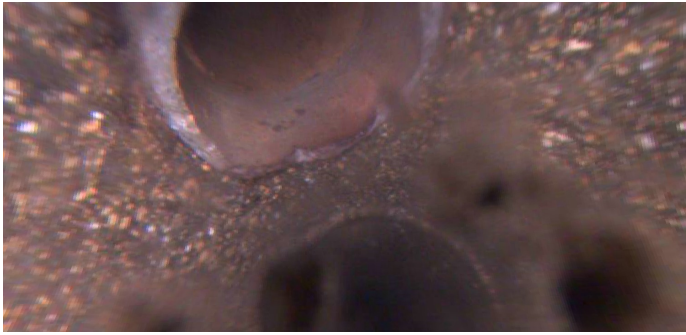
Code: **TB**
Description: **Tap Break-in**

Distance (ft): **64.5**
Structural Grade: **0**
O&M Grade: **0**
Clock Start/From: **1**
Clock To:
1st Value: **6.000**
2nd Value:
Value Percent:
Continuous Index:
Within 8" of Joint: **YES**
Remarks:

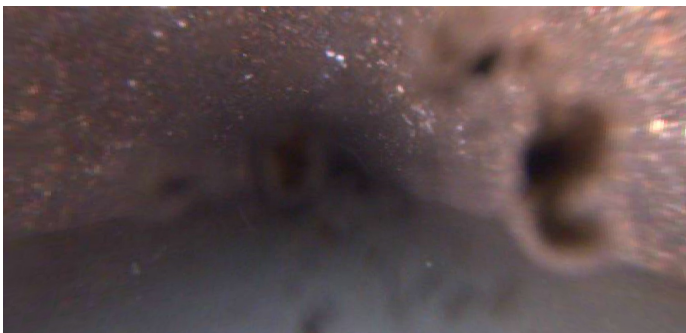
Code: **MWL**
Description: **Water Level**

Distance (ft): **98.2**
Structural Grade: **0**
O&M Grade: **0**
Clock Start/From:
Clock To:
1st Value:
2nd Value:
Value Percent: **50.000**
Continuous Index:
Within 8" of Joint: **NO**
Remarks:

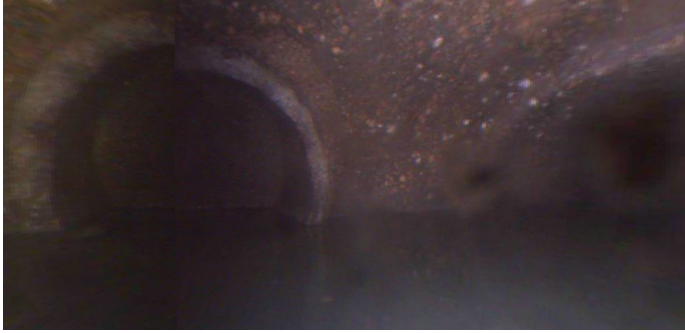
Code: **TBC**
Description: **Tap Break-in Capped**

Distance (ft): **100.4**
Structural Grade: **0**
O&M Grade: **2**
Clock Start/From: **9**
Clock To:
1st Value: **6.000**
2nd Value:
Value Percent:
Continuous Index:
Within 8" of Joint:
Remarks:

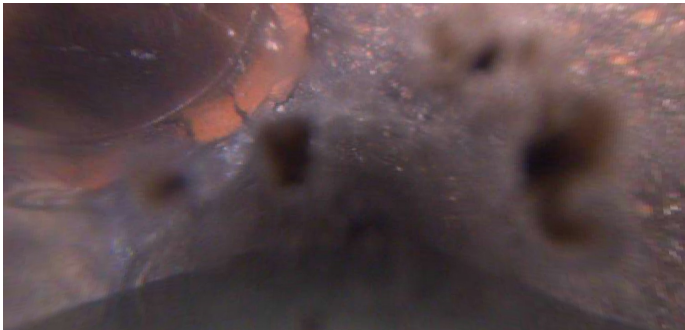
Code: **TB**
Description: **Tap Break-in**

Distance (ft): **104.6**
Structural Grade: **0**
O&M Grade: **0**
Clock Start/From: **11**
Clock To:
1st Value: **6.000**
2nd Value:
Value Percent:
Continuous Index:
Within 8" of Joint:
Remarks:

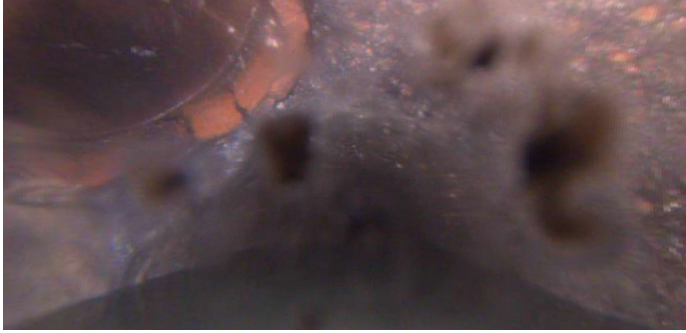
Code: **MSA**
Description: **Abandoned Survey**

Distance (ft): **104.6**
Structural Grade: **0**
O&M Grade: **0**
Clock Start/From:
Clock To:
1st Value:
2nd Value:
Value Percent:
Continuous Index:
Within 8" of Joint: **NO**
Remarks: **no blockage**

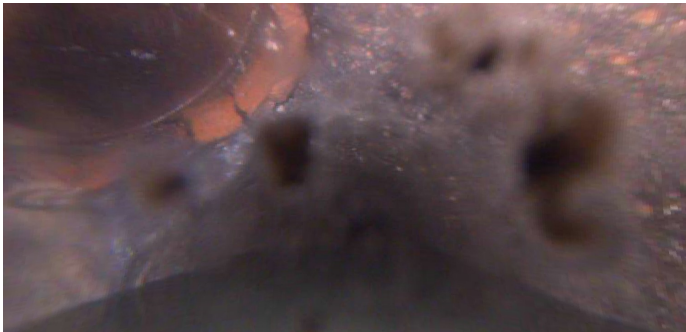
Code: **RFJ**
Description: **Roots Fine Joint**

Distance (ft): **104.6**
Structural Grade: **0**
O&M Grade: **1**
Clock Start/From: **8**
Clock To: **4**
1st Value:
2nd Value:
Value Percent:
Continuous Index: **F02**
Within 8" of Joint: **YES**
Remarks: **wandering**

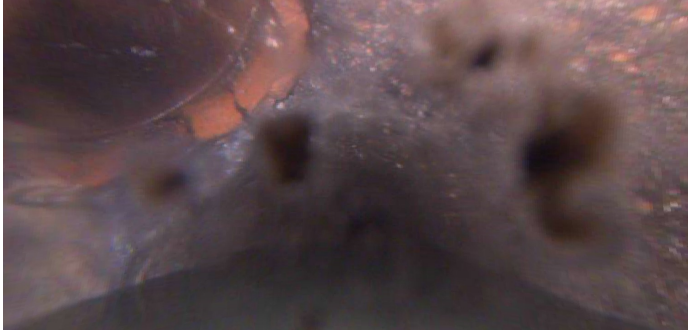
Code:	SAV
Description:	Surface Aggregate Visible
Distance (ft):	104.6
Structural Grade:	3
O&M Grade:	0
Clock Start/From:	8
Clock To:	4
1st Value:	
2nd Value:	
Value Percent:	
Continuous Index:	F01
Within 8" of Joint:	
Remarks:
