## Profile/Photo Observation Report

Street:	<b>ALLEY BETWEEN N GUYER ST &amp; N CA</b>	Flow Control:	<b>Not Controlled</b>
City:	<b>Hobart, IN</b>	Year Renewed:	
Location:	<b>Light Highway</b>	Tape/Media #:	
Purpose:	<b>Not Known</b>	Dia/Height:	<b>12"</b>
Use:	<b>Sanitary</b>	Material:	<b>VCP</b>
Drain Area:	<b>NA</b>	Lining:	
Category:	<b>NA</b>		
Comment:

Location Details:		Direction of Survey:	<b>Upstream</b>
US MH:	<b>M-504-124</b>	DS MH:	<b>M-504-123</b>
		Total Length Surveyed (ft):	<b>141.8</b>

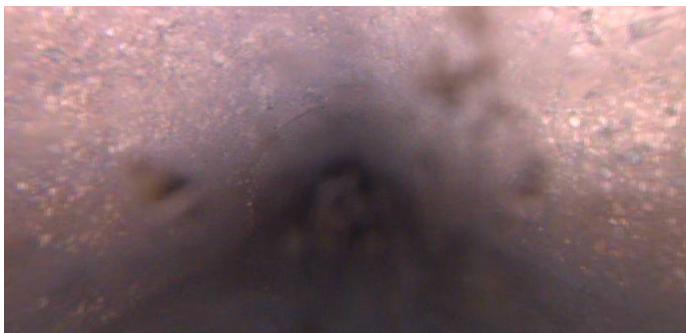
Code: **AMH**  
Description: **Manhole**

Distance (ft): **.0**  
Structural Grade: **0**  
O&M Grade: **0**  
Clock Start/From:  
Clock To:  
1st Value:  
2nd Value:  
Value Percent:  
Continuous Index:  
Within 8" of Joint: **NO**  
Remarks: **M-504-124**

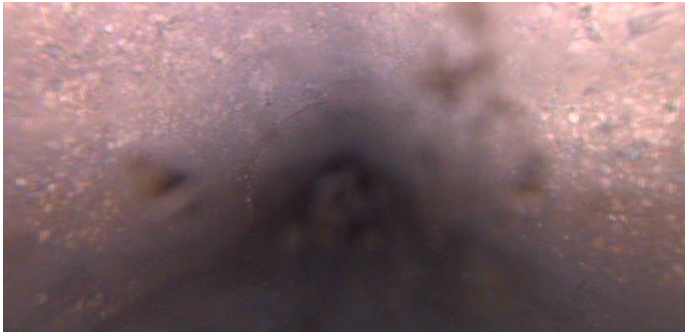
Code:	<b>MWL</b>
Description:	<b>Water Level</b>

Distance (ft):	<b>.0</b>
Structural Grade:	<b>0</b>
O&M Grade:	<b>0</b>
Clock Start/From:	
Clock To:	
1st Value:	
2nd Value:	
Value Percent:	<b>15.000</b>
Continuous Index:	
Within 8" of Joint:	<b>NO</b>
Remarks:

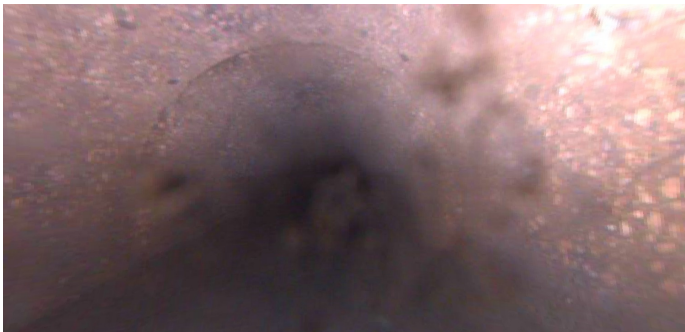
Code:	<b>SAP</b>
Description:	<b>Surface Aggregate Projecting</b>

Distance (ft):	<b>1.6</b>
Structural Grade:	<b>3</b>
O&M Grade:	<b>0</b>
Clock Start/From:	<b>7</b>
Clock To:	<b>5</b>
1st Value:	
2nd Value:	
Value Percent:	
Continuous Index:	<b>S01</b>
Within 8" of Joint:	<b>YES</b>
Remarks:	<b>WANDER</b>

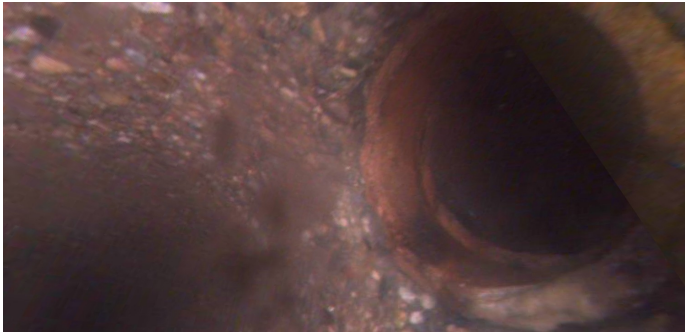
Code: **TBI**  
Description: **Tap Break-in Intruding**

Distance (ft): **35.7**  
Structural Grade: **0**  
O&M Grade: **2**  
Clock Start/From: **1**  
Clock To:  
1st Value: **4.000**  
2nd Value: **1.000**  
Value Percent:  
Continuous Index:  
Within 8" of Joint:  
Remarks:

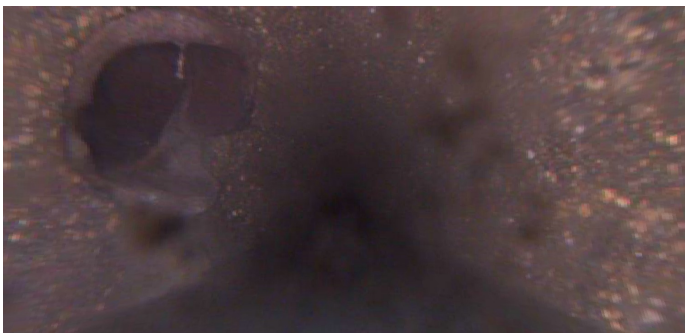
Code: **TBI**  
Description: **Tap Break-in Intruding**

Distance (ft): **42.8**  
Structural Grade: **0**  
O&M Grade: **2**  
Clock Start/From: **9**  
Clock To:  
1st Value: **4.000**  
2nd Value: **1.000**  
Value Percent:  
Continuous Index:  
Within 8" of Joint:  
Remarks:

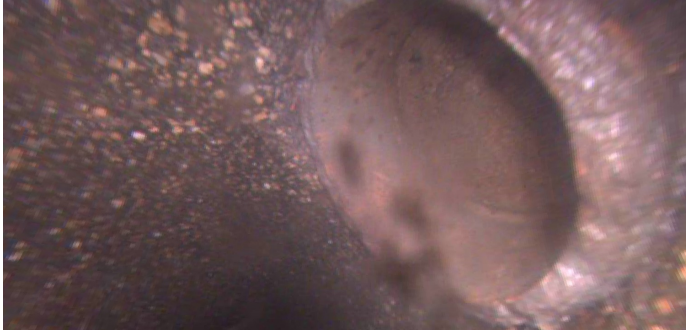
Code: **TBI**  
Description: **Tap Break-in Intruding**

Distance (ft): **84.9**  
Structural Grade: **0**  
O&M Grade: **2**  
Clock Start/From: **2**  
Clock To:  
1st Value: **4.000**  
2nd Value: **1.000**  
Value Percent:  
Continuous Index:  
Within 8" of Joint:  
Remarks:

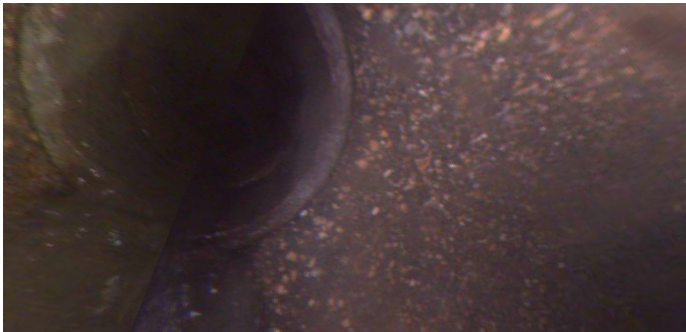
Code: **TB**  
Description: **Tap Break-in**

Distance (ft): **88.2**  
Structural Grade: **0**  
O&M Grade: **0**  
Clock Start/From: **10**  
Clock To:  
1st Value: **4.000**  
2nd Value:  
Value Percent:  
Continuous Index:  
Within 8" of Joint:  
Remarks:

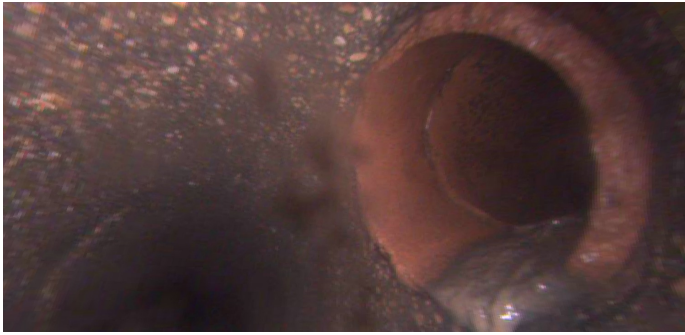
Code: **TBI**  
Description: **Tap Break-in Intruding**

Distance (ft): **91.5**  
Structural Grade: **0**  
O&M Grade: **2**  
Clock Start/From: **3**  
Clock To:  
1st Value: **4.000**  
2nd Value: **1.000**  
Value Percent:  
Continuous Index:  
Within 8" of Joint:  
Remarks:

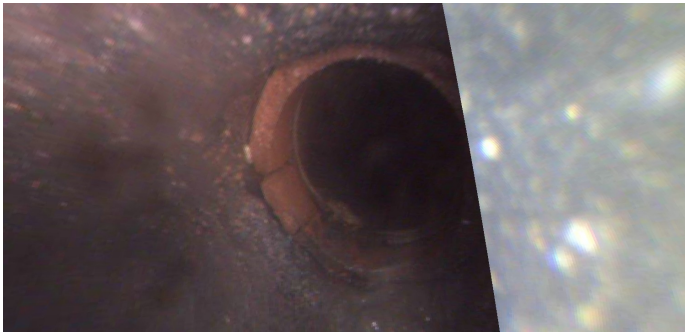
Code: **TB**  
Description: **Tap Break-in**

Distance (ft): **137.0**  
Structural Grade: **0**  
O&M Grade: **0**  
Clock Start/From: **2**  
Clock To:  
1st Value: **4.000**  
2nd Value:  
Value Percent:  
Continuous Index:  
Within 8" of Joint: **NO**  
Remarks:

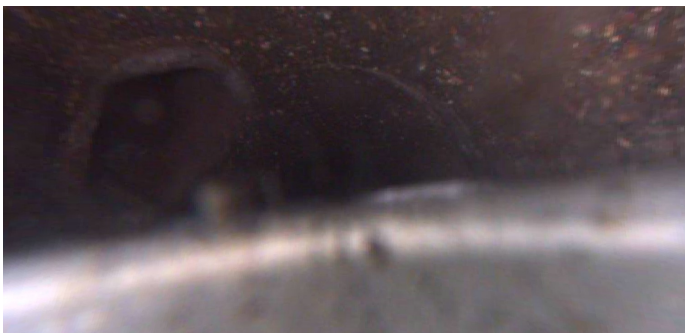
Code: **TBI**  
Description: **Tap Break-in Intruding**

Distance (ft): **137.9**  
Structural Grade: **0**  
O&M Grade: **2**  
Clock Start/From: **10**  
Clock To:  
1st Value: **4.000**  
2nd Value: **1.000**  
Value Percent:  
Continuous Index:  
Within 8" of Joint:  
Remarks:

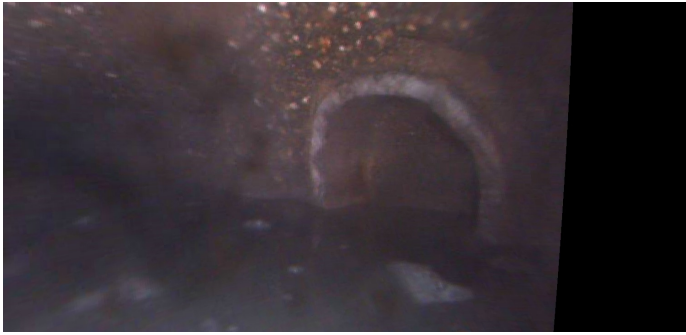
Code: **TFC**  
Description: **Tap Factory Capped**

Distance (ft): **141.2**  
Structural Grade: **0**  
O&M Grade: **0**  
Clock Start/From: **3**  
Clock To:  
1st Value: **4.000**  
2nd Value:  
Value Percent:  
Continuous Index:  
Within 8" of Joint:  
Remarks:

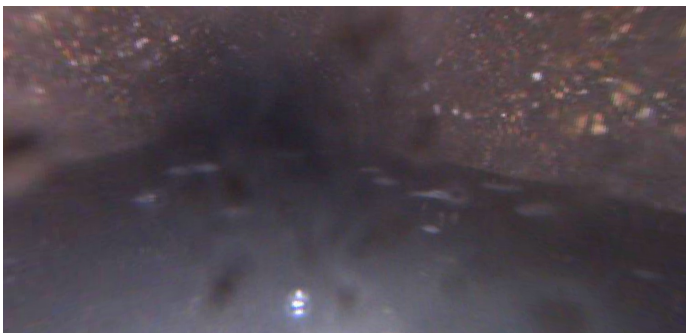
Code: **SAP**  
Description: **Surface Aggregate Projecting**

Distance (ft): **141.8**  
Structural Grade: **3**  
O&M Grade: **0**  
Clock Start/From: **7**  
Clock To: **5**  
1st Value:  
2nd Value:  
Value Percent:  
Continuous Index: **F01**  
Within 8" of Joint: **YES**  
Remarks: **WANDER**

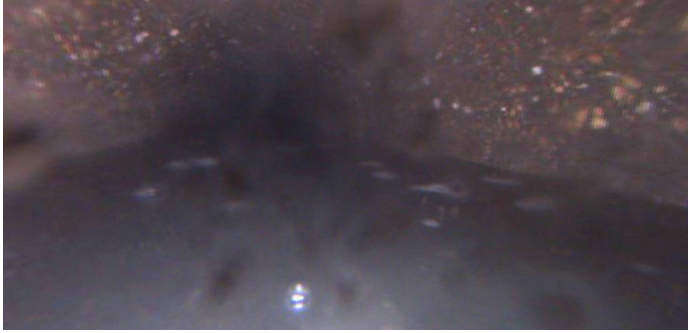
Code:	<b>MSA</b>
Description:	<b>Abandoned Survey</b>
Distance (ft):	<b>141.8</b>
Structural Grade:	<b>0</b>
O&M Grade:	<b>0</b>
Clock Start/From:	
Clock To:	
1st Value:	
2nd Value:	
Value Percent:	
Continuous Index:	
Within 8" of Joint:	<b>NO</b>
Remarks:	<b>ROBOT HAS STOPPED</b>
