Profile/Photo Observation Report

Date:	04/17/2018	Weather:		Coding:	PACP 6.0
Pipe Length (ft):	262.9	Owner:	NA	Pre Clean:	Not Known
P.O.#:		Surveyor:	Justin Gonzales	PSR:	P-504-124-123
Customer:		Clean Date:	01/01/1900	Shape:	C

Street:	Summerlin	Flow Control:	Not Controlled
City:	Hobart, IN	Year Renewed:	
Location:	Light Highway	Tape/Media #:	
Purpose:	Not Known	Dia/Height:	12"
Use:	Sanitary	Material:	VCP
Drain Area:	NA	Lining:	
Category:	NA		
Comment:

Location Details:		Direction of Survey:	Upstream
US MH:	M-504-124	DS MH:	M-504-123
		Total Length Surveyed (ft):	141.8

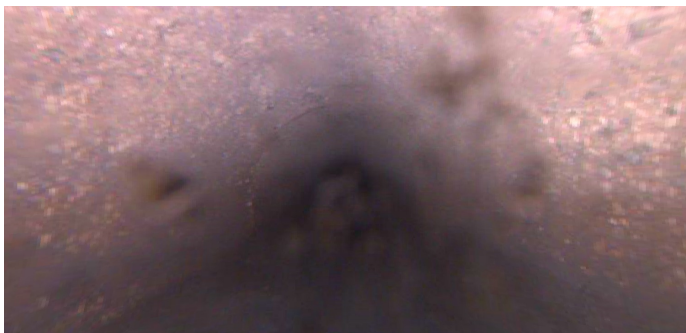
Code: **AMH**
Description: **Manhole**

Distance (ft): **.0**
Structural Grade: **0**
O&M Grade: **0**
Clock Start/From:
Clock To:
1st Value:
2nd Value:
Value Percent:
Continuous Index:
Within 8" of Joint: **NO**
Remarks: **M-504-124**

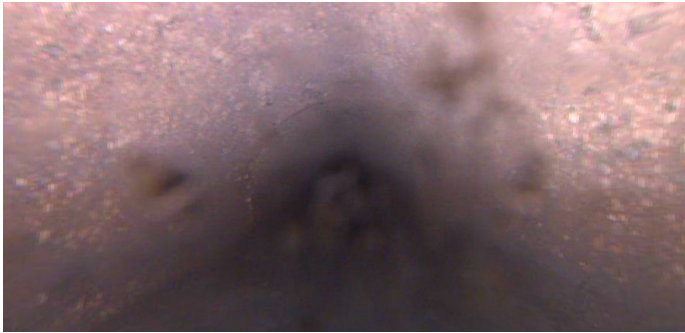
Code:	MWL
Description:	Water Level

Distance (ft):	.0
Structural Grade:	0
O&M Grade:	0
Clock Start/From:	
Clock To:	
1st Value:	
2nd Value:	
Value Percent:	15.000
Continuous Index:	
Within 8" of Joint:	NO
Remarks:

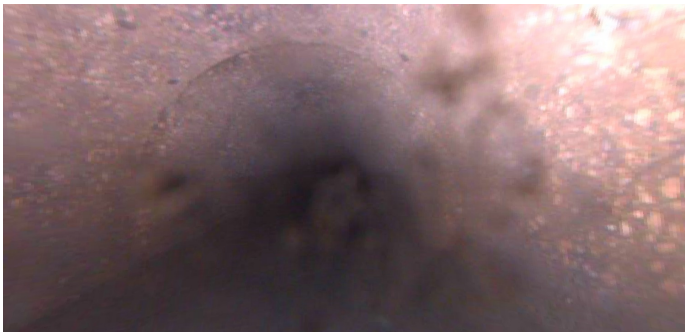
Code:	SAP
Description:	Surface Aggregate Projecting

Distance (ft):	1.6
Structural Grade:	3
O&M Grade:	0
Clock Start/From:	7
Clock To:	5
1st Value:	
2nd Value:	
Value Percent:	
Continuous Index:	S01
Within 8" of Joint:	YES
Remarks:	WANDER

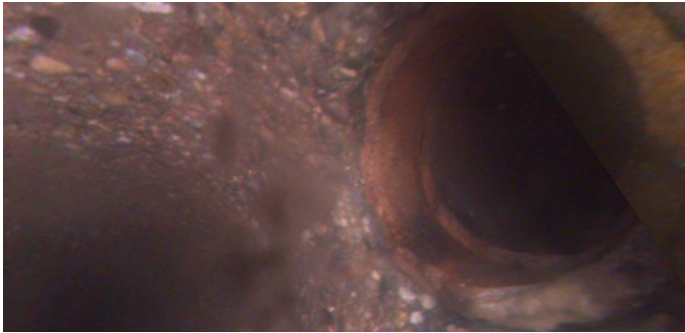
Code: **TBI**
Description: **Tap Break-in Intruding**

Distance (ft): **35.7**
Structural Grade: **0**
O&M Grade: **2**
Clock Start/From: **1**
Clock To:
1st Value: **4.000**
2nd Value: **1.000**
Value Percent:
Continuous Index:
Within 8" of Joint:
Remarks:

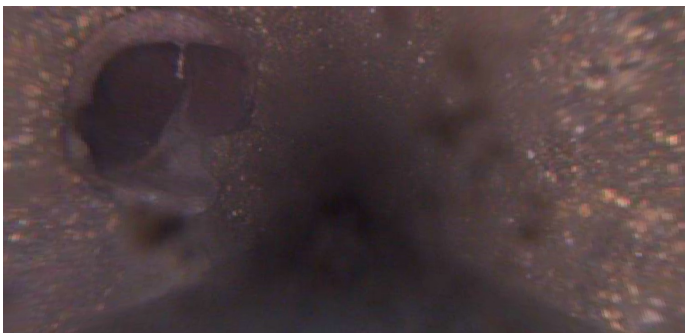
Code: **TBI**
Description: **Tap Break-in Intruding**

Distance (ft): **42.8**
Structural Grade: **0**
O&M Grade: **2**
Clock Start/From: **9**
Clock To:
1st Value: **4.000**
2nd Value: **1.000**
Value Percent:
Continuous Index:
Within 8" of Joint:
Remarks:

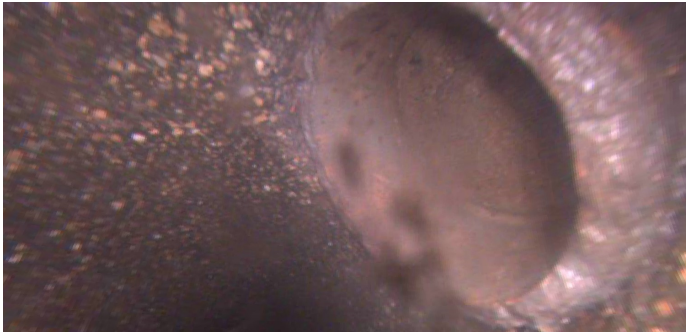
Code: **TBI**
Description: **Tap Break-in Intruding**

Distance (ft): **84.9**
Structural Grade: **0**
O&M Grade: **2**
Clock Start/From: **2**
Clock To:
1st Value: **4.000**
2nd Value: **1.000**
Value Percent:
Continuous Index:
Within 8" of Joint:
Remarks:

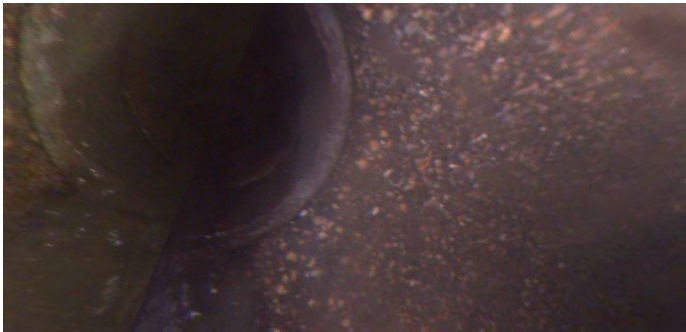
Code: **TB**
Description: **Tap Break-in**

Distance (ft): **88.2**
Structural Grade: **0**
O&M Grade: **0**
Clock Start/From: **10**
Clock To:
1st Value: **4.000**
2nd Value:
Value Percent:
Continuous Index:
Within 8" of Joint:
Remarks:

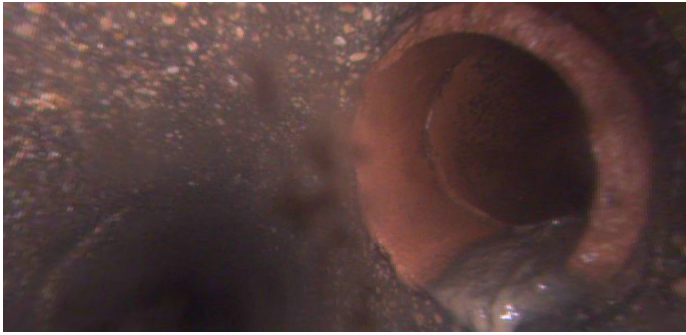
Code: **TBI**
Description: **Tap Break-in Intruding**

Distance (ft): **91.5**
Structural Grade: **0**
O&M Grade: **2**
Clock Start/From: **3**
Clock To:
1st Value: **4.000**
2nd Value: **1.000**
Value Percent:
Continuous Index:
Within 8" of Joint:
Remarks:

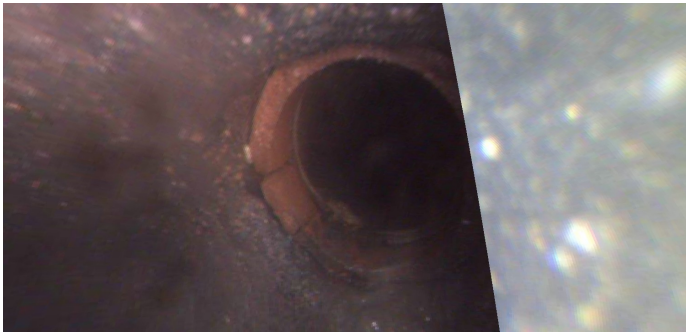
Code: **TB**
Description: **Tap Break-in**

Distance (ft): **137.0**
Structural Grade: **0**
O&M Grade: **0**
Clock Start/From: **2**
Clock To:
1st Value: **4.000**
2nd Value:
Value Percent:
Continuous Index:
Within 8" of Joint: **NO**
Remarks:

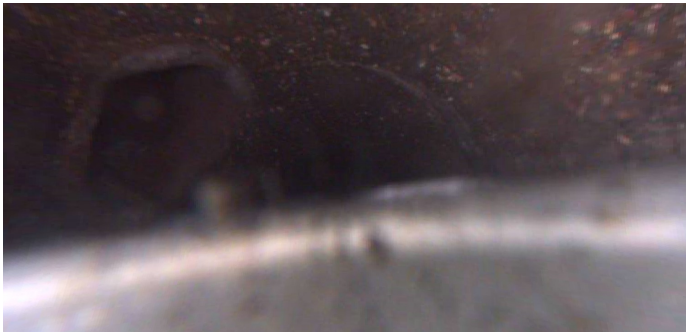
Code: **TBI**
Description: **Tap Break-in Intruding**

Distance (ft): **137.9**
Structural Grade: **0**
O&M Grade: **2**
Clock Start/From: **10**
Clock To:
1st Value: **4.000**
2nd Value: **1.000**
Value Percent:
Continuous Index:
Within 8" of Joint:
Remarks:

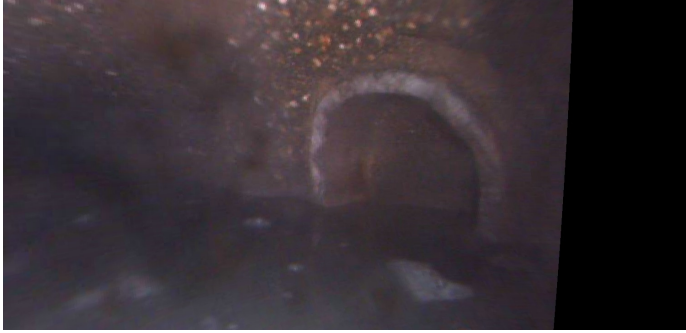
Code: **TFC**
Description: **Tap Factory Capped**

Distance (ft): **141.2**
Structural Grade: **0**
O&M Grade: **0**
Clock Start/From: **3**
Clock To:
1st Value: **4.000**
2nd Value:
Value Percent:
Continuous Index:
Within 8" of Joint:
Remarks:

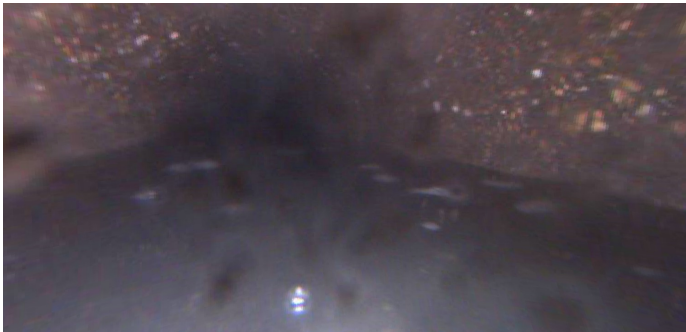
Code: **SAP**
Description: **Surface Aggregate Projecting**

Distance (ft): **141.8**
Structural Grade: **3**
O&M Grade: **0**
Clock Start/From: **7**
Clock To: **5**
1st Value:
2nd Value:
Value Percent:
Continuous Index: **F01**
Within 8" of Joint: **YES**
Remarks: **WANDER**

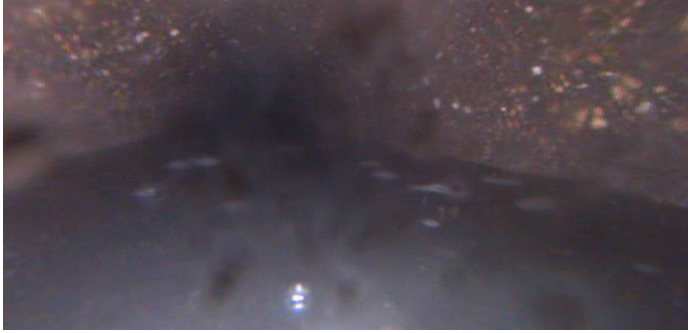
Code:	MSA
Description:	Abandoned Survey
Distance (ft):	141.8
Structural Grade:	0
O&M Grade:	0
Clock Start/From:	
Clock To:	
1st Value:	
2nd Value:	
Value Percent:	
Continuous Index:	
Within 8" of Joint:	NO
Remarks:	ROBOT HAS STOPPED
