## Profile/Photo Observation Report

Date:	<b>04/09/2018</b>	Weather:		Coding:	<b>PACP 6.0</b>
Pipe Length (ft):	<b>238.5</b>	Owner:	<b>NA</b>	Pre Clean:	<b>Not Known</b>
P.O.#:		Surveyor:	<b>Jen Costello</b>	PSR:	<b>P-504-125-124</b>
Customer:		Clean Date:	<b>01/01/1900</b>	Shape:	<b>C</b>

Street:	<b>W 40th ave</b>	Flow Control:	<b>Not Controlled</b>
City:	<b>Hobart, IN</b>	Year Renewed:	
Location:	<b>Other</b>	Tape/Media #:	
Purpose:	<b>Not Known</b>	Dia/Height:	<b>10"</b>
Use:	<b>Sanitary</b>	Material:	<b>CP</b>
Drain Area:	<b>NA</b>	Lining:	
Category:	<b>NA</b>		
Comment:

Location Details:		Direction of Survey:	<b>Upstream</b>
US MH:	<b>M-504-124</b>	DS MH:	<b>M-504-125</b>
		Total Length Surveyed (ft):	<b>9.8</b>

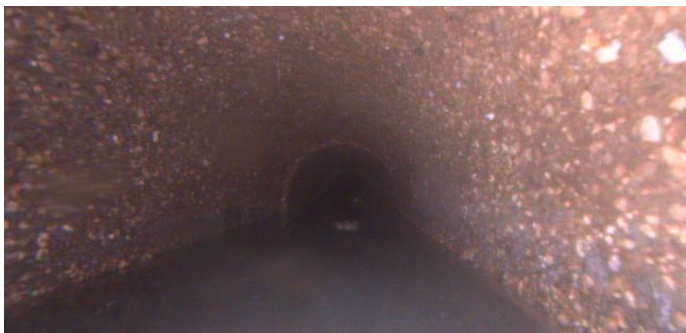
Code: **AMH**  
Description: **Manhole**

Distance (ft): **.0**  
Structural Grade: **0**  
O&M Grade: **0**  
Clock Start/From:  
Clock To:  
1st Value:  
2nd Value:  
Value Percent:  
Continuous Index:  
Within 8" of Joint: **NO**  
Remarks: **M-504-125**

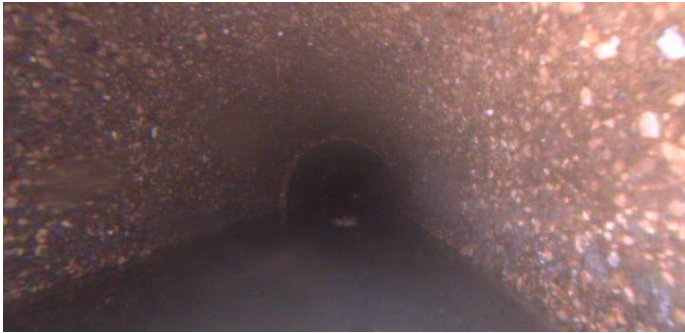
Code:	<b>MWL</b>
Description:	<b>Water Level</b>

Distance (ft):	<b>.0</b>
Structural Grade:	<b>0</b>
O&M Grade:	<b>0</b>
Clock Start/From:	
Clock To:	
1st Value:	
2nd Value:	
Value Percent:	<b>20.000</b>
Continuous Index:	
Within 8" of Joint:	<b>NO</b>
Remarks:

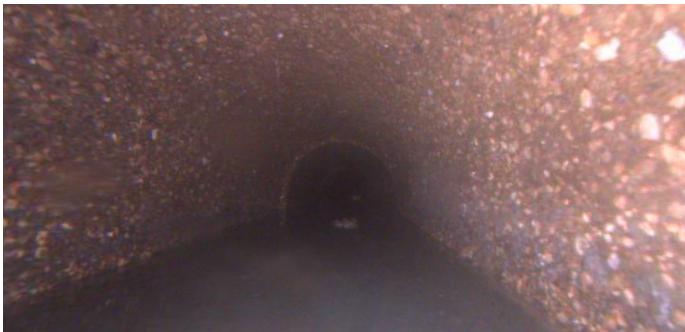
Code:	<b>SAP</b>
Description:	<b>Surface Aggregate Projecting</b>

Distance (ft):	<b>.0</b>
Structural Grade:	<b>3</b>
O&M Grade:	<b>0</b>
Clock Start/From:	<b>8</b>
Clock To:	<b>4</b>
1st Value:	
2nd Value:	
Value Percent:	
Continuous Index:	
Within 8" of Joint:	
Remarks:

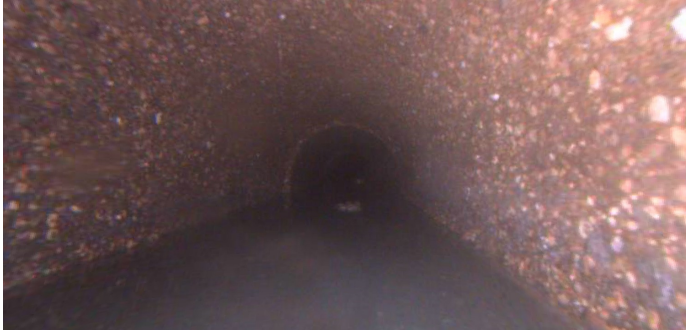
Code: **SAP**  
Description: **Surface Aggregate Projecting**

Distance (ft): **.0**  
Structural Grade: **3**  
O&M Grade: **0**  
Clock Start/From: **8**  
Clock To: **4**  
1st Value:  
2nd Value:  
Value Percent:  
Continuous Index: **S01**  
Within 8" of Joint:  
Remarks:

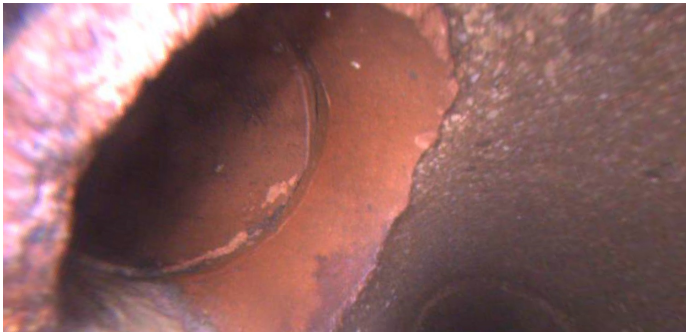
Code: **TBI**  
Description: **Tap Break-in Intruding**

Distance (ft): **7.5**  
Structural Grade: **0**  
O&M Grade: **2**  
Clock Start/From: **10**  
Clock To:  
1st Value: **4.000**  
2nd Value: **1.000**  
Value Percent:  
Continuous Index:  
Within 8" of Joint:  
Remarks:

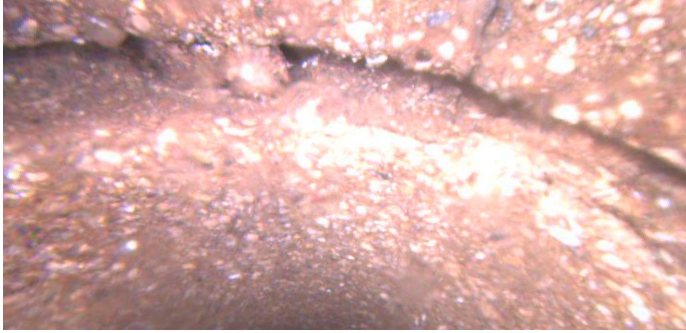
Code: **FL**  
Description: **Fracture Longitudinal**

Distance (ft): **9.8**  
Structural Grade: **3**  
O&M Grade: **0**  
Clock Start/From: **12**  
Clock To:  
1st Value:  
2nd Value:  
Value Percent:  
Continuous Index:  
Within 8" of Joint: **YES**  
Remarks:

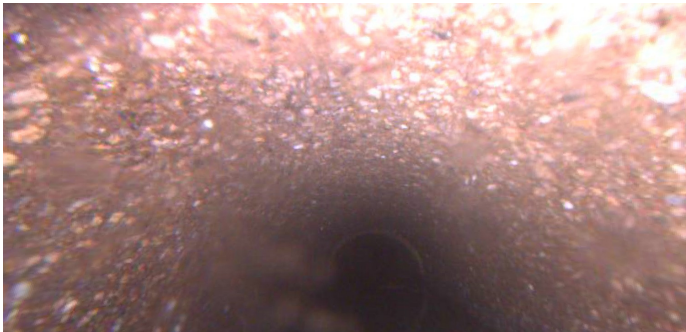
Code: **SAP**  
Description: **Surface Aggregate Projecting**

Distance (ft): **9.8**  
Structural Grade: **3**  
O&M Grade: **0**  
Clock Start/From: **8**  
Clock To: **4**  
1st Value:  
2nd Value:  
Value Percent:  
Continuous Index: **F01**  
Within 8" of Joint:  
Remarks:

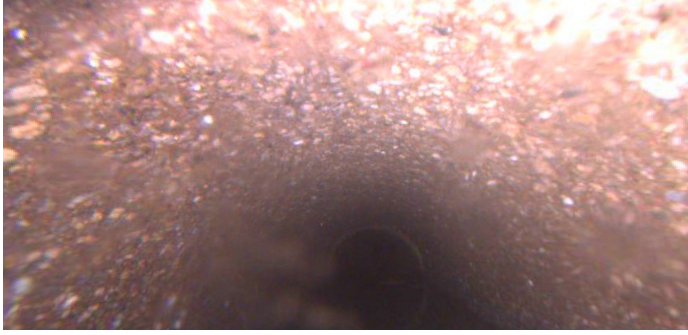
Code:	<b>MSA</b>
Description:	<b>Abandoned Survey</b>
Distance (ft):	<b>9.8</b>
Structural Grade:	<b>0</b>
O&M Grade:	<b>0</b>
Clock Start/From:	
Clock To:	
1st Value:	
2nd Value:	
Value Percent:	
Continuous Index:	
Within 8" of Joint:	<b>NO</b>
Remarks:	<b>unknown</b>
