Profile/Photo Observation Report

Street:	W 40th ave	Flow Control:	Not Controlled
City:	Hobart, IN	Year Renewed:	
Location:	Other	Tape/Media #:	
Purpose:	Not Known	Dia/Height:	10"
Use:	Sanitary	Material:	CP
Drain Area:	NA	Lining:	
Category:	NA		
Comment:

Location Details:		Direction of Survey:	Upstream
US MH:	M-504-124	DS MH:	M-504-125
		Total Length Surveyed (ft):	9.8

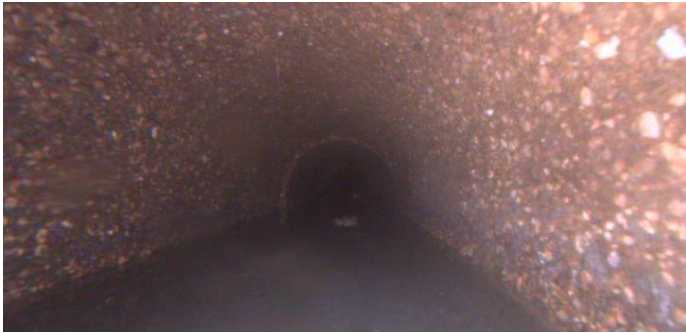
Code:	MWL
Description:	Water Level

Distance (ft):	.0
Structural Grade:	0
O&M Grade:	0
Clock Start/From:	
Clock To:	
1st Value:	
2nd Value:	
Value Percent:	20.000
Continuous Index:	
Within 8" of Joint:	NO
Remarks:

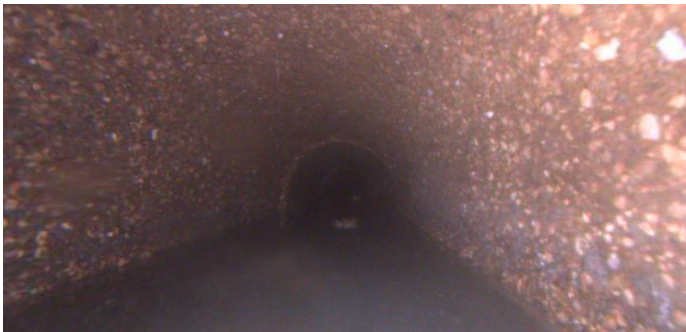
Code:	SAP
Description:	Surface Aggregate Projecting

Distance (ft):	.0
Structural Grade:	3
O&M Grade:	0
Clock Start/From:	8
Clock To:	4
1st Value:	
2nd Value:	
Value Percent:	
Continuous Index:	
Within 8" of Joint:	
Remarks:

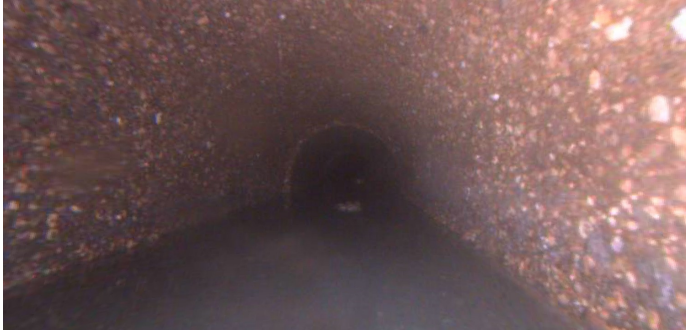
Code: **SAP**
Description: **Surface Aggregate Projecting**

Distance (ft): **.0**
Structural Grade: **3**
O&M Grade: **0**
Clock Start/From: **8**
Clock To: **4**
1st Value:
2nd Value:
Value Percent:
Continuous Index: **S01**
Within 8" of Joint:
Remarks:

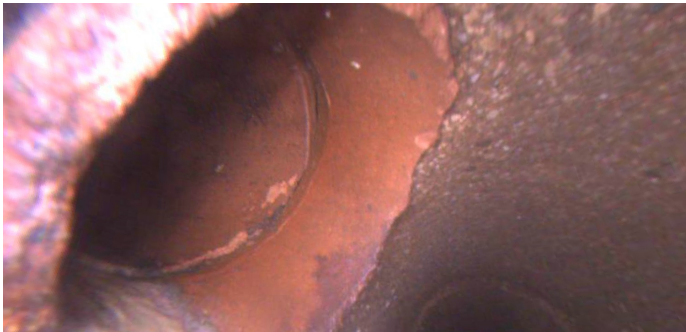
Code: **TBI**
Description: **Tap Break-in Intruding**

Distance (ft): **7.5**
Structural Grade: **0**
O&M Grade: **2**
Clock Start/From: **10**
Clock To:
1st Value: **4.000**
2nd Value: **1.000**
Value Percent:
Continuous Index:
Within 8" of Joint:
Remarks:

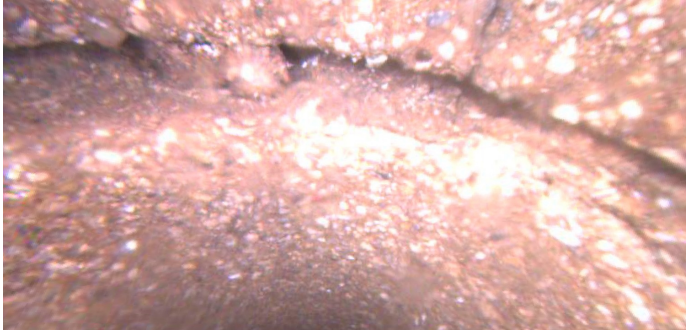
Code: **FL**
Description: **Fracture Longitudinal**

Distance (ft): **9.8**
Structural Grade: **3**
O&M Grade: **0**
Clock Start/From: **12**
Clock To:
1st Value:
2nd Value:
Value Percent:
Continuous Index:
Within 8" of Joint: **YES**
Remarks:

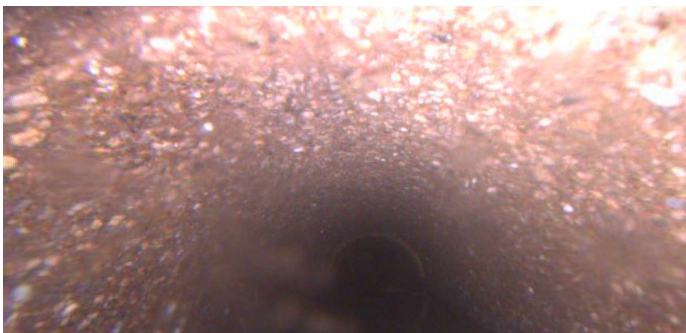
Code: **SAP**
Description: **Surface Aggregate Projecting**

Distance (ft): **9.8**
Structural Grade: **3**
O&M Grade: **0**
Clock Start/From: **8**
Clock To: **4**
1st Value:
2nd Value:
Value Percent:
Continuous Index: **F01**
Within 8" of Joint:
Remarks:

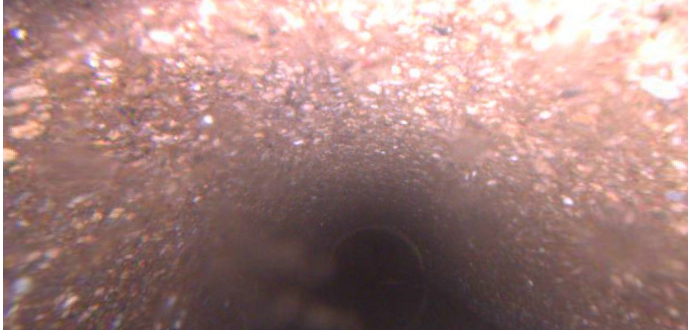
Code:	MSA
Description:	Abandoned Survey
Distance (ft):	9.8
Structural Grade:	0
O&M Grade:	0
Clock Start/From:	
Clock To:	
1st Value:	
2nd Value:	
Value Percent:	
Continuous Index:	
Within 8" of Joint:	NO
Remarks:	unknown
