Profile/Photo Observation Report

Date:	04/09/2018	Weather:		Coding:	PACP 6.0
Pipe Length (ft):	238.5	Owner:	NA	Pre Clean:	Not Known
P.O.#:		Surveyor:	Mark Ruby	PSR:	P-504-125-124
Customer:		Clean Date:	01/01/1900	Shape:	C

Street:	W 40th ave	Flow Control:	Not Controlled
City:	Hobart, IN	Year Renewed:	
Location:	Other	Tape/Media #:	
Purpose:	Not Known	Dia/Height:	10"
Use:	Sanitary	Material:	CP
Drain Area:	NA	Lining:	
Category:	NA		
Comment:

Location Details:		Direction of Survey:	Upstream
US MH:	M-504-124	DS MH:	M-504-125
		Total Length Surveyed (ft):	241.9

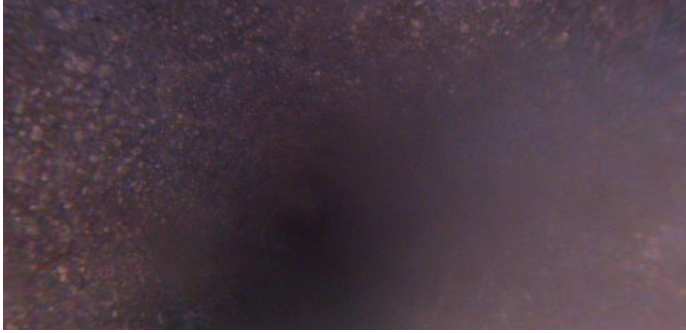
Code: **SAP**
Description: **Surface Aggregate Projecting**

Distance (ft): **.0**
Structural Grade: **3**
O&M Grade: **0**
Clock Start/From: **7**
Clock To: **5**
1st Value:
2nd Value:
Value Percent:
Continuous Index: **S01**
Within 8" of Joint:
Remarks:

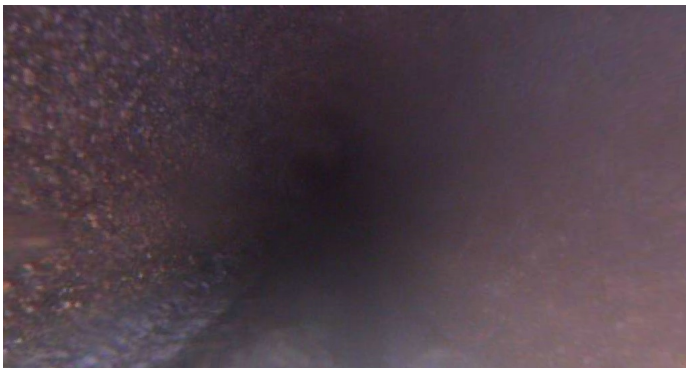
Code: **AMH**
Description: **Manhole**

Distance (ft): **.0**
Structural Grade: **0**
O&M Grade: **0**
Clock Start/From:
Clock To:
1st Value:
2nd Value:
Value Percent:
Continuous Index:
Within 8" of Joint: **NO**
Remarks: **M-504-125**

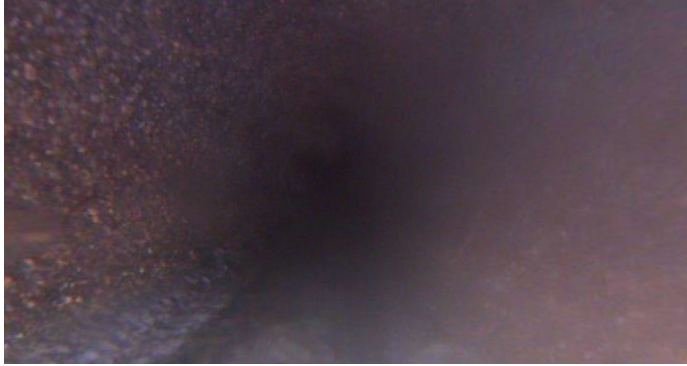
Code:	MWL
Description:	Water Level
Distance (ft):	.0
Structural Grade:	0
O&M Grade:	0
Clock Start/From:	
Clock To:	
1st Value:	
2nd Value:	
Value Percent:	10.000
Continuous Index:	
Within 8" of Joint:	NO
Remarks:

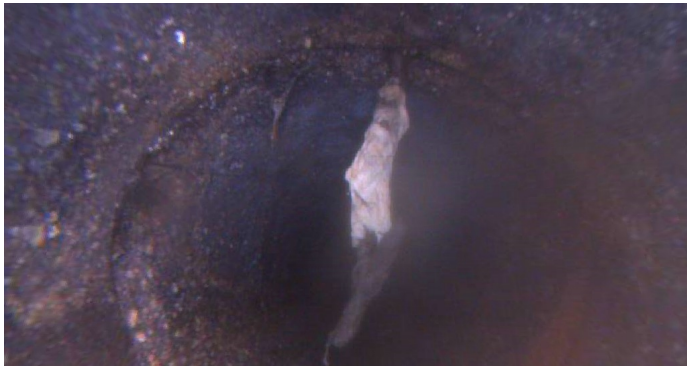
Code:	RMJ
Description:	Roots Medium Joint
Distance (ft):	18.7
Structural Grade:	0
O&M Grade:	3
Clock Start/From:	12
Clock To:	
1st Value:	
2nd Value:	
Value Percent:	5.000
Continuous Index:	
Within 8" of Joint:	YES
Remarks:

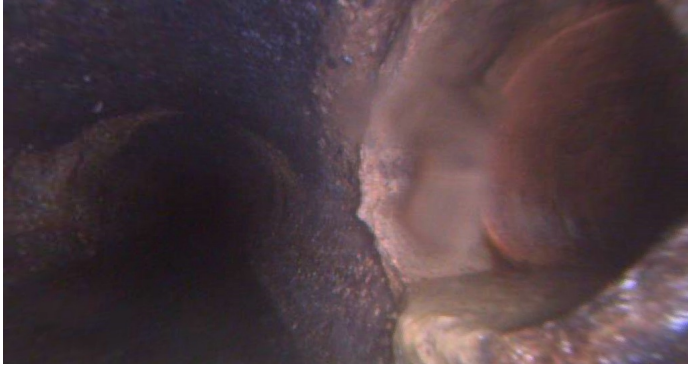
Code: **TBI**
Description: **Tap Break-in Intruding**

Distance (ft): **42.4**
Structural Grade: **0**
O&M Grade: **2**
Clock Start/From: **4**
Clock To:
1st Value: **4.000**
2nd Value: **1.000**
Value Percent:
Continuous Index:
Within 8" of Joint:
Remarks:

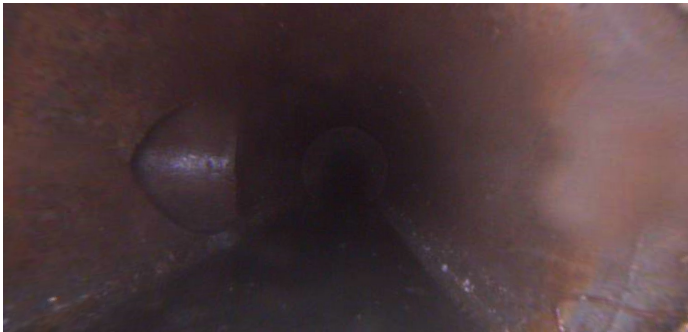
Code: **SAP**
Description: **Surface Aggregate Projecting**

Distance (ft): **65.8**
Structural Grade: **3**
O&M Grade: **0**
Clock Start/From: **7**
Clock To: **5**
1st Value:
2nd Value:
Value Percent:
Continuous Index: **F01**
Within 8" of Joint:
Remarks:

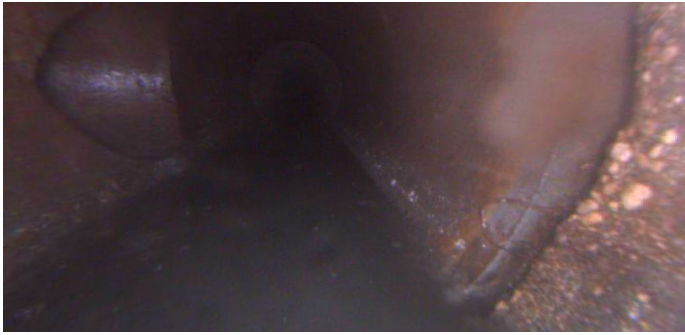
Code: **RFJ**
Description: **Roots Fine Joint**

Distance (ft): **65.8**
Structural Grade: **0**
O&M Grade: **1**
Clock Start/From: **3**
Clock To: **4**
1st Value:
2nd Value:
Value Percent:
Continuous Index:
Within 8" of Joint: **YES**
Remarks:

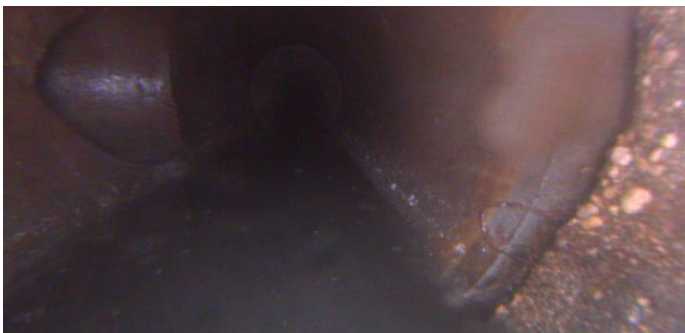
Code: **MMC**
Description: **Material Change**

Distance (ft): **65.8**
Structural Grade: **0**
O&M Grade: **0**
Clock Start/From:
Clock To:
1st Value:
2nd Value:
Value Percent:
Continuous Index:
Within 8" of Joint: **NO**
Remarks: **VCP**

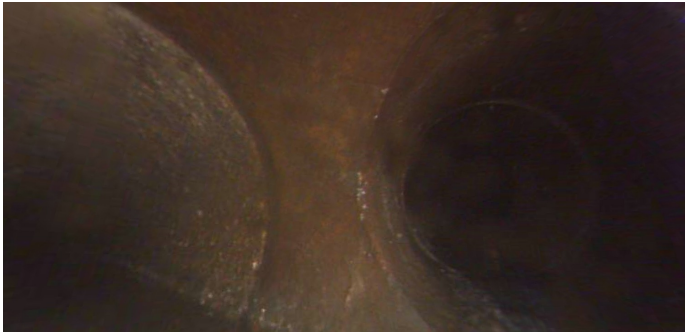
Code: **TFA**
Description: **Tap Factory Active**

Distance (ft): **67.1**
Structural Grade: **0**
O&M Grade: **0**
Clock Start/From: **9**
Clock To:
1st Value: **4.000**
2nd Value:
Value Percent:
Continuous Index:
Within 8" of Joint:
Remarks:

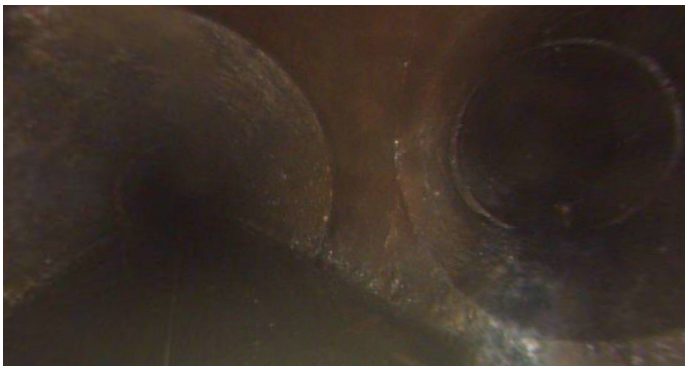
Code: **TF**
Description: **Tap Factory**

Distance (ft): **67.3**
Structural Grade: **0**
O&M Grade: **0**
Clock Start/From: **8**
Clock To:
1st Value: **4.000**
2nd Value:
Value Percent:
Continuous Index:
Within 8" of Joint:
Remarks: **Photo taken from rear camera.**

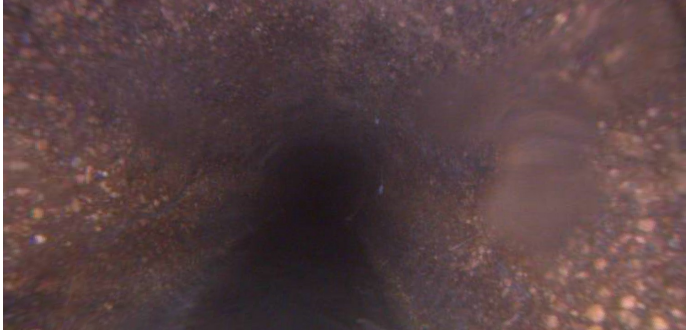
Code: **MMC**
Description: **Material Change**

Distance (ft): **68.9**
Structural Grade: **0**
O&M Grade: **0**
Clock Start/From:
Clock To:
1st Value:
2nd Value:
Value Percent:
Continuous Index:
Within 8" of Joint: **NO**
Remarks: **SAP**

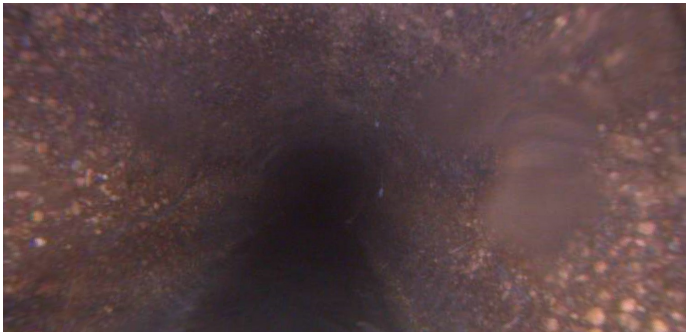
Code: **SAP**
Description: **Surface Aggregate Projecting**

Distance (ft): **68.9**
Structural Grade: **3**
O&M Grade: **0**
Clock Start/From: **7**
Clock To: **5**
1st Value:
2nd Value:
Value Percent:
Continuous Index: **S02**
Within 8" of Joint:
Remarks:

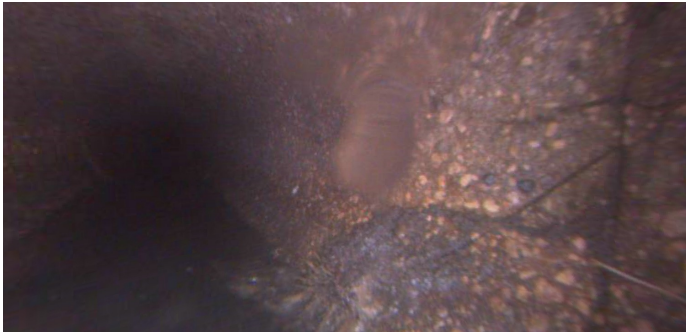
Code: **RFJ**
Description: **Roots Fine Joint**

Distance (ft): **75.3**
Structural Grade: **0**
O&M Grade: **1**
Clock Start/From: **3**
Clock To: **4**
1st Value:
2nd Value:
Value Percent:
Continuous Index:
Within 8" of Joint: **YES**
Remarks:

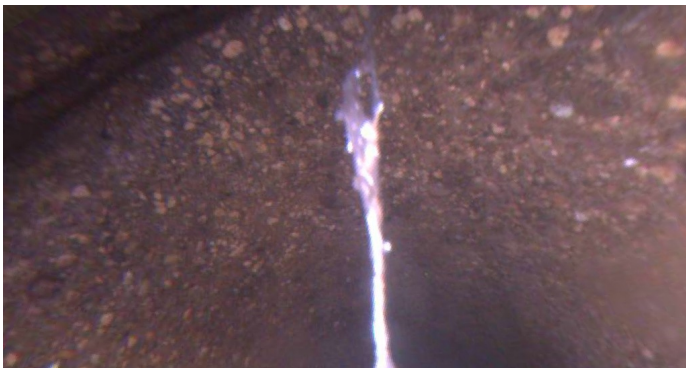
Code: **RFJ**
Description: **Roots Fine Joint**

Distance (ft): **84.6**
Structural Grade: **0**
O&M Grade: **1**
Clock Start/From: **1**
Clock To:
1st Value:
2nd Value:
Value Percent:
Continuous Index:
Within 8" of Joint: **YES**
Remarks:

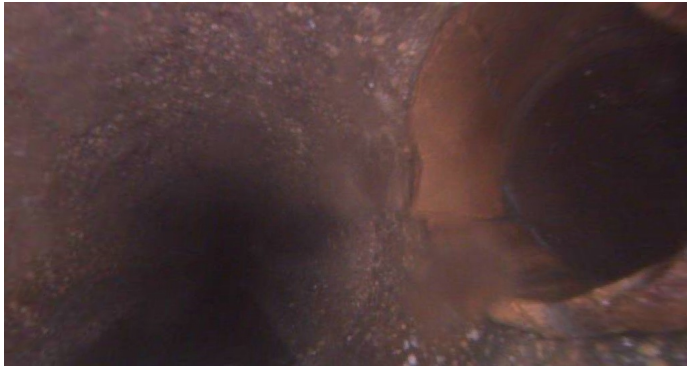
Code: **TBI**
Description: **Tap Break-in Intruding**

Distance (ft): **96.0**
Structural Grade: **0**
O&M Grade: **2**
Clock Start/From: **4**
Clock To:
1st Value: **4.000**
2nd Value: **1.000**
Value Percent:
Continuous Index:
Within 8" of Joint:
Remarks:

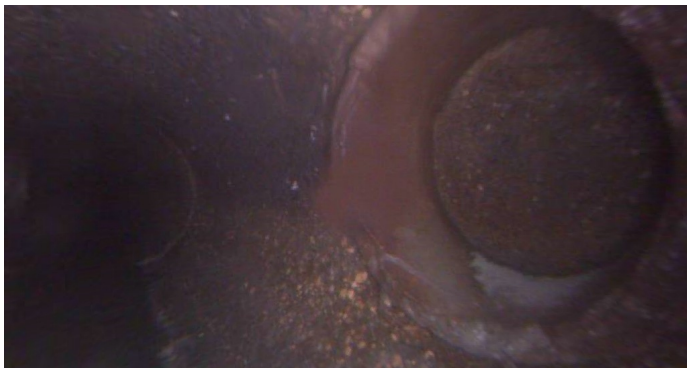
Code: **TBI**
Description: **Tap Break-in Intruding**

Distance (ft): **101.0**
Structural Grade: **0**
O&M Grade: **2**
Clock Start/From: **3**
Clock To:
1st Value: **4.000**
2nd Value: **1.000**
Value Percent:
Continuous Index:
Within 8" of Joint:
Remarks: **CAPPED**

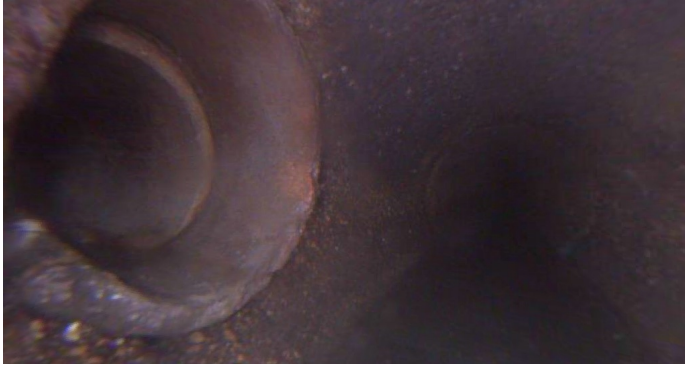
Code: **TBI**
Description: **Tap Break-in Intruding**

Distance (ft): **103.8**
Structural Grade: **0**
O&M Grade: **2**
Clock Start/From: **9**
Clock To:
1st Value: **4.000**
2nd Value: **1.000**
Value Percent:
Continuous Index:
Within 8" of Joint:
Remarks:

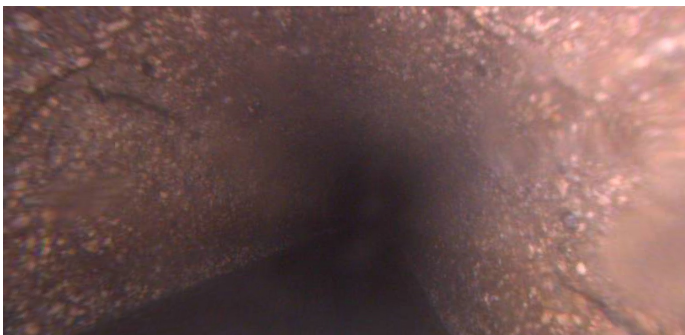
Code: **FM**
Description: **Fracture Multiple**

Distance (ft): **130.6**
Structural Grade: **4**
O&M Grade: **0**
Clock Start/From: **10**
Clock To: **4**
1st Value:
2nd Value:
Value Percent:
Continuous Index:
Within 8" of Joint: **YES**
Remarks:

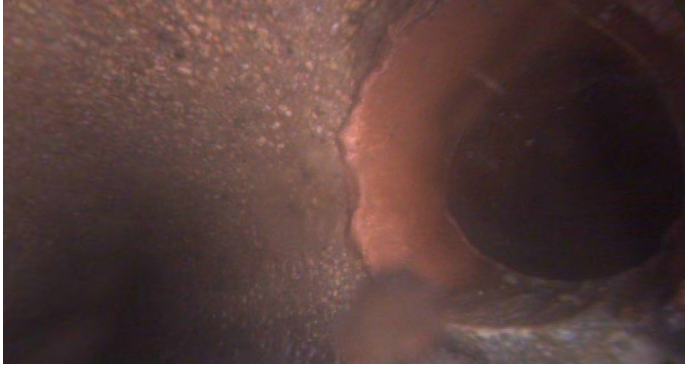
Code: **TBI**
Description: **Tap Break-in Intruding**

Distance (ft): **141.1**
Structural Grade: **0**
O&M Grade: **2**
Clock Start/From: **3**
Clock To:
1st Value: **4.000**
2nd Value: **1.000**
Value Percent:
Continuous Index:
Within 8" of Joint:
Remarks:

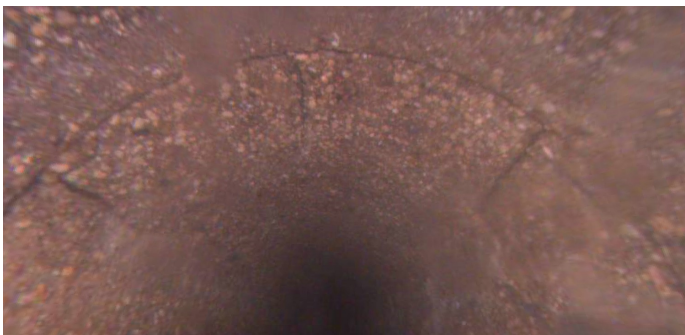
Code: **FM**
Description: **Fracture Multiple**

Distance (ft): **143.1**
Structural Grade: **4**
O&M Grade: **0**
Clock Start/From: **10**
Clock To: **2**
1st Value:
2nd Value:
Value Percent:
Continuous Index:
Within 8" of Joint: **YES**
Remarks:

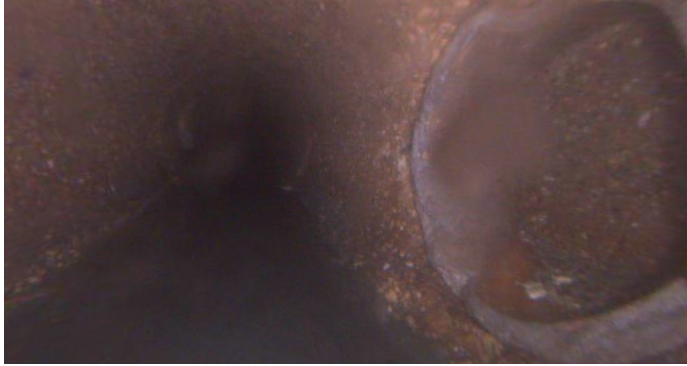
Code: **TBI**
Description: **Tap Break-in Intruding**

Distance (ft): **150.3**
Structural Grade: **0**
O&M Grade: **2**
Clock Start/From: **3**
Clock To:
1st Value: **4.000**
2nd Value: **1.000**
Value Percent:
Continuous Index:
Within 8" of Joint:
Remarks: **CAPPED**

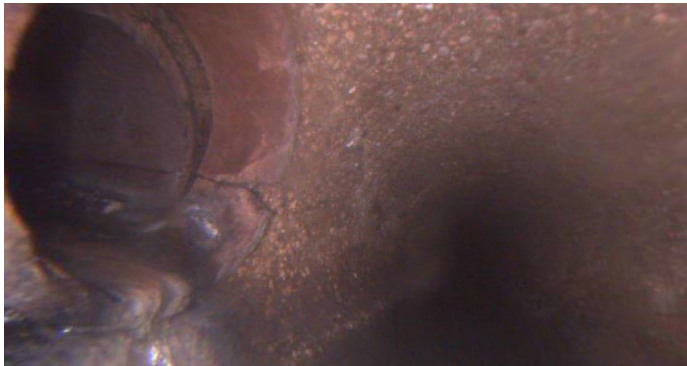
Code: **TBI**
Description: **Tap Break-in Intruding**

Distance (ft): **153.5**
Structural Grade: **0**
O&M Grade: **2**
Clock Start/From: **9**
Clock To:
1st Value: **4.000**
2nd Value: **1.000**
Value Percent:
Continuous Index:
Within 8" of Joint:
Remarks:

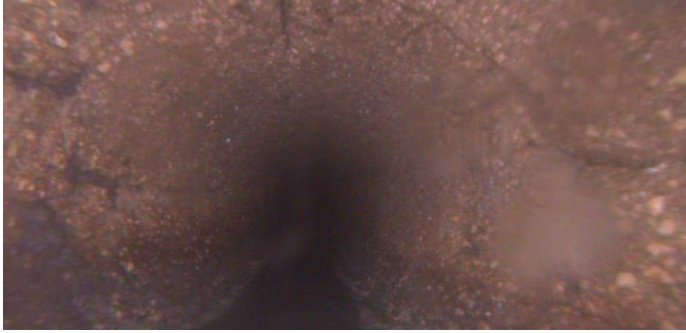
Code: **FM**
Description: **Fracture Multiple**

Distance (ft): **155.2**
Structural Grade: **4**
O&M Grade: **0**
Clock Start/From: **8**
Clock To: **4**
1st Value:
2nd Value:
Value Percent:
Continuous Index: **S03**
Within 8" of Joint: **YES**
Remarks:

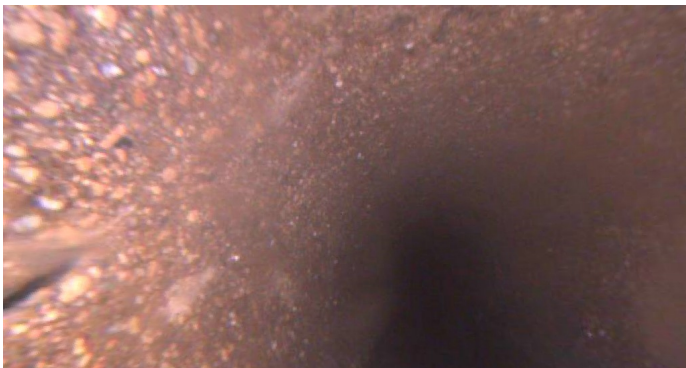
Code: **CS**
Description: **Crack Spiral**

Distance (ft): **168.1**
Structural Grade: **2**
O&M Grade: **0**
Clock Start/From: **8**
Clock To: **9**
1st Value:
2nd Value:
Value Percent:
Continuous Index:
Within 8" of Joint: **YES**
Remarks:

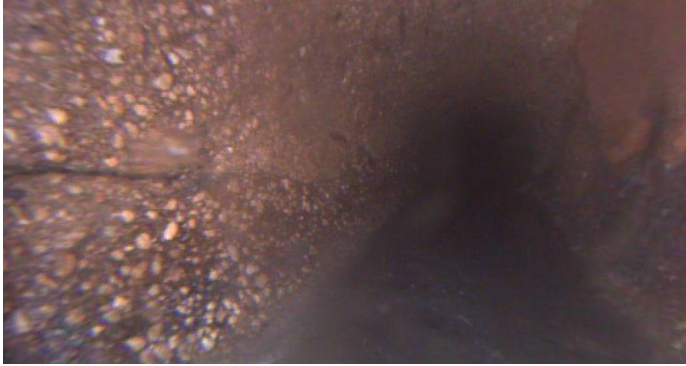
Code: **CL**
Description: **Crack Longitudinal**

Distance (ft): **189.5**
Structural Grade: **2**
O&M Grade: **0**
Clock Start/From: **8**
Clock To:
1st Value:
2nd Value:
Value Percent:
Continuous Index:
Within 8" of Joint: **YES**
Remarks:

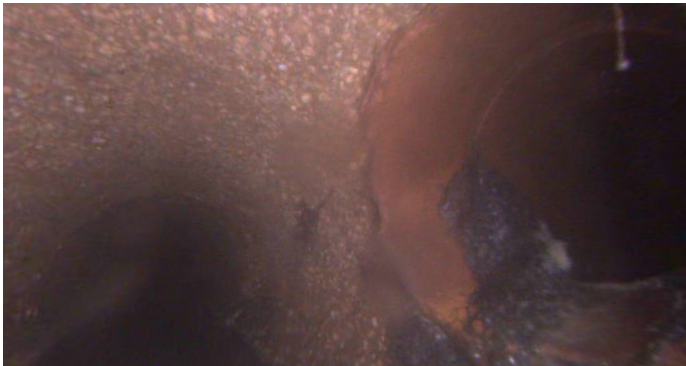
Code: **TBI**
Description: **Tap Break-in Intruding**

Distance (ft): **190.5**
Structural Grade: **0**
O&M Grade: **2**
Clock Start/From: **3**
Clock To:
1st Value: **4.000**
2nd Value: **1.000**
Value Percent:
Continuous Index:
Within 8" of Joint:
Remarks:

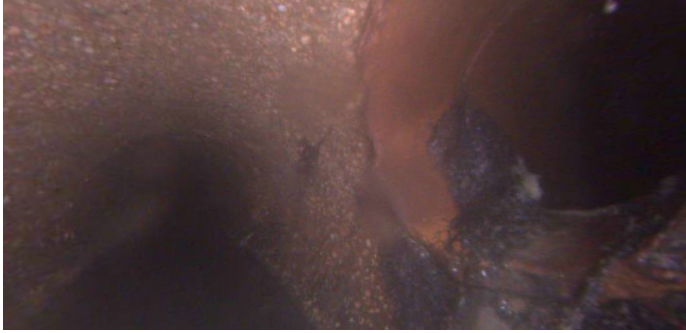
Code: **RFC**
Description: **Roots Fine Connection**

Distance (ft): **190.5**
Structural Grade: **0**
O&M Grade: **1**
Clock Start/From: **3**
Clock To:
1st Value:
2nd Value:
Value Percent:
Continuous Index:
Within 8" of Joint: **NO**
Remarks:

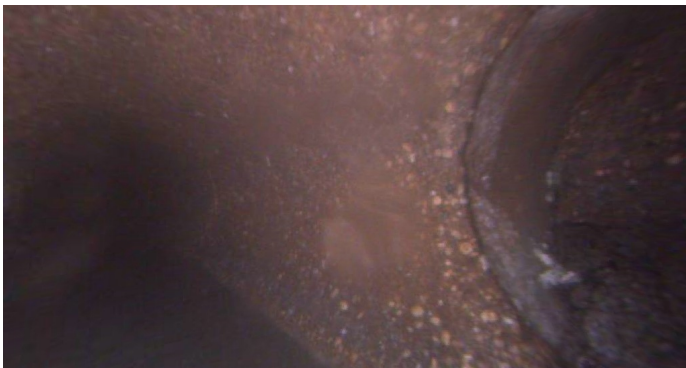
Code: **TBC**
Description: **Tap Break-in Capped**

Distance (ft): **196.8**
Structural Grade: **0**
O&M Grade: **2**
Clock Start/From: **4**
Clock To:
1st Value: **4.000**
2nd Value:
Value Percent:
Continuous Index:
Within 8" of Joint:
Remarks:

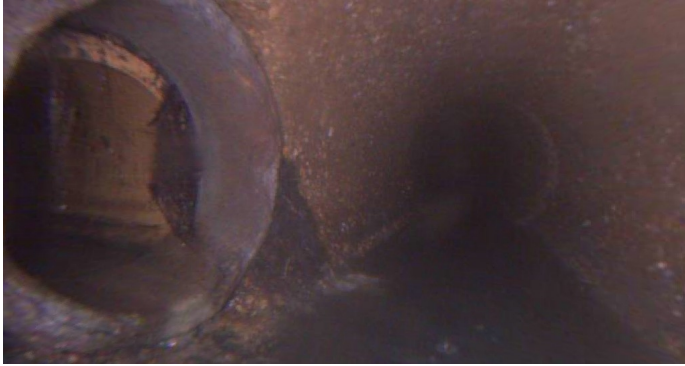
Code: **TBI**
Description: **Tap Break-in Intruding**

Distance (ft): **199.5**
Structural Grade: **0**
O&M Grade: **2**
Clock Start/From: **9**
Clock To:
1st Value: **4.000**
2nd Value: **1.000**
Value Percent:
Continuous Index:
Within 8" of Joint:
Remarks:

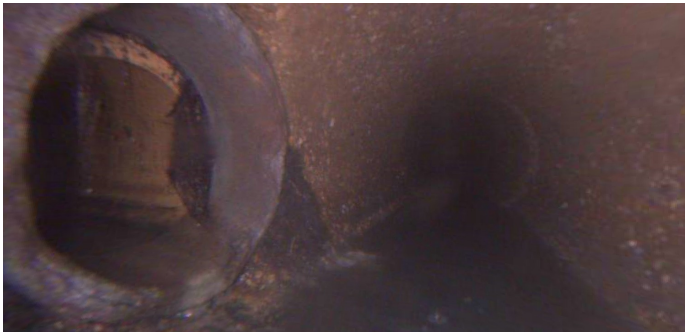
Code: **RFC**
Description: **Roots Fine Connection**

Distance (ft): **199.5**
Structural Grade: **0**
O&M Grade: **1**
Clock Start/From: **8**
Clock To: **9**
1st Value:
2nd Value:
Value Percent:
Continuous Index:
Within 8" of Joint: **NO**
Remarks:

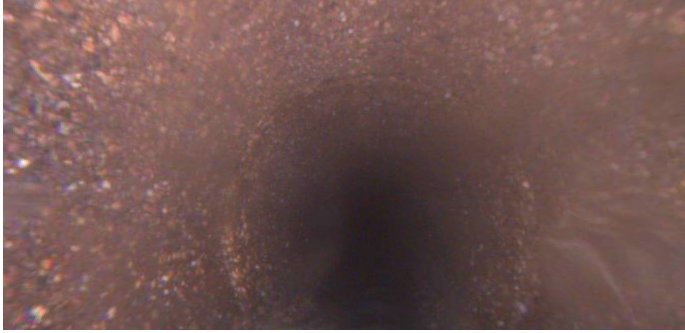
Code: **FM**
Description: **Fracture Multiple**

Distance (ft): **213.4**
Structural Grade: **4**
O&M Grade: **0**
Clock Start/From: **8**
Clock To: **4**
1st Value:
2nd Value:
Value Percent:
Continuous Index: **F03**
Within 8" of Joint: **YES**
Remarks:

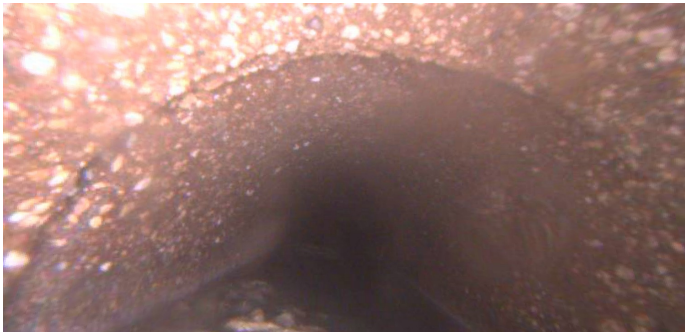
Code: **SAP**
Description: **Surface Aggregate Projecting**

Distance (ft): **241.9**
Structural Grade: **3**
O&M Grade: **0**
Clock Start/From: **7**
Clock To: **5**
1st Value:
2nd Value:
Value Percent:
Continuous Index: **F02**
Within 8" of Joint:
Remarks:

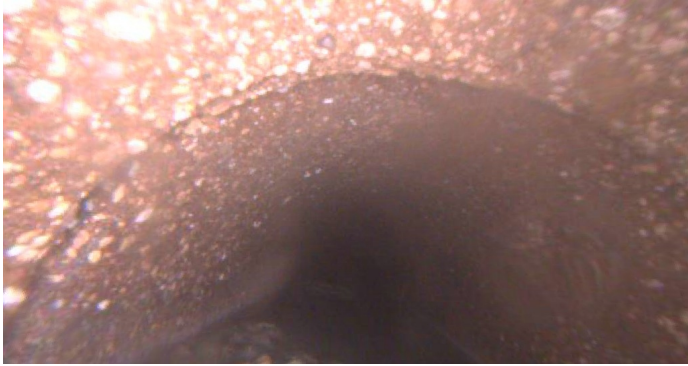
Code:	MSA
Description:	Abandoned Survey
Distance (ft):	241.9
Structural Grade:	0
O&M Grade:	0
Clock Start/From:	
Clock To:	
1st Value:	
2nd Value:	
Value Percent:	
Continuous Index:	
Within 8" of Joint:	NO
Remarks:	Debris
