Profile/Photo Observation Report

Date:	04/09/2018	Weather:		Coding:	PACP 6.0
Pipe Length (ft):	238.5	Owner:	NA	Pre Clean:	Not Known
P.O.#:		Surveyor:	Mark Ruby	PSR:	P-504-125-124
Customer:		Clean Date:	01/01/1900	Shape:	C

Street:	W 40th ave	Flow Control:	Not Controlled
City:	Hobart, IN	Year Renewed:	
Location:	Other	Tape/Media #:	
Purpose:	Not Known	Dia/Height:	10"
Use:	Sanitary	Material:	CP
Drain Area:	NA	Lining:	
Category:	NA		
Comment:

Location Details:		Direction of Survey:	Upstream
US MH:	M-504-124	DS MH:	M-504-125
		Total Length Surveyed (ft):	241.9

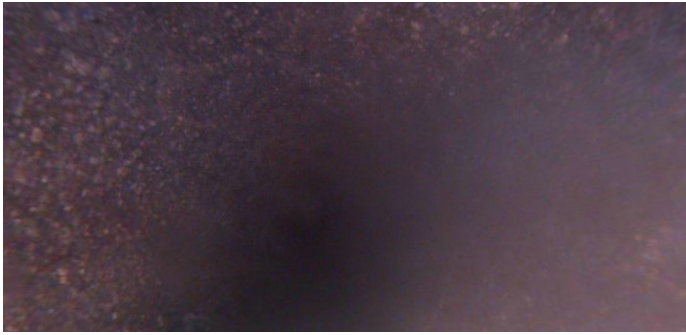
Code: **SAP**
Description: **Surface Aggregate Projecting**

Distance (ft): **.0**
Structural Grade: **3**
O&M Grade: **0**
Clock Start/From: **7**
Clock To: **5**
1st Value:
2nd Value:
Value Percent:
Continuous Index: **S01**
Within 8" of Joint:
Remarks:

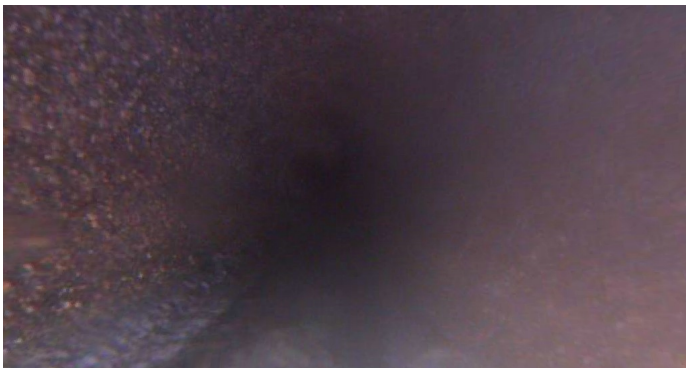
Code: **AMH**
Description: **Manhole**

Distance (ft): **.0**
Structural Grade: **0**
O&M Grade: **0**
Clock Start/From:
Clock To:
1st Value:
2nd Value:
Value Percent:
Continuous Index:
Within 8" of Joint: **NO**
Remarks: **M-504-125**

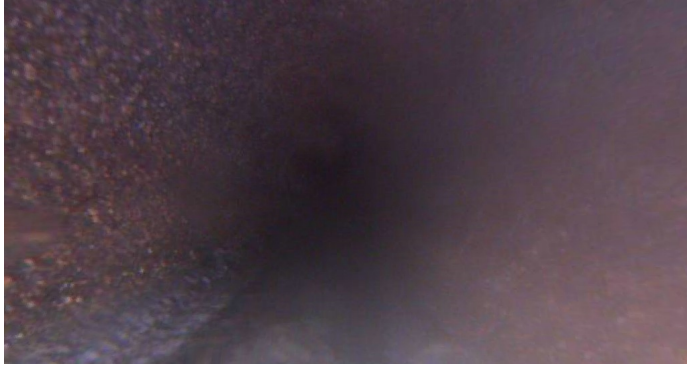
Code: **MWL**
Description: **Water Level**

Distance (ft): **.0**
Structural Grade: **0**
O&M Grade: **0**
Clock Start/From:
Clock To:
1st Value:
2nd Value:
Value Percent: **10.000**
Continuous Index:
Within 8" of Joint: **NO**
Remarks:

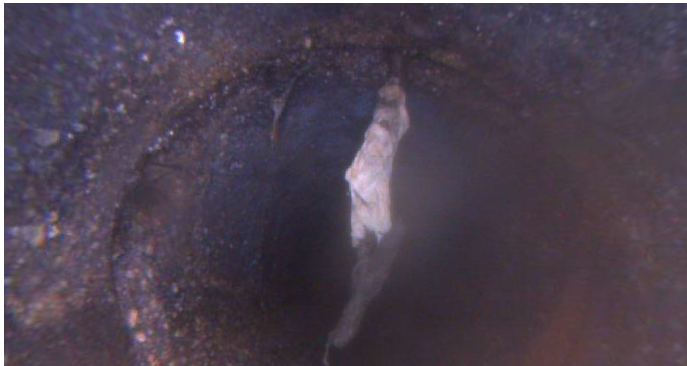
Code: **RMJ**
Description: **Roots Medium Joint**

Distance (ft): **18.7**
Structural Grade: **0**
O&M Grade: **3**
Clock Start/From: **12**
Clock To:
1st Value:
2nd Value:
Value Percent: **5.000**
Continuous Index:
Within 8" of Joint: **YES**
Remarks:

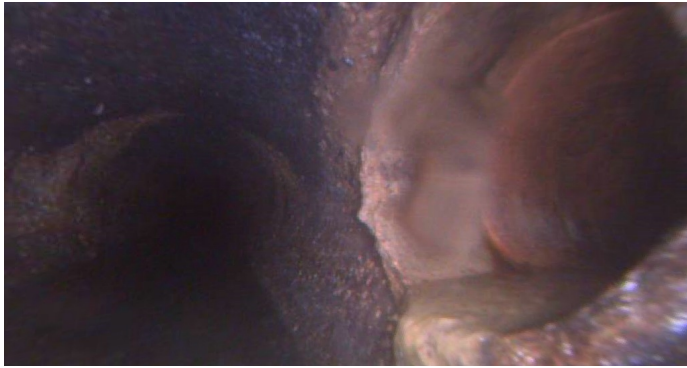
Code: **TBI**
Description: **Tap Break-in Intruding**

Distance (ft): **42.4**
Structural Grade: **0**
O&M Grade: **2**
Clock Start/From: **4**
Clock To:
1st Value: **4.000**
2nd Value: **1.000**
Value Percent:
Continuous Index:
Within 8" of Joint:
Remarks:

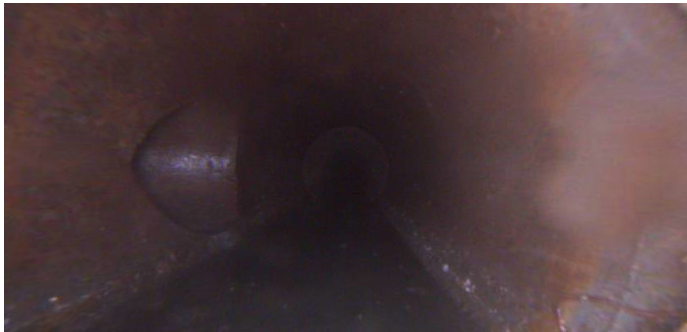
Code: **SAP**
Description: **Surface Aggregate Projecting**

Distance (ft): **65.8**
Structural Grade: **3**
O&M Grade: **0**
Clock Start/From: **7**
Clock To: **5**
1st Value:
2nd Value:
Value Percent:
Continuous Index: **F01**
Within 8" of Joint:
Remarks:

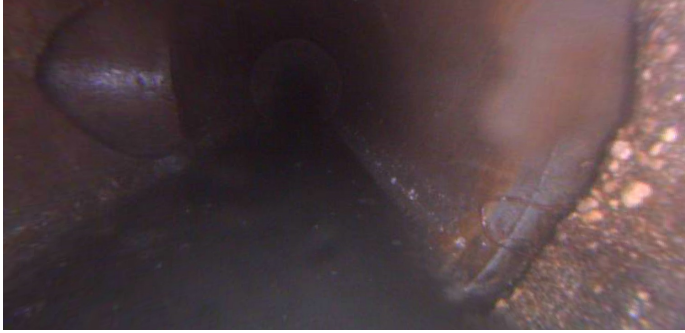
Code: **RFJ**
Description: **Roots Fine Joint**

Distance (ft): **65.8**
Structural Grade: **0**
O&M Grade: **1**
Clock Start/From: **3**
Clock To: **4**
1st Value:
2nd Value:
Value Percent:
Continuous Index:
Within 8" of Joint: **YES**
Remarks:

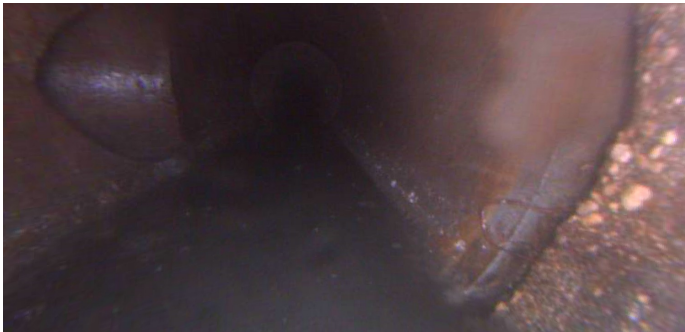
Code: **MMC**
Description: **Material Change**

Distance (ft): **65.8**
Structural Grade: **0**
O&M Grade: **0**
Clock Start/From:
Clock To:
1st Value:
2nd Value:
Value Percent:
Continuous Index:
Within 8" of Joint: **NO**
Remarks: **VCP**

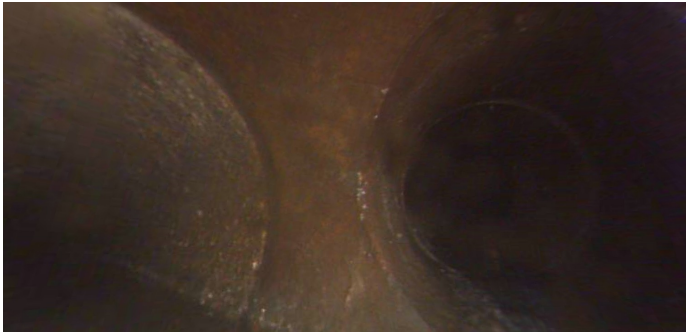
Code: **TFA**
Description: **Tap Factory Active**

Distance (ft): **67.1**
Structural Grade: **0**
O&M Grade: **0**
Clock Start/From: **9**
Clock To:
1st Value: **4.000**
2nd Value:
Value Percent:
Continuous Index:
Within 8" of Joint:
Remarks:

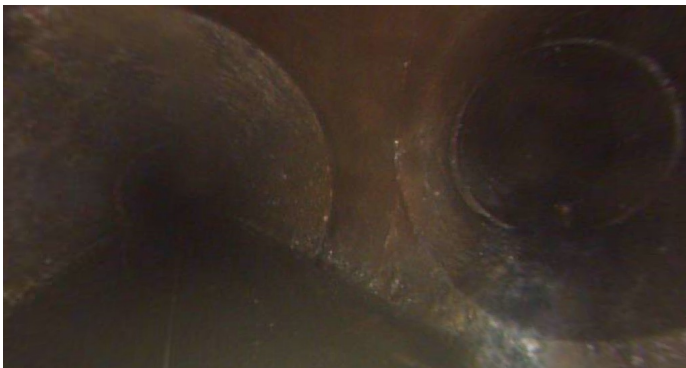
Code: **TF**
Description: **Tap Factory**

Distance (ft): **67.3**
Structural Grade: **0**
O&M Grade: **0**
Clock Start/From: **8**
Clock To:
1st Value: **4.000**
2nd Value:
Value Percent:
Continuous Index:
Within 8" of Joint:
Remarks: **Photo taken from rear camera.**

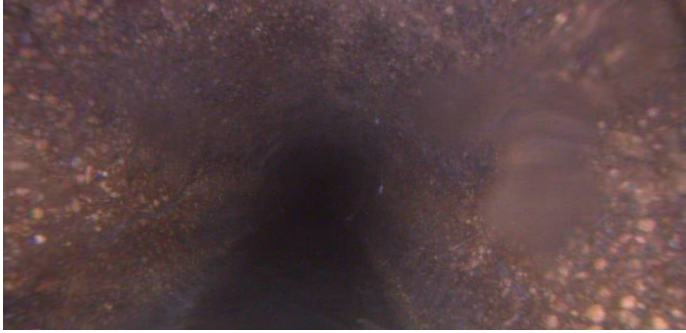
Code: **MMC**
Description: **Material Change**

Distance (ft): **68.9**
Structural Grade: **0**
O&M Grade: **0**
Clock Start/From:
Clock To:
1st Value:
2nd Value:
Value Percent:
Continuous Index:
Within 8" of Joint: **NO**
Remarks: **SAP**

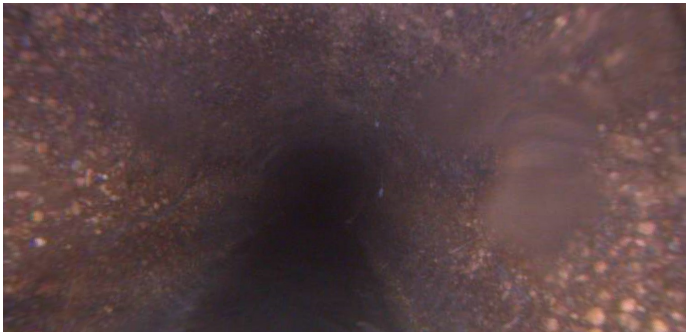
Code: **SAP**
Description: **Surface Aggregate Projecting**

Distance (ft): **68.9**
Structural Grade: **3**
O&M Grade: **0**
Clock Start/From: **7**
Clock To: **5**
1st Value:
2nd Value:
Value Percent:
Continuous Index: **S02**
Within 8" of Joint:
Remarks:

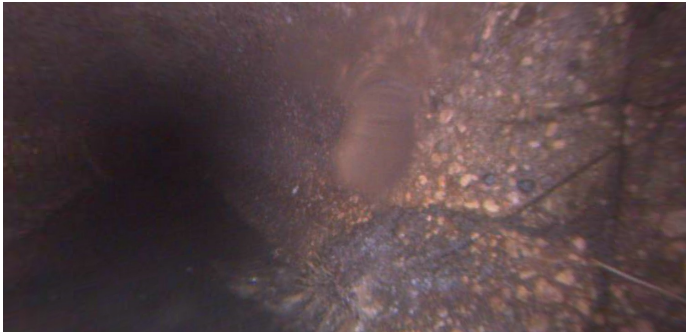
Code: **RFJ**
Description: **Roots Fine Joint**

Distance (ft): **75.3**
Structural Grade: **0**
O&M Grade: **1**
Clock Start/From: **3**
Clock To: **4**
1st Value:
2nd Value:
Value Percent:
Continuous Index:
Within 8" of Joint: **YES**
Remarks:

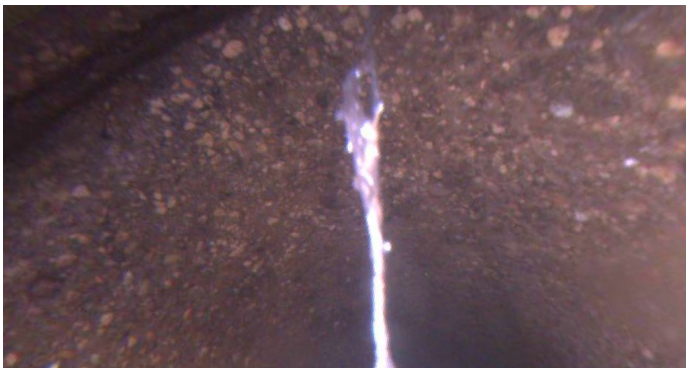
Code: **RFJ**
Description: **Roots Fine Joint**

Distance (ft): **84.6**
Structural Grade: **0**
O&M Grade: **1**
Clock Start/From: **1**
Clock To:
1st Value:
2nd Value:
Value Percent:
Continuous Index:
Within 8" of Joint: **YES**
Remarks:

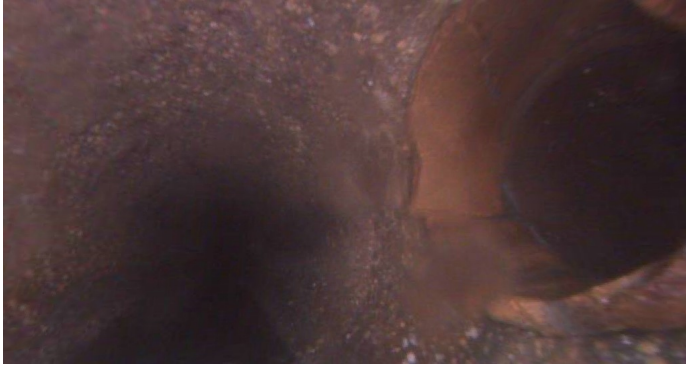
Code: **TBI**
Description: **Tap Break-in Intruding**

Distance (ft): **96.0**
Structural Grade: **0**
O&M Grade: **2**
Clock Start/From: **4**
Clock To:
1st Value: **4.000**
2nd Value: **1.000**
Value Percent:
Continuous Index:
Within 8" of Joint:
Remarks:

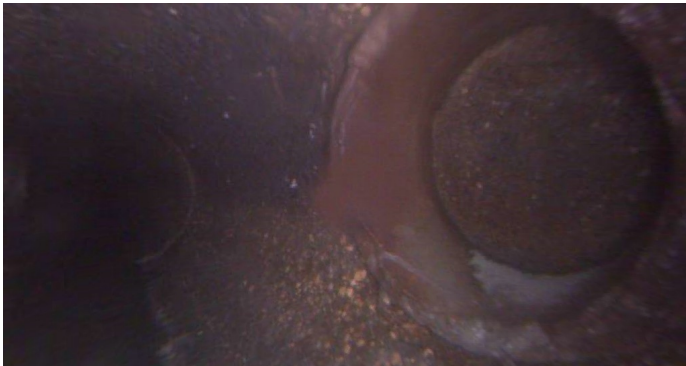
Code: **TBI**
Description: **Tap Break-in Intruding**

Distance (ft): **101.0**
Structural Grade: **0**
O&M Grade: **2**
Clock Start/From: **3**
Clock To:
1st Value: **4.000**
2nd Value: **1.000**
Value Percent:
Continuous Index:
Within 8" of Joint:
Remarks: **CAPPED**

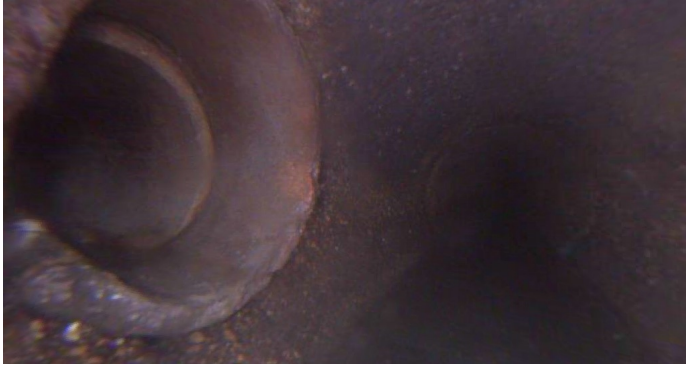
Code: **TBI**
Description: **Tap Break-in Intruding**

Distance (ft): **103.8**
Structural Grade: **0**
O&M Grade: **2**
Clock Start/From: **9**
Clock To:
1st Value: **4.000**
2nd Value: **1.000**
Value Percent:
Continuous Index:
Within 8" of Joint:
Remarks:

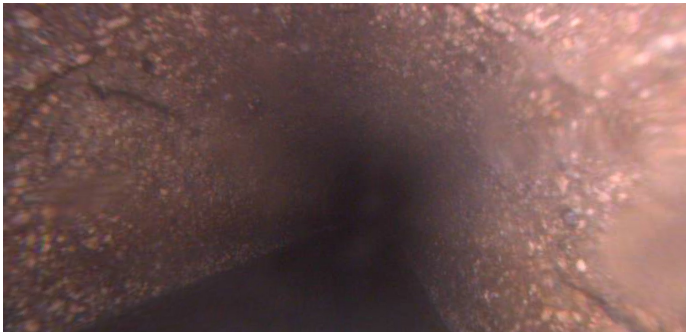
Code: **FM**
Description: **Fracture Multiple**

Distance (ft): **130.6**
Structural Grade: **4**
O&M Grade: **0**
Clock Start/From: **10**
Clock To: **4**
1st Value:
2nd Value:
Value Percent:
Continuous Index:
Within 8" of Joint: **YES**
Remarks:

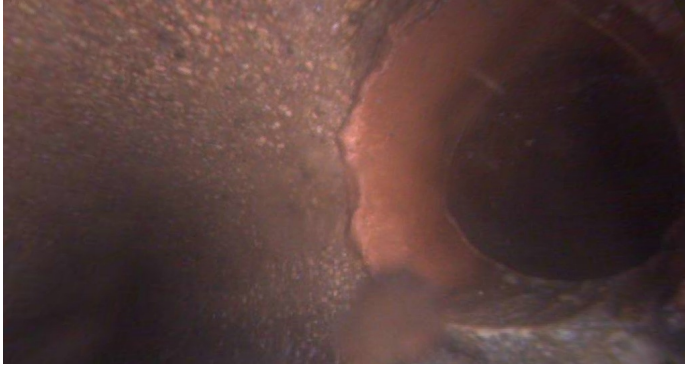
Code: **TBI**
Description: **Tap Break-in Intruding**

Distance (ft): **141.1**
Structural Grade: **0**
O&M Grade: **2**
Clock Start/From: **3**
Clock To:
1st Value: **4.000**
2nd Value: **1.000**
Value Percent:
Continuous Index:
Within 8" of Joint:
Remarks:

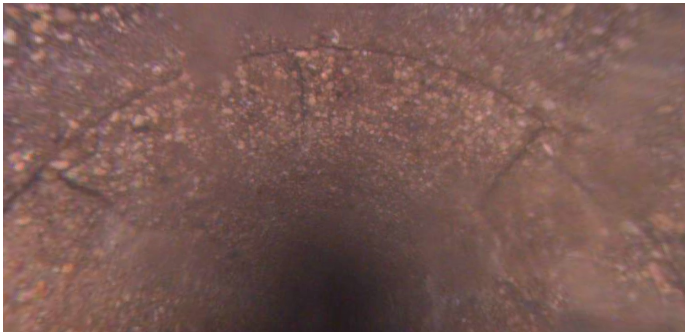
Code: **FM**
Description: **Fracture Multiple**

Distance (ft): **143.1**
Structural Grade: **4**
O&M Grade: **0**
Clock Start/From: **10**
Clock To: **2**
1st Value:
2nd Value:
Value Percent:
Continuous Index:
Within 8" of Joint: **YES**
Remarks:

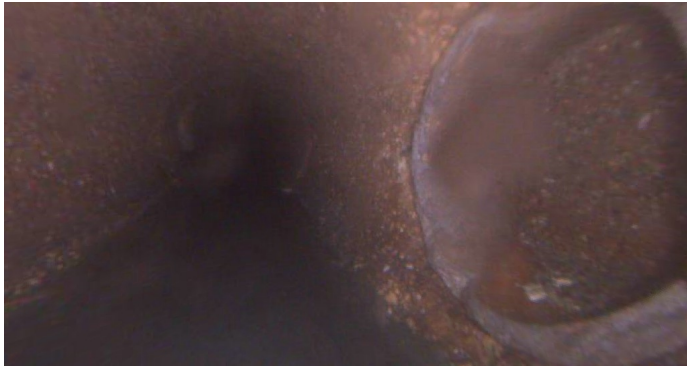
Code: **TBI**
Description: **Tap Break-in Intruding**

Distance (ft): **150.3**
Structural Grade: **0**
O&M Grade: **2**
Clock Start/From: **3**
Clock To:
1st Value: **4.000**
2nd Value: **1.000**
Value Percent:
Continuous Index:
Within 8" of Joint:
Remarks: **CAPPED**

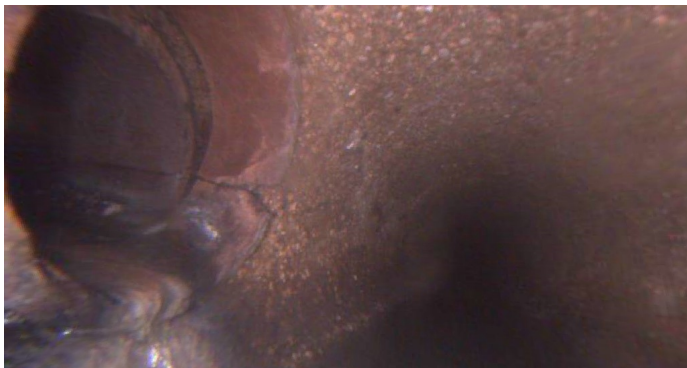
Code: **TBI**
Description: **Tap Break-in Intruding**

Distance (ft): **153.5**
Structural Grade: **0**
O&M Grade: **2**
Clock Start/From: **9**
Clock To:
1st Value: **4.000**
2nd Value: **1.000**
Value Percent:
Continuous Index:
Within 8" of Joint:
Remarks:

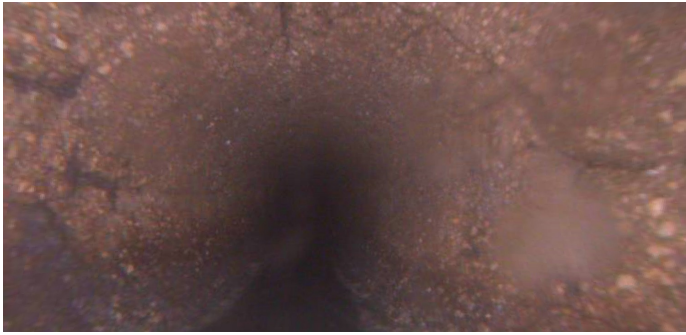
Code: **FM**
Description: **Fracture Multiple**

Distance (ft): **155.2**
Structural Grade: **4**
O&M Grade: **0**
Clock Start/From: **8**
Clock To: **4**
1st Value:
2nd Value:
Value Percent:
Continuous Index: **S03**
Within 8" of Joint: **YES**
Remarks:

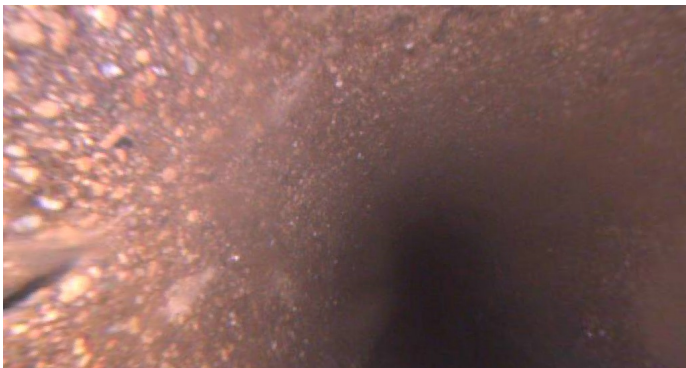
Code: **CS**
Description: **Crack Spiral**

Distance (ft): **168.1**
Structural Grade: **2**
O&M Grade: **0**
Clock Start/From: **8**
Clock To: **9**
1st Value:
2nd Value:
Value Percent:
Continuous Index:
Within 8" of Joint: **YES**
Remarks:

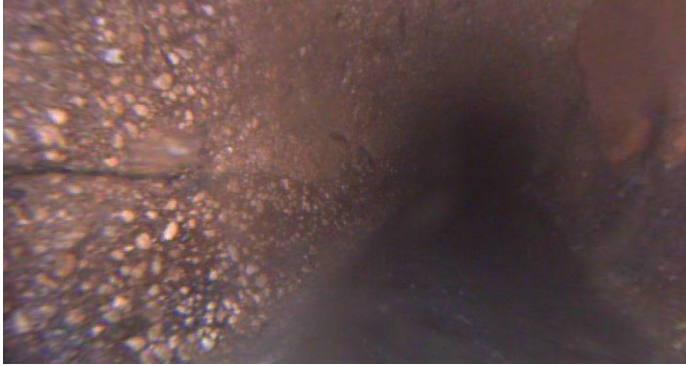
Code: **CL**
Description: **Crack Longitudinal**

Distance (ft): **189.5**
Structural Grade: **2**
O&M Grade: **0**
Clock Start/From: **8**
Clock To:
1st Value:
2nd Value:
Value Percent:
Continuous Index:
Within 8" of Joint: **YES**
Remarks:

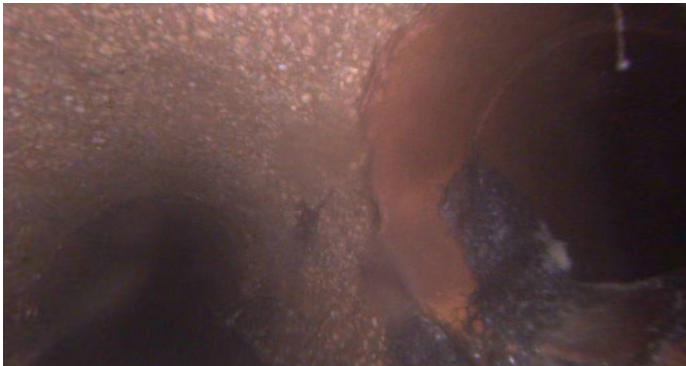
Code: **TBI**
Description: **Tap Break-in Intruding**

Distance (ft): **190.5**
Structural Grade: **0**
O&M Grade: **2**
Clock Start/From: **3**
Clock To:
1st Value: **4.000**
2nd Value: **1.000**
Value Percent:
Continuous Index:
Within 8" of Joint:
Remarks:

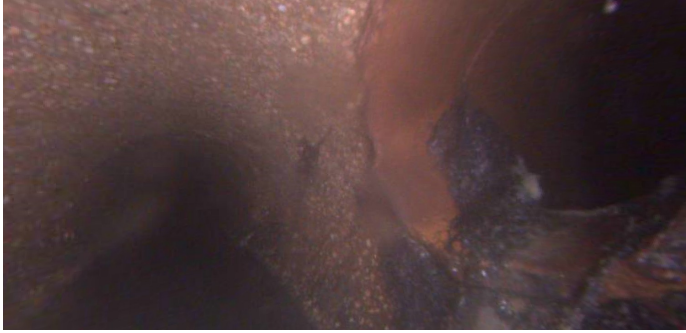
Code: **RFC**
Description: **Roots Fine Connection**

Distance (ft): **190.5**
Structural Grade: **0**
O&M Grade: **1**
Clock Start/From: **3**
Clock To:
1st Value:
2nd Value:
Value Percent:
Continuous Index:
Within 8" of Joint: **NO**
Remarks:

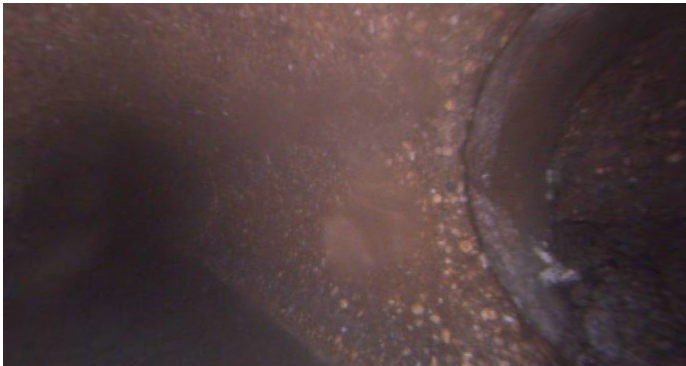
Code: **TBC**
Description: **Tap Break-in Capped**

Distance (ft): **196.8**
Structural Grade: **0**
O&M Grade: **2**
Clock Start/From: **4**
Clock To:
1st Value: **4.000**
2nd Value:
Value Percent:
Continuous Index:
Within 8" of Joint:
Remarks:

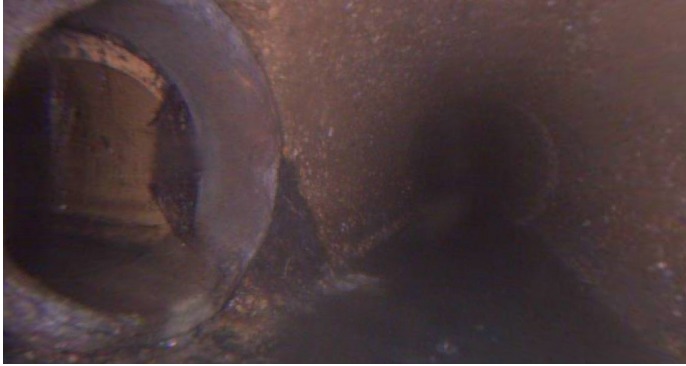
Code: **TBI**
Description: **Tap Break-in Intruding**

Distance (ft): **199.5**
Structural Grade: **0**
O&M Grade: **2**
Clock Start/From: **9**
Clock To:
1st Value: **4.000**
2nd Value: **1.000**
Value Percent:
Continuous Index:
Within 8" of Joint:
Remarks:

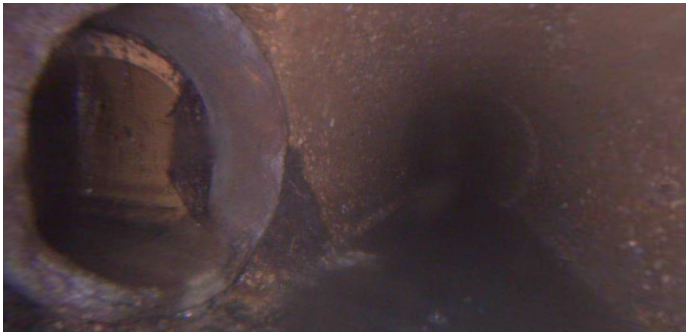
Code: **RFC**
Description: **Roots Fine Connection**

Distance (ft): **199.5**
Structural Grade: **0**
O&M Grade: **1**
Clock Start/From: **8**
Clock To: **9**
1st Value:
2nd Value:
Value Percent:
Continuous Index:
Within 8" of Joint: **NO**
Remarks:

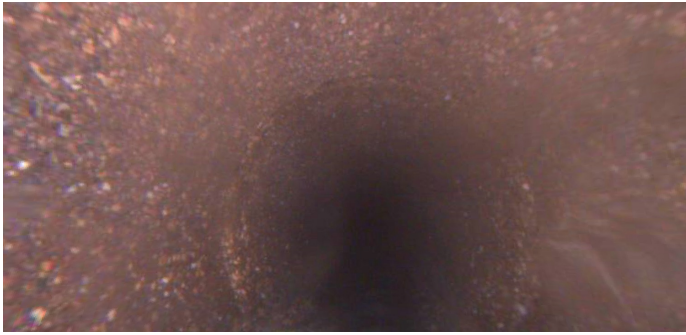
Code: **FM**
Description: **Fracture Multiple**

Distance (ft): **213.4**
Structural Grade: **4**
O&M Grade: **0**
Clock Start/From: **8**
Clock To: **4**
1st Value:
2nd Value:
Value Percent:
Continuous Index: **F03**
Within 8" of Joint: **YES**
Remarks:

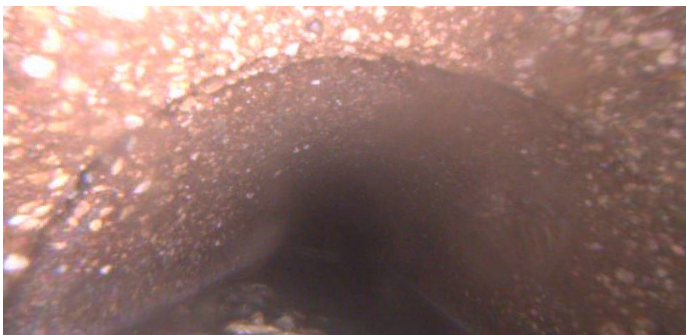
Code: **SAP**
Description: **Surface Aggregate Projecting**

Distance (ft): **241.9**
Structural Grade: **3**
O&M Grade: **0**
Clock Start/From: **7**
Clock To: **5**
1st Value:
2nd Value:
Value Percent:
Continuous Index: **F02**
Within 8" of Joint:
Remarks:

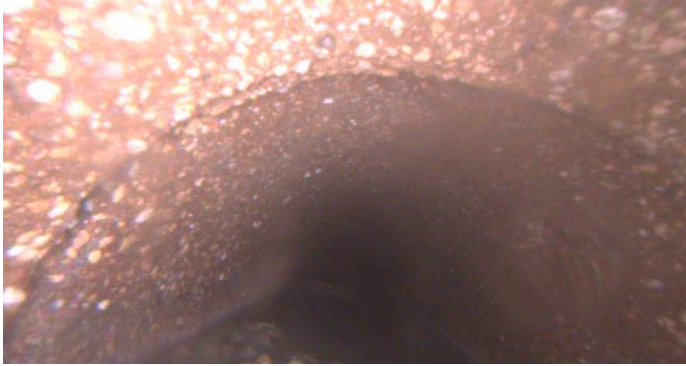
Code:	MSA
Description:	Abandoned Survey
Distance (ft):	241.9
Structural Grade:	0
O&M Grade:	0
Clock Start/From:	
Clock To:	
1st Value:	
2nd Value:	
Value Percent:	
Continuous Index:	
Within 8" of Joint:	NO
Remarks:	Debris
